# Near miss at Helpston manually controlled barrier level crossing, 21 October 2025

At 08:16 on Tuesday 21 October 2025, a near miss occurred at Helpston manually controlled barrier (MCB) level crossing, situated near Peterborough.

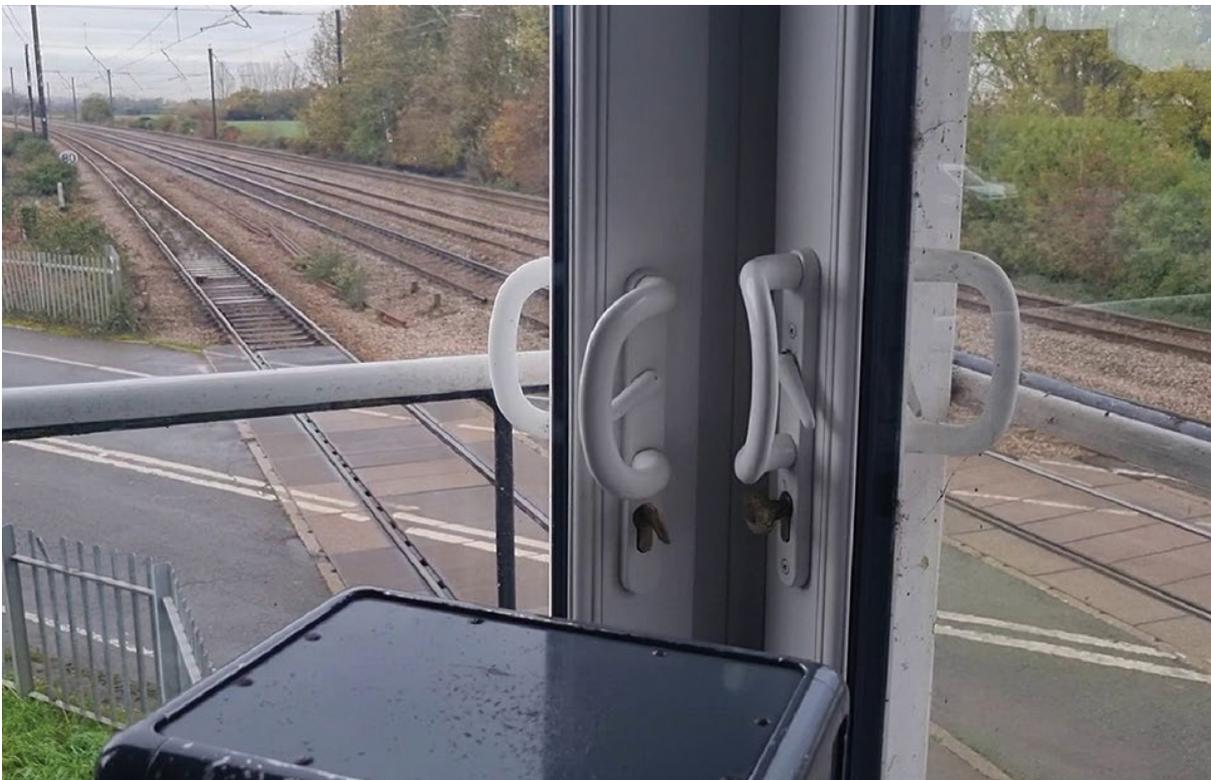
**View of the East Coast Main Line from Helpston signal box. The top of the crossing control box is visible at the bottom centre left of the picture. The Stamford lines are out of sight to the left.**
