Abbreviated Vibration Monitoring Report

Monitoring Period: 02 February 2026 to 01 March 2026

Project: Grenfell Tower

Document Ref: EEMC-VMR-201/106 – Grenfell Tower Rev 00

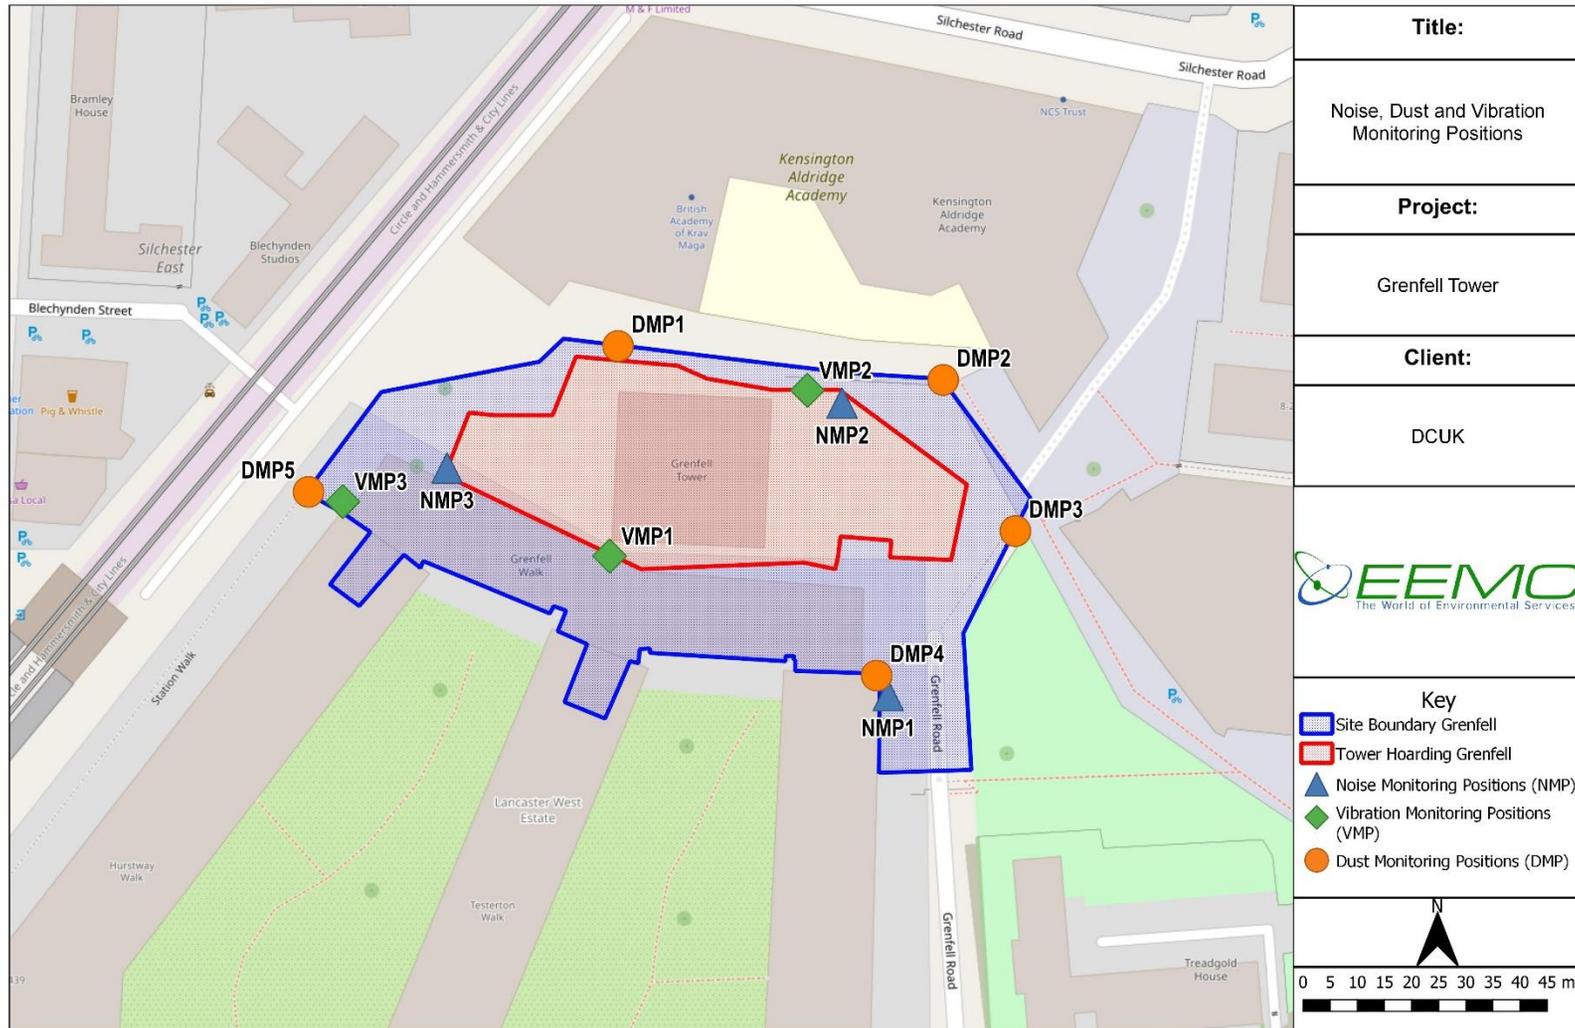
Image 2 – VMP1 Monitoring Location

ID Reference	Location
VMP1	Opposite Southeast corner of tower between two (2) concrete blocks
VMP2	Base of North hoarding co located with NMP2
VMP3	Mobile unit- Located base of NW hoarding with DMP5 and NMP3

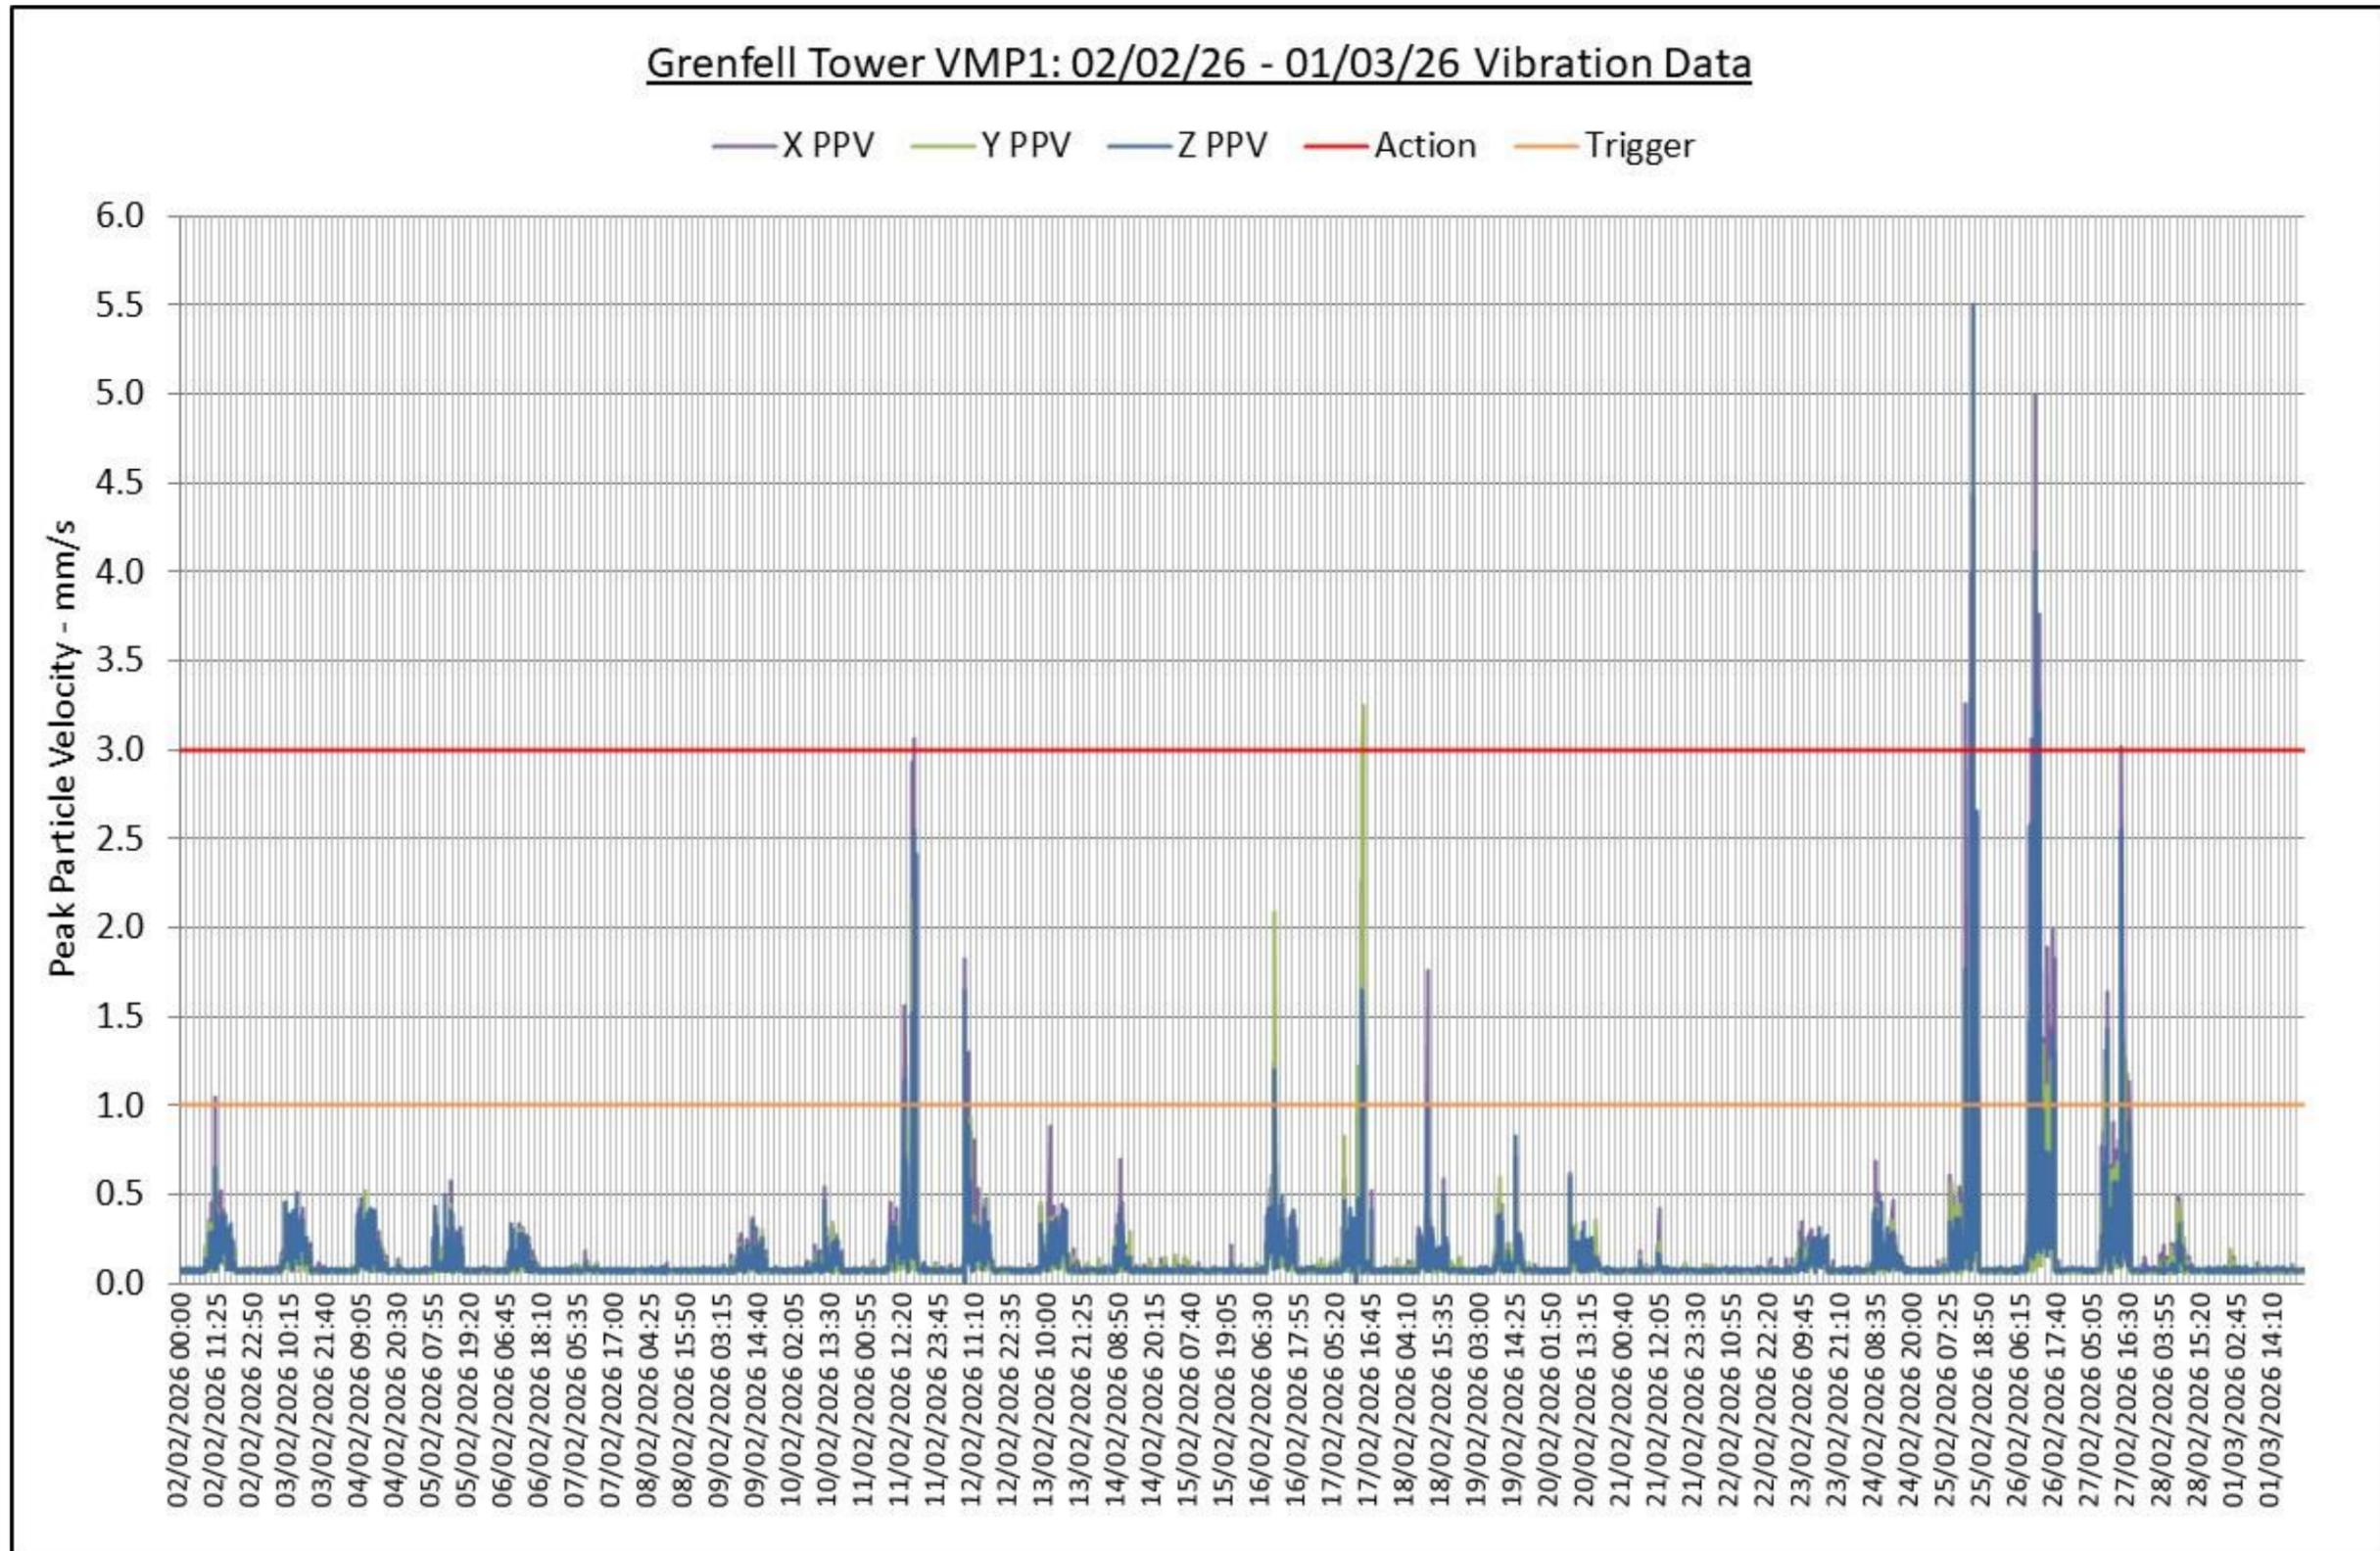
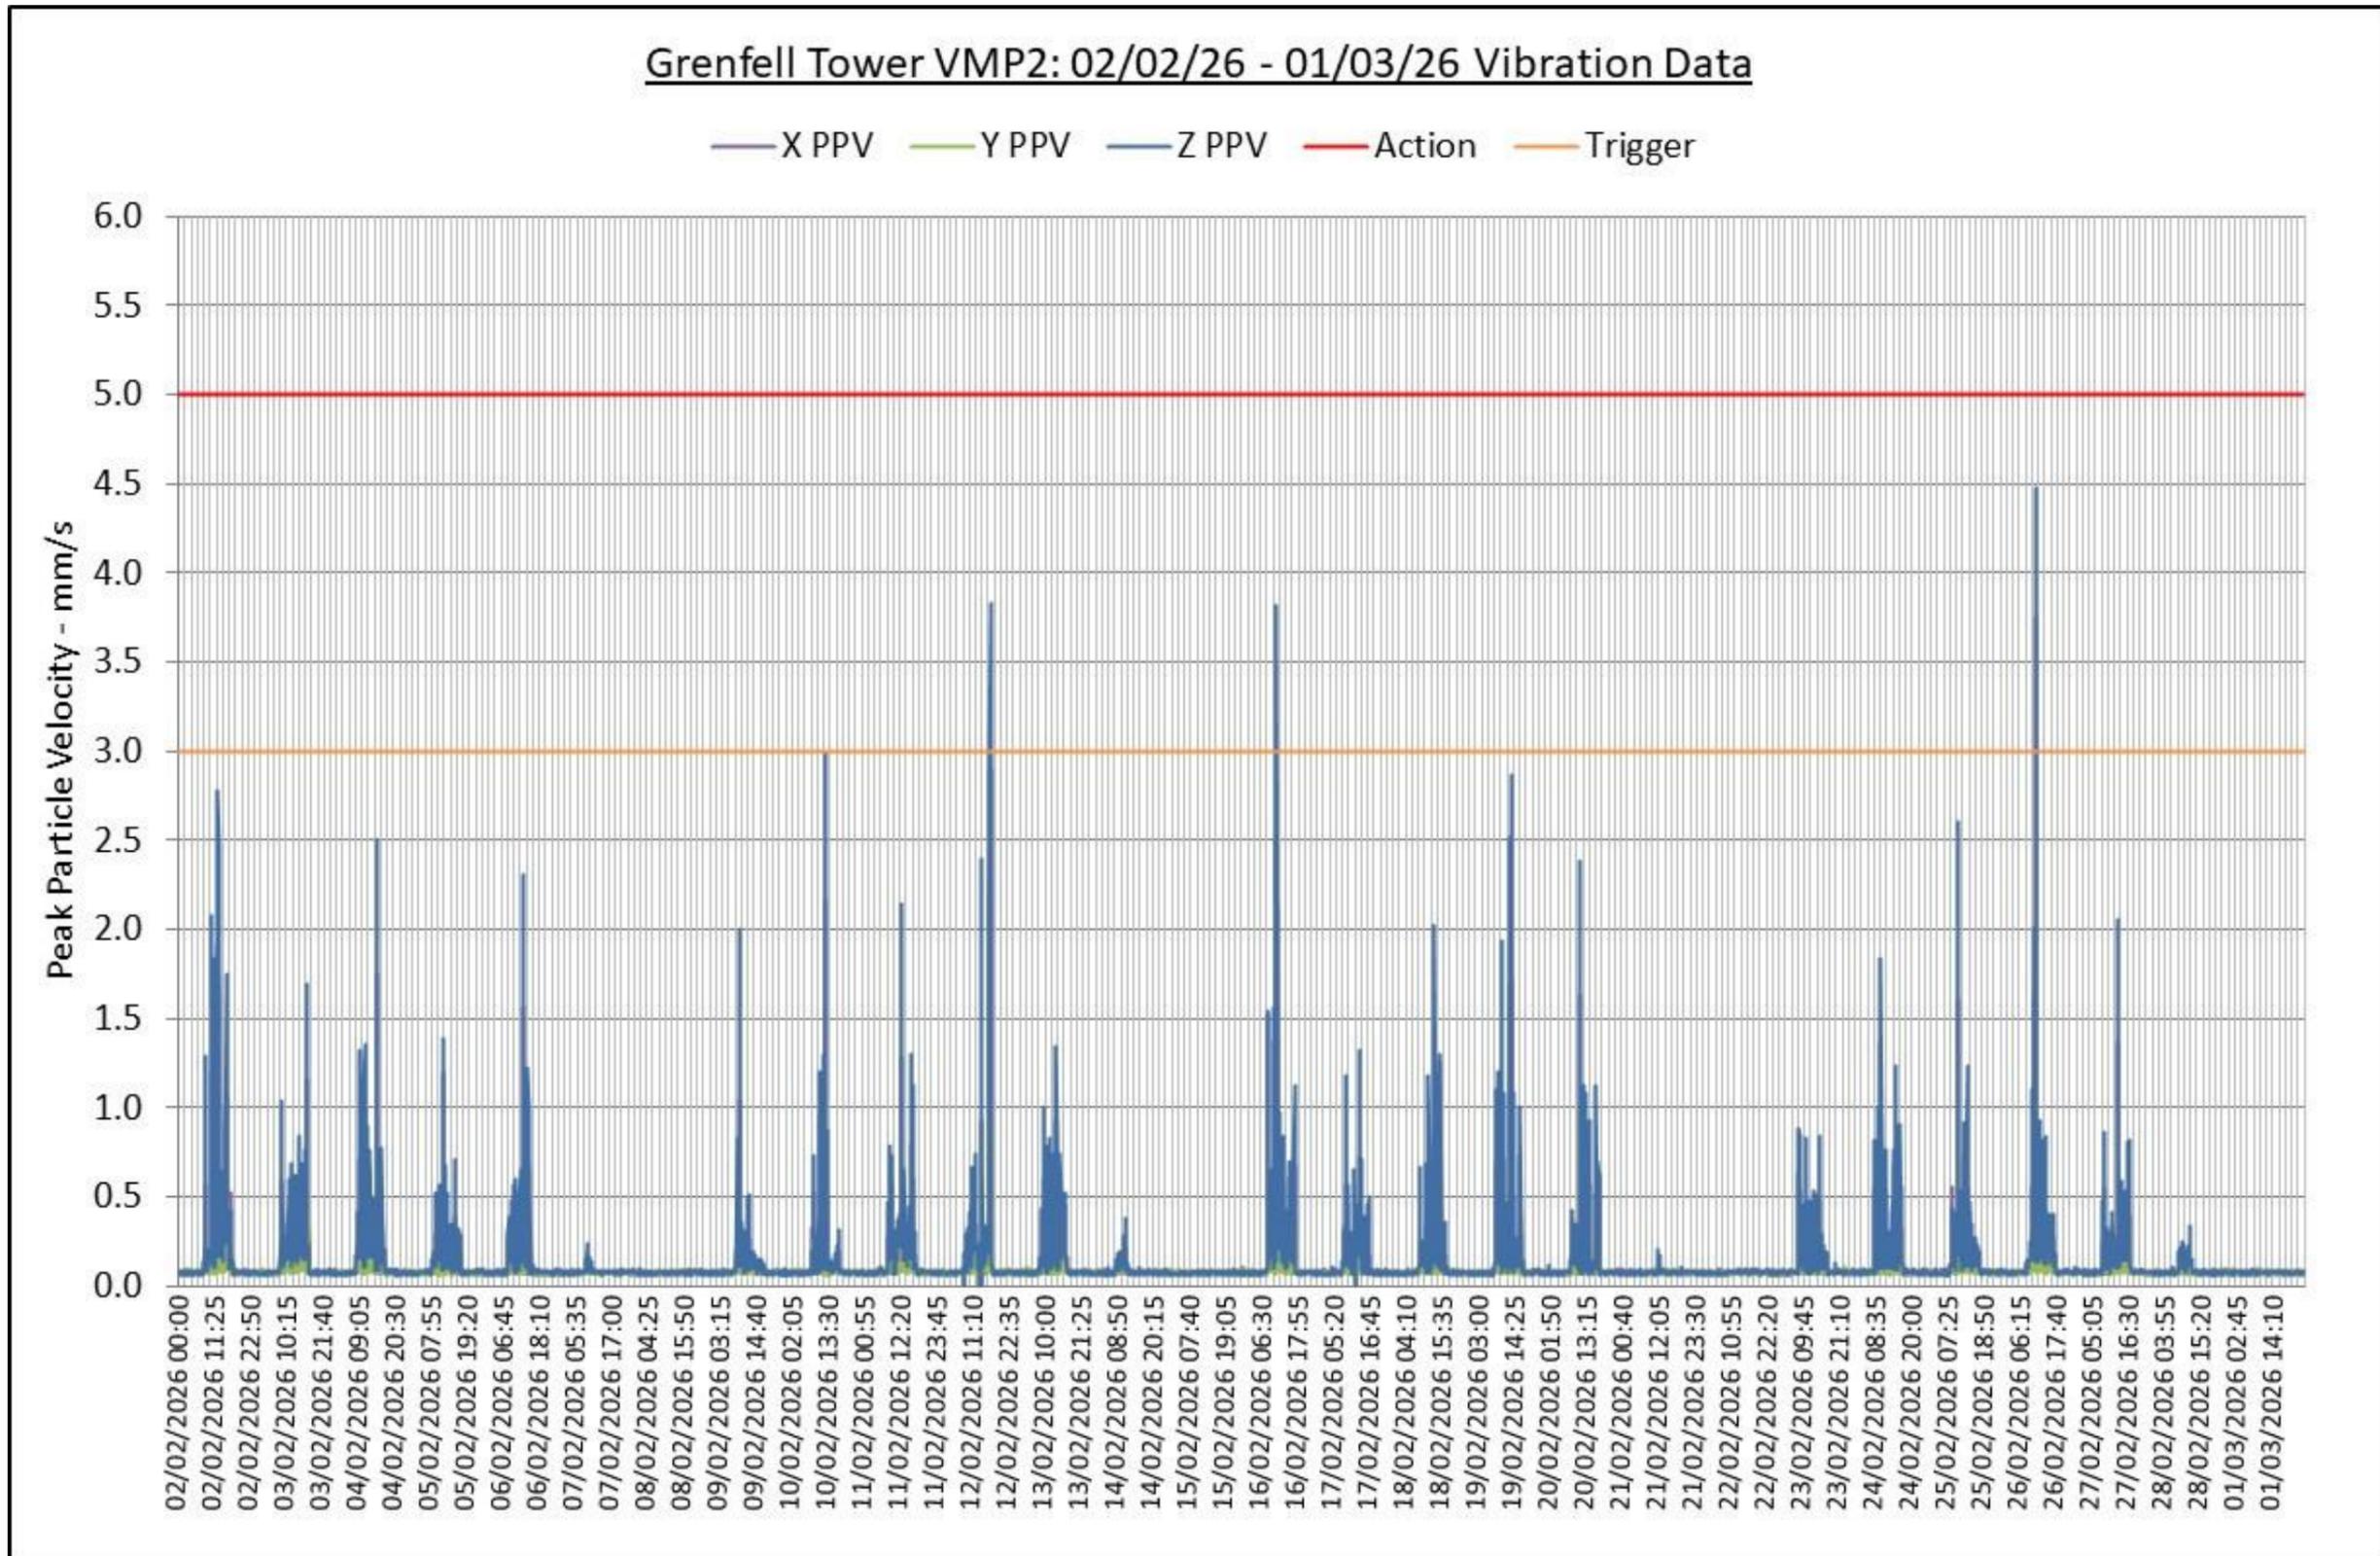
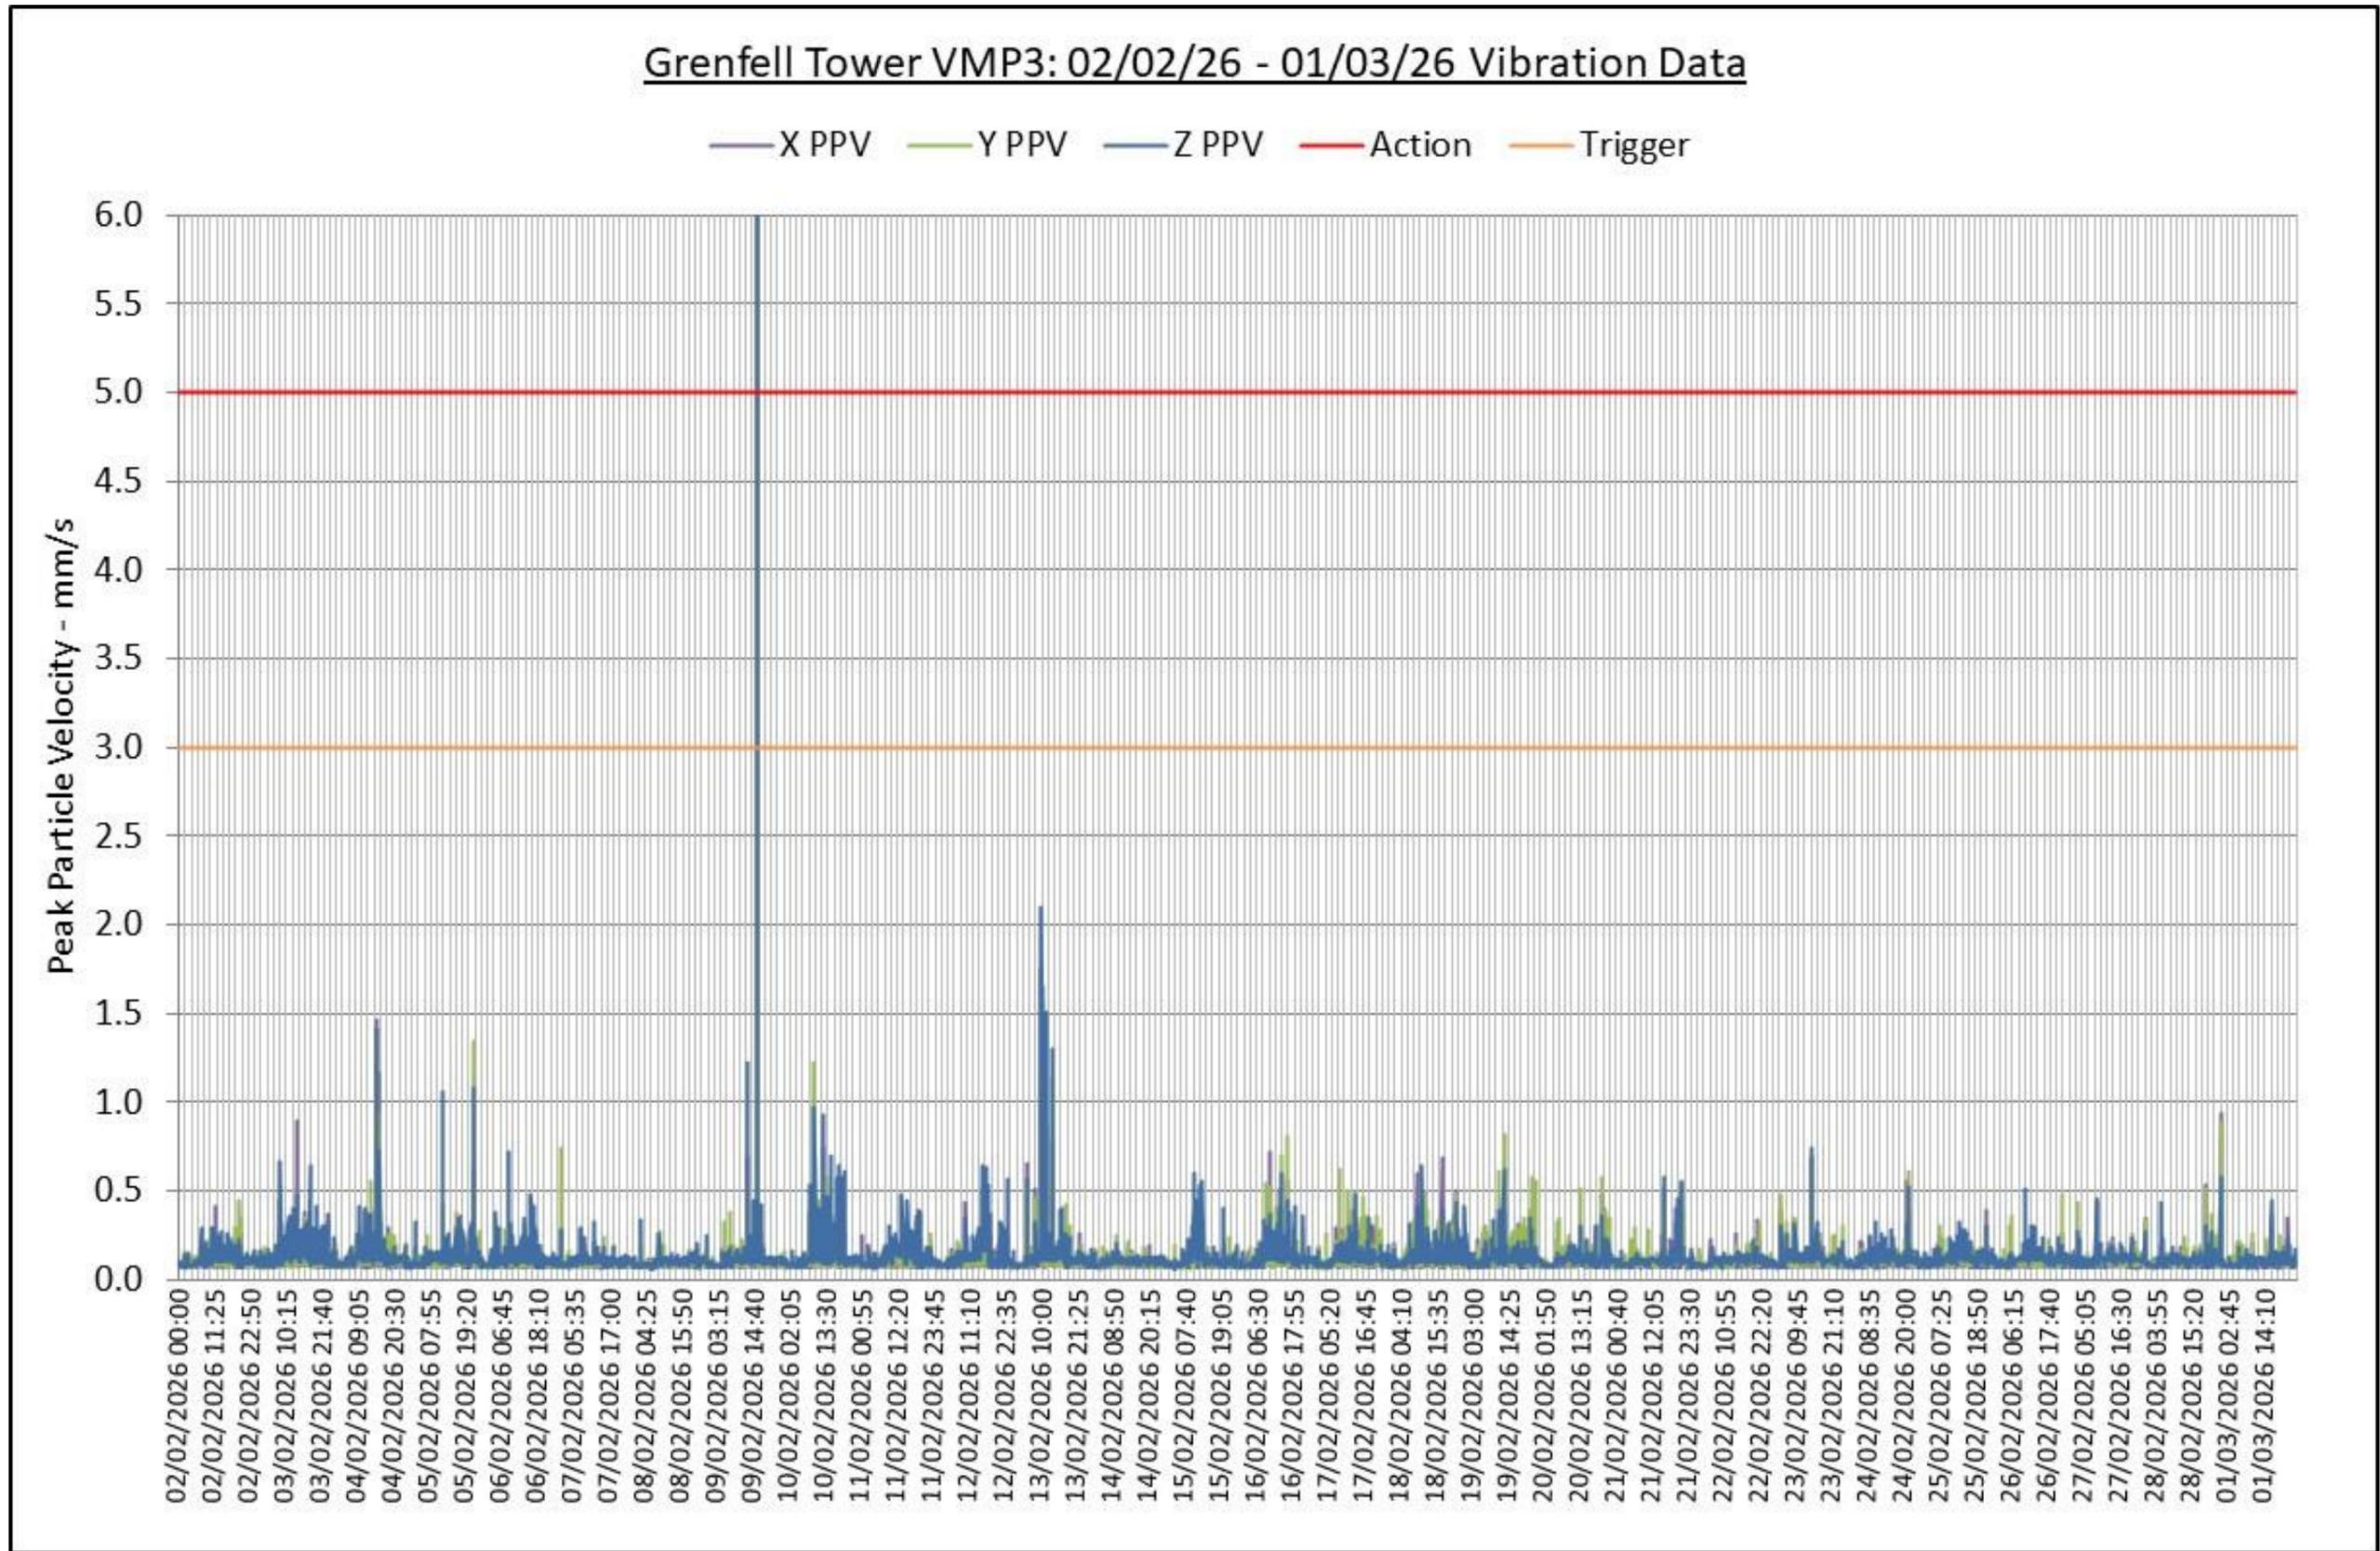
6. Vibration Monitoring Graphs

Monitoring Location	Time and Date of Exceedance	Measured Level of Exceedance (mm/s)	Amber Trigger Alert Level (mm/s)	Cause of Exceedance
VMP1	02/02/2026 11:15	1.04	1.0mm/s	No works undertaken near monitoring location, given the isolated nature of this exceedance this may have been caused by an accidental disturbance of the MEMS sensor.
	11/02/2026 13:00	1.34		Soft stripping close to the monitor.
	11/02/2026 13:30	1.56		
	11/02/2026 15:30	1.86		
	11/02/2026 15:50	2.93		
	11/02/2026 16:05	1.64		
	11/02/2026 16:35	1.80

27/02/2026 15:50	1.09		
	27/02/2026 16:25	1.18		
	27/02/2026 16:50	1.13		
	27/02/2026 17:05	1.12		
VMP2	12/02/2026 16:40	3.83	3.0mm/s	No works undertaken near monitoring location, given the isolated nature of this exceedance this may have been caused by an accidental disturbance of the MEMS sensor.
	16/02/2026 11:15	3.82		14T digger loading rebar into skip in close proximity to the monitor.
	26/02/2026 11:05	4.47		
	26/02/2026 11:10	3.09		
VMP3	-	-	-	-

Monitoring Location	Date and Time of Exceedance	Measured Level of Exceedance (mm/s)	Red Action Alert Level (mm/s)	Cause of Exceedance	Mitigation
VMP1	11/02/2026 16:30	3.07	3.0mm/s	Soft stripping close to the monitor.	Soft stripping methodology reviewed with operatives; works briefed to minimise direct impact adjacent to monitor. Reduced use of percussive tools within exclusion zone and increased supervision during close-proximity activities.
	17/02/2026 14:20	3.02		Scaffolding close to the monitor.	Scaffolding installation sequence reviewed; manual handling prioritised over impact
	17/02/2026 14:25	3.24			Works temporarily paused following alert. Installation method adjusted to reduce dynamic loading and avoid sudden impacts. Continued monitoring maintained during remaining works.
	25/02/2026 13:20	3.26		Operatives installing Temporary	Temporary works installation methodology reviewed and sequenced to limit vibration generation. Increased

26/02/2026 12:45	3.76			Refined working method to minimise repetitive impacts. Continued real-time monitoring maintained and works undertaken in shorter controlled durations.
VMP1	27/02/2026 14:40	3.02		Installation of the Temporary propping close to the monitor	Propping installation sequence revised to reduce vibration transmission. Manual tightening methods prioritised over mechanical impact tools and operatives briefed on proximity constraints.
VMP2	-	-		-	-
VMP3	09/02/2026 15:25	9.31	5.0mm/s		Given the magnitude and isolated nature of this exceedance, it was likely caused by an accidental disturbance of the MEMS sensor and not related to site works.
