Sealant Suitability

HSS4H: 5147/06/2021 (Var. 3)

Final Report v6.0

Client: DESNZ
Project code: 316
Date: 18th June 2024
Authors: [REDACTED] [REDACTED]
[REDACTED] [REDACTED]
Technical Partner: [REDACTED] DNV

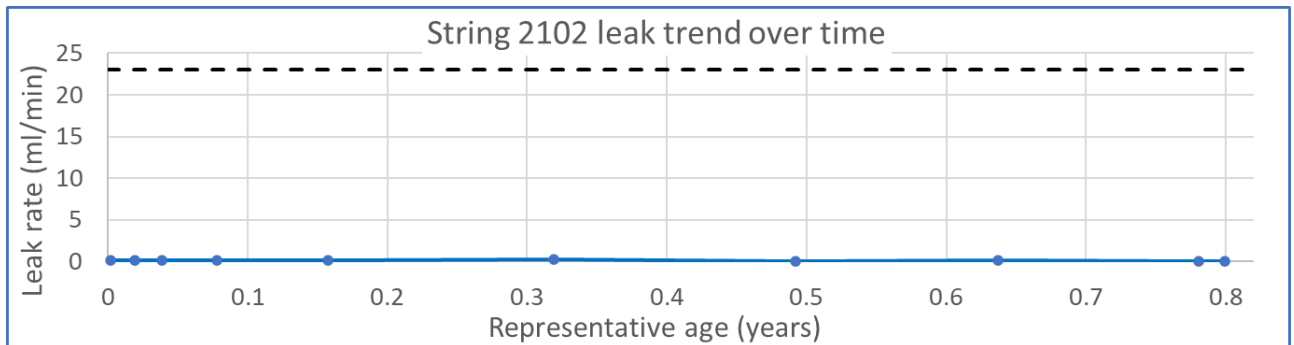
Figure 33: 2102 leak development over time

The concentration was generally high, with notable low concentrations in strings 8101, 2102, 8102 and 8105. String 2102 has low concentrations for many of the tests, but this does not correlate to the leakage measured. The leak rate for 2102 is shown in Figure 33.

The issue of valve stems leaking appeared to be generally when the valves were open. Results such as that seen for 2102 may indicate valve stem leaks when the valve is closed. The mechanism for this is less likely however, due to the positioning of the seat seals relative to the stem leak path.

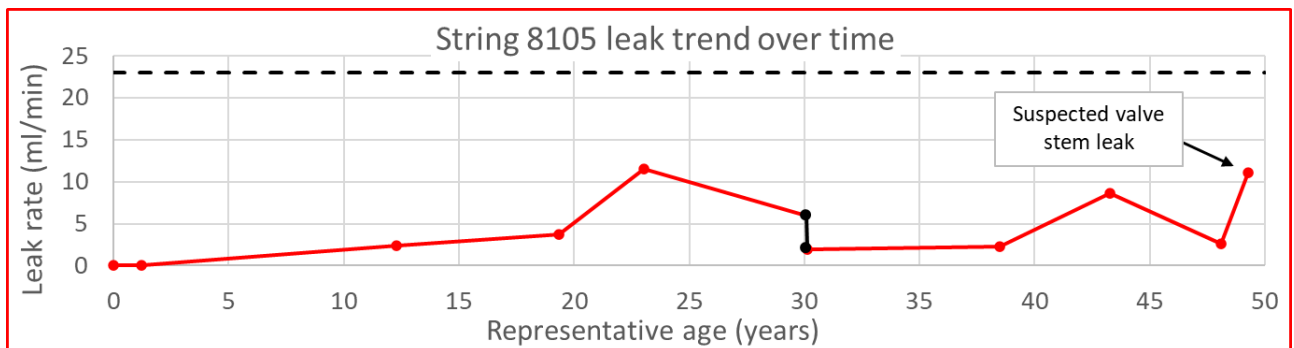
Figure 34: 8105 leak development over time

The leak rates for 8105 are shown in Figure 34, and represent a more expected profile when considering the concentrations measured.

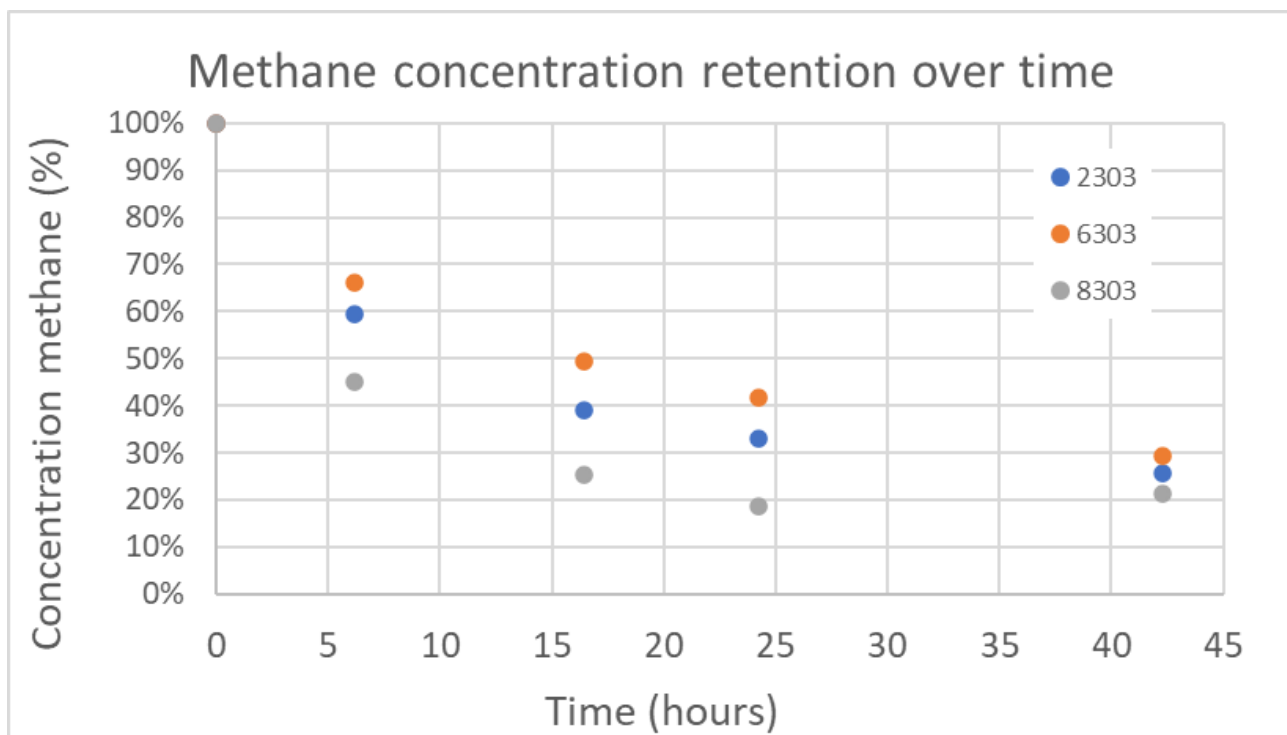
Figure 35: Methane concentration decay over time - graph

The results for the concentration decay over time are shown in Figure 35 for methane, and Figure 36 for hydrogen.

The reduction in hydrogen concentration happens approximately three times as quickly as for methane. This finding is based on a very limited data set, but is an indication that the hydrogen concentration will fall quicker than methane.

It should be noted that the volume contained in these test samples is very small, which greatly amplifies the effect seen here. A more thorough investigation is required to determine if this phenomenon needs to be addressed.

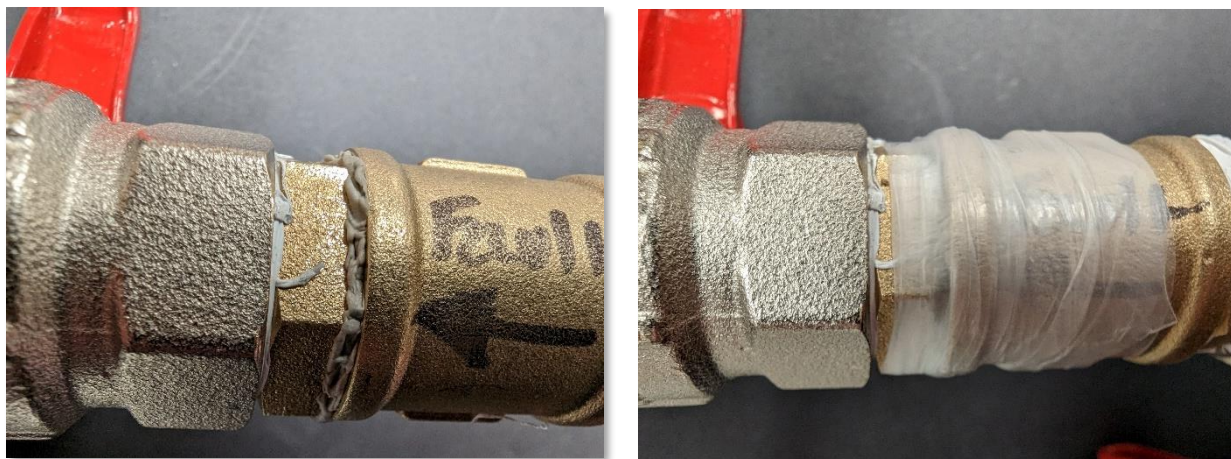
Figure 39: 'Retired' joint example

The proposed method for retiring joints that leaked above the agreed MPLR was trialled prior to agreeing the experimental plan. To produce this external seal, vacuum putty was pushed into the throat of the leaking joint, and wrapped with self-amalgamating tape. This example provided in the project proposal is shown in Figure 39. This was successful at sealing a joint in an example string with a deliberately created leak.

The putty was used for the first joint retirements, but based on the initial leak prevention results, *self-amalgamating tape* was not deemed necessary. The retirement process highlighted that there would be an issue with any joints where there was any protruding cord or tape, and those where the sealant had left an oily residue on the exposed parts. Self-amalgamating sealing tape would not be suitable for these strings, as it would not be able to adhere or seal to the fitting surface.

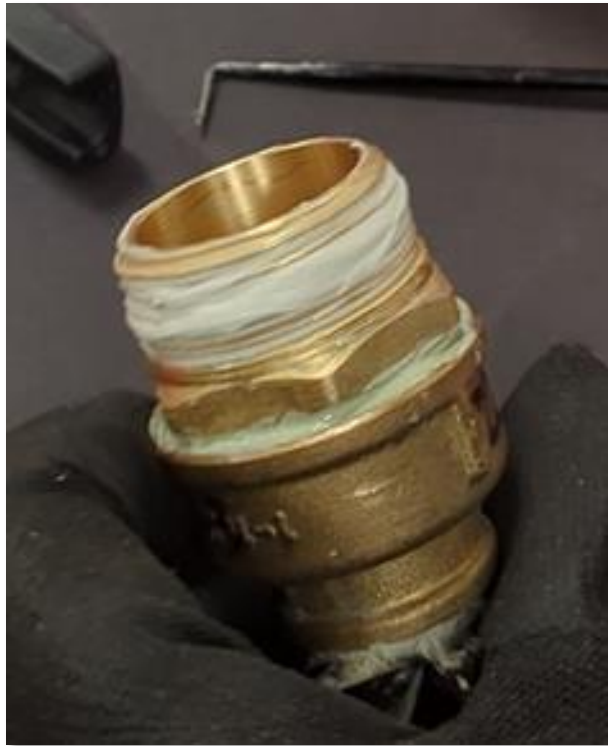
Figure 42: Application of PTFE cord to retired joint B of string 2202-3

The retired joint was then wrapped with PTFE cord, leaving the existing compound in place on the threads. This step for joint B of string 2202-3 is shown in Figure 42.

The retirement method was reviewed and amended, and the decision made to carefully disassemble and remake the joints that had already been retired, using PTFE cord and compound. Care was taken to only use the flats on the joint being disassembled, to prevent affecting the remaining joints. Thin bladed adjustable spanners were used for this purpose. The barrel and 1" part of the reducer could be held loosely in a vice, with only the grip protrusions preventing rotation rather than clamping. This avoided compressing the fitting, which may have affected the non-retired joints. This process is demonstrated in Figure 41 for joint B of string 2202-3.

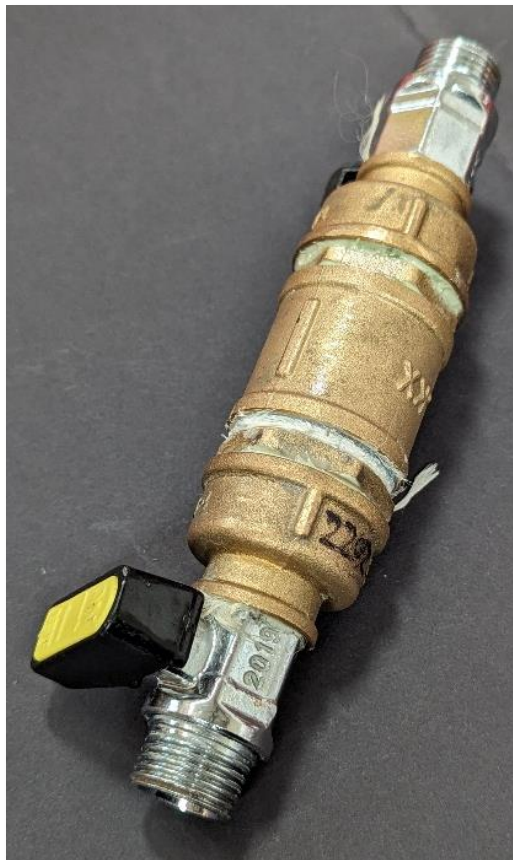
Figure 43: String 2202-3 remade as string 2202-3ACDV

Finally, the previously retired joint was re-assembled. At this stage the string was renamed to represent only the remaining joints (including both valves). String 2202-3ACDV is shown in Figure 43.

This method was successful initially, but again the leak rate increased over time. This rendered results for that string are invalid, as the proportion of the leak from the retired joint could not be determined.

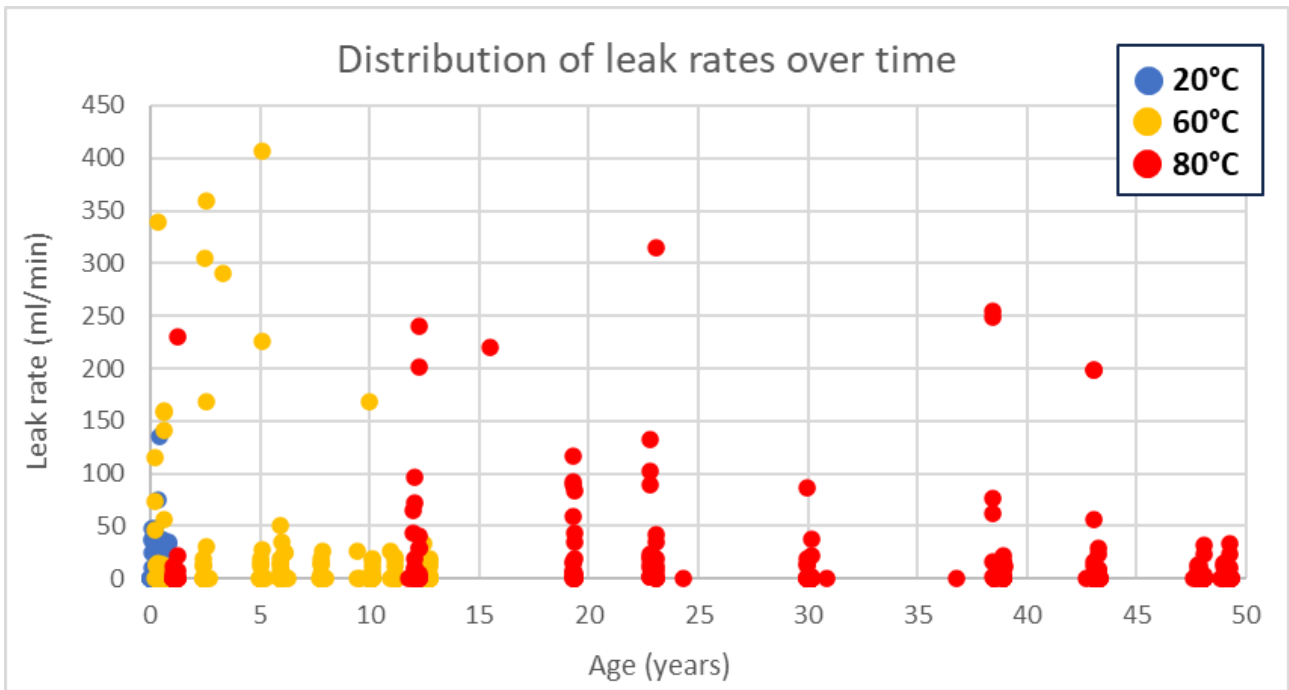
Figure 47: Distribution of leak rates over time - all data

All leak rates are plotted against the total age in Figure 47. There is no indication of leak rate increase over the test programme. This does not show the trend of individual test pieces. The results are not included for any string after a retirement has taken place. This may account for the apparent decrease in the higher leak rates.

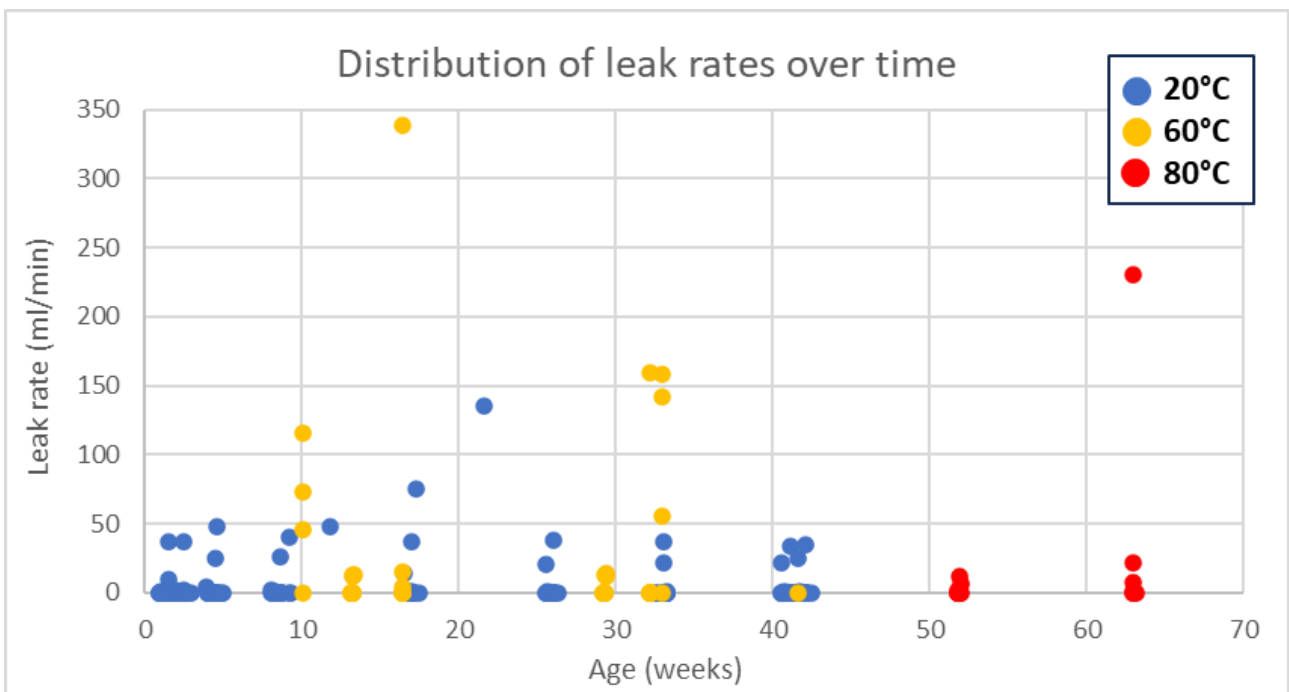
Figure 48: Scatter of leak rate development over time

When this is scaled to show the early test results (Figure 48), there is potentially an indication of an upward trend with increasing age.

The dataset is too small relative to the deviation to draw a firm conclusion however, and cannot prove the accuracy of the Arrhenius chemical ageing in this case.

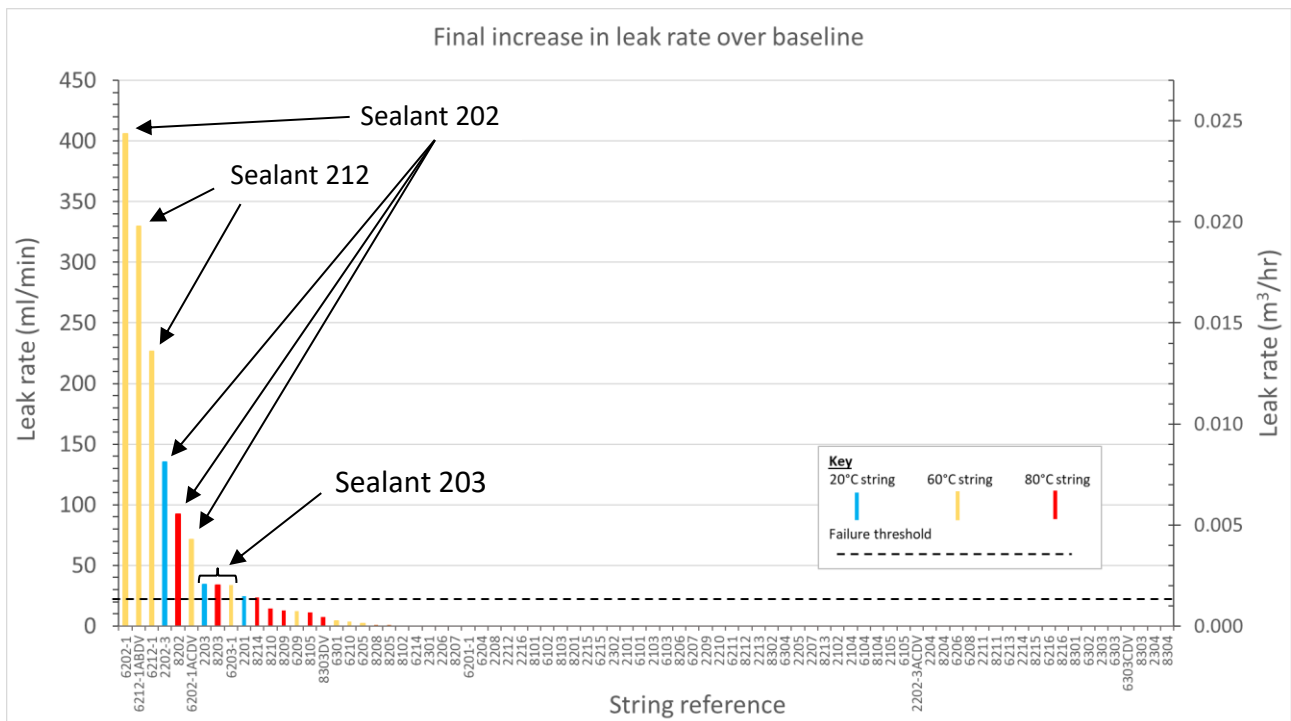
Figure 50: Final leak rates

A plot of the increase in leak rate at the final test for each string is given in Figure 50. The exception is 8202, where there was a particularly high peak during the testing which had reduced to nothing by the final test. For this string the peak is included. Where a string had joints retired the point at which that took place is included, as is the 'replacement' string.

In total, five sealants and a total of eleven strings had an increase in leakage above the failure rate. This includes 6212-1 and 6202 that had a joint retired and subsequently developed a leak from the remaining joints. Three others had a leak rate above the failure rate from the start, but did not deteriorate (therefore not apparent in Figure 50). Three sealants were accountable for the nine highest increases in leak rate. After the initially leaking joint in string 6212-1 was retired, two other joints also began leaking. The 20°C and 80°C strings for this sealant did not develop leakage however.

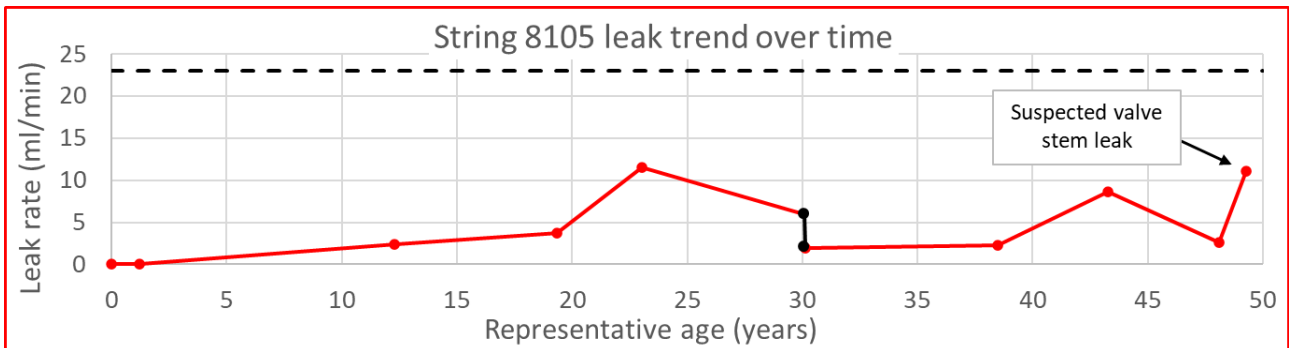
Figure 54: 8105 leak development over time

Figure 54 shows the leak rate trend of string 8105 over time. After test 4 this was identified as predominantly being from the stem of Valve 1.

Valve 1 was replaced during test 5, reducing the leak rate from 11.5 ml/min (0.00069 m³/hr) to 1.9 ml/min (0.00011 m³/hr). At the final test, valve 1 was identified as having a stem leakage again, which was expected to account for the leak rate recorded. This was not replaced as the leak rate was below the failure rate.

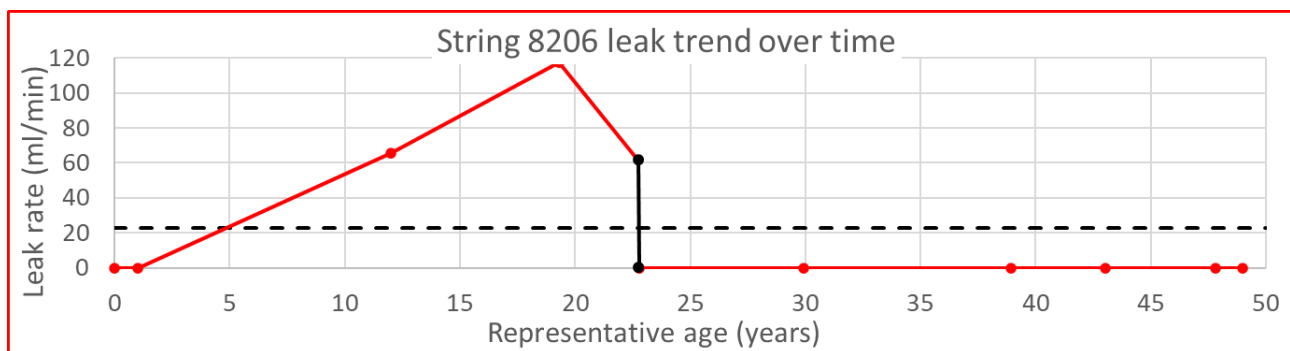
Figure 58: 8206 leak development over time

The concentration is good for all strings, with the exception of string 8206 in test 5. The leak trend of 8206 is shown in Figure 58.

The leakage is from a valve stem, and is only present when the valve is open. This indicates that the 0% concentration in test 5 was likely due to experimental error, the most likely explanation that a valve was inadvertently opened while removing from the oven.

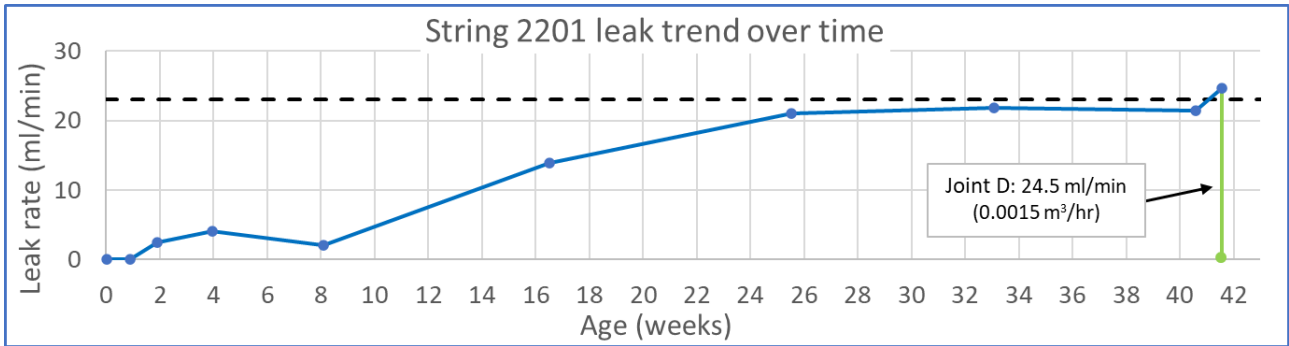
Figure 61: 2201 leak development over time

2201 leaked 24.7 ml/min (0.00148 m³/hr) at the final test. This string was used to demonstrate the relative leak rates of air, methane and hydrogen at a leak size around the failure threshold (see chapter 6.1 for details). The leak rate in air was 8.4 ml/min (0.0005 m³/hr). The leakage had been identified as coming from joint D. The day after measuring the relative leak rates, joint D was retired, to determine how much of the leakage was from D. At this point the total leakage had reduced to 19.5 ml/min. Retiring joint D reduced the leakage to 0.2 ml/min. The leak trend of 2201 is shown in Figure 61. The hydrogen concentration retained in 2201 was reasonably high.

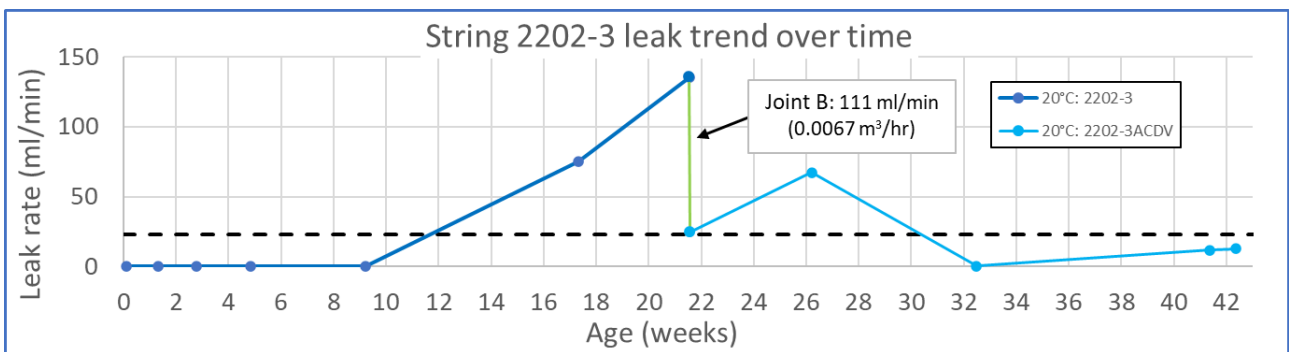
Figure 63: 2202-3 leak development over time

2202-3 developed a large leak of 135.3 (0.0081 m³/hr), and joint B was retired after 151 days (both real and representative age). Leakage was reduced to 24.7 ml/min (0.0015 m³/hr), indicating a final leak rate from joint B of 110.6 ml/min (0.0066 m³/hr). The string with B retired continued in the test programme named 2202-3ACDV, with 24.7 ml/min as the baseline leak rate and the final leak rate was 12.8 ml/min. During test 6, just after 26 weeks, the leakage was noted as being from joints A and B. This datapoint is therefore potentially invalid, as it includes leakage from the already retired joint B. for the following test in week 32, joint B was re-sealed. During the final leak test, joint B was re-retired twice, with leakage reducing from 16.6 ml/min to the 12.8 ml/min final leak rate. This indicates that the remaining leakage was not from B. Applying leak detection fluid demonstrated clearly that the leak was coming from joint A. No leakage was detected from joints C and D, or the valves. The leak trend of 2202-3 is shown in Figure 63.

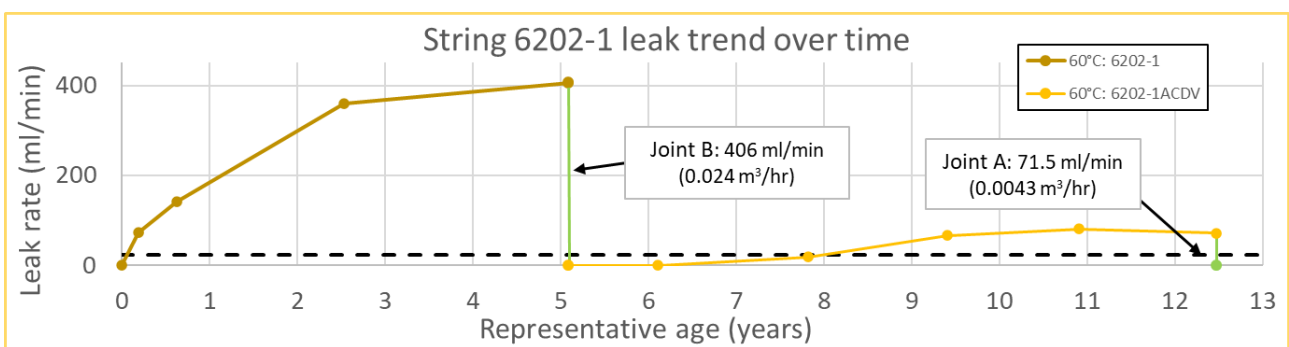
Figure 64: 6202-1 leak development over time

6202-1 developed a leak of 406.0 ml/min (0.024 m³/hr). This was the largest test joint leak found during the test programme. Joint B was retired when the representative age was approximately 5 years old, accounting for all of that leak. The remaining string 6202-1ACDV slowly increased in leak rate, eventually leaking at 71.8 ml/min (0.0043 m³/hr). During final test retirement joint B was re-retired, but with no decrease in leak rate. Leakage was identified as being from joint A, and when this was retired the leak rate dropped to 0.3 ml/min. The leak trend of 6202-1 is shown in Figure 64.

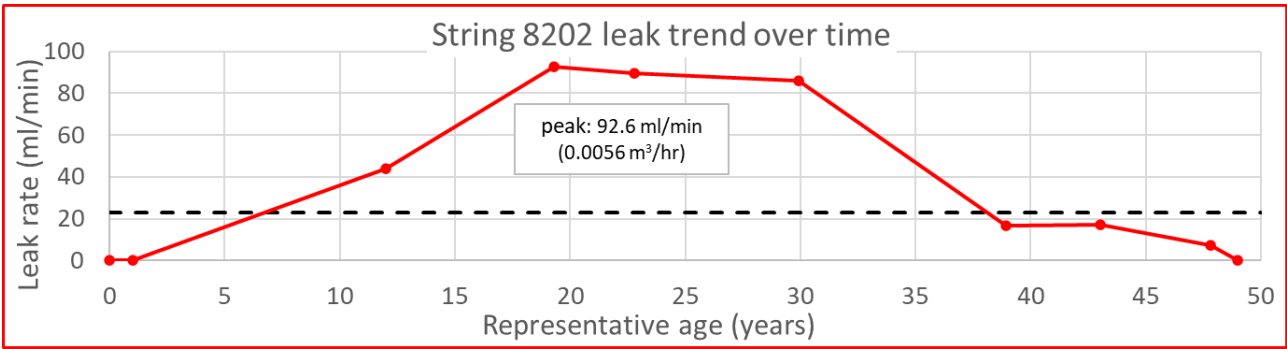
Figure 65: 8202 leak development over time

While 8202 demonstrated no leakage at the final test, the leak rate during the test programme peaked at 92.6 ml/min (0.0056 m³/hr). This leakage is believed to be from valves and from test joints. Notes taken during test 4 (23 years) indicate that leakage was from valve 2 and joint C or D. Similar notes for test 5 (30 years) indicate leakage from mostly C and D, with some from A or B. No change was made for test 6, when the leakage decreased to 17.5 l/min (0.0011 m³/hr). In test 7 the initial leak rate for 8202 was 55 ml/min, with leakage detected from the stem of valve 1. The string was rotated 180° to use valve 2 as the input. The leak rate increased to 130 ml/min. Both valves were removed and replaced. When tested again in the normal orientation (valve 1 upstream), the leak rate was initially 27 ml/min, which dropped to 18 ml/min over the course of around three minutes. Note that this was still decreasing at this point. The raw pressure and flow trace for this final attempt is provided in Figure 66.

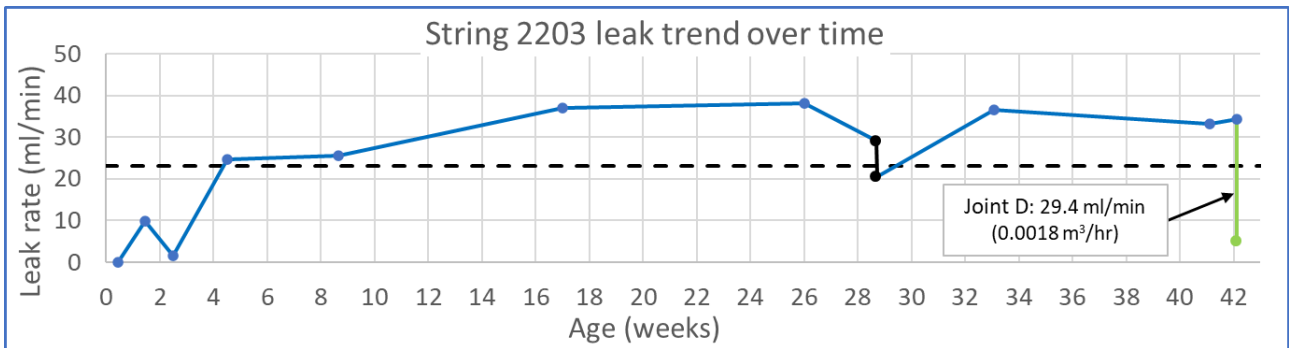
Figure 67: 2203 leak development over time

All three 203 strings had no baseline leakage, but all developed leaks marginally above the failure threshold. The leak trend of 2203 is shown in Figure 67.

In the final leak test, the leakage was identified as being from joint D. Retiring this reduced the leak rate from 34.4 to 5.0 ml/min, indicating that joint D had a 29.4 ml/min (0.0018 m³/hr) leak. The leak rate development for string 6203-1 is given in Figure 68.

Valve 1 was replaced between tests 6 and 7, when the string was approaching 0.6 years old. Leakage was reduced from 29 ml/min (0.0017 m³/hr) to 20.5 ml/min (0.0012 m³/hr). Note that this step was done outside of the scheduled testing, and the leak rate measured at that time was slightly lower than the leakage previously observed.

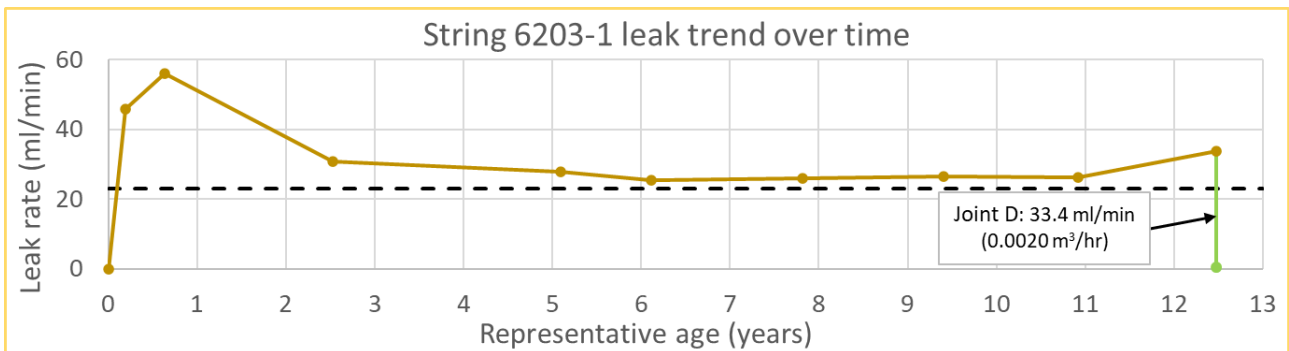
Figure 68: 6203-1 leak development over time

String 6203-1 was part of Batch 3, as the original string leaked at 50 ml/min (0.003 m³/hr) at the first test (increased from a baseline leak rate of zero). This had been in the oven for one week, but was aged approximately 115 days. The replacement string also began to leak by a similar amount after a week. The leak rate spiked to 56.1 ml/min, before stabilising to approximately 26 ml/min (0.0016 m³/hr). The results for string 6203-1 are shown in Figure 68.

The reason for this leak rate spike early in the test programme is not known. Identification of leak location was not carried out in these early tests, and no experimental notes regarding this were made at the time. The valves were not changed or re-sealed between tests 2 and 3, but variability in valve leak rate from test to test has been observed in a number of other strings. No leakage was identified as being from the valves during the test programme.

The final leak rate was 33.6 ml/min (0.0020 m³/hr). This was identified as being from joint D, and when retired this reduced the leak rate to 0.2ml/min.

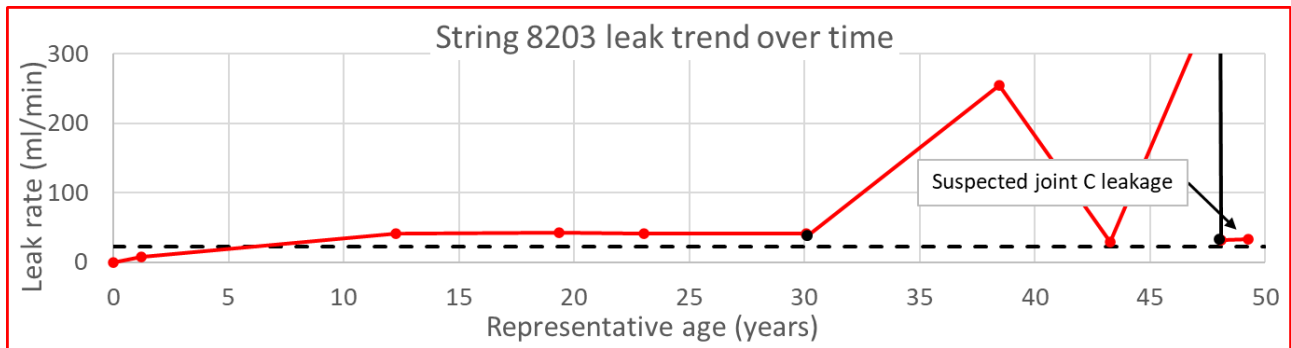
Figure 69: 8203 leak development over time

Leakage from 8203 stabilised at around 30 ml/min (0.0018 m³/hr). Valve 1 was replaced for test 5, but the leak rate was not significantly reduced. The spike to 254 ml/min (0.015 m³/hr) in test 6 was a temporary feature, which reduced again to a similar level as previously. This spike is typical of intermittent valve stem leakage (with the valve open), but this could not be confirmed during the test. Valve 1 was replaced again between tests 7 and 8, at an age of approximately 48 years. While the officially recorded leak rate at test 7 was 29.1 ml/min, the leak rate at the start of the valve replacement was 400 ml/min (0.024 m³/hr). Changing the valve reduced this to 32.8 ml/min (0.0020 m³/hr).

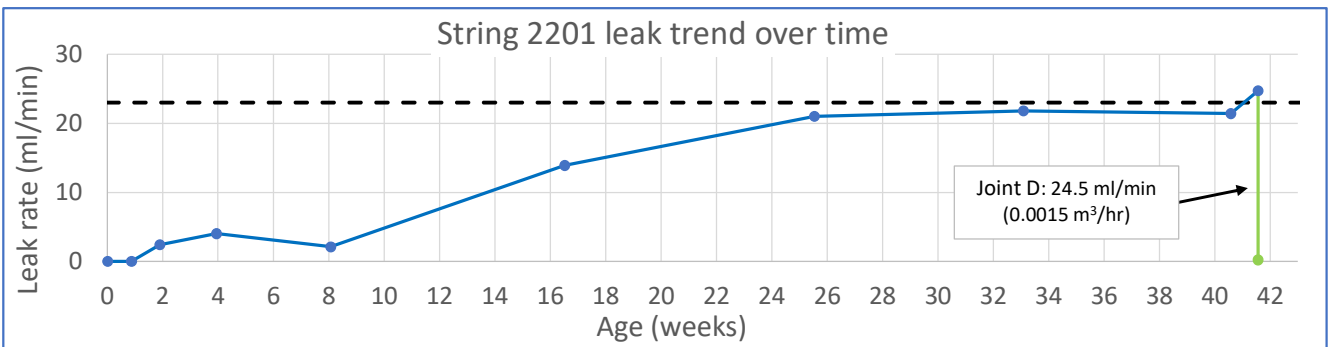
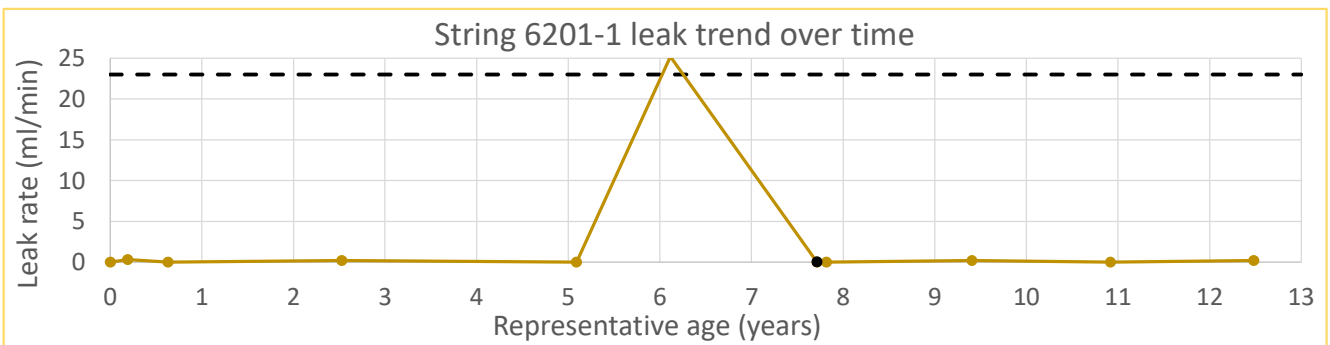
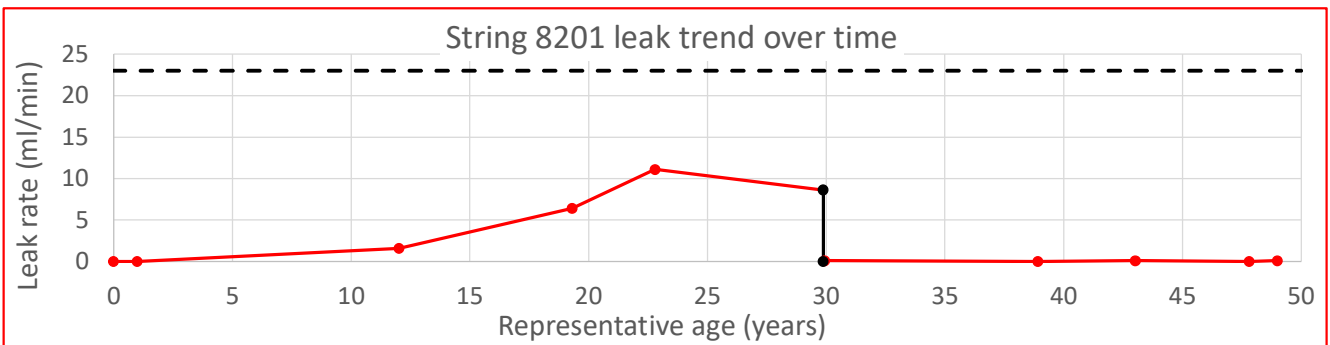
String reference		
2201	6201-1	8201

Sealant 201 failed on joint D of 2201 with a leak rate of 24.5 ml/min (0.0015 m³/hr). The rest of string 2201 showed no leakage. 6201 failed after 1 week and was remade as 6201-1. The leakage in 6201-1 and 8201 was from the stem of valve 1.

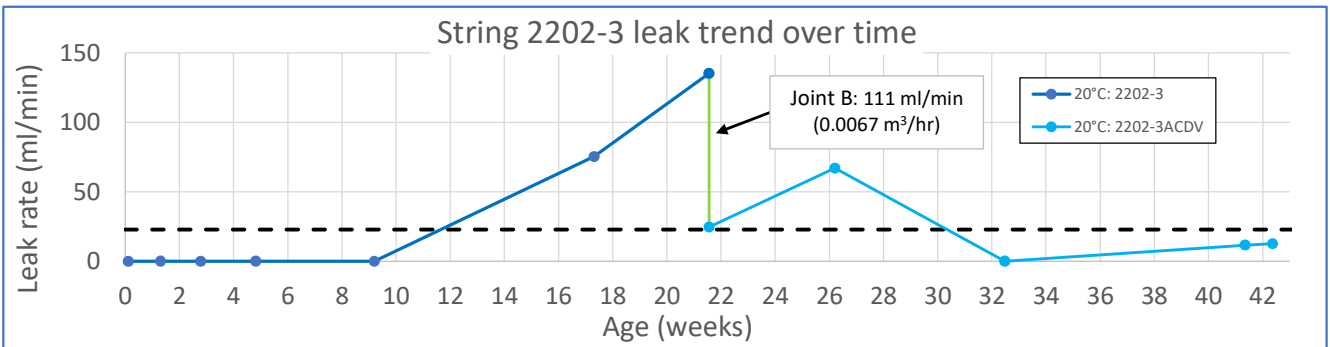
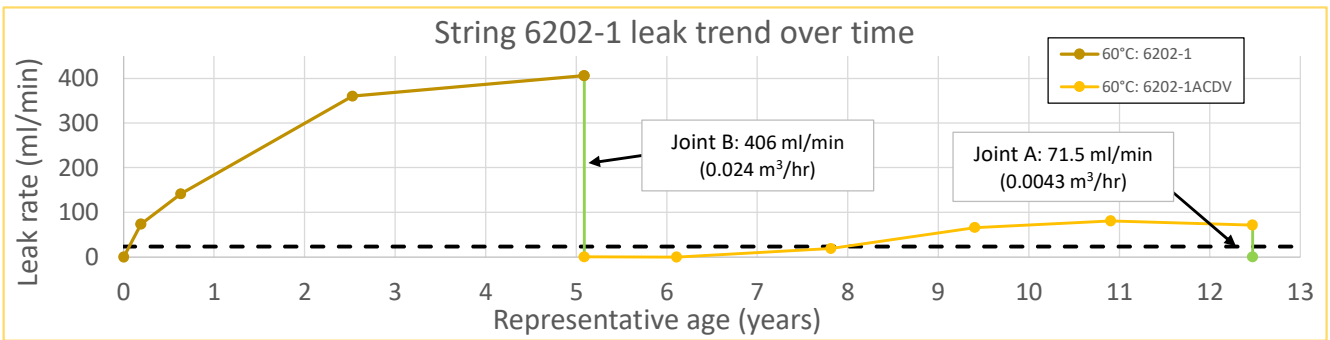
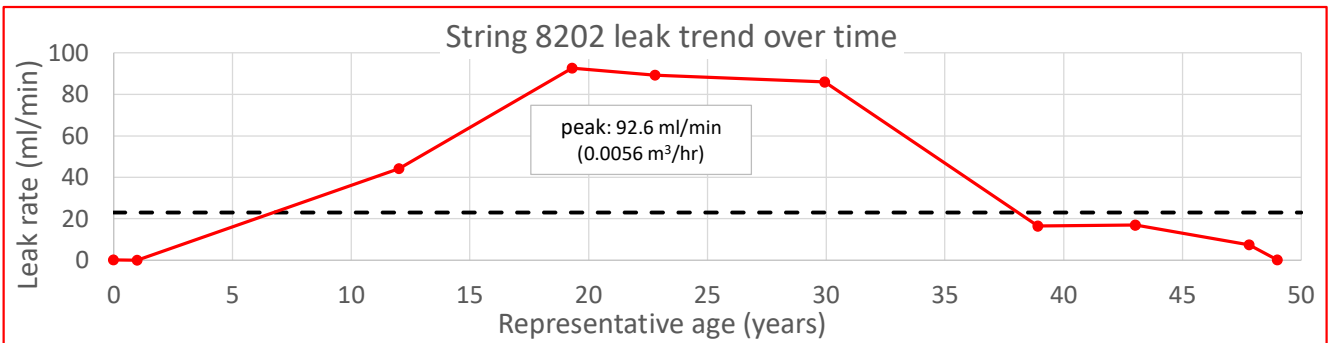
String reference		
2202-3	6202-1	8202

2202 and 6202 both failed after week 1 and were remade. 2202 was remade three times to produce a leak-free string. One joint in 2202-3 and two in 6202-1 failed and were retired. 6202-1 developed the largest leak in the test programme, of 406 ml/min (0.024 m³/hr). 8202 developed a leak of 92.6 ml/min (0.0056 m³/hr) but this reduced to nothing without apparent interference. This is considered to be a failure.

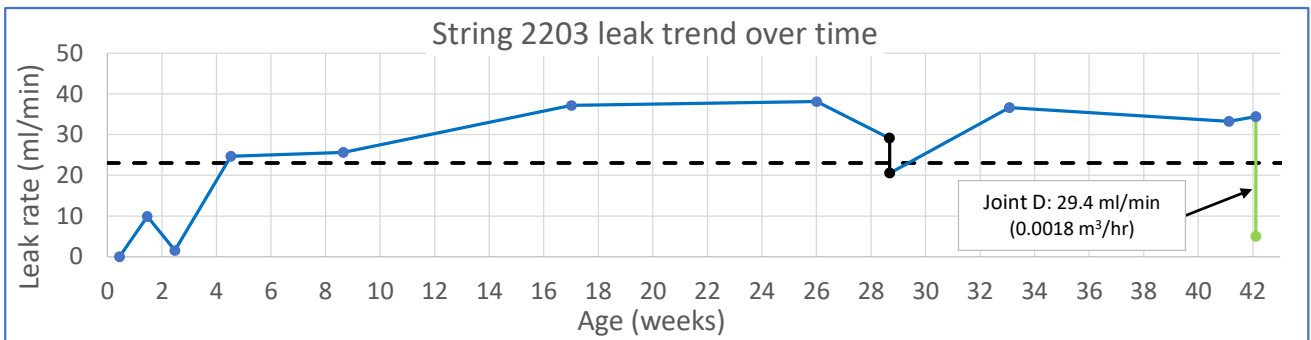
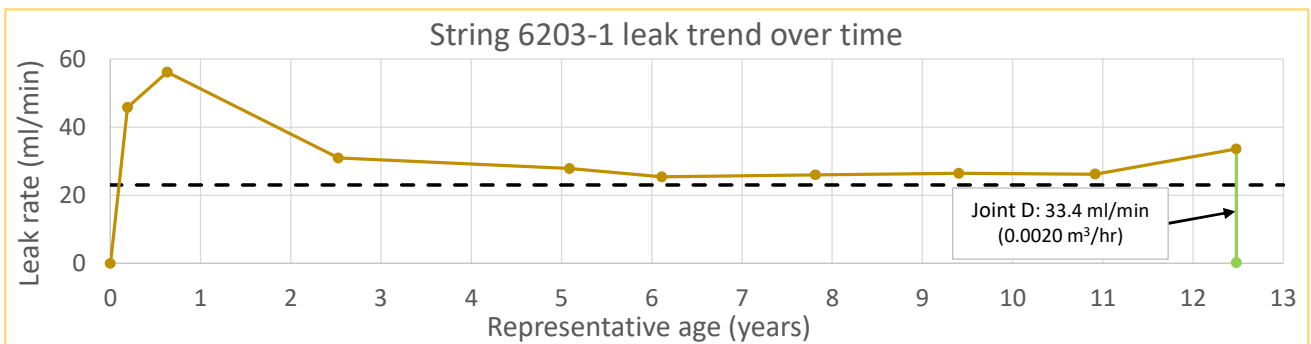
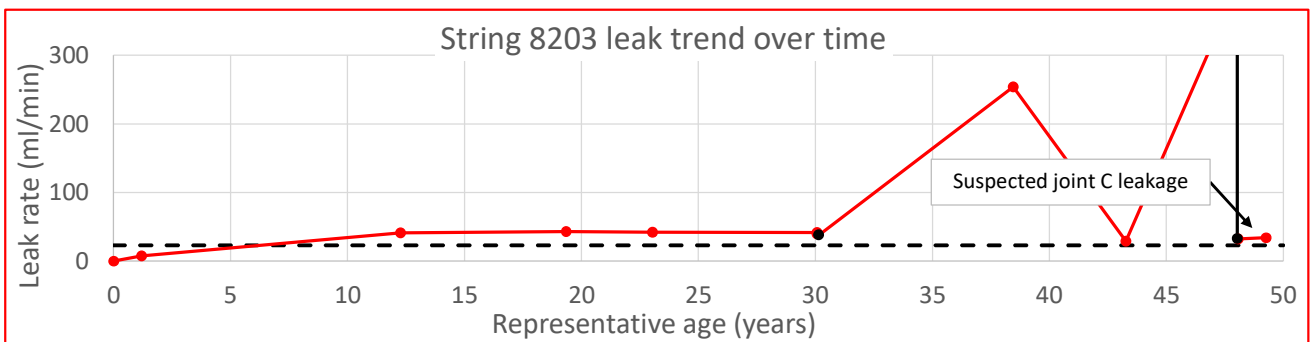
String reference		
2203	6203-1	8203

6203 failed after week 1 and was remade.

All three strings developed failure leak rates over the course of the test programme. The leakage was mostly from joints D in 2203 and 6203-1. The peak observed in 8203 (up to 400 ml/min not shown) was due to valve stem leakage. Leakage during the final test was identified as being from joint C. Sealant in 8203 cured hard and a final joint retirement to measure individual joint leak rates was not done.

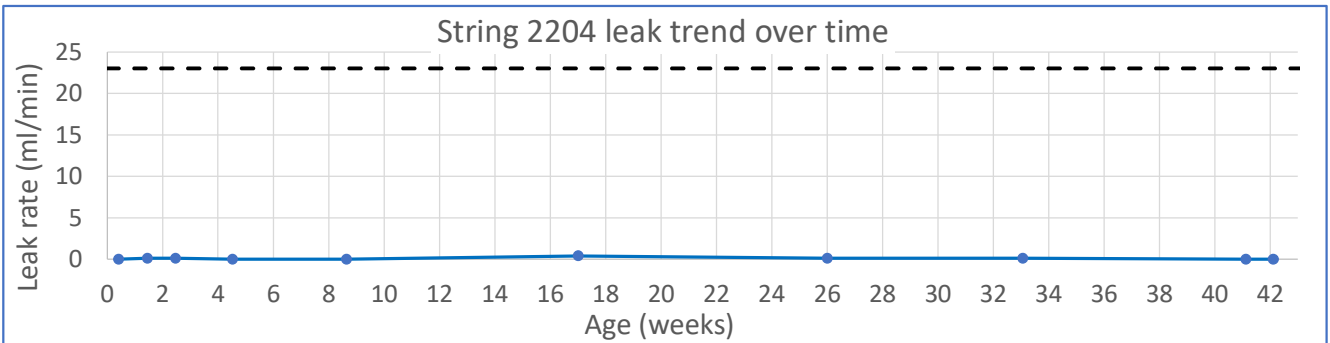
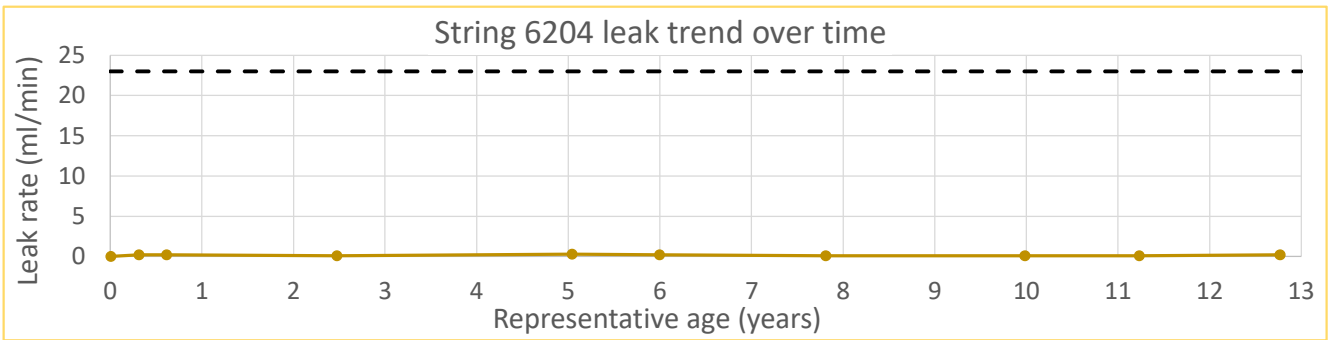
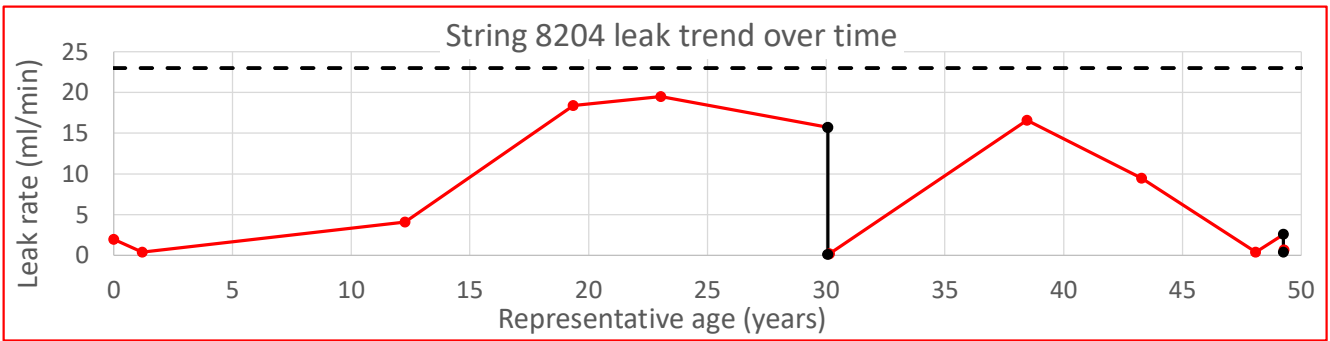
String reference		
2204	6204	8204

Sealant 204 passed with no leakage. The leaks in 8204 were valve stem leaks.

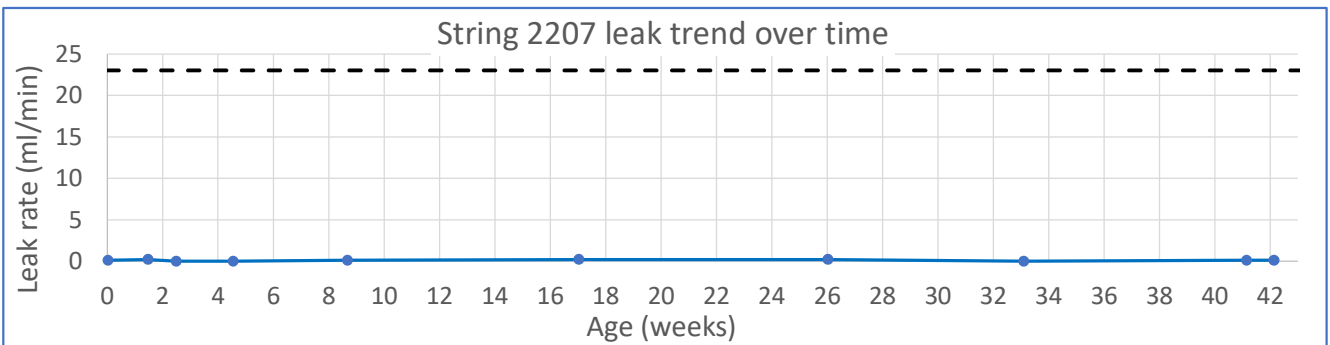
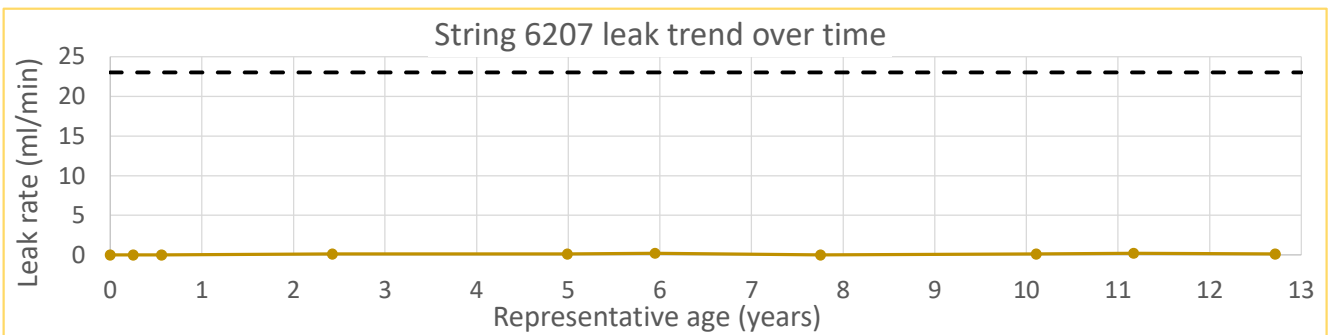
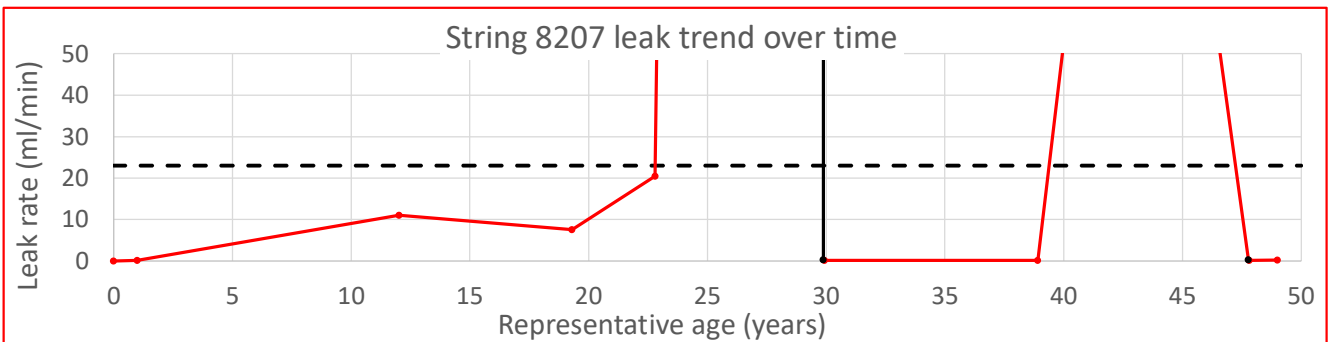
String reference		
2207	6207	8207

Sealant 207 passed with no leakage. Leakage recorded from 8207 peaked at 3,000 ml/min (0.18 m³/hr) and was from the stem of valve 1. Leakage of 198.6 ml/min (0.012 m³/hr) from 8207 at 43 years was temporary and believed to be from a valve stem.

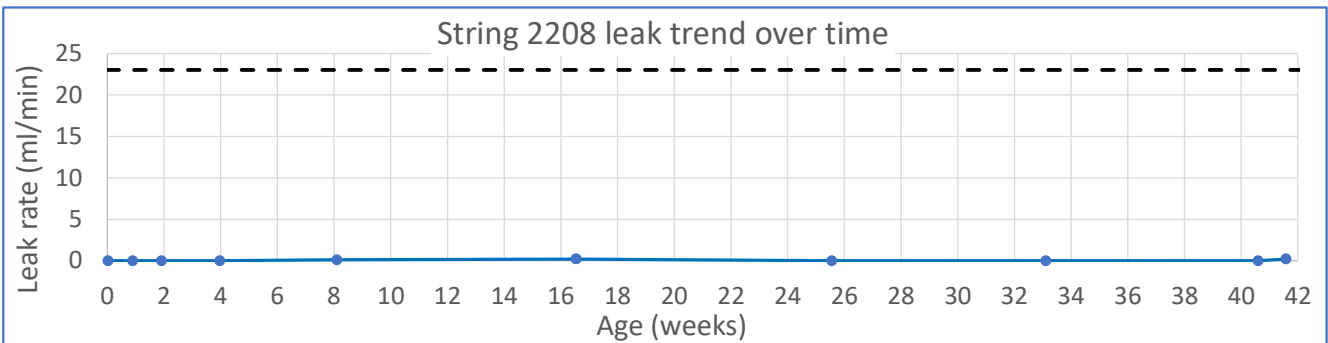
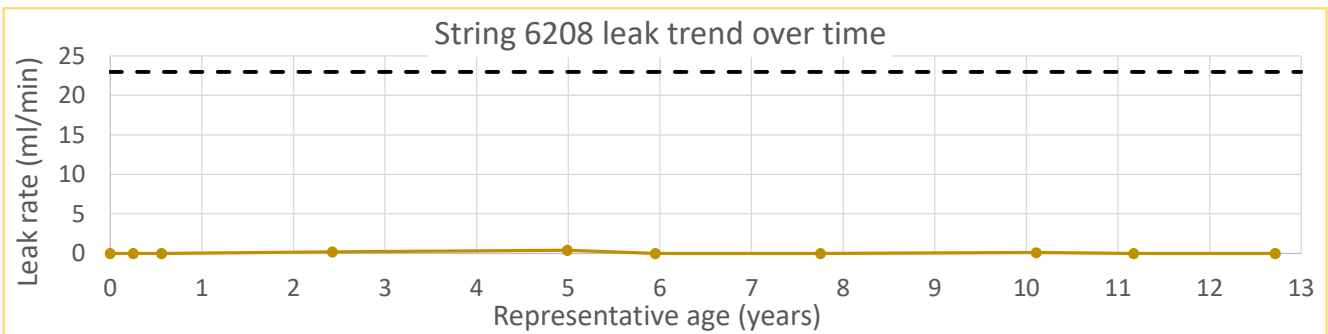
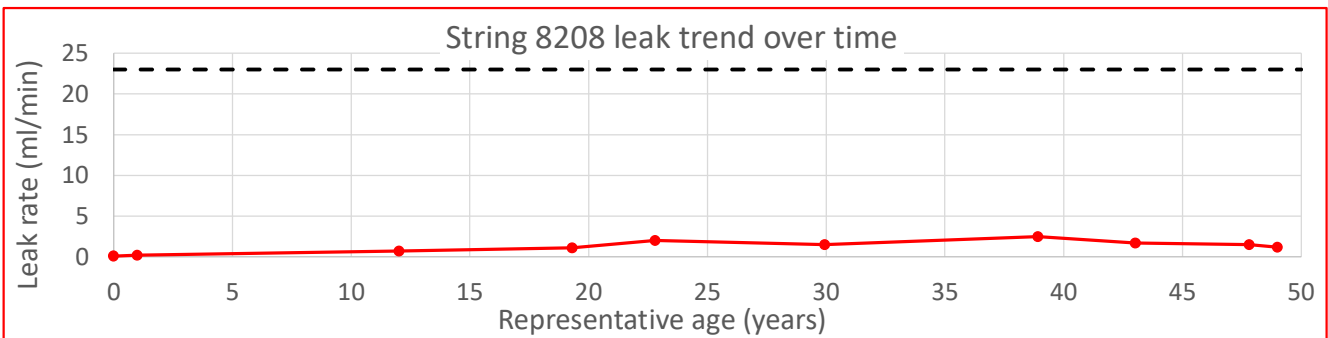
String reference		
2208	6208	8208

Sealant 208 passed with no leakage from 2208 and 6208, while leakage from 8208 was minimal. It is unknown whether 8208 leakage was from a valve stem or test joints.
