Sealant Suitability

HSS4H: 5147/06/2021 (Var. 3)

Final Report v6.0

Client: DESNZ
Project code: 316
Date: 18th June 2024
Authors: [REDACTED] [REDACTED]
[REDACTED] [REDACTED]
Technical Partner: [REDACTED] DNV

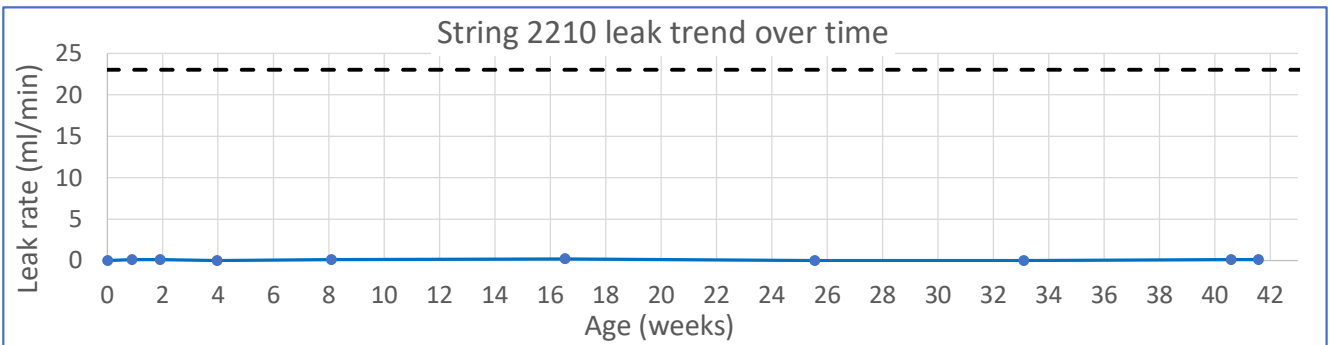
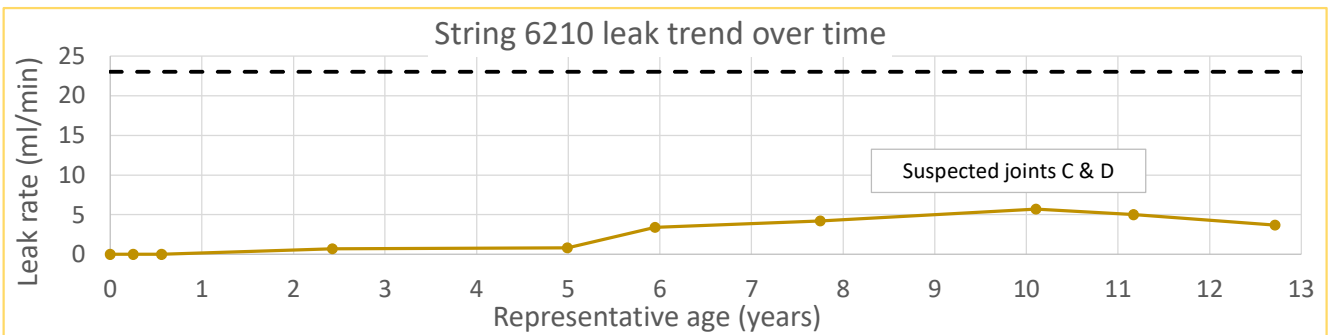
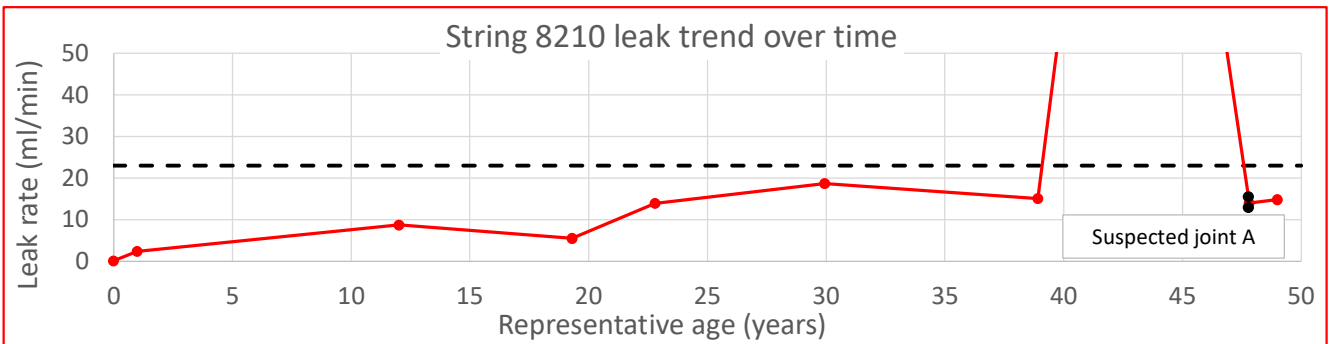
String reference		
2210	6210	8210

All three sealant 210 strings passed, however 6210 and 8210 developed leaks. A spike of 198.7 ml/min (0.012 m³/hr) from 8210 was mostly from a valve stem, the remainder suspected to be from joint A.

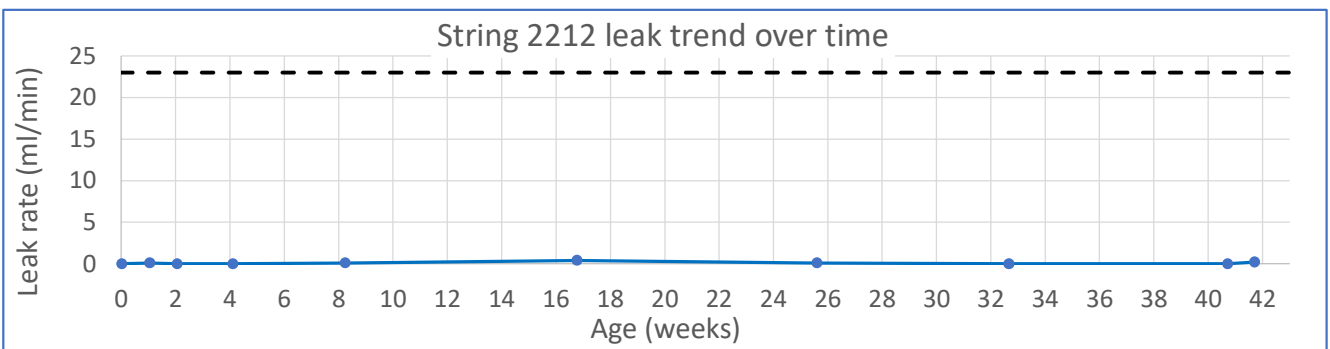
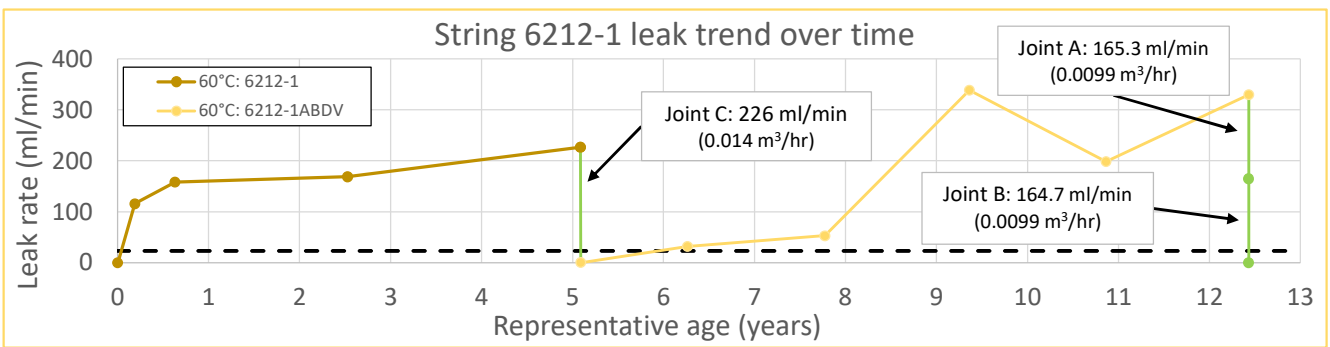
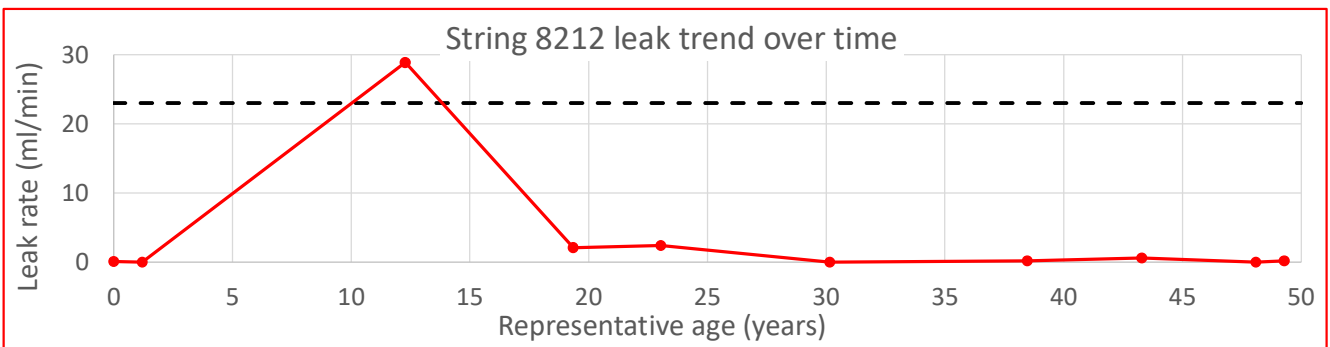
String reference		
2212	6212-1	8212

Two strings of sealant 212 passed with no significant leakage. 8212 leaked temporarily for one test, the cause or location is not known, but the profile is typical of a vale stem leak.

6212 leaked after week 1 and was remade. 6212-1 also developed a leak and joint C was retired with a leak rate of 226 ml/min (0.014 m³/hr). The remaining string then developed final leak rates of 165 ml/min from A and 165 ml/min from B (both 0.0099 m³/hr).

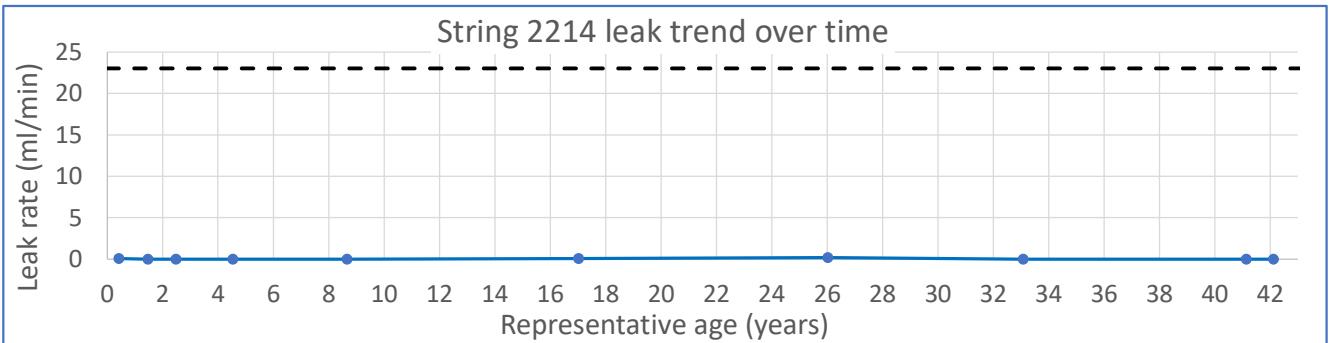
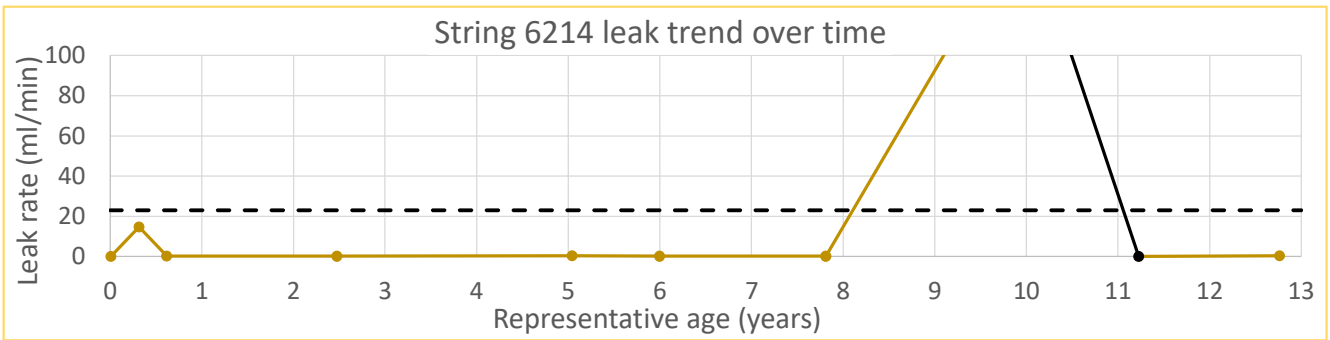
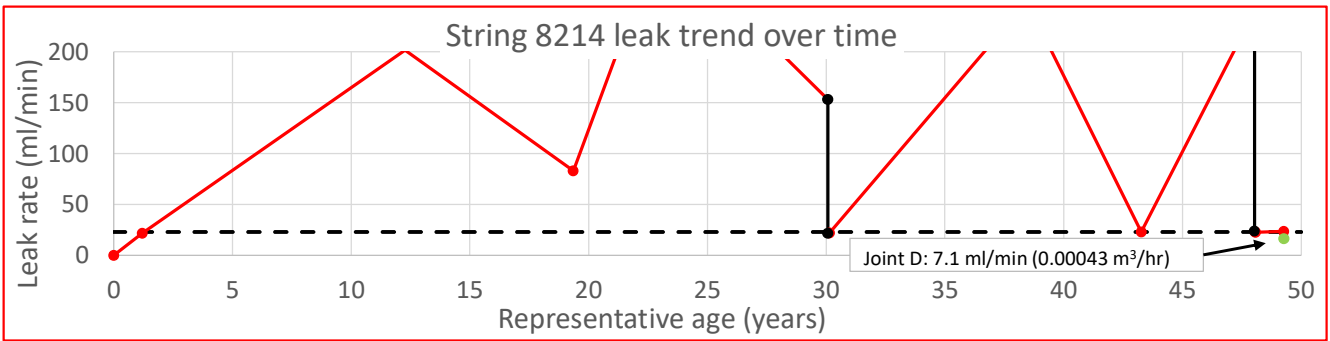
String reference		
2214	6214	8214

Sealant 214 had no leakage from 2214 or 6214. 8214 had leakage from valve stems, spiking up to 240 ml/min (0.014 m³/hr). 8214 had a final marginal failure leak rate of 23.5 ml/min (0.0014 m³/hr), of which 7.1 ml/min (0.00043 m³/hr) was attributed to joint D. None of the individual joints in 8214 had a large enough leak rate to fail.

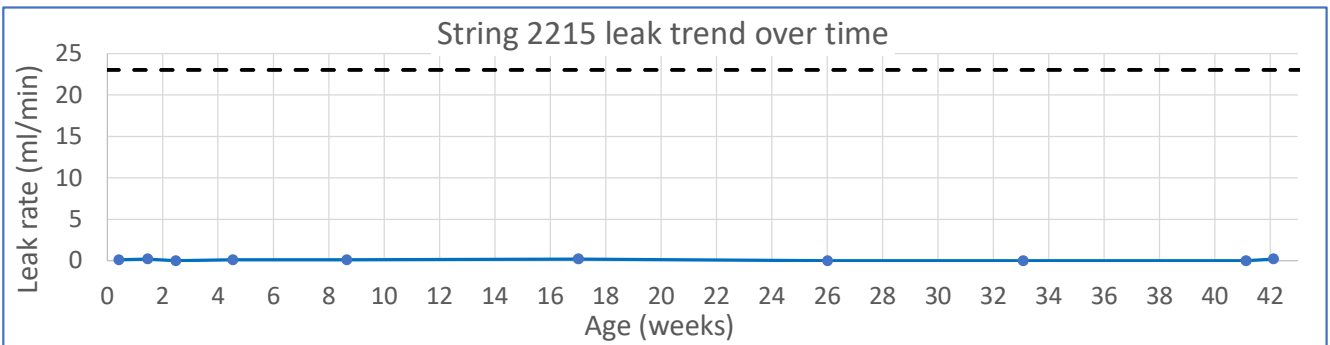
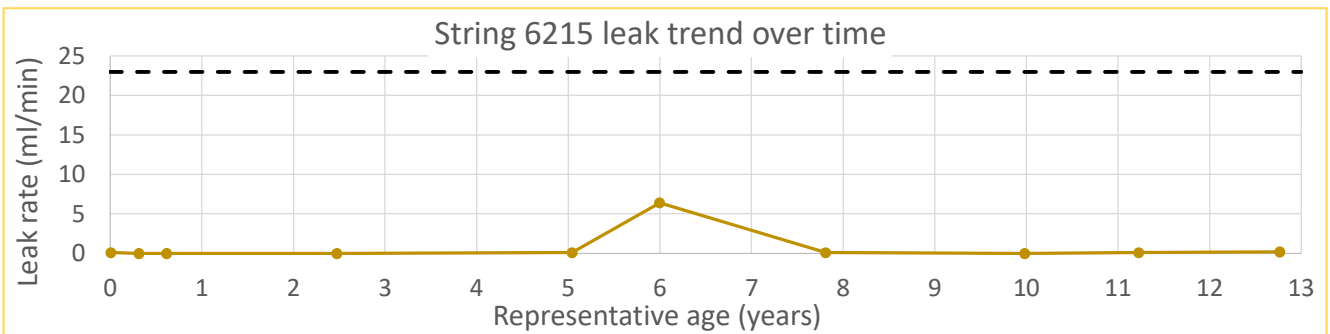
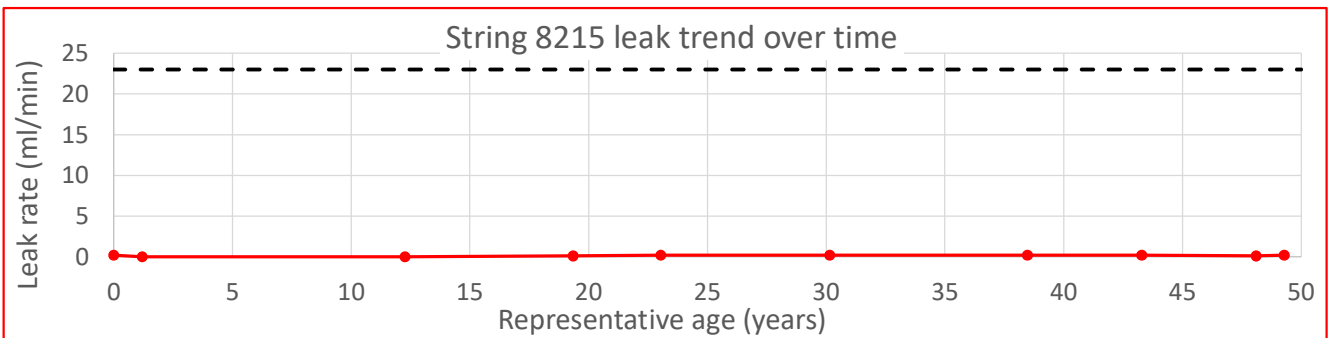
String reference		
2215	6215	8215

Sealant 215 passed with no significant leakage.

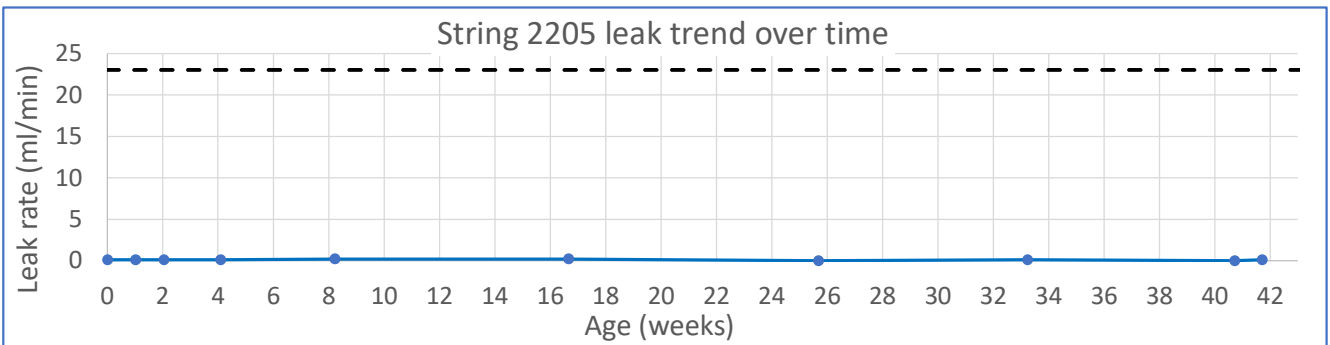
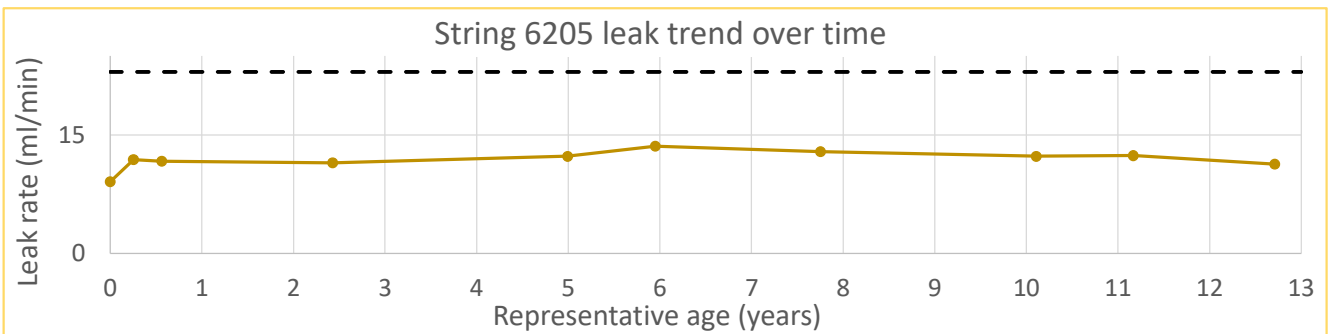
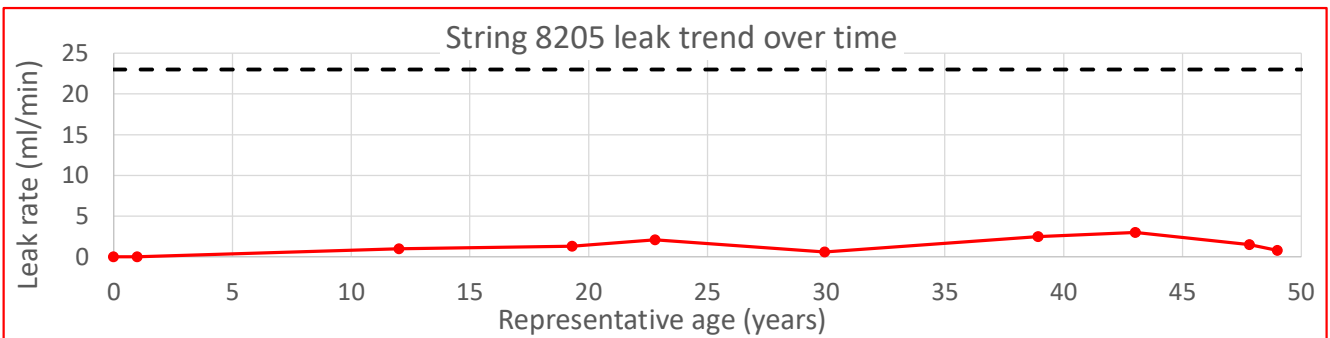
String reference		
2205	6205	8205

No significant increase in leakage was observed with sealant 205. 6205 had some leakage from initial assembly. 8205 showed signs of leakage during the test programme but this did not develop into a significant leak.

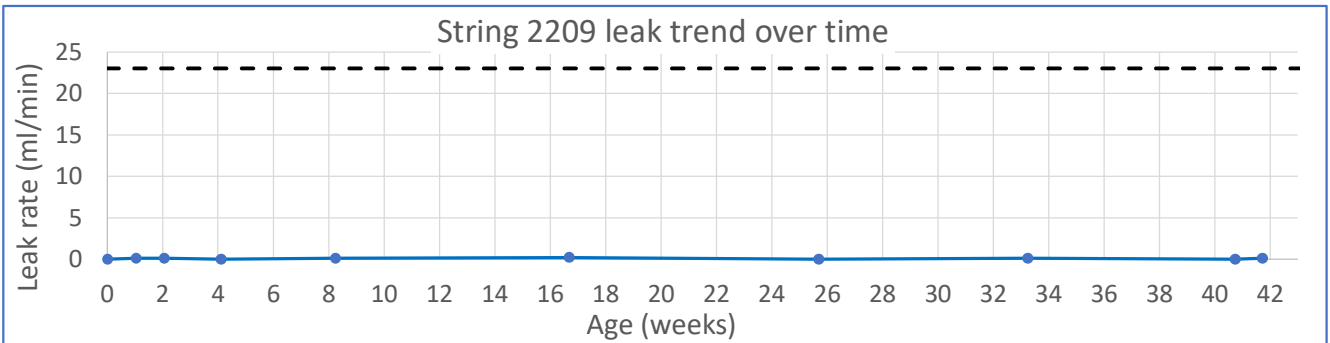
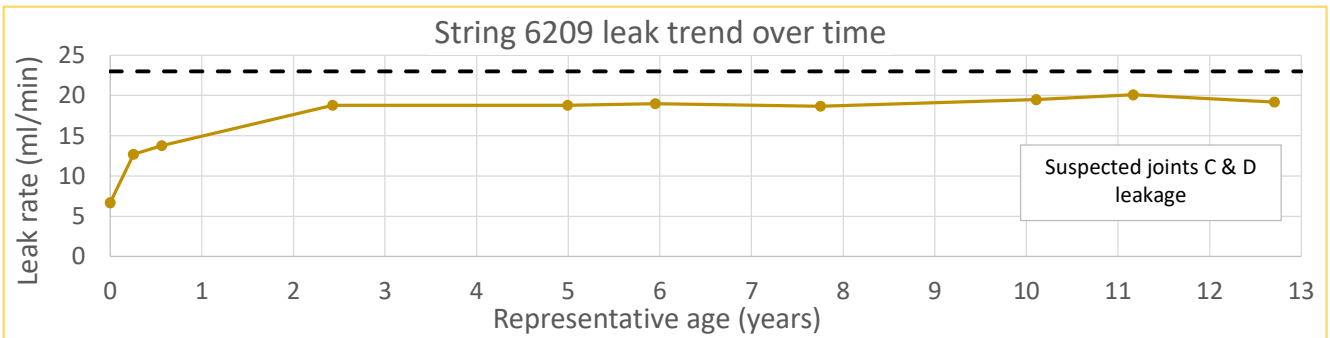
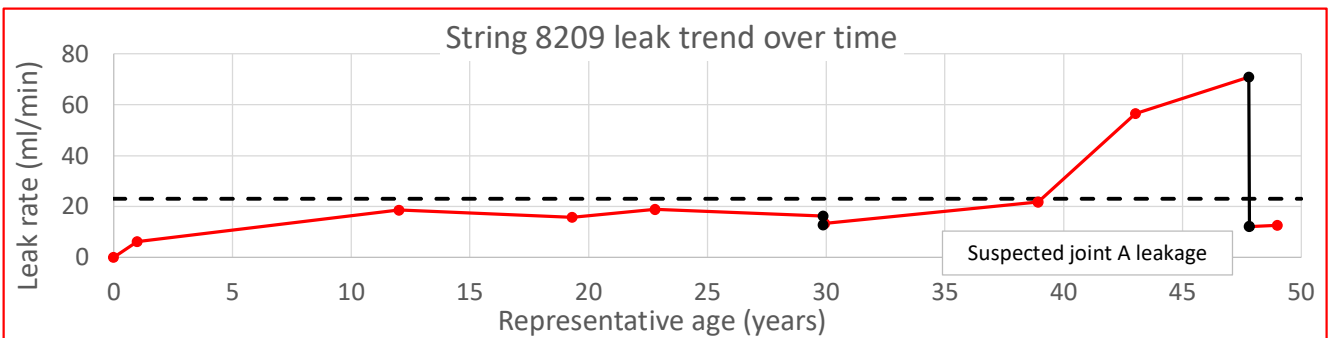
String reference		
2209	6209	8209

Sealant 209 developed some leakage in 6209 and 8209. Neither was beyond the failure leak rate, and 6209 had a baseline leak rate of 6.7 ml/min, indicating an increase of 13.4 ml/min (0.00080 m³/hr). This appeared to be mostly from joint C, with some from D. The leakage from 8209 after 40 years was from a valve stem, while the final leakage appeared to be from joint A. 2209 showed no sign of leakage.

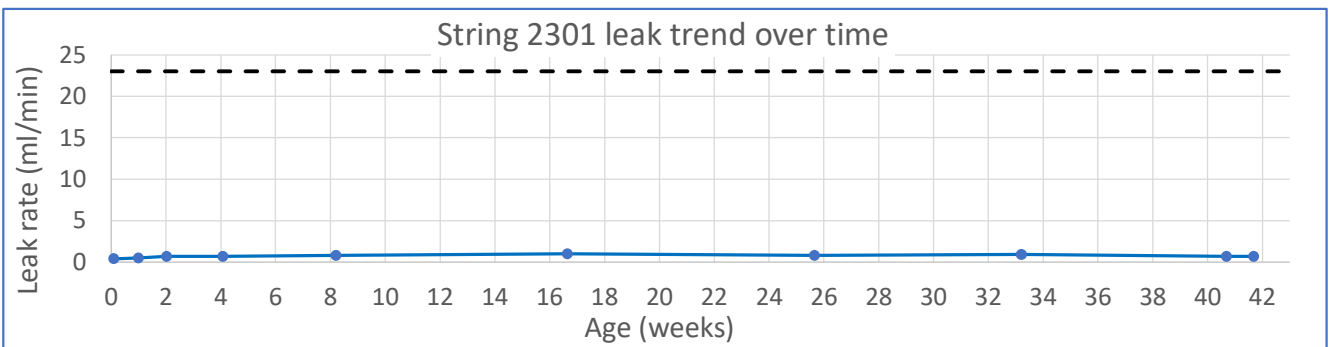
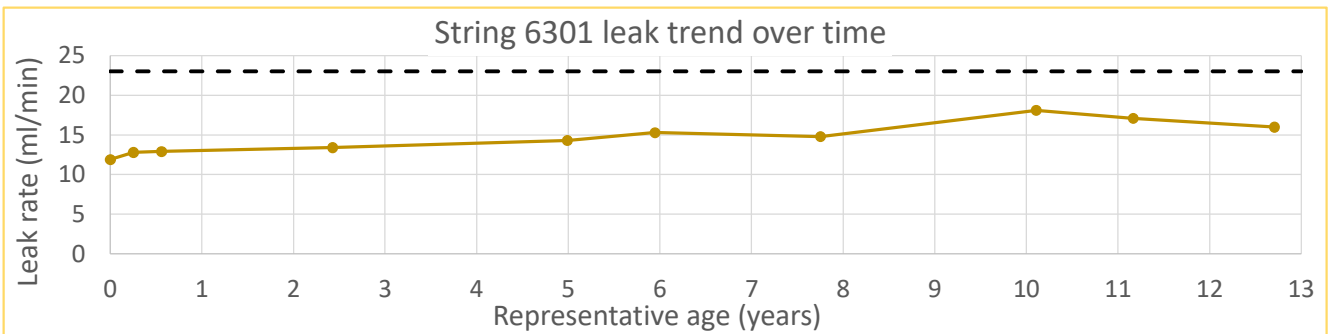
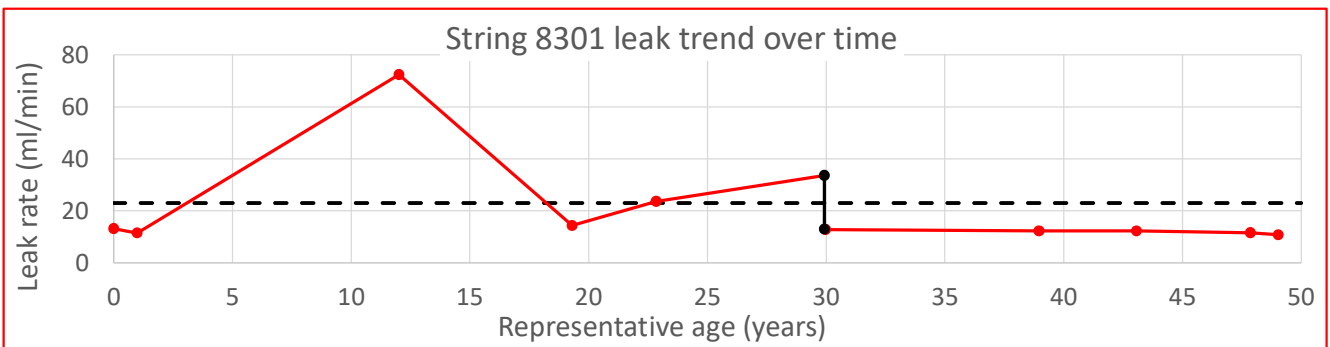
String reference		
2301	6301	8301

All three thick PTFE tape (yellow) strings showed some leakage from the initial assembly, though below the failure rate. Leakage from the 303 strings did not significantly increase over time. The spike of 72.4 ml/min (0.0043 m³/hr) from 8301 is likely but not confirmed to be from a valve stem.

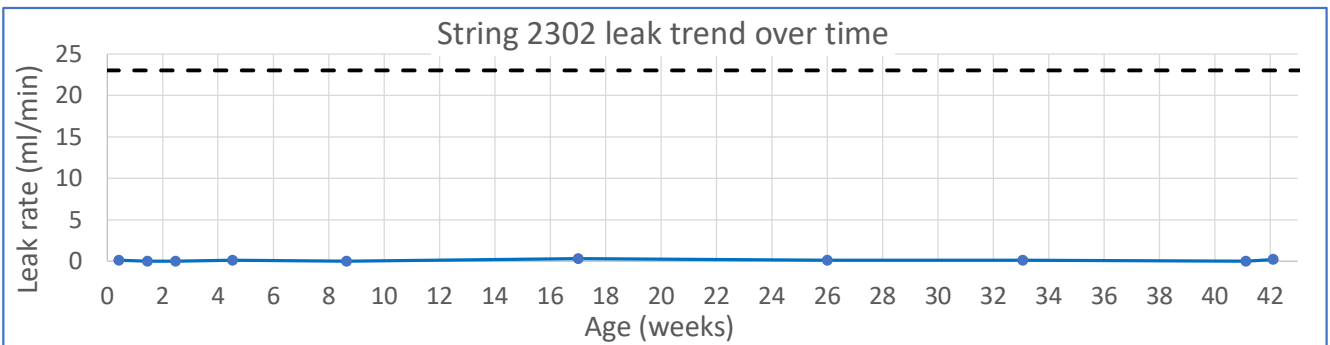
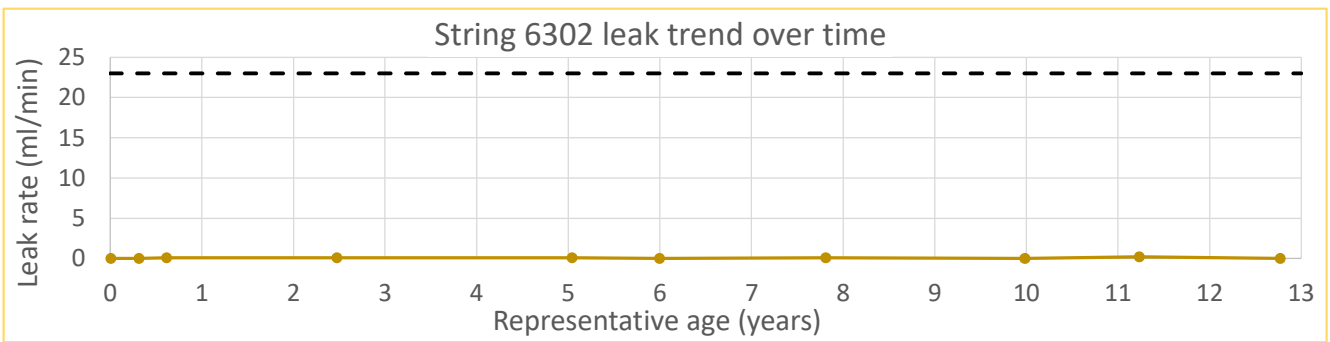
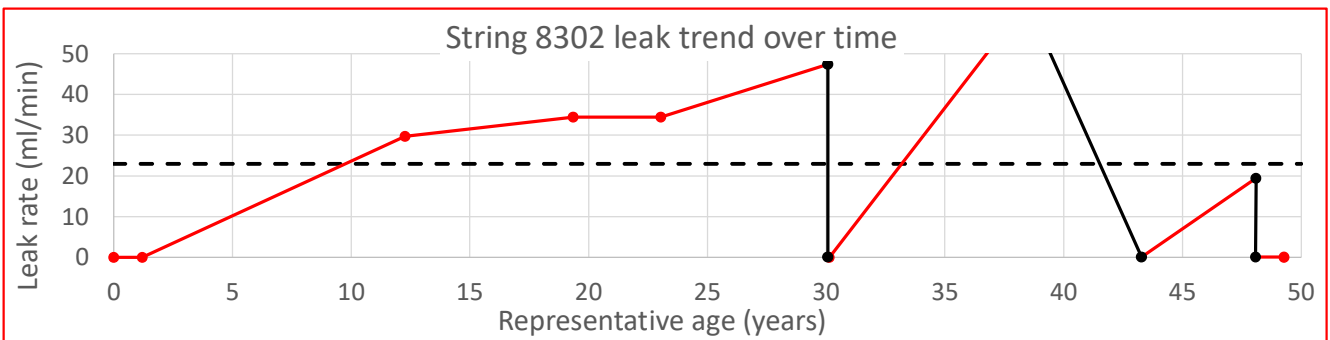
String reference		
2302	6302	8302

Thin PTFE tape (white) with compound passed with no leakage. Spikes measured in 8302 were leaks from the stem of valve 1.

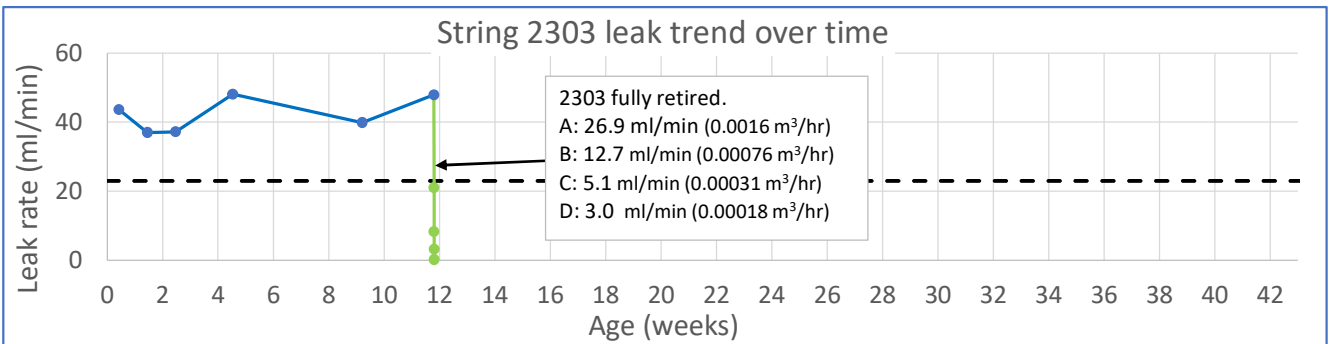
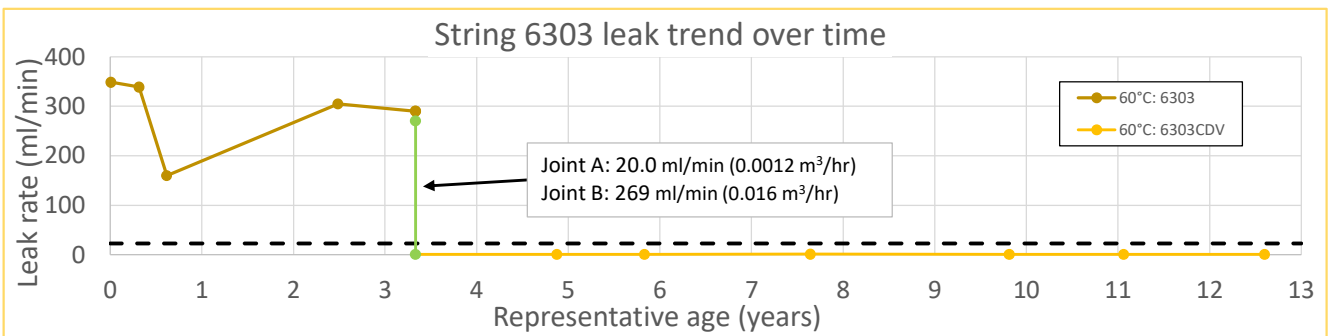
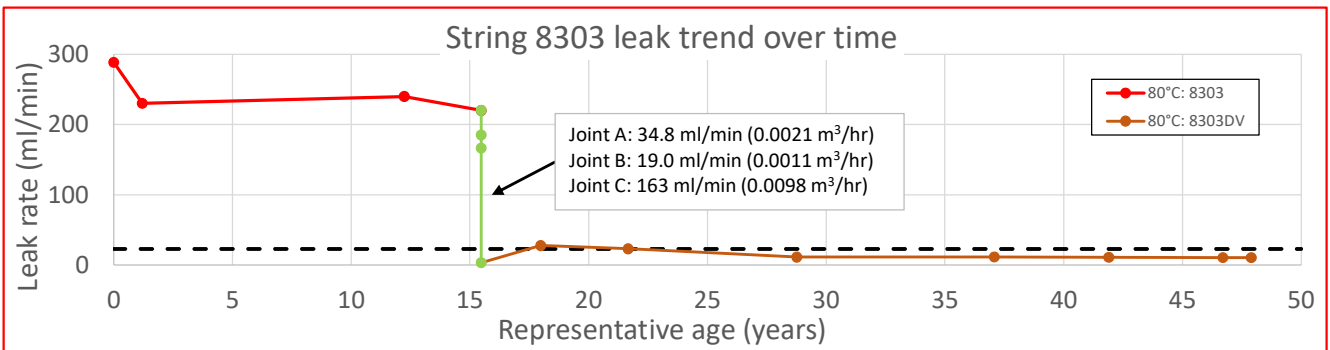
String reference		
2303	6303	8303

All three thin PTFE tape (white) strings leaked from their initial assembly. Attempts to remake leak-free strings were not successful. Leakage did not increase over time.

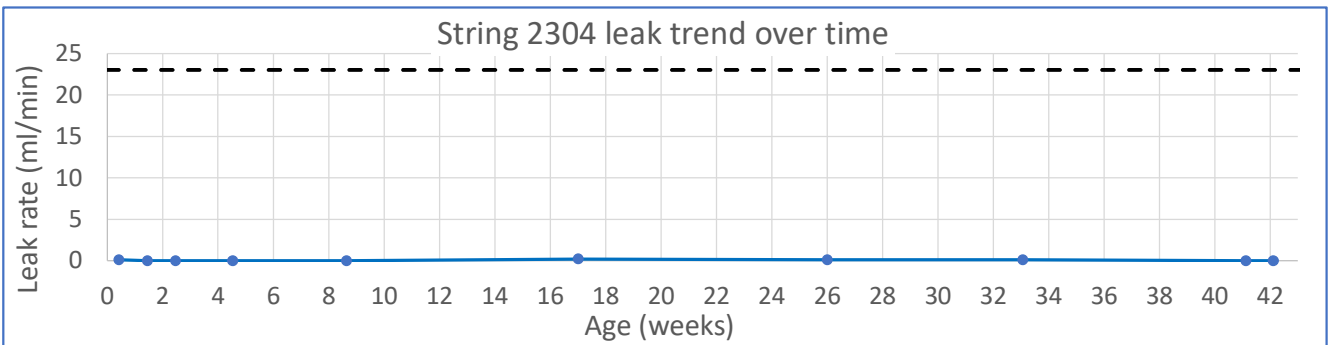
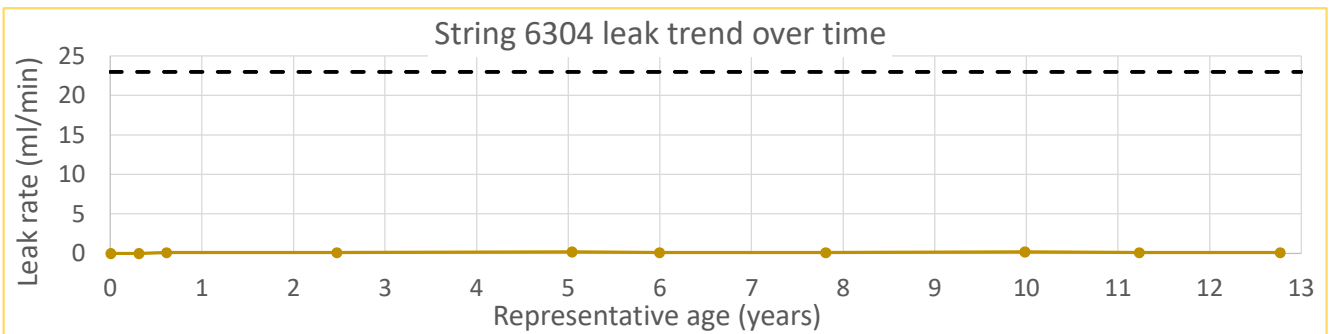
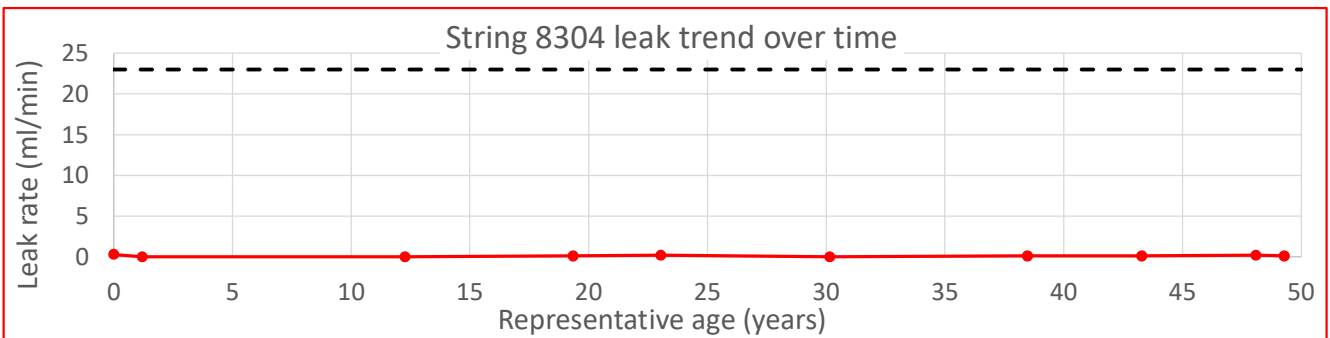
String reference		
2304	6304	8304

Thick PTFE tape (yellow) with compound passed with no leakage.
