# ***AAIB Bulletin***

***4/2026***

<b>Aircraft Type and Registration:</b>	Bristell NG5 Speed Wing, G-STEL	
<b>No &amp; Type of Engines:</b>	1 Jabiru 3300A piston engine	
<b>Year of Manufacture:</b>	2013 (Serial no: LAA 385-15235)	
<b>Date &amp; Time (UTC):</b>	20 May 2025 at 0842 hrs	
<b>Location:</b>	Near Gordon, Berwickshire	
<b>Type of Flight:</b>	Private	
<b>Persons on Board:</b>	Crew - 1	Passengers - None
<b>Injuries:</b>	Crew - 1 (Fatal)	Passengers - N/A
<b>Nature of Damage:</b>	Aircraft destroyed	
<b>Commander's Licence:</b>	Private Pilot's Licence (Aeroplanes) (Microlights Only)	
<b>Commander's Age:</b>	59 Years	
<b>Commander's Flying Experience:</b>	795 hours (of which 32 were on type) Last 90 days - 17 hours Last 28 days - 6 hours	
<b>Information Source:</b>	AAIB Field Investigation

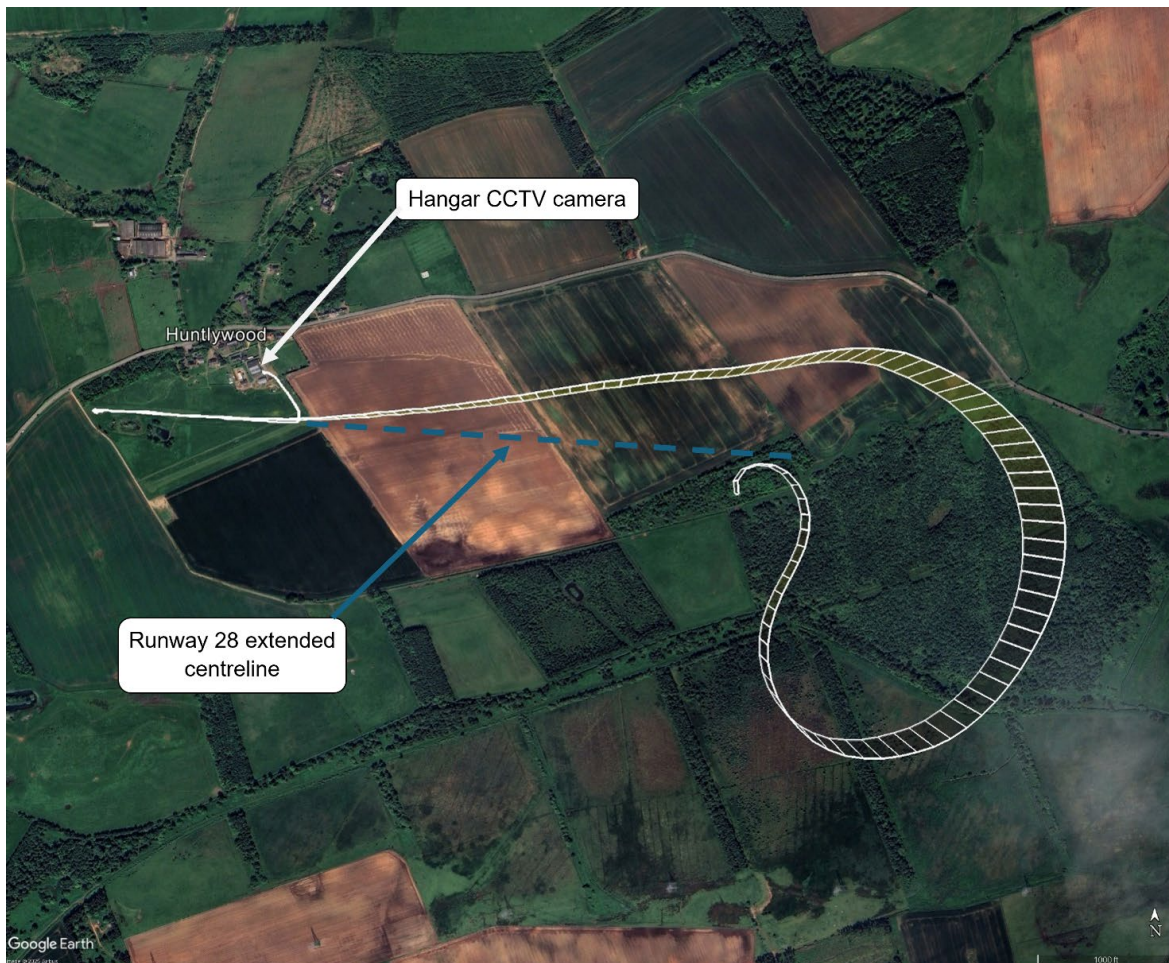
**Figure 1**

G-STEL flight path from GNSS data

A return to land on a runway reciprocal to the runway used for takeoff requires continuous manoeuvring, as shown in Figure 1. Whilst starting the left turn to align with Runway 28, the pilot appeared to enter cloud, and at the point that the aircraft re-appeared on CCTV it had a high bank angle and steep nose-down attitude consistent with a spiral descent following a loss of control. It is likely, therefore, that the pilot became spatially disorientated very rapidly after entering cloud and when emerging from the cloud had insufficient height to understand and correct the flightpath.

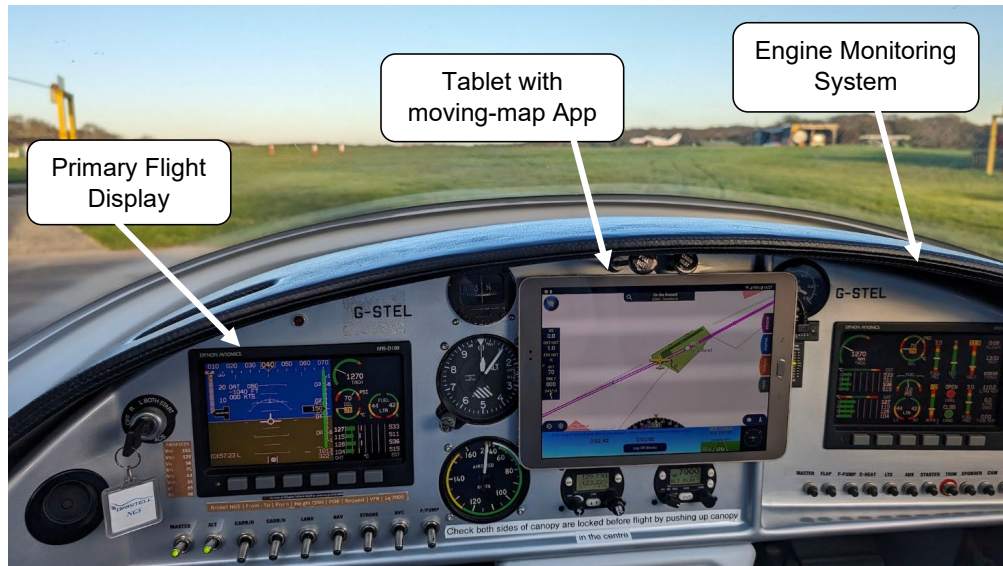
**Figure 2**

The aircraft was fitted with a number of avionics components including a Primary Flight Display (PFD) and Engine Monitoring System (EMS), (Figure 2). In addition, a tablet was attached to the instrument panel and was known to be used with a flight planning and navigation app, which included a moving map.

G-STEL cockpit image (photograph used with permission)

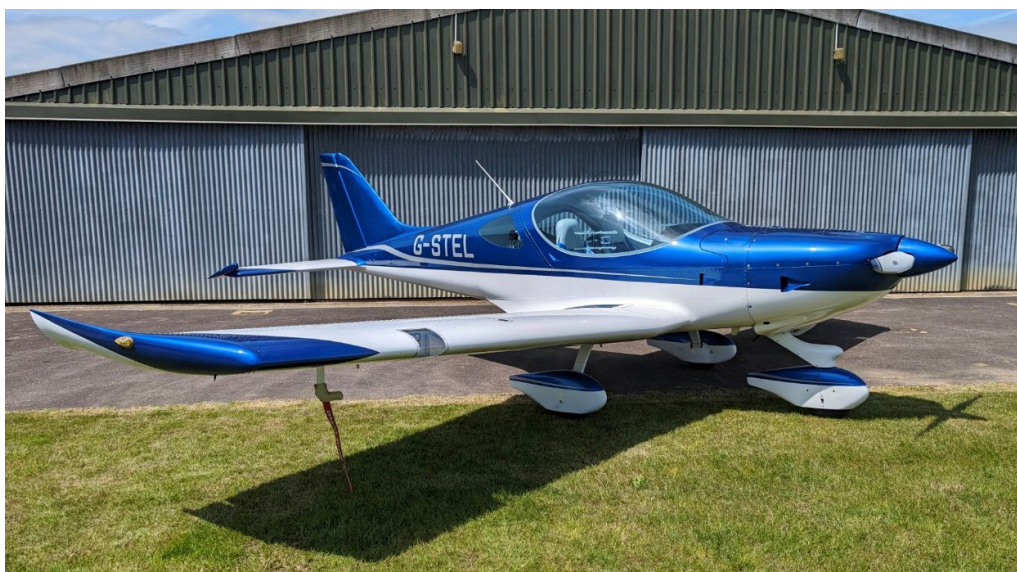
**Figure 3**

The aircraft (Figure 3) was built in 2013 and had accrued about 630 flying hours at the time of the accident. It had a Jabiru 3300A, six-cylinder engine driving a two-bladed composite propeller.

G-STEL (photograph used with permission)

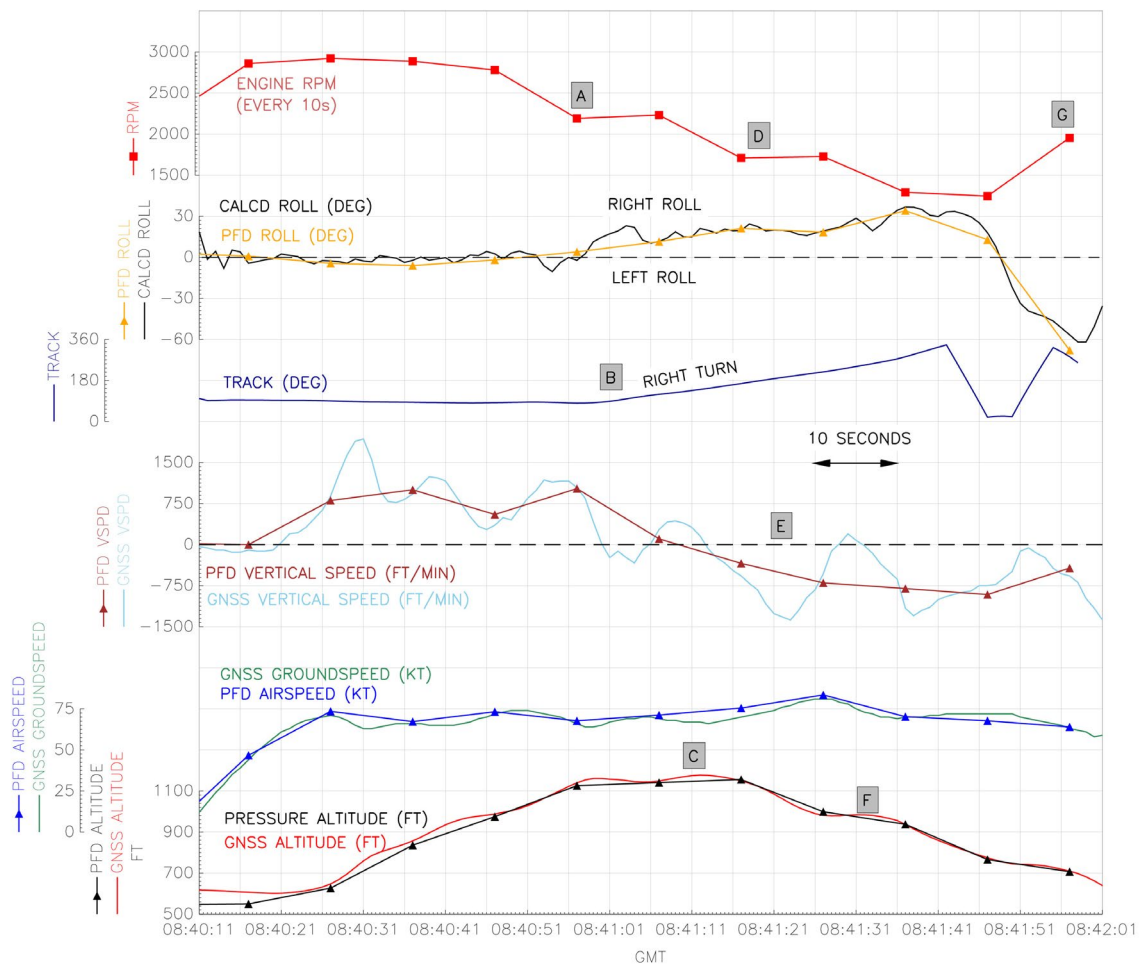
**Figure 4**

G-STEL flight data from GNSS, PFD and EMS recordings

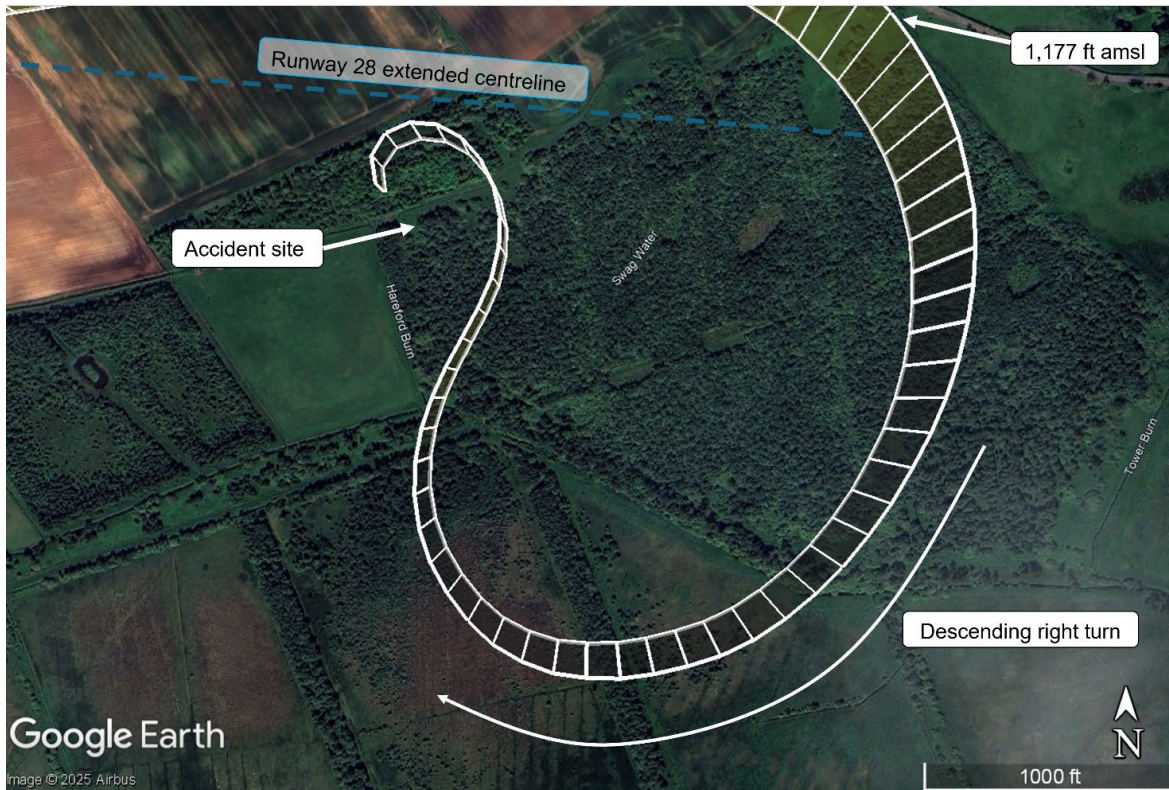
**Figure 5**

G-STEL aircraft track from recorded GNSS data

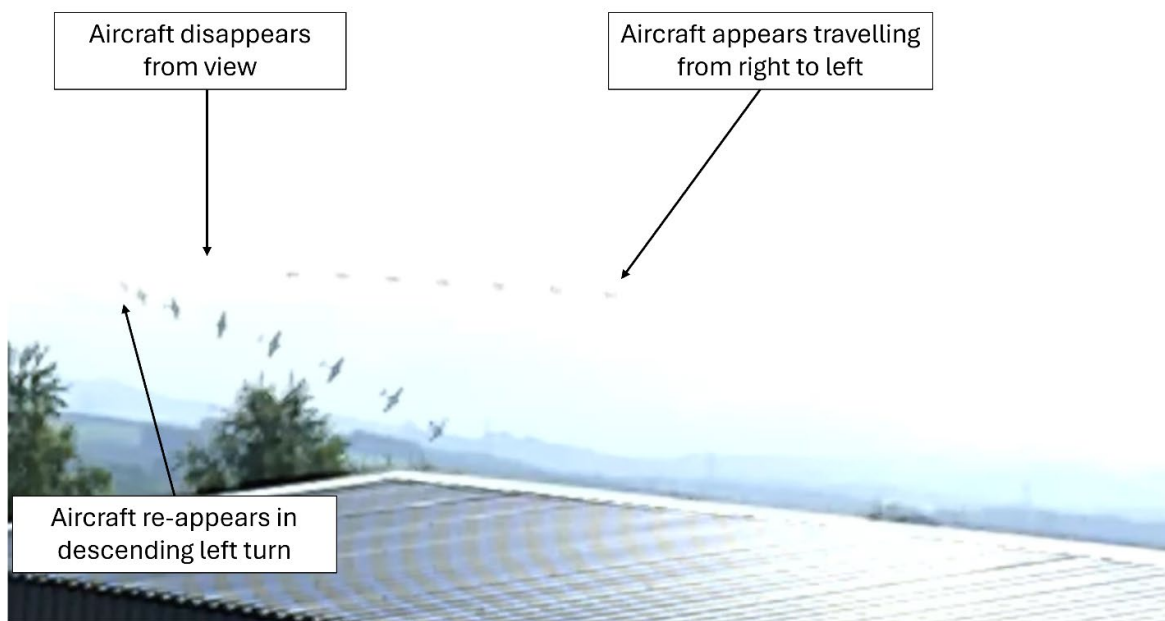
As the left turn commenced, CCTV recording from the airfield captured the aircraft on a camera mounted to the airfield hangar. This camera was approximately 0.6 nm from the accident site and the aircraft appeared in the top right corner. The footage showed the aircraft moving from right-to-left for around three seconds before disappearing from view. It re-appeared around three seconds later in a steeper descending left turn which continued until out of sight. Figure 6 shows a portion of the CCTV footage as a compound view of frames approximately every 0.5 seconds.

**Figure 6**  
G-STEL CCTV image

The period when the aircraft disappeared from the CCTV view suggested that there were pockets of poor visibility and/or cloud.

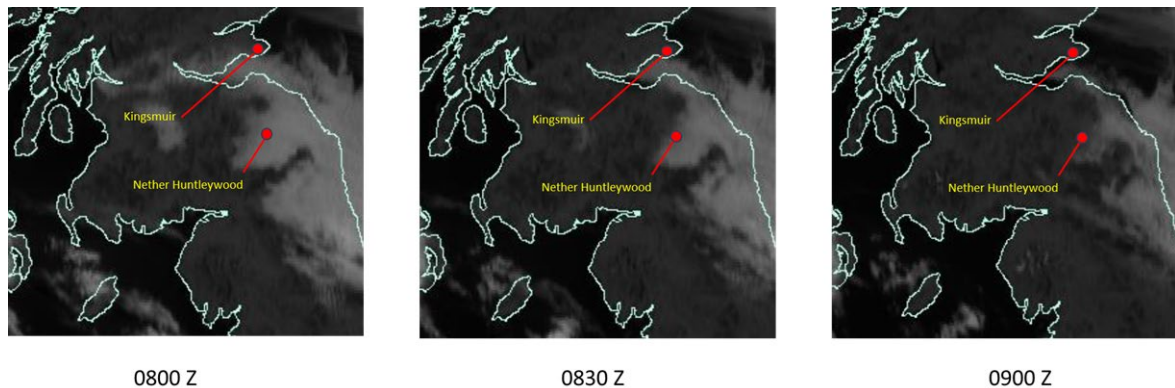
**Figure 7**

settled with a bank of cloud affecting the east coast from the Firth of Forth southwards. This cloud penetrated inland and affected the Huntlywood area during the morning but cleared by 0900 hrs. Some low cloud would also have affected the Kingsmuir area during the early part of the morning, but this appears to have cleared by 0830 hrs. From the observations, surface visibility remained above 10 km throughout the period of interest.

Met Office Aftercast cloud cover

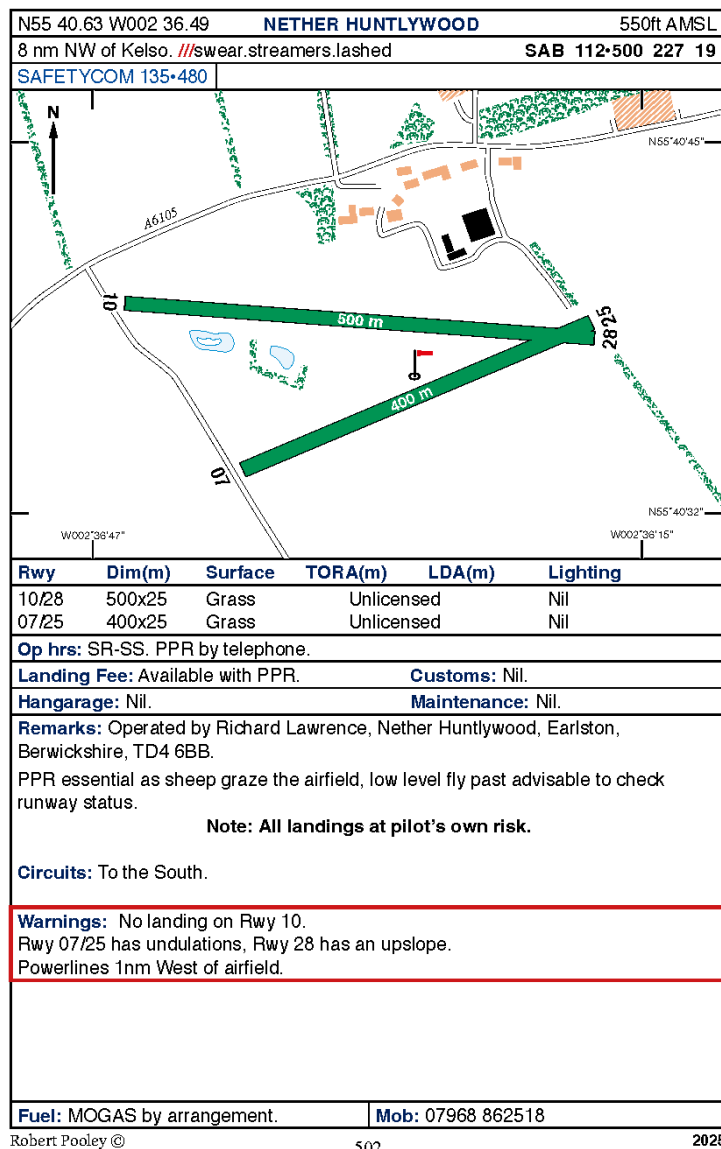
**Figure 8**

The airfield sits at an elevation of 550 ft amsl, with sheep commonly grazing on the runways. In the *'Warnings'* section of the Pooley's guide to the airfield it states: *'No landing on Rwy 10'*.

Pooley's Nether Huntlywood airfield plate

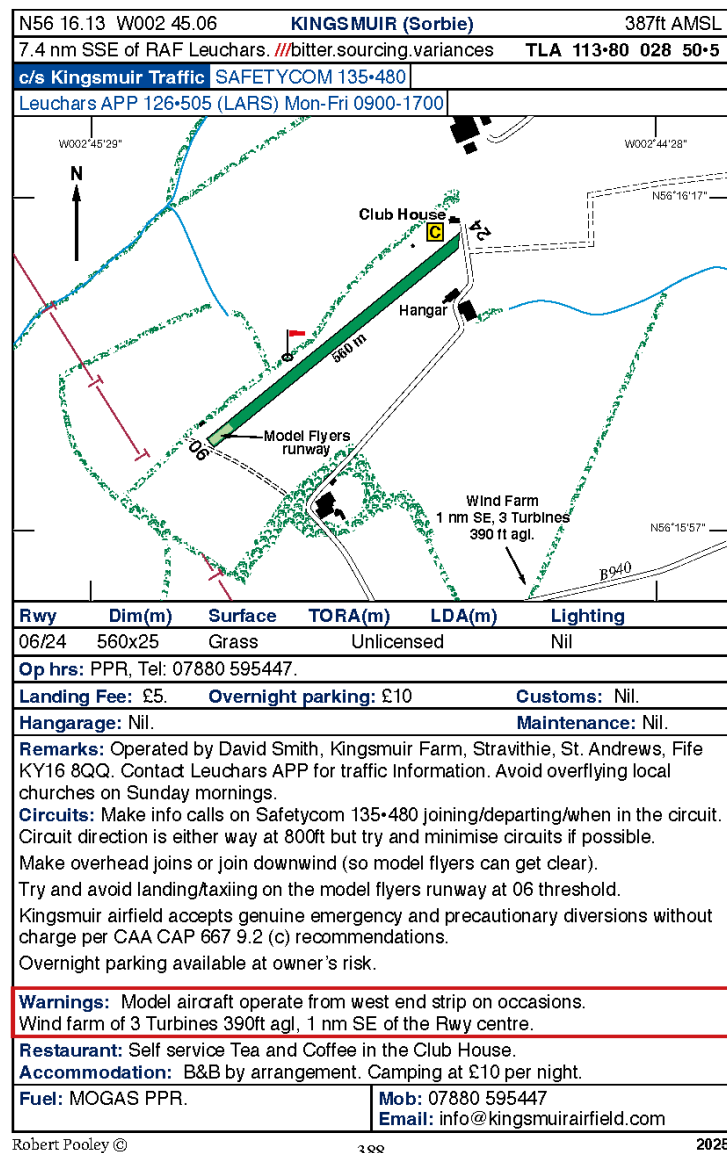
Figure 9

Pooley's Kingsmuir airfield plate

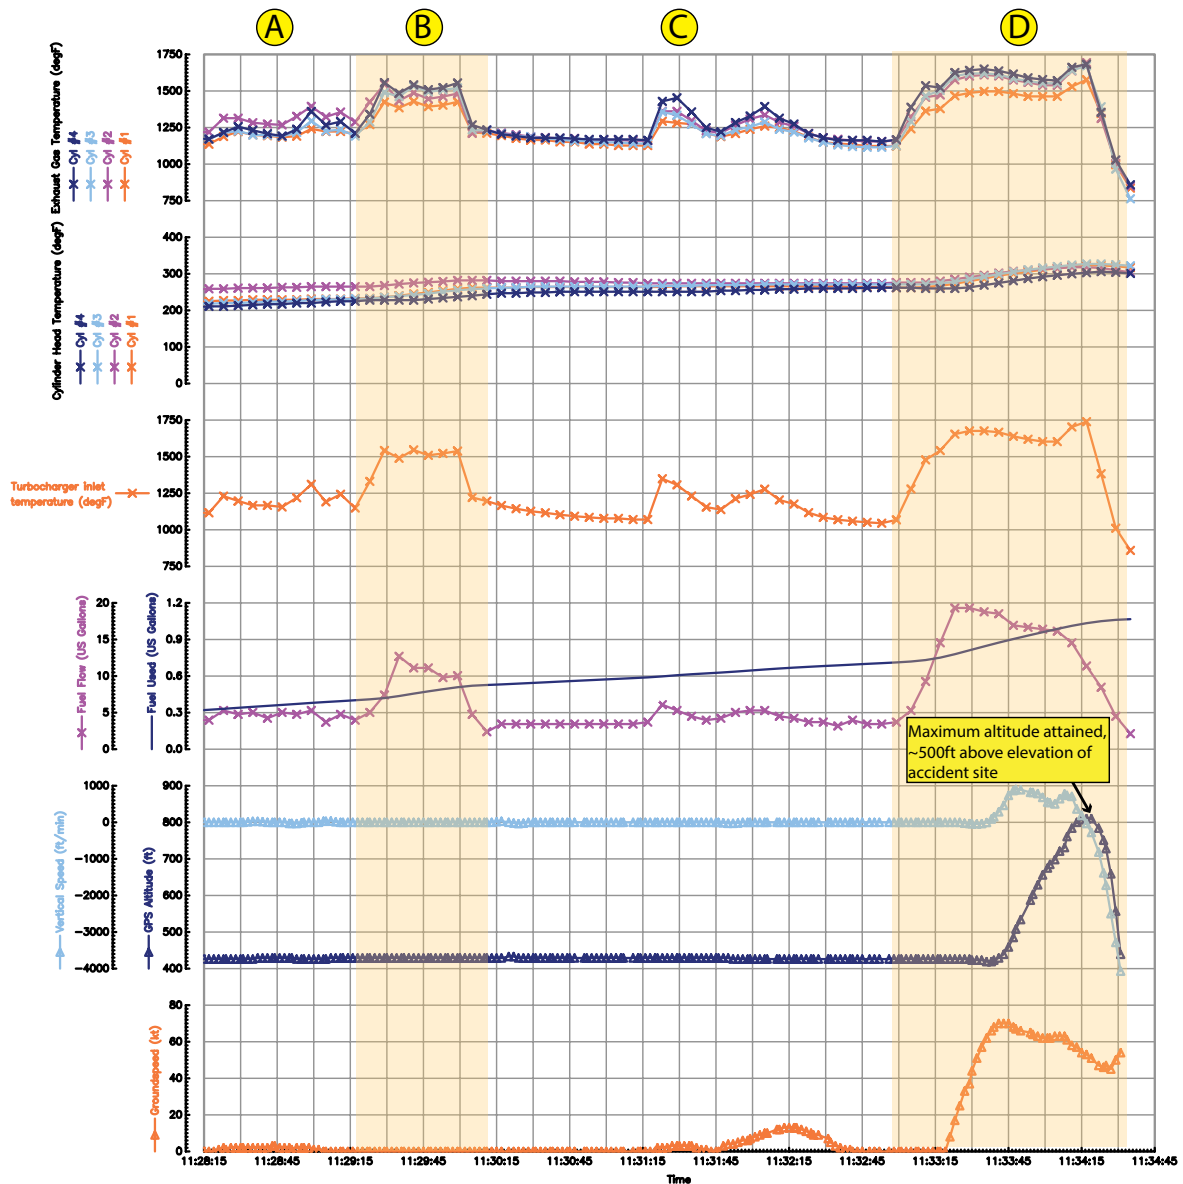
Pilot Aware and engine monitor data for the accident flight

Area A of Figure 2 shows N4698W taxiing to the area where engine run-up checks were performed, area B the actual engine run-up, area C the taxiing and back-tracking of the runway and area D the takeoff and initial climb-out. Of note is the solid blue line with no markers that represents the cumulative fuel used in US gallons (US gal). This shows that approximately 1.1 US gal of fuel was used before the engine parameters indicated that the engine was failing.

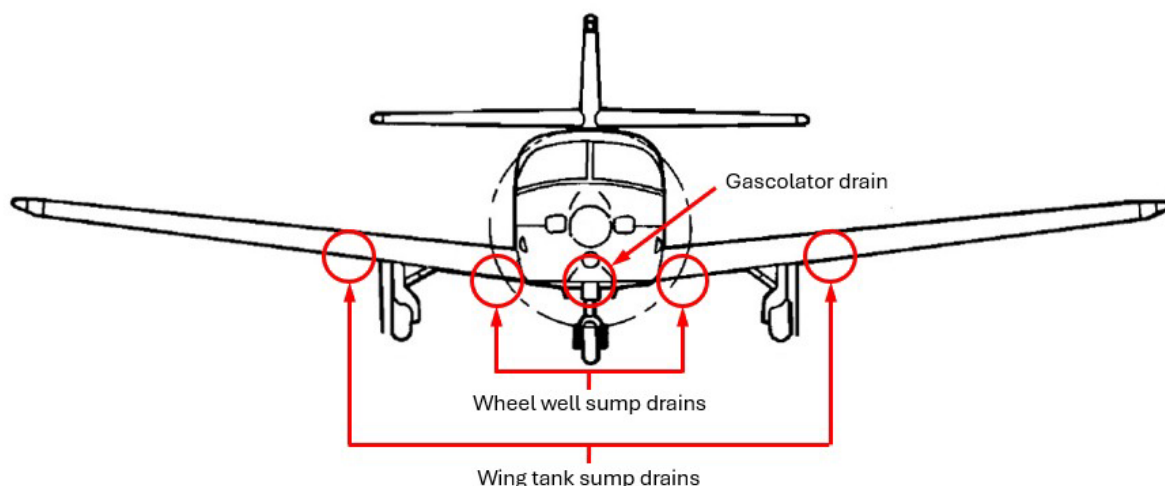
**Figure 3**

The Rockwell Commander 112 TCA is a four-seat light aircraft powered by a single turbocharged four-cylinder piston engine, driving a three-bladed constant speed propeller. The aircraft has one fuel tank in each wing and each tank has a useable capacity of 34 US gal. Two fuel sump drain points are provided for each wing, one at the inboard end of the tank and a second inboard of the main landing gear wheel well, close to the fuselage side (Figure 3).

Rockwell Commander 112TCA fuel sump drain locations

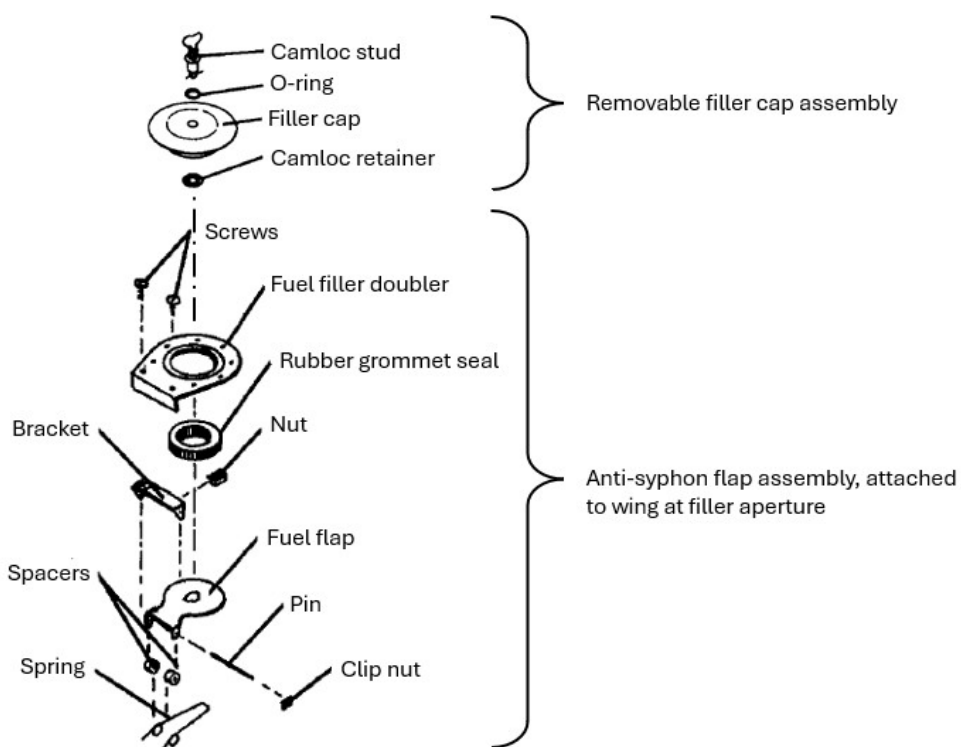
**Figure 4**

Each wing fuel tank has a single filler cap that is secured in place by a quick-release Camloc stud (Figure 4). The stud engages with a hinged flap immediately beneath the fuel filler aperture. The hinged flap provides an anti-syphon function in case the filler cap releases in-flight. When the stud is engaged in the hinged flap, the filler cap is pulled downwards against a rubber grommet seal, to seal the filler cap to the wing. The stud's shaft has an O-ring seal that is compressed when the filler cap is locked, to provide sealing between the head of the stud and the top of the filler cap.

Wing fuel tank filler cap and anti-syphon flap assembly (adapted from Rockwell Commander 112TCA Illustrated Parts Catalogue, courtesy of Commander Aircraft Corp)

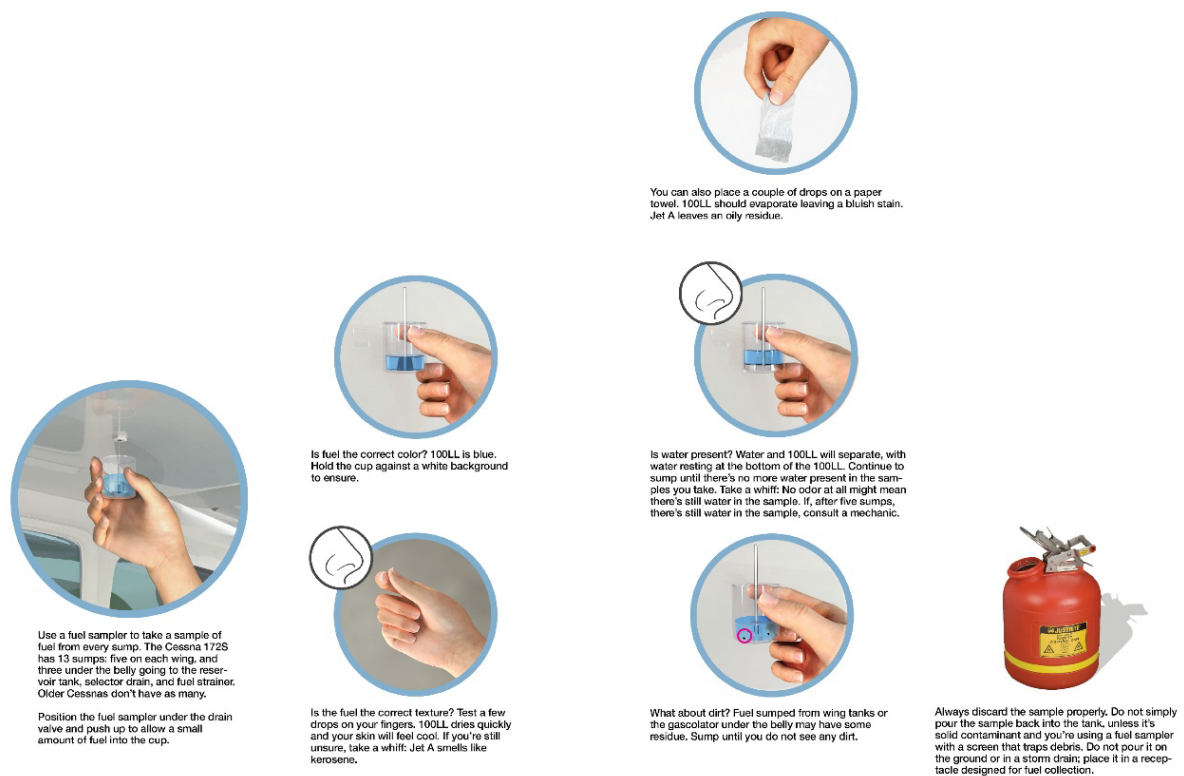
**Figure 10**

AOPA article on fuel sumping techniques

The CAA’s ‘Safety sense leaflet number 28: Fuel Handling and Storage’ covers fuel sampling and testing. It states, ‘Draw fuel from each drain or sump and examine it in accordance with the Flight Manual or Operating Handbook’. Further, when discussing drawing a fuel sample it states that ‘If you see no separation in the sample, confirm that the sample is all fuel rather than all water’.

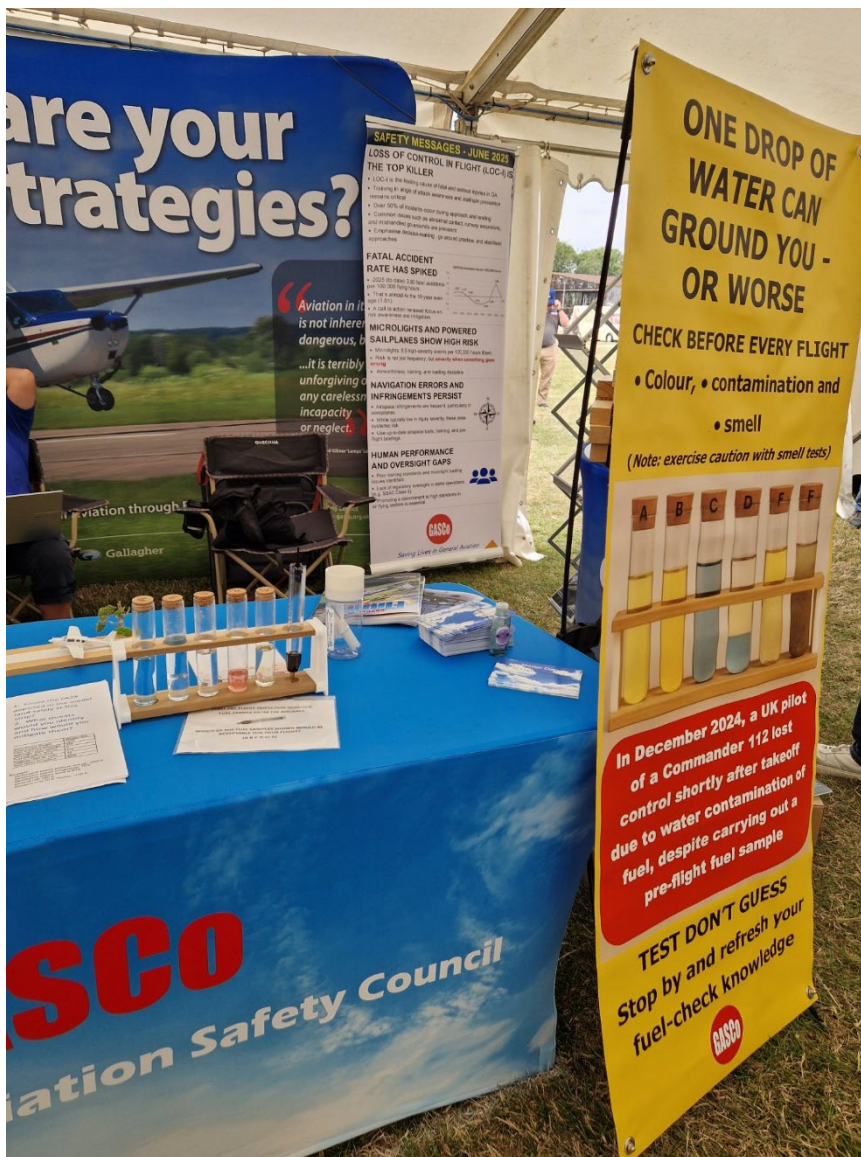
The AAIB is aware that the UK General Aviation Safety Council (GASCo) has also been highlighting the risk of fuel contamination at various general aviation events over the summer in response to AAIB Special Bulletin S1/2025 on this accident. They have been demonstrating that smell alone does not confirm the sample is Avgas and that it can be visually challenging to tell the difference between a full sample of water or Avgas using several test tubes filled with different combinations of fuel and water for pilots to learn from.

**Figure 11**  
GASCo Safety Promotion work

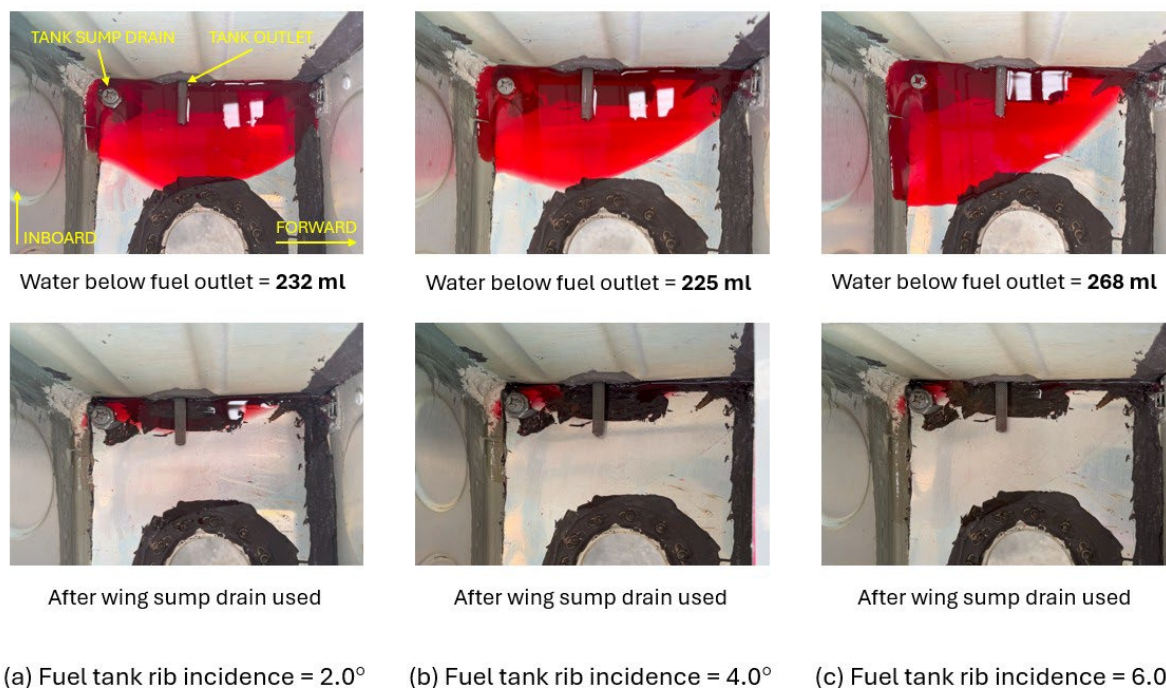
**Figure 12**

Nine other Rockwell Commander 112/114/115<sup>9</sup> aircraft were measured to assess the typical range of wing pitch attitudes (measured at the rib at the inboard end of the wing fuel tank) when parked, and what the dihedral<sup>10</sup> angle of wings was at the inboard end of the wing fuel tank. The average wing dihedral measured was 6.2°, and the incidence of the inboard fuel tank rib ranged between 2.0° and 5.7°. N4698W's right wing was supported at a dihedral angle of 6.2° and at three different pitch angles, 2.0°, 4.0° and 6.0°, to cover the range observed in the other aircraft assessed. For each pitch angle, a measured volume of water, coloured red to aid visibility, was added to the fuel tank to assess how much water could collect at the inboard end of the tank before it began to flow out of the tank outlet fitting (Figure 12). The amount of water able to collect in the wing tank varied between 225 ml and 268 ml, depending on the wing pitch attitude.

The effect of draining the water from the fuel tank using the tank sump drain was also assessed for each pitch angle. In every case, the tank sump drain was effective in removing all but a very small residue of the water in the fuel tank.

Water retained in the wing fuel tank at varying wing pitch angles and effect of using the fuel tank sump drain. Water coloured red to aid visibility

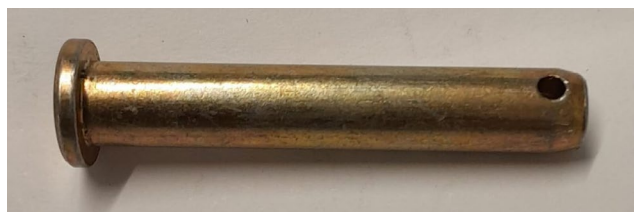
**Figure 3**

Assessment by the aircraft repair organisation identified that the equivalent clevis pin on the right aileron was a non-standard part (Figure 2) and had a larger diameter than the part specified by the aircraft manufacturer (Figure 3), and that the hinge bracket was also worn.

Unused clevis pin, part number AN394-41 that should be fitted to PA-22-108 aileron hinges
