Rail Accident Investigation Branch

Rail Accident Report

Derailment at Denbigh Hall South Junction, near Bletchley, Buckinghamshire 26 June 2025

Report 04/2026
April 2026

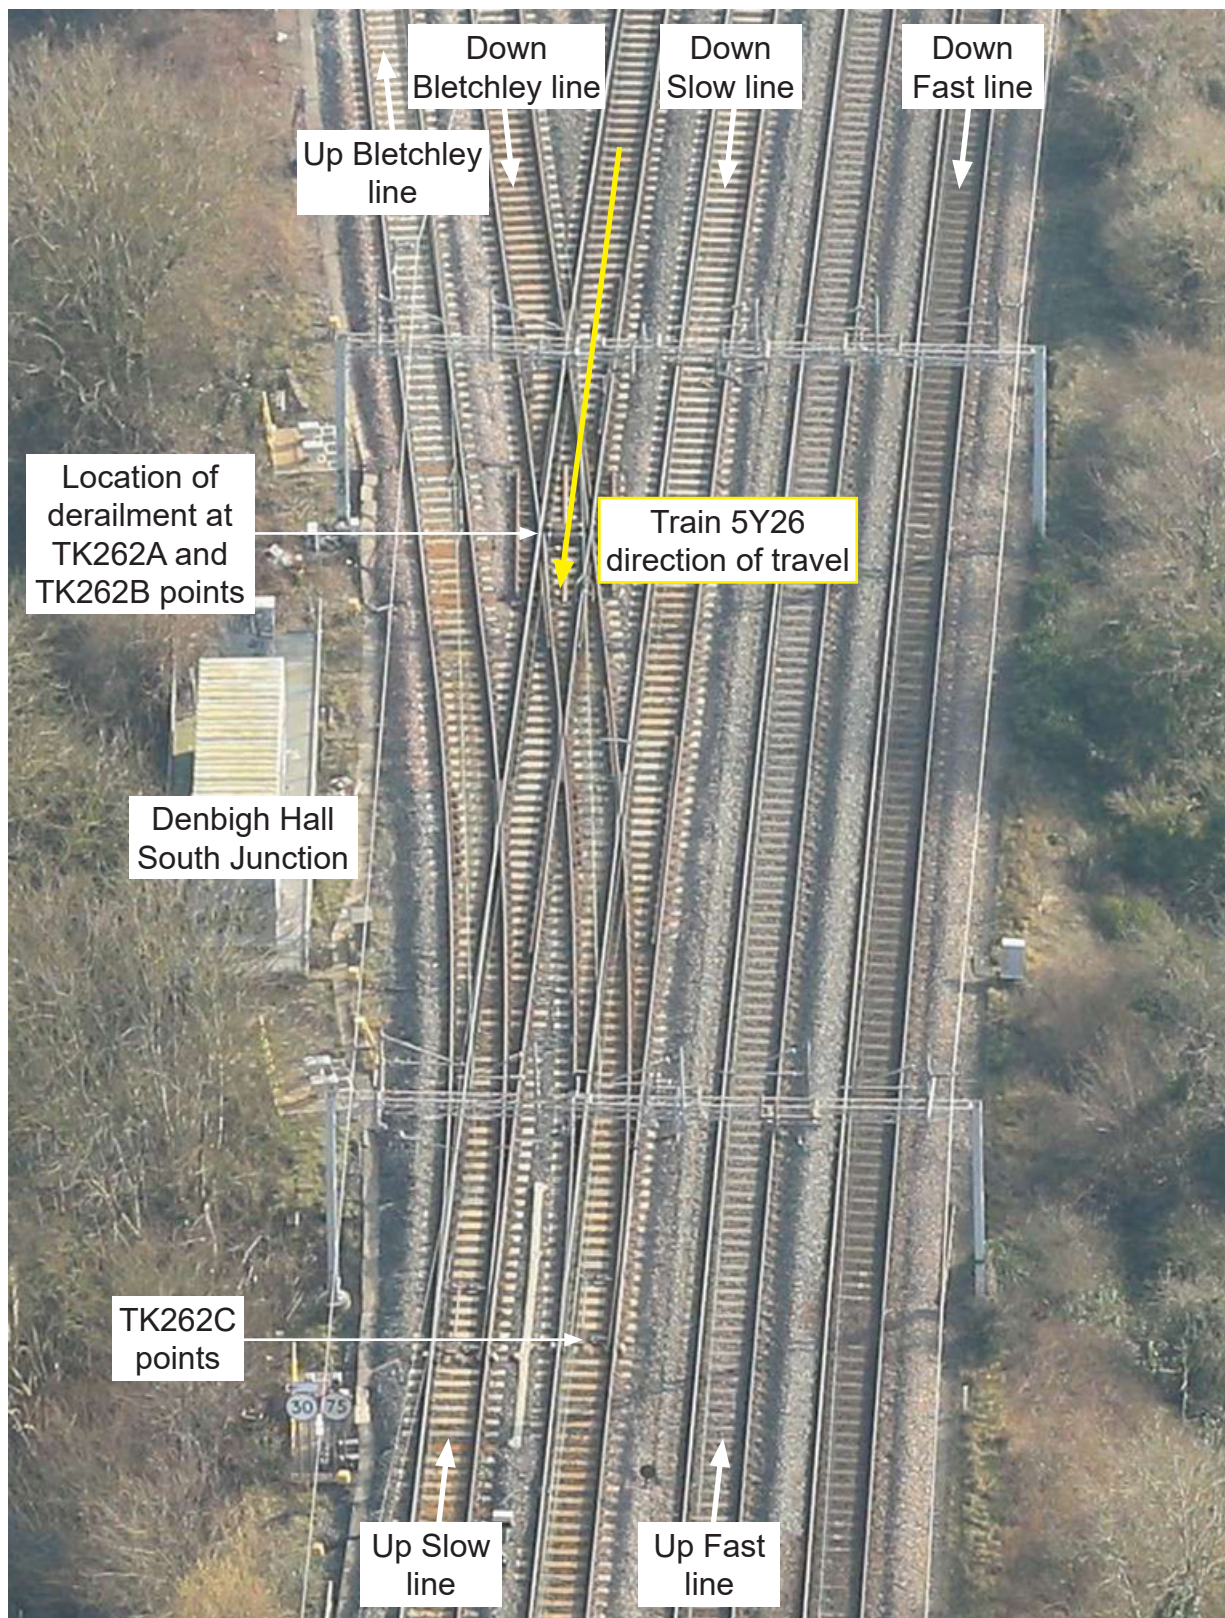
Figure 5: Denbigh Hall South Junction viewed from above (courtesy of Network Rail with RAIB annotations).

- 17 The switch diamond points at Denbigh Hall South Junction allow trains travelling on the Down Bletchley line to cross the Up Slow line and then join the Down Slow line (figure 5). Similarly, they allow trains travelling on the Up Slow line to cross the Down Bletchley line and continue on the Up Slow line. The points that facilitate these train movements are identified as TK262 points. The switch diamond points, located where the two lines cross, comprise two point ends which are identified as TK262A and TK262B. A third set of points, identified as TK262C, also form part of TK262 points and is located where the Down Bletchley line joins the Down Slow line (figure 5).

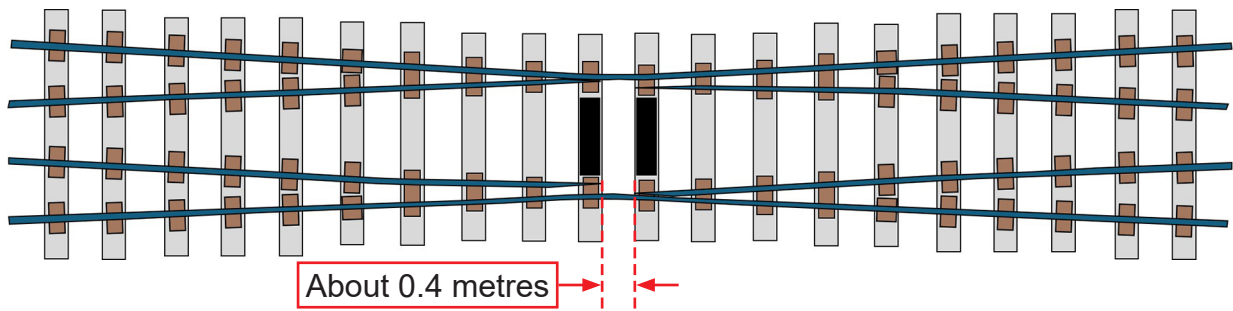
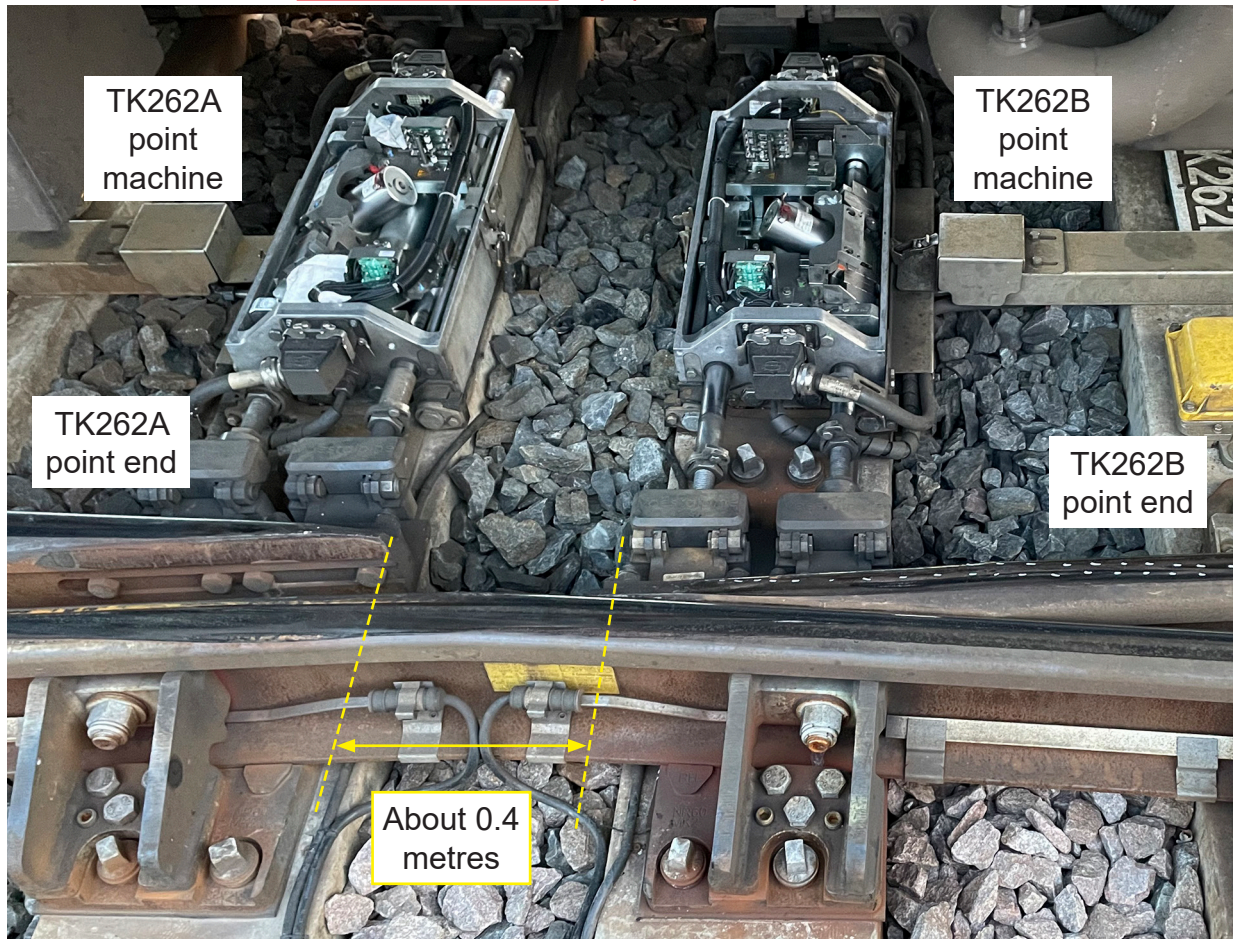
Figure 7: Switch diamond point end arrangement.

- 18 Network Rail company standard NR/L2/TRK/2102, 'Design and Construction of Track', issue 13 dated 1 March 2025, defines a switch diamond as consisting of two obtuse crossings in which the obtuse point rails are replaced by switch rails (figure 7). Consequently, the switch rails used for a switch diamond are different to the switch rails found at a standard set of points, being much shorter and less tapered. The two point ends are also located very close to each other. At Denbigh Hall South Junction they were separated by one sleeper bay, so were about 0.4 metres apart.

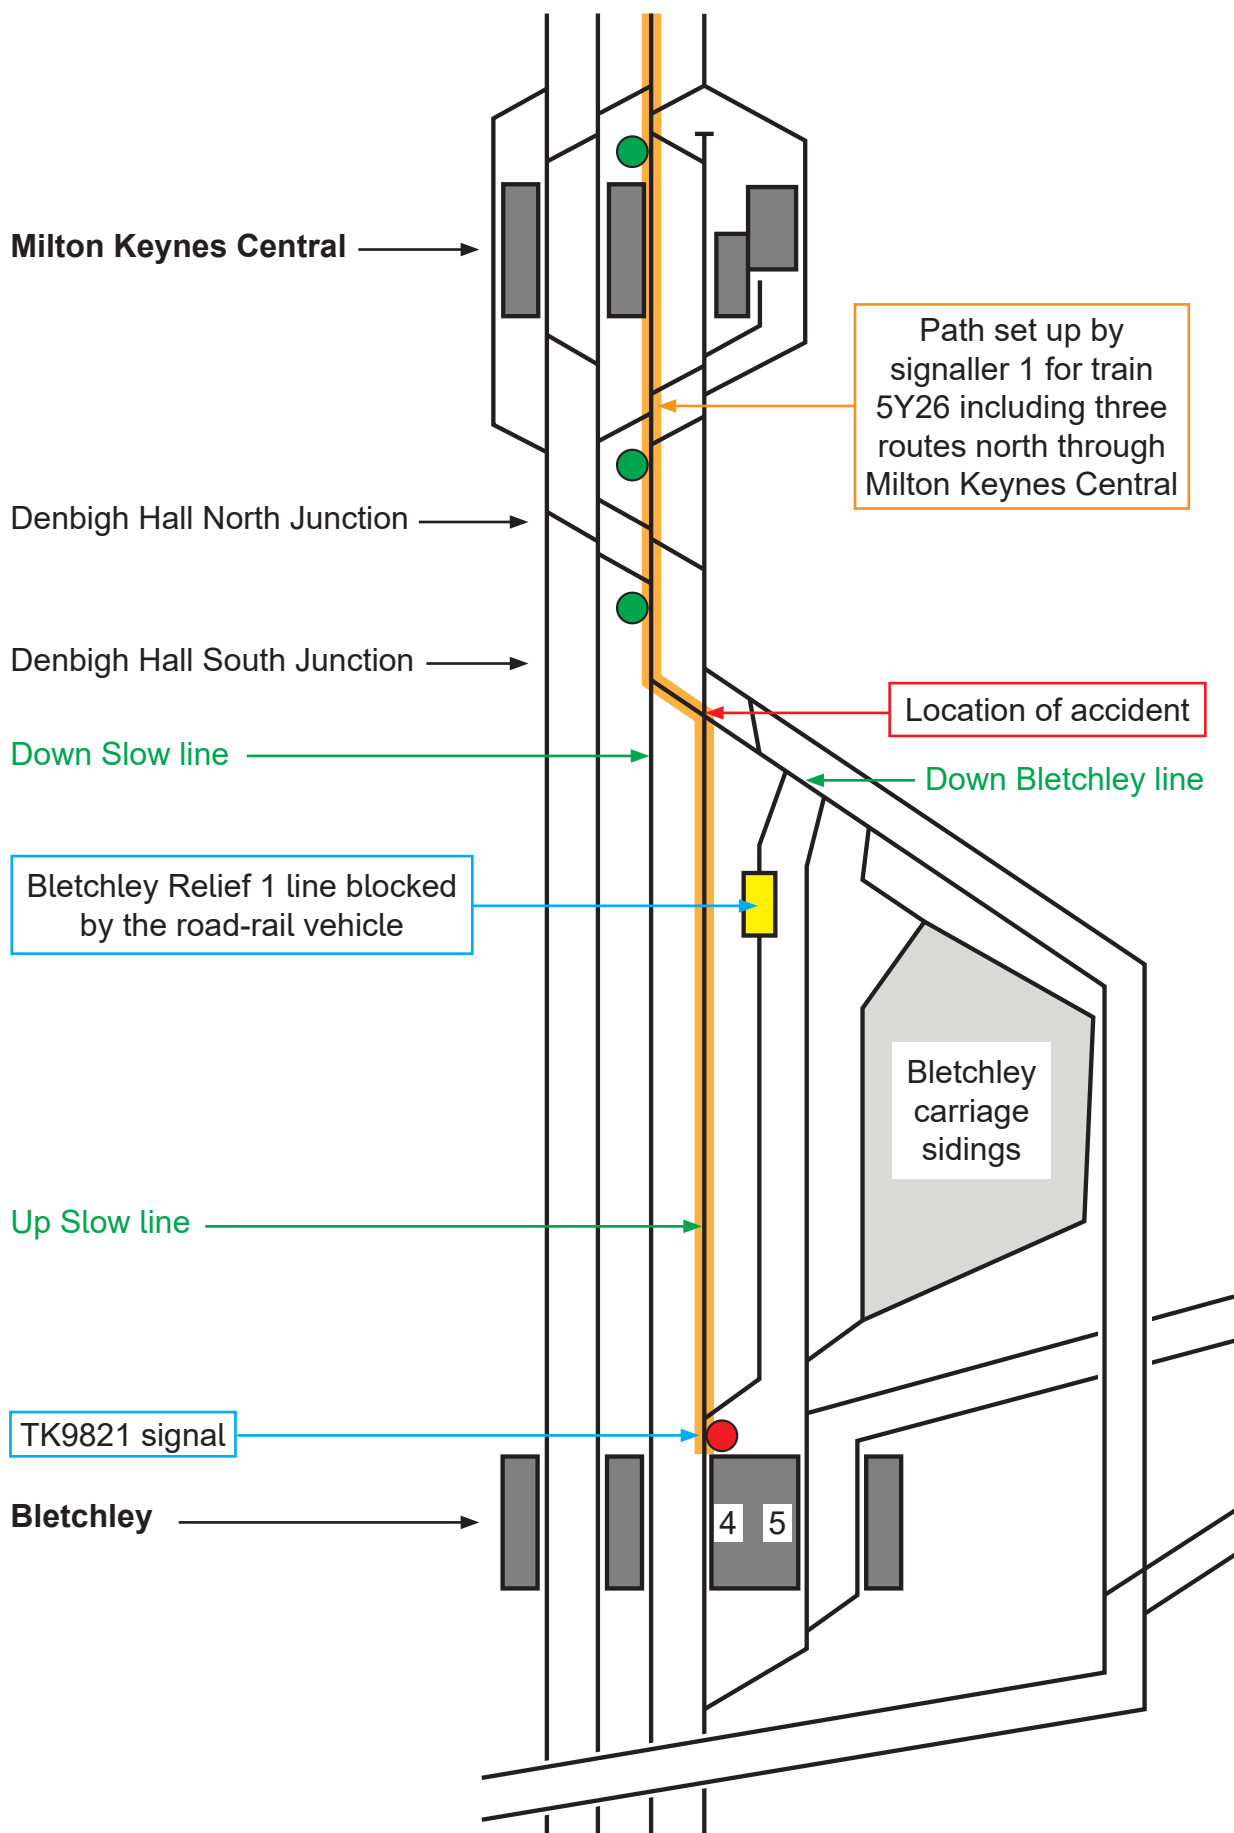
Figure 10: The path set up by signaller 1 for train 5Y26.

- 45 Signaller 1 then set up the path for the train's wrong-direction movement, which included moving TK262 points to their reverse position and placing a reminder on the controls for them. The reminder provided a visual indication to signaller 1 that TK262 points should not be moved. The reminder also implemented a control in the signalling system that prevented TK262 points from being moved even if requested to move by the signaller. During this time, signaller 1 communicated with both the SSM and signaller 2 about the setting up and checking of the path. Signaller 1 also set three signalled routes for the train to continue along the Down Slow line at Denbigh Hall North Junction and beyond Milton Keynes Central station (figure 10).

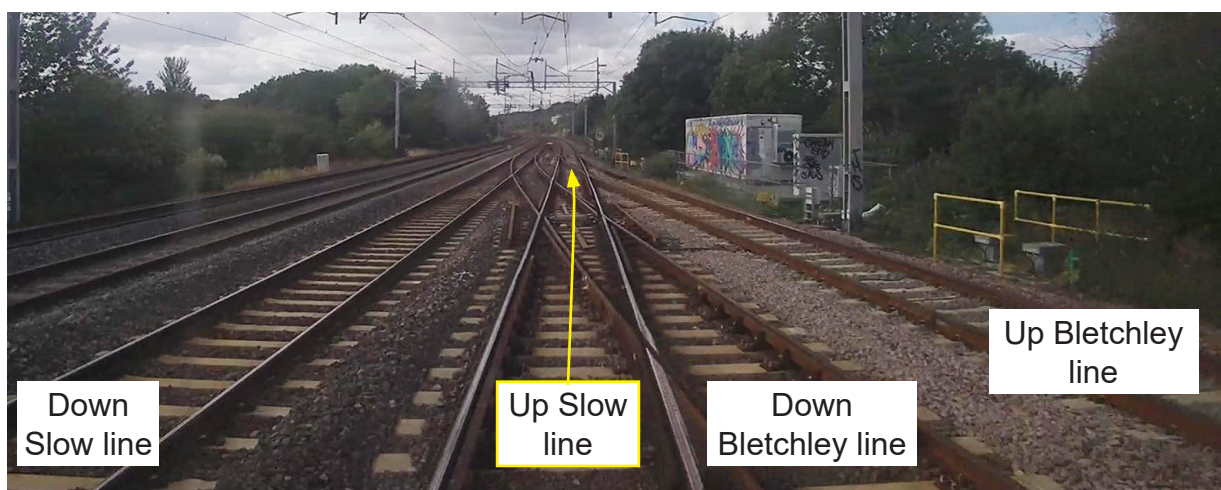
Figure 15: Only valid path over TK262A and TK262B points when in their normal position (courtesy of Network Rail with RAIB annotations).

- 57 TK262A and TK262B switch diamond points were in an unsafe position for the direction that train 5Y26 was travelling over them.
- 58 Train 5Y26 approached the junction on the Up Slow line. This meant the only valid way for the train to have travelled over TK262A and TK262B switch diamond points was for it to have continued along the Up Slow line (paragraph 17). This required these point ends to be in their normal position (figure 15).

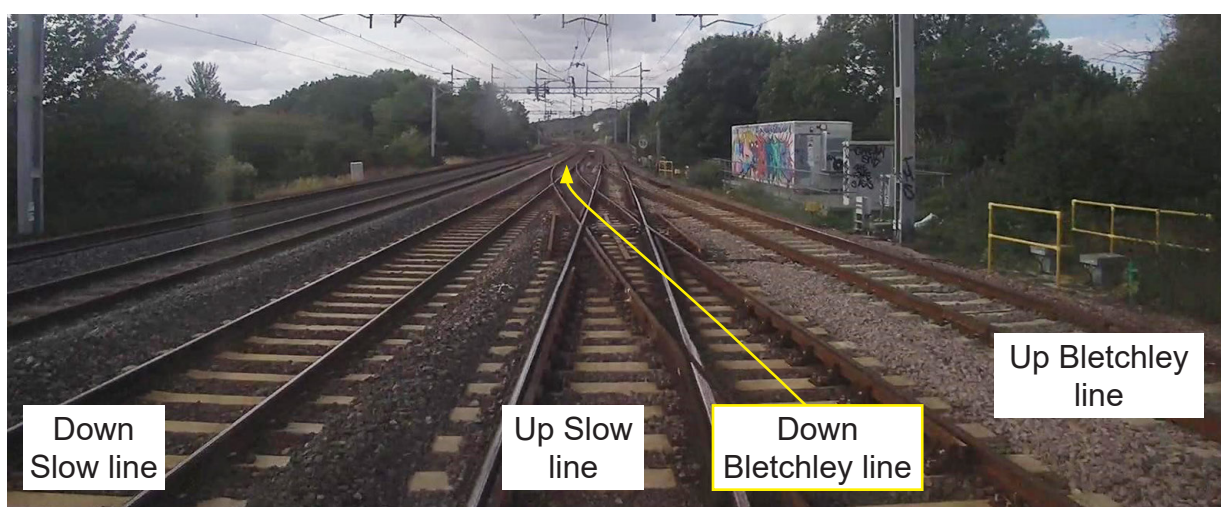
Figure 16: Only valid path over TK262A and TK262B points when in their reverse position (courtesy of Network Rail with RAIB annotations).

- 59 However, the signalling system recorded that TK262A and TK262B point ends were in their reverse position (paragraph 48). These switch diamond points should be in this position when a train is travelling over the junction from the Down Bletchley line to the Down Slow line (figure 16). In their reverse position, the switch diamond points only allow trains making this movement to cross the Up Slow line.

- 60 When the train approached on the Up Slow line, it was unsafe for the switch diamond points to be in their reverse position. It meant that the trailing TK262A points were run through by the train's leading wheels and the facing TK262B points were set to divert the train's leading wheels sharply to the left onto the Down Bletchley line (figure 17). The switch diamond points were never designed to allow this (figure 8).

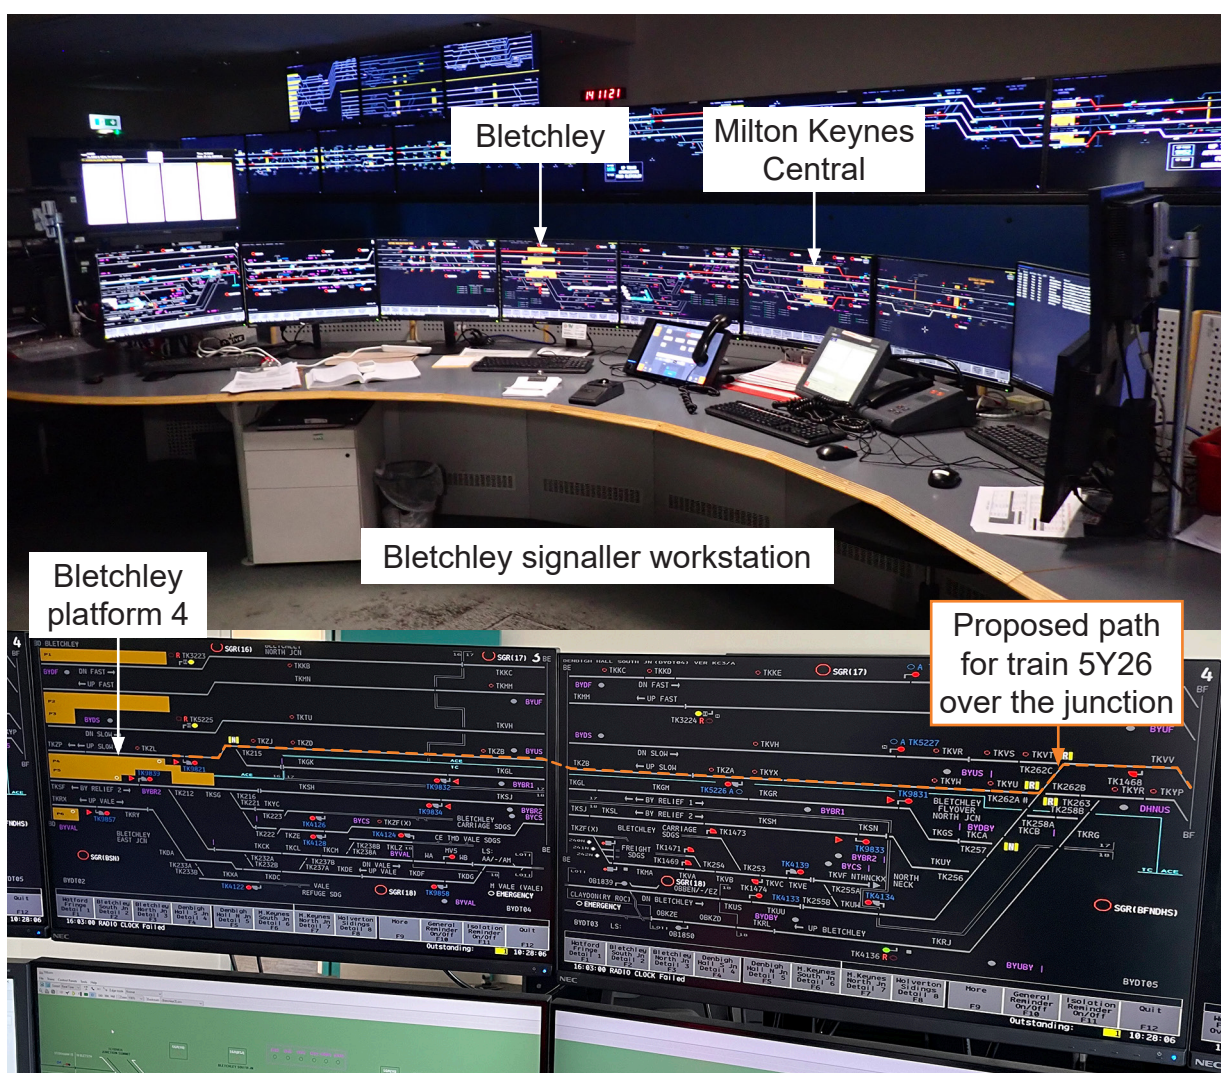
Figure 20: The Bletchley signaller workstation and finger check for the train's path across multiple display screens.

- 101 As the signalling staff involved had not used a route card, they checked the path for the wrong-direction movement by carrying out what is known as a finger check, or finger trace. This involves using a finger to follow the line of the proposed path for the train on the signaller workstation, which might need to go across multiple display screens (figure 20). When following the line, the signaller should check that the points along the line are in the right position and that reminders are applied to those points.

102 Signallers should also look for any gaps in the line along the train's proposed path when carrying out this check. A continuous line through all the points along the proposed path for a train indicates that the path has been set up correctly for the safe passage of the train. Conversely, a gap in the line at a set of points shows that the path is not set up correctly at those points. However, none of the checks by anyone on the day of the accident identified that there was a gap in the line at TK262A and TK262B points (figure 21).

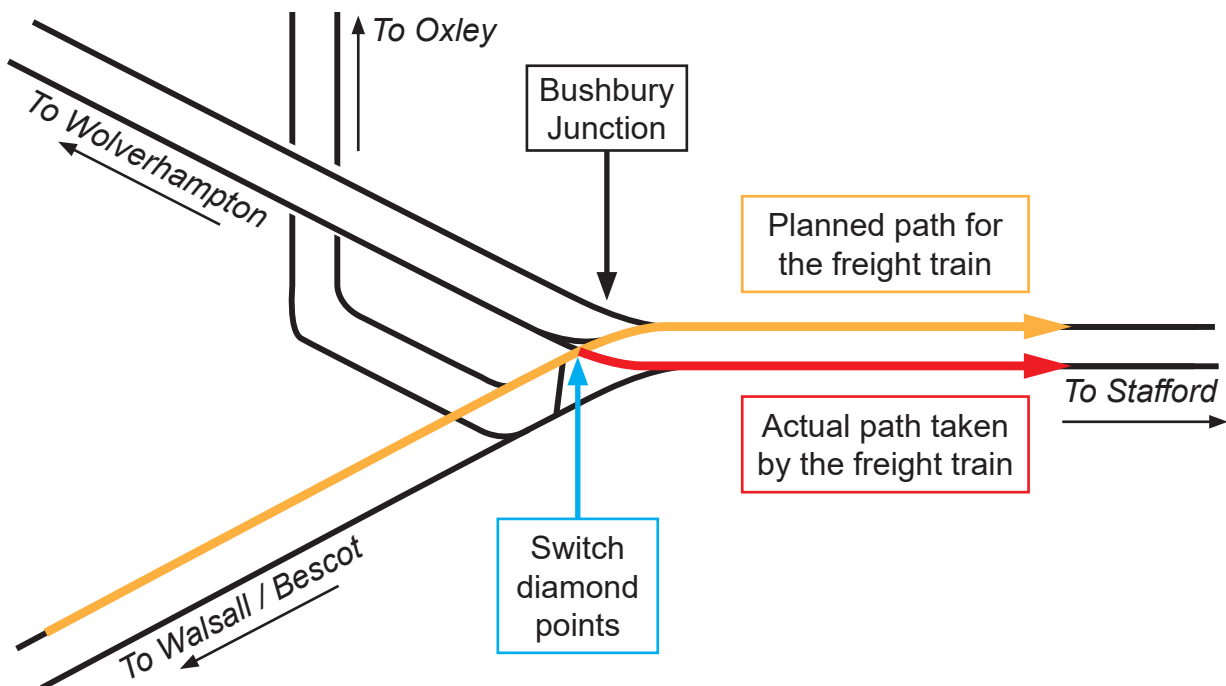
Figure 23: Intended and actual paths taken by the freight train at Bushbury Junction.

158 RAIB identified one further incident in the data which involved switch diamond points. It happened at Bushbury Junction on 16 July 2019. A freight train was diverted onto the wrong line via switch diamond points after only one of the point ends was secured in the correct position (figure 23). At the time, a trainee signaller was managing a points failure which required the freight train to be authorised to pass a signal at danger in accordance with Rule Book module S5.

- 159 A MOM, who was at the junction and acting as a route setting agent, was told by the trainee signaller to secure only one of the switch diamond point ends. A route setting agent is a competent person appointed to co-ordinate the manual operation of points during a complex points failure (paragraph 124). The trainee signaller then authorised the driver to move after giving their instructions. The train set off and passed over the switch diamond points which were in an unsafe position. However, the train did not derail and instead was diverted onto the adjacent line, going in the wrong direction. It then continued along the adjacent line towards a stationary passenger train. The freight train stopped about 0.25 miles (0.4 km) from the passenger train when the driver realised that they were on the wrong line. As the incident happened at night, the driver did not see that the switch diamond points were in the wrong position for the movement.
