Abbreviated Dust Monitoring Report

Project: Grenfell Tower

Document Ref: EEMC-DMR-201/107 – Grenfell Tower Rev 01

Period: 02 March 2026 to 29 March 2026

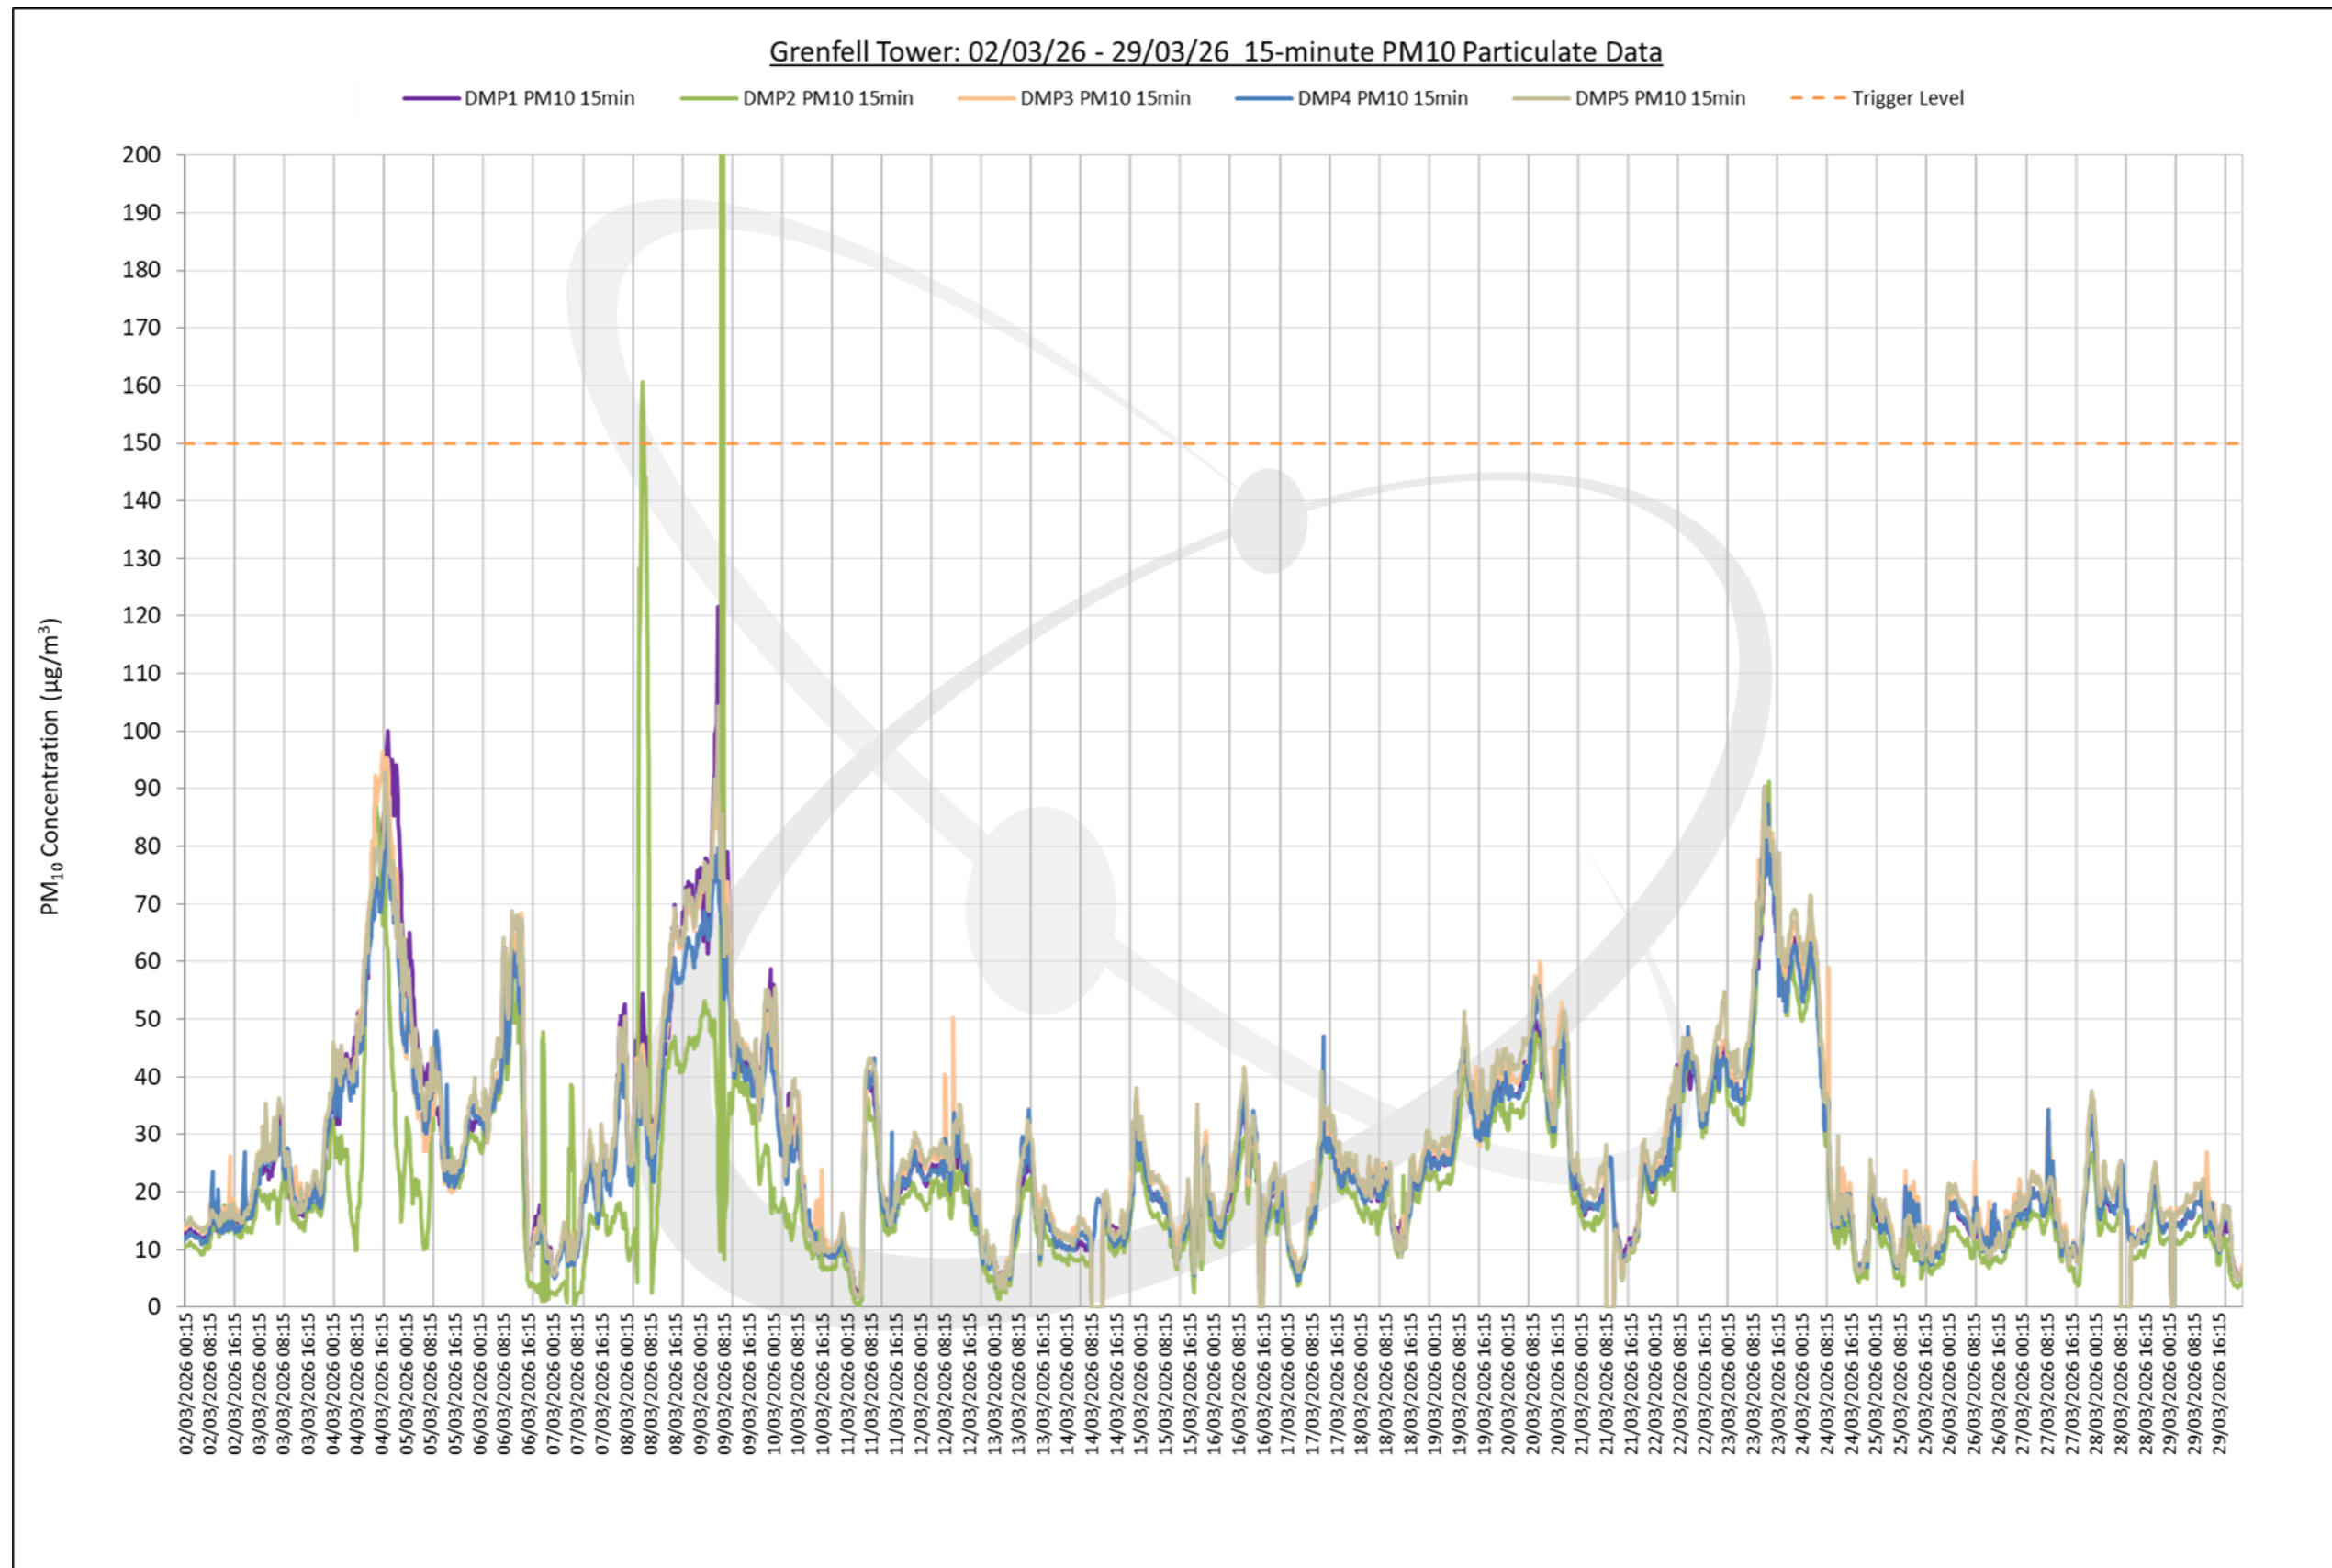
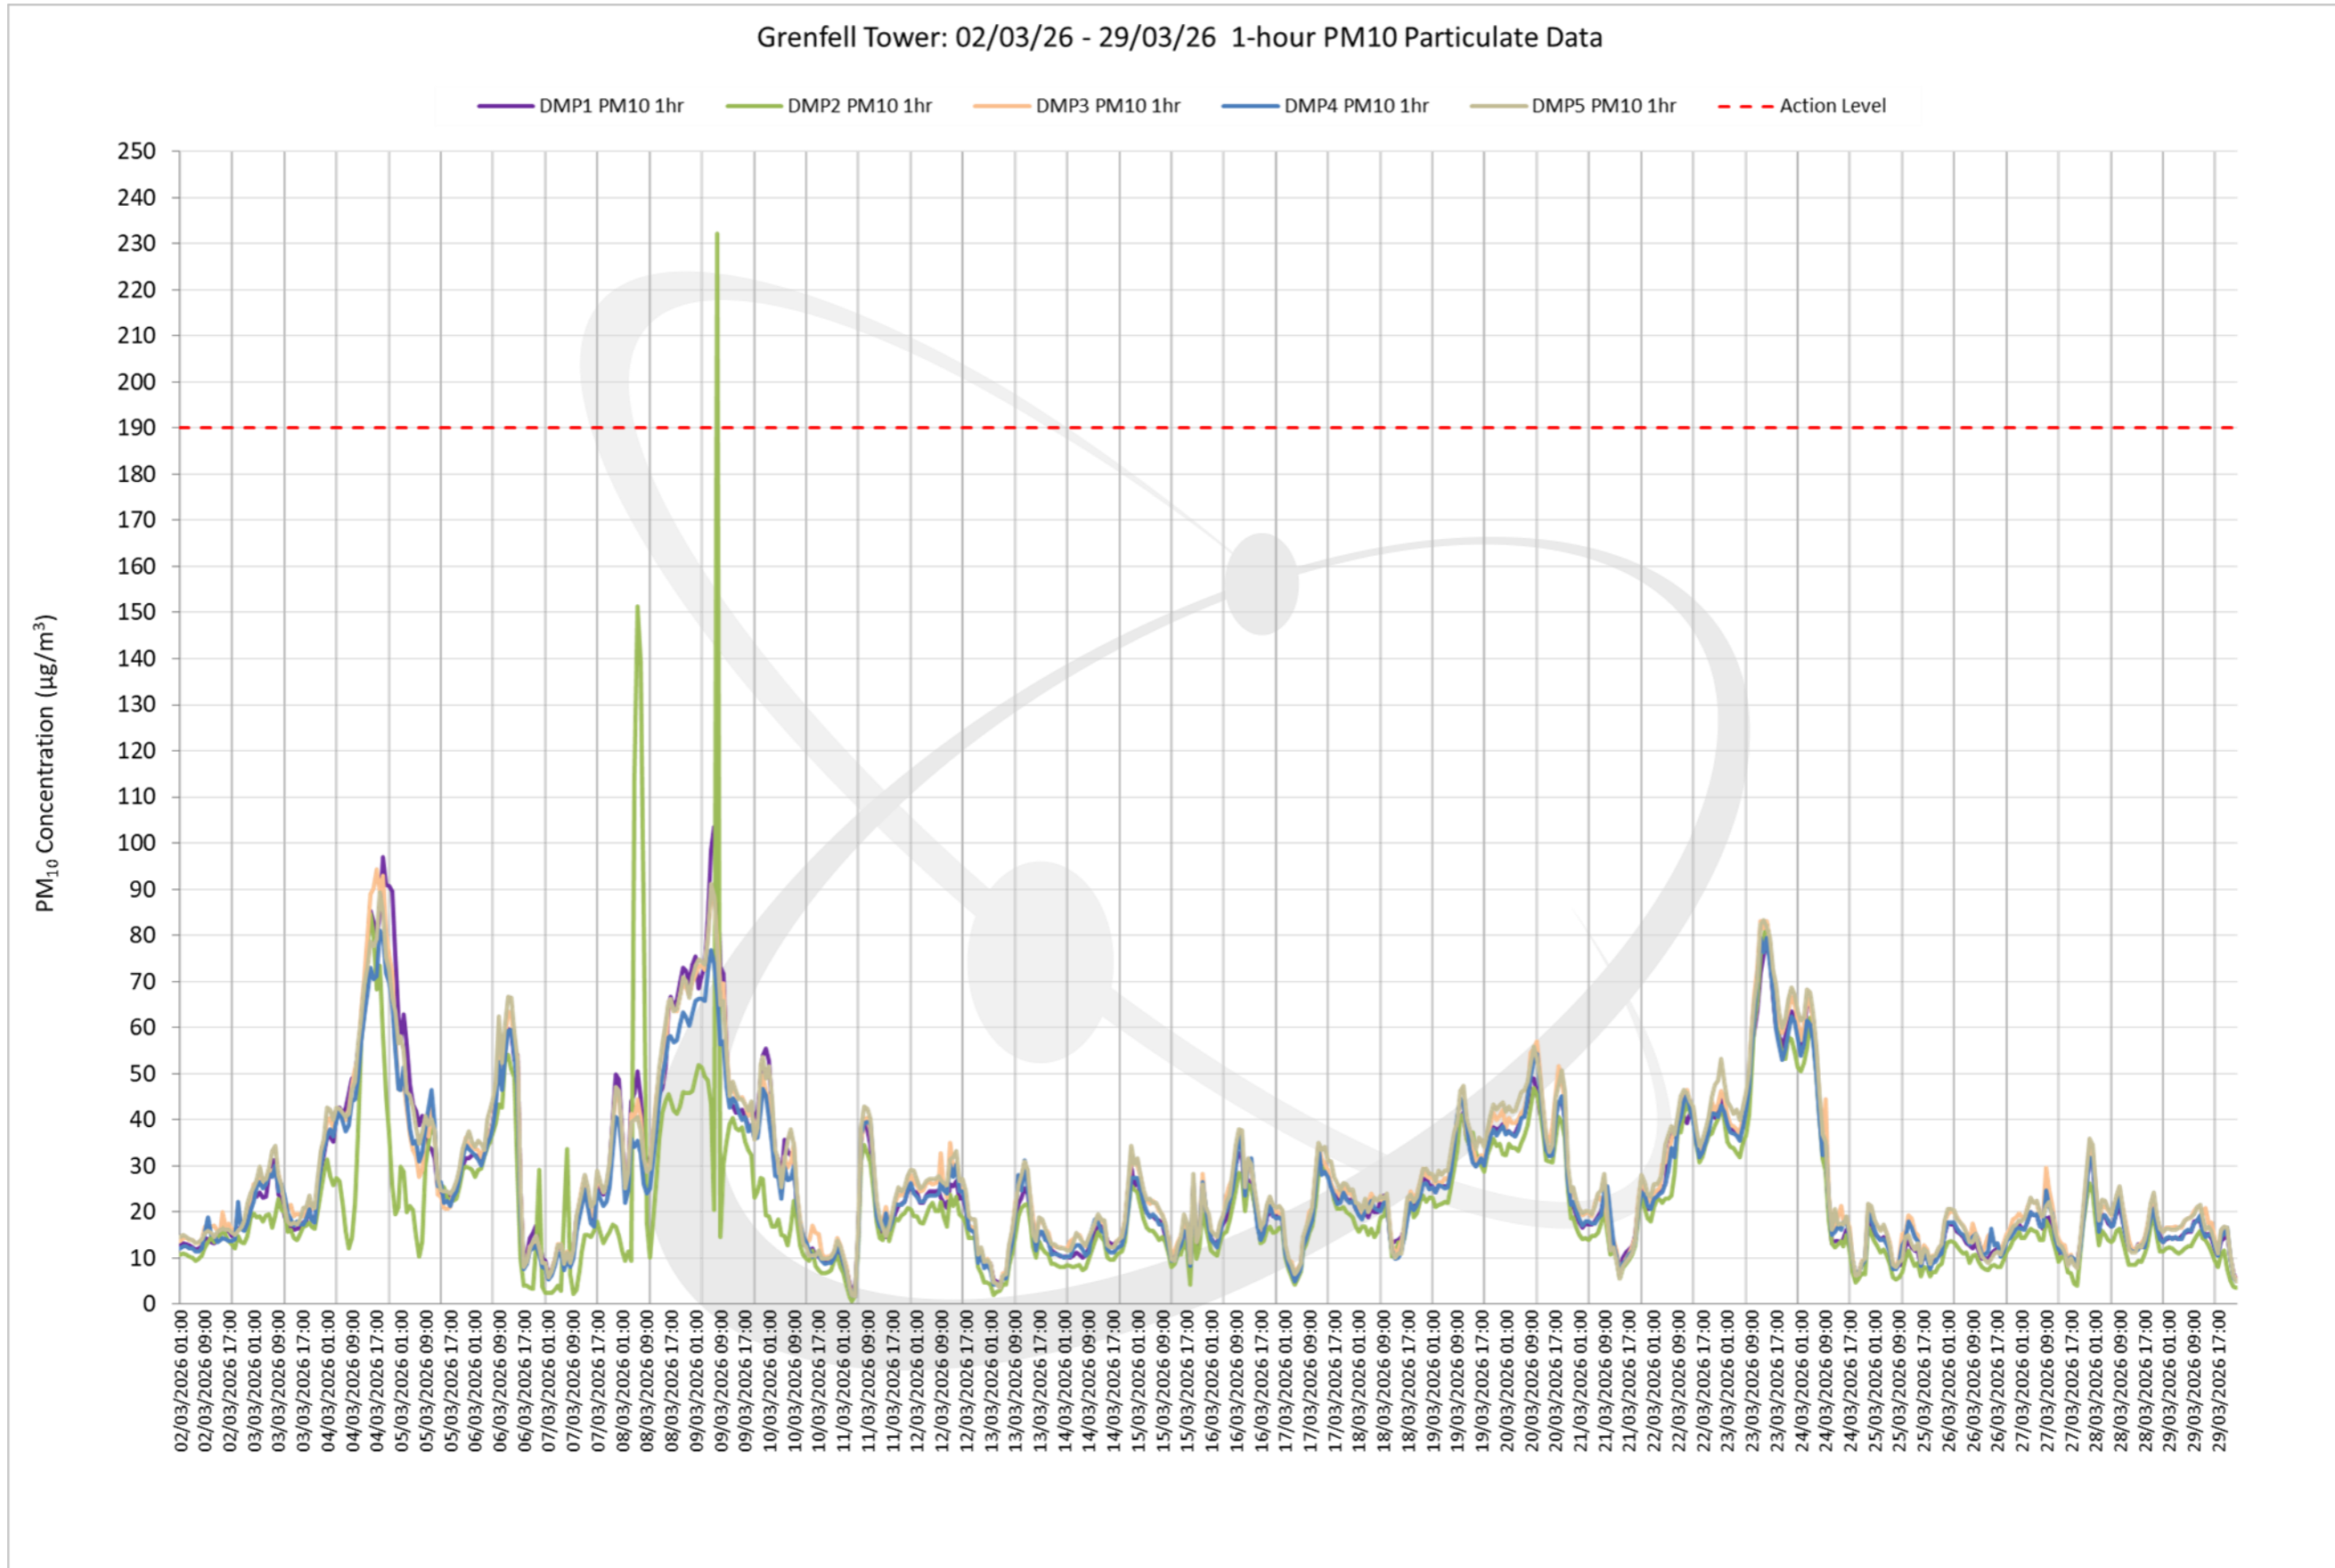
7. PM₁₀ Dust Monitoring Graphs

The results of the Dust measurements in this period are presented graphically for PM₁₀ and PM_{2.5} in Sections 7 and 8 respectively of this report.
