Report on the investigation of
the double man overboard from the potter
Weston Bay (GY123)
resulting in one fatality
approximately 12 nautical miles south-east
of Spurn Head, England
on 22 May 2024

SYNOPSIS

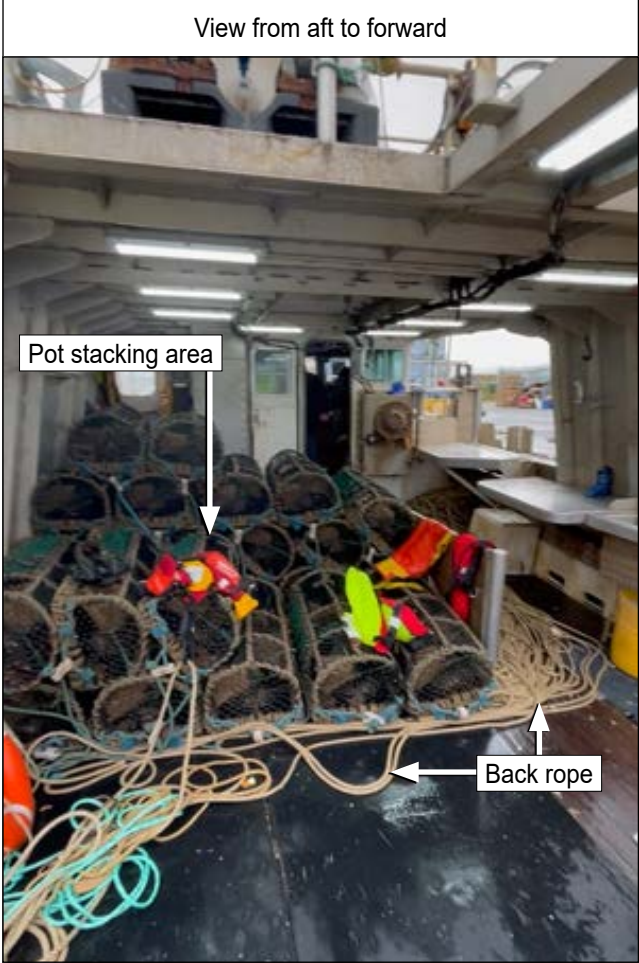
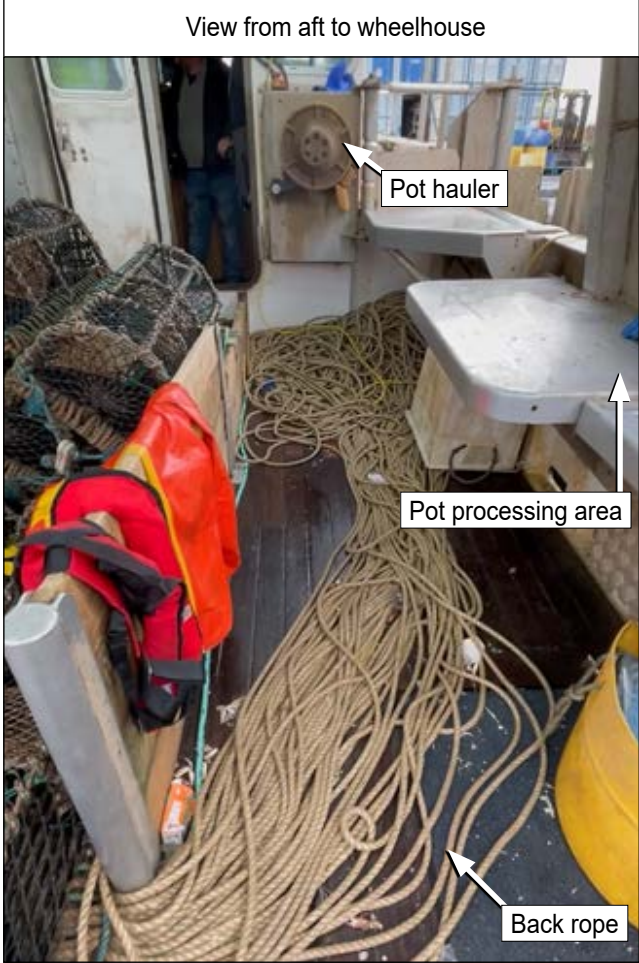
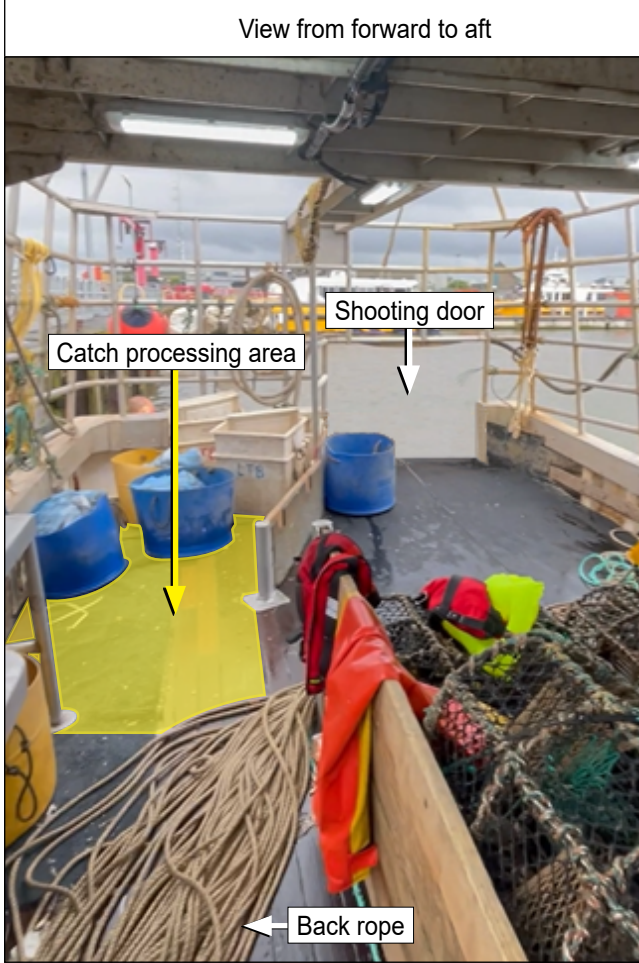
Figure 2: Weston Bay's working deck layout

Weston Bay's working deck was divided by two pound boards to separate the crew from the running gear that ran between the port side pot stacking area and the starboard side catch processing area (see **Figure 2**). *Weston Bay's* freeboard was 1,180mm at the transom shooting door (**Figure 5**). A hydraulic pot hauler was mounted on the vessel's starboard side.

Before shooting, the pots were stacked from forward to aft in rows of five and up to four rows high (see **Figure 2** and **Figure 3**). The back rope was flaked on the deck in the area between the pot stacking area and the catch processing area (see **Figure 2**). The four deckhands would rotate stations on each string, with the skipper remaining in the wheelhouse. The deckhand responsible for stacking the pots would oversee their deployment as they were familiar with the order in which the pots were stacked.

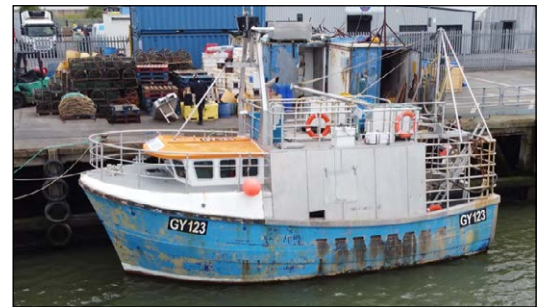
The accident happened when the inexperienced deckhand 1 was struck and knocked onto the deck (see **figure**) while downstacking a string of shooting pots and was taken overboard by the next pot in sequence. Deckhand 2 entered the water as he went to assist.
