Grounding and subsequent loss of the fishing vessel *Crystal Stream* (LH 147) on Barmore Island, Loch Fyne, Scotland on 6 June 2025

SUMMARY

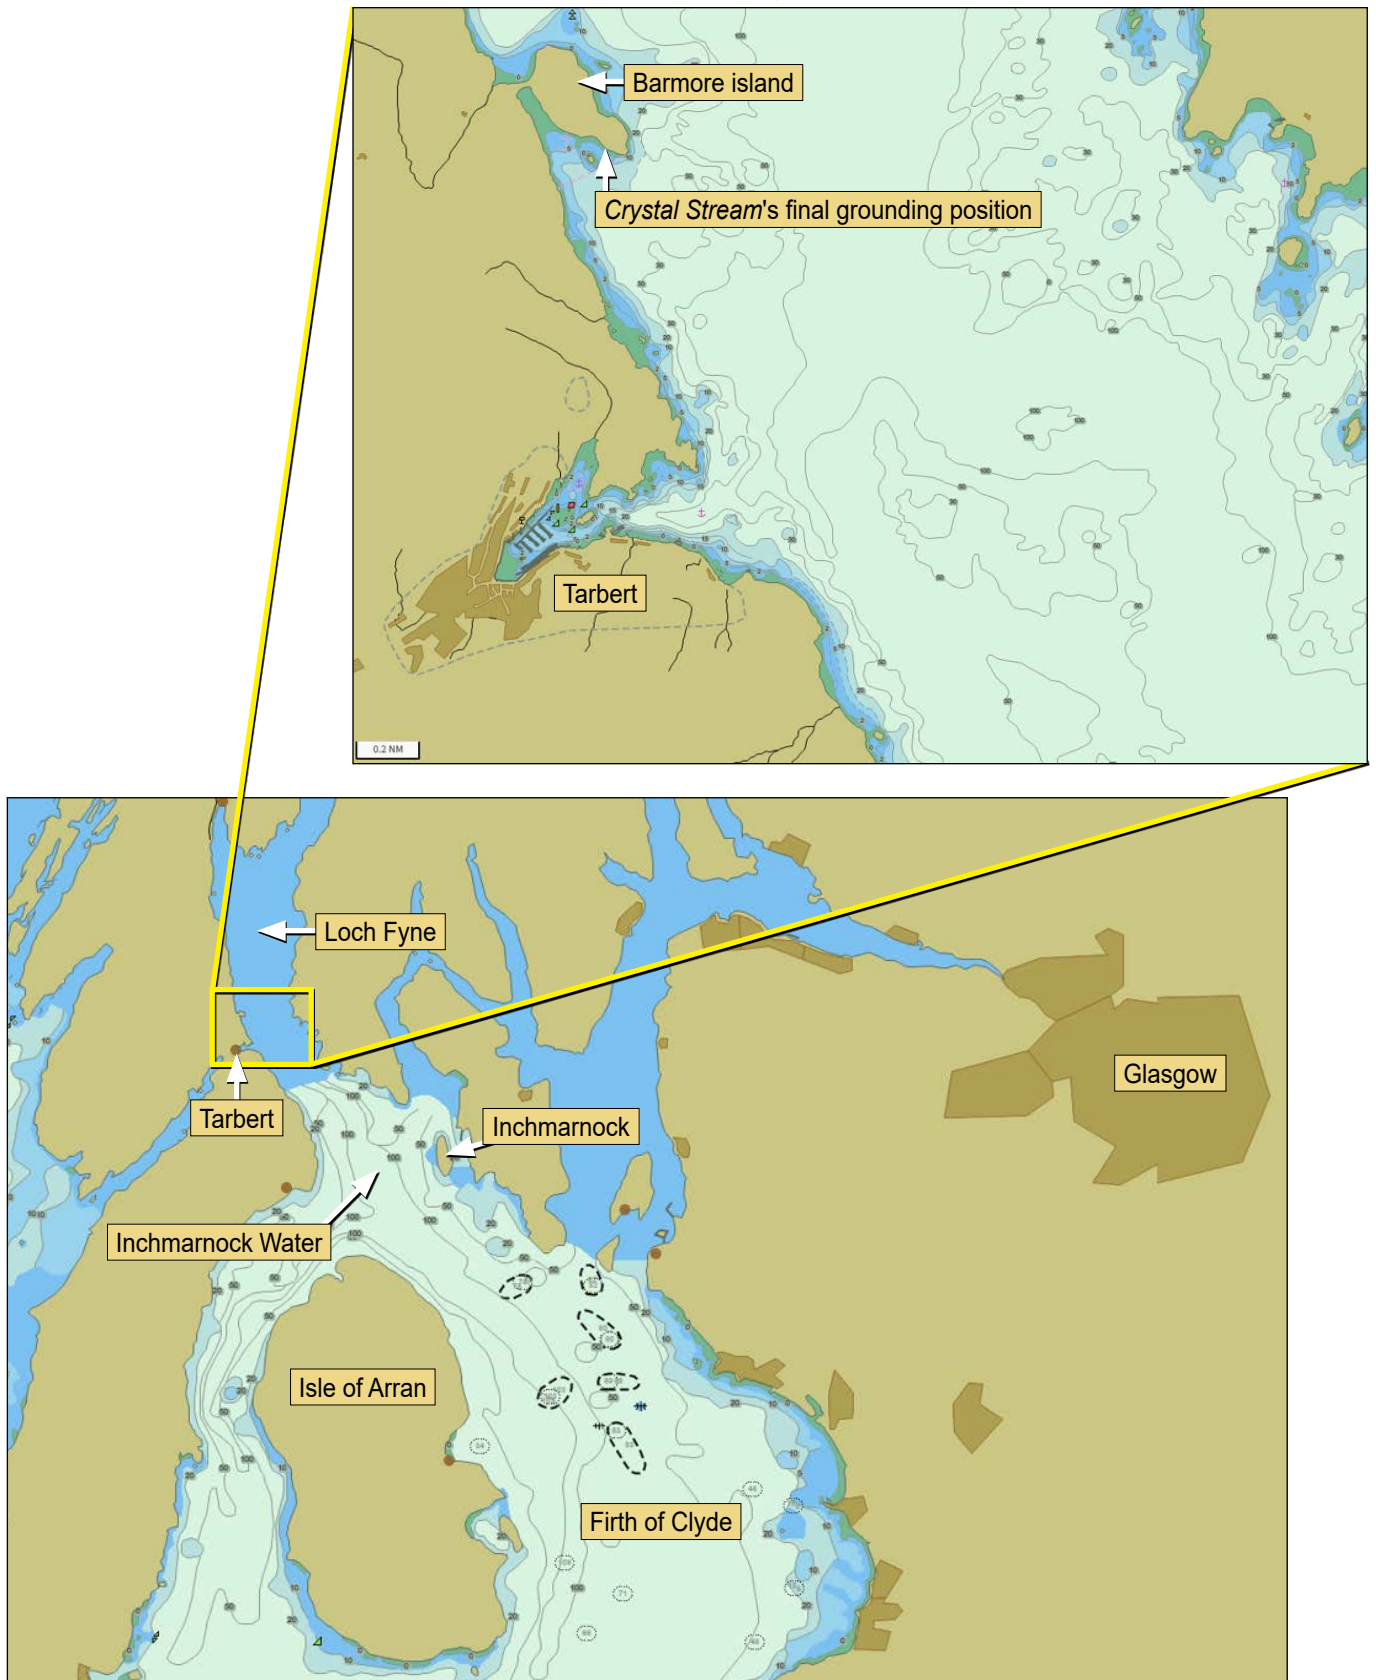
At about 0330 on 5 June 2025, the fishing vessel *Crystal Stream* departed Tarbert, Argyll and Bute, Scotland (**Figure 1**). On board were the skipper, a mate and two deckhands (deckhands 1 and 2). Deckhand 2 was feeling very unwell. The skipper was at the helm as the vessel headed south towards the fishing grounds in the Firth of Clyde to begin its fourth and final day of fishing that week. At 0350, the skipper handed over the watch to the mate and went below to sleep.

At about 1930, the skipper and crew ate a large dinner as the vessel approached Inchmarnock Water (**Figure 1**). At about 2200, *Crystal Stream* passed the island of Inchmarnock and deckhand 1 offered to take the watch, but the skipper declined. At 2315, the last tow was completed and the nets were recovered. While the crew sorted the catch on deck, the skipper remained on watch in the wheelhouse and increased the vessel's speed to about 7kts.

Figure 1: Accident location and (inset) *Crystal Stream's* fishing grounds
