Rail Accident Investigation Branch

Rail Accident Report

**Pedestrian struck by a train at Pewsey footpath crossing, Pewsey, Wiltshire
26 February 2025**

Report 05/2026
May 2026

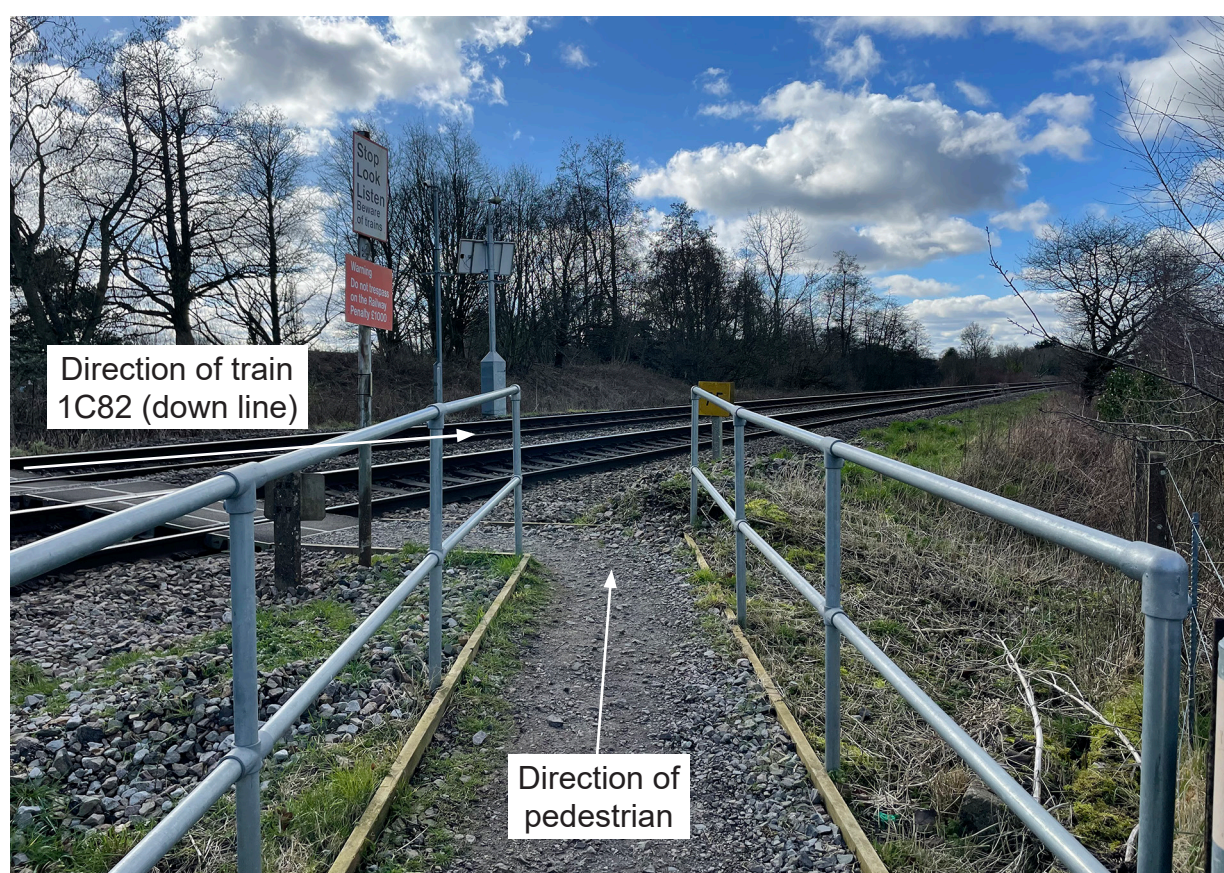
Figure 5: Approach to the crossing's north signage via the fenced corridor.

- 9 As pedestrians approach the crossing, a self-closing pedestrian gate leads them through the northern railway boundary onto a path which is enclosed with metal fencing. At the time of the accident, there were signs at the end of this corridor which warned users (figure 5):
- to ‘Stop, Look, Listen – Beware of trains’
 - not to trespass on the railway
 - that oncoming trains can be hidden by other trains.
- 10 The surface of the corridor from the pedestrian gate to beyond the signs is a compacted crushed-stone surface. Network Rail stated that the crossing deck consists of metal-framed polymer concrete panels. These have a noticeable height difference between the panels on the outer and inner parts of the deck, consistent with the cant (slope) of the track.

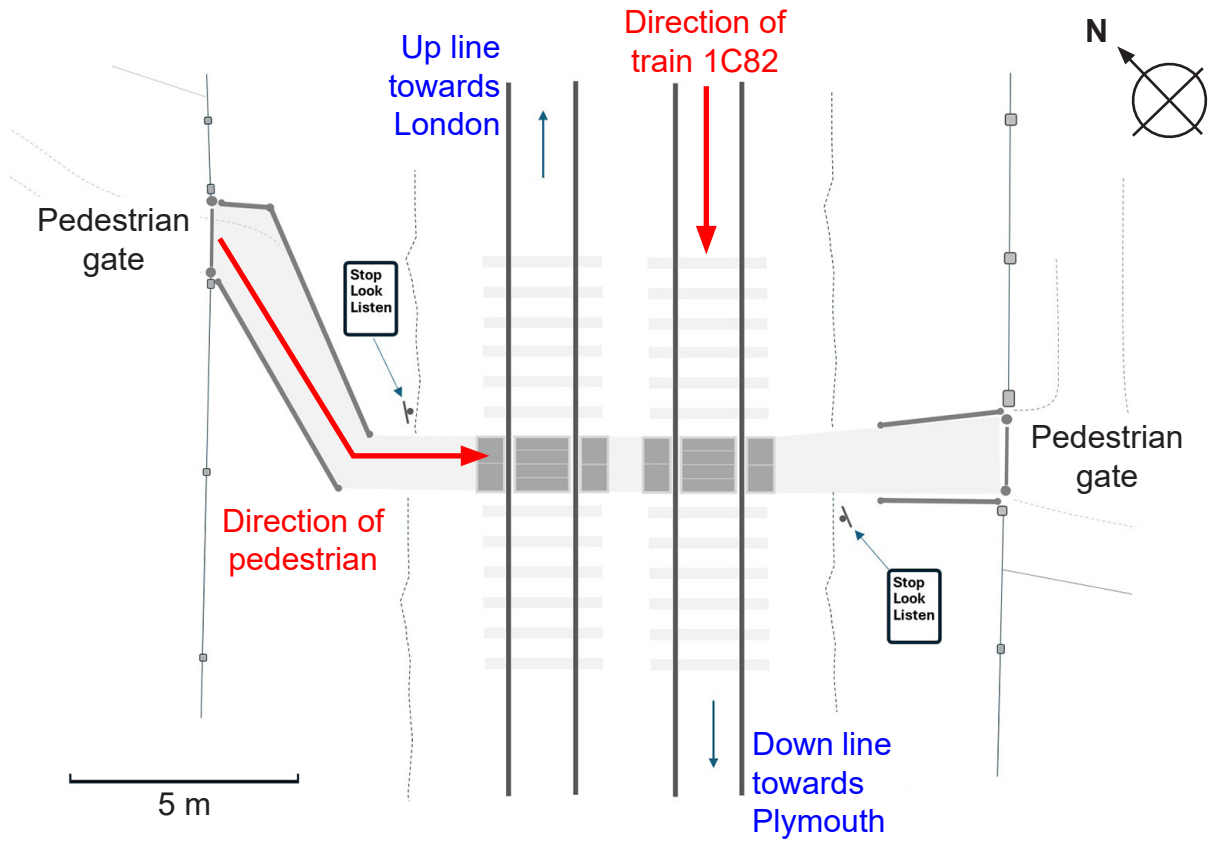
Figure 6: Layout of the crossing.

C11 At the crossing, the sound level had reduced to an average of 48.1 dB(A) at the decision point and 42.6 dB(A) at the crossing gate (figure 6). The attenuation of sound during the testing was measured to be 9 dB to 13 dB per doubling of distance (9 to 13 dB/dd) with the median rate of approximately 12.0 dB/dd. The rates of attenuation due to distance were similar to the data that had been collected during previous research in the railway environment (paragraph 46).
