Serious Incident

Aircraft Type and Registration:	DG Flugzeugbau DG-1000T, G-CKLY	
No & Type of Engines:	1 SOLO 2350 C piston engine	
Year of Manufacture:	2005 (Serial no: 10-66T6)	
Date & Time (UTC):	26 April 2025 at 1623 hrs	
Location:	Court Place Farm Nature Park, Oxfordshire	
Type of Flight:	Private	
Persons on Board:	Crew - 1	Passengers - 1
Injuries:	Crew - None	Passengers - None
Nature of Damage:	Damage to propeller, fuselage and left wing. Propeller coupling separated	
Commander's Licence:	Light Aircraft Pilot's Licence	
Commander's Age:	57 years	
Commander's Flying Experience:	1,500 hours (of which 52 were on type) Last 90 days - 9 hours Last 28 days - 4 hours	
Information Source:	Aircraft Accident Report Form submitted by the pilot and further enquiries by the AAIB

Synopsis

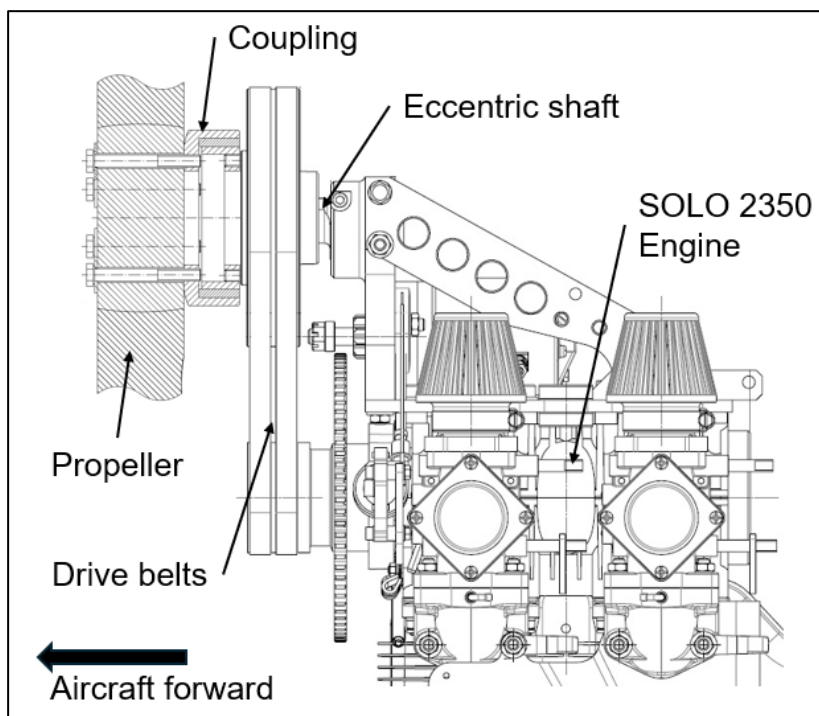
Figure 2

Engine / Coupling / Propeller system

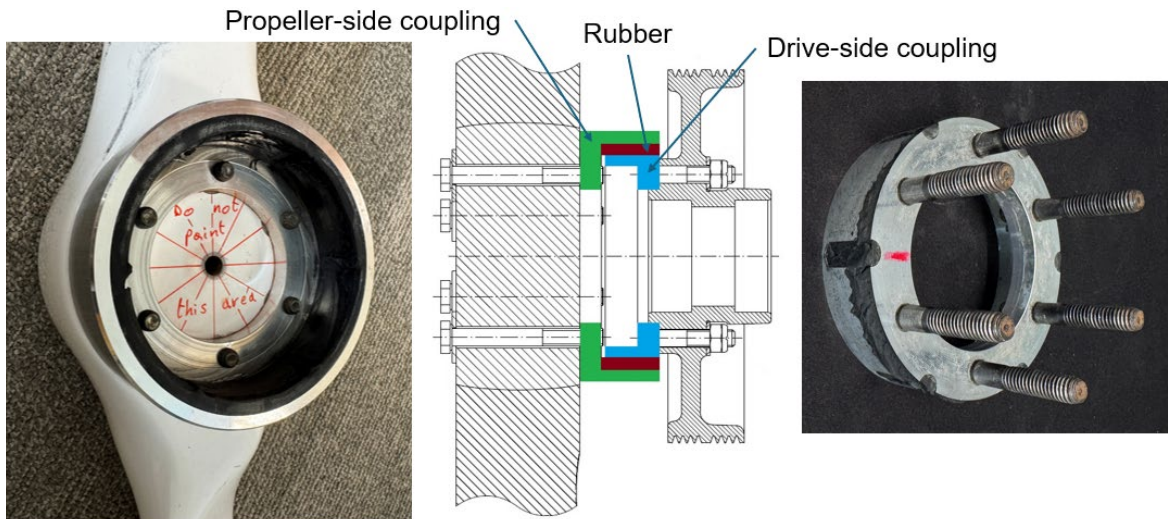
The two-part rubber coupling attaches the propeller to the final drive of the engine. The coupling consists of two machined aluminium components joined together with vulcanised rubber (Figure 3). The coupling was designed to reduce the loads on the eccentric shaft from the gyroscopic effects of the propeller.

Figure 3
Two-part rubber coupling

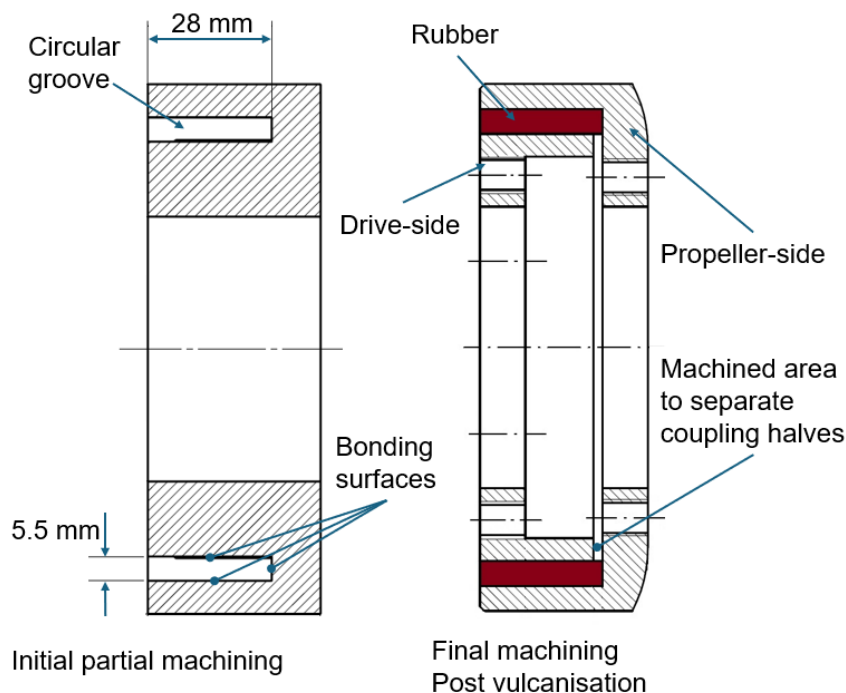
Figure 4

The coupling starts as one piece of 7022-T6 aluminium alloy bar stock and it is partially machined (Figure 4) to include a 28 mm deep by 5.5 mm wide circular groove to accept the rubber. The groove is then media blasted with 850 – 1180 μm corundum particles and then cleaned with an alcohol-based primer. The surface finish is not specified on the drawing except for a generic Ra 3.2 μm which is typical for CNC machining. There are no production acceptance criteria for the surface blasted areas. A surface primer, followed by adhesive is then applied to the surfaces to be bonded to the rubber. The Nitrile Butadiene Rubber (NBR) is pressed into the groove and the coupling is heated to vulcanise the rubber, resulting in a rubber Shore A hardness of 70. After the vulcanisation process is complete the remaining features are machined into the coupling, which includes separating the coupling into two metallic components joined together by the NBR. This manufacturing process ensures good concentricity of the two metallic halves of the coupling. No protective treatments are applied as 7022 aluminium was determined to have sufficient corrosion resistance for the component's five-year life in service.

Coupling manufacturing steps
