# ***AAIB Bulletin***

***5/2026***

<b>Aircraft Type and Registration:</b>	Cessna FRA150L, G-PPFS
<b>No &amp; Type of Engines:</b>	1 Continental Motors Corp O-240-A piston engine
<b>Year of Manufacture:</b>	1972 (Serial no: 0126)
<b>Date &amp; Time (UTC):</b>	28 July 2024 at 0845 hrs
<b>Location:</b>	Near Thorganby, North Yorkshire
<b>Type of Flight:</b>	Private
<b>Persons on Board:</b>	Crew - 1                      Passengers - 1
<b>Injuries:</b>	Crew - 1 (Fatal)              Passengers - 1 (Fatal)
<b>Nature of Damage:</b>	Aircraft destroyed
<b>Commander's Licence:</b>	Private Pilot's Licence
<b>Commander's Age:</b>	21 years
<b>Commander's Flying Experience:</b>	153 hours (of which 131 were on type) Last 90 days - 53 hours Last 28 days - 13 hours
<b>Information Source:</b>	AAIB Field Investigation

<b>Aircraft Type and Registration:</b>	Taylor Monoplane, G-AYSH	
<b>No &amp; Type of Engines:</b>	1 Volkswagen 1600 piston engine	
<b>Year of Manufacture:</b>	1973 (Serial no: PFA 1413)	
<b>Date &amp; Time (UTC):</b>	17 June 2025 at 0936 hrs	
<b>Location:</b>	Nayland Airfield, Suffolk	
<b>Type of Flight:</b>	Private	
<b>Persons on Board:</b>	Crew - 1	Passengers - None
<b>Injuries:</b>

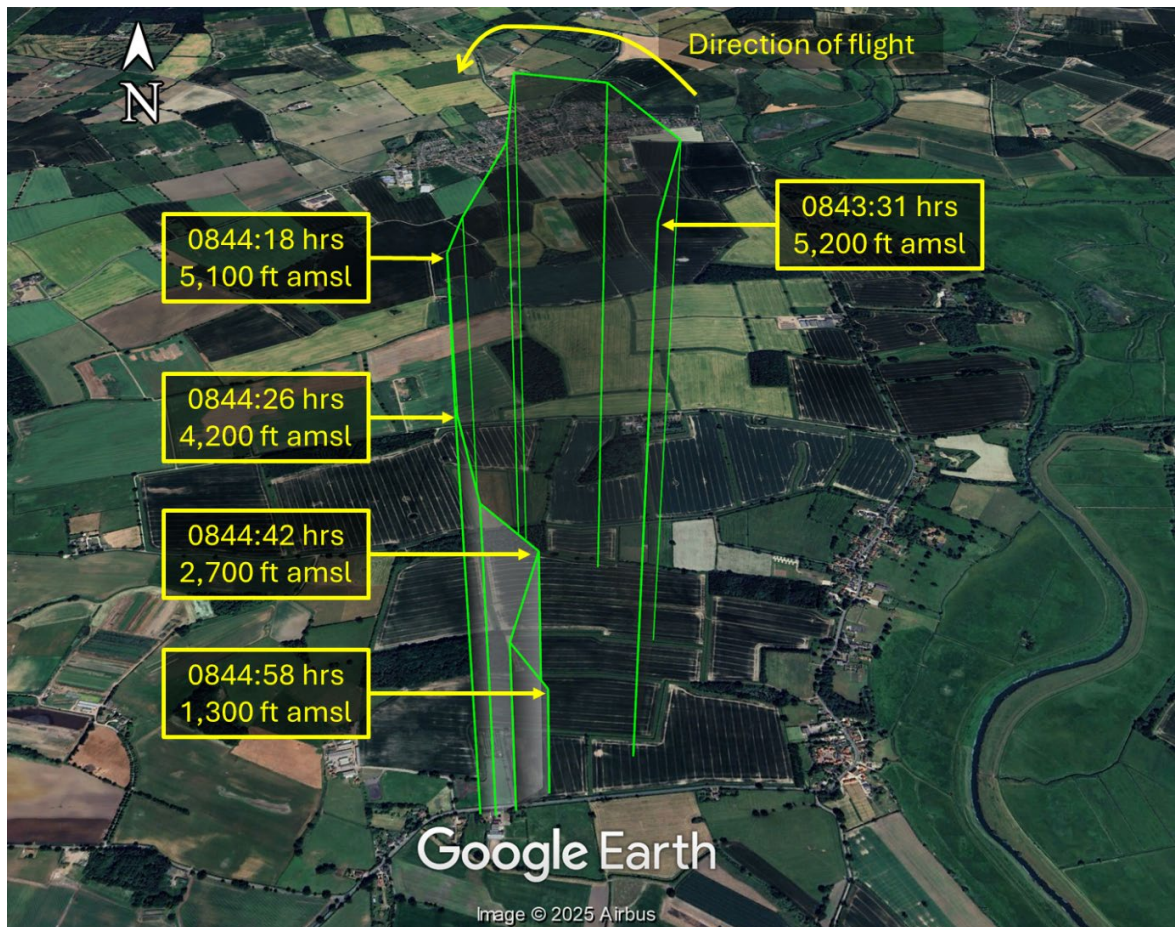
**Figure 2**

Aircraft's flight path during the descent

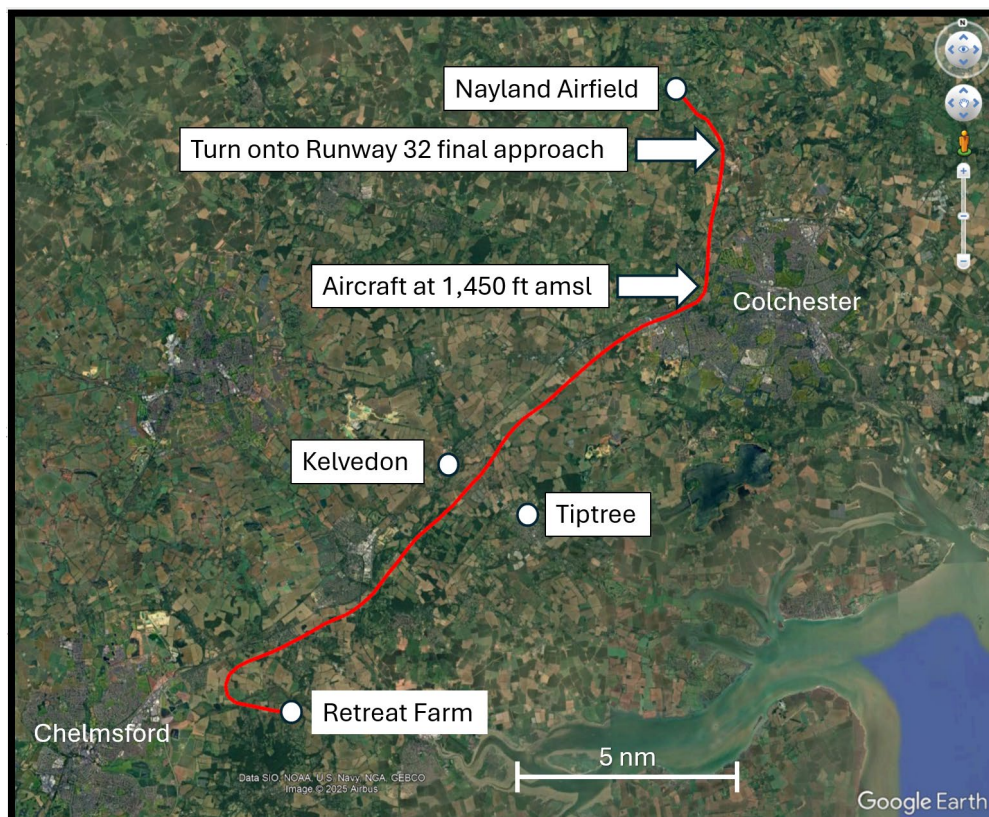
**Figure 2**  
GPS track from Retreat Farm to Nayland

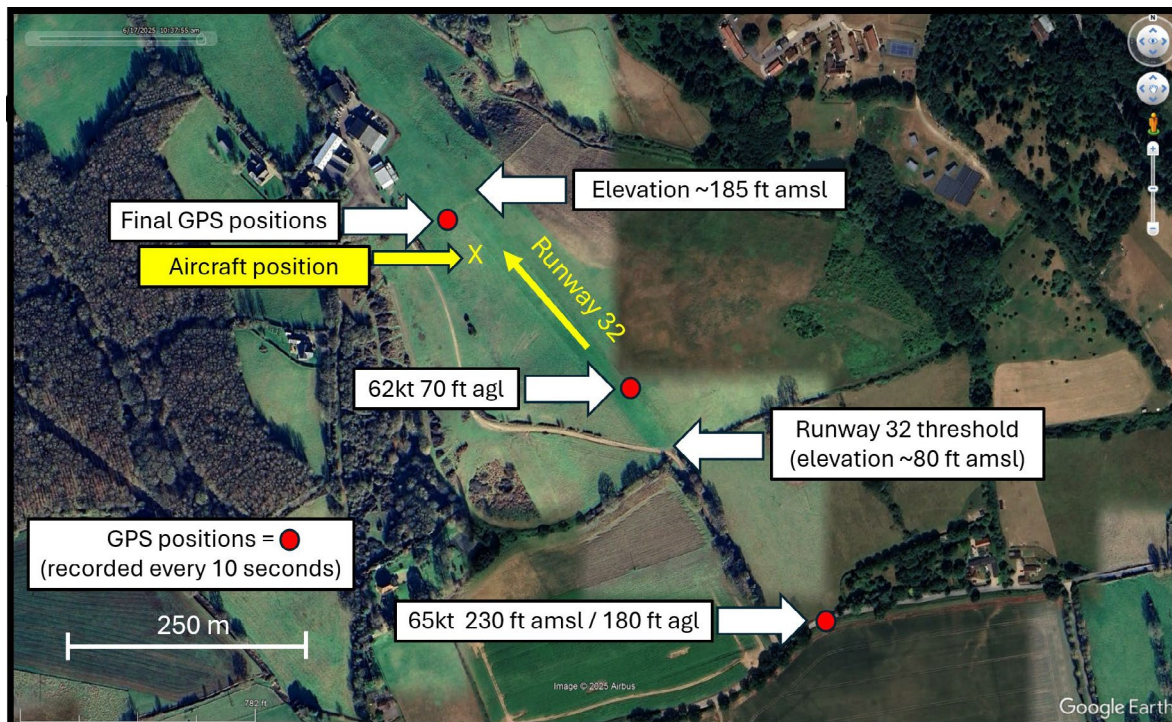
**Figure 3**  
Final GPS points

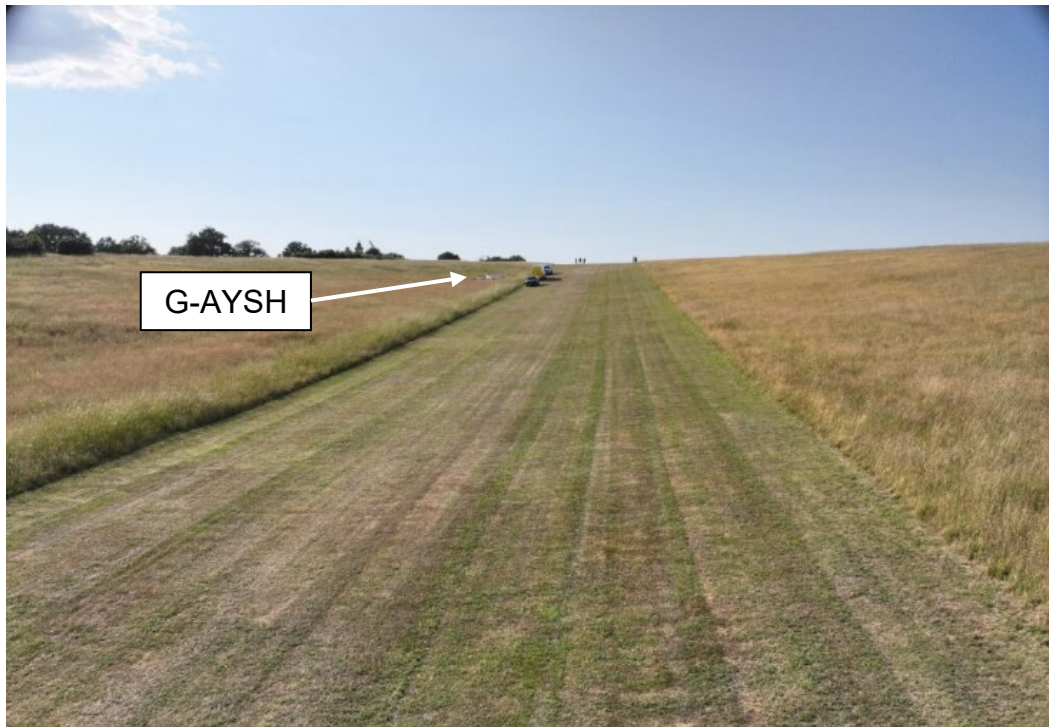
**Figure 9**

Nayland is a privately owned, unlicensed airfield located five nautical miles north-west of Colchester, at an elevation of 180 ft amsl. The preferred method of joining the circuit for Runway 32 is via the overhead, into a left-hand circuit. Runway 32 has an upslope gradient of approximately 5.5 % over its length. However, the initial 320 m has an upslope of about 9.5 %. The touchdown point and final position of G-AYSH were not visible from the clubhouse (Figure 9).

Nayland Airfield looking along Runway 32

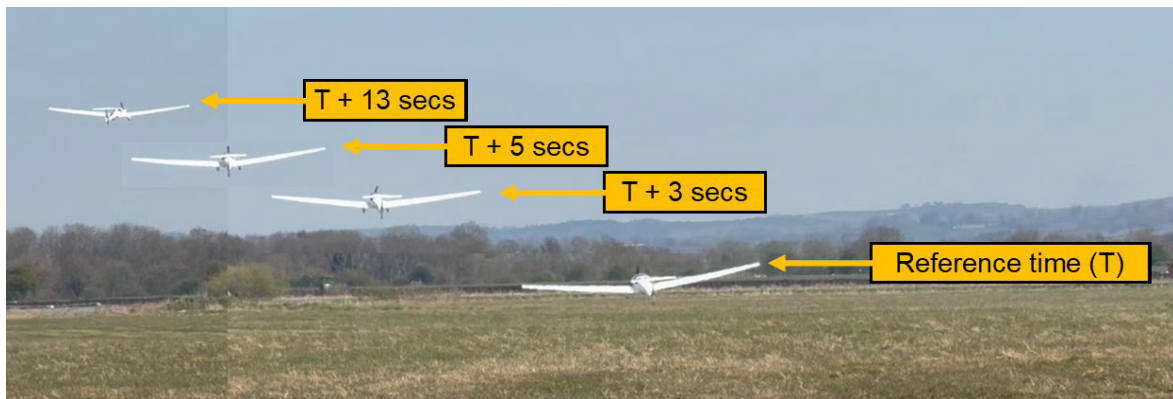
**Figure 1**

Composite image showing initial yaw and heading change after lift off  
(Reference time (T) is close to, but not precisely coincident with, lift off)

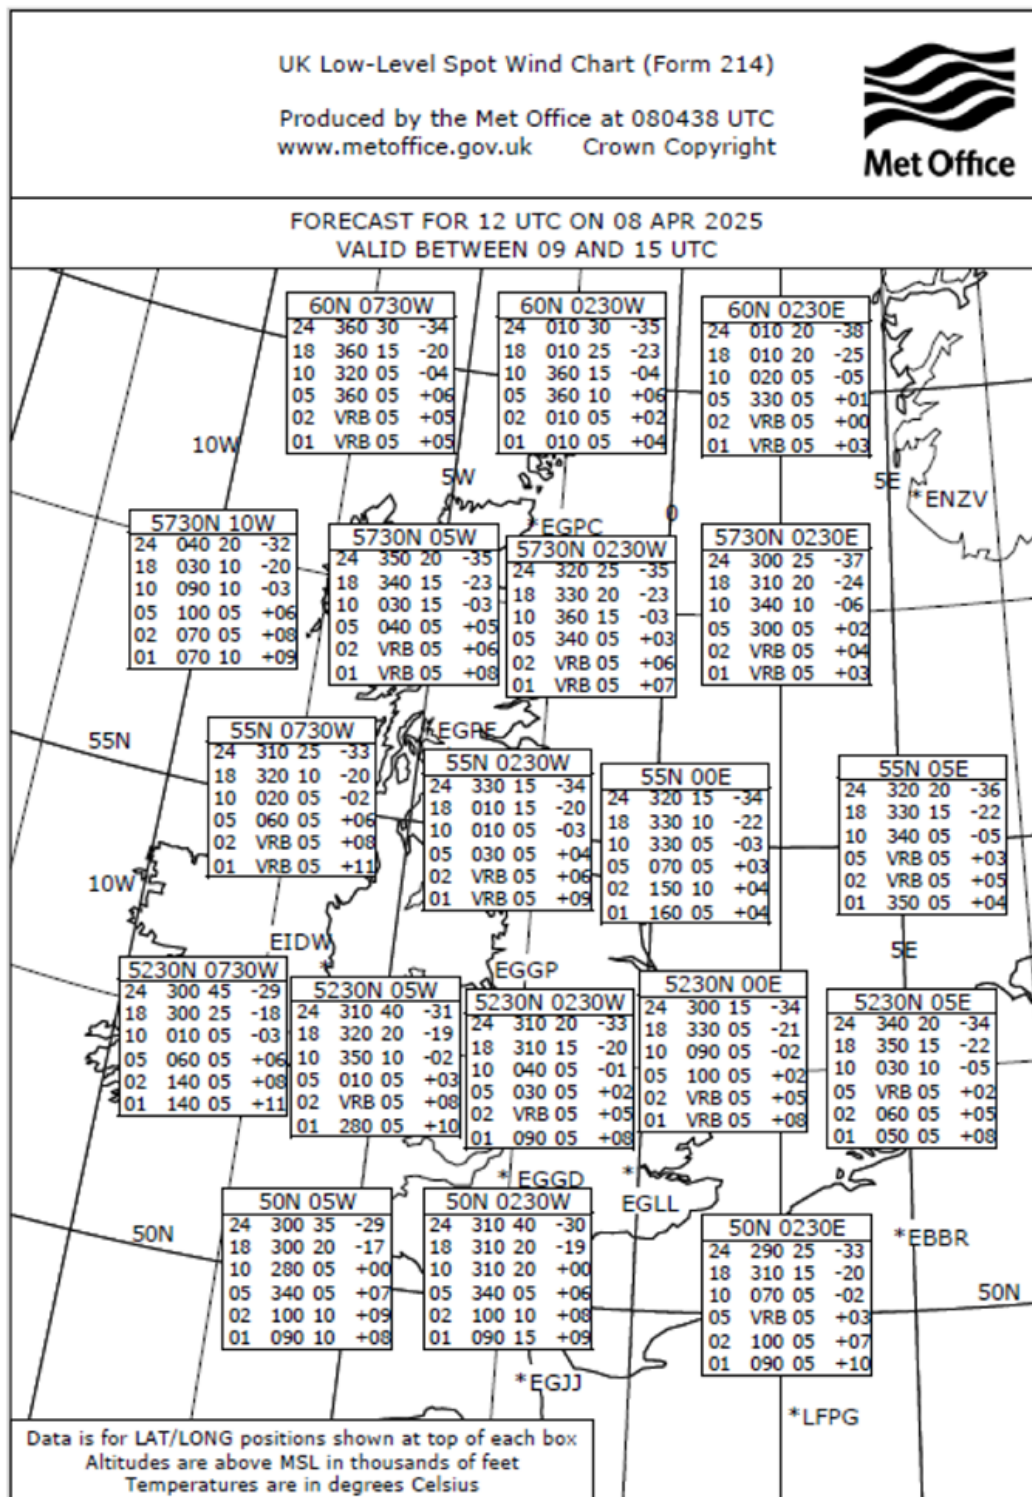
Figure 6 reproduces the UK low-level spot wind forecast (Form 214) for 1200 hrs on 8 April 2025 which was published by the Met Office and valid for the period 0900-1500 hrs. Darley Moor Airfield's location is approximately 53°N/001°45'W. Interpolation using the spot wind tables around that latitude and longitude indicated that below 5,000 ft the mean wind speed was forecast to be 5 kt. The wind direction would have been variable, most likely

Met Office Form 214 valid between 0900 and 1500 on 8 April 2025

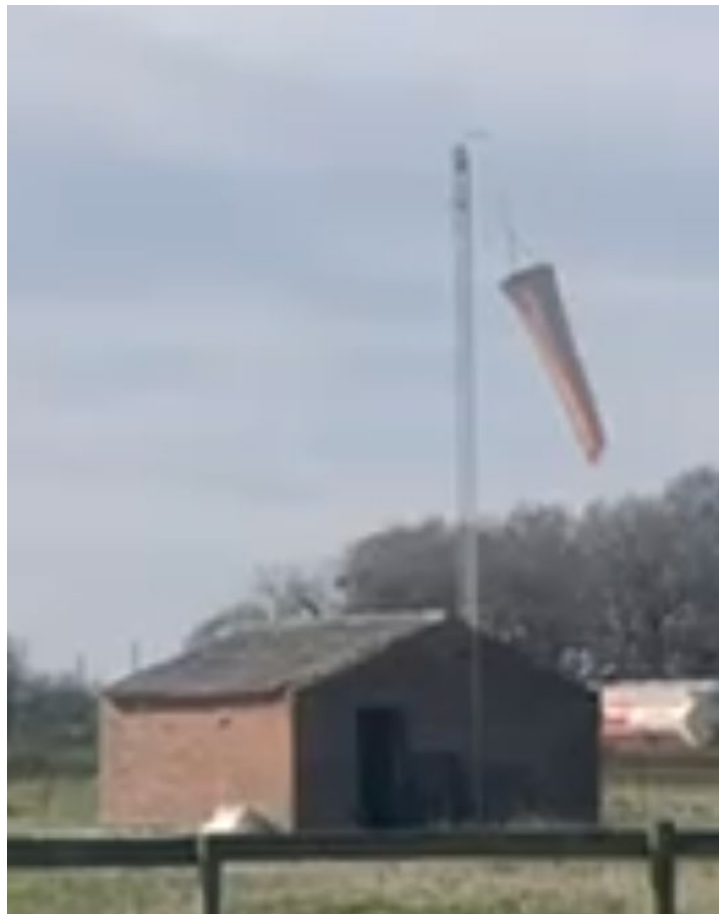
**Figure 7**

Local wind effects for individual airfields are not reflected in the UK-wide forecast on Form 214 but the operator reported that *'easterly winds are accentuated at Darley Moor with altitude due to the venturi influence of its geographical position with respect to the Peak District hills.'* The investigation did not find accurate surface or low-level wind data measured in the immediate vicinity of the airfield but was provided with video evidence of the local environmental conditions, filmed approximately 10 minutes after the accident. Figure 7 is a screenshot from that video, captured when the camera was facing in a south-south-westerly direction towards the airfield windsock. Referencing the fence in the foreground which is aligned approximately east-west, this image indicates the surface wind was easterly at around 5 kt when the video was taken.

Screenshot showing airfield windsock at approximately 1035 hrs on 8 April 2025

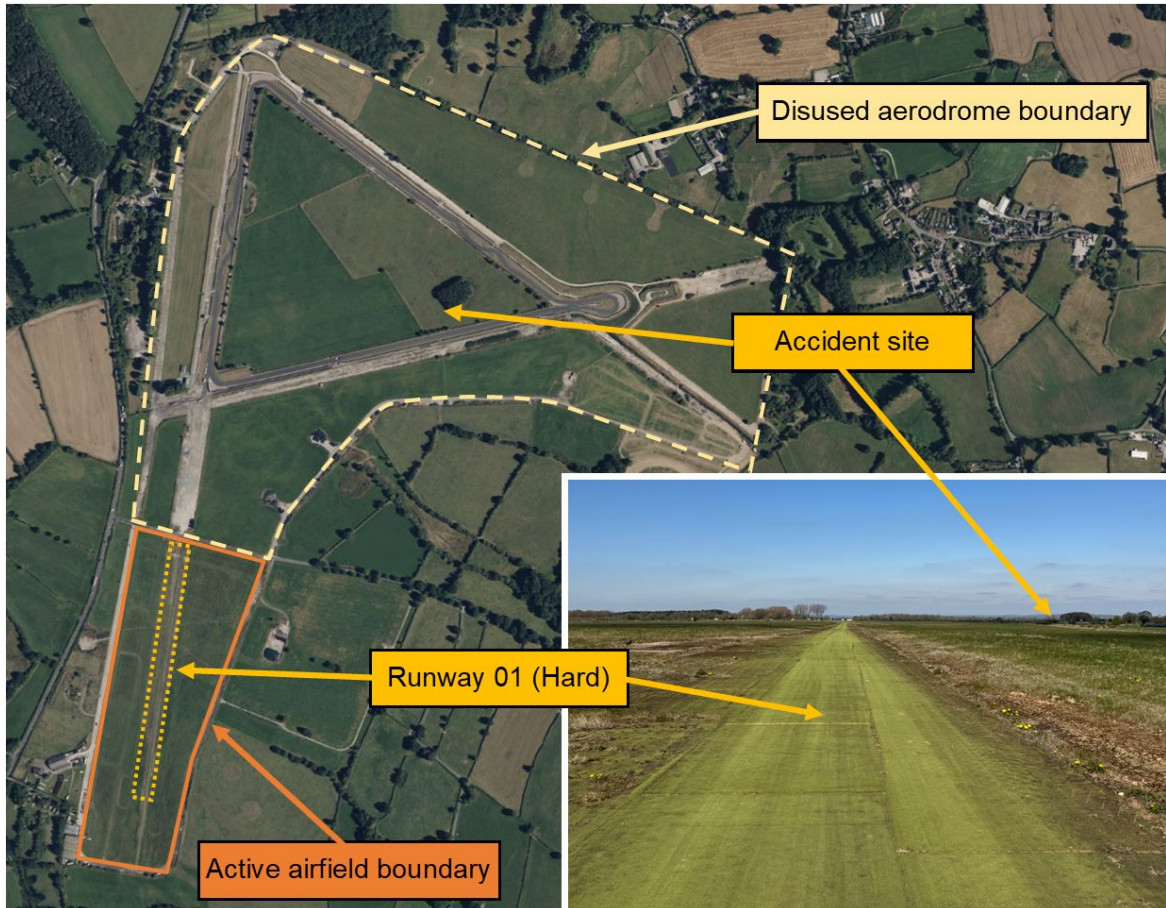
**Figure 8**

Darley Moor is an unlicensed airfield approximately 2 nm south of Ashbourne in Derbyshire. The active airfield area occupies the southern section of a disused wartime aerodrome. The northern section of the disused aerodrome is used as a vehicle racing circuit (Figure 8). Runway 01 (Hard) is formed from the southern end one of the wartime aerodrome's original concrete runways. In recent years the deteriorating concrete was overlaid with matting re-purposed from artificial sports pitches to make it smoother and more weatherproof.

Overview of Darley Moor Airfield with inset view from threshold of Runway 01 (Hard)  
(Satellite imagery ©Vexcel Imaging)

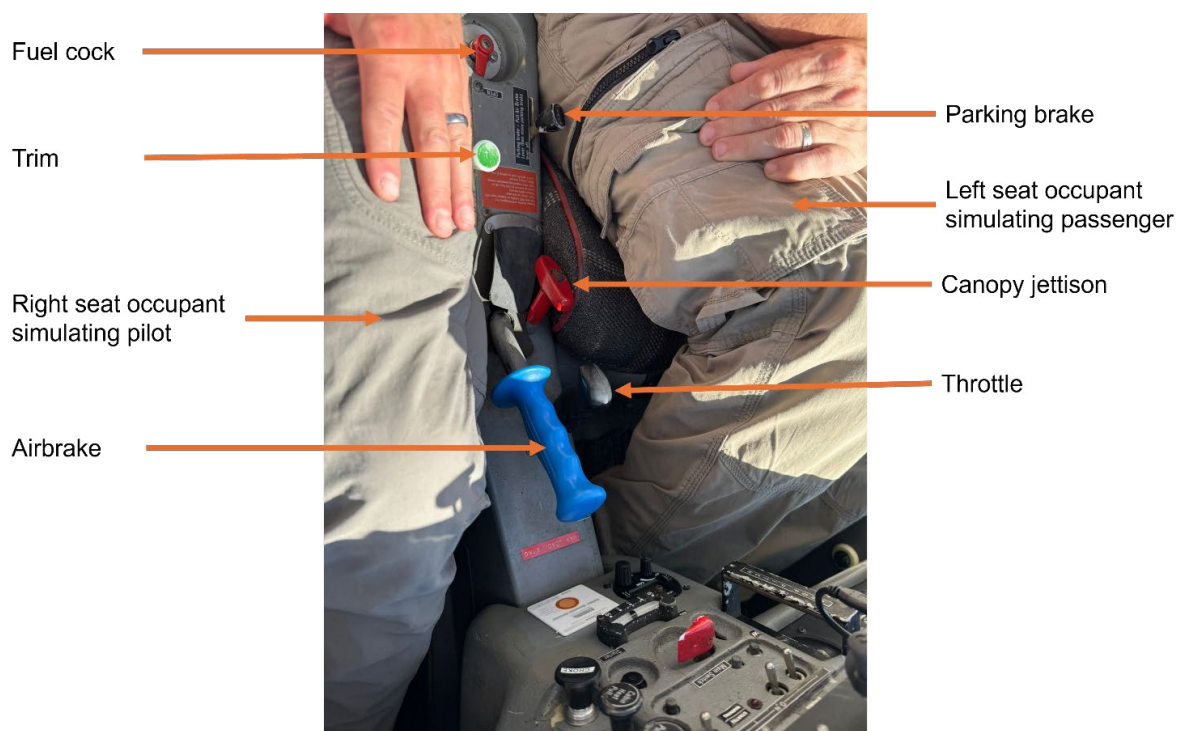
**Figure 12**

When the participants were seated in a relaxed posture, all controls on the lower centre console were fully or partially visually obscured and the controls on the left side of the centre console were partially physically obstructed by the right leg of the person in the left seat. Moving their right leg to the left to avoid obstructing these controls, resulted in fouling of the control column.

Position of controls on the centre console (picture taken from above instrument panel looking towards the rear of the aircraft)

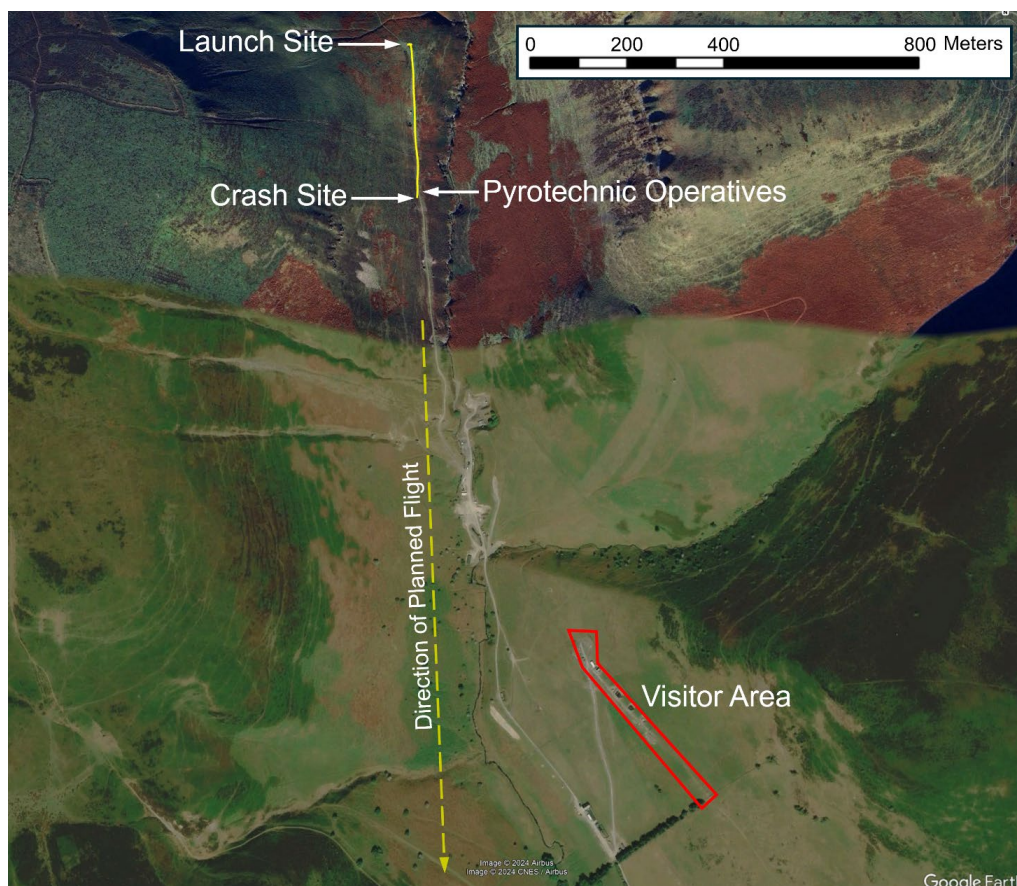
**Figure 1**

The aircraft's technicians performed its assembly and pre-flight checklists normally. Loaded to its MTOW of 55 kg, the aircraft was started at 1114 hrs, facing into a reported headwind for the route of 12-13 kt. It took off vertically then transitioned to a forward climb. Around twelve seconds later the right wing detached. The aircraft descended rapidly, striking the ground near some pyrotechnic operatives who were standing under the flight path (Figure 1).

Overview of flight path and location of pyrotechnic operatives and visitor area

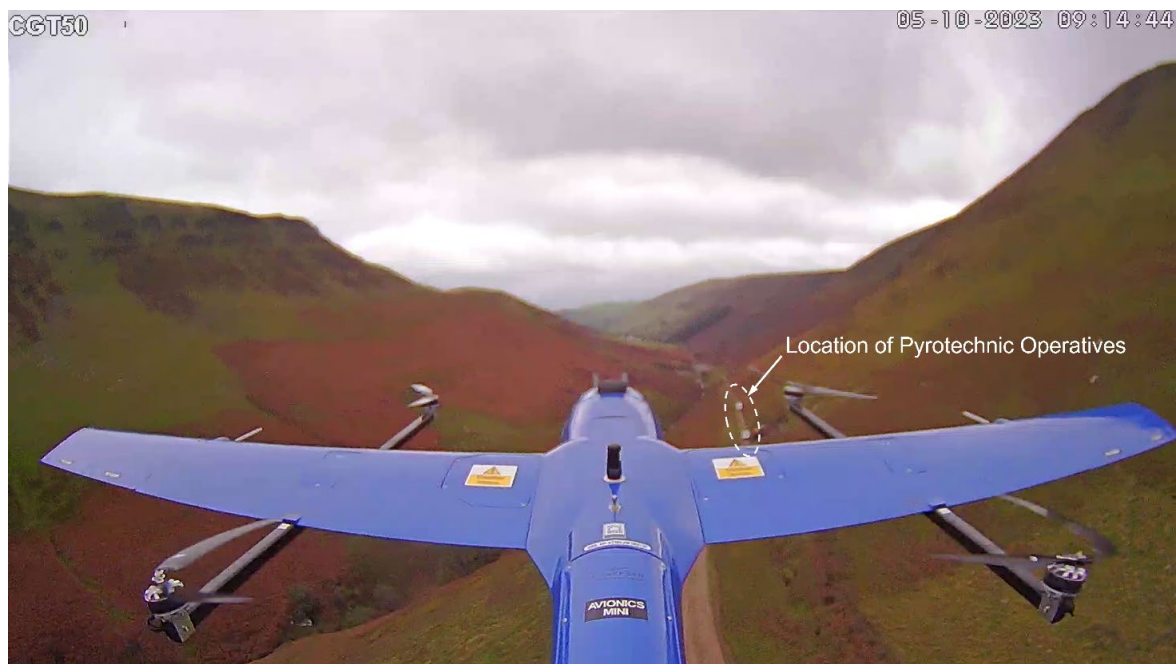
**Figure 2**

The range operations director (ROD) explained the pyrotechnic operatives were scheduled to be present in the operating area until 1300 hrs (Figure 1), when the accident flight was due to commence. However, the flight was brought forward because of an earlier weather window, meaning they were still near the planned flight path when the flight occurred. Although the flight team made a radio call before taking off, both the ROD and the operator's RP commented that radio communication between them was somewhat unclear. The pyrotechnic operatives were visible on the aircraft's FPV camera (Figure 2). They had radio contact with the range, but not with the flight team.

View from fin-mounted FPV camera showing location of pyrotechnic operatives

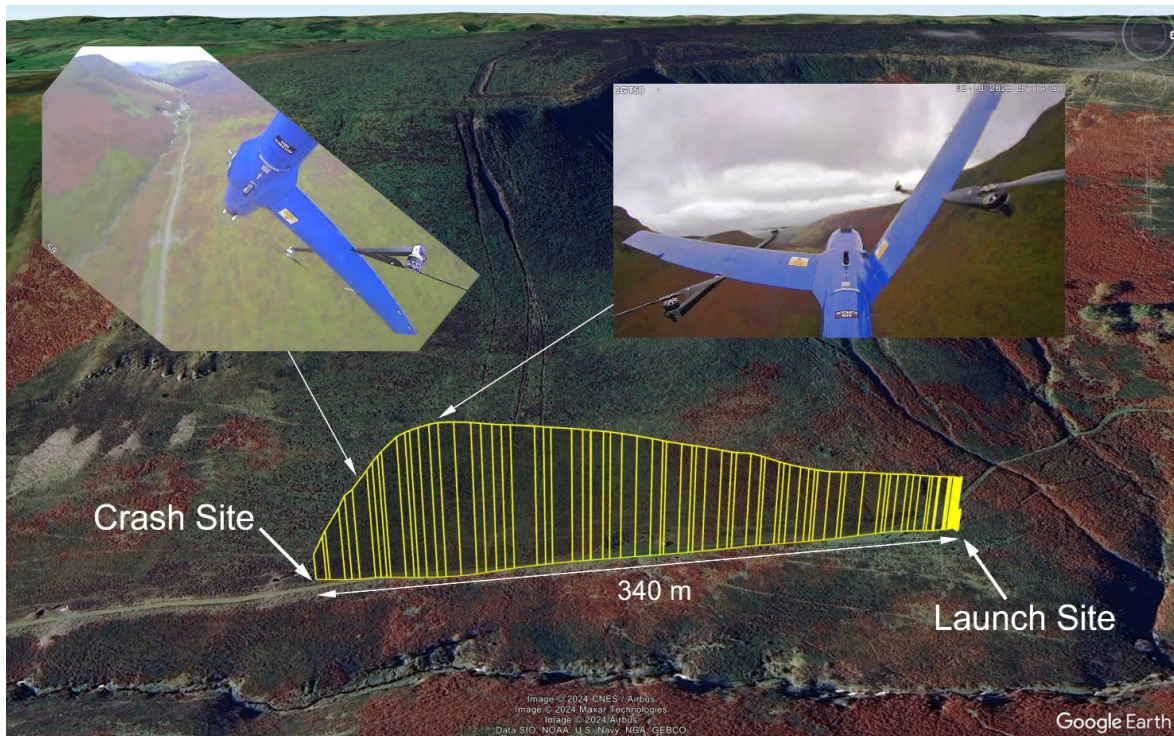
**Figure 3**

The video images are consistent with the aircraft nominally in 1 g flight conditions ie wings level and no indication of buffet when the wing failed. Acceleration data from the aircraft’s attitude and heading reference system (AHRS) was only recorded at the GCS (at 1 Hz) and not in the cloud storage. These 1 Hz samples were unlikely to have recorded any spikes in the acceleration data given such spikes happen over a fraction of a second with an instantaneous peak.

Flight path of the aircraft showing the view from the fin-mounted FPV camera when the wing failed and two seconds later as the aircraft tumbled towards the ground

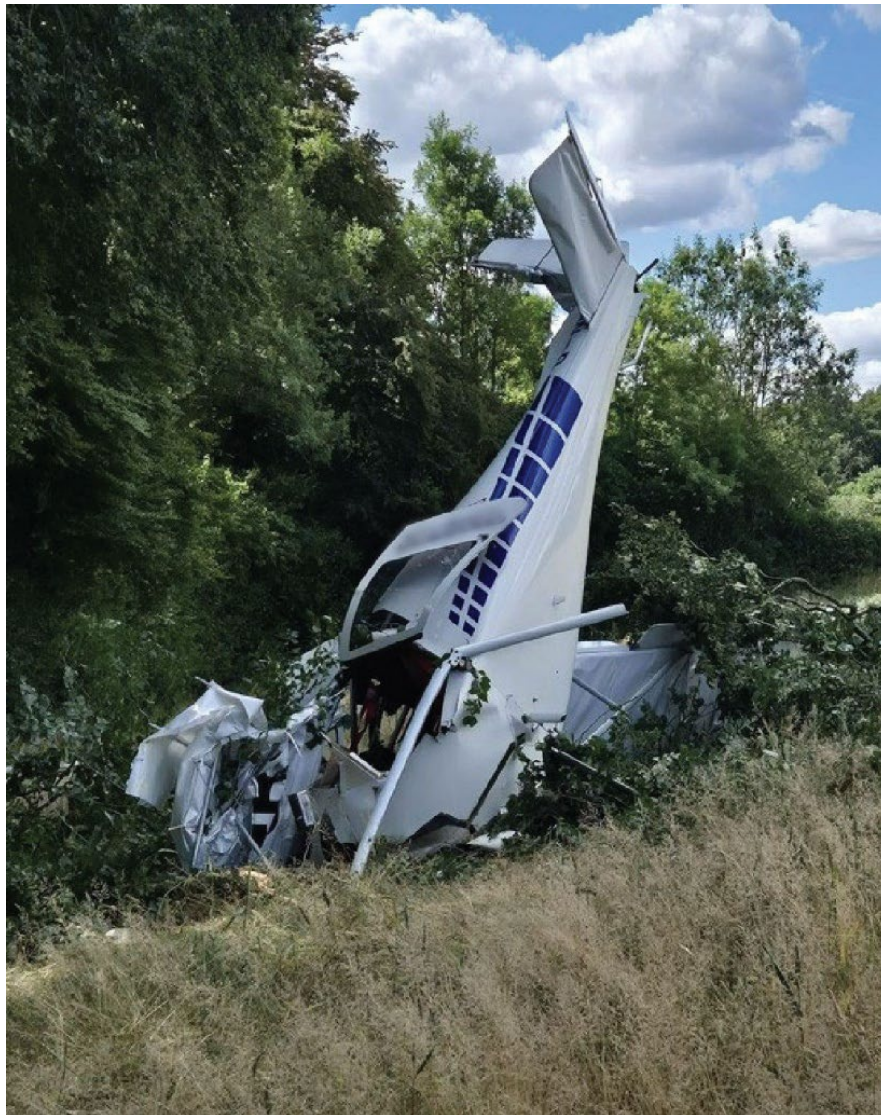
**Figure 1**  
G-MOOD after the accident

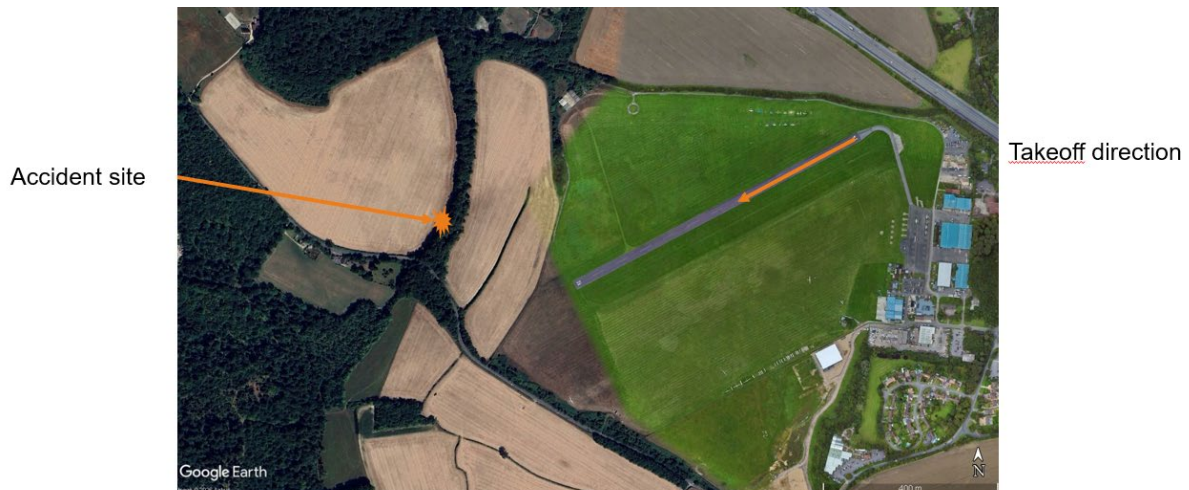
**Figure 2**  
Accident site location
