# Rail Accident Report

**Collision between a passenger train and an agricultural trailer at Nordan Farm user worked crossing, near Leominster, Herefordshire  
22 May 2025**

Report 06/2026  
May 2026

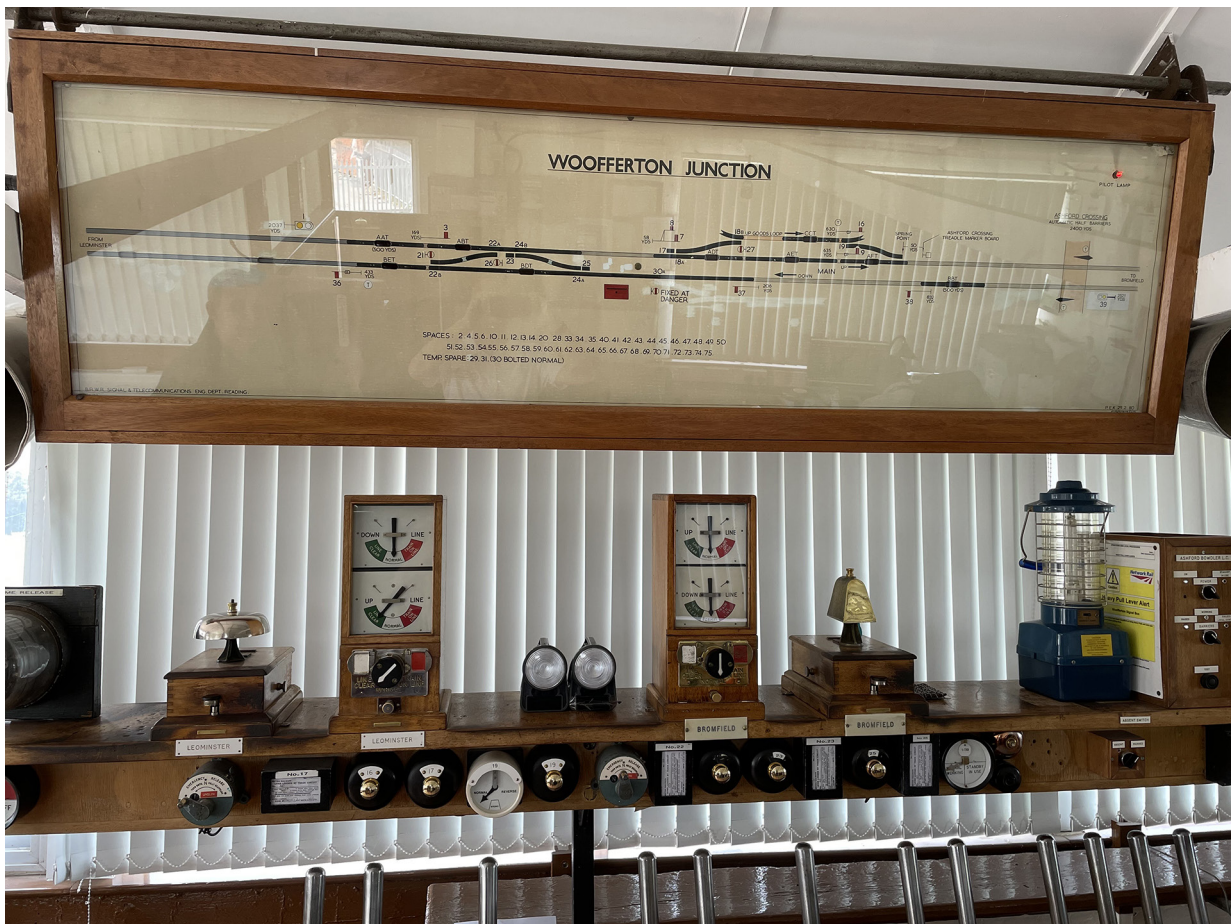
Figure 6: The block instruments at Woofferton.

- 76 The block instruments within Woofferton signal box are positioned towards the centre of the block shelf, adjacent to the signalling bells (figure 6). The left-hand block instrument, furthest from the telephone and the occurrence book lectern, shows the status of the line between Woofferton and Leominster. At the time the signaller granted permission for the tractor to cross, this block instrument was displaying TRAIN ON LINE on the down line and LINE CLEAR on the up line. The TRAIN ON LINE indication showed that there was a southbound train on the down line between Woofferton and Leominster, which includes Nordan Farm UWC(T).
