AAIB Bulletin

6/2026

Leonardo AW139	G-CIMU	13-Jun-22	3
----------------	--------	-----------	---

Aircraft Type and Registration:	Leonardo AW139, G-CIMU	
No & Type of Engines:	2 Pratt & Whitney Canada PT6C-67C turboshaft engines	
Year of Manufacture:	2015 (Serial no: 31583)	
Date & Time (UTC):	13 June 2022 at 1801 hrs	
Location:	Norwich Airport	
Type of Flight:	N/A found during maintenance inspection	
Persons on Board:	Crew - None	Passengers - None
Injuries:	Crew - N/A	Passengers - N/A
Nature of Damage:	Bearing failure	
Commander's Licence:	N/A	
Commander's Age:	N/A	
Commander's Flying Experience:	N/A	
Information Source:	AAIB Field Investigation

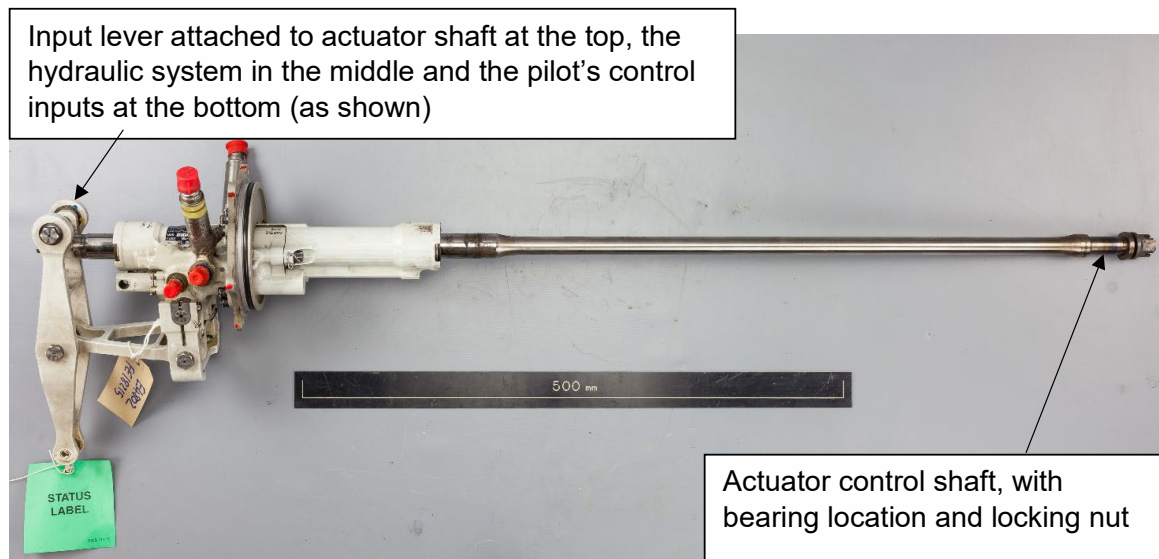
Figure 3

Adjustment of the tail rotor blade pitch is achieved by a tail rotor control actuator. The control shaft of the actuator extends and retracts in response to the movement of hydraulic fluid on either side of a set of pistons, in response to the pilot's pedal inputs. The input from the pedals is via an input lever which is attached to the end of the actuator shaft by a castellated locking nut. On the AW139 this nut has a left-hand thread. This ensures that if the actuator shaft rotates due to a failure of the system, the nut will tighten, and the input lever will remain connected to the actuator.

AW139 Tail rotor control actuator

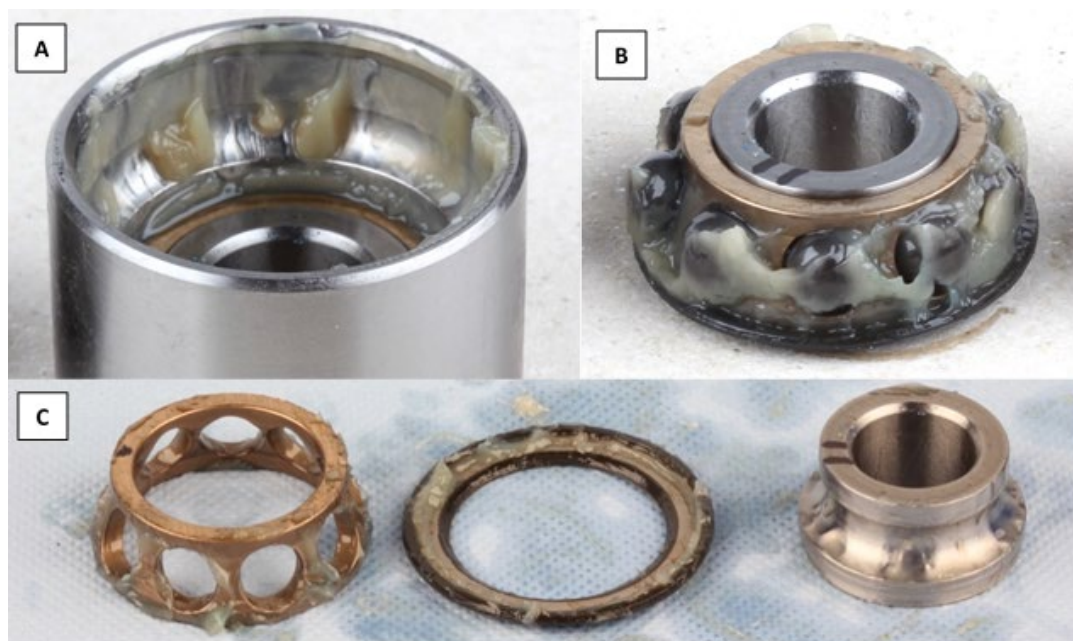
Bearing in new condition - (A) Housing and outer race, (B) inner race, cage and balls assembled, (C) cage, seal and inner race disassembled

Figure 6 shows the housing and the outboard row, outer race in image A. Image B shows the inner race, cage and balls as they have been removed from the housing in image A and turned over (the top surface in view is normally located in the middle of the bearing). Image C shows the inner race, cage and seal after they have been disassembled and the balls removed. The other row of the bearing is identical but is installed the opposite way around (mirror image).

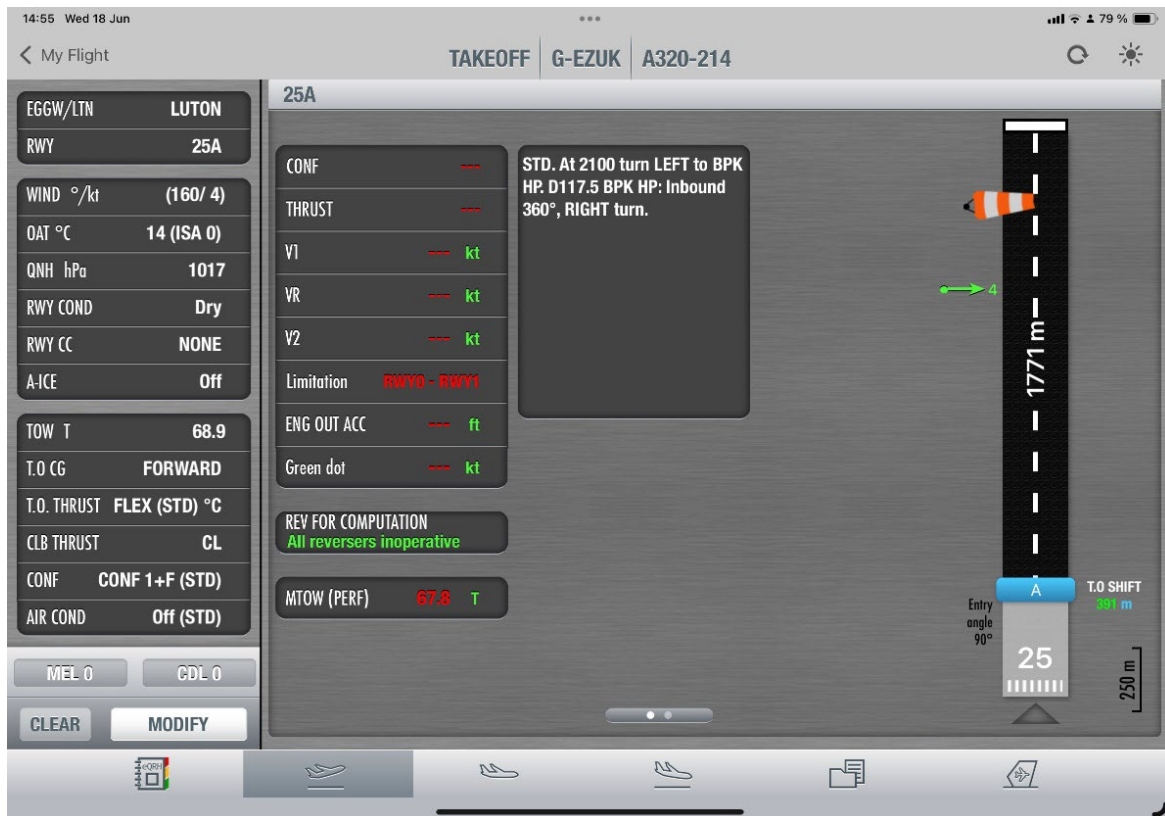
The crew calculated takeoff performance using flaps at CONF 1+F, for a takeoff from Runway 25 at LTN, at a weight of 68,887 kg. They input a wind from 160° at 4 kt as a worst case. Figure 2 shows the indications on the EFB showing that the takeoff was not permitted from Intersection Alpha for the conditions input.

Takeoff performance from Intersection Alpha, Runway 25

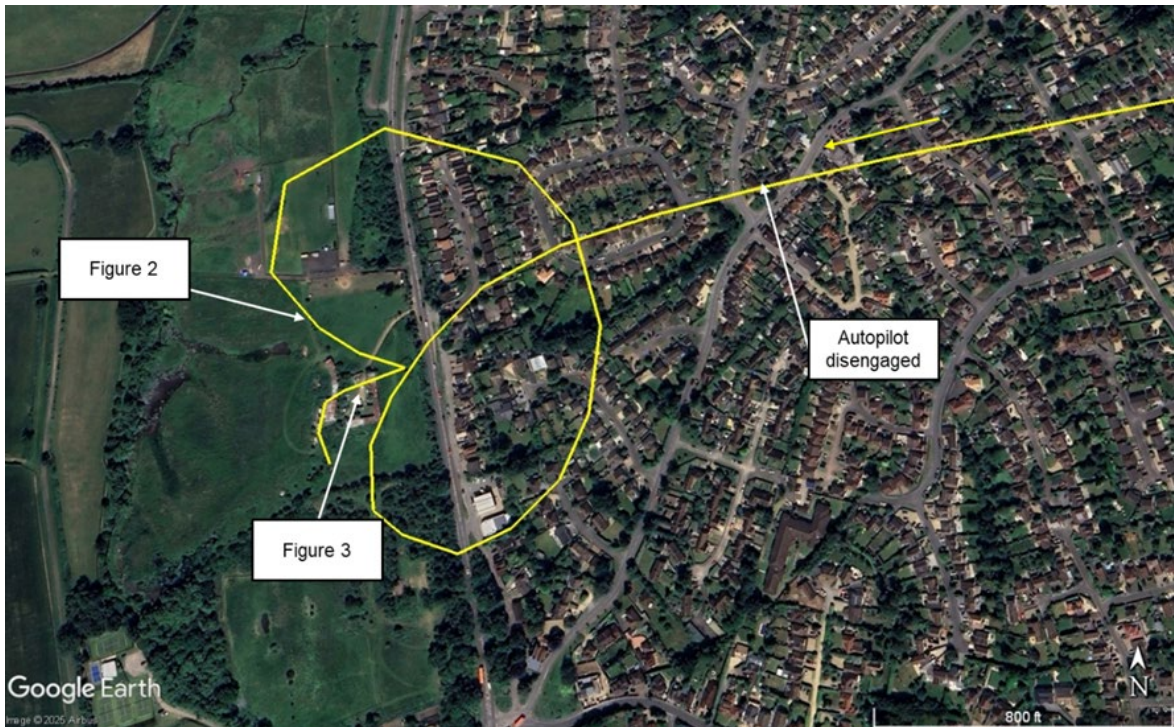
Figure 4
ADS-B flightpath data from FlightAware

The helicopter rolled level with the pilot applying full power, but the main rotor RPM quickly fell below 80%, probably due to overpitching³. The pilot had been thrown to the left when the helicopter rolled inverted causing his left foot to push forward on the yaw pedal and it remained in that position as the helicopter entered a rapid yaw to the left. The yaw continued until the helicopter struck the ground in a field next to a paddock with outbuildings. A plan view of the flightpath is shown in Figure 4.

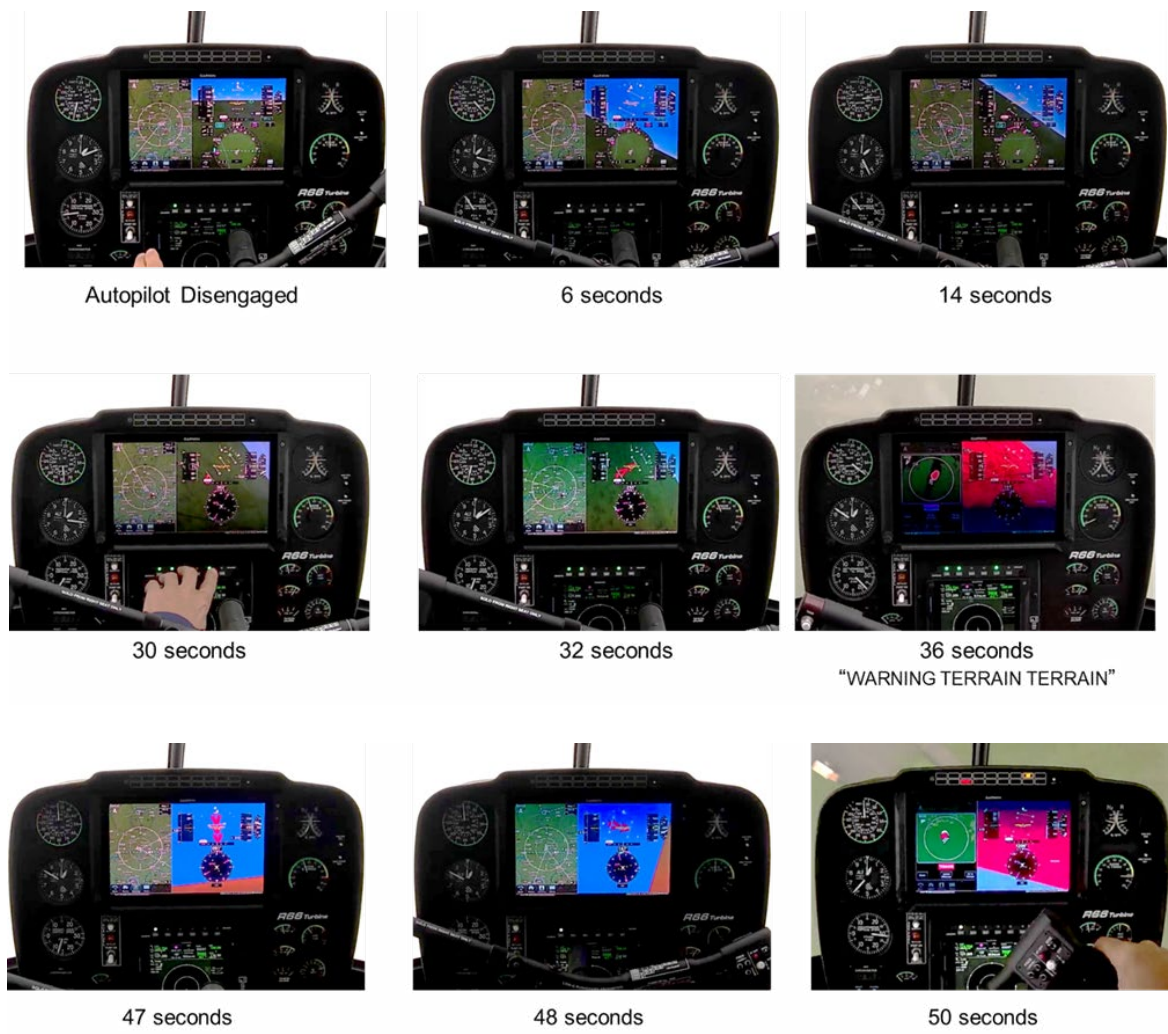
Figure 6
Loss of control sequence of events

The pilot rolled level and pulled up, the hdg and alt modes disengaged leaving the SAS mode light green, and the helicopter entered cloud again, pitching to 60° nose-up. The pilot pressed the SAS button again, which disengaged the autopilot system. The helicopter rolled right to approximately 170° AOB, the nose dropped rapidly, and the helicopter emerged from the base of the cloud near inverted at approximately 450 ft agl with 3,000 ft/min rate of descent (Figure 3).

Figure 6 shows a sequence of images of the instrument panel during the loss of control described above.
