Rail Accident Investigation Branch

Rail Accident Report

**Pedestrian struck by a train at Pewsey footpath crossing, Pewsey, Wiltshire
26 February 2025**

Report 05/2026
May 2026

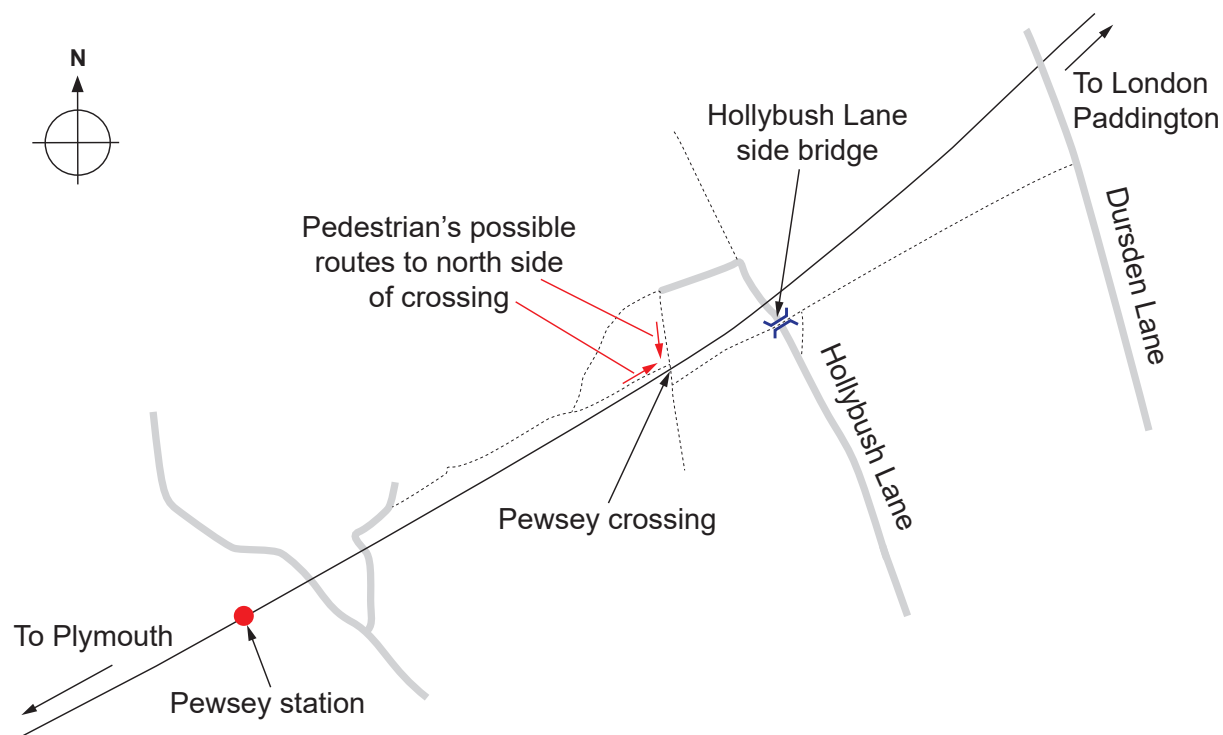
Figure 2: Diagram of the area around the crossing.

- 5 A public footpath runs along the north side of the railway. This joins a second footpath, which runs approximately north to south, and leads to the north entrance of Pewsey crossing (figure 2). South of the crossing, this second public footpath joins a third footpath which runs along the south side of the railway.
- 6 This third path leads to Dursden Lane, which is a public road. As it does so, it crosses over Hollybush Lane (also a public road) via a lineside footbridge, known as 'Hollybush Lane side bridge' (figure 3). Just beyond this footbridge, a separate path (which is not a recorded public right of way) branches off from the public footpath and provides pedestrian access to Hollybush Lane.

- 168 The risk assessment noted an alternative route at Dursden Lane, a minor public road, that passes over the railway around 560 metres north-east from the crossing (figure 2). Dursden Lane was connected to the crossing to the south of the railway via a public footpath running adjacent to the railway and to the north via footpaths within an adjacent nature reserve. This option was considered via cost-benefit analysis and resulted in a 3.02 ratio (7.5 with the gross disproportionate factor applied). This meant the safety benefit of closing the crossing via the alternative route was between 3 to 7.5 times greater than the cost of doing so. However, this option was marked as '*discounted*' in the conclusions section of the assessment without any documented reasoning as to why this was the case.

- 171 RAIB found no evidence that an alternative route via Hollybush Lane was considered during the 2024 assessment, and witness evidence shows the LCM was not aware that Hollybush Lane was accessible to pedestrians via the public footpath to the south of the level crossing (figure 2).

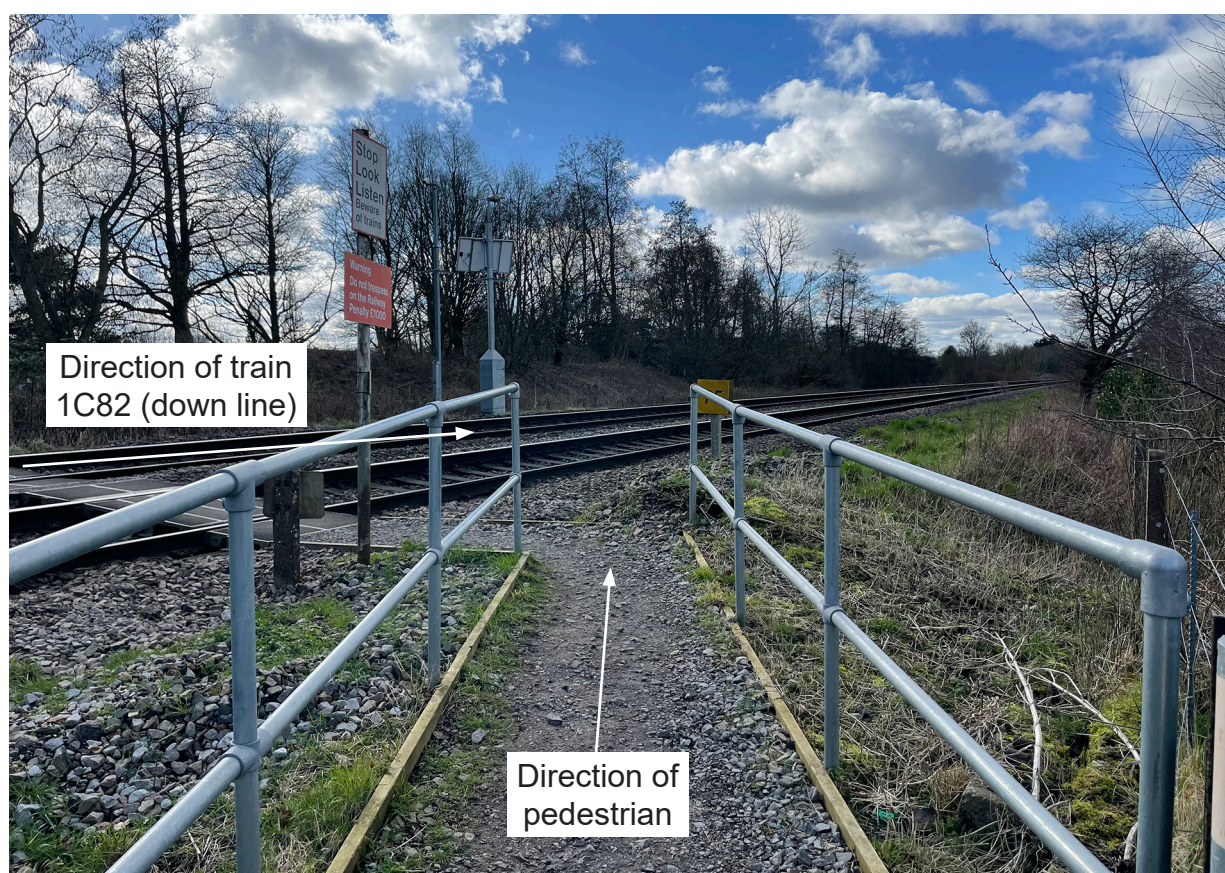
- 9 As pedestrians approach the crossing, a self-closing pedestrian gate leads them through the northern railway boundary onto a path which is enclosed with metal fencing. At the time of the accident, there were signs at the end of this corridor which warned users (figure 5):
- to ‘Stop, Look, Listen – Beware of trains’
 - not to trespass on the railway
 - that oncoming trains can be hidden by other trains.
- 10 The surface of the corridor from the pedestrian gate to beyond the signs is a compacted crushed-stone surface. Network Rail stated that the crossing deck consists of metal-framed polymer concrete panels. These have a noticeable height difference between the panels on the outer and inner parts of the deck, consistent with the cant (slope) of the track.

Figure 5: Approach to the crossing's north signage via the fenced corridor.

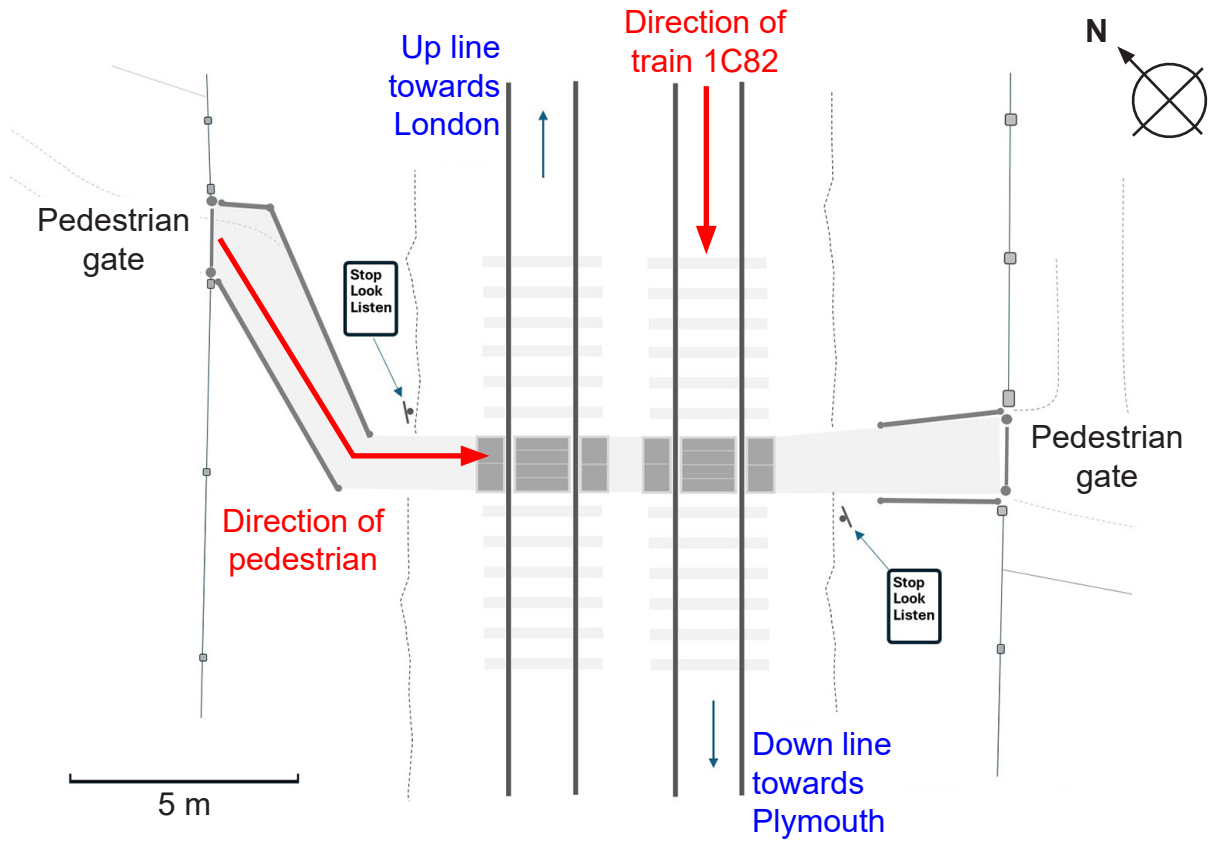
Figure 6: Layout of the crossing.

C11 At the crossing, the sound level had reduced to an average of 48.1 dB(A) at the decision point and 42.6 dB(A) at the crossing gate (figure 6). The attenuation of sound during the testing was measured to be 9 dB to 13 dB per doubling of distance (9 to 13 dB/dd) with the median rate of approximately 12.0 dB/dd. The rates of attenuation due to distance were similar to the data that had been collected during previous research in the railway environment (paragraph 46).

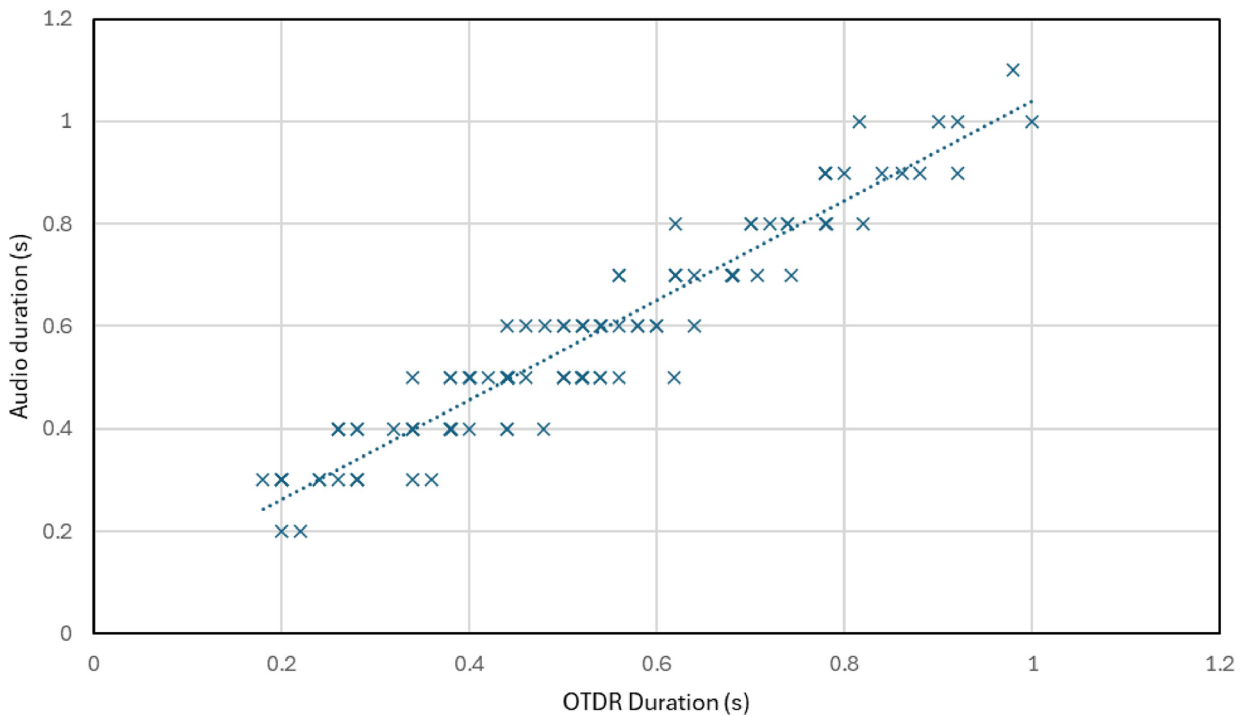
Figure C2: Duration of horn sounding recorded by OTDR and actual duration of sound recorded.
