Rail Accident Investigation Branch

Rail Accident Report

Near miss with track workers at Bookham Tunnel, Surrey 29 April 2025

Report 07/2026
June 2026

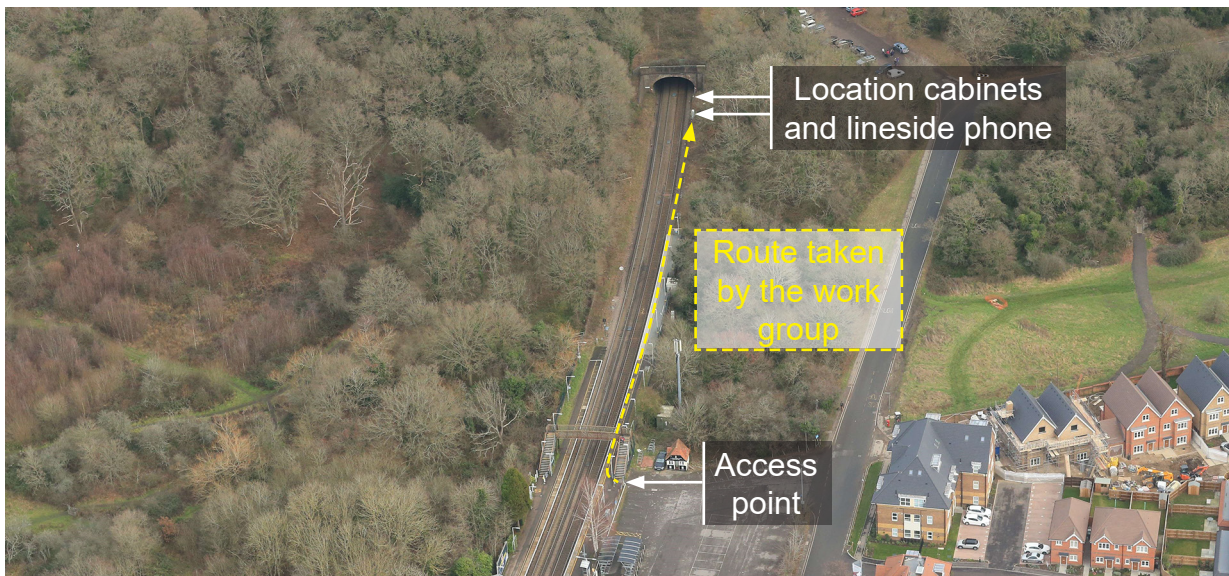
Figure 9: Track workers location before taking first line blockage (courtesy of Network Rail with RAIB annotations).

- 54 Once the work on the telephone at the western end of Bookham Tunnel was completed, the PIC called the signaller at Wimbledon at 11:00 to request the granting of the booked line blockage. This was intended to allow the group to walk through Bookham Tunnel on the down line to undertake work on the telephone on the eastern side of the structure (figure 9).

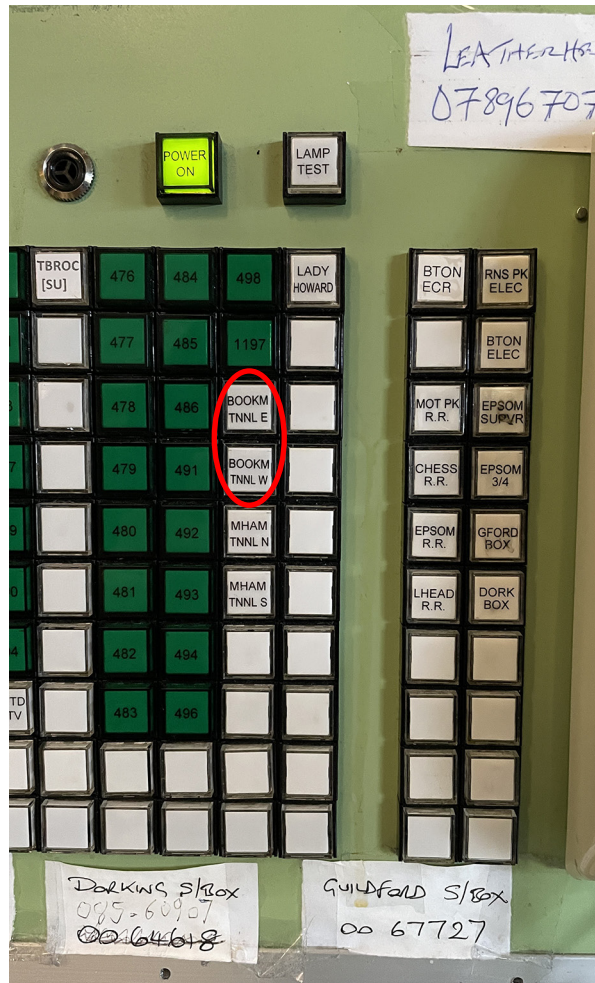
Figure 11: Phone concentrator on Wimbledon panel No.4 with Bookham Tunnel east and west telephone buttons highlighted.

- 109 The signaller was initially contacted by trackworker 1 at 10:56 to test the telephone at the western end of Bookham Tunnel (paragraph 53). When an incoming call is received from the Bookham Tunnel telephones, there is an audible ring on the concentrator phone, and the button labelled 'Bookm Tnnl E' or 'Bookm Tnnl W' flashes (figure 11). This indicates where the call is coming from. To answer the call, a signaller needs to lift the receiver and press the flashing button. Although the buttons on the concentrator for the two tunnels are positioned relatively close together on the concentrator (figure 11), the signaller was provided with information to show that the call was coming from Bookham Tunnel. The signaller saw the incoming call on the concentrator but did not immediately answer the call as they were busy. During the follow-up call, trackworker 1 also confirmed they were at Bookham Tunnel. The signaller and trackworker 1 spoke again on the Bookham Tunnel west telephone at 10:57.

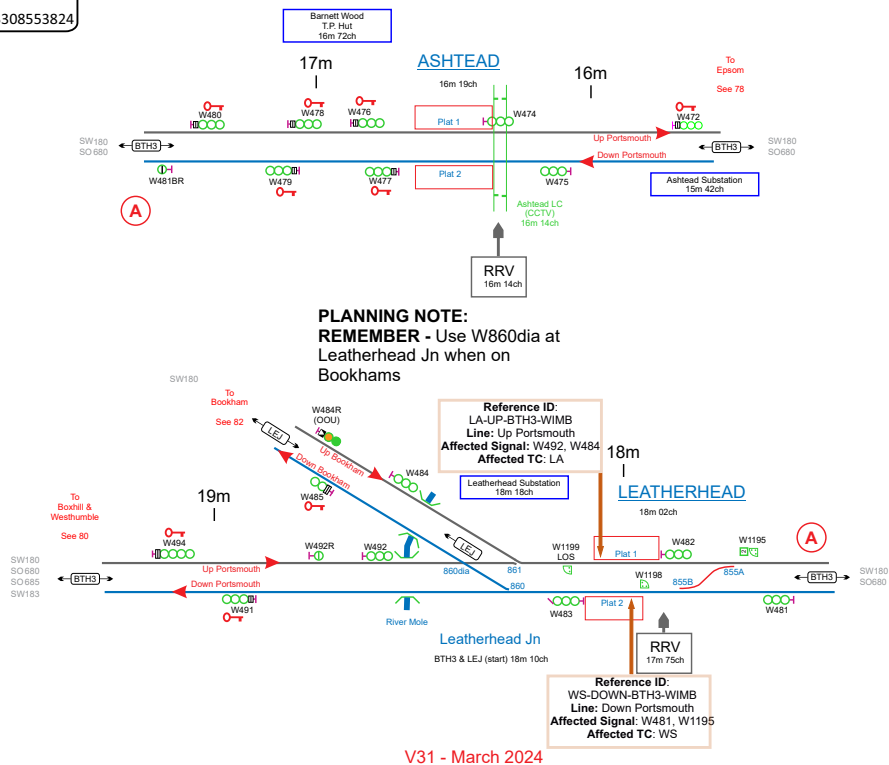
Figure 16: Track diagrams for Leatherhead Junction (courtesy of Network Rail)

- 76 The entry blocking points for both Bookham and Mickleham Tunnels are both at Leatherhead Junction (figure 16). The blocking points are very similar, with 860 diamond crossing used for Bookham Tunnel and 860 points for Mickleham Tunnel. However, the exit blocking points are different, with signal CA186 used for Mickleham Tunnel and signal GD623 for Bookham Tunnel.

- 106 The only way to provide additional protection to the site would have been via a signal disconnection of the signal beyond the 860 diamond crossing (figure 16). This would potentially have meant a further SWP and additional staff resources to undertake this action.
- 107 This causal factor arose because neither the signaller nor the PIC realised that the group was in a different location to the line blockage (paragraph 108).

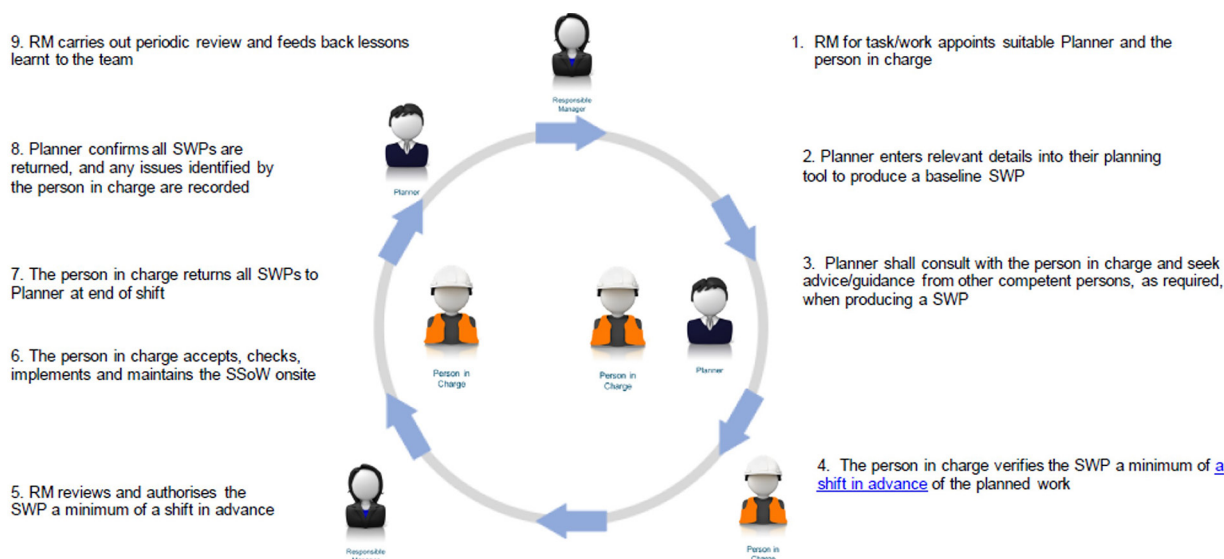
Figure 17: Workflow diagram for NR/L2/OHS/019 (courtesy of Network Rail).

86 Network Rail standard NR/L2/OHS/019 (paragraph 31) states that the planner and PIC shall collaborate and create the SWP together (figure 17). Previous versions of the standard had allowed for a PIC not undertaking the work to be involved in the planning phase, but this had been removed from the version of NR/L2/OHS/019 which was current at the time of the incident.

- 88 The planner would, therefore, regularly undertake the planning of work tasks and their associated SSoWs without the input of the PIC who delivered the work. Had the PIC been involved during the planning stage, it is possible that the discrepancy between the location of works and the location of the SWP would have been identified at this stage of the process.
