Rail Accident Investigation Branch

Rail Accident Report

Near miss with track workers at Bookham Tunnel, Surrey 29 April 2025

Report 07/2026
June 2026

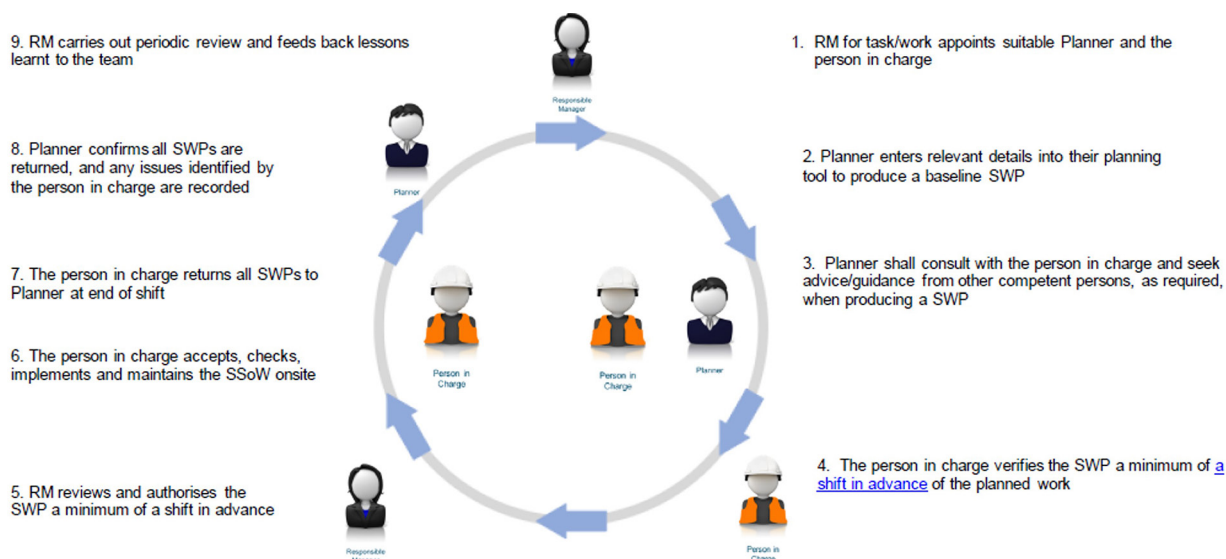
Figure 17: Workflow diagram for NR/L2/OHS/019 (courtesy of Network Rail).

86 Network Rail standard NR/L2/OHS/019 (paragraph 31) states that the planner and PIC shall collaborate and create the SWP together (figure 17). Previous versions of the standard had allowed for a PIC not undertaking the work to be involved in the planning phase, but this had been removed from the version of NR/L2/OHS/019 which was current at the time of the incident.

- 88 The planner would, therefore, regularly undertake the planning of work tasks and their associated SSoWs without the input of the PIC who delivered the work. Had the PIC been involved during the planning stage, it is possible that the discrepancy between the location of works and the location of the SWP would have been identified at this stage of the process.
