Rail Accident Investigation Branch

Rail Accident Report

Collision between two passenger trains near Talerddig, Powys 21 October 2024

Report 08/2026
June 2026

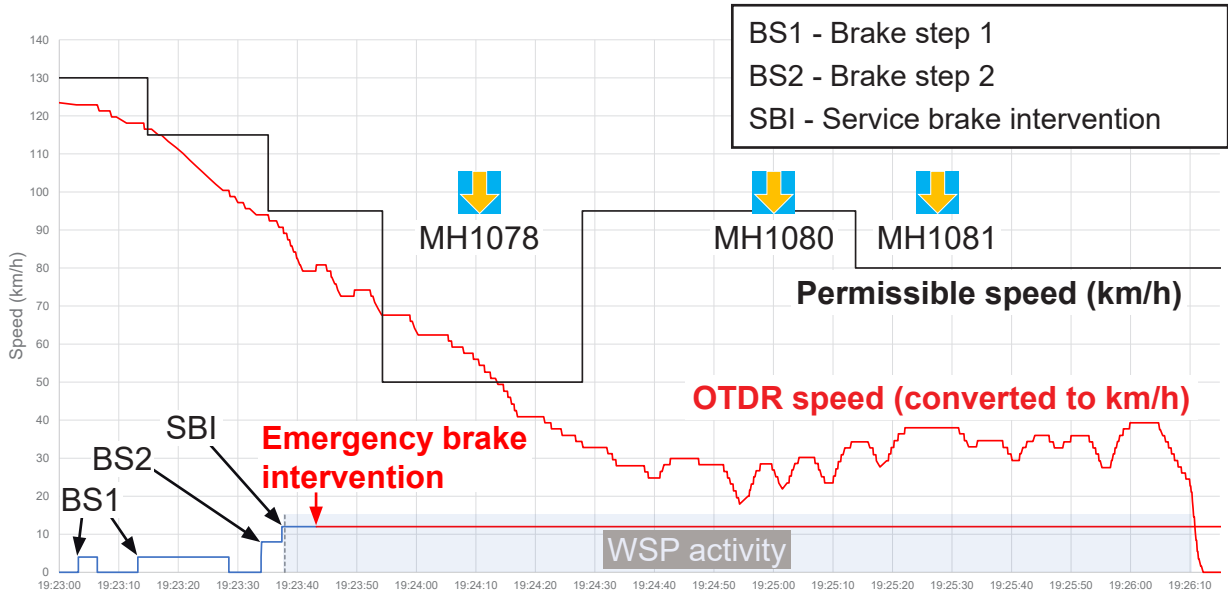
Figure 12: Data from the OTDR on train 1J25, showing braking profile, speed and block marker locations.

- 52 A simplified sequence of events is shown in figure 11. At approximately 19:22, train 1J25 approached Talerddig loop from the east. Data from the OTDR of train 1J25 shows that the driver shut off traction power while the train was travelling at 125 km/h. At this point, the intended stopping position, at block marker MH1078, was approximately 1,900 metres away. Over the next 39 seconds, the driver made two separate step 1 brake applications to bring the train's speed down to 94 km/h. The train's brakes were released after each of these brake applications (figures 12 and 13).

- 53 At approximately 19:23, the driver selected step 2 braking (figures 12 and 13). The intended stopping position was now approximately 730 metres away. Between 3 to 4 seconds later, an application of full service braking (step 3) was made when block marker MH1078 was approximately 640 metres away. The train had not yet reached the start of the passing loop. Data from the JRU shows that ETCS applied the full service brake automatically, although witness evidence indicates that the driver also made a full service brake application at approximately the same time. Limitations in the way the OTDR records data means it is not possible to confirm when the driver manually applied full service braking after the application had been made by the signalling system. RAIB has concluded from its analysis of OTDR data that the train's wheel slide protection (WSP) system (see paragraph 88) intervened to control wheel rotation approximately 1 second after the full service brake application.

- 54 After about 6 seconds of full service braking, with train 1J25 travelling at approximately 80 km/h, the on-board signalling system intervened with an emergency brake demand. On class 158 units, the emergency brake provides the same level of braking force as the full service brake (see paragraph 86). The intended stopping position was now approximately 500 metres away.

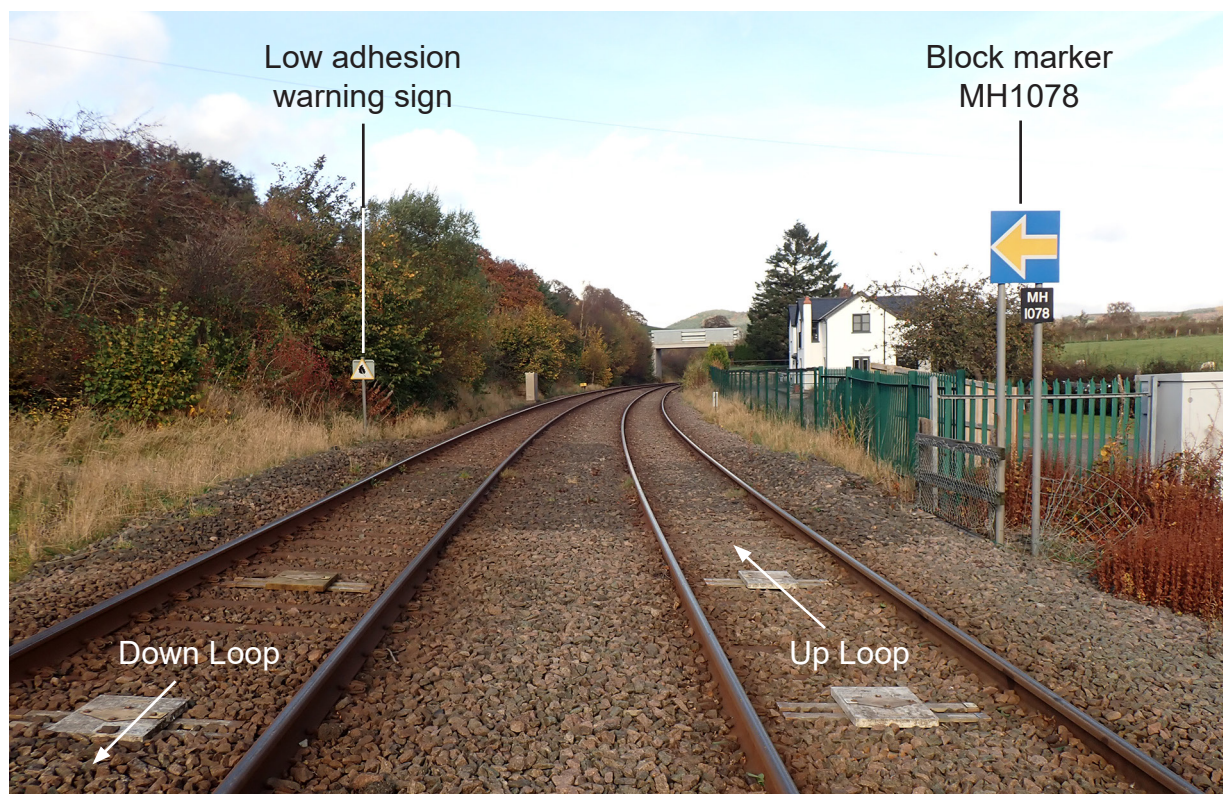
- 55 The driver of train 1J25 then used the train's GSM-R radio to call the signaller to report that the train was sliding and was probably going to pass block marker MH1078 (figures 14 and 15). Less than 20 seconds after starting the call, the train passed block marker MH1078 at approximately 54 km/h. The area beyond block marker MH1078 is an area designated as being at high risk of low adhesion (see paragraph 247).

Figure 15: The intended stopping position for train 1J25, at block marker MH1078 on the Up Loop. A low adhesion warning sign is also visible on the left side of the Down Loop.

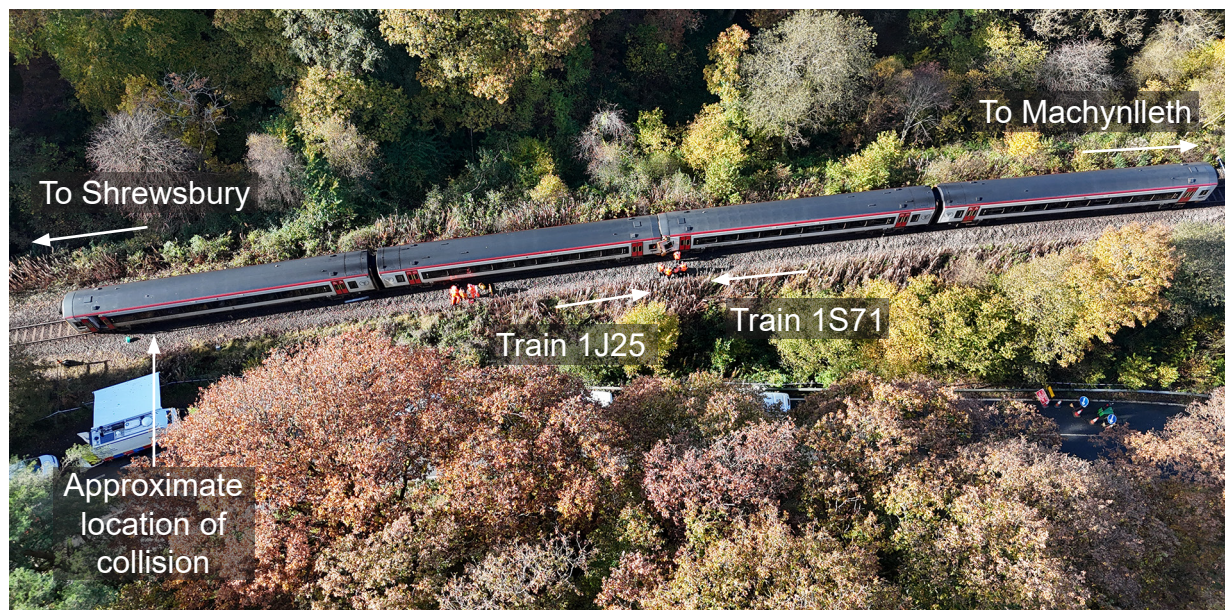
Figure 16: The trains involved, showing the approximate location of the collision and the final resting position.

- 62 During the initial collision, train 1J25 lost a significant amount of its forward speed, and train 1S71 reversed direction. The two trains separated slightly and continued down the gradient. Approximately 5 seconds later, the two trains collided again, although there was considerably less energy in this second impact. The two trains then came to rest together approximately 35 metres from the location of the initial collision (figure 16).

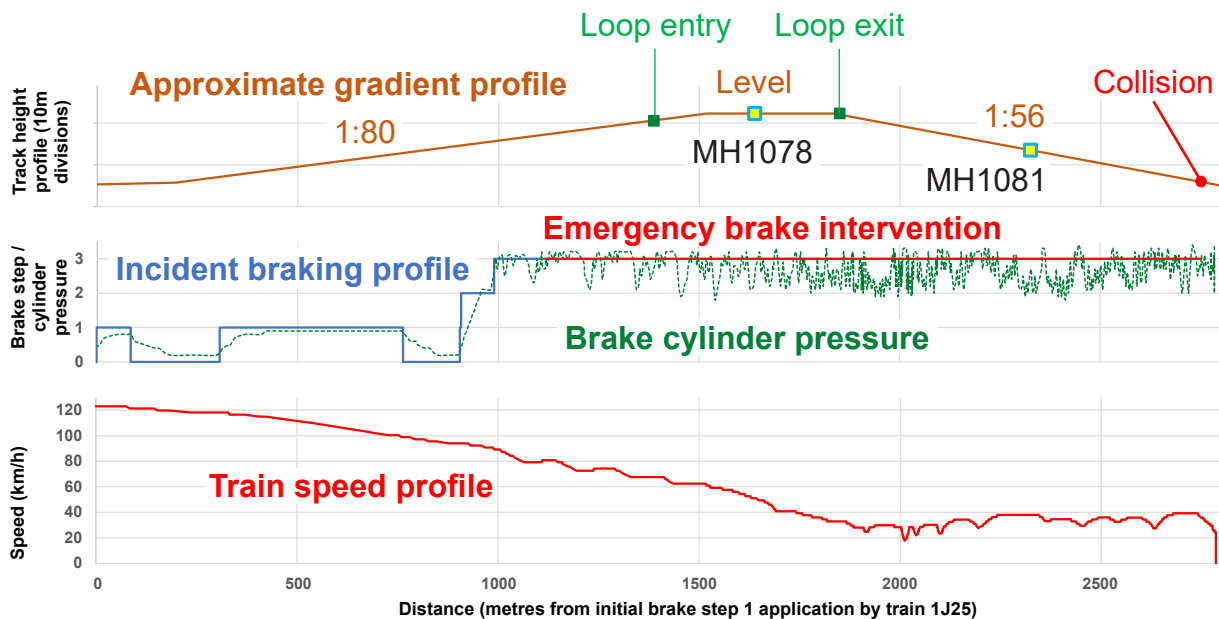
Figure 18: Track gradient on the approach to the accident site, together with OTDR data from vehicle 57841.

104 Data from the OTDR on train 1J25 shows that on the approach to Talerddig loop the driver shut off traction power and made two separate brake step 1 applications, followed by periods when the train's brakes were released. The driver then selected brake step 2. This was followed by a full service brake demand which was made by the ETCS system (paragraph 52) and subsequently by the driver. After a few more seconds, an emergency brake application was also made by the ETCS system (paragraph 54).

105 OTDR data (figure 18) shows that significant pressure fluctuations started to occur as the brake cylinder pressure climbed to the full service brake level (approximately 3 bar). Pressure fluctuations like these normally indicate that the brake demand has exceeded the available wheel-rail adhesion and the train's WSP system is functioning to control wheel slide.

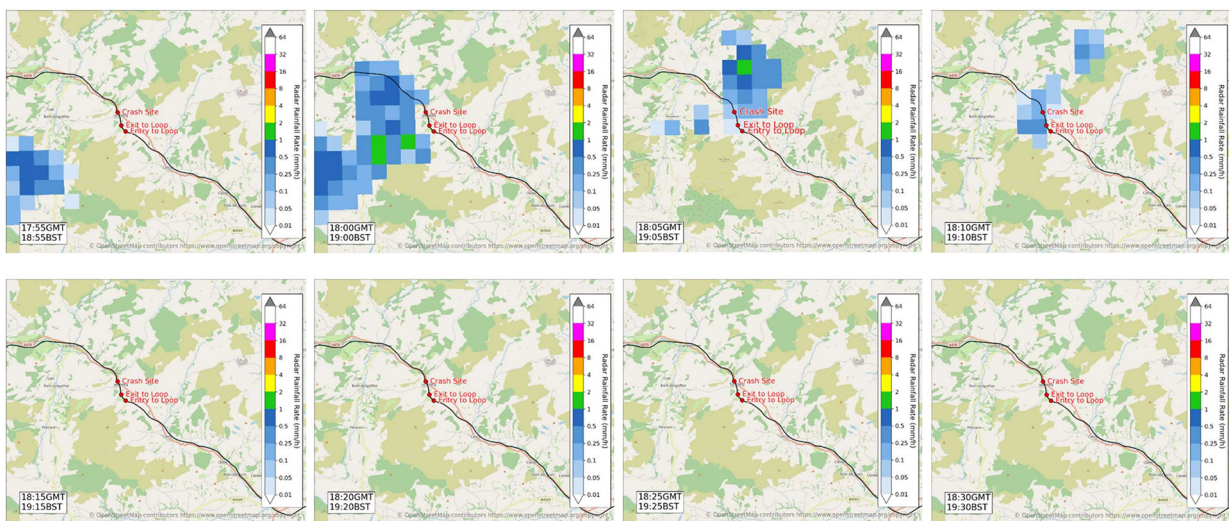
Figure 23: Instantaneous rain rates from Met Office radar on 21 October 2024 along the Cambrian lines, at 5-minute intervals from 18:55 to 19:10 (top row) and 19:15 to 19:30 (bottom row). Times in BST (courtesy of Met Office).

117 Analysis of rainfall radar imagery shows that there was persistent light rainfall on 21 October from the early hours until approximately 08:00. The weather then turned dry, until a shower brought rainfall to the Talerddig area around 19:00 and then over the collision site at 19:05 and 19:10 (figure 23). The rainfall was light with rain rates between 0.01 and 1 mm/h. The shower is shown to reduce in extent and intensity as it passes over the line and is likely to have introduced low levels of moisture onto the railhead.

118 The rainfall radar imagery indicates that it was not raining in the vicinity of train 1J25 at the time it started braking for Talerddig loop at 19:22; this is supported by the available witness evidence. Sunset occurred at approximately 18:05, and so it was dark by this time, with cooling temperatures reducing the rate of drying by evaporation. It is, therefore, likely that the railhead remained damp following the rainfall.

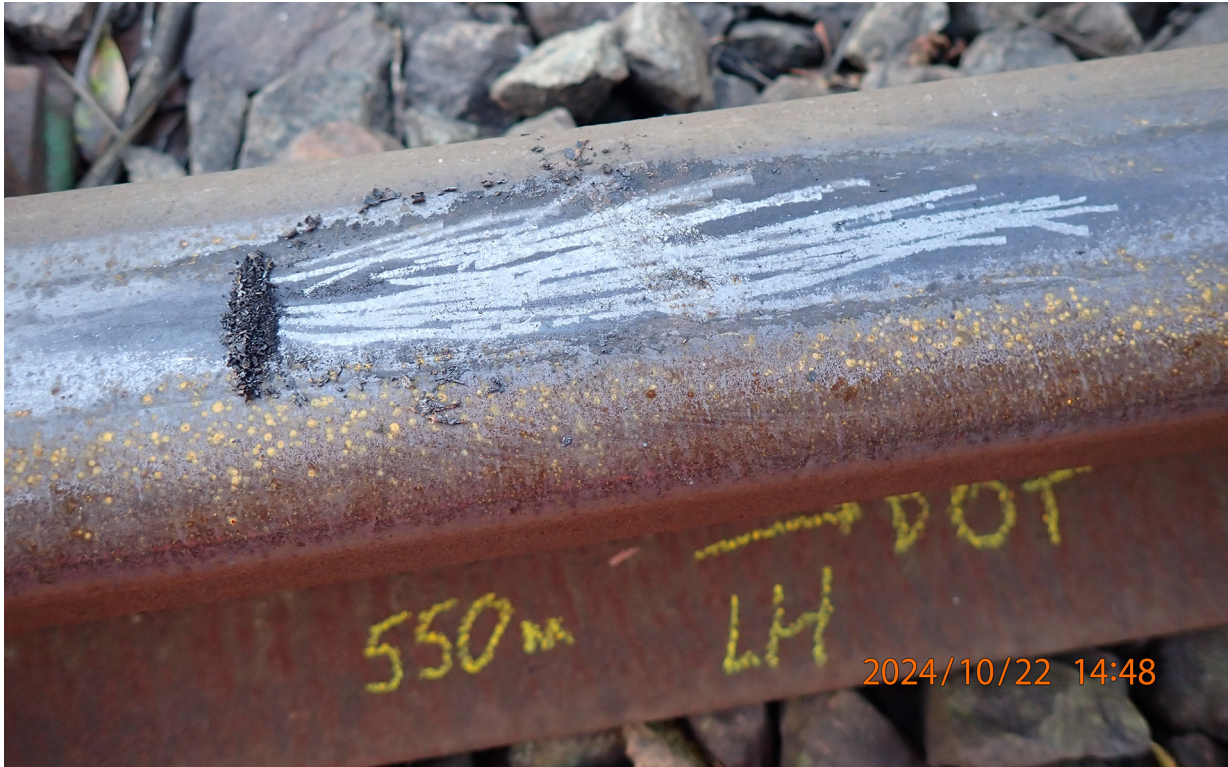
Figure 26: Example of sample collection (scraping) on the day after the accident, taken at a location 550 metres on approach to the point of collision.

123 RAIB also collected railhead contamination samples on the day after the accident, including railhead scrapings (figure 26).

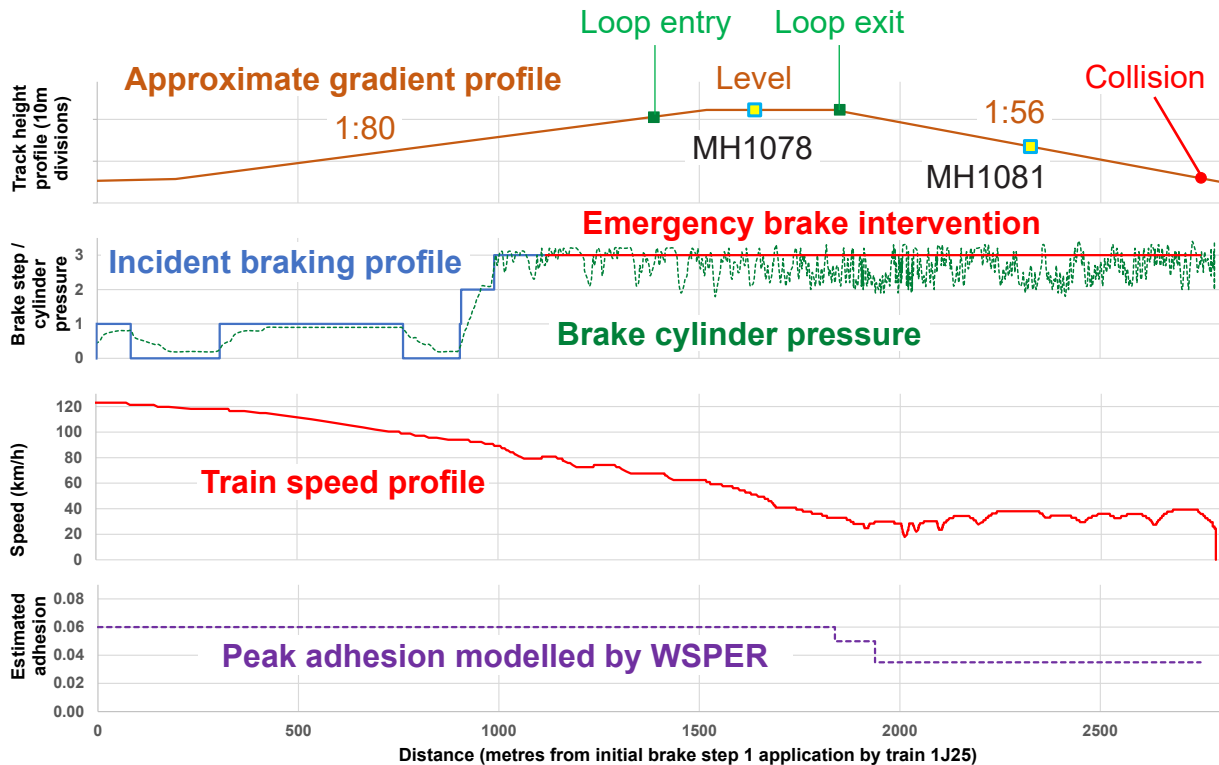
Figure 27: Track gradient on the approach to the accident site, together with OTDR data from vehicle 57841 and the peak adhesion modelled by WSPER.

- 132 The data from the OTDR on train 1J25 provided an actual speed profile for the incident. A series of WSPER simulations were undertaken with different adhesion profiles, iterating until the speed profile from the simulation was comparable to the actual OTDR speed profile from the incident. After this iterative process, the best match was found with an adhesion profile with a peak¹⁰ μ value of 0.06 on the approach to block marker MH1078. This is classed as 'low adhesion' (paragraph 74, table 1 and figure 27). This level of wheel-rail adhesion was not exceptional for the area around Talerddig during October. Beyond block marker MH1078, the WSPER simulations estimated that the adhesion would reduce to peak $\mu = 0.05$, before reducing to peak $\mu = 0.035$ (exceptionally low adhesion) on the descending gradient beyond Talerddig passing loop.

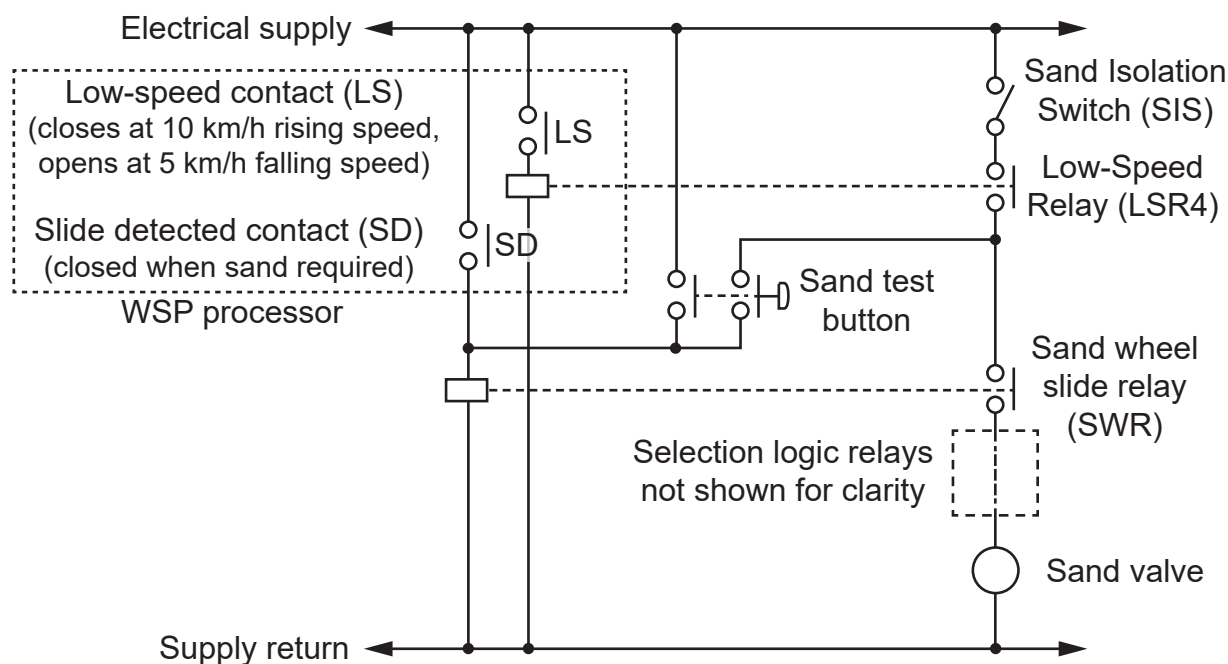
Figure 30: Simplified schematic of the electrical sanding control circuitry.

167 A build-up of discharged sand can, in some circumstances, prevent a train from being detected by railway signalling systems (appendix C). To address this issue, class 158 units prevent sand from being deployed at low speed by use of an electromechanical relay contact within the electrical supply downstream of the SIS in the sander activation circuit (figure 30). This is the LSR4 relay (paragraph 160).

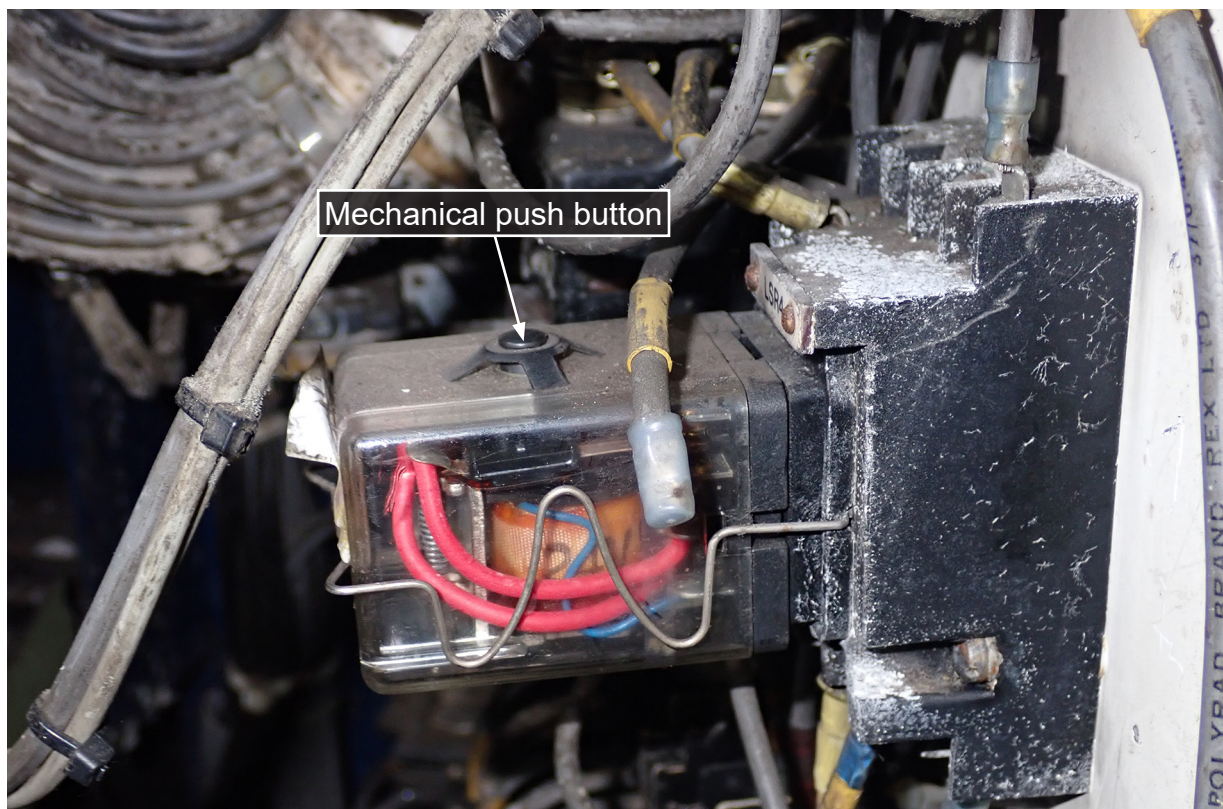
169 The LSR4 relay was located under the driver's desk and close to the front of the unit damaged by the impact. Despite this, the relay was correctly seated in its base receptacle and a spring clip, intended to prevent the relay from being dislodged, was engaged. This type of relay is provided with an override push button which acts upon the internal mechanism to allow the manual closing of the (normally open) contacts for testing purposes (figure 32).

Figure 32: The LSR4 relay correctly seated and restrained in its receptacle base.

- 170 When this manual override push button was pressed, the normally open contacts closed as expected and electrical current passed through the relevant relay contact, permitting the sanding circuit to function. The LSR4 relay was removed and replaced with another relay of the same type, after which the sand discharge test was performed successfully. Following this successful test, the LSR4 relay and base receptacle were removed by RAIB for further testing.

- 171 This bench testing of the LSR4 relay found it would function normally without the base receptacle but, when the two parts were assembled, an intermittent failure occurred. This failure was found to be an intermittent break in the coil circuit located between a base contact terminal and the internal coil feed wiring. This break would cause the coil to de-energise when only small amounts of external pressure were applied to the external relay case.

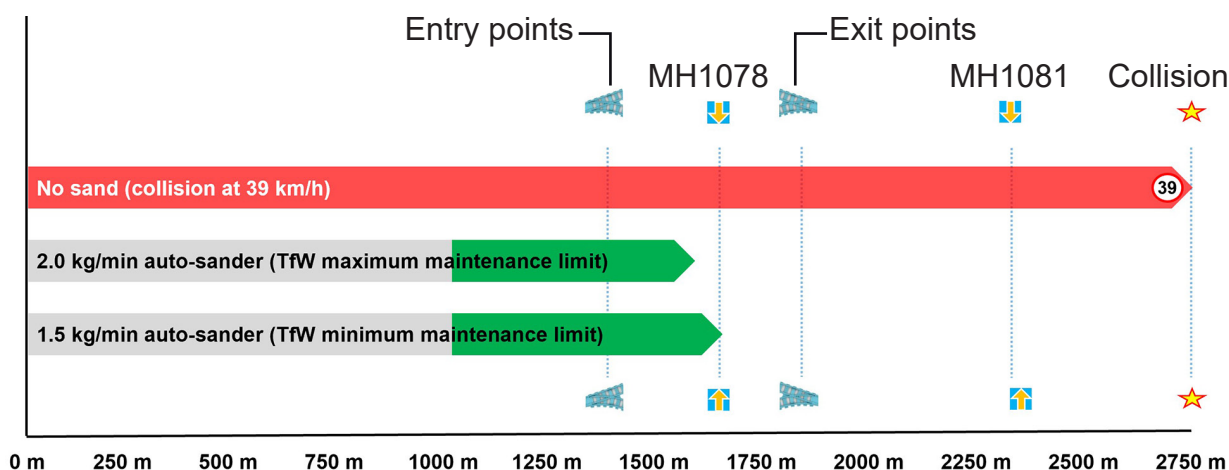
- 189 These simulations show that a functioning automatic sanding system delivering 2 kg/minute of sand would have enabled the train to stop before block marker MH1078. A train delivering 1.5 kg/minute of sand would have stopped at, or very slightly beyond the block marker, well before there was any risk of its movement conflicting with another train.

Figure 33: Estimated effect of a functioning automatic sanding system with different sand delivery rates.

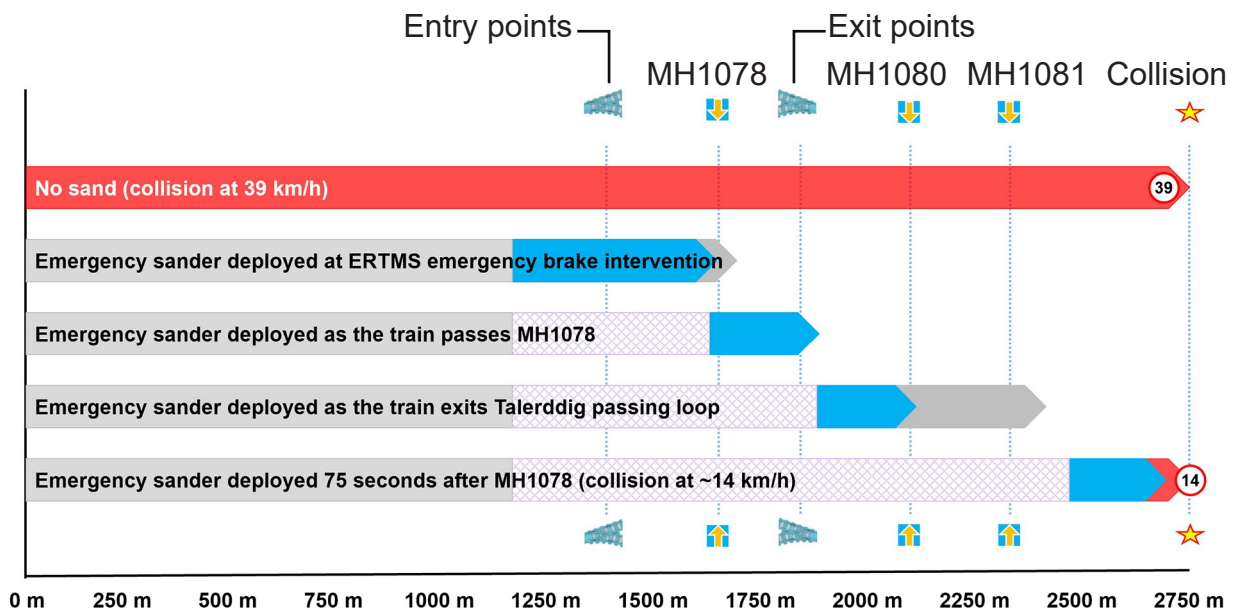
- at the moment that the ETCS system intervened with an emergency brake intervention, when the emergency sander would have first become available (paragraph 194), train 1J25 would have stopped just beyond block marker MH1078
- when passing the intended stopping position at block marker MH1078, train 1J25 would have stopped just beyond the points at the exit of Talerddig loop
- as the train exited Talerddig loop (approximately 18 seconds after passing block marker MH1078), then train 1J25 would have stopped just beyond block marker MH1081 (where train 1S71 had been instructed to stop)
- 75 seconds after passing block marker MH1078,¹² then the collision would probably still have occurred, although the speed of train 1J25 would have been significantly reduced, to around 14 km/h.

Figure 37: Estimated effect of emergency one-shot sanding system deployed at different locations/times. The purple hatched area indicates when the emergency sander is available, and the blue coloured area indicates the 30 second period of emergency sand delivery.

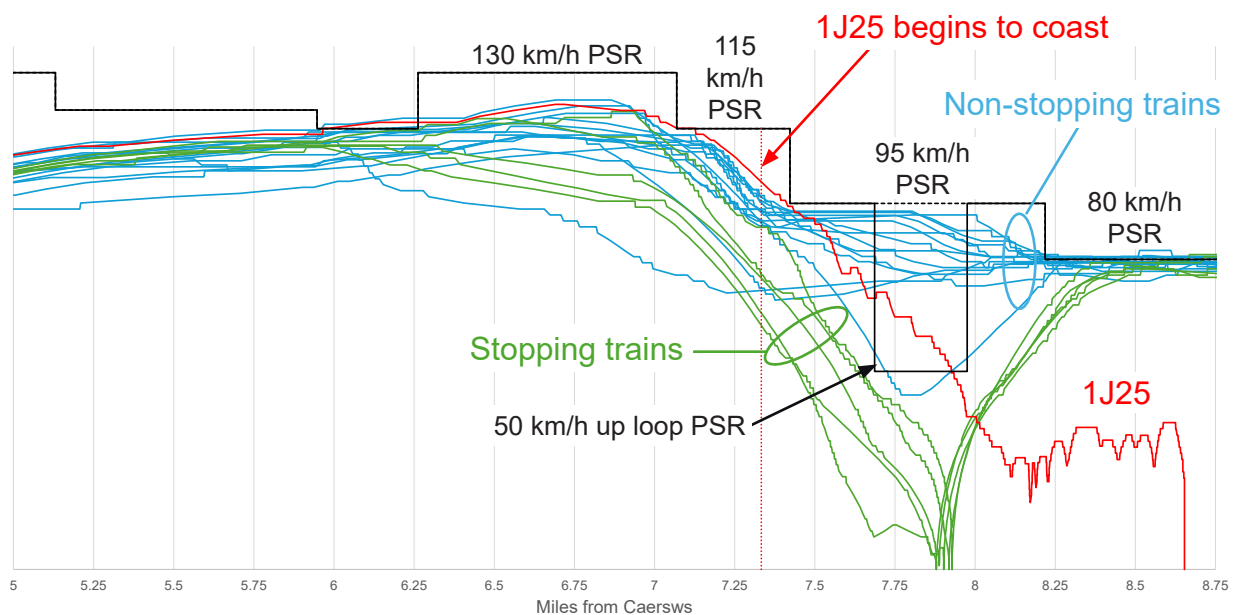
238 Of these 19 trains, 3 have not been considered because of their lower approach speed or because the way they were being driven did not make them suitable for comparison. Of the remaining 16 trains, the 5 which were required to stop in the loop continued to apply their brakes after the start of the 95 km/h speed restriction without any period of coasting. In contrast, the drivers of the 11 other trains released their train's brakes around the same time as the driver of train 1J25 did on the day of the accident. These trains were not due to stop in the loop. They were also routed through the Down Loop and so were not subject to the 50 km/h speed restriction which applied to train 1J25 on the day of the accident.

239 Although this comparison uses a small sample of drivers, it indicates that train 1J25 was being driven on the day of the accident in a manner similar to that adopted by other drivers when following the higher speed profile through the Down Loop.

Figure 45: Comparison of the handling of train 1J25 to other trains approaching Talerddig loop.

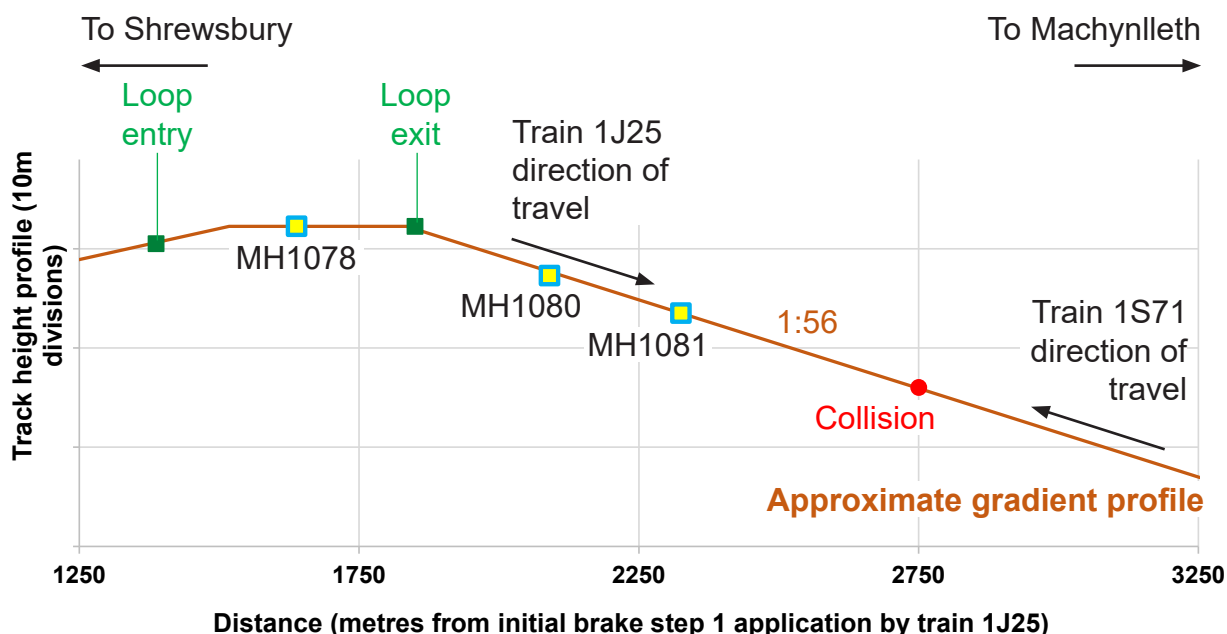
244 Historic records of the gradients on the Cambrian lines, corroborated by a detailed survey of the accident site by RAIB, show that after leaving Talerddig loop train 1J25 encountered a descending gradient of approximately 1:56 which continues to the collision location and beyond (figure 46).

Figure 46: The track descends on a 1:56 downhill gradient after exiting Talerddig loop.

245 As the train progressed further along the descending gradient, on-train data shows that it did not decelerate despite the continuous emergency brake demand. This demonstrates that the available braking was balanced by the train's inherent acceleration due to gravity as it descended the gradient.

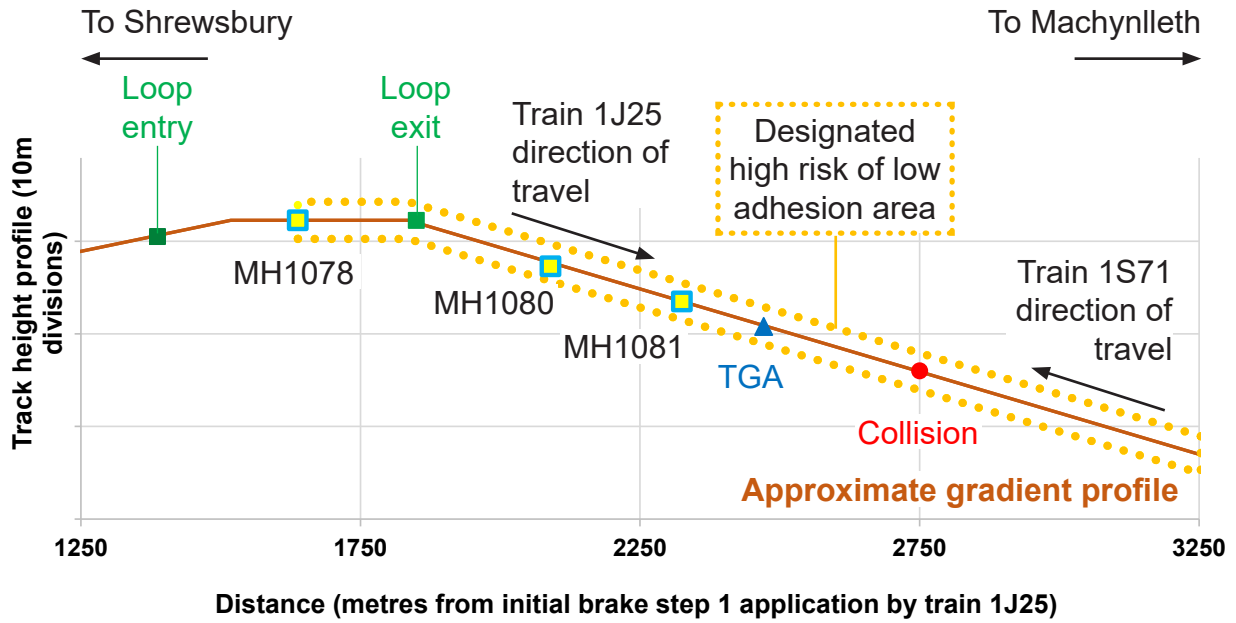
254 TfWRL produced an 'Autumn seasonal risk guide' for train drivers, issue 2 dated September 2023, which also identified the HRLA site at Talerddig. Due to the high risk of low adhesion a traction gel applicator (TGA) is provided within the HRLA, along the route taken by train 1J25. This, and its possible effect on the accident, is discussed further at paragraph 288.

Figure 49: The area of known low adhesion (outlined yellow) and the location of the traction gel applicator (blue triangle), superimposed on the track height profile (brown) and significant features.

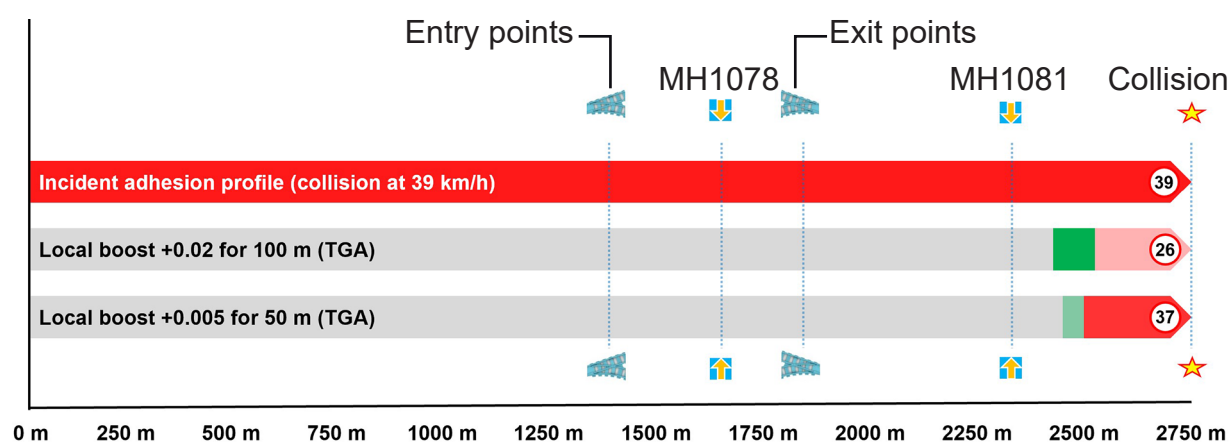
295 Because the effectiveness of traction gel is not quantified, RAIB modelled a range of scenarios on the WSPER system. The 'best case' was an adhesion increase of 0.02 (from peak $\mu = 0.035$ to peak $\mu = 0.055$) centred at the location of the TGA and applied over 100 metres, which resulted in an estimated collision speed of 26 km/h instead of the actual collision speed of 39 km/h. The 'worst case' modelled was an adhesion increase of 0.005 (from peak $\mu = 0.035$ to peak $\mu = 0.04$) applied for 50 metres, which resulted in an estimated collision speed of 37 km/h (figure 53).

296 RAIB has, therefore, concluded that no credible scenario exists where a functioning TGA at the location of Talerddig 1 could have prevented the accident. However, there are scenarios where a functioning TGA at this location might have lowered the speed of the collision. Such a speed reduction would have reduced the collision energy.

Figure 53: Estimated effect of a range of short local adhesion boosts (centred around the TGA location).

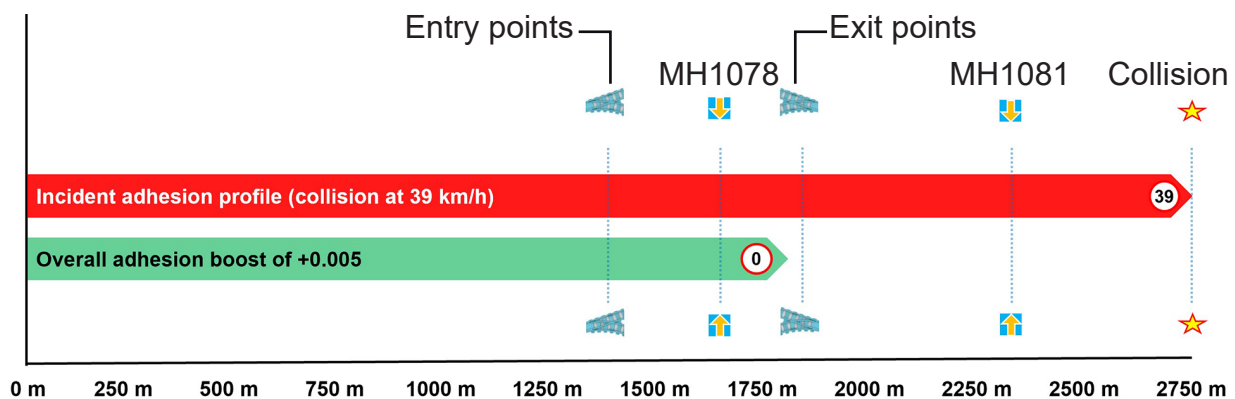
301 Assuming that an adhesion boost of 0.005 from a RHTT-delivered adhesion modifier had been available at the time train 1J25 approached Talerddig, RAIB calculated that it would have probably stopped after passing MH1078 but before reaching the exit points of Talerddig loop (figure 54).

Figure 54: Estimated effect of an adhesion boost of +0.005 through the accident site.

302 However, the expected performance provided by the adhesion modifier currently used on other Network Rail routes is not known. In addition, a 0.005 adhesion increase calculated from events at Stonegate in 2010 represents a single data point, and the following variables are likely to have an effect on the performance of any adhesion modifier that could have been used at Talerddig:

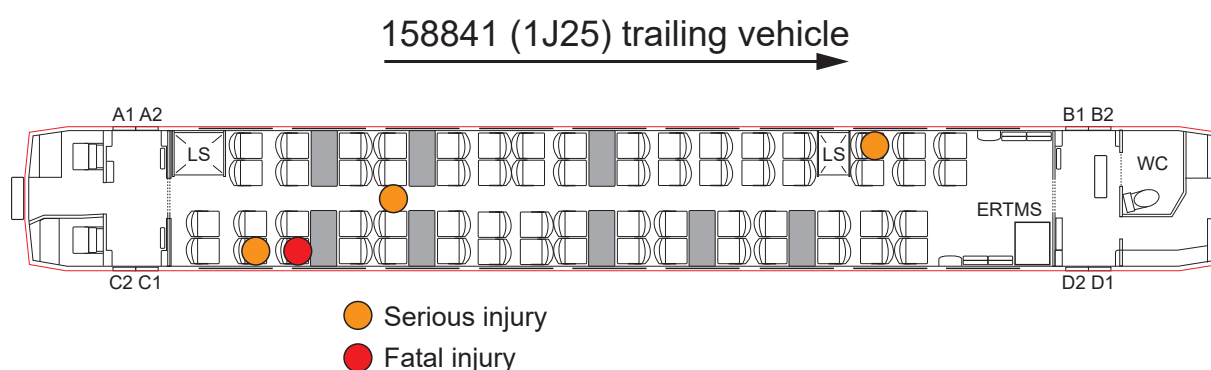
305 One passenger travelling on train 1J25 received fatal injuries as a result of colliding with a saloon table. This passenger was seated in the rear vehicle, 52841 (figure 55). Another passenger in the same vehicle suffered serious facial injuries as a result of their face striking the back of the seat in front of them. This passenger sustained fractures to the jaw and nose and lost a tooth. A third passenger in the same vehicle reported being knocked unconscious for about 20 seconds.

306 The guard in train 1J25 had just left the rear vestibule and was walking along the aisle in the direction of travel when the trains collided. The guard was projected forward and onto the floor. They sustained head trauma, tearing to tendons on both shoulders and a laceration to the right forearm, along with other injuries.

Figure 55: The location of individuals on board vehicle 52841 who sustained serious or fatal injuries.

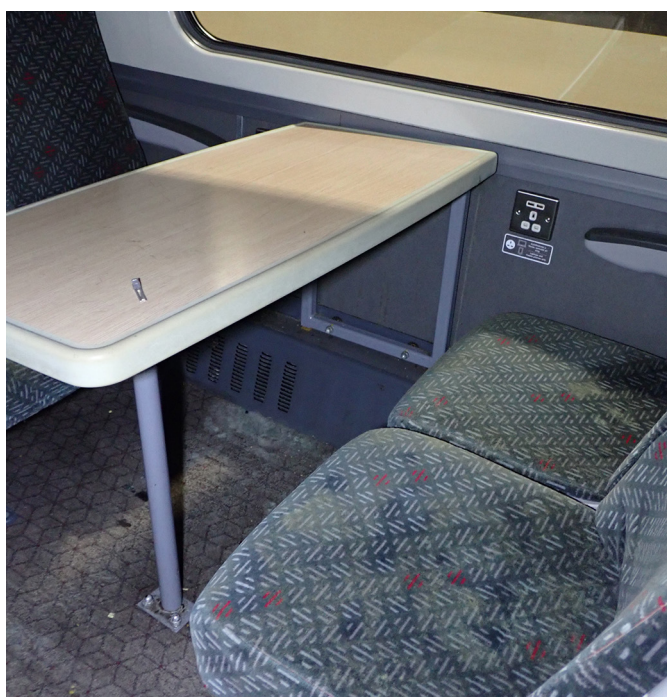
316 The design of the saloon tables was such that a passenger sustained fatal injuries due to impact with one.

Figure 58: General arrangement of seating and table in a TfWRL class 158 vehicle.

- 318 The fatally injured passenger was seated at the rearmost table on the right-hand side of the trailing vehicle of train 1J25 (vehicle 52841, figure 55). The passenger was facing the direction of travel in the seat nearest to the window. The seat opposite was occupied, and the neighbouring seat was unoccupied. At the point of collision, the rapid deceleration involved brought the passenger into hard contact with the table edge. Witness and CCTV evidence is that they were showing signs of having suffered a serious injury immediately after the accident. Post-mortem evidence indicates a clear link between the passenger's death and the injuries sustained from the impact with the table.

- 319 When examined by RAIB after the accident, the table which the passenger impacted had not detached and remained firmly attached to both the bodyside bracket and support leg. There was, however, evidence that the table was displaced, with measurements taken from the base of the body side bracket showing a small movement of the tabletop consistent with the impact. Other forward-facing passengers also impacted tables during the collision and, as a result, two tabletops in each train were broken from their fixings (figure 59).

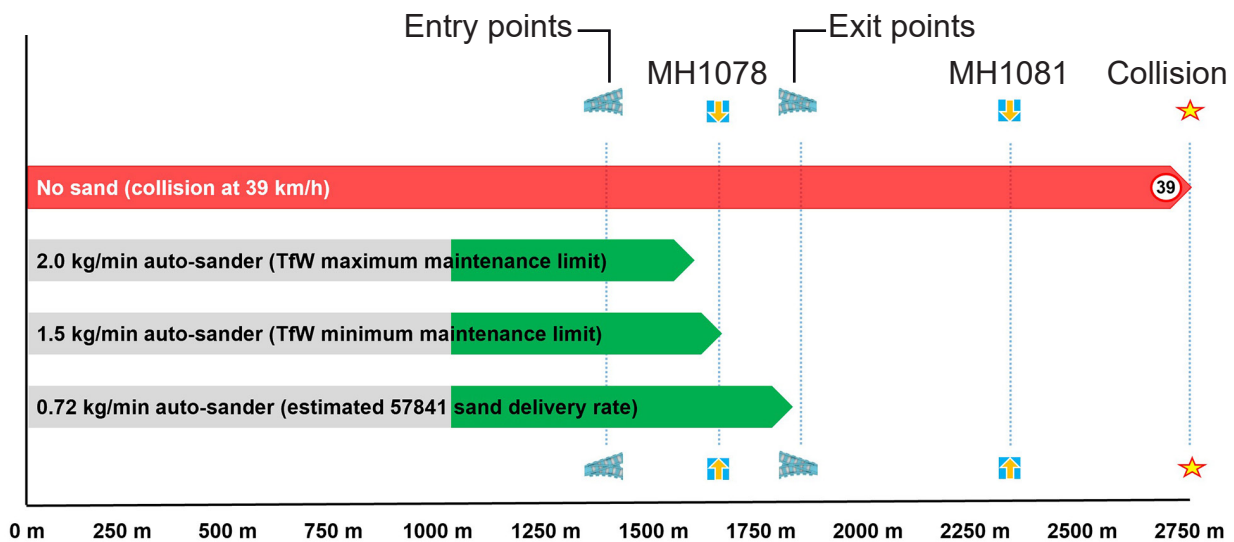
404 These simulations showed that, with a functional automatic sanding system discharging sand at the lower rate of 0.72 kg/minute, the train would probably have stopped shortly before the exit points of Talerddig loop (figure 60). For this reason, RAIB concluded that, had the automatic sander been working, the accident would still have been avoided even with the low sand delivery rate arising from the other defects.

Figure 60: Estimated effect of a functioning automatic sanding system with a reduced sand delivery rate (0.72 kg/min). Higher sand delivery rates (paragraph 184) shown for comparison.

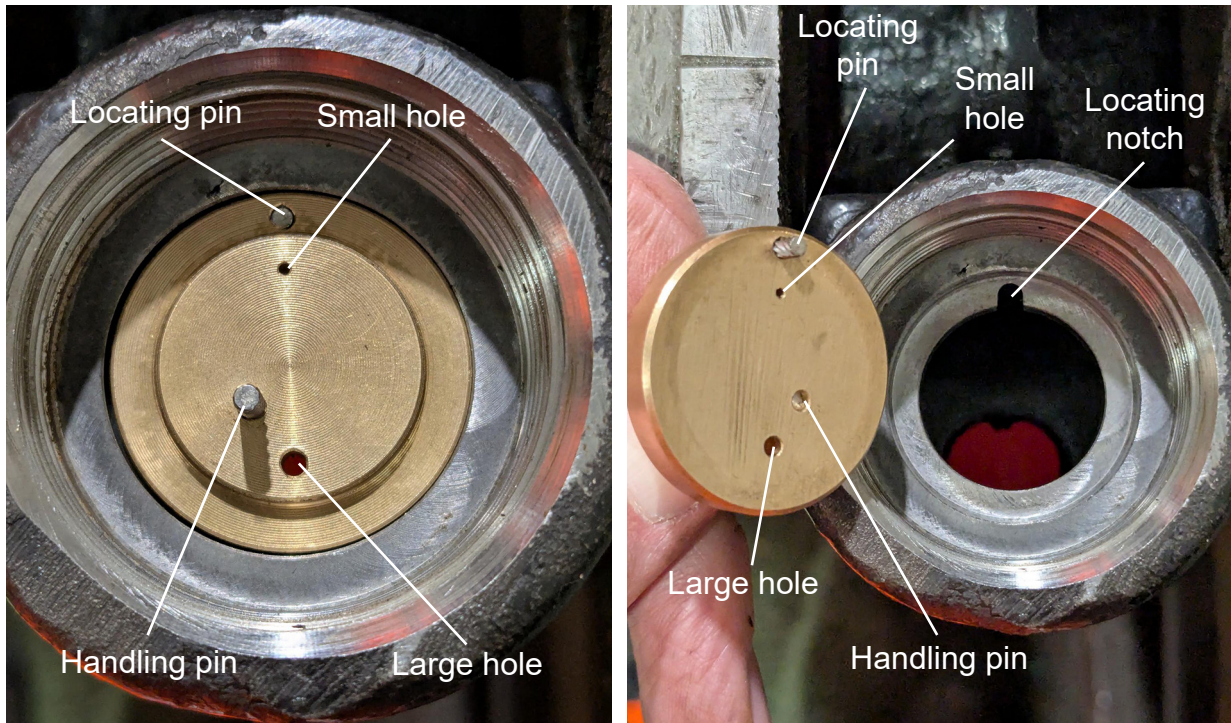
C17 When the sand valves from vehicle 57841 were removed it was noted that the orifice plates were incorrectly installed. The orifice plates inside both sand valves were upside down and were rotated out of alignment. In particular, the orifice plate in the non-driver's side sand valve was significantly misaligned and its sealing washer was also missing.

Figure C4: New orifice plate installed in a new sand valve casting (left) and during assembly showing locating pin and corresponding notch (right).

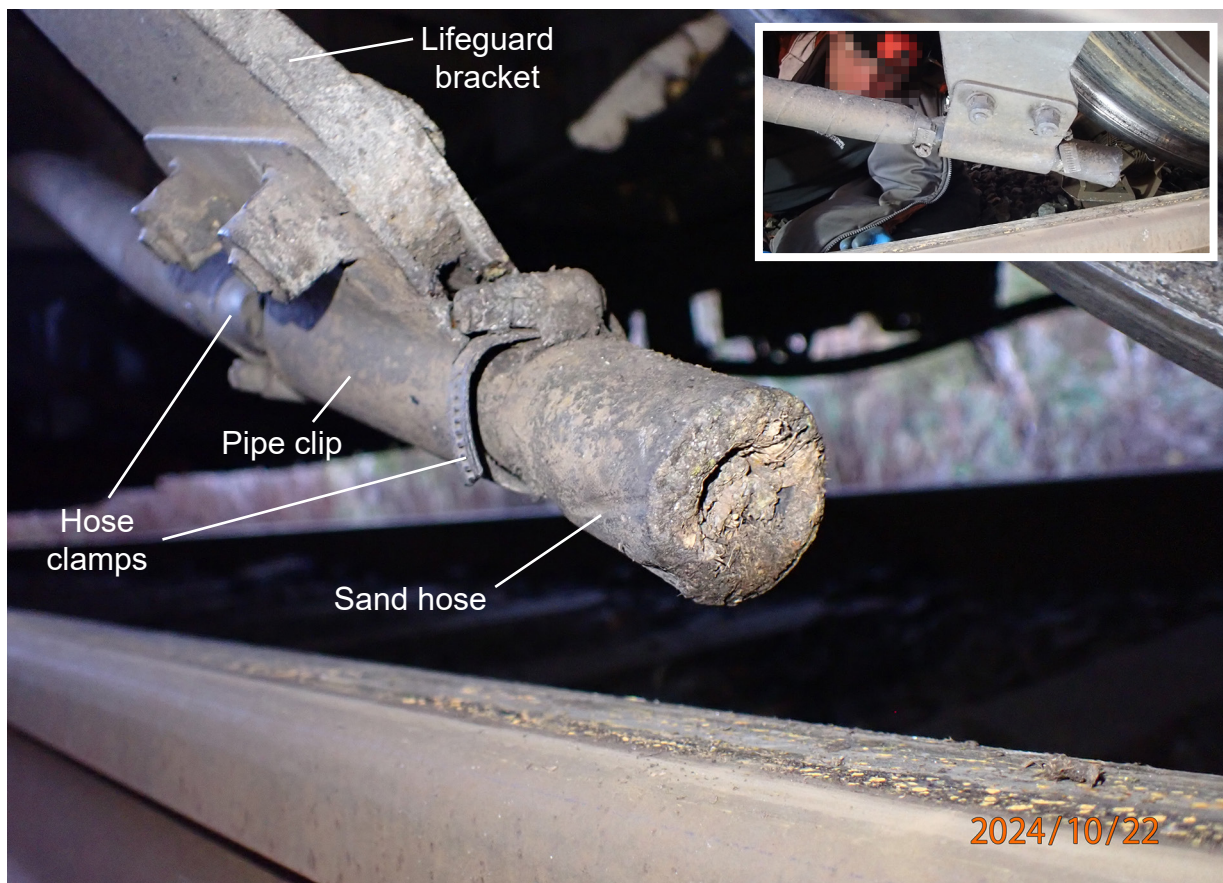
- C27 One of the hose clamps was deformed (figure C8). After cutting the sand hose near the hose clamp, the severity of the restriction to the air flow could be seen (figure C9). RAIB estimated that the hose clamp had reduced the cross-sectional area of the sand hose by approximately 60%.

- C28 TfWRL Maintenance procedure ASS0630, 'Sander Lanyard & Bogie Bracket Security Check', issue A2 dated January 2021, states that '*sand hoses should be held in position using Silkaflex 221 adhesive and a jubilee clip either side of the bracket*'. ASS0630 also states that '*it is important that the dimension from the end of the hose to the bracket is correct and that the jubilee clips are not overtightened and reducing the pipe bore. This may indicate a softened hose which will require changing*'.

Figure C7: Sand hose securing arrangement showing lifeguard bracket, pipe clip and hose clamps used on 57841.

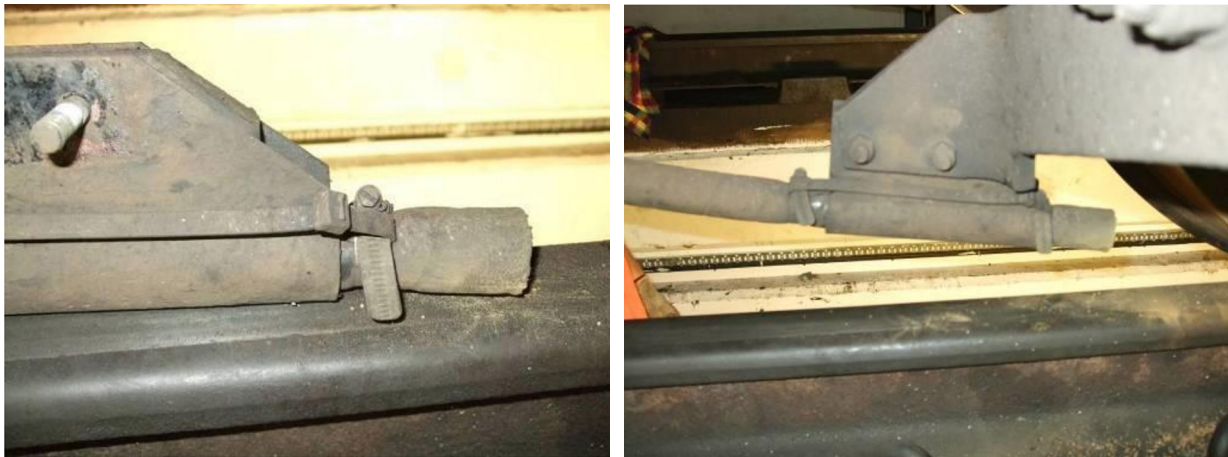
C29 RSSB document ‘Sander Maintenance good practice guide’ highlights the risk associated with using hose clamps on sand hoses and provides photographs of poor practice (figure C10).

Figure C10: Extract from RSSB Sander maintenance good practice guide showing poor practice with hose clamps (courtesy of RSSB).

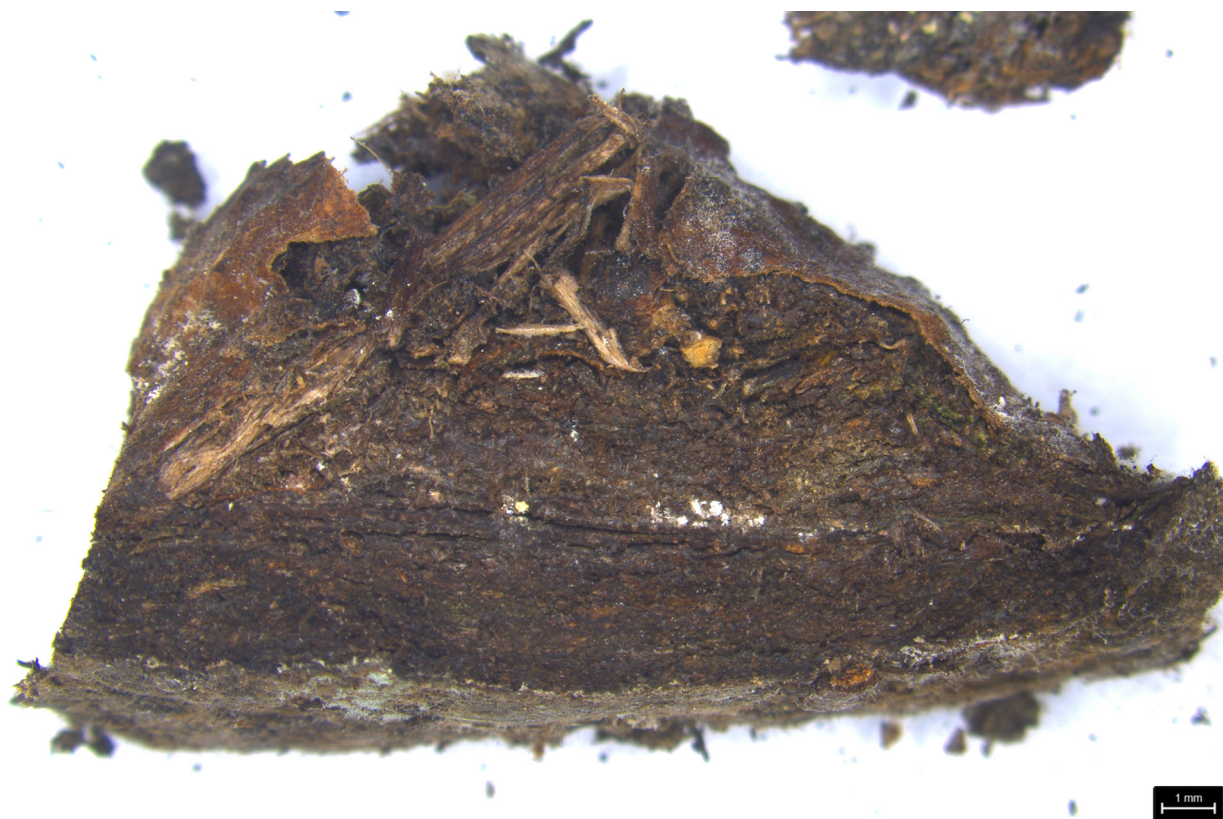
D3 Examination revealed multiple layers and individually identifiable pieces of organic material such as a leaf stem and leaves (figure D3). DNA analysis was conducted on five of the observable layers within the plug of material. This revealed the dense organic material to be predominantly from ash trees, although other species such as acer and wild cherry were also identified towards the edges of the material.

Figure D3: Close-up of the plug of material showing the location of the five layers used for DNA testing.
