Rail Accident Investigation Branch

Rail Accident Report

Collision between two passenger trains near Talerddig, Powys 21 October 2024

Report 08/2026
June 2026

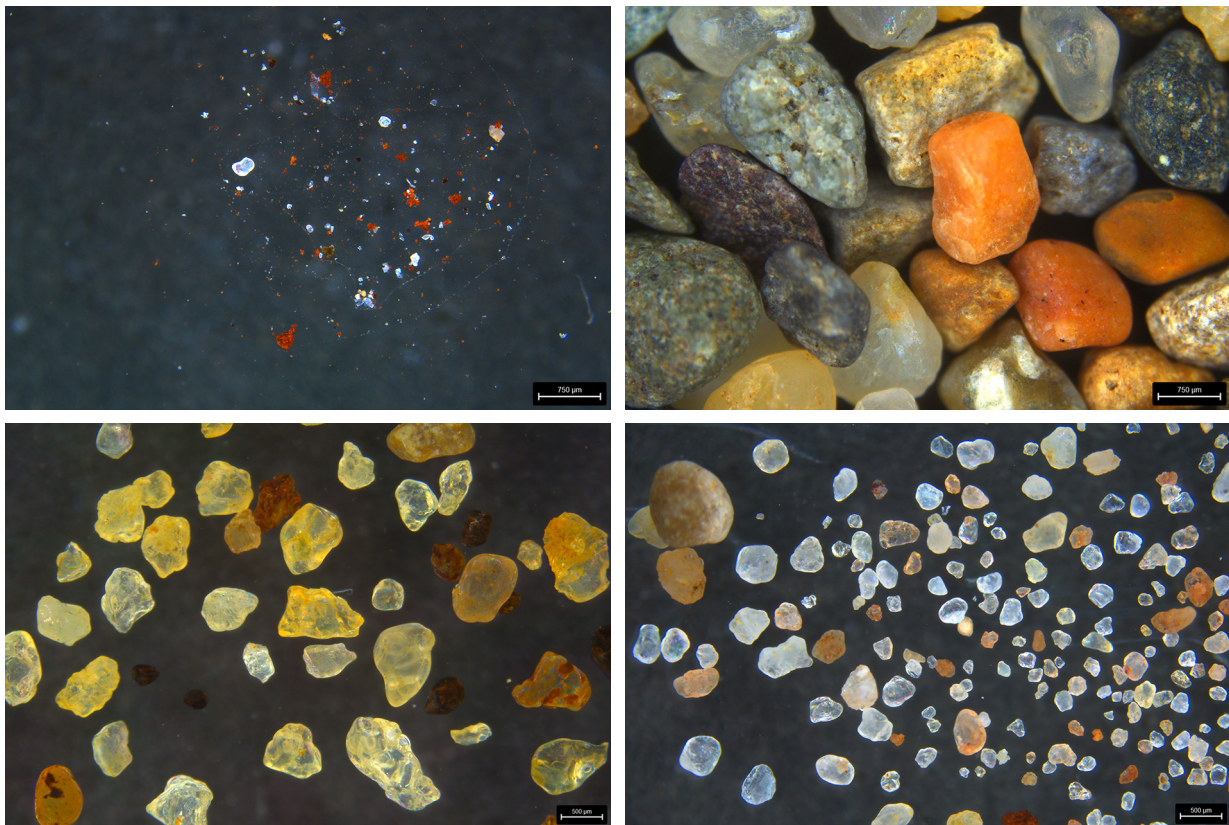
D4 To analyse the mineral fragments, some of the blockage material was dissolved and centrifuged to separate the particles. High magnification examination revealed the majority of particles to be translucent, angular and less than 0.1 mm in size. These were compared to some known sources of minerals, including sand from the automatic sanding system, and sand extracted from adhesion modifiers. The particles found in the sand hose blockage material were significantly smaller and more angular than those in the reference samples (figure D4), suggesting they could be remnants of larger particles that had been crushed at the wheel-rail interface. The general appearance of the particles was similar in colour to those found in the TGA traction gel.

Figure D4: High-magnification images - top left: small particles of sand found in the hose blockage material; top right: sand from the train's automatic sander; bottom left: sand particles from traction gel delivered by RHTTs; bottom right: sand particles from TGA traction gel.
