Report on the investigation of
a fall overboard from the crab potting vessel

Amadeus (TH7)

resulting in one fatality

on 13 December 2023

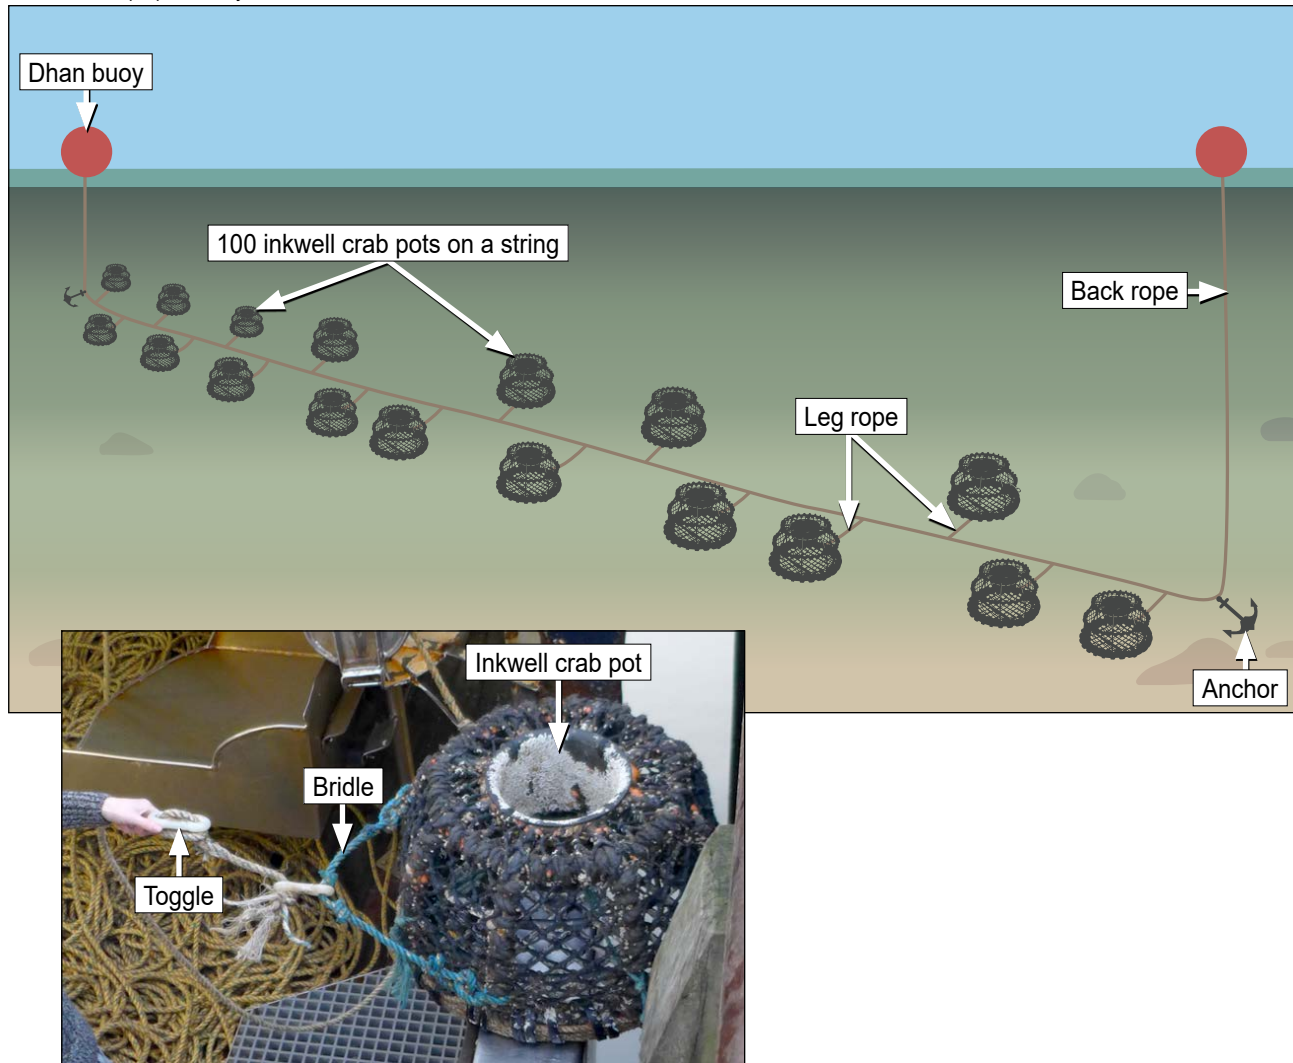
Figure 5: Layout of an inkwell crab pot string, showing the arrangement of pots when hauled on board *Amadeus* and (inset) an inkwell crab pot

Each string was anchored at both ends and marked with a dhan¹⁰ buoy to indicate its position and assist with recovery (**Figure 5**).

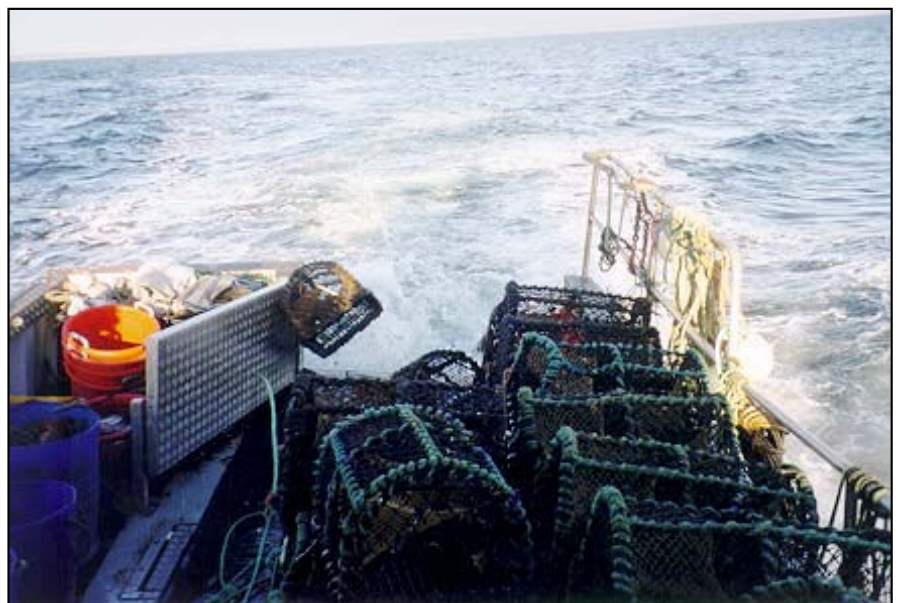
The roller has the advantage over the davit block in that the manual effort of lifting the pots/creels inboard has been eliminated. The pots/creels pass over the roller directly onto the table and only have to be lifted once for stacking ready for shooting. However, one aspect of concern with the roller is the danger of a pot/creel flying up over the roller if the hauler control is left unattended with the hauler running at high speed. Do not leave the hauler control unattended.
