Housing Health and Safety Rating System (HHSRS)

Example A3.5
Post-1979
Detached House
(Non-HMO)

Case Studies

Hazard A3
Falling Between
Levels

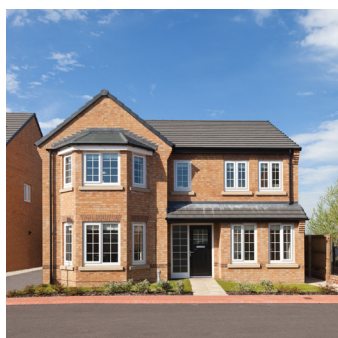
1
Front exterior

This is a four-bedroomed detached house built in the mid-1980s but extensively modified since then. It is rented to a family of two adults and three children. The property is generally in good repair throughout.
