## Housing Health and Safety Rating System (HHSRS)

## Case Studies

Hazard A4  
Fire and Explosions

Example A4.6  
Post-1979  
Common parts of  
Residential High-rise

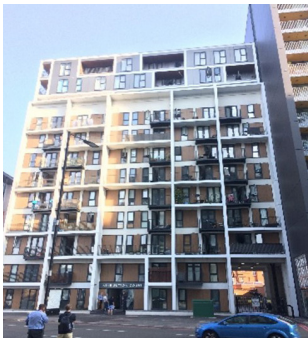
1  
Front exterior

Visual examination of the block and inspection of available documents confirm the external elevations consist of a mixture of ACM cladding panels (estimated at 20% of the total façade), HPL cladding panels (15%), rendered areas (45%), window glazing (15%) and masonry and quarry tiles (5%).
