Report on the investigation of
the serious injury to a crew member on board the
scallop dredger

Jacoba (BM77)

29 nautical miles south-south-east of
Beachy Head, England
on 10 May 2025

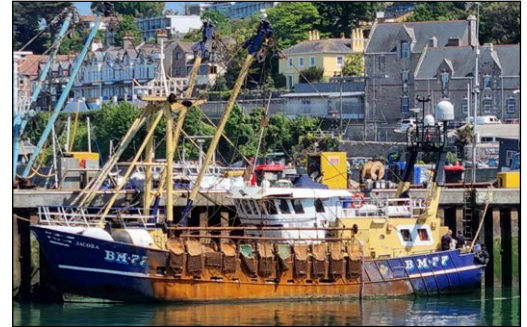
On 10 May 2025, a deckhand on the UK registered fishing vessel *Jacoba* was seriously injured while the vessel was dredging for scallops in the English Channel. The deckhand had been attempting to free a snagged dredge bag chain from the dredge teeth when recovering the dredges and was standing on the conveyor, positioned beneath the port side main beam. The mate then operated the winch from the wheelhouse and lowered the main beam, which struck the deckhand and crushed them against the tipping bar (see **figure**). The deckhand suffered multiple serious injuries and was evacuated to hospital by helicopter.

The investigation found that the accident happened because the main beam was lowered while a deckhand was positioned beneath suspended gear. The absence of documented procedures for dealing with snagged dredging gear and an incomplete understanding of the vessel's risk assessment meant that the risks associated with this task were not fully appreciated. Unsafe working practices were therefore able to develop during routine operations.
