# Rail Accident Report

## **Dangerous occurrence involving a portable access ramp at Norwood Junction station 1 July 2025**

Report 09/2026  
June 2026

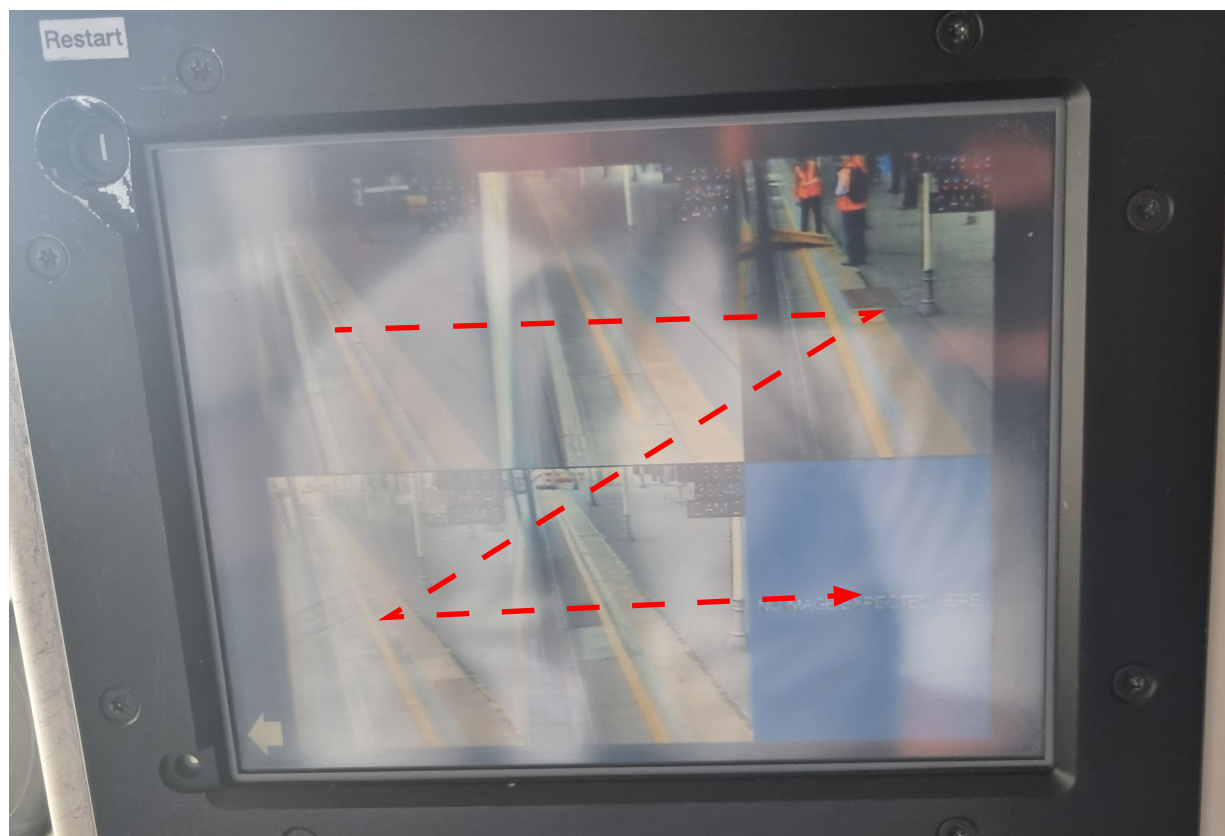
Figure 12: DOO in-cab door monitor z-scan pattern of the five bodyside camera images during reconstruction (see paragraph 89).

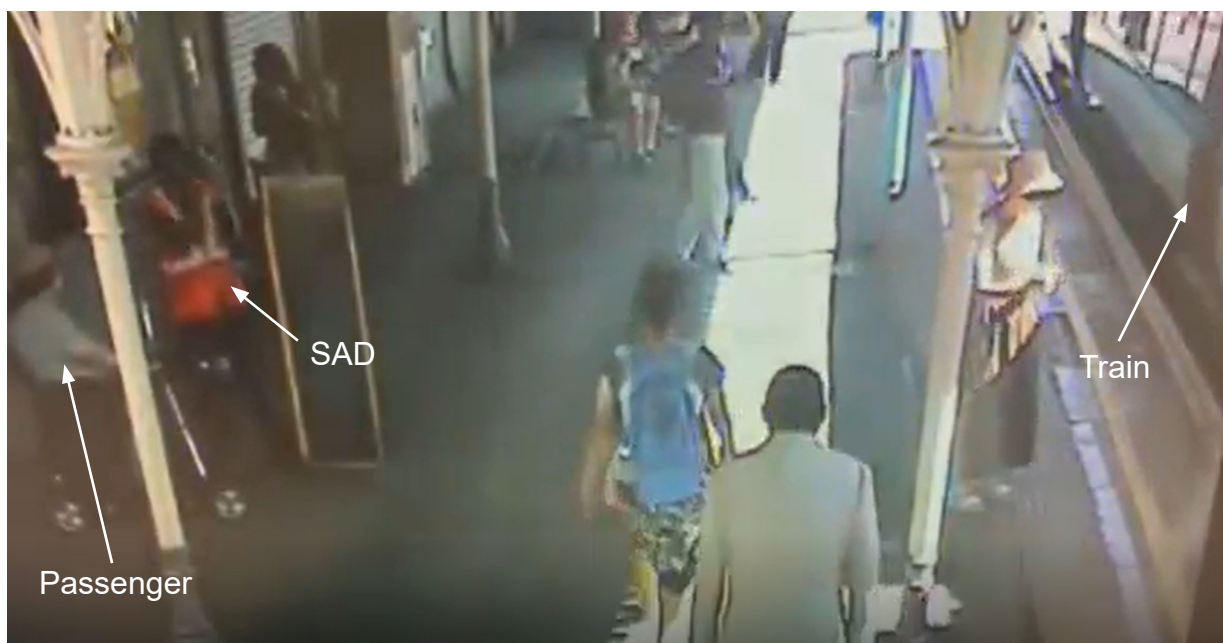
66 After the SAD had released the portable access ramp from its storage position at the back of the platform, they remained with the passenger on the mobility scooter (paragraph 21). The SAD stated that this was to provide answers to the passenger's questions about train services. As a result, when train 9D18 arrived at the platform, the SAD was not in full view of the driver and was partially obscured by other passengers and the platform canopy structure (figure 18).

Figure 18: Position of the SAD and passenger as train 9D18 arrived at platform 1 at Norwood Junction station (courtesy of ARL).

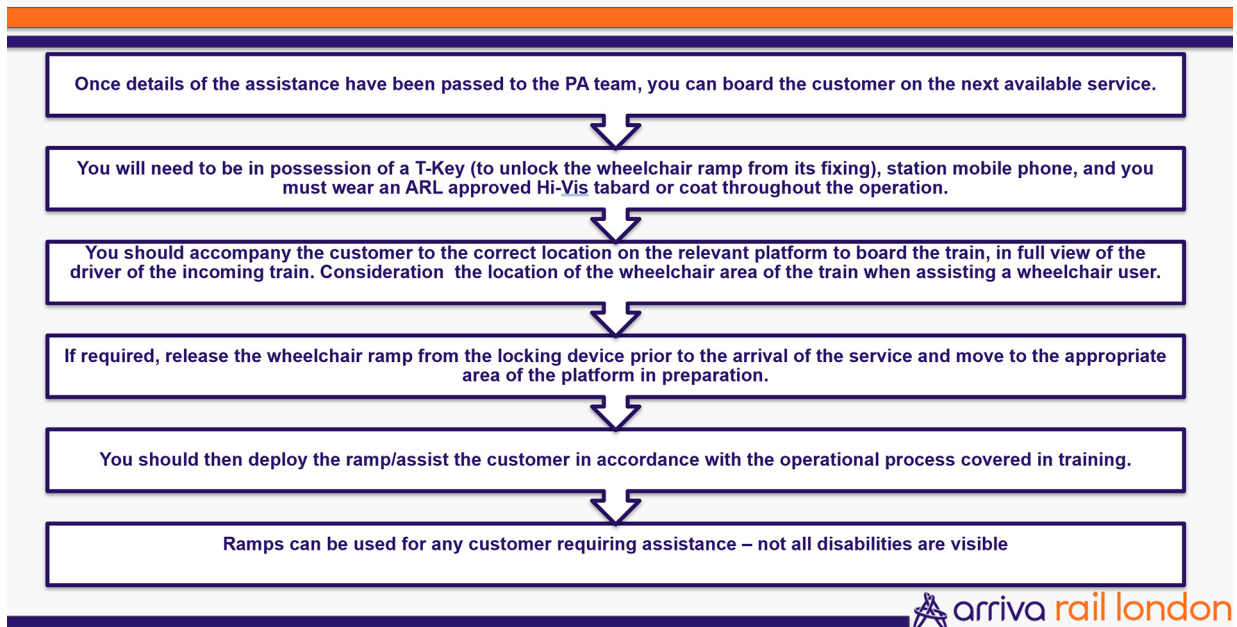
68 RAIB could find no evidence that these requirements were rebriefed to platform staff following this initial briefing until February 2025, when ARL started to brief an updated set of step-by-step procedures around portable access ramp use (figure 20). These updated procedures stated that platform staff should be holding the portable access ramp when a train arrives at a station and '*You should position yourself on the platform prior to the arrival of the train and in view of the driver*' (figure 21). At the time of the accident, 261 out of 291 station staff employed directly by ARL had received the briefing. However, the SAD involved in this accident had not yet attended it.

Figure 20: ARL's portable access ramp procedure at the time of the accident (courtesy of ARL).

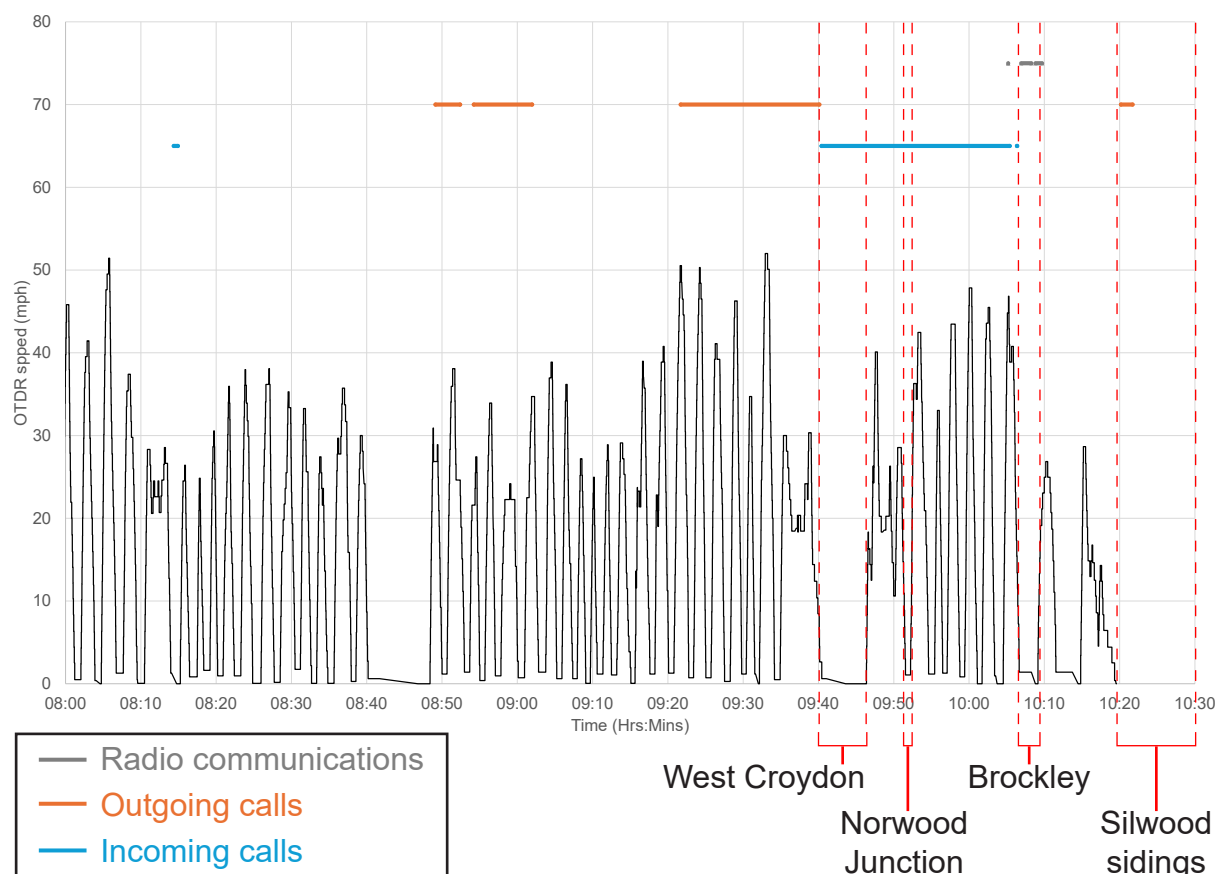
- 72 However, phone records obtained by RAIB established that the driver's personal mobile phone was switched on for the duration of their shift and that five phone calls of lengths from 33 seconds up to 25 minutes were made or received while they were driving various trains (paragraph 19, figure 22).

Figure 22: Train speeds from left to right for train 9D10 (07:45 from West Croydon), train 9C14 (08:48 from Highbury & Islington), and train 9D18 (09:46 from West Croydon). Overlaid are incoming and outgoing calls made from the mobile phone and radio messages and calls with the signaller.

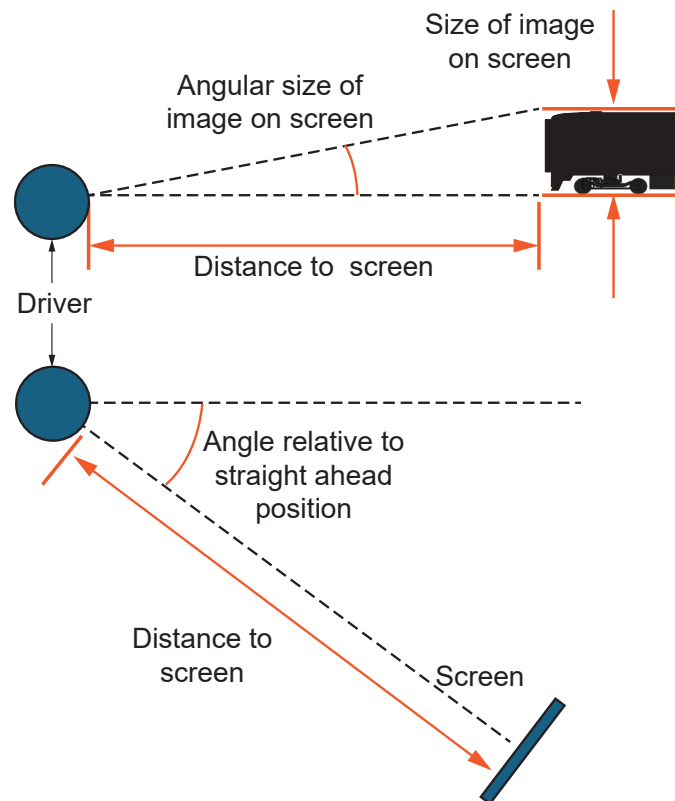
- *'The DCO OTCM system shall automatically control the angular size, resolution, brightness, contrast, shape distortion, refresh rate and the speed of adaptation to brightness and contrast of each image displayed.'*
- *'The visual detection of the target object shall include a minimum angular size of the height of the target object as displayed on the DCO OTCM system monitor and subtended at the observer's eye. This minimum angular size shall be 20 minutes of arc.'<sup>5</sup>*
- *'It is good practice for the monitors to be within 60° of the driver's visual field of view' (figure 23).'*

Figure 23: Angular measurements of image size and screen angle from RIS-2703-RST.
