AAIB Bulletin

6/2026

Aircraft Type and Registration:	Leonardo AW139, G-CIMU	
No & Type of Engines:	2 Pratt & Whitney Canada PT6C-67C turboshaft engines	
Year of Manufacture:	2015 (Serial no: 31583)	
Date & Time (UTC):	13 June 2022 at 1801 hrs	
Location:	Norwich Airport	
Type of Flight:	N/A found during maintenance inspection	
Persons on Board:	Crew - None	Passengers - None
Injuries:	Crew - N/A	Passengers - N/A
Nature of Damage:	Bearing failure	
Commander's Licence:	N/A	
Commander's Age:	N/A	
Commander's Flying Experience:	N/A	
Information Source:	AAIB Field Investigation

The failure of an AW139 tail rotor duplex bearing was identified during a post-flight maintenance check from wear damage on the bearing/actuator cover. The extent of the damage to the bearing confirmed that a loss of tail rotor control event would likely have occurred had the helicopter continued to operate with the bearing fitted. The bearing is defined as a critical part and failure of a similar design of bearing fitted to an AW169 helicopter resulted in a fatal accident in 2018. Despite a full forensic assessment, the bearing was too badly damaged to determine the cause of failure. Three Safety Recommendation

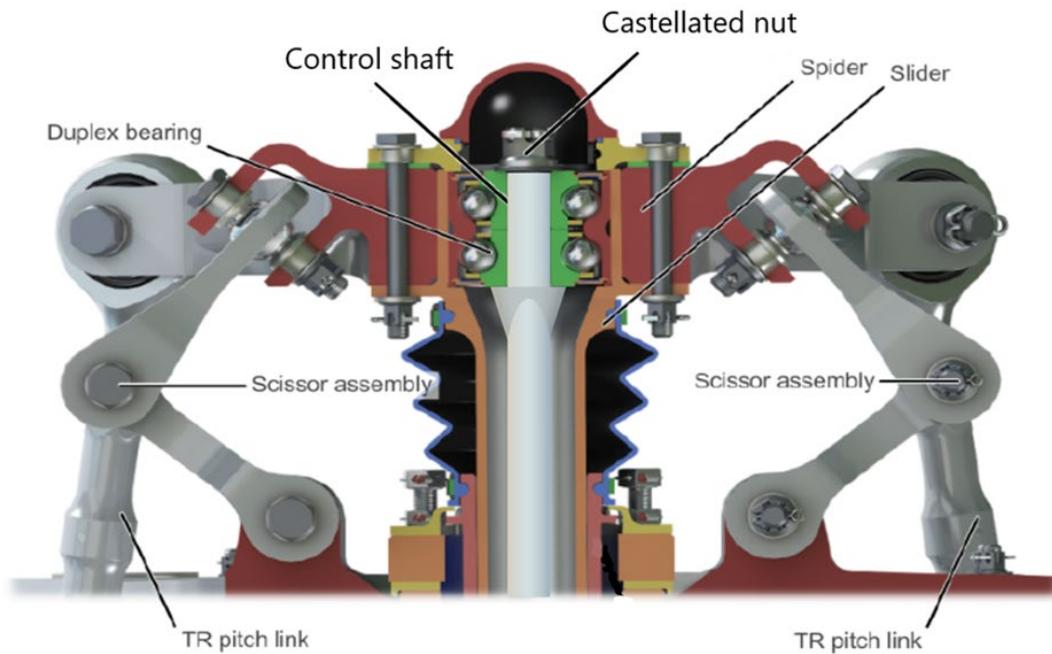
Figure 4

The inner race of the bearing is fitted to the control shaft and is locked in place by a securing nut, while the outer race rotates with the tail rotor hub. A smaller hub called the spider is attached to the tail rotor hub by scissor links and locates a slider which supports the outer race of the duplex bearing. The slider guides the movement of the spider as it is extended and retracted by the action of the control shaft. Each of the arms of the spider is connected by a rod (pitch link) to the rear of a tail rotor blade (Figure 4).

Tail rotor spider and pitch link assembly
(Original image courtesy of the manufacturer)

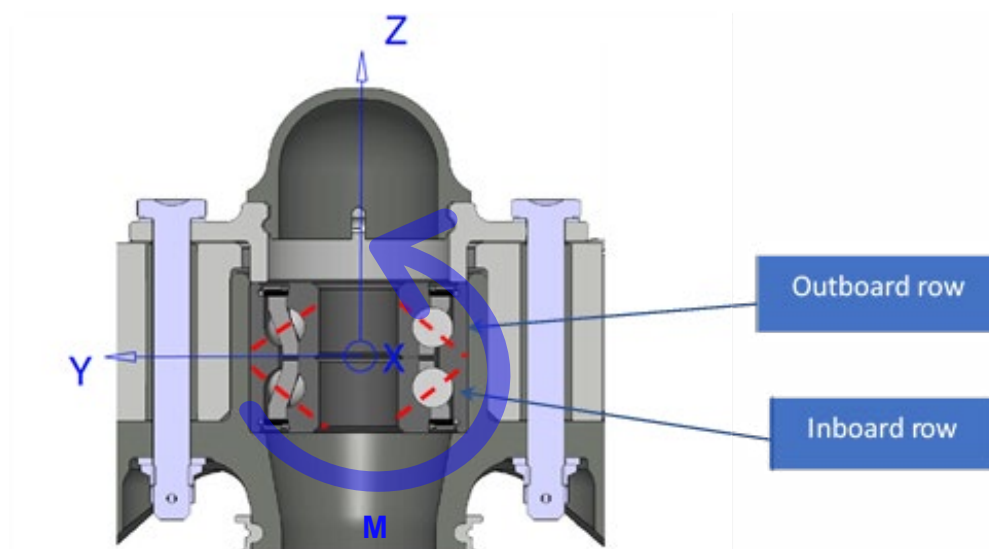
Figure 5

As the control shaft moves in two directions (extend/retract), the bearing is required to have two rows positioned back-to-back to support the axial load in each direction. In order to support loads in both the axial (F_z) and radial (F_y) directions, the running surfaces of each row are angled at approximately 30° . The control shaft also experiences a bending moment (M) which is transferred to the bearing (Figure 5).

Diagram (with control shaft removed) showing two halves of the bearing (inboard and outboard) and the 30° orientation
(Original image courtesy of the manufacturer)

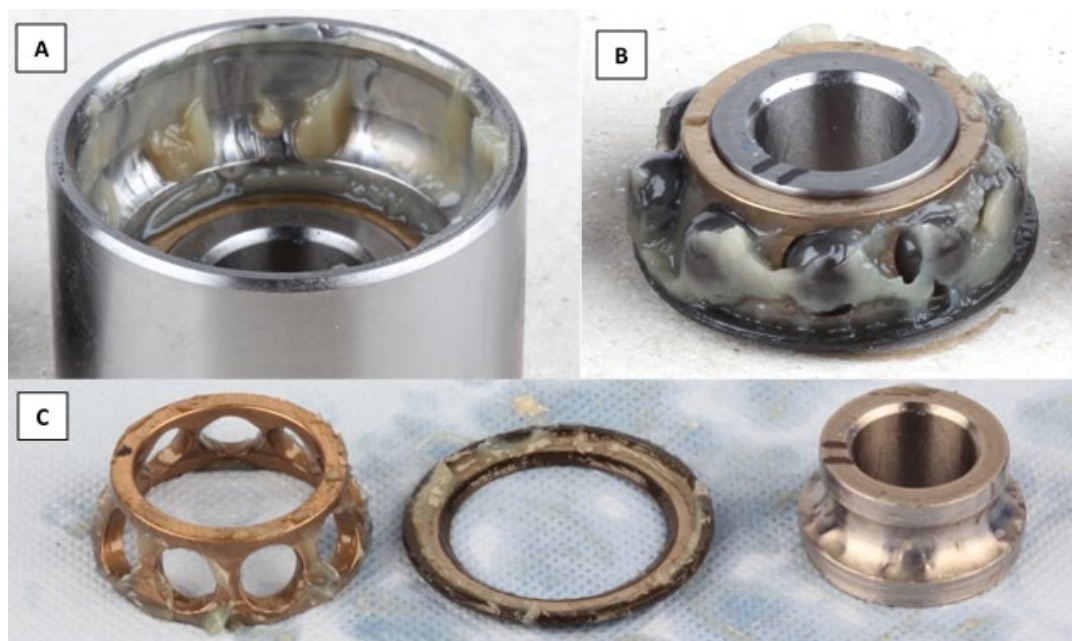
The bearing drawing was amended in 2021 from requiring 100% grease fill to specifying a minimum 33% fill, which equates to 2 g of grease in total.

Bearing in new condition - (A) Housing and outer race, (B) inner race, cage and balls assembled, (C) cage, seal and inner race disassembled

Figure 6 shows the housing and the outboard row, outer race in image A. Image B shows the inner race, cage and balls as they have been removed from the housing in image A and turned over (the top surface in view is normally located in the middle of the bearing). Image C shows the inner race, cage and seal after they have been disassembled and the balls removed. The other row of the bearing is identical but is installed the opposite way around (mirror image).
