# ***AAIB Bulletin***

***7/2026***

Published: 9 July 2026.

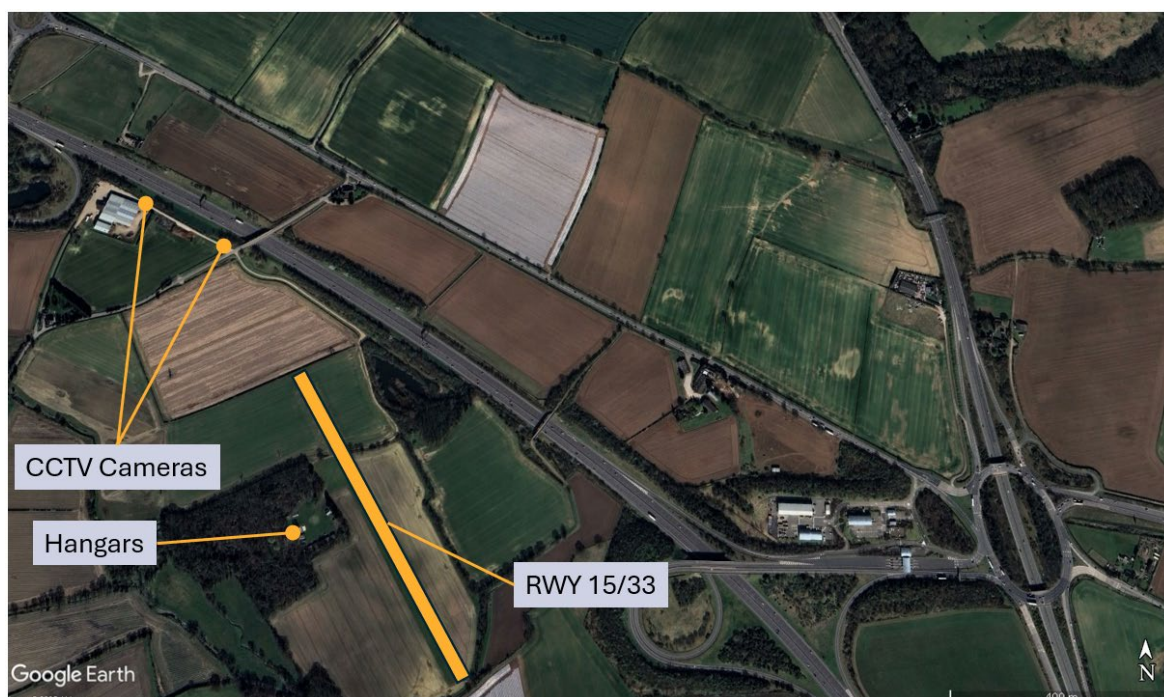
**Figure 2**

Two CCTV cameras, one positioned at a gateway opposite the entrance to the farm strip with a view down the runway and the other on a farm building approximately 200 m further away from the strip captured most of the accident flight (Figure 2).

Shenstone Hall Airfield and location of CCTV cameras
