Report on the investigation of  
the collision of the rigid inflatable boat

***Peaky Blinder***

with a navigation beacon in Portsmouth Harbour, England  
resulting in two fatalities  
on 14 August 2025

REPORT NO 15/2026

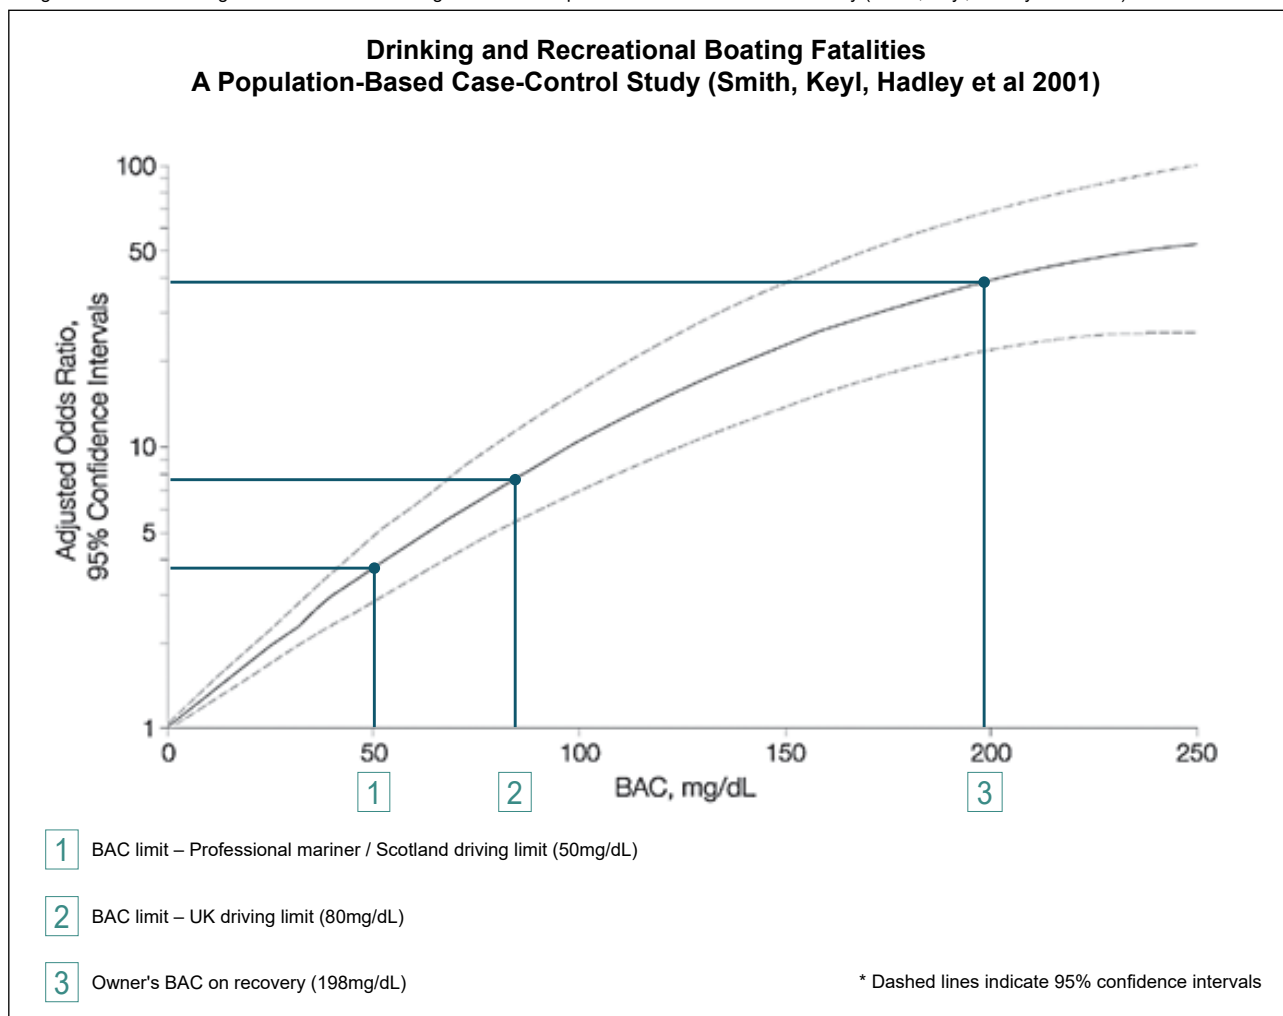
**Figure 6:** Relative fatality risk while boating by BAC (mg/dL), Maryland and North Carolina, USA\*

The NICE review's conclusions broadly aligned with those of a December 2001 paper<sup>15</sup> published in the USA that sought to determine the association between alcohol use and the estimated relative risk of dying while boating. This paper concluded that *drinking increases the [relative risk] of dying while boating, which becomes apparent at low levels of BAC and increases as BAC increases (Figure 6).*

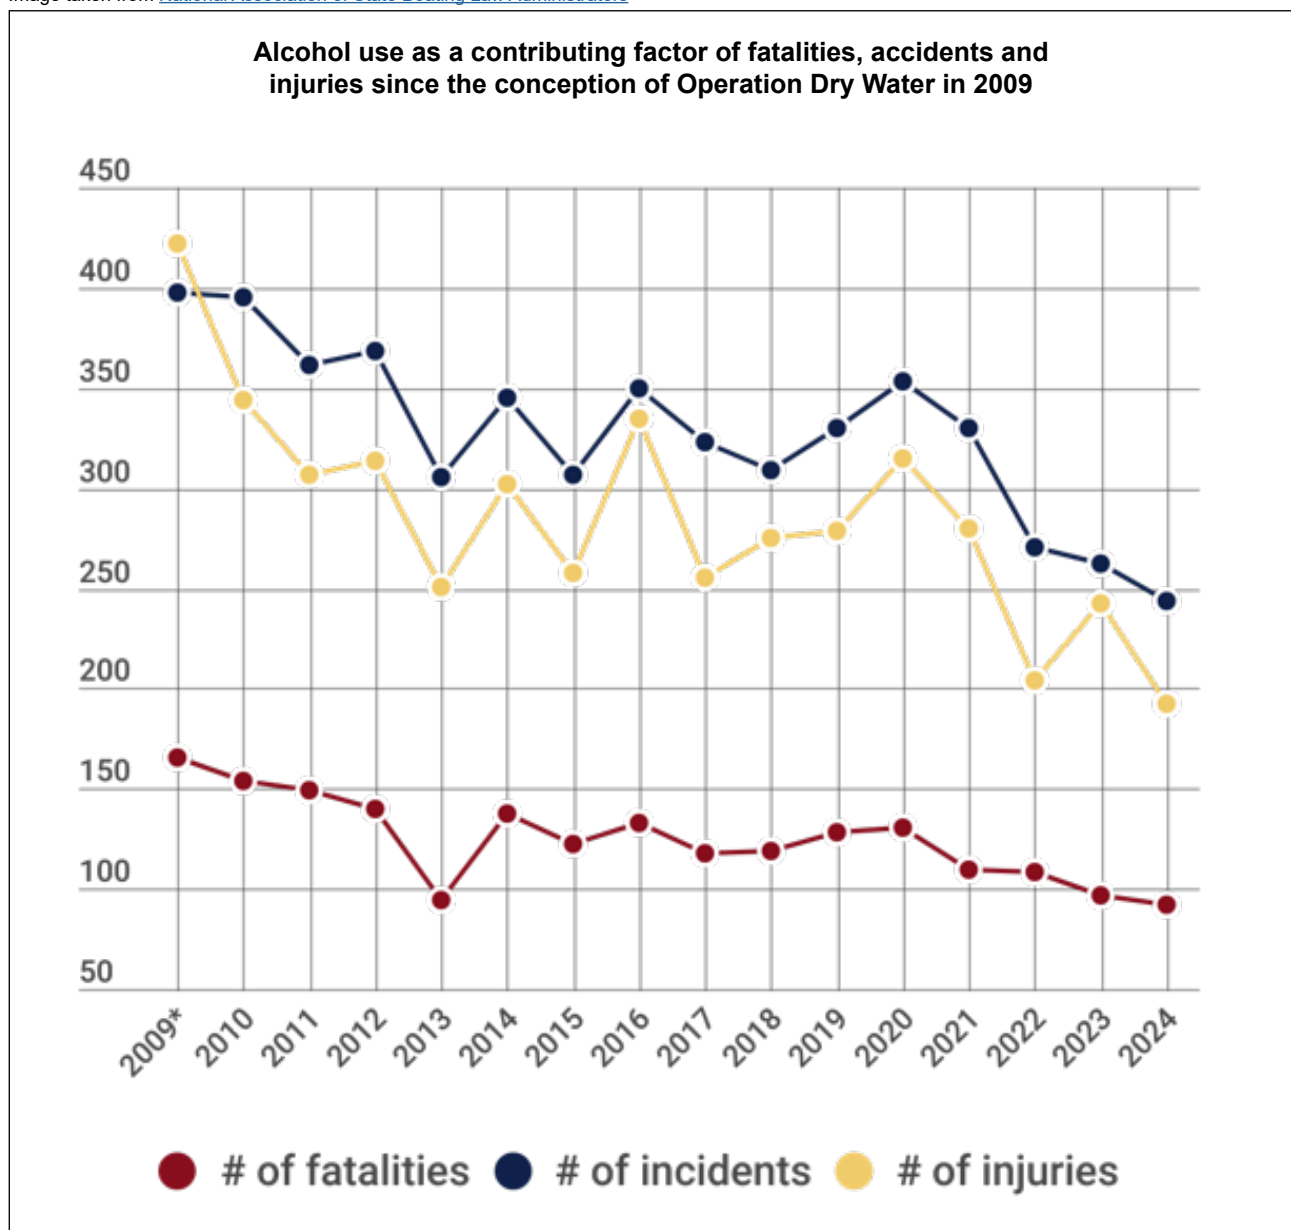
**Figure 7:** Graph showing the decline in injuries and fatalities due to boating accidents in the USA between 2009 and 2024 where alcohol was a contributory factor

In the USA, the National Association of State Boating Law Administrators (NASBLA) coordinated a programme of awareness and enforcement activities titled Operation Dry Water<sup>17</sup>. Started in 2009, the programme involved both state and federal agencies. Statistics gathered by Operation Dry Water to document the effectiveness of the programme showed a marked decline in alcohol-related incidents, injuries and fatalities since its inception (**Figure 7**). The various state limits on BAC were supplemented by national advice and education programmes such as the Sober Skipper programme delivered by the non-profit Sea Tow Foundation, intended to highlight the number of preventable boating-related accidents, injuries and deaths on the water (**Annex A**).

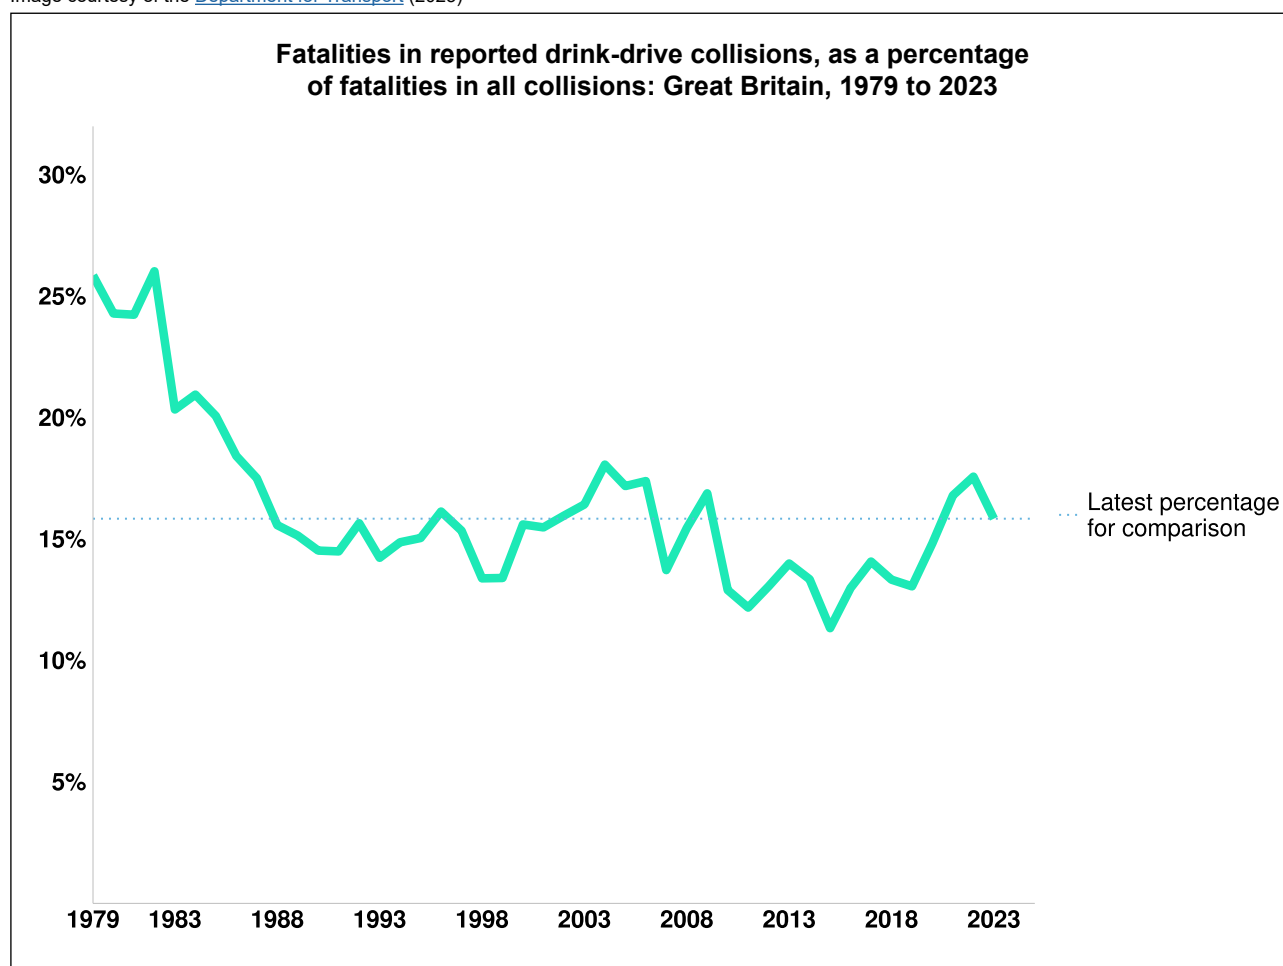
**Figure 8:** Graph showing the annual decline in fatalities on UK roads between 1979 and 2023 where alcohol was a contributory factor

This had fallen to 15% by 1989. The percentage of drink-driving road deaths up to 2023 varied between 12% and 18%. In 2023, the proportion of drink-driving road deaths was 16% (**Figure 8**).
