# Rail Accident Report

## **Collision between a tram and two pedestrians at Staniforth Road, Sheffield 22 June 2025**

Report 10/2026  
July 2026

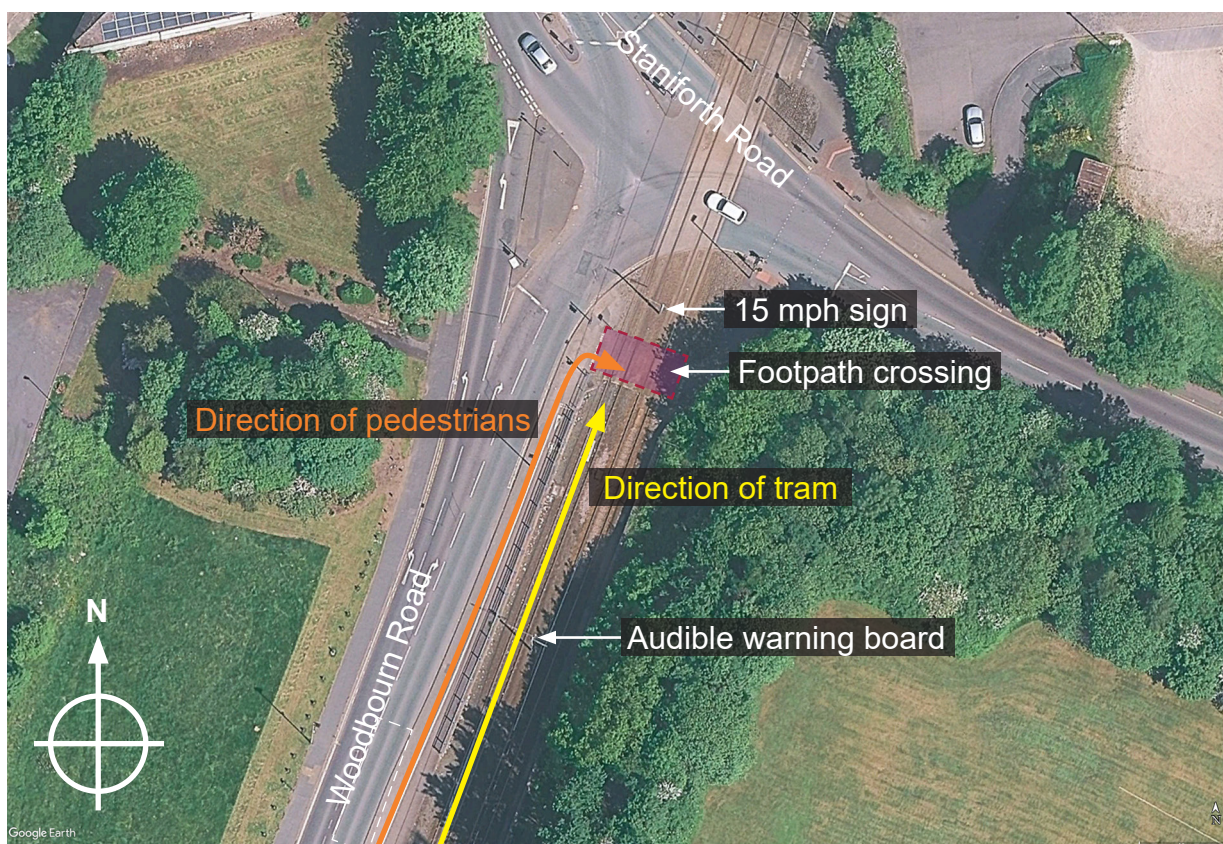
- 7 The road junction of Woodbourn Road and Staniforth Road is managed by traffic lights which are interlinked with a tram signal (figure 4) that authorises trams to cross Staniforth Road. Immediately before the tramway intersection with Staniforth Road, the pavement alongside Woodbourn Road leads to a tramway footpath crossing. This footpath crossing is located 276 metres to the north of Woodbourn Road tram stop and 15 metres from Staniforth Road (figure 3). It is the most southerly of the two tramway footpath crossings at the intersection with Staniforth Road.

Figure 4: The location of the footpath crossing (courtesy of Google with RAIB annotations).

- 46 An audible warning board (figure 4) is provided approximately 30 metres before the crossing. It reminds the tram driver of a requirement to sound an audible warning on the approach to the footpath and vehicle crossings. It was originally fitted in response to an accident involving a pedestrian at the same crossing in 2005 (see paragraph 90).

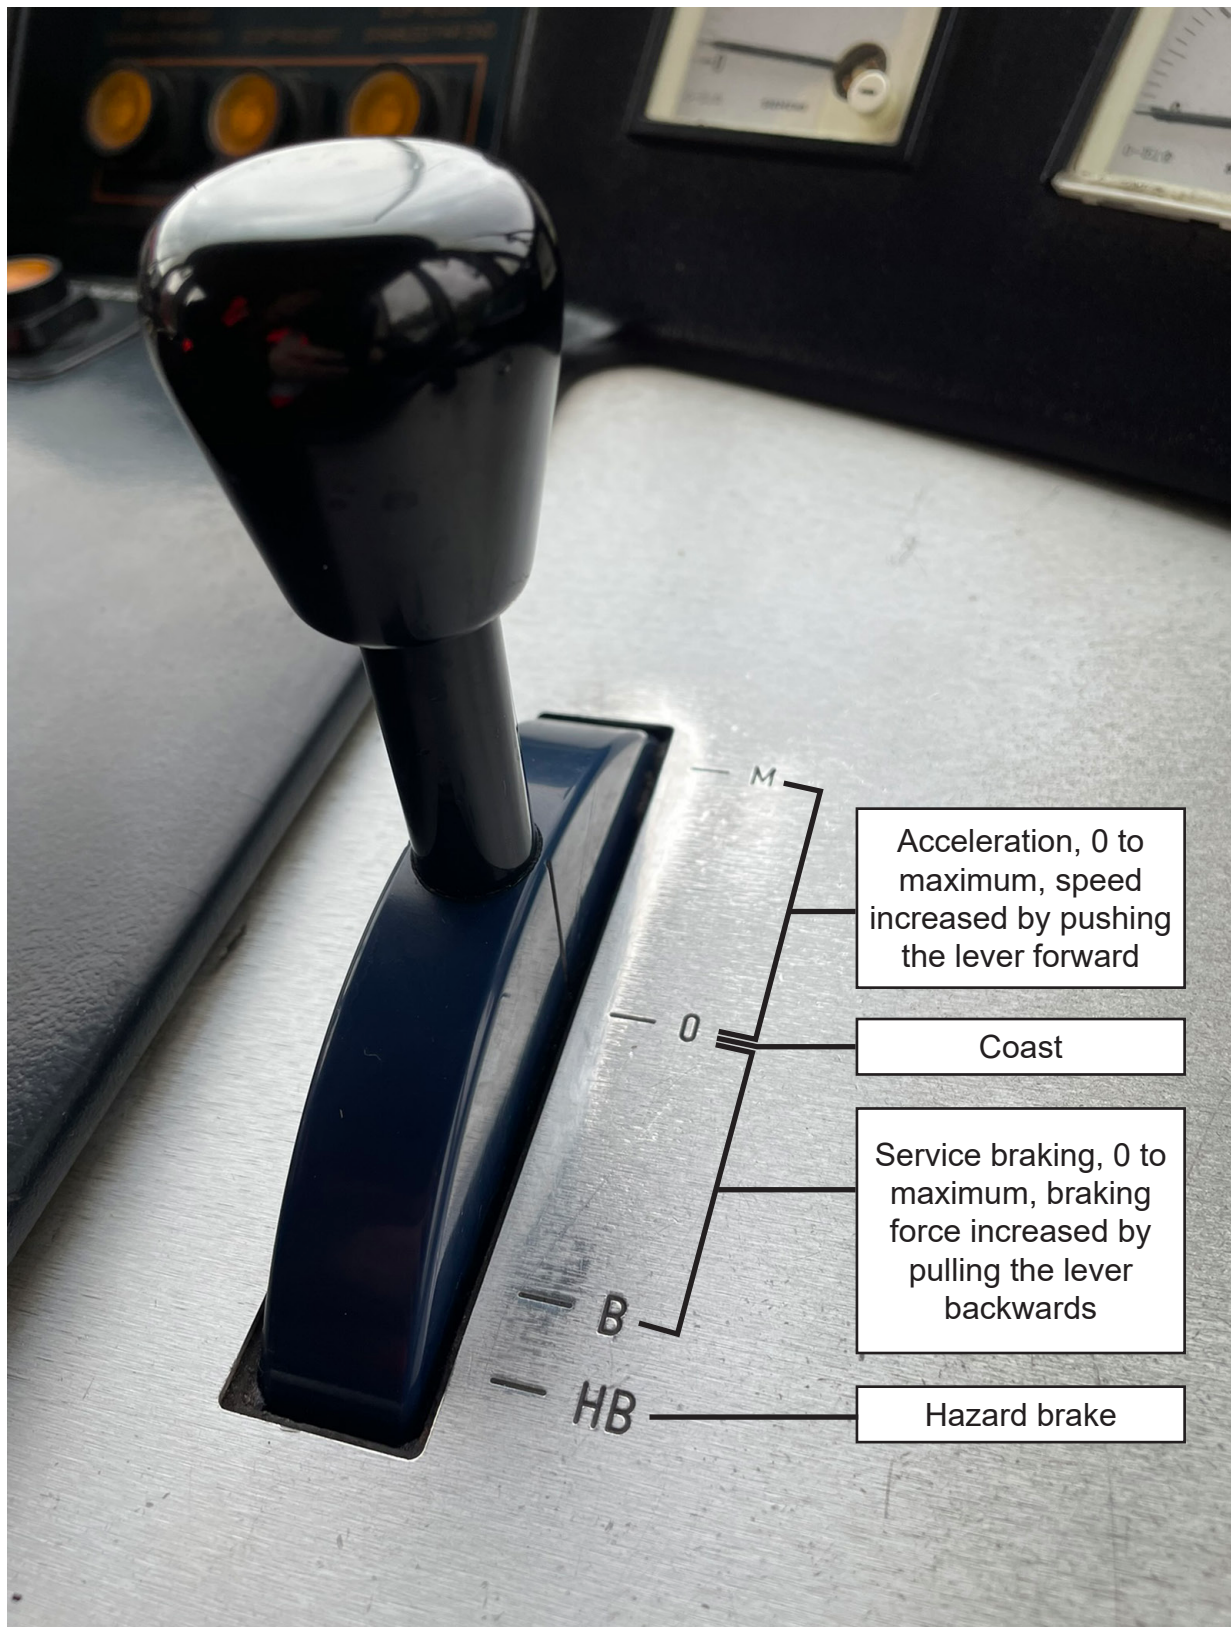
- 14 The tram is fitted with a service brake, which is initiated by moving the combined power/brake control handle in the driving cab back towards the driver (figure 6). The level of braking increases as the control handle is moved further back. There is a notch or 'detent' at the end of the service braking section, marking the point where the hazard brake is applied. The hazard brake applies electromagnetic track brakes and sand for greater braking effect (see paragraph 35) and can be cancelled by moving the handle forward through the detent. The tram has a separate plunger button for the emergency brake, which was not used during the accident. The hazard and emergency brakes provide the same level of braking. They differ solely in the control system used to apply the brake. Unlike many more modern trams, an audible warning is not automatically sounded when the hazard or emergency brake is deployed.

Figure 6: The combined power/brake control handle used to control acceleration and braking.

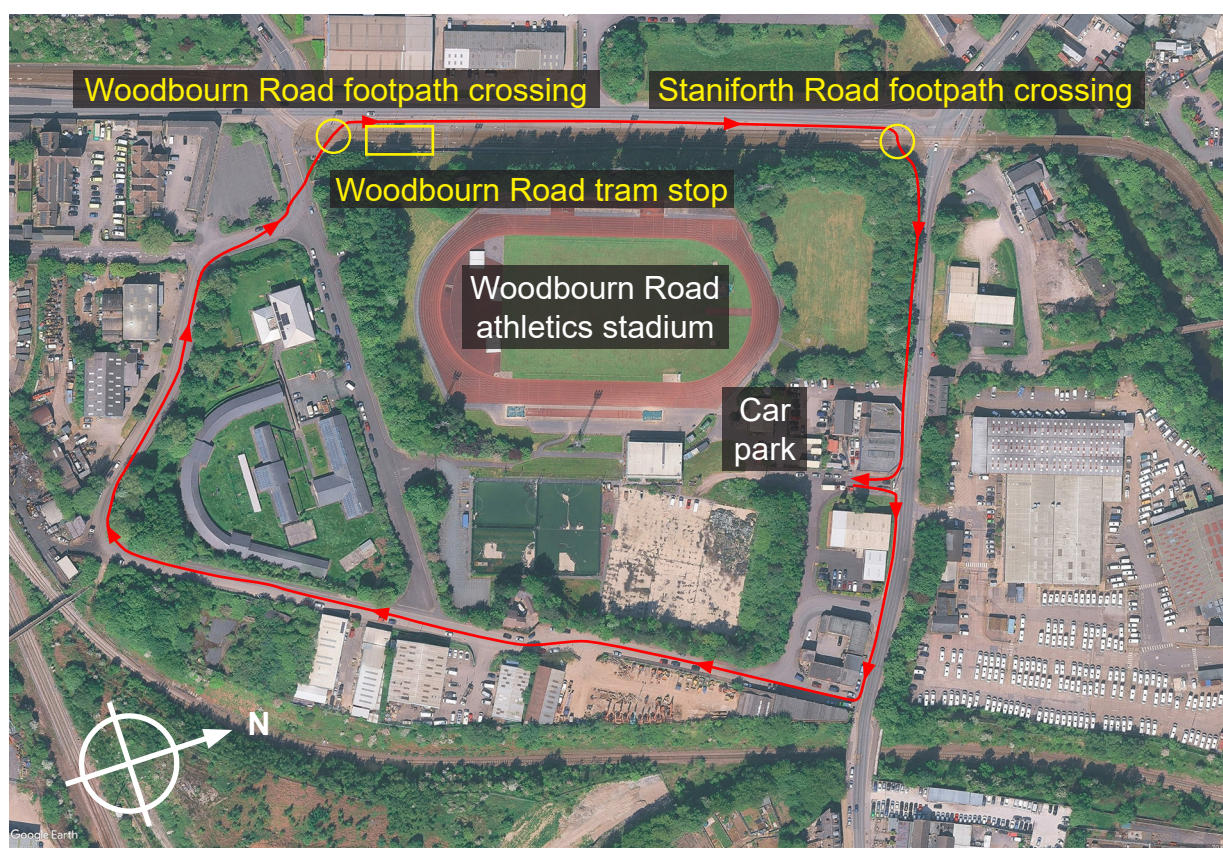
- 57 The cool-down run route is 1.2 km (0.75 miles) and takes approximately 6 mins to complete, starting and ending at the stadium car park (figure 10). Each full circuit of the route sees the pedestrians crossing the tramway twice. They had completed this route less than 10 times before as part of other race meets and had never encountered a tram while crossing the tramway. This may have influenced their expectation as to the likely presence of trams, with witness evidence showing that neither pedestrian was expecting to have to stop for a tram when crossing the tramway.

Figure 10: Cool-down route taken by the pedestrians when using Woodbourn Road athletics stadium (courtesy of Google with RAIB annotations).

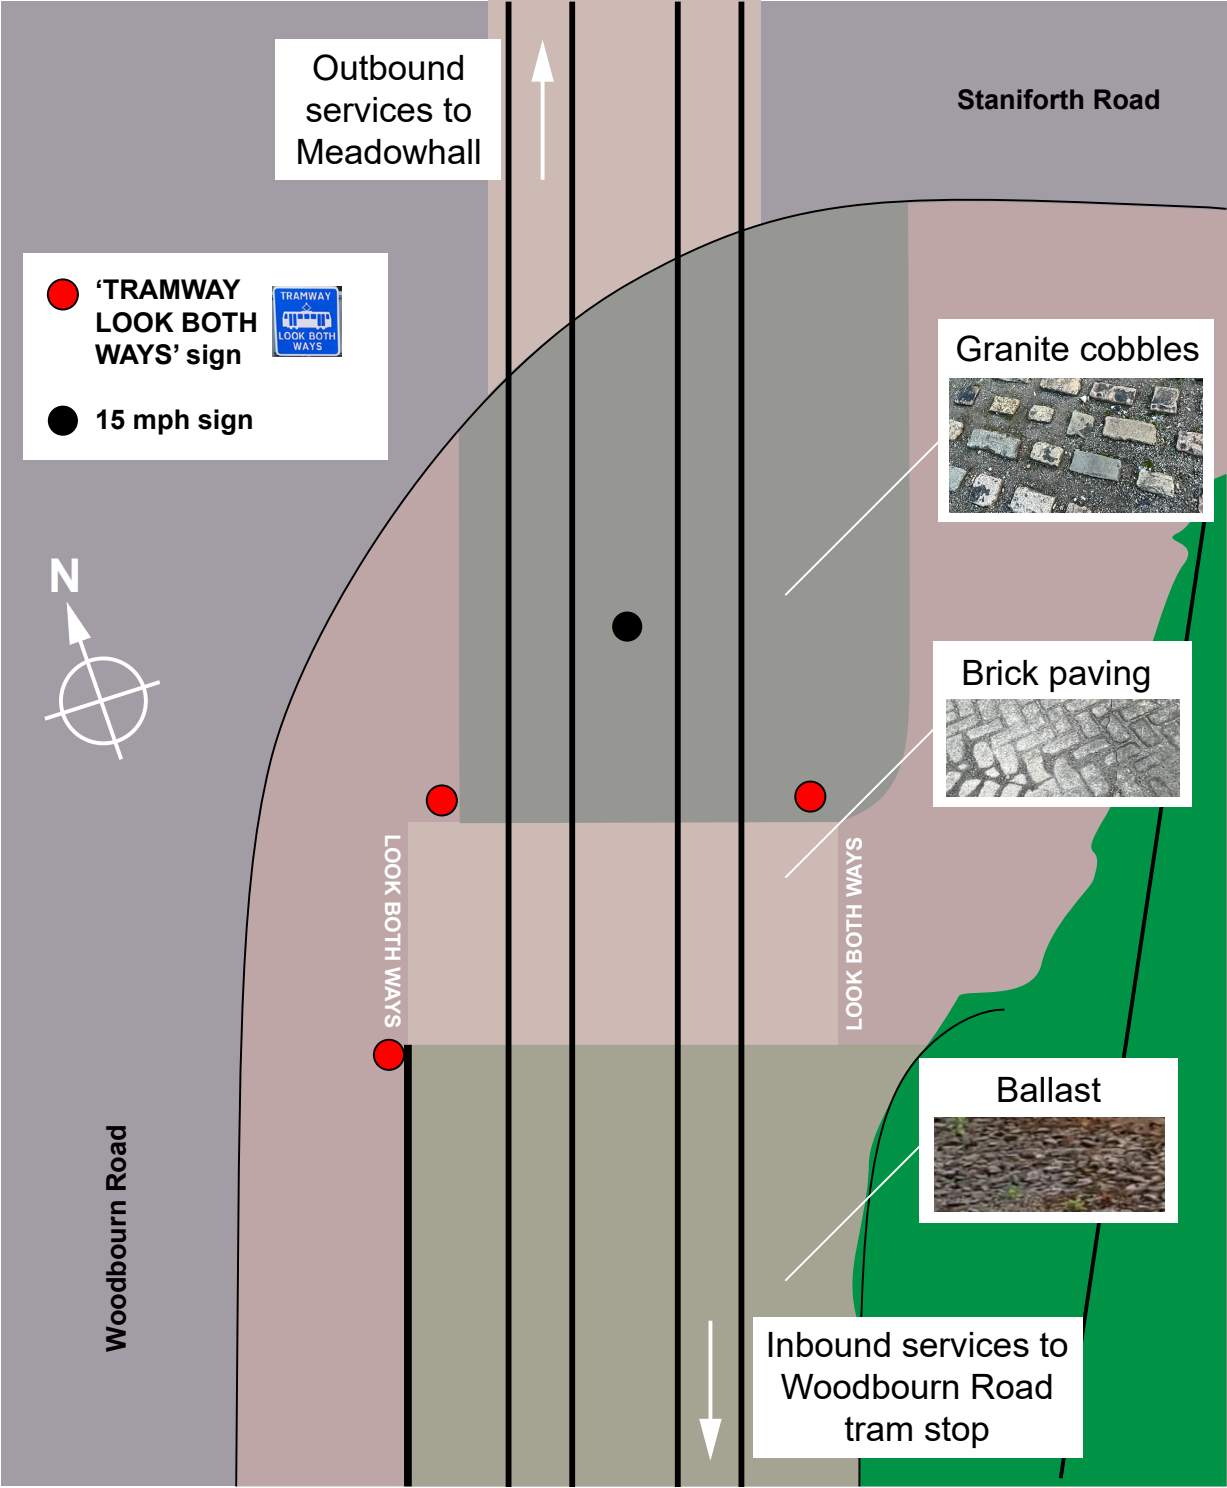
- 61 On turning east (right) to cross the tramway, a user can see two more 'TRAMWAY LOOK BOTH WAYS' signs, one on either side of the crossing. The text 'LOOK BOTH WAYS' is also painted on the pavement immediately before the user steps onto a short stretch of tactile paving leading to the crossing (figure 12), reminding users of the requirement of rule 33 of the Highway Code for pedestrians to '*look both ways along the track before crossing*'.<sup>5</sup> Once the tactile paving is passed, the crossing surface itself is defined by paved brick, with segregated ballasted track to the south, and raised granite cobbles to the north, between the crossing at Staniforth Road itself.

- 63 The information conveyed by the signage and road markings was not effective in informing the pedestrians, who were running and conversing, and were unfamiliar with the location and the tramway, of the correct way to use the crossing. The layout and design of the crossing also did not challenge the pedestrians' expectation that they would not encounter a tram when using it (paragraph 57). The management of the crossing and its safety are examined further from paragraph 64.

Figure 12: Diagram of Staniforth Road footpath crossing.
