**Serious Incident**

| <b>Aircraft Type and Registration:</b> | Boeing 747-433, G-ONEE | |
| <b>Date &amp; Time (UTC):</b> | 8 February 2024 at 0813 hrs | |
| <b>Location:</b> | After departure from London Heathrow Airport | |

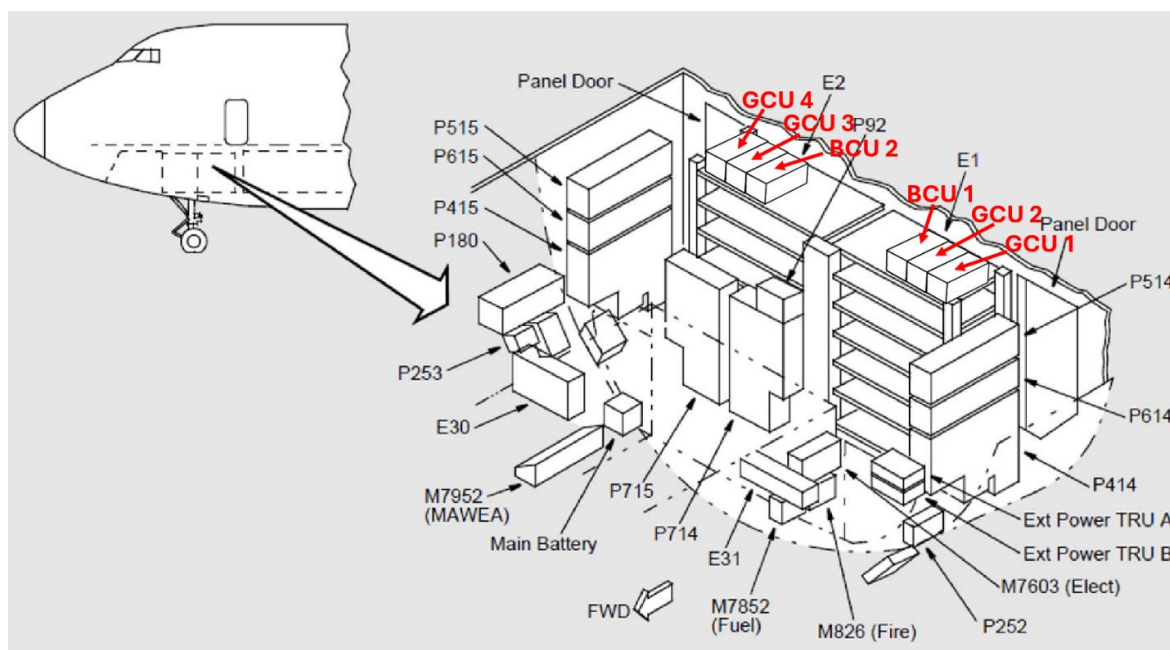
**Figure 7**

The four GCUs and two BCUs are located on the top rows of the E1 and E2 avionics racks in the MEC, below the main cargo deck floor and forward of the left forward L1 door (Figure 7). GCU 1 is in the far-left corner of the E1 rack and GCU 4 is in the far-right corner of the E2 rack.

GCU and BCU locations on top shelf of E1 and E2 racks in Main Equipment Centre  
(image © The Boeing Company)

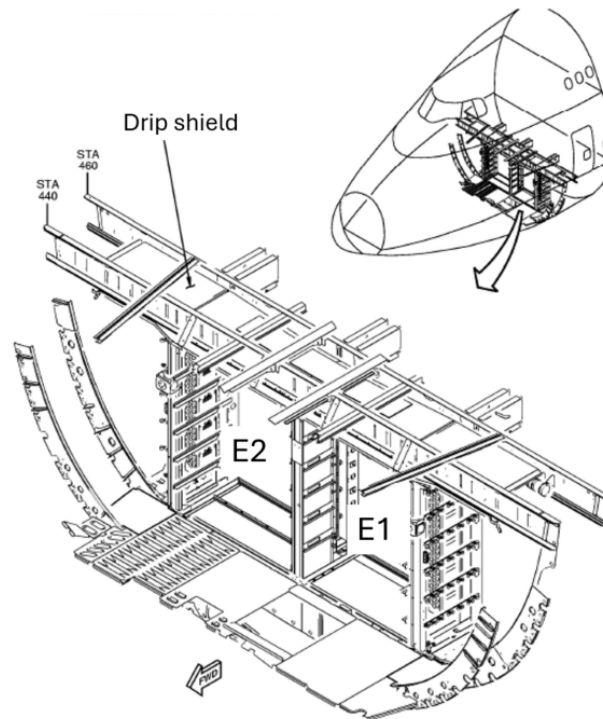
**Figure 8**

- A sealant material between the floor panels.
- 10 cm wide polyurethane tape over the top of the sealant and overlapping the edges of the floor panels.
- 91 cm wide 3M 8663 moisture barrier tape applied over the entire deck area.
- Drains in some floor panels and below the PDUs.
- A drip shield over the E1/E2 rack with drains at both ends (Figure 8).
- Moisture barrier 'curtains' attached to the front of the E1/E2 rack (which were not fitted on G-ONEE at the time of the incident).

Location of drip shield above E1 and E2 avionics racks  
(image © The Boeing Company)

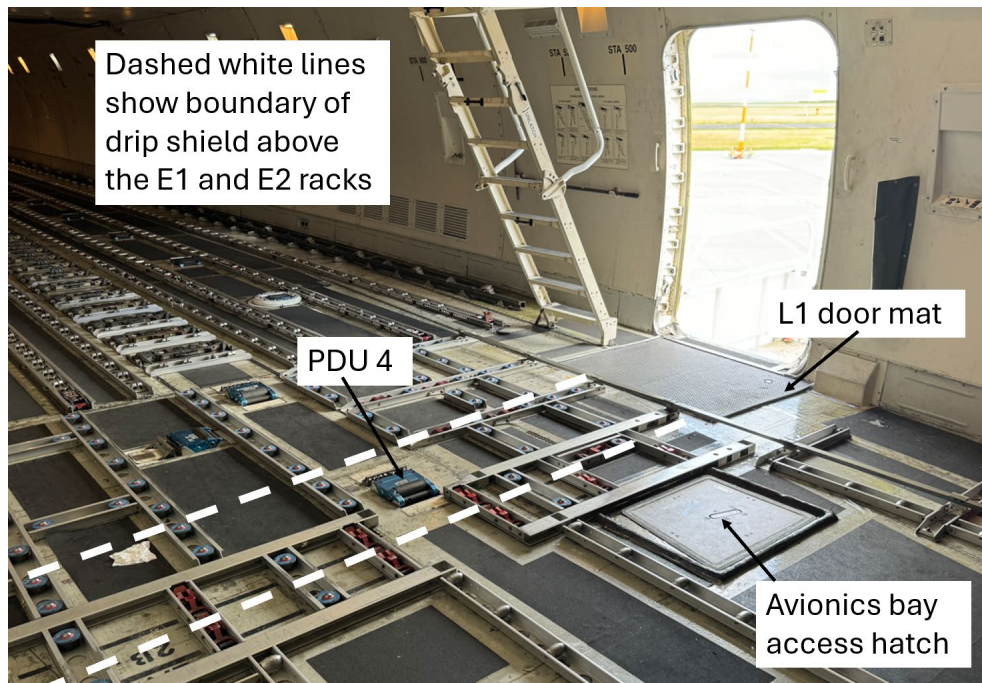
**Figure 13**

In June 2024 the AAIB carried out an additional examination of the aircraft. Figure 13 shows the L1 door mat that was wet prior to the incident flight, and its location relative to the E1 and E2 racks containing the GCUs. The door mat has a rubber barrier surrounding it to contain any water and help ensure the water passes down the drain hole in the mat.

A close examination of the door mat revealed that the forward right corner was missing sealant between the rubber barriers, creating a path for water to travel along the floor above the E1/E2 racks (Figure 14).

Location of L1 door mat and PDU 4 relative to the E1 and E2 racks beneath the cargo deck floor

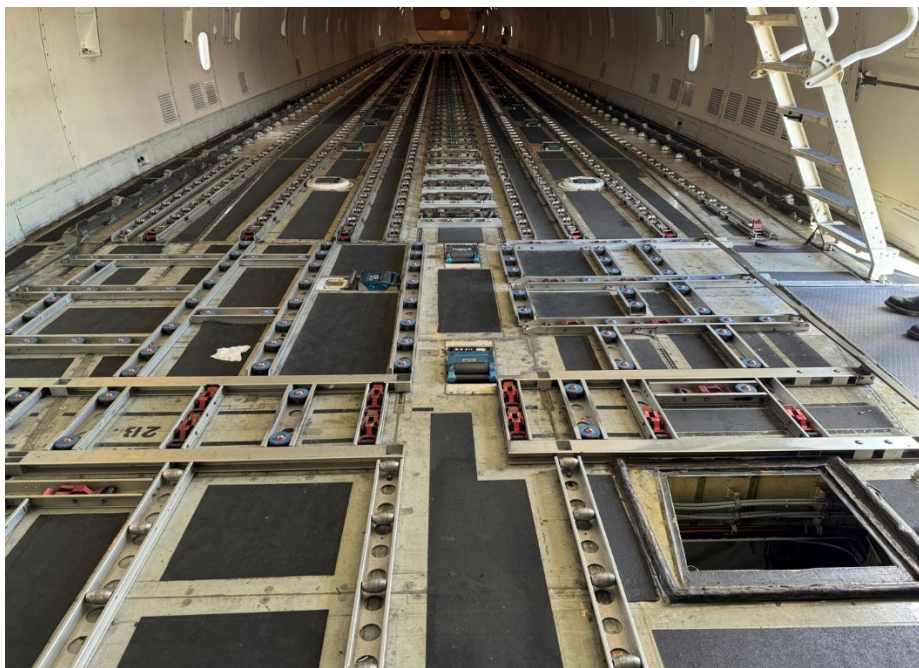
**Figure 22**

The aircraft manufacturer's 747-400 Maintenance Planning Document (MPD)<sup>21</sup> contains a task for 'Main Deck Cargo Container Compartment' which states '*Perform an external inspection of the interior of main deck cargo container compartment*'. This is a general 'zonal inspection' of the entire cargo deck (an area about 56 m by 6 m, Figure 22), which is carried out at each A-check (every 1,000 flight hours), usually from a standing height. The MPD does not contain a maintenance task for a specific visual inspection of the condition of the floor, the floor seals, or the protective tape over the MEC area, or the condition of the rubber dam around the door mat.

G-ONEE main cargo deck floor

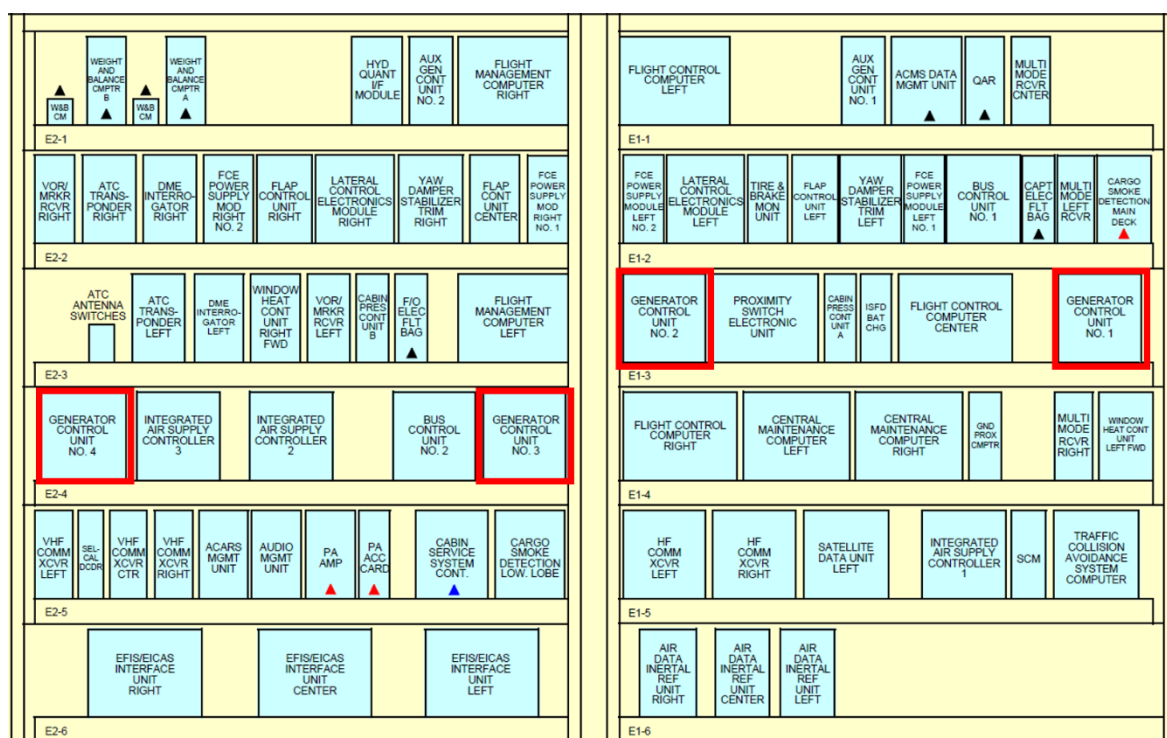
**Figure 23**

In the E1 and E2 racks on the 747-8 the GCUs are no longer on the top shelf, but are on different shelves lower down, and spaced further apart (Figure 23). The moisture barriers are also fitted as standard equipment.

Location of GCUs highlighted in red in E1 and E2 racks on Boeing 747-8 aircraft
