# ***AAIB Bulletin***

**9/2026**

| Boeing 747-433 | G-ONEE | 8-Feb-24 | 3 |

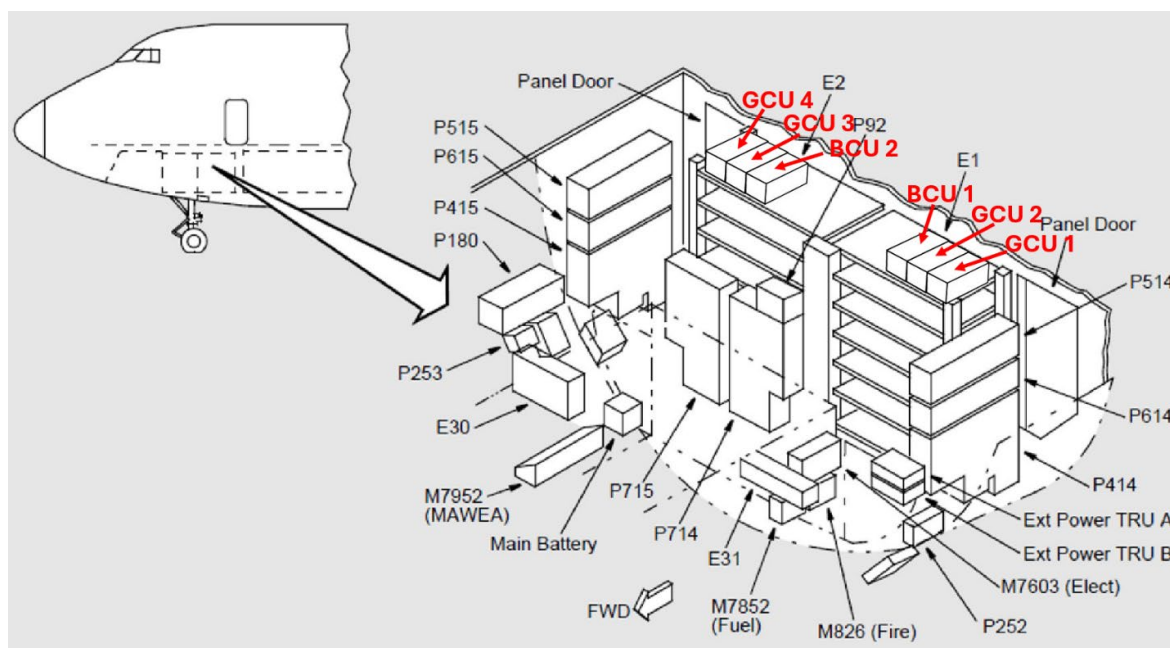
**Figure 7**

The four GCUs and two BCUs are located on the top rows of the E1 and E2 avionics racks in the MEC, below the main cargo deck floor and forward of the left forward L1 door (Figure 7). GCU 1 is in the far-left corner of the E1 rack and GCU 4 is in the far-right corner of the E2 rack.

GCU and BCU locations on top shelf of E1 and E2 racks in Main Equipment Centre  
(image © The Boeing Company)

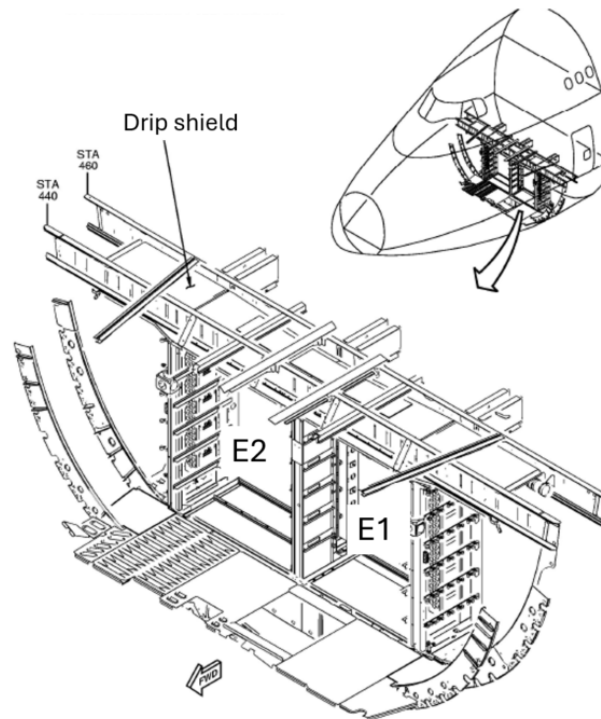
**Figure 8**

- A sealant material between the floor panels.
- 10 cm wide polyurethane tape over the top of the sealant and overlapping the edges of the floor panels.
- 91 cm wide 3M 8663 moisture barrier tape applied over the entire deck area.
- Drains in some floor panels and below the PDUs.
- A drip shield over the E1/E2 rack with drains at both ends (Figure 8).
- Moisture barrier 'curtains' attached to the front of the E1/E2 rack (which were not fitted on G-ONEE at the time of the incident).

Location of drip shield above E1 and E2 avionics racks  
(image © The Boeing Company)

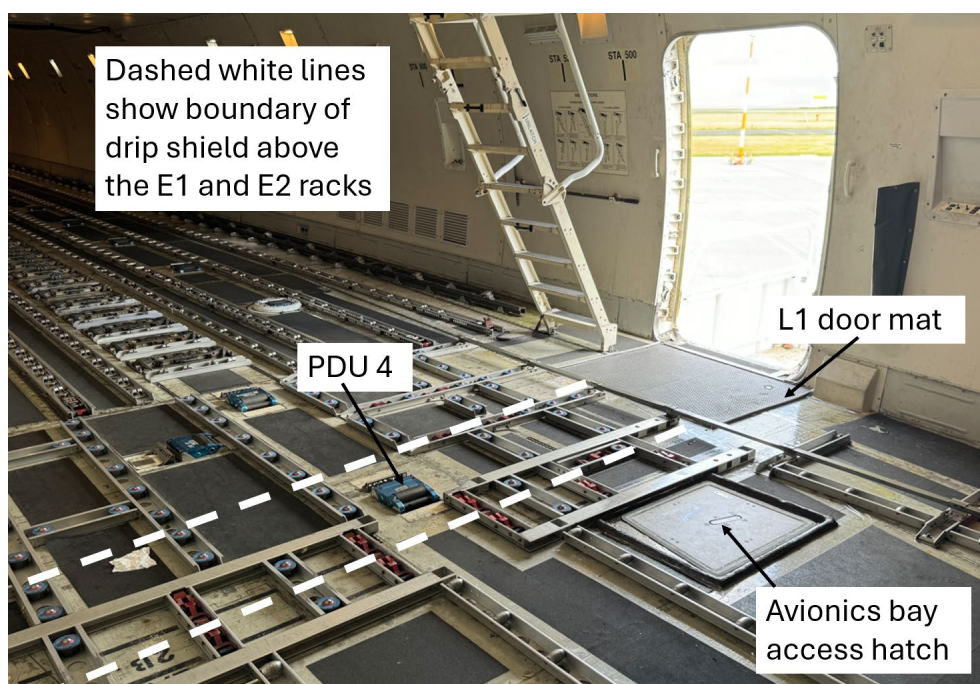
**Figure 13**

In June 2024 the AAIB carried out an additional examination of the aircraft. Figure 13 shows the L1 door mat that was wet prior to the incident flight, and its location relative to the E1 and E2 racks containing the GCUs. The door mat has a rubber barrier surrounding it to contain any water and help ensure the water passes down the drain hole in the mat.

A close examination of the door mat revealed that the forward right corner was missing sealant between the rubber barriers, creating a path for water to travel along the floor above the E1/E2 racks (Figure 14).

Location of L1 door mat and PDU 4 relative to the E1 and E2 racks beneath the cargo deck floor

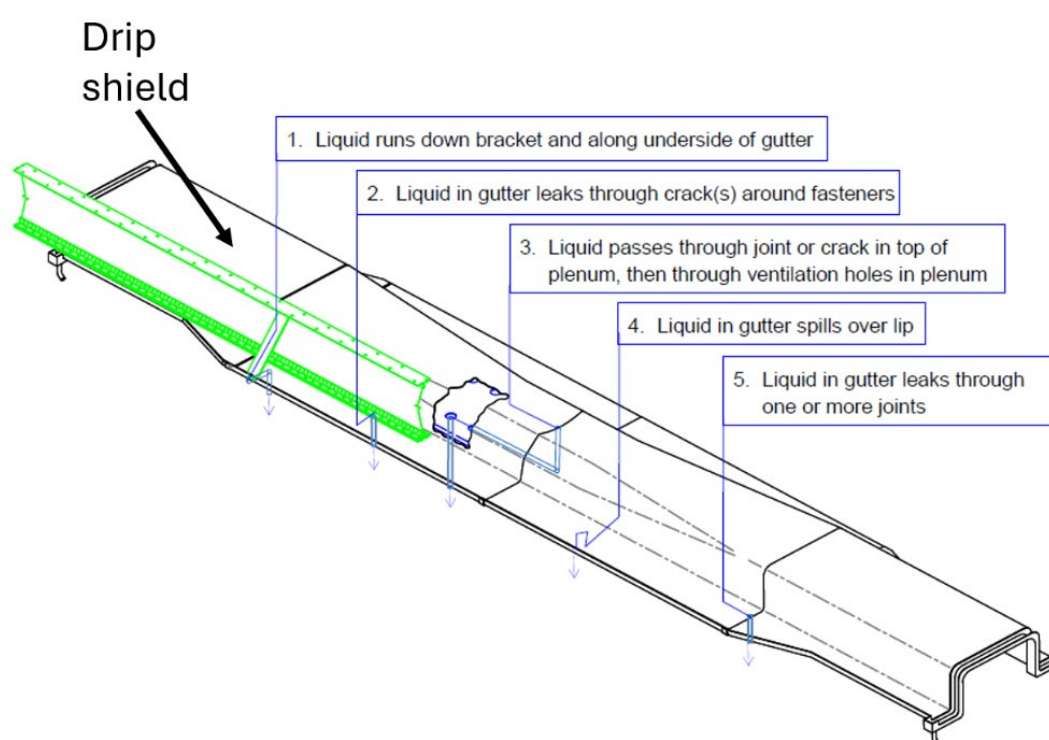
**Figure 20**

The Australian Transportation Safety Board (ATSB) published a report on an electrical failure event involving a passenger variant of the Boeing 747-400 that occurred on 7 January 2008<sup>20</sup> (registration VH-OJM). During the descent and approach into Bangkok International Airport, power was lost from AC buses 1, 2 and 3 and the power was not recovered. The aircraft suffered multiple system failures, but the flight crew were able to land safely under VMC conditions. Prior to the failures the cabin crew had reported a substantial water leak in the forward galley, which is located above the MEC. The investigation revealed that the cause of the failures was water ingress into GCUs 1, 2 and 3. The path the water took from the galley floor into the top of the GCUs was not identified but a number of possible paths were identified as shown in Figure 20 (extracted from the ATSB report).

Potential water paths identified by ATSB in report on VH-OJM electrical failure event  
(image courtesy of ATSB)

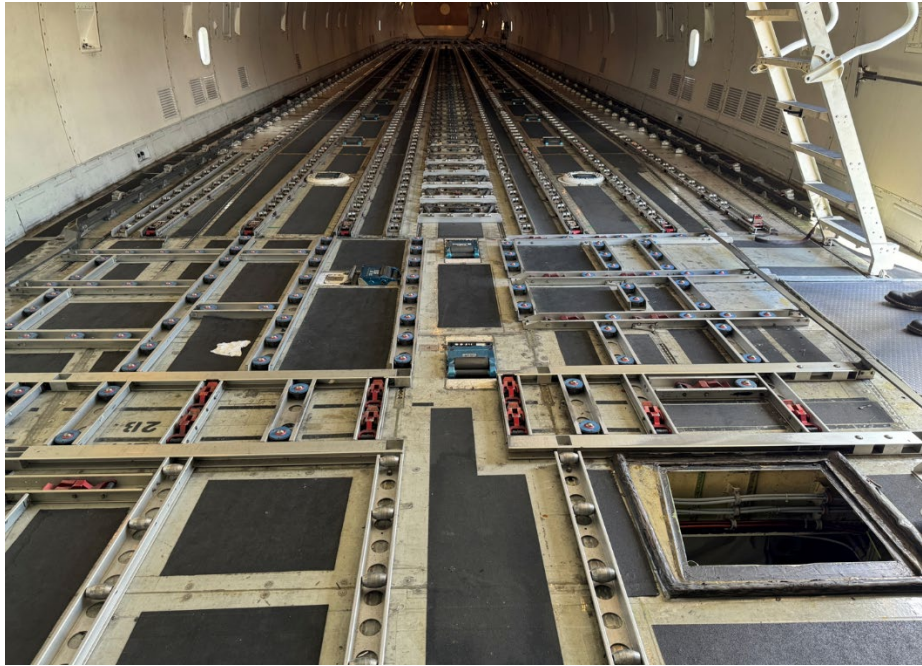
**Figure 22**

The aircraft manufacturer's 747-400 Maintenance Planning Document (MPD)<sup>21</sup> contains a task for 'Main Deck Cargo Container Compartment' which states *'Perform an external inspection of the interior of main deck cargo container compartment'*. This is a general 'zonal inspection' of the entire cargo deck (an area about 56 m by 6 m, Figure 22), which is carried out at each A-check (every 1,000 flight hours), usually from a standing height. The MPD does not contain a maintenance task for a specific visual inspection of the condition of the floor, the floor seals, or the protective tape over the MEC area, or the condition of the rubber dam around the door mat.

G-ONEE main cargo deck floor

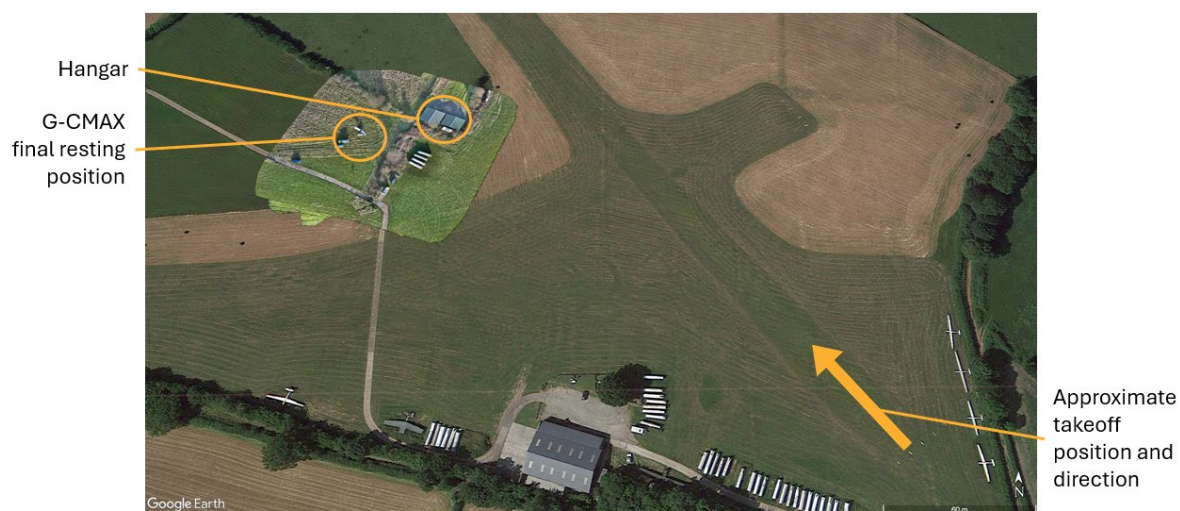
**Figure 1**

The aircraft came to rest in a field to the west of and adjacent to the gliding site (Figure 1). Damage to the aircraft's wings, a wire fence on the edge of the field and ground scars in the field indicated that the aircraft initially clipped the top of the fence with its left wingtip before striking the ground in a nose down attitude. It then turned horizontally through 270° before coming to rest on its wheels, facing in a northerly direction. The glider towing line remained attached to the aircraft and trailed over the boundary fence and foliage, indicating the direction from which the aircraft had come (Figure 2).

Google Earth image of Talgarth Airfield with aerial image of G-CMAX accident site overlaid

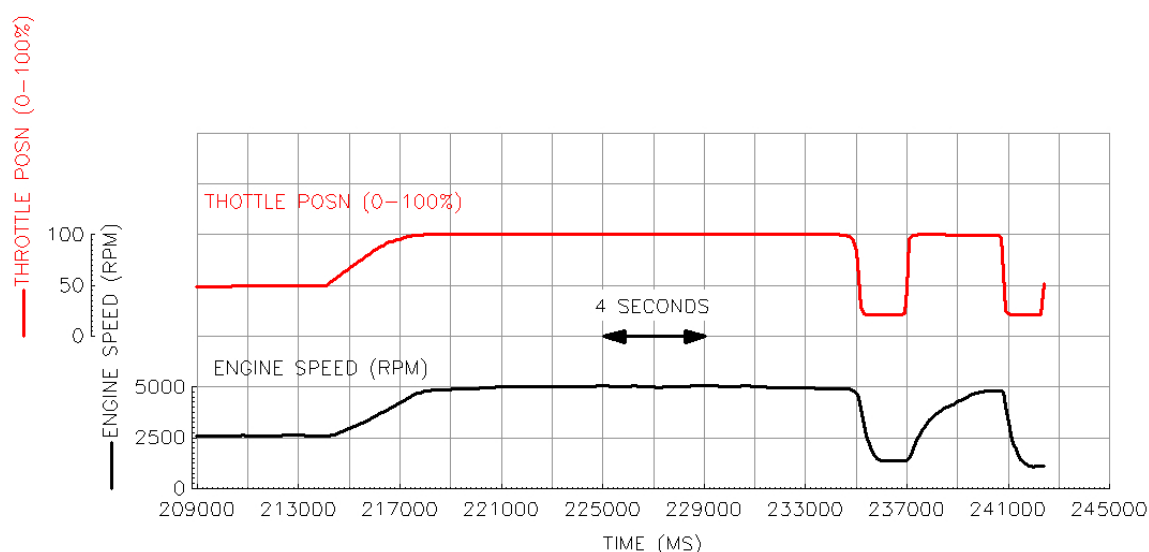
**Figure 4**  
G-CMAX ECU data

The aircraft was fitted with an Engine Control Unit (ECU) which logged engine parameters for the last hour of operation. The ECU was downloaded and the accident flight was recorded at up to 10 samples per second. The data confirmed that the engine was responding and operating as expected. Figure 4 shows the throttle command and engine speed, showing a full power demand on takeoff with engine rpm maintaining approximately 5,000 rpm. Towards the end of the recording, the throttle command was reduced to 21% for approximately 2 seconds before being restored to 100%.
