# Rail Accident Report

**Near miss with track workers at Bookham  
Tunnel, Surrey  
29 April 2025**

Report 07/2026  
June 2026

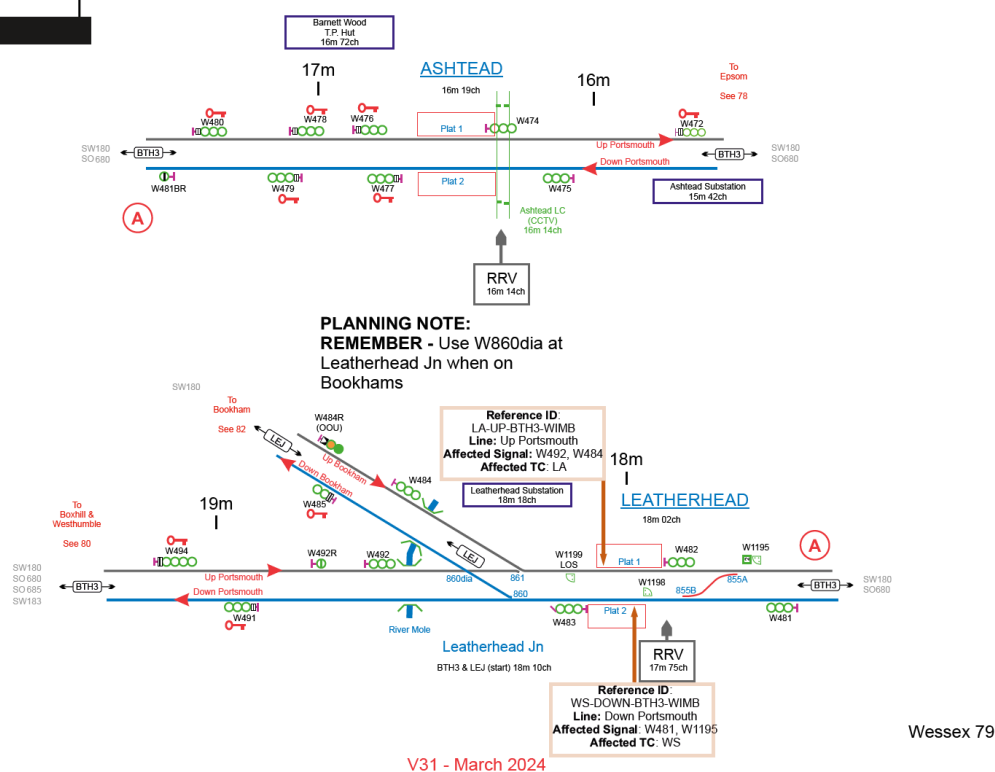
- 76 The entry blocking points for both Bookham and Mickleham Tunnels are both at Leatherhead Junction (figure 16). The blocking points are very similar, with 860 diamond crossing used for Bookham Tunnel and 860 points for Mickleham Tunnel. However, the exit blocking points are different, with signal CA186 used for Mickleham Tunnel and signal GD623 for Bookham Tunnel.

Figure 16: Track diagrams for Leatherhead Junction (courtesy of Network Rail).

- 106 The only way to provide additional protection to the site would have been via a signal disconnection of the signal beyond the 860 diamond crossing (figure 16). This would potentially have meant a further SWP and additional staff resources to undertake this action.
- 107 This causal factor arose because neither the signaller nor the PIC realised that the group was in a different location to the line blockage (paragraph 108).

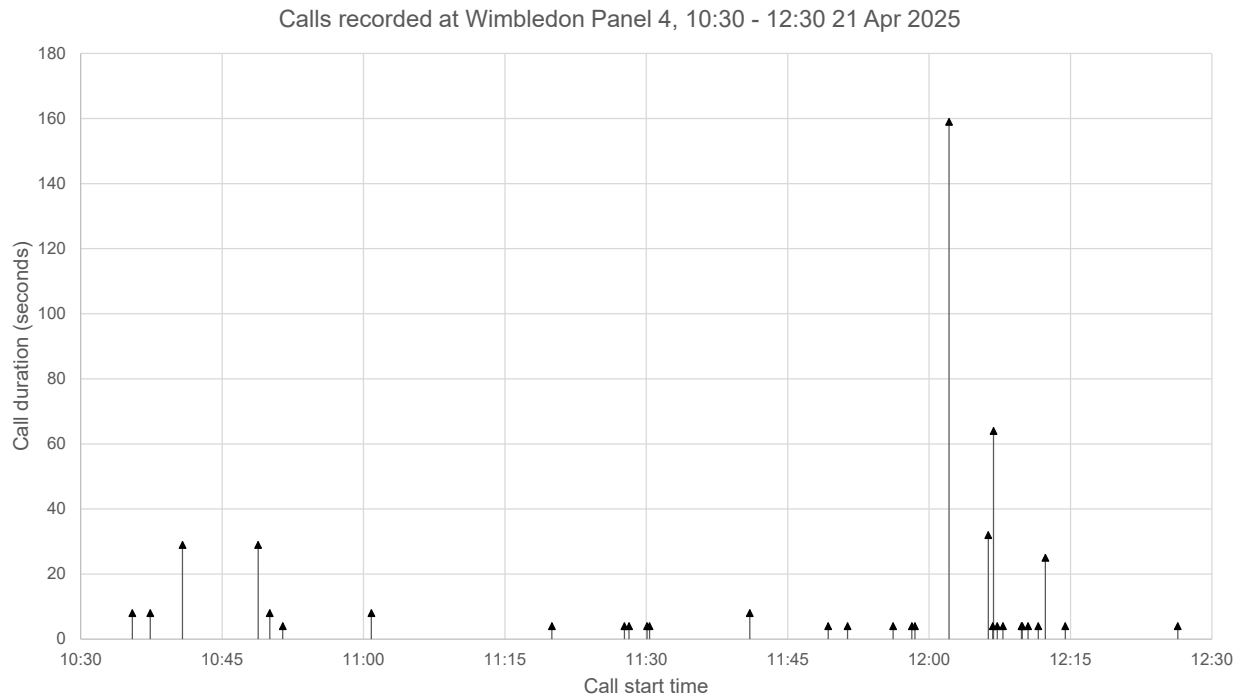
- 114 Witness evidence suggests that Tuesdays were seen as busy days for the signaller on duty at Wimbledon as they handled a greater number of preplanned requests compared to other days. This is supported by analysis of incoming calls to the signaller on the day of the incident, which showed an increased workload compared to any other day (figures 18 and 19). Although Network Rail had recently carried out an assessment of the signaller's workload at this control panel, it did not show any issues with signaller workload. This assessment had been done on a Wednesday.

Figure 19: Telephone calls being dealt with by a signaller on a typical day.
