# Rail Accident Report

**Near miss with track workers at Bookham  
Tunnel, Surrey  
29 April 2025**

Report 07/2026  
June 2026

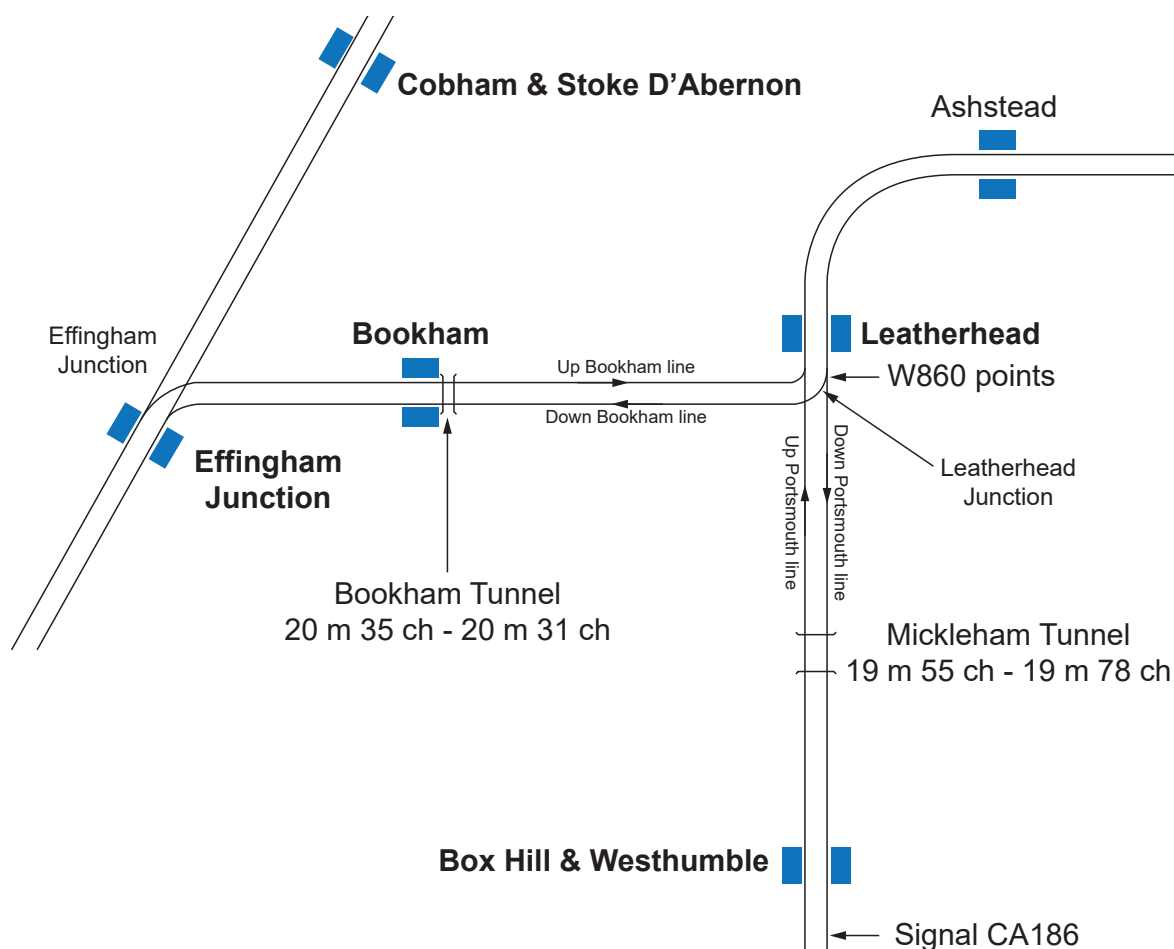
- 7 The incident occurred in Bookham Tunnel which is located between Leatherhead and Bookham stations, on the Leatherhead and Effingham Junction line (figure 3). The tunnel runs between 20 miles 31 chains (a chain is 22 yards or around 20 metres) and 20 miles 35 chains, measured from a zero-reference located at Waterloo via Worcester Park. The tunnel is located approximately 0.1 miles (0.2 km) east of Bookham station and is on a curve within a shallow cutting.

- 9 There is a second tunnel in the area called Mickleham Tunnel (figure 3). Mickleham Tunnel is located between Leatherhead and Box Hill & Westhumble stations. It runs between 19 miles 55 chains and 19 miles 78 chains on the Epsom Junction to Horsham Junction line. This is also on a twin-track railway consisting of the Up Portsmouth line (on which trains travel towards Leatherhead) and the Down Portsmouth line (on which trains travel toward Dorking).

Figure 3: Track layout with relevant infrastructure highlighted.

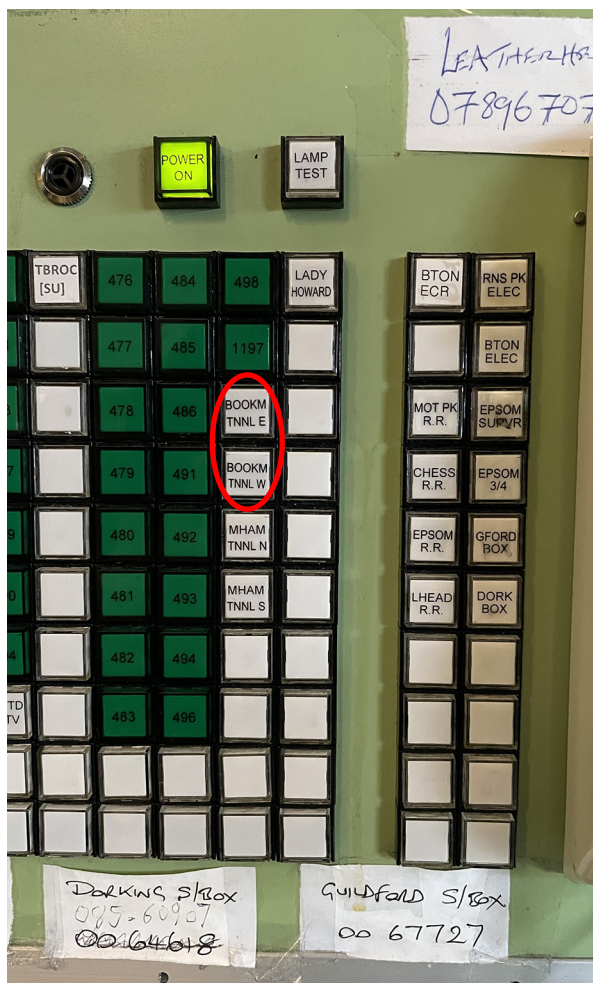
Figure 11: Phone concentrator on Wimbledon panel No.4 with Bookham Tunnel east and west telephone buttons highlighted.

- 109 The signaller was initially contacted by trackworker 1 at 10:56 to test the telephone at the western end of Bookham Tunnel (paragraph 53). When an incoming call is received from the Bookham Tunnel telephones, there is an audible ring on the concentrator phone, and the button labelled 'Bookm Tnnl E' or 'Bookm Tnnl W' flashes (figure 11). This indicates where the call is coming from. To answer the call, a signaller needs to lift the receiver and press the flashing button. Although the buttons on the concentrator for the two tunnels are positioned relatively close together on the concentrator (figure 11), the signaller was provided with information to show that the call was coming from Bookham Tunnel. The signaller saw the incoming call on the concentrator but did not immediately answer the call as they were busy. During the follow-up call, trackworker 1 also confirmed they were at Bookham Tunnel. The signaller and trackworker 1 spoke again on the Bookham Tunnel west telephone at 10:57.

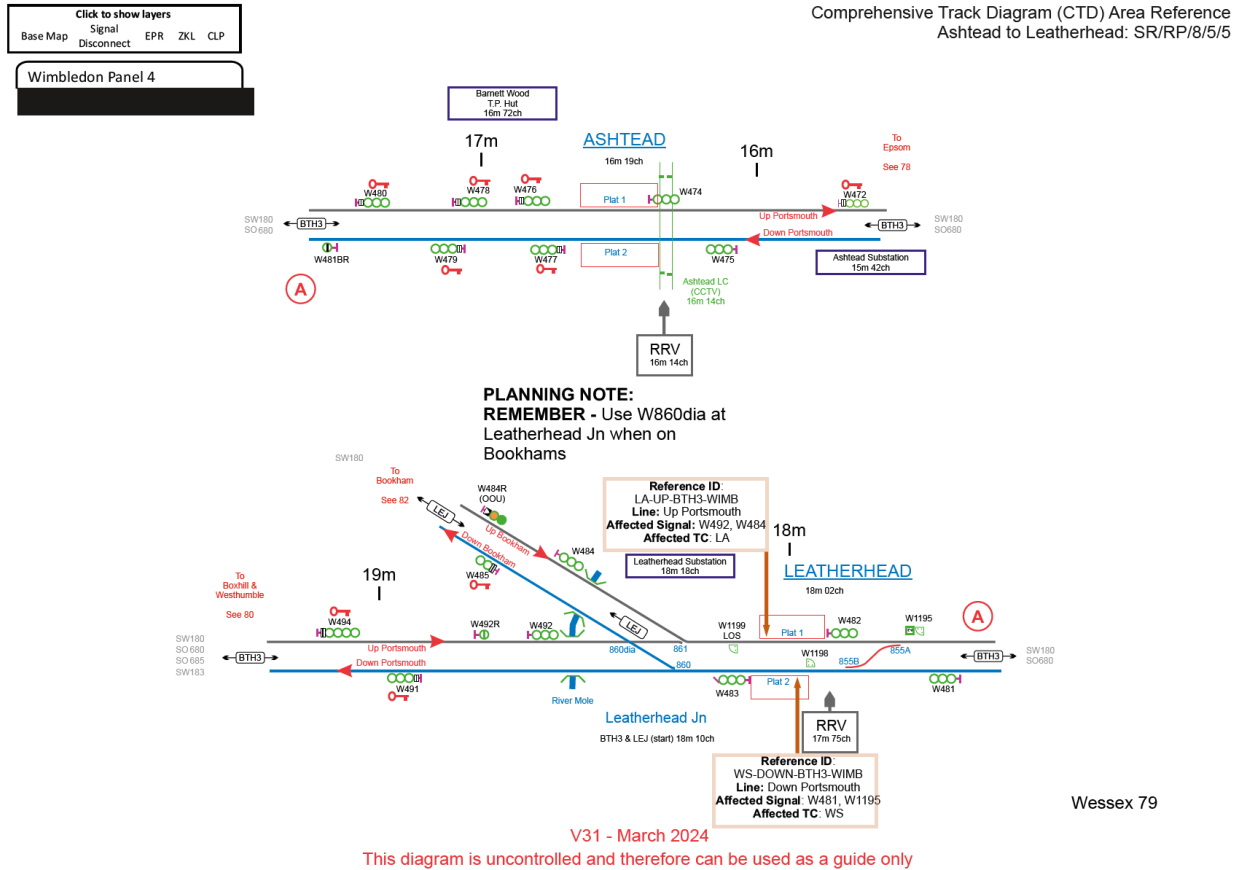
- 76 The entry blocking points for both Bookham and Mickleham Tunnels are both at Leatherhead Junction (figure 16). The blocking points are very similar, with 860 diamond crossing used for Bookham Tunnel and 860 points for Mickleham Tunnel. However, the exit blocking points are different, with signal CA186 used for Mickleham Tunnel and signal GD623 for Bookham Tunnel.

Figure 16: Track diagrams for Leatherhead Junction (courtesy of Network Rail).

- 106 The only way to provide additional protection to the site would have been via a signal disconnection of the signal beyond the 860 diamond crossing (figure 16). This would potentially have meant a further SWP and additional staff resources to undertake this action.
- 107 This causal factor arose because neither the signaller nor the PIC realised that the group was in a different location to the line blockage (paragraph 108).

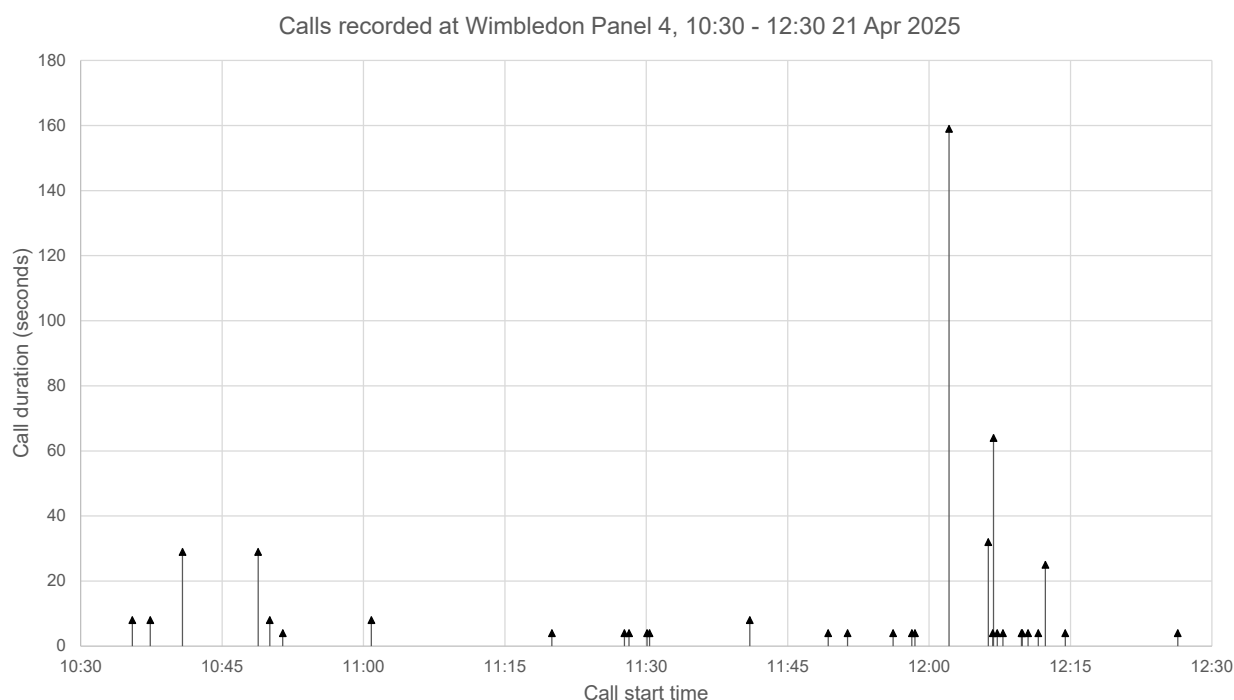
- 114 Witness evidence suggests that Tuesdays were seen as busy days for the signaller on duty at Wimbledon as they handled a greater number of preplanned requests compared to other days. This is supported by analysis of incoming calls to the signaller on the day of the incident, which showed an increased workload compared to any other day (figures 18 and 19). Although Network Rail had recently carried out an assessment of the signaller's workload at this control panel, it did not show any issues with signaller workload. This assessment had been done on a Wednesday.

Figure 19: Telephone calls being dealt with by a signaller on a typical day.
