Report on the investigation of  
the foundering of the longline fishing vessel

***Argos Georgia***

approximately 190 nautical miles east of Port Stanley,  
Falkland Islands

REPORT NO 19/2026

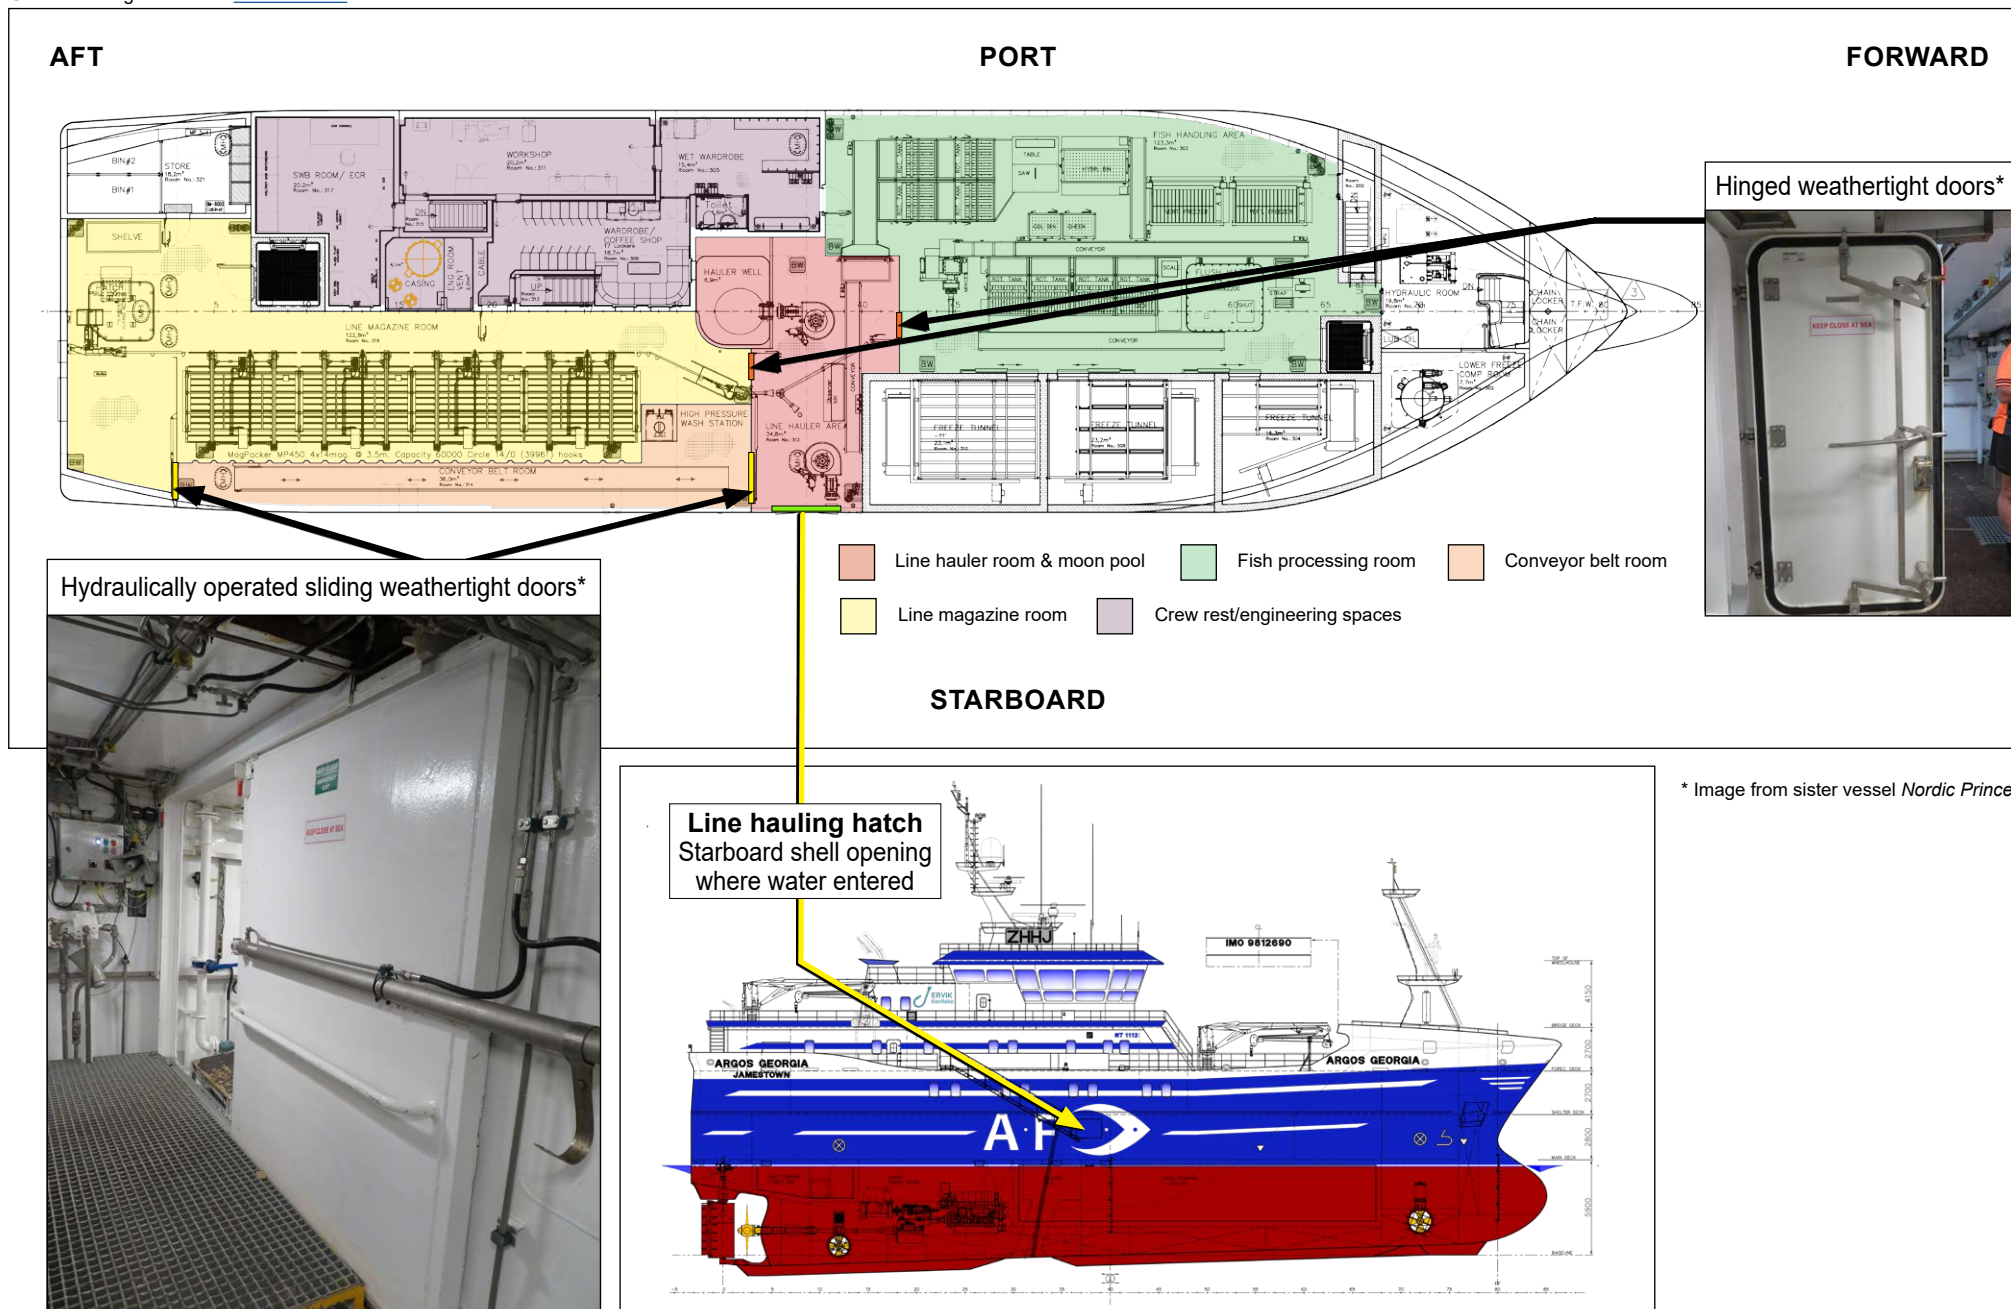
Figure 1: Argos Georgia main deck general arrangement

*Argos Georgia* (**Figure 1**) was a 53.85m longline fishing vessel with a 13m beam. The vessel had accommodation for 28 people, a longline fishing capacity of approximately 40,000 hooks and a cold storage volume of 655m<sup>3</sup>.

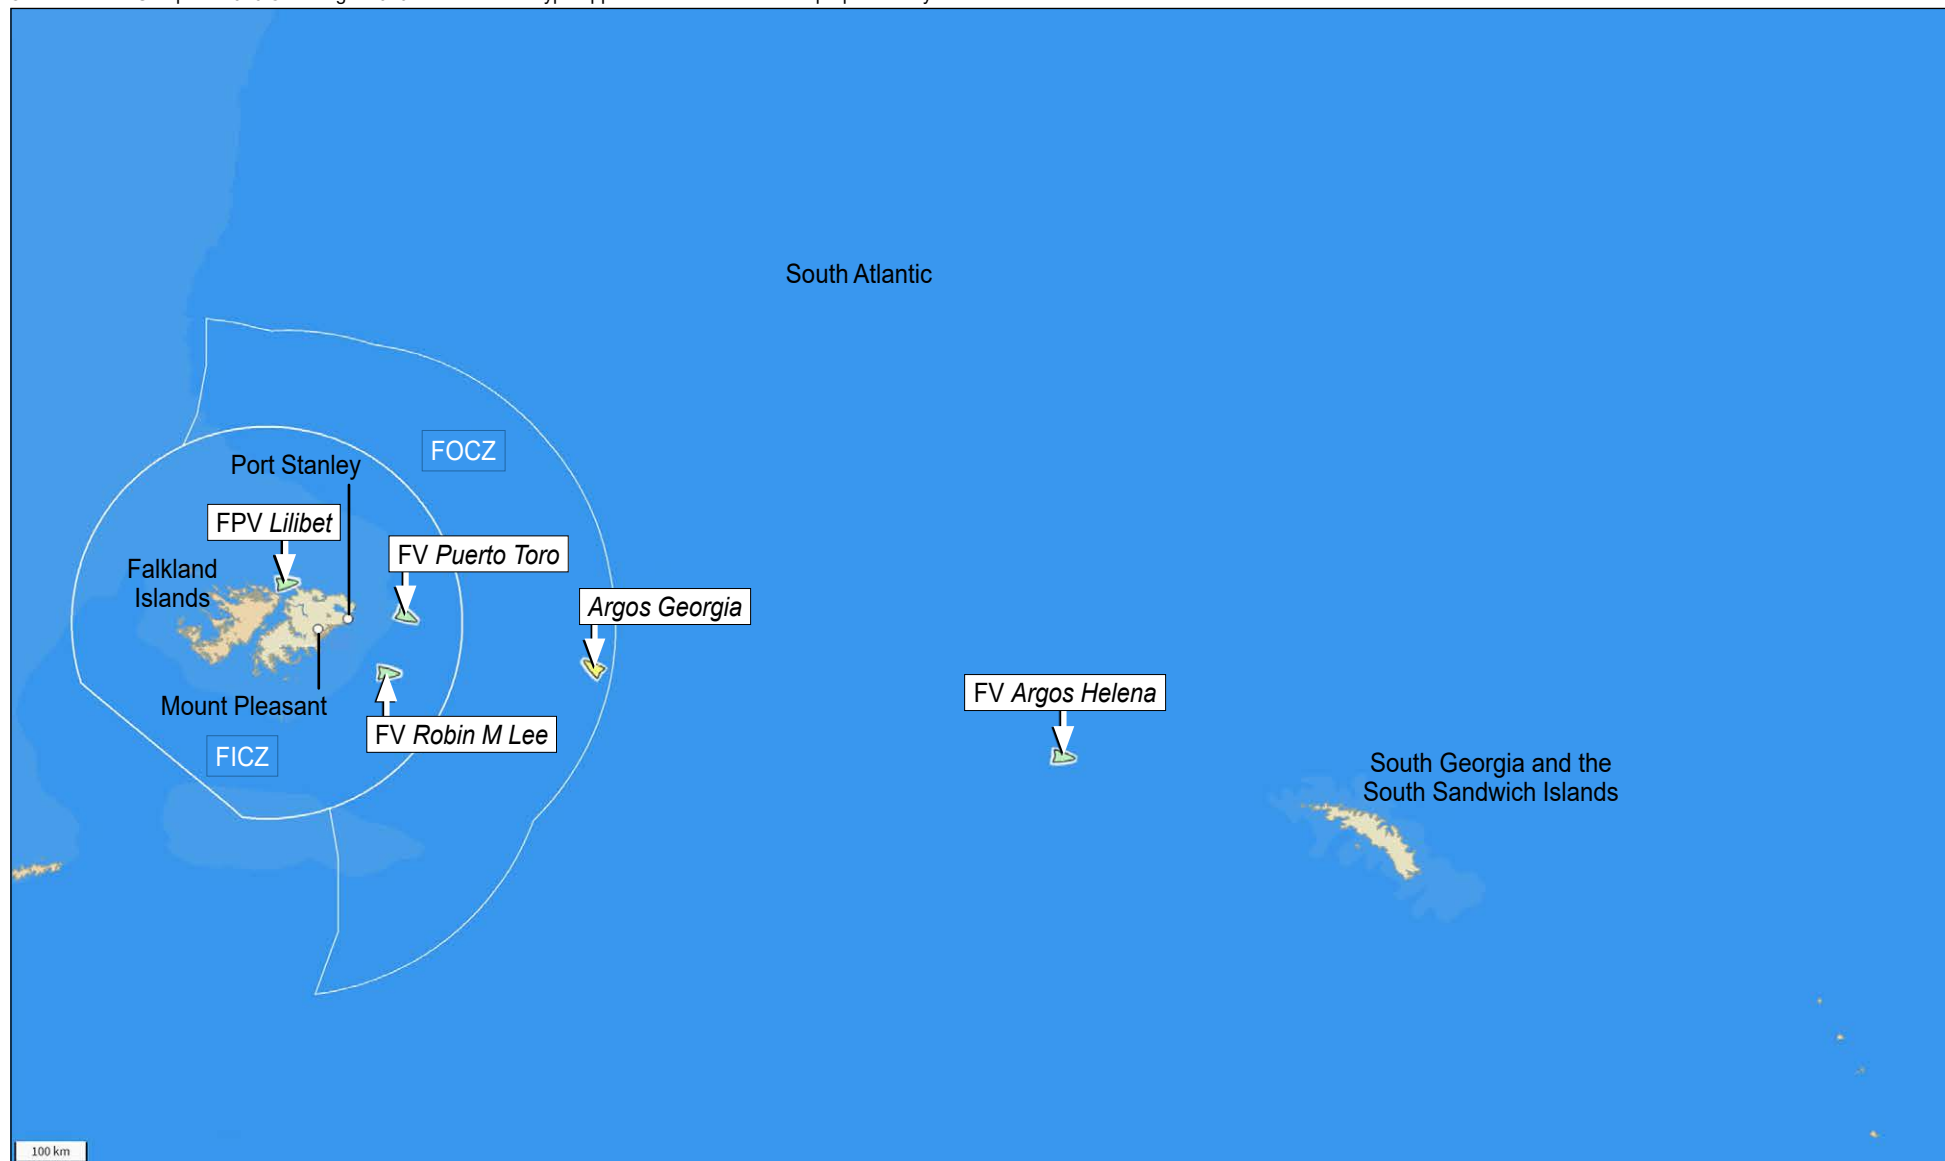
**Figure 3:** Location of accident and disposition of supporting vessels

Shortly after the 1357 WhatsApp message from *Argos Georgia*'s 2/E to *Puerto Toro*, FIMA received a phone call from Polar Seafish Ltd informing it that *Argos Georgia* had reported water ingress from the line hauling hatch and was requesting assistance. The vessel's position was 52°21.56'S, 052°49.5'W, approximately 190nm east of Port Stanley (**Figure 3**). A local weather forecast application reported westerly winds at 40kts with 8m swells.

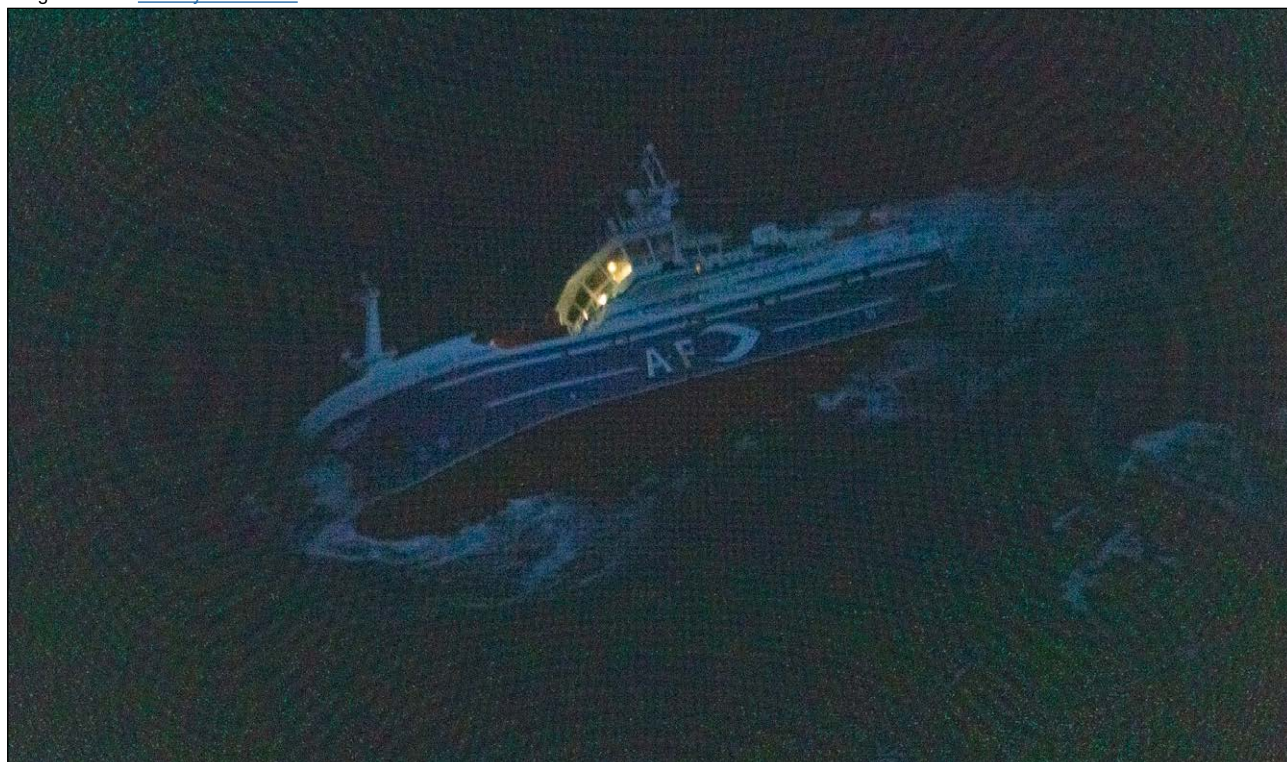
**Figure 5:** Last light observed from *Argos Georgia* by the fixed-wing aircraft at about 1835

The fixed-wing aircraft provided updates on the last light observed from *Argos Georgia* at about 1835 (**Figure 5**), liferaft positions, and tracking seven locator beacons in the water. At about 1900, *Argos Georgia* foundered. The fixed-wing aircraft remained on scene until 2100, when an RAF A330 Voyager tanker aircraft replaced it.

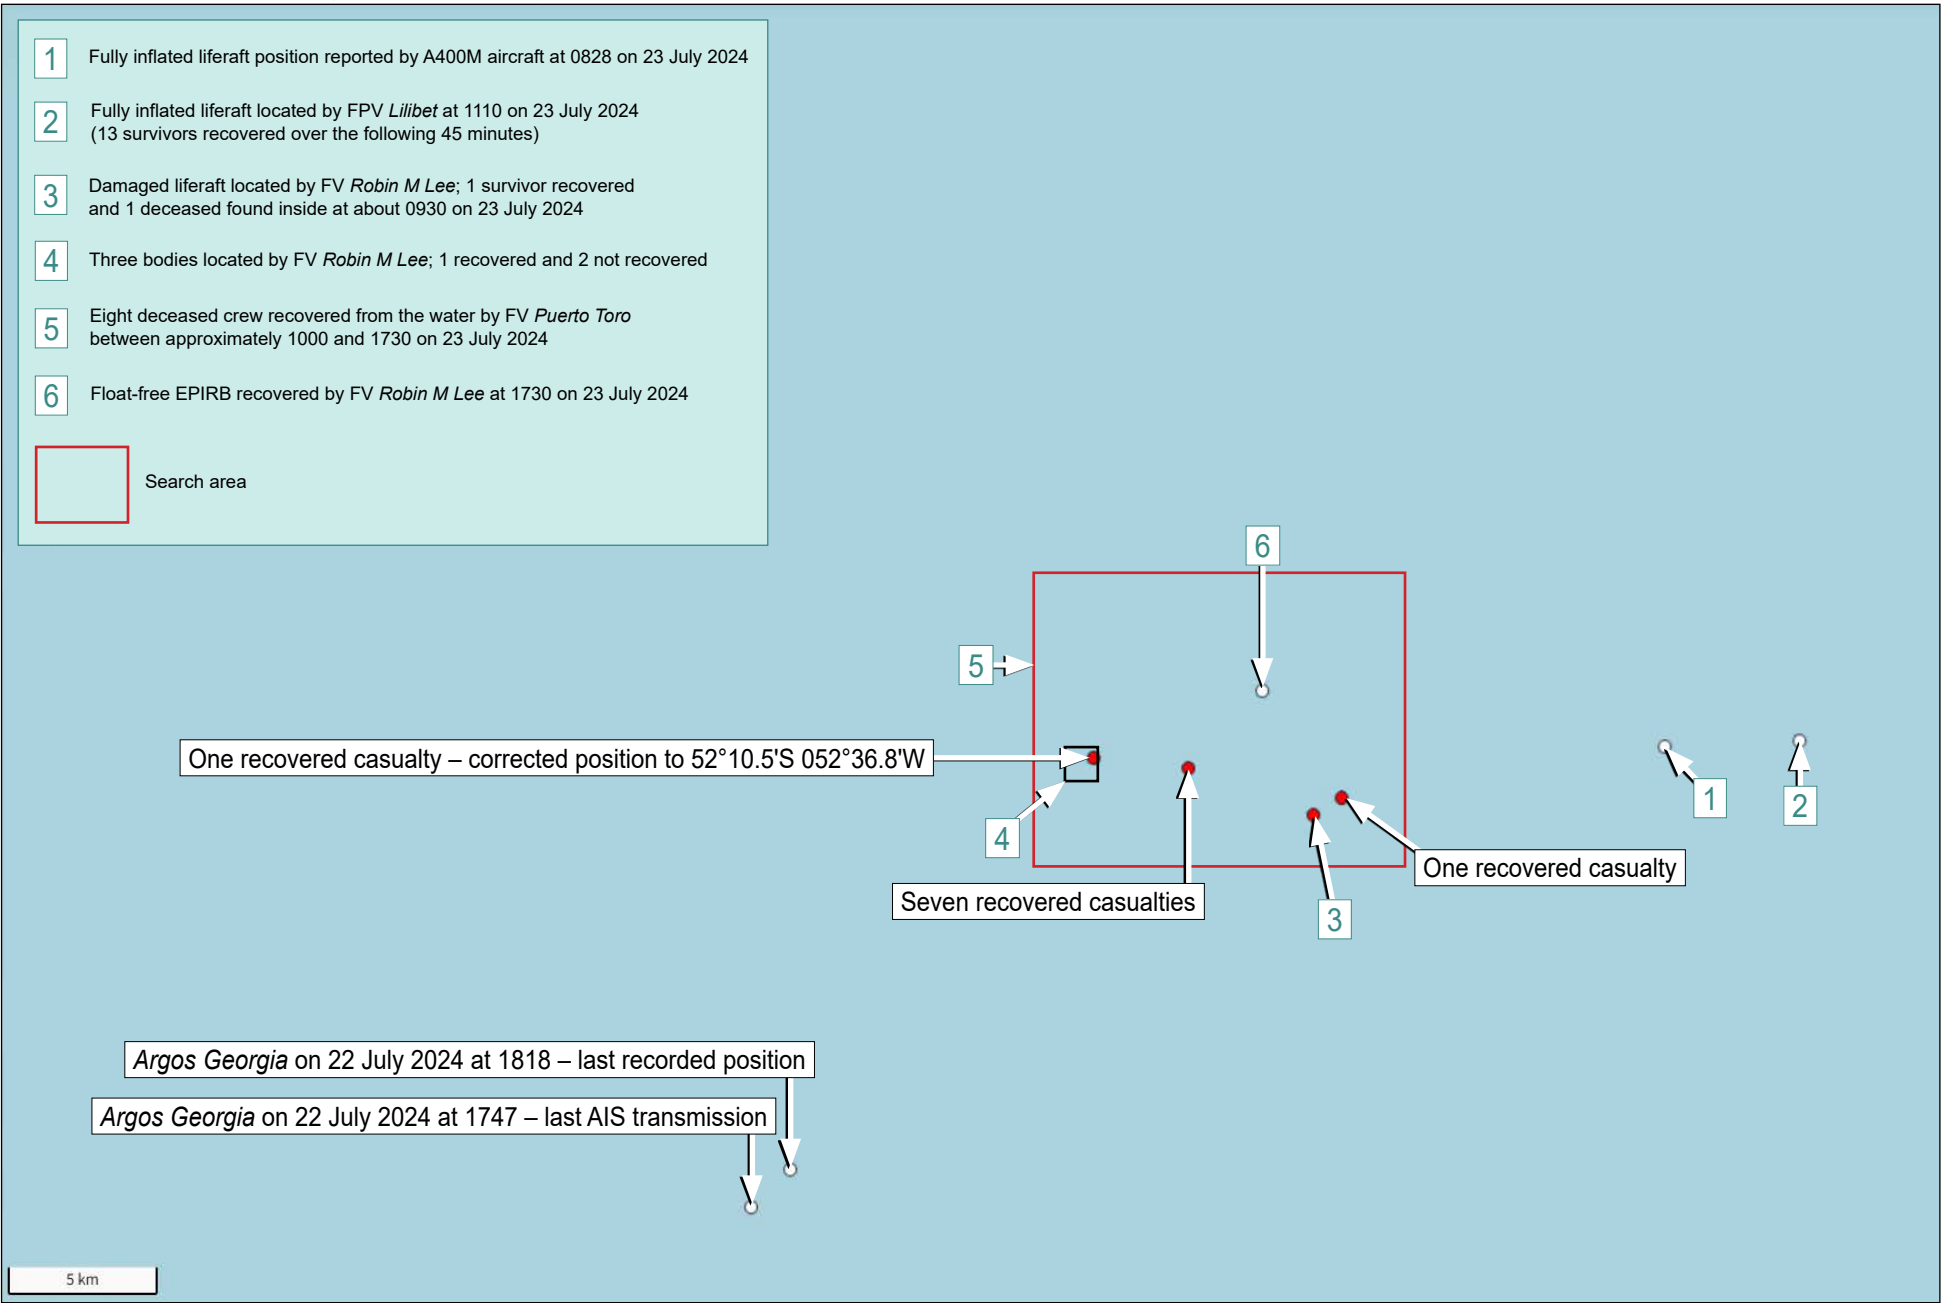
**Figure 6:** Search and rescue assets and recovery locations

At about 0534 on 23 July, FV *Robin M Lee* arrived on scene (**Figure 6**). The reported weather conditions included wind speeds of up to 75kts and a 7m to 8m swell, and the vessel's master had established communications with the RAF A330 Voyager tanker aircraft.

At 1014, FPV *Lilibet* arrived and took over as on-scene commander (OSC). By 1110, the vessel had located the fully inflated liferaft in position 52°10.2'S, 052°15.4'W (**Figure 6**). The 13 survivors were recovered from the liferaft over the following 45 minutes. The weather conditions were reported as winds of 25kts to 30kts and 10m waves. Subsequently, FIMA directed FPV *Lilibet* to handover OSC duties to FV *Robin M Lee* and return to Port Stanley with the survivors.

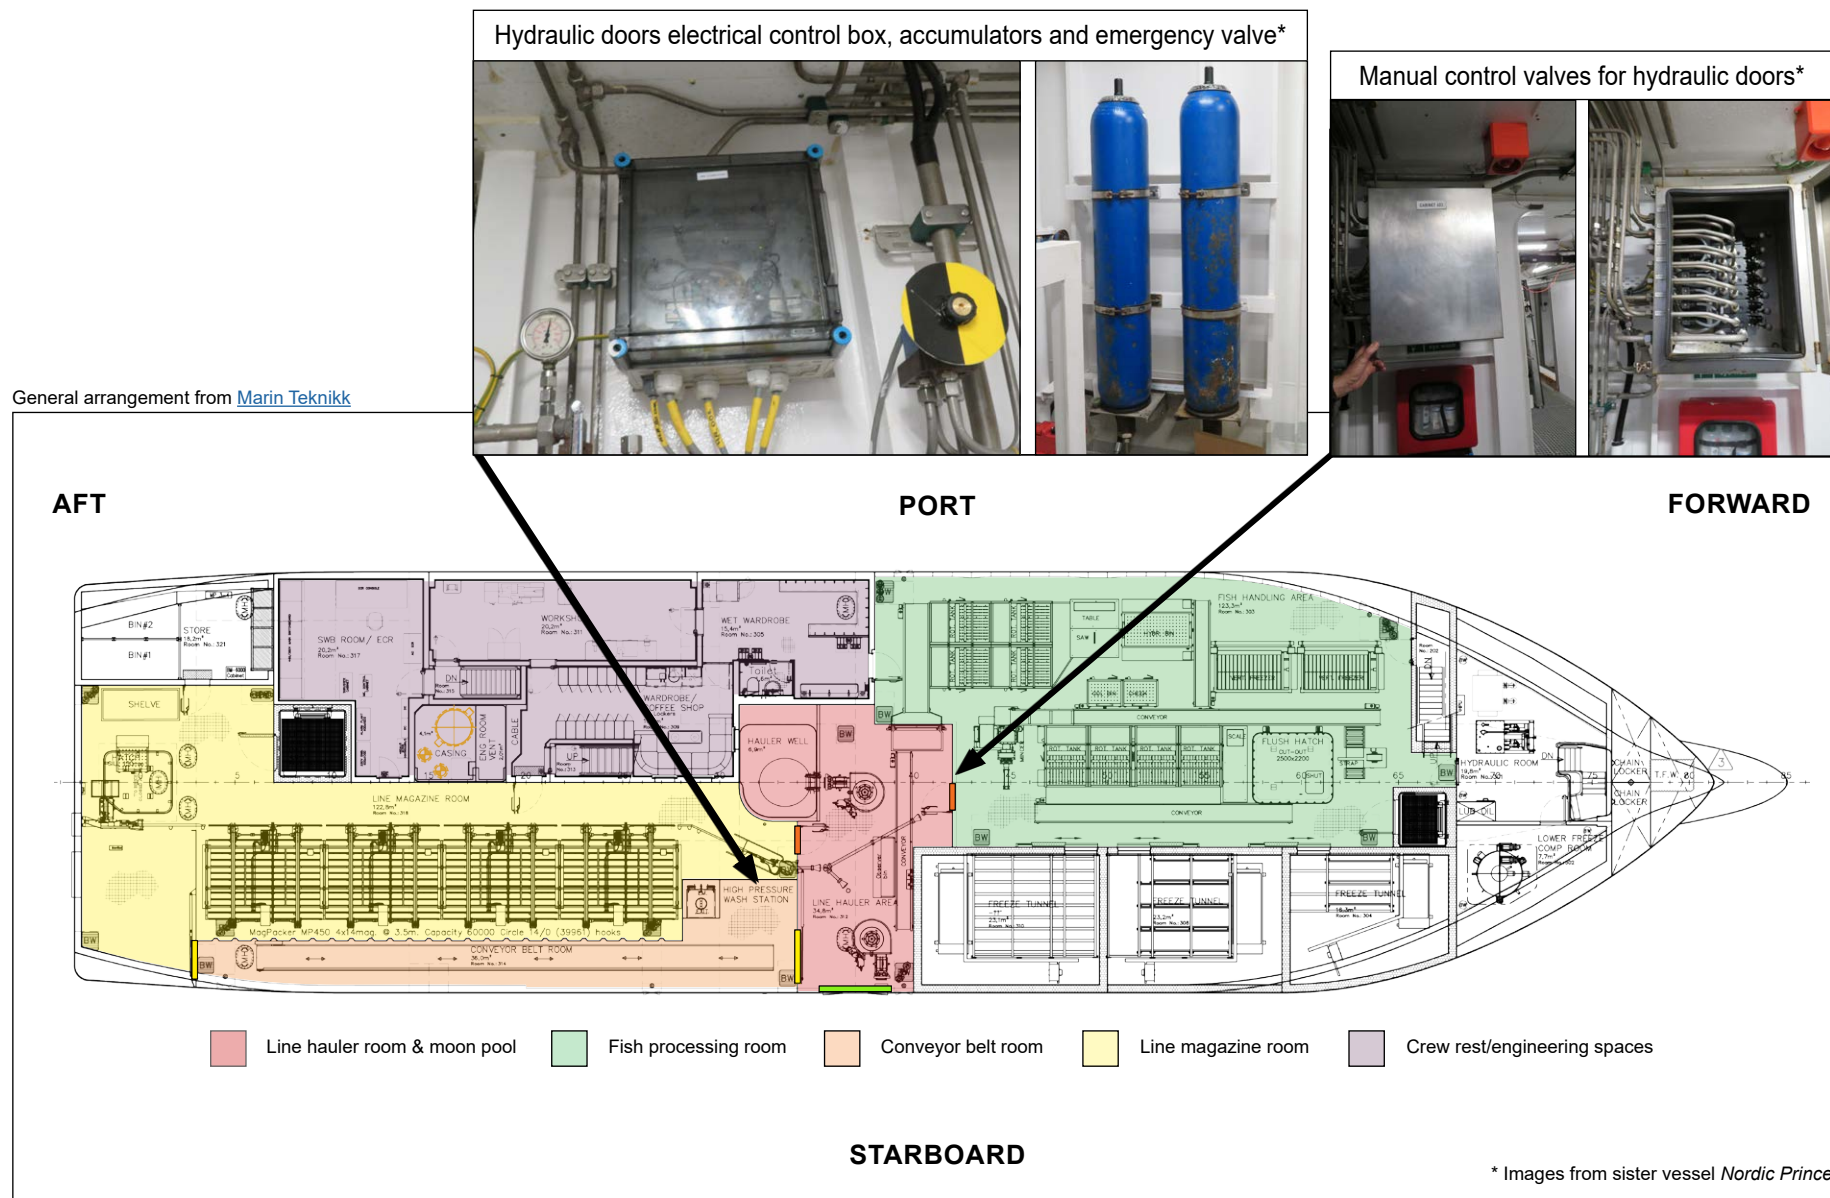
**Figure 10:** Disposition of the doors and operating controls

With the electrical system functioning, all hydraulically operated doors, hatches and main deck bilge valves could be closed from the wheelhouse using the touchscreen mimic monitor. Door status changed from red to green when closed, and the system prioritised closure in order of forward conveyor belt room door, aft conveyor belt room door, then line hauling hatch. The hydraulic door electrical control box was IP65<sup>18</sup> rated and mounted to the forward inboard bulkhead of the conveyor belt room (**Figure 10**).

The hydraulically operated doors and the line hauling hatch and stern hatches could also be closed using manually operated control valves housed in a stainless steel cabinet within the line hauler room. A separate emergency arrangement used the stored hydraulic pressure in the accumulators to close the conveyor belt room doors and the line hauling hatch directly, by manually operating an emergency valve located near the forward conveyor belt room door (**Figure 10**).
