Report on the investigation of  
the foundering of the longline fishing vessel

***Argos Georgia***

VERY SERIOUS MARINE CASUALTY

REPORT NO 19/2026

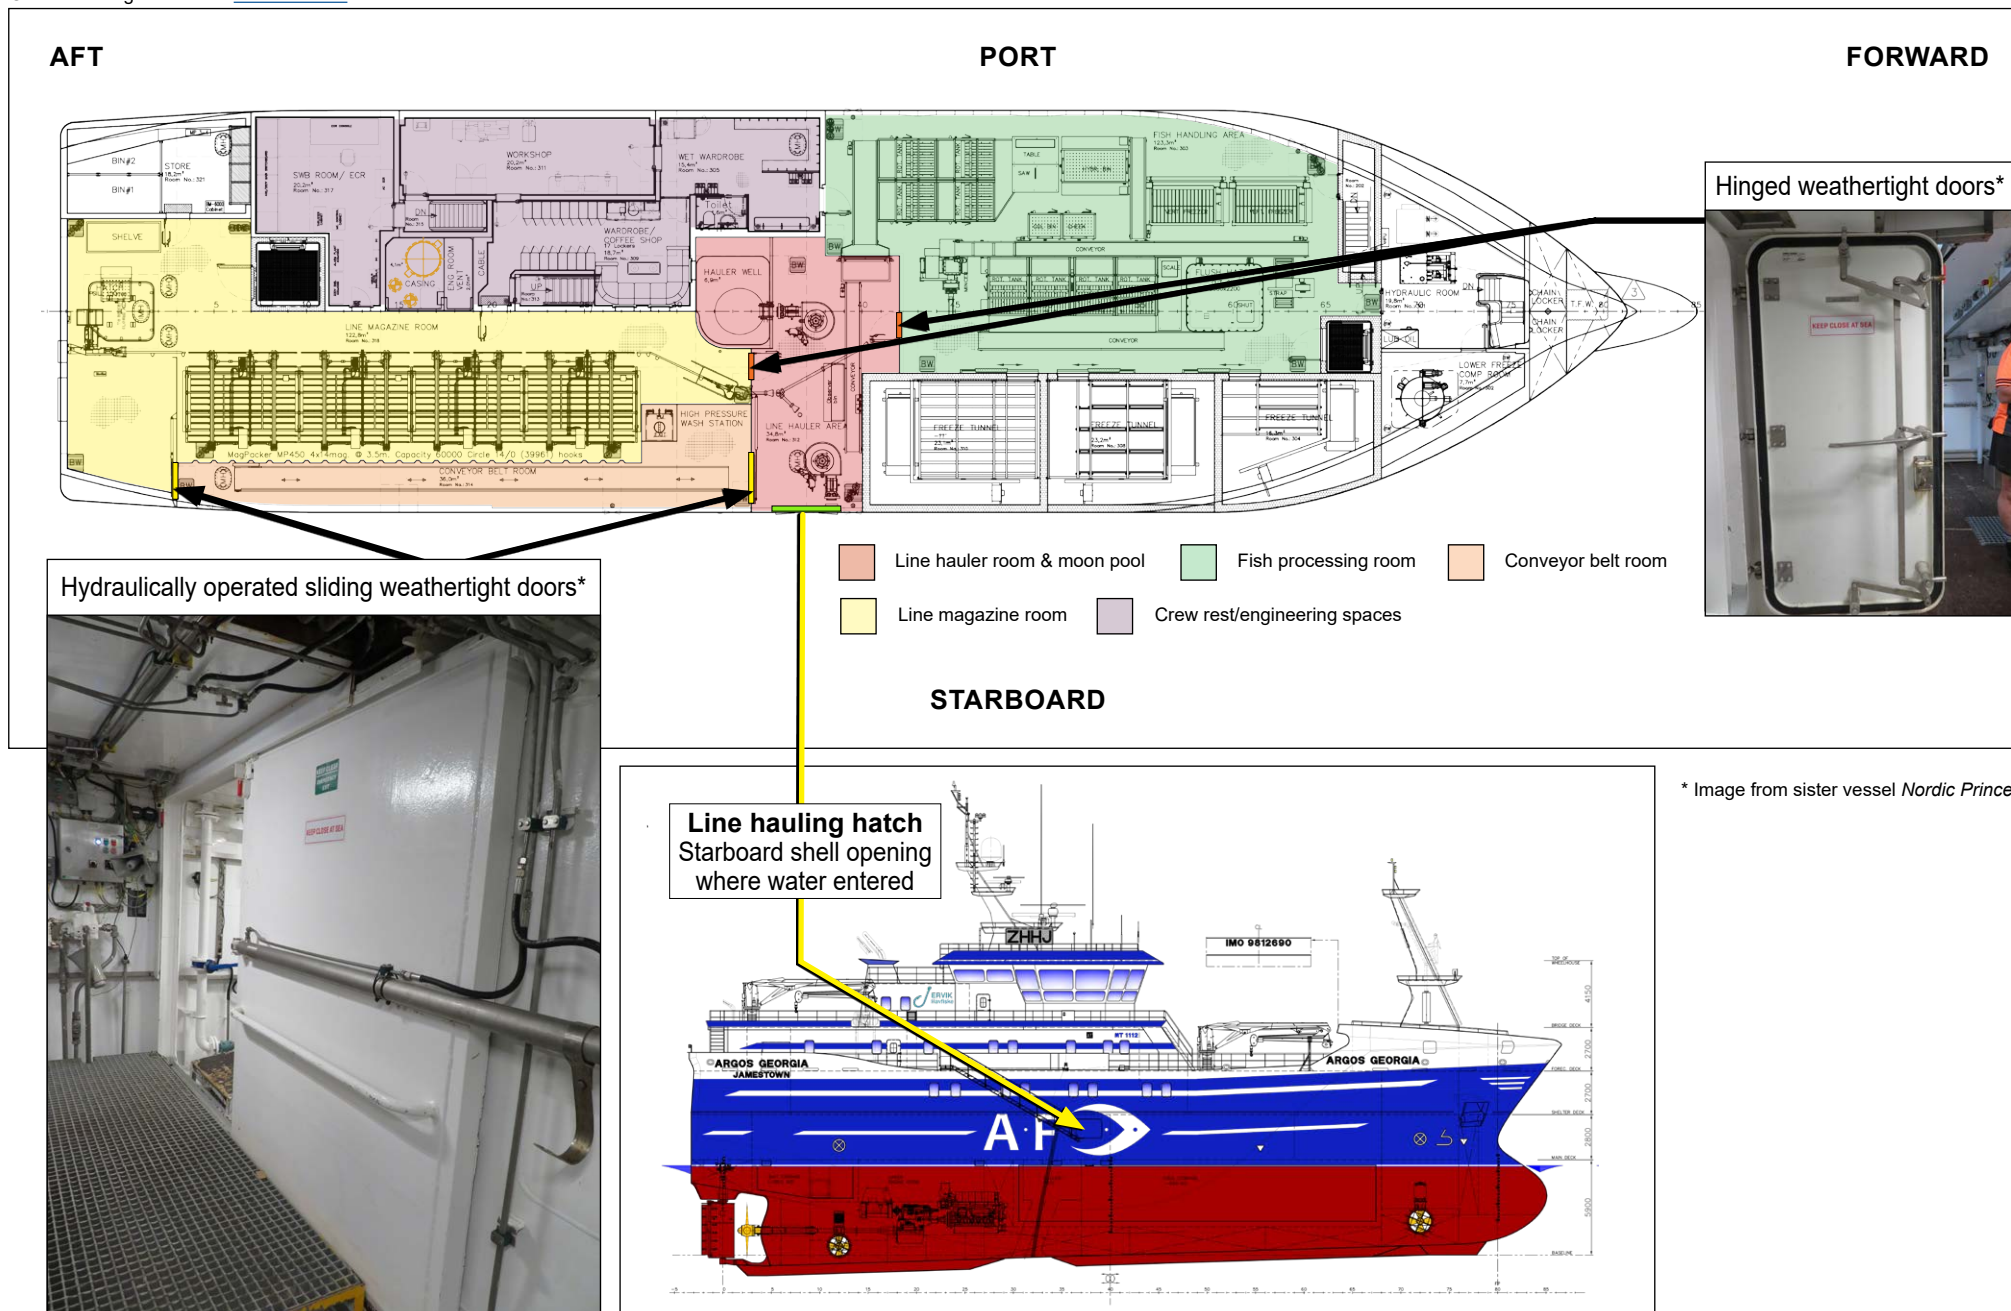
Figure 1: *Argos Georgia* main deck general arrangement

*Argos Georgia* (**Figure 1**) was a 53.85m longline fishing vessel with a 13m beam. The vessel had accommodation for 28 people, a longline fishing capacity of approximately 40,000 hooks and a cold storage volume of 655m<sup>3</sup>.

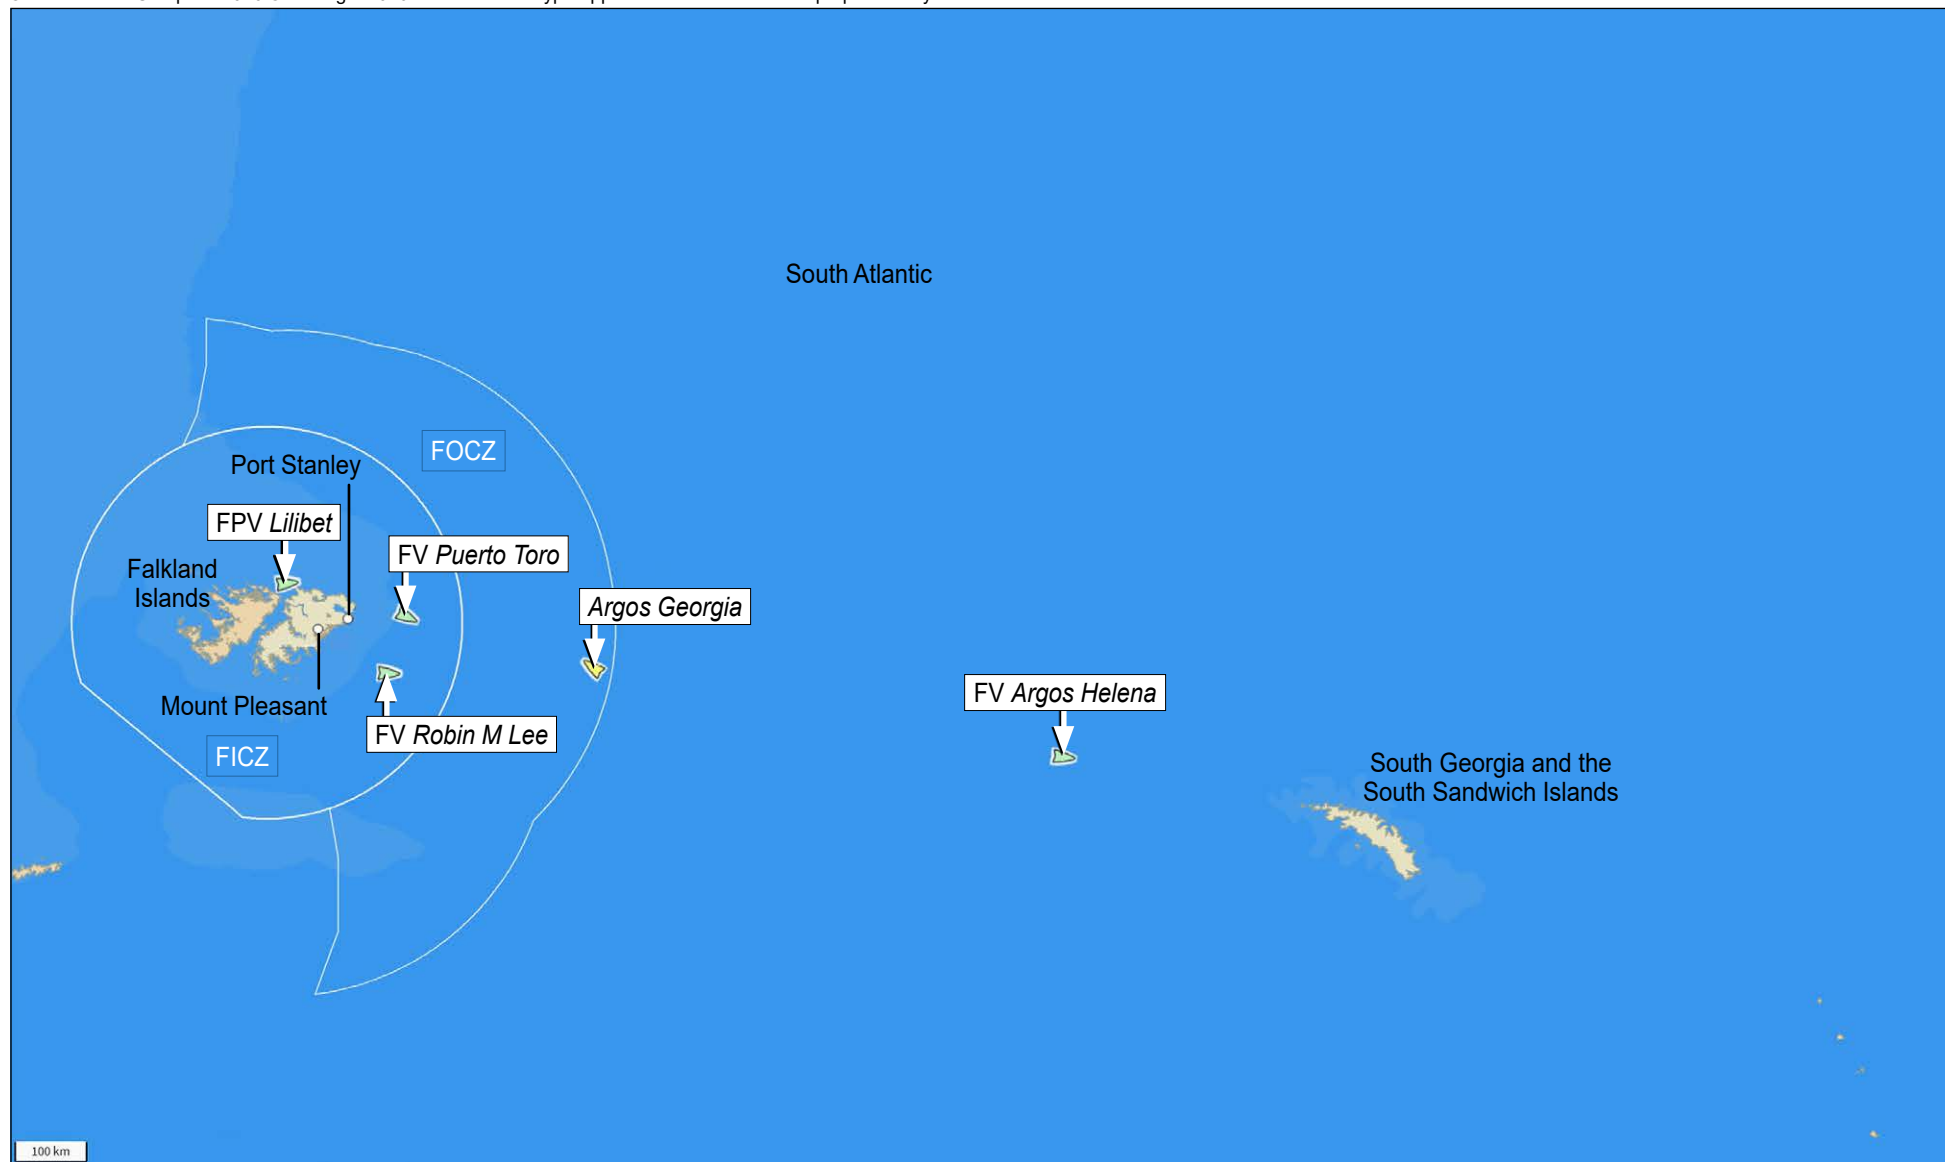
**Figure 3:** Location of accident and disposition of supporting vessels

Shortly after the 1357 WhatsApp message from *Argos Georgia*'s 2/E to *Puerto Toro*, FIMA received a phone call from Polar Seafish Ltd informing it that *Argos Georgia* had reported water ingress from the line hauling hatch and was requesting assistance. The vessel's position was 52°21.56'S, 052°49.5'W, approximately 190nm east of Port Stanley (**Figure 3**). A local weather forecast application reported westerly winds at 40kts with 8m swells.
