# Rail Accident Investigation: Interim Report

**Collision between passenger trains near Elstow,  
Bedfordshire  
19 June 2026**

# Collision between passenger trains near Elstow, Bedfordshire, 19 June 2026

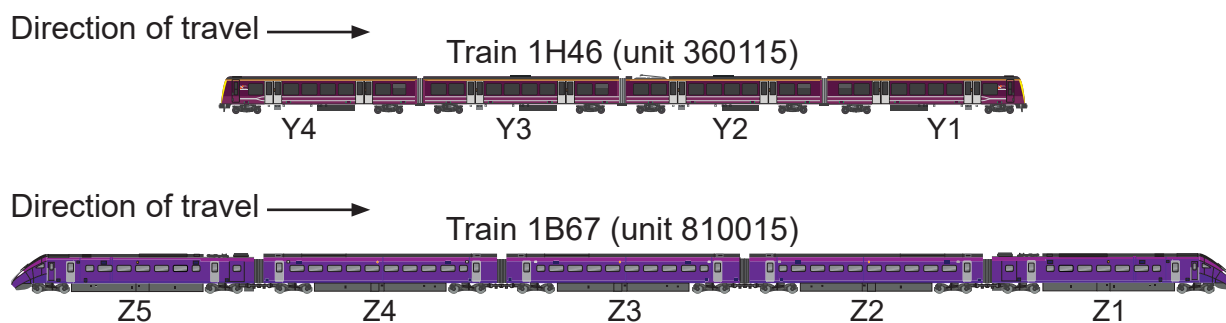
Figure 3: Formation of trains 1H46 and 1B67. The Y and Z numbering system was assigned by RAIB after the accident to assist with identifying vehicles.

- 12 Train 1B67 was formed of a five-car class 810 bi-mode multiple unit, number 810015 (figure 3). From saloon and platform CCTV footage, RAIB has so far identified 100 people as being on board this train, including eight EMR staff. This included the train's driver, who was already qualified as a driver and was undertaking additional training to drive class 810 trains, and a driver-instructor, who was with the driver in the cab at the time of the accident.

- 14 Train 1H46 was formed of a four-car class 360/1 electric multiple unit, number 360115 (figure 3). Using saloon and platform CCTV footage, RAIB has so far identified 157 people as being on board this train, including two EMR staff. These were the train's driver and the guard.
