# Rail Accident Report

## Unsafe movement of locomotives being coupled on the Bluebell Railway, East Sussex 9 August 2025

Report 11/2026  
October 2026

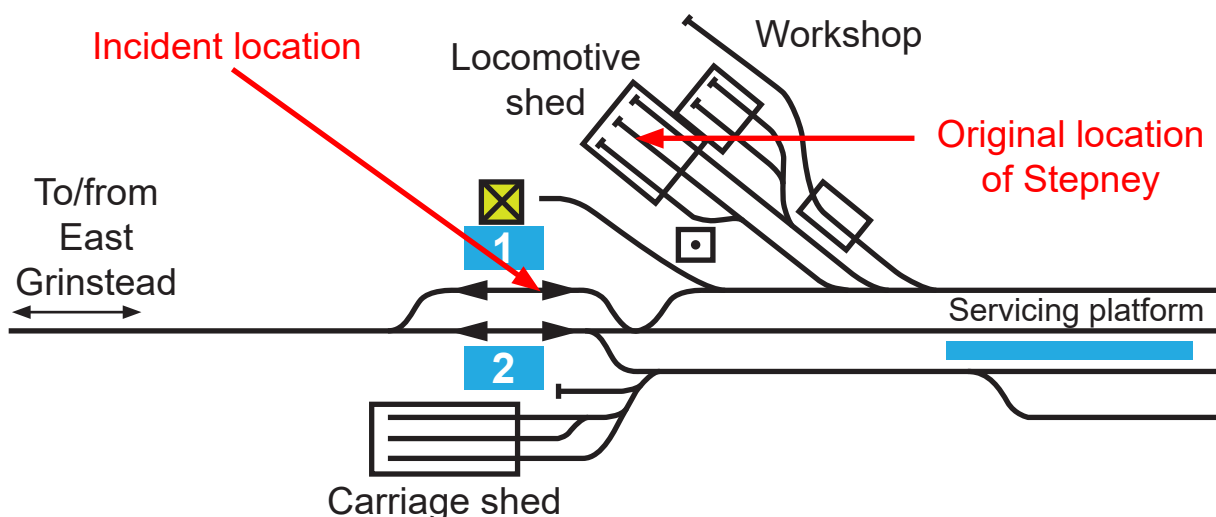
- 7 Sheffield Park station is located at the south-western end of the railway's route. It has two platforms and has connections to the nearby locomotive shed, workshop, museum and sidings. The incident occurred adjacent to platform 1 (figure 3). The track at the location where the incident occurred is straight and level.

Figure 3: Track layout showing Sheffield Park station, nearby connections, the incident location, and the original position of the locomotive 'Stepney'.

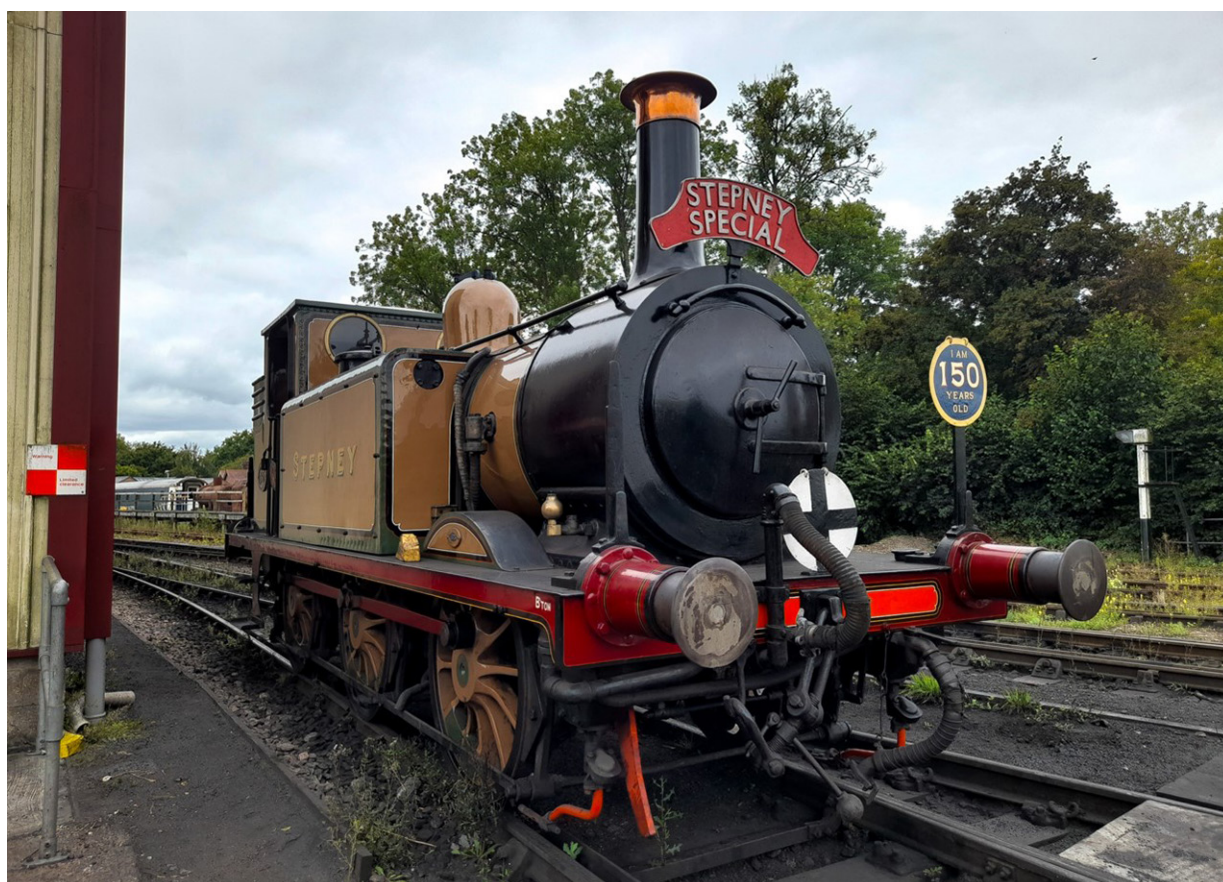
- 12 Both locomotives involved in the incident were part of the London, Brighton and South Coast Railway class A1X, commonly known as 'Terriers'. Such locomotives were built between 1872 and 1880 and were originally designed to haul passenger trains on the urban rail network of south-east London.
- 13 Locomotive No. 55, 'Stepney', arrived on the Bluebell Railway in 1960 and was the railway's first locomotive (figure 4). It had a major overhaul in 2010 but has been out of service since a steam pipe failure in 2014. The locomotive is unable to move under its own power and is normally displayed in the museum. It is fitted with a handbrake to secure it when stationary and unattended. On the day of the incident, Stepney had been hauled by Fenchurch from the shed to platform 1 for a photo shoot. It was then secured using the handbrake (see paragraph 44).

Figure 4: Stepney (courtesy of James Cummins).

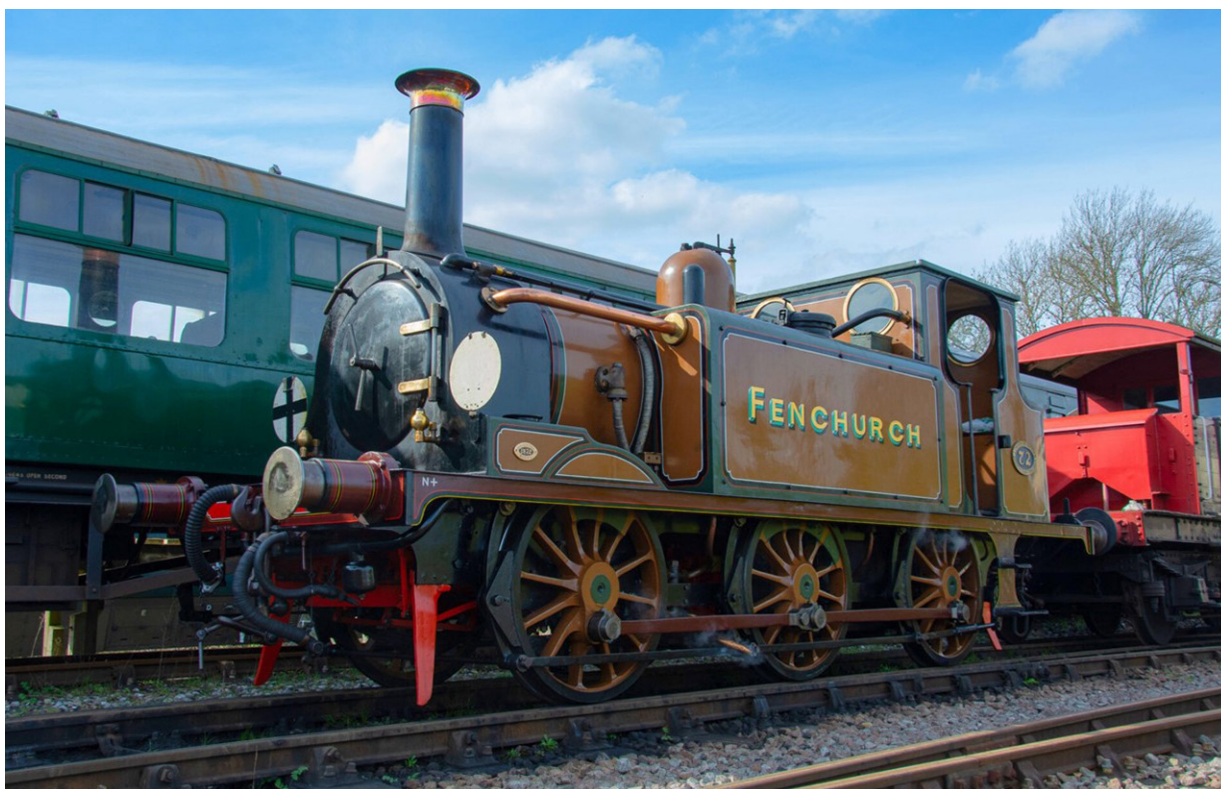
- 14 Locomotive No. 72, 'Fenchurch', has been based at the Bluebell Railway since 1964, undergoing major overhauls in 2001 and 2022 (figure 5). While the locomotive itself is equipped only with air-operated brakes, it is fitted with vacuum-brake equipment to operate the railway's coaching stock (see paragraph 42).

Figure 5: Fenchurch (courtesy of James Cummins).

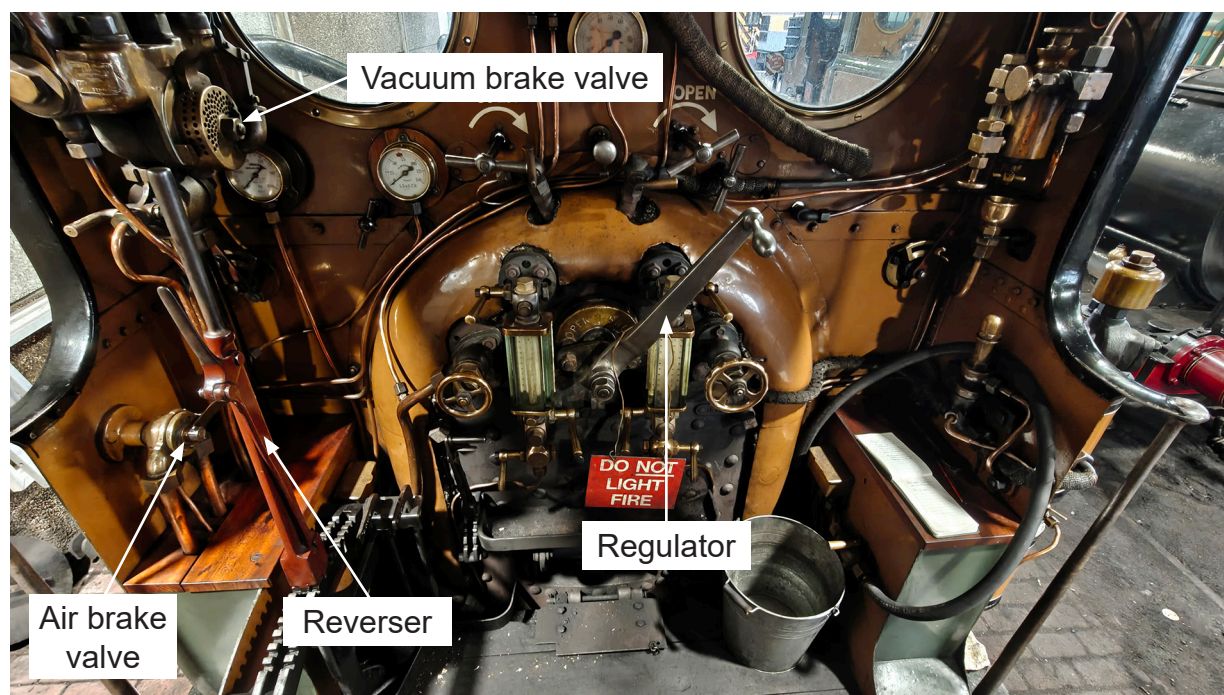
- 34 The controls of steam locomotives can vary significantly between individual types and designs. However, there are several controls which are common, including some which are relevant to this investigation (figure 6).

Figure 6: The controls on Fenchurch.

- 42 Fenchurch is fitted with air brakes. A steam-driven pump provides compressed air to the air brake valve in the driving cab. The air brake valve, operated by the driver (figure 6), allows this compressed air to be supplied to a brake cylinder on the locomotive which in turn applies the brake blocks to the wheels by means of mechanical linkages. As with the vacuum braking system, the locomotive can provide air to other vehicles via the automatic air brake pipe. With the brakes released, this pipe is pressurised and a loss of air pressure causes the brakes to apply, again providing a fail-safe function. This loss of pressure can occur if vehicles separate unintentionally, or if an air brake pipe cock (located on the automatic air brake pipes at the front and rear of the locomotive) is opened, venting the air to atmosphere.
