## Accident

| <b>Aircraft Type and Registration:</b> | Zenair CH 601HDS, G-CHZS | |
| <b>Location:</b> | Tatenhill Airfield, Staffordshire | |

## Synopsis

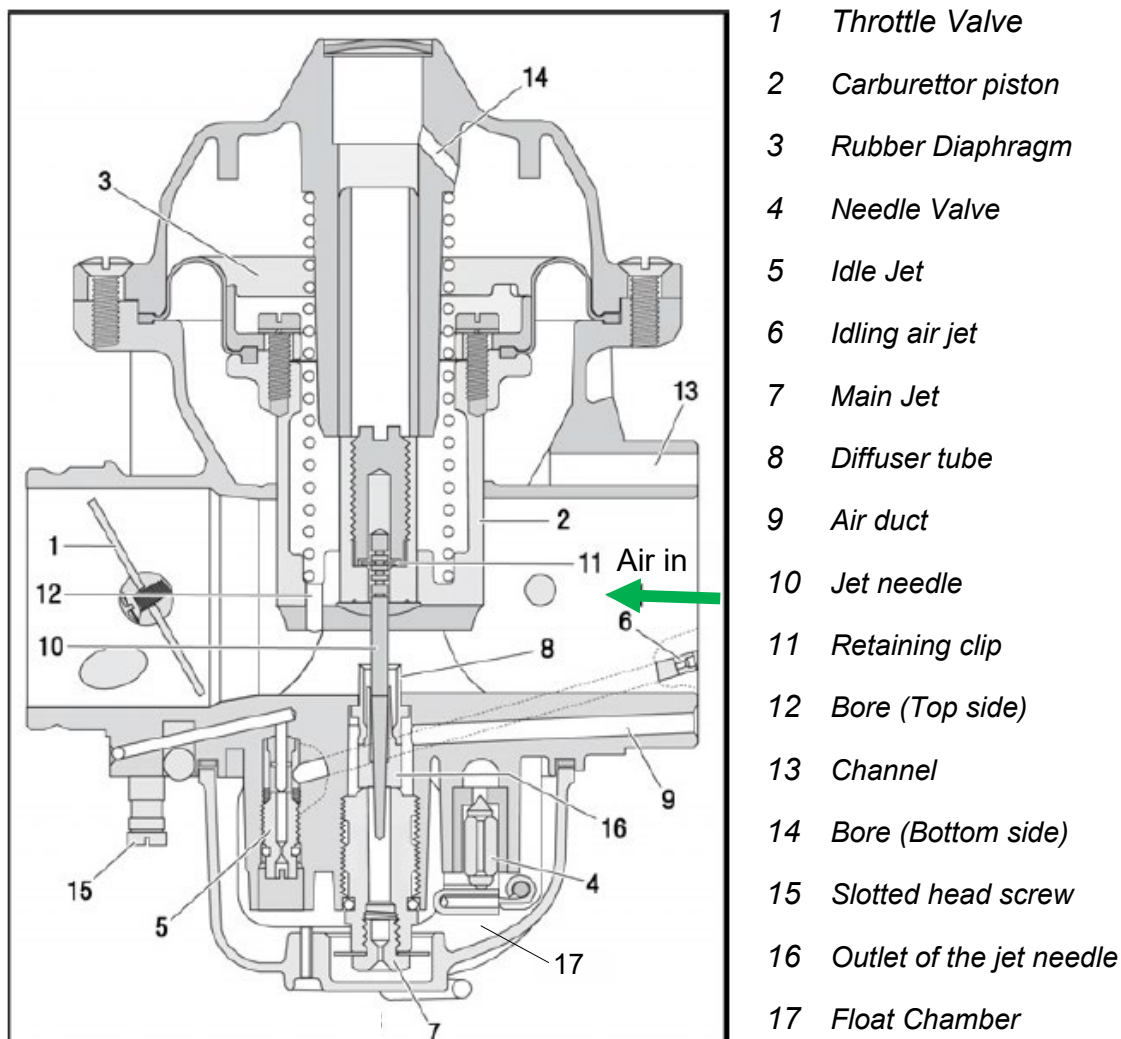
Figure 6

A carburettor piston which is suspended from a rubber diaphragm, is seated inside a venturi in the body of the carburettor, (Figure 6). During engine operation, when the pilot opens the throttle, it in turn, opens the throttle valve. The volume of fuel-air mixture drawn in by the engine is determined by the cross-sectional area of the venturi. When the throttle valve opens, the airflow in the venturi increases and causes a vacuum build up at the outlet of the jet needle. The vacuum in the venturi also acts on the top side of the diaphragm via the topside bore in the carburettor piston and lifts the piston against its own weight and the piston spring. Attached to the piston is the jet needle and as the piston rises the needle lifts out of the jet, the annular opening increases and more fuel is drawn up from the float chamber by the increased suction caused by the vacuum at the jet needle outlet. Lifting the piston also increases the area of the venturi, which in turn reduces both the vacuum pressure and the air flow restriction until a balanced fuel-air flow rate is achieved at the new throttle setting. The adjusting piston causes the pressure drop to remain almost constant (hence the term 'constant depression'). The reference pressure for the piston is created by ambient air which is applied to the underside of the diaphragm via the bottom side bore.

Carburettor cross-section diagram<sup>1</sup>

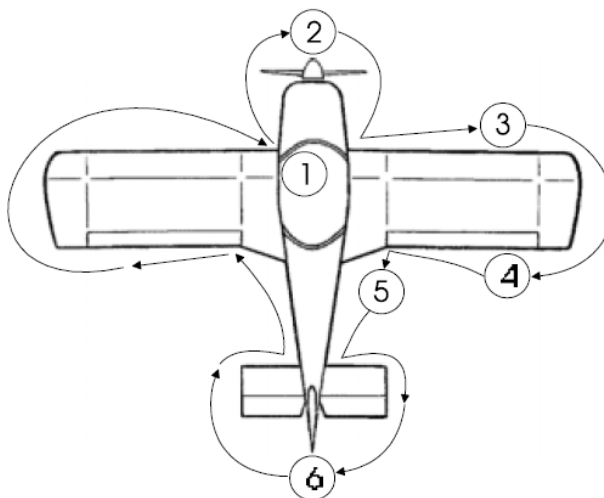
**Figure 13**

The walk around list provided with the aircraft paperwork (Figure 12) was the previous owner's mind-map of the pre-flight checks he needed to conduct. It did not reflect the Zenair CH 601 Pilot's Operating Handbook pre-flight inspection 'walk around' (Figure 13) and omitted the requirement to check the fuel drains and gascolator for the presence of water.

Zenair CH 601 Pilots Operating Handbook walk round guide
