# ***AAIB Bulletin***

# ***10/2026***

Published: 8 October 2026.

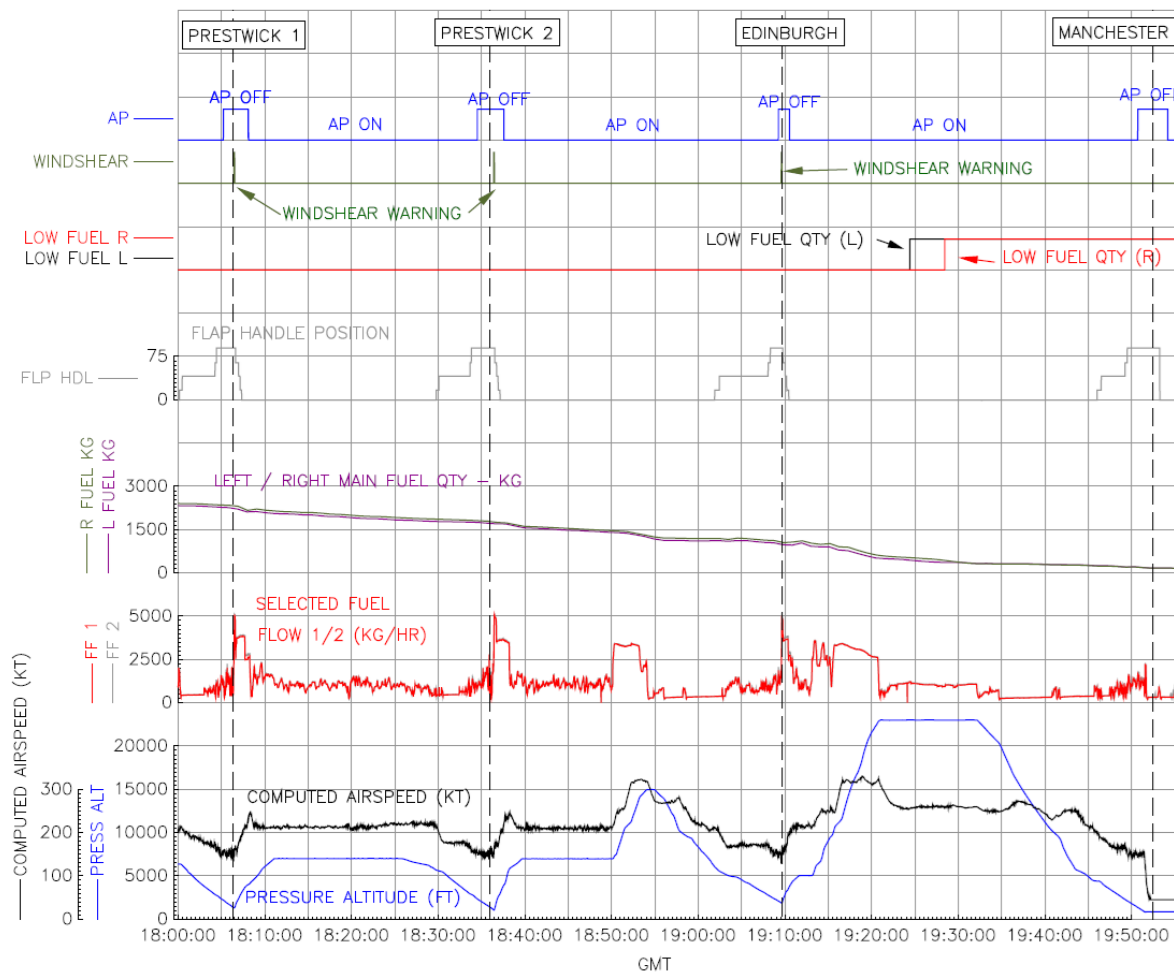
**Figure 6**

ATC cleared the aircraft to land at Prestwick Airport Runway 20, passing the wind conditions of 250° at 29 kt. The controller continued to pass the instant wind conditions as the aircraft continued the approach, the last of which was 250° at 40 kt. At 1806:27 hrs when 0.7 nm from the runway threshold at 215 ft agl, a windshear warning was recorded on the CVR and FDR and the flight crew performed a go-around. At the time, recorded fuel quantity was approximately 4,608 kg<sup>5</sup> (Figure 6).

9H-QBD Flight Data for the four approaches

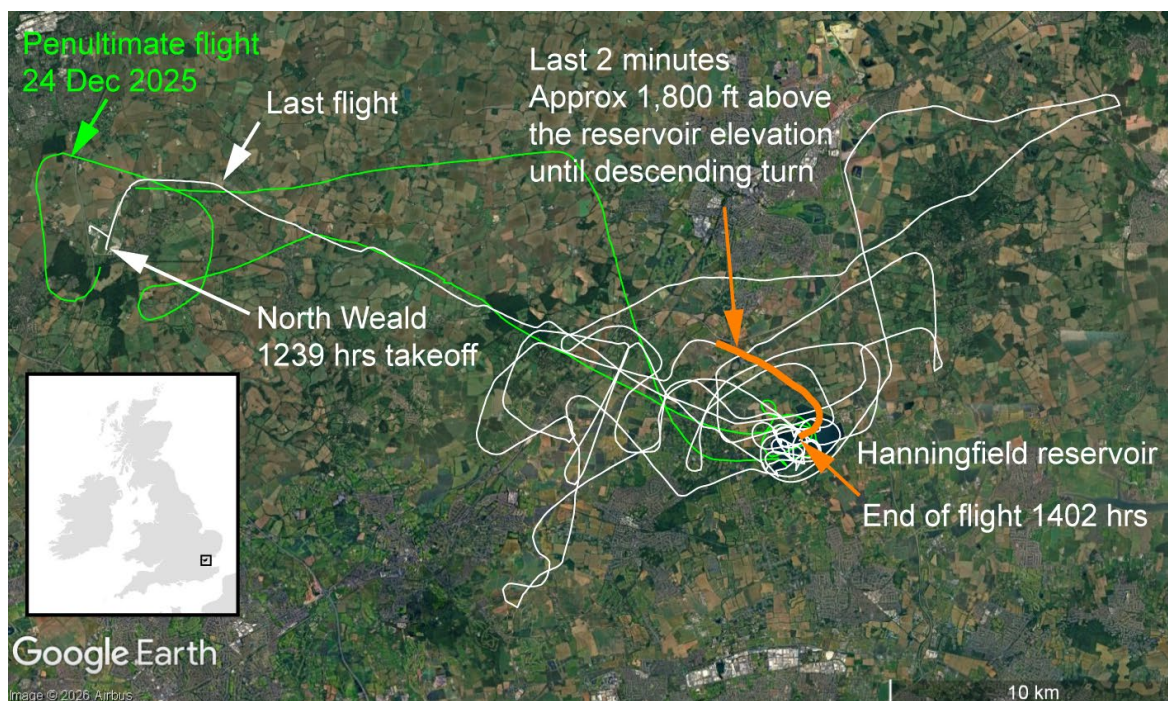
**Figure 1**

Aircraft's flight path on 24 and 28 December 2025

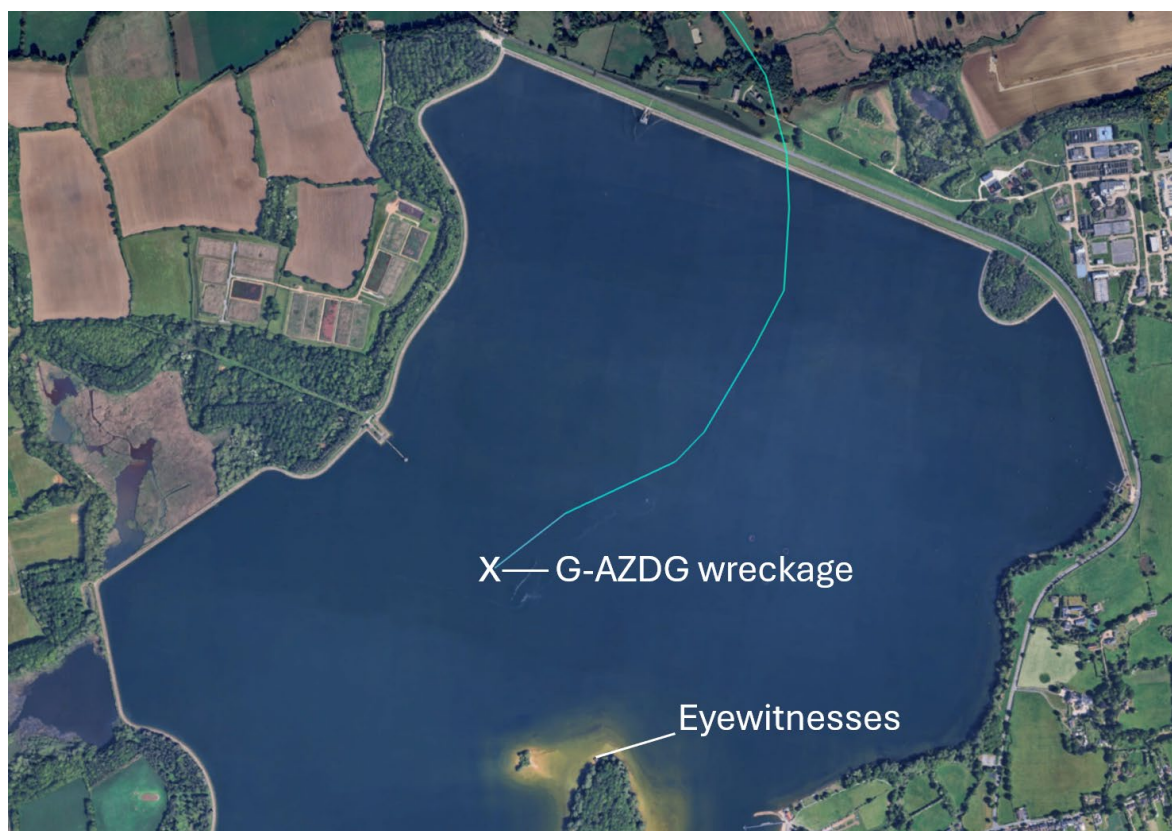
**Figure 2**

The aircraft wreckage was found on 30 December 2025 using side-scan sonar and police divers. It was submerged at a depth of about 6 m near the centre of Hanningfield Reservoir (Figure 2).

Wreckage and eyewitnesses' location with final flight path from recorded tracking services  
© Google Earth, Image © Airbus

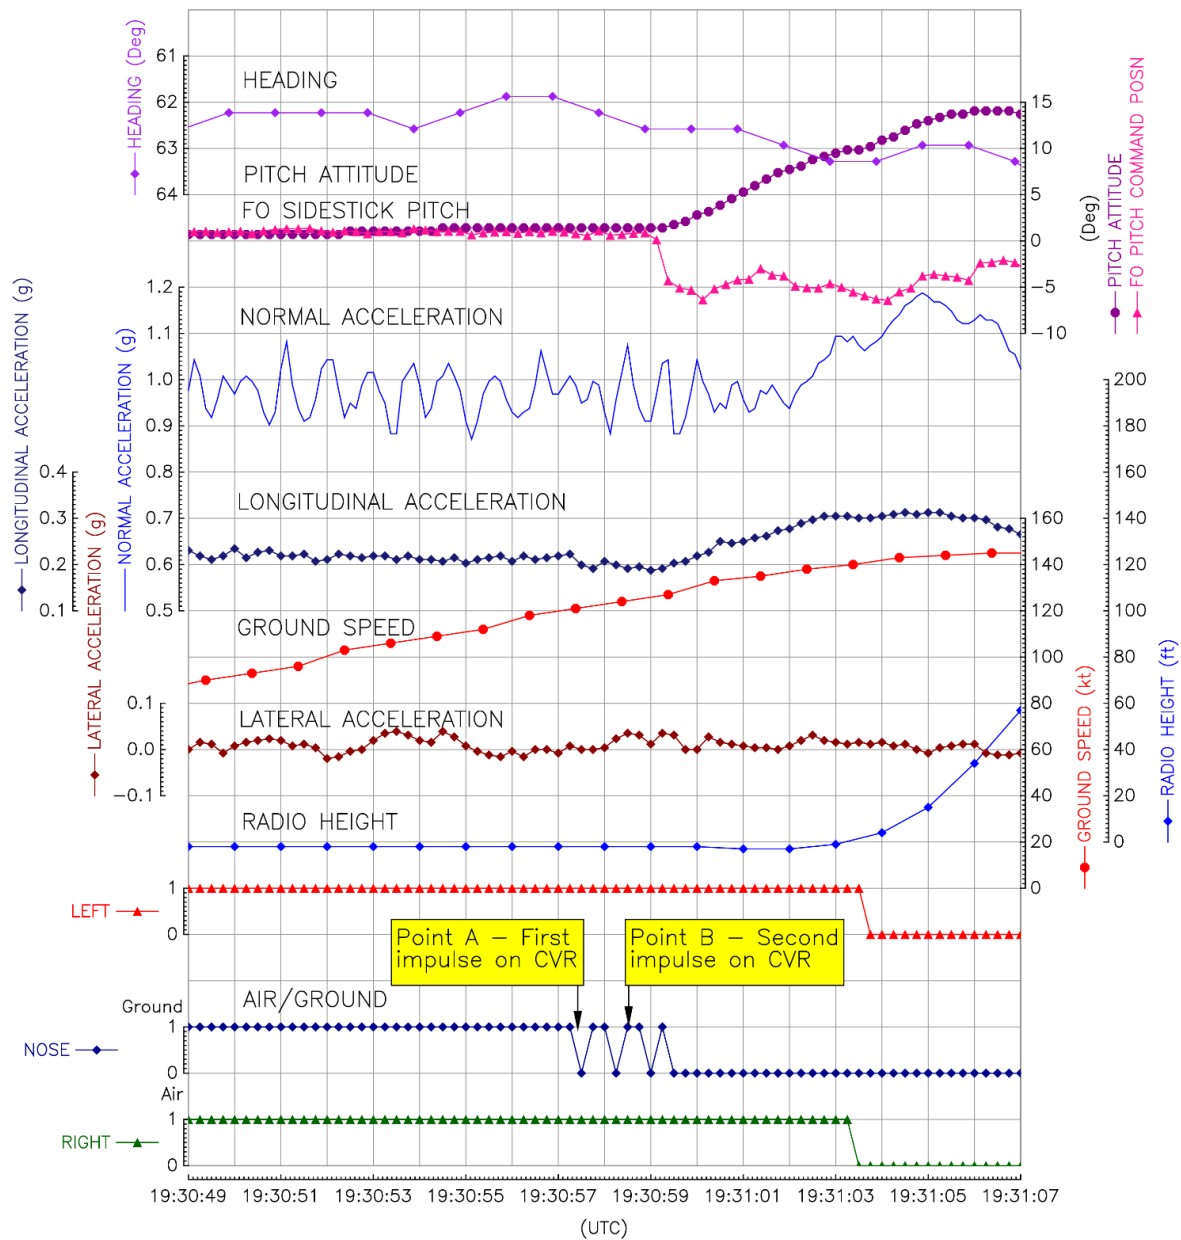
The taxi out to the runway and initial takeoff roll appeared normal. As the aircraft accelerated along the runway, rhythmic sound pulses were recorded on the CVR cockpit area microphone (CAM), which were consistent with one of the NLG tyres contacting the runway centreline lights. As the aircraft reached a ground speed of about 118 kt (an airspeed of 128 KCAS), the amplitude of one of the sound impulses increased (Figure 1 and Figure 2 - Point A). This coincided with the aircraft's NLG squat switch (recorded at an update rate of four samples per second) starting to oscillate quickly back and forth between its GROUND and AIR indication. One second later (Figure 1 and Figure 2 - Point B), there was a further short duration sound impulse, which was of sufficient intensity to be captured by the CAM and the pilot's headset hot-microphones<sup>6</sup>. Less than one second after this, the aircraft's airspeed reached  $V_R$  and the PF applied aft stick, rotating the aircraft into the climb.

**Figure 1**  
Relative timing of CVR sounds during takeoff roll
