APPENDIX B

PHOTOGRAPHS

Boeing 747 - 121 Leading Dimensions

Figure B-1

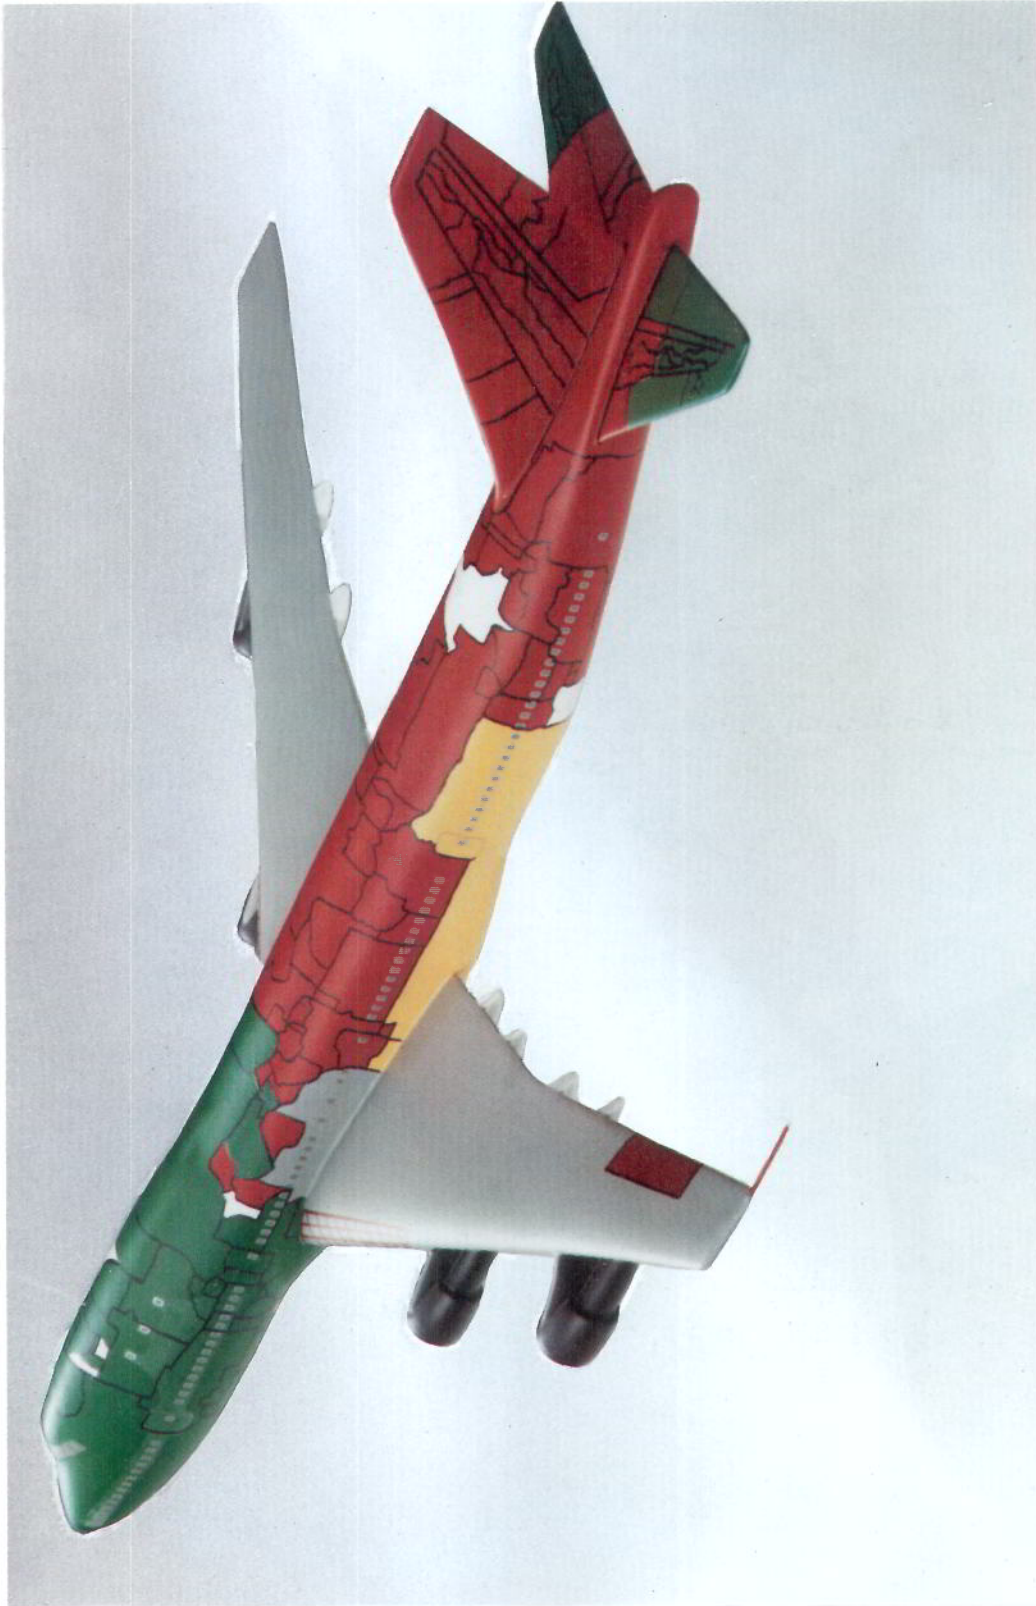
Figure B-5

Model showing fuselage and tail surface fracture lines
(colour coded to show location of items on the ground)

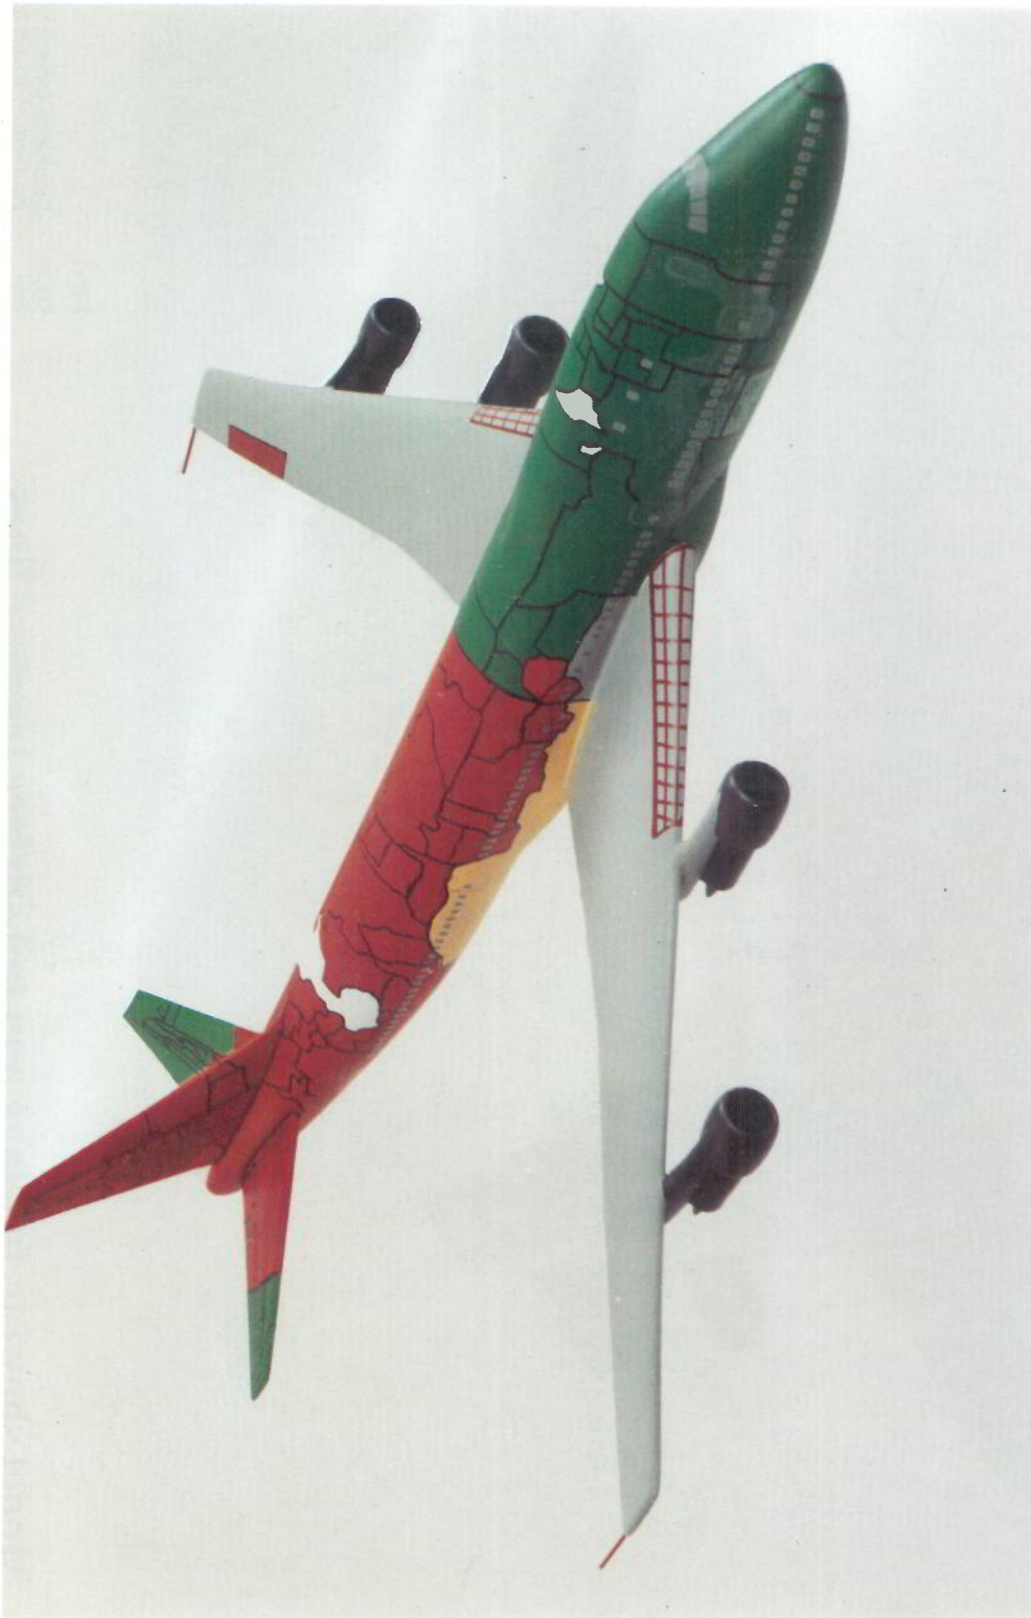
Figure B-6

Model showing fuselage and tail surface fracture lines
 (colour coded to show location of items on the ground)

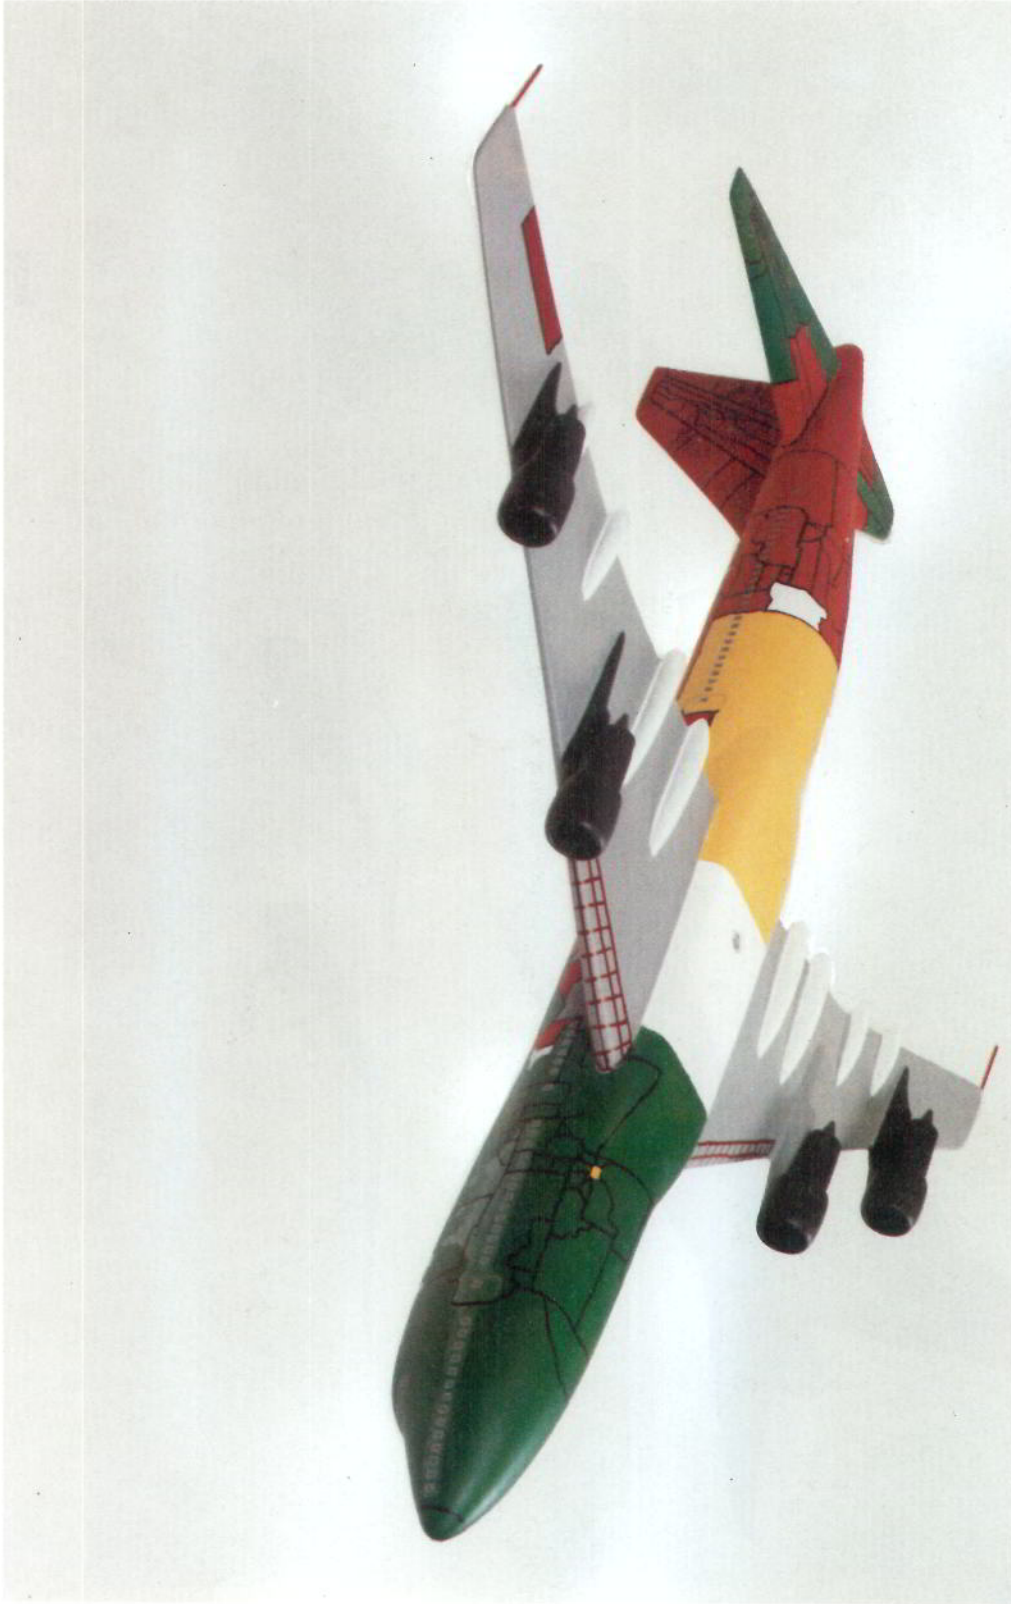
Figure B-7

Model showing fuselage and tail surface fracture lines
(colour coded to show location of items on the ground)

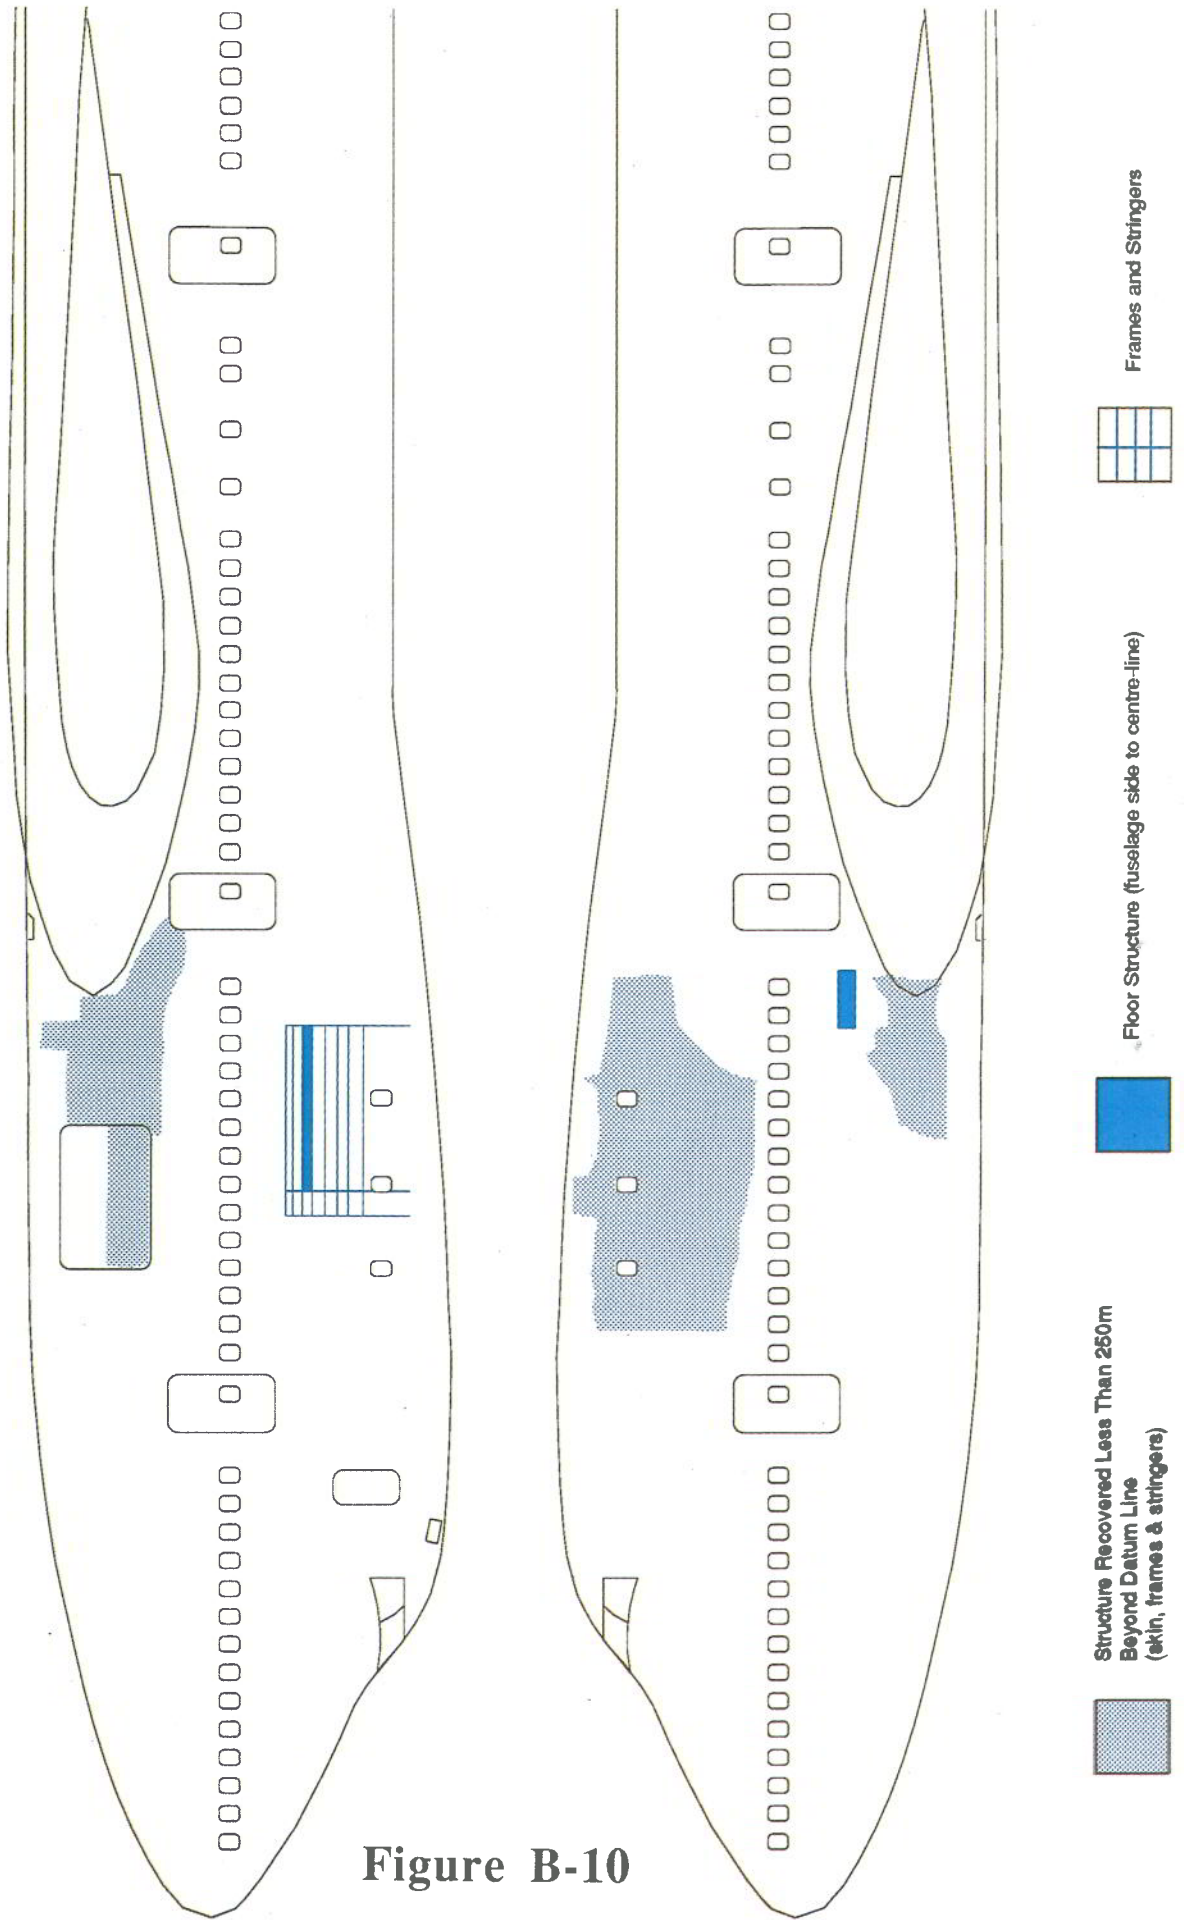
Figure B-10

Distribution of Major Wreckage Items Located in Southern Trail.

Structure Recovered Less than 300m Beyond Datum Line

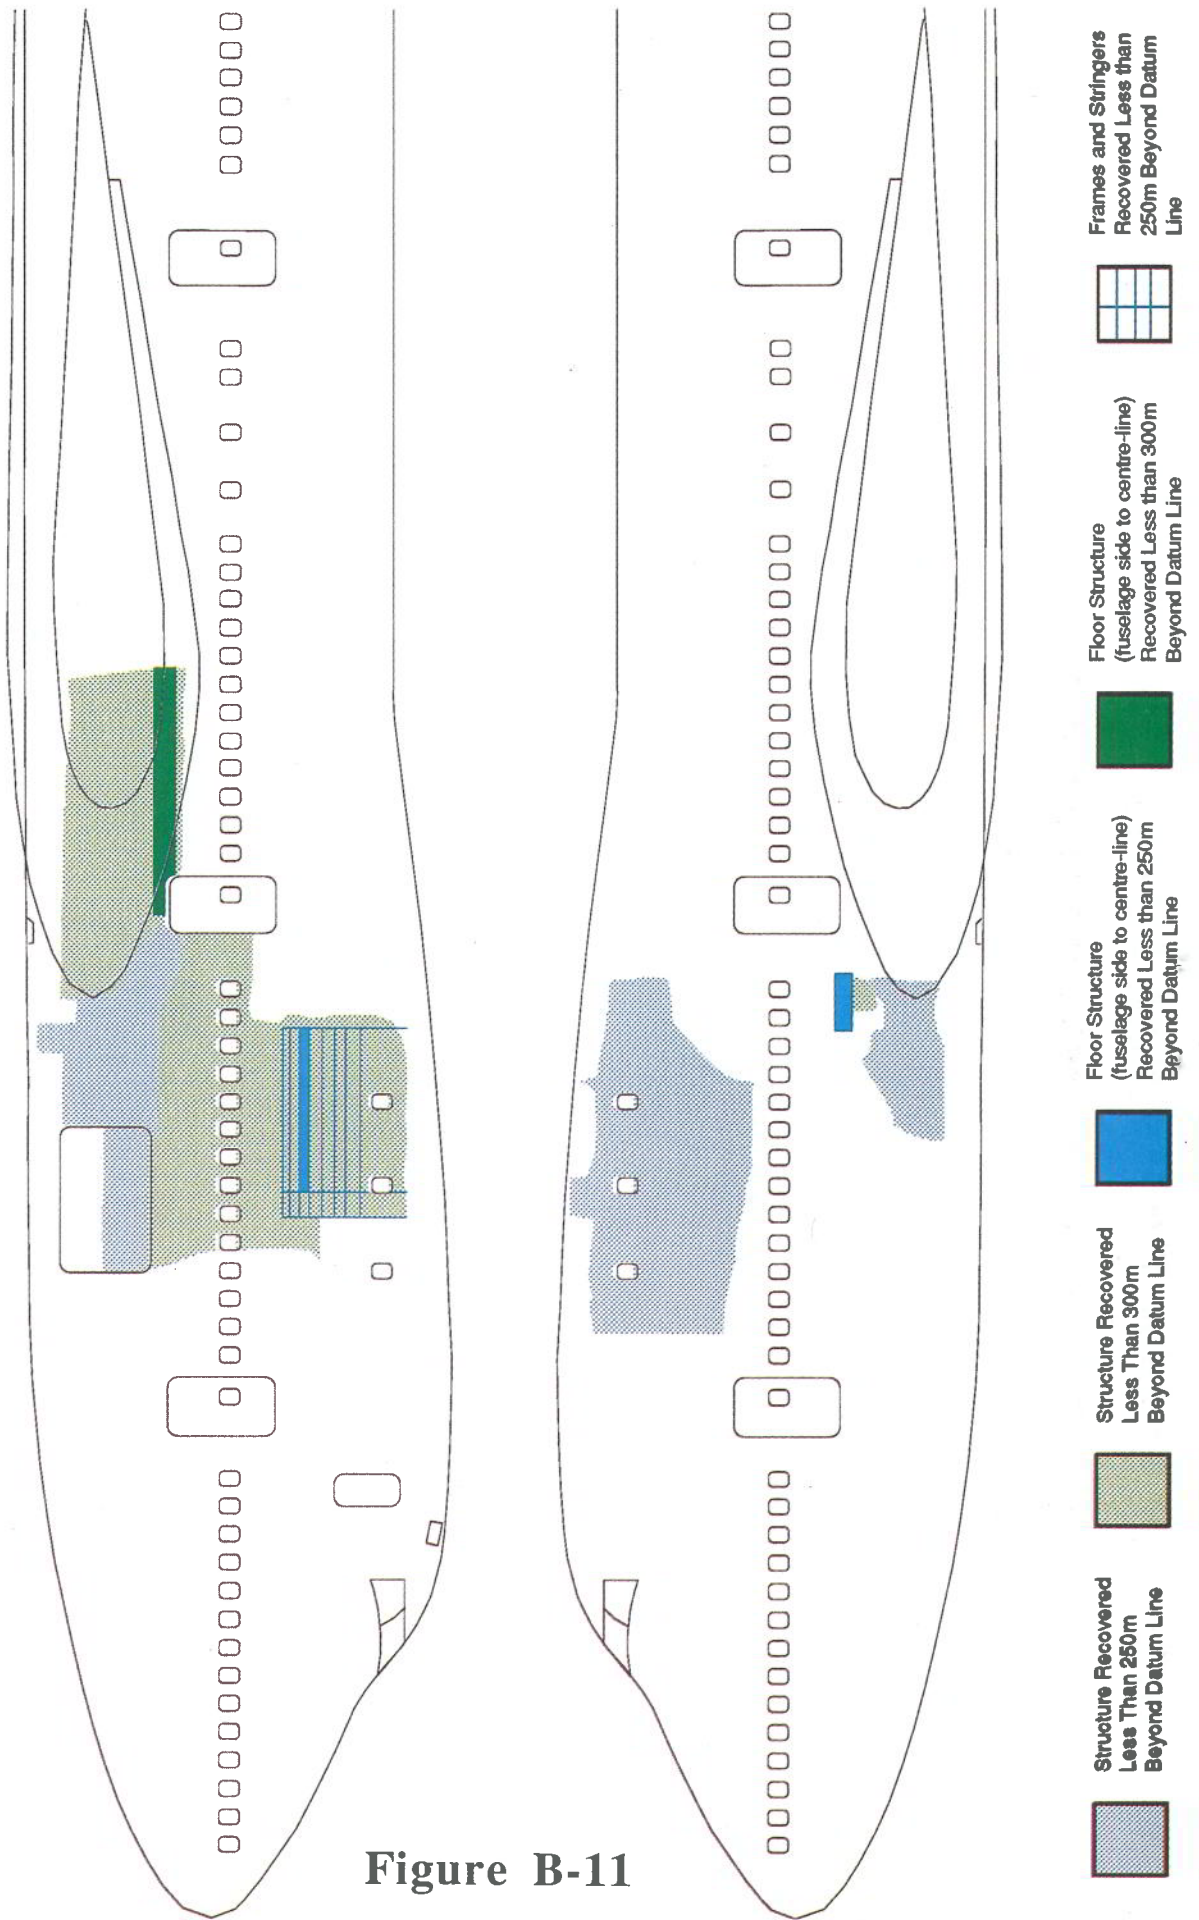
Figure B-11

Distribution of Major Wreckage Items Located in Southern Trail.

Structure Recovered Less than 600m Beyond Datum Line

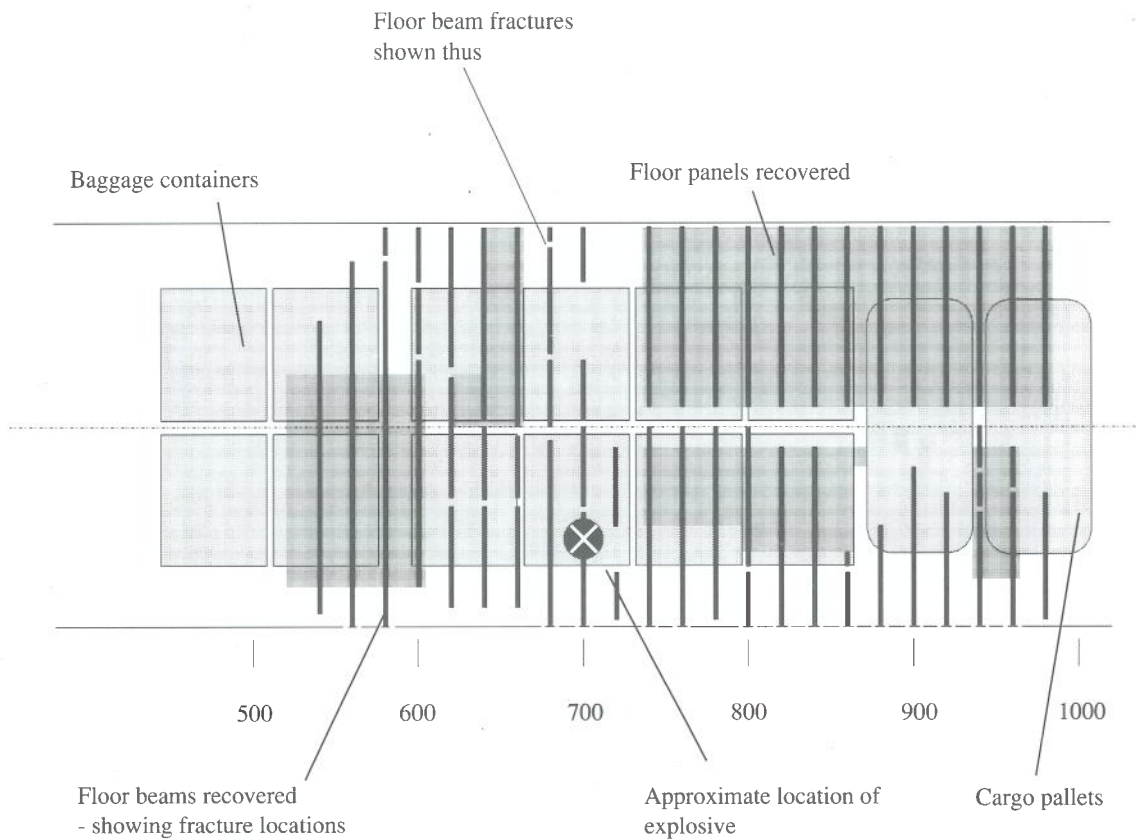
Figure B-18

Plot of floor damage in area of explosion
 (structure & floor panel details based on those items recovered, identified, and incorporated into the three-dimensional reconstruction)

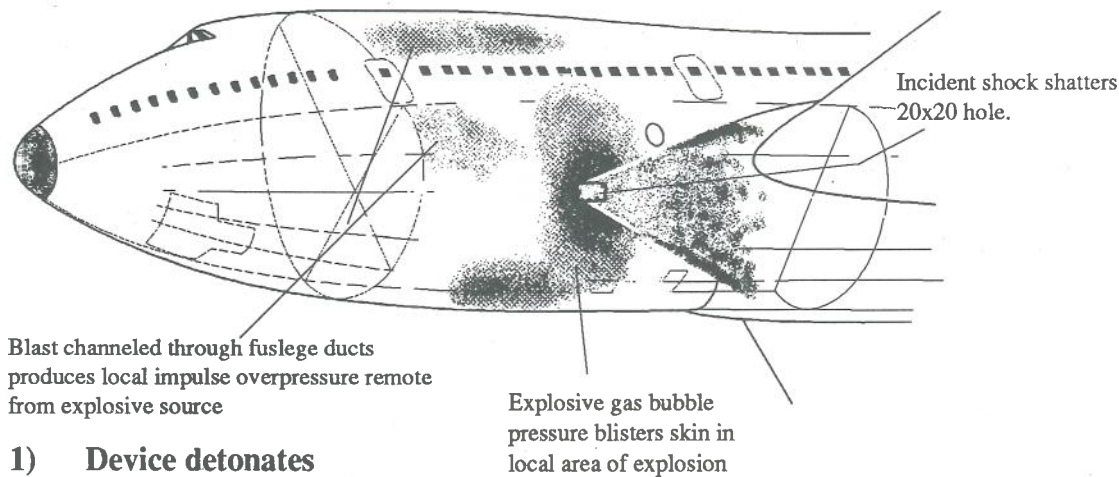
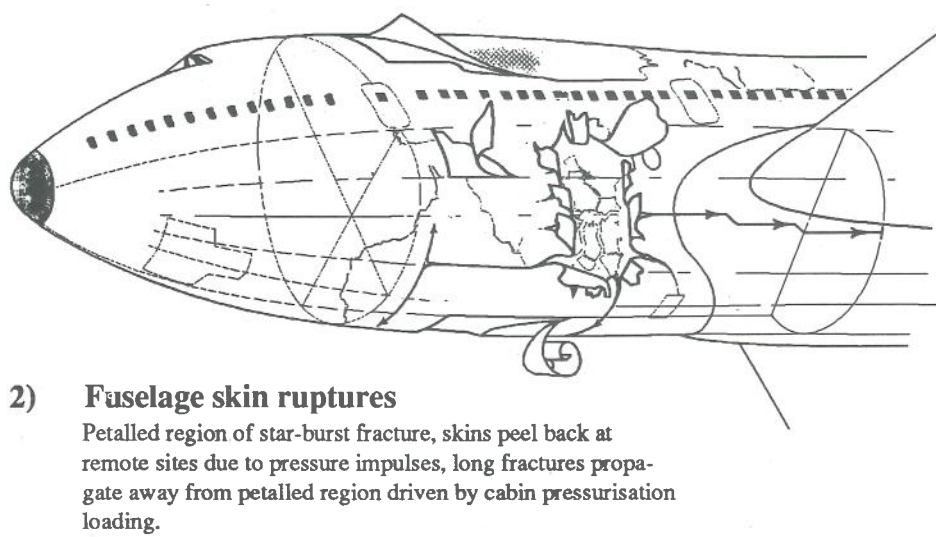
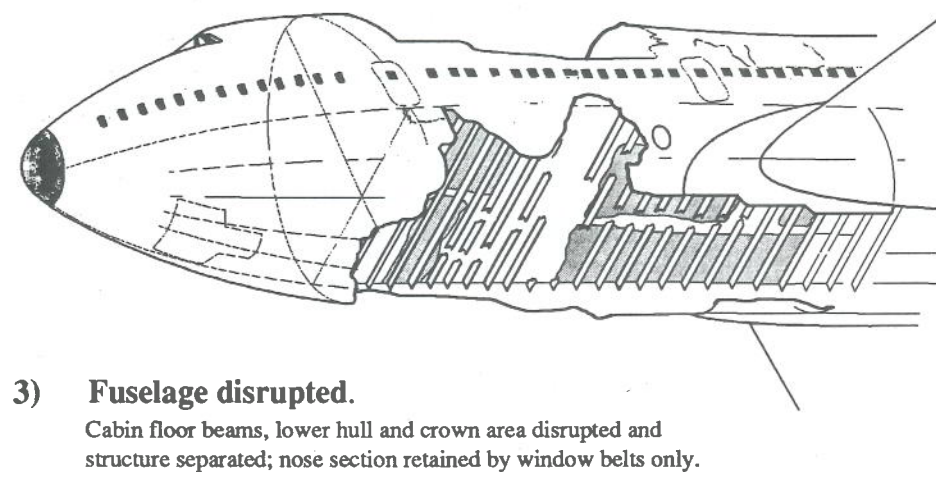
Figure B-24

Fuselage Initial Damage Sequence
 (schematic representation)

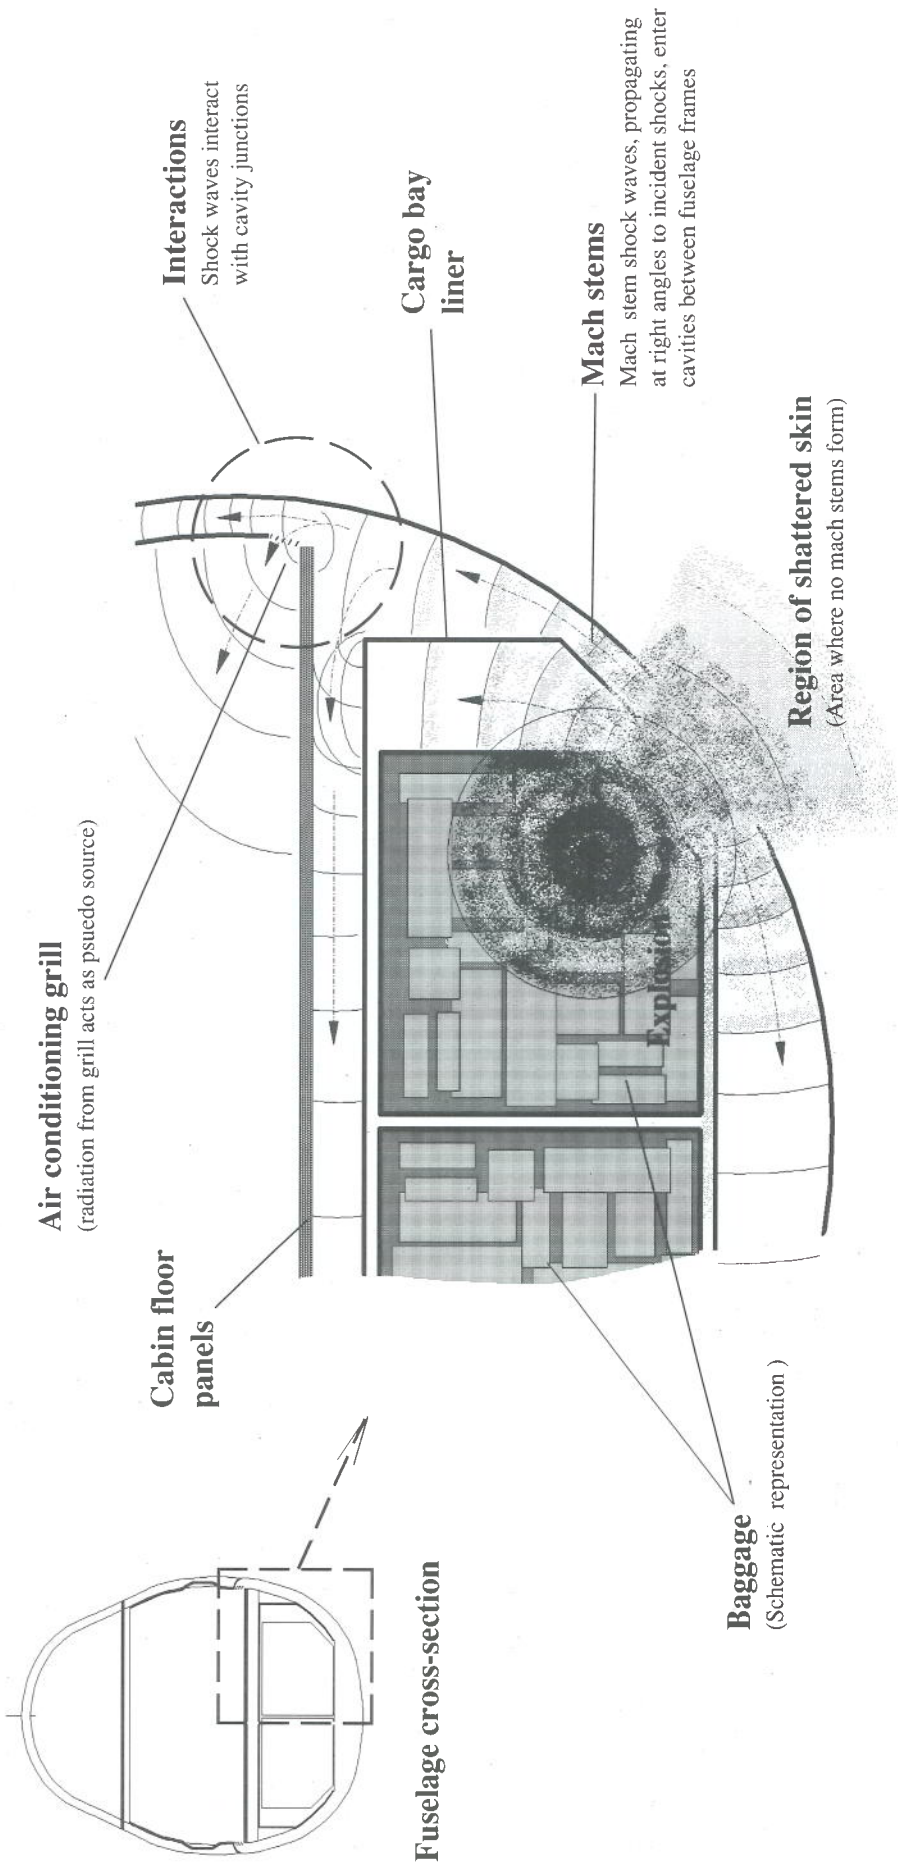
Figure B-25

Incident Shock & Regions of Mach Stem Propagation

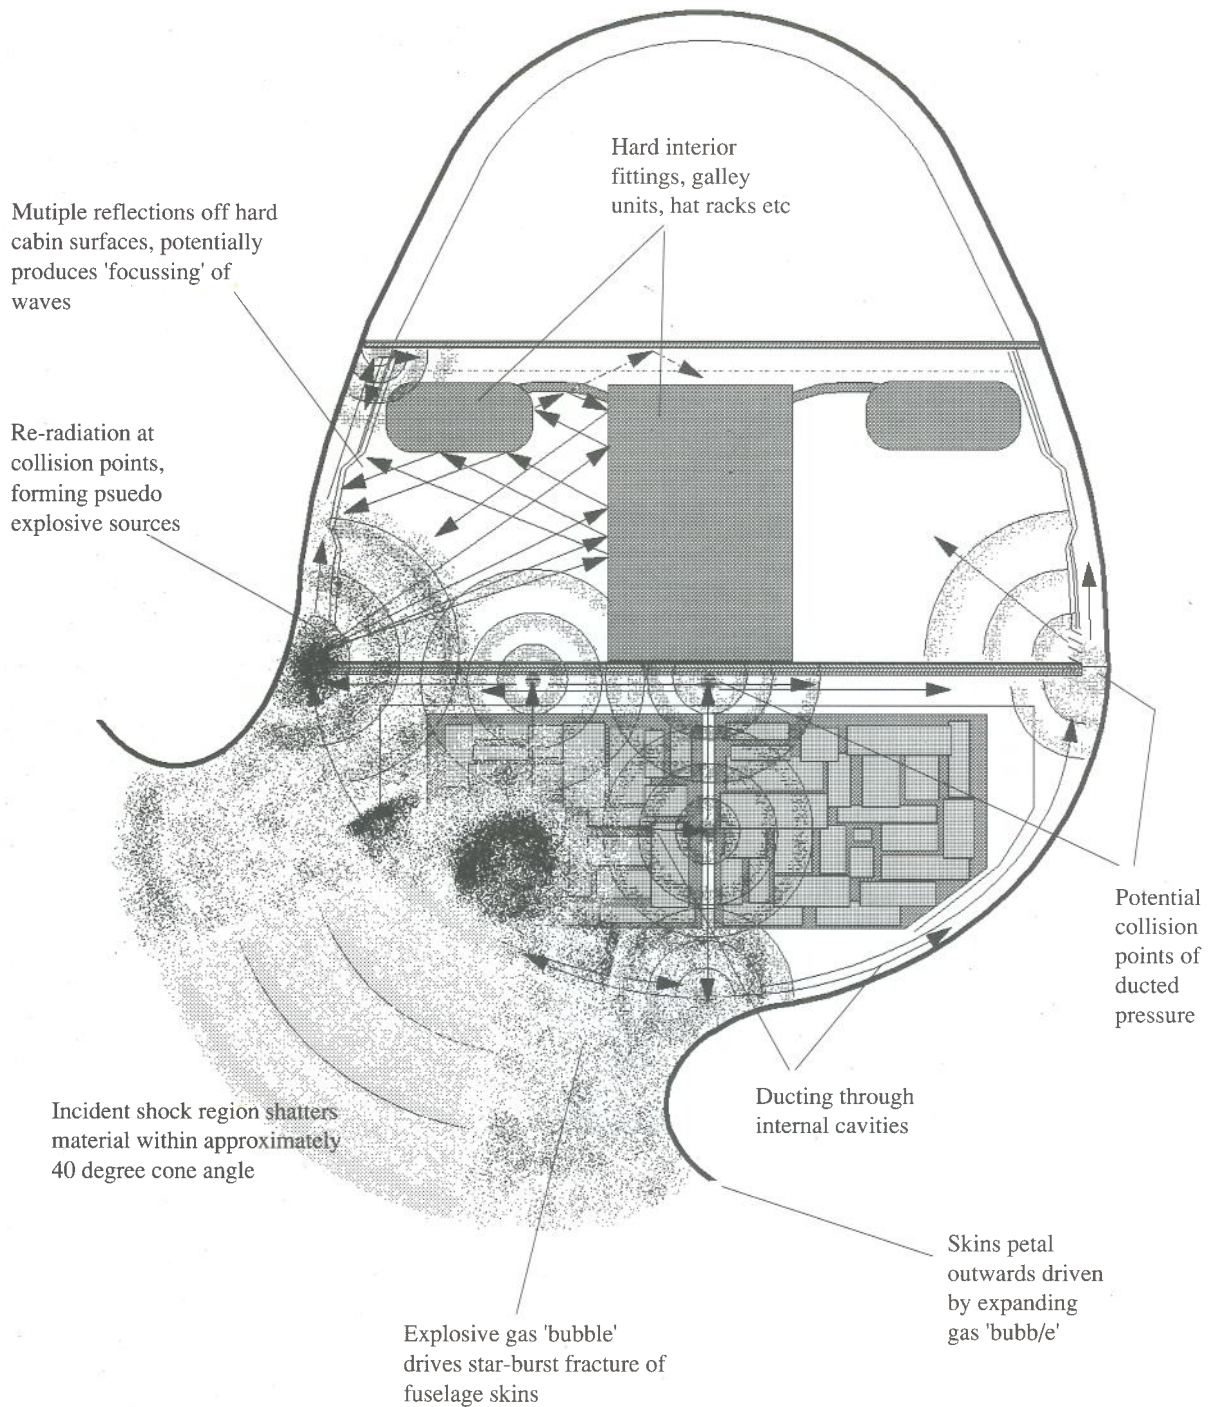
Figure B-26

Potential Shock and Explosive Gas Propagation Paths
 (schematic representation)

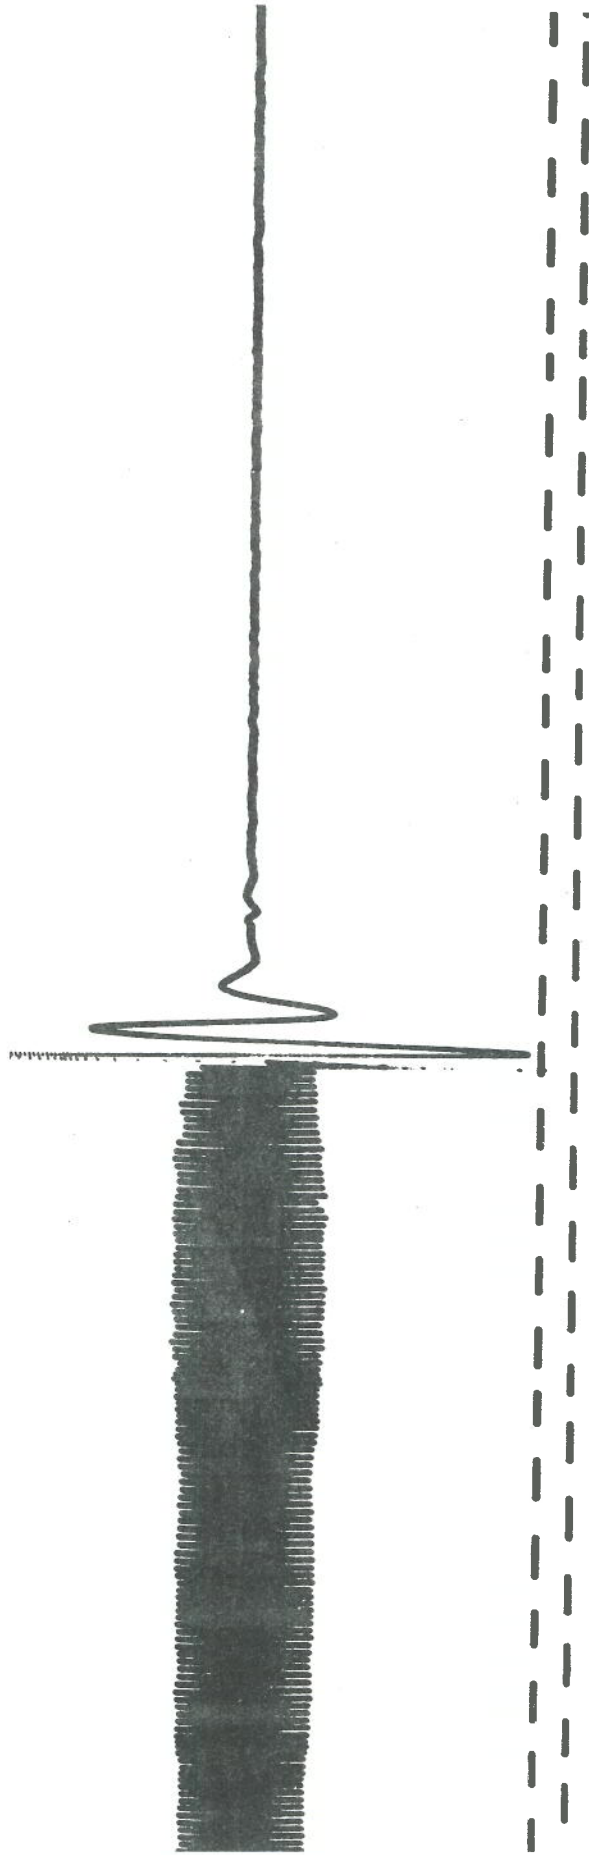
Figure C-2

To determine the mechanism that stopped the recorder a bench test rig was constructed utilizing an A100 CVR and an A152 CAM. Figures C-2 to C-5 show the effect of shorting, earthing or disconnecting the CAM signal wires. Figure C-8 shows the CAM channel signal response to the event which occurred on Flight PA103. From this it can be seen that there are no characteristic transients similar to those caused by shorting or earthing the CAM signal wires. Neither does the signal stop cleanly and quickly as shown in Figure C-5, indicating that the CAM signal wires were not interrupted. The UV trace shows the recorded signal decaying in a manner similar to that shown in Figure C-6, which demonstrates the effect of disconnecting electrical power from the recorder. The tests were

The effect on the recorded signal of shorting
the signal wires to the CAM

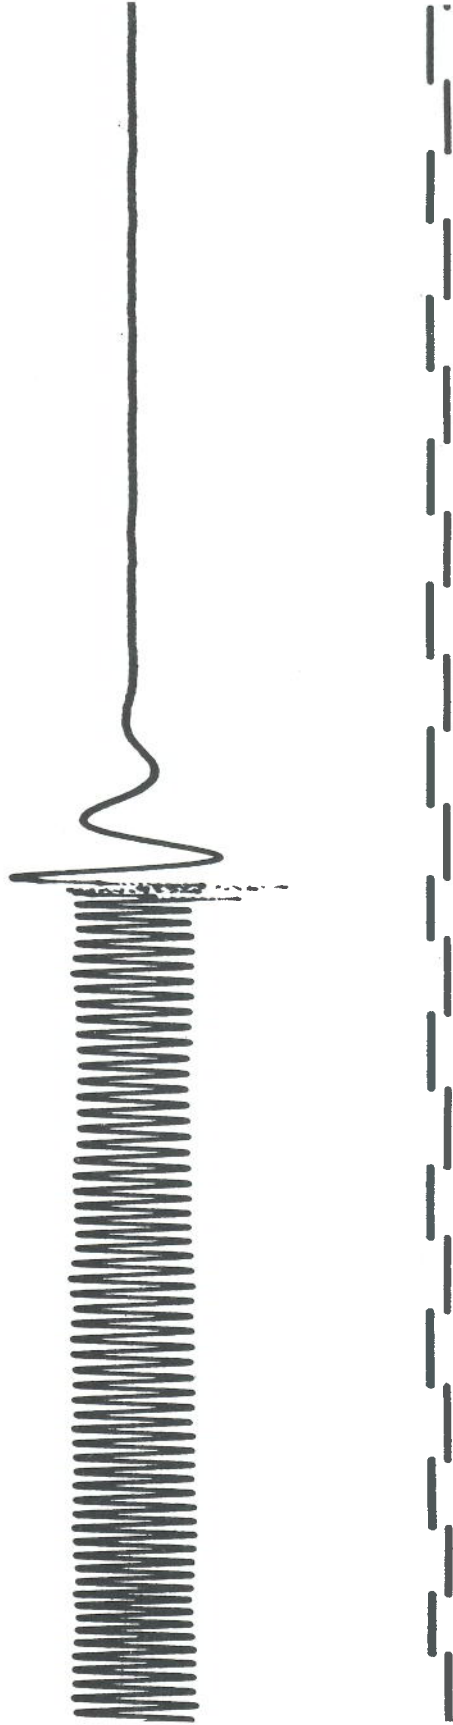
Figure C-3

The effect on the recorded signal of earthing
the hi wire to the CAM

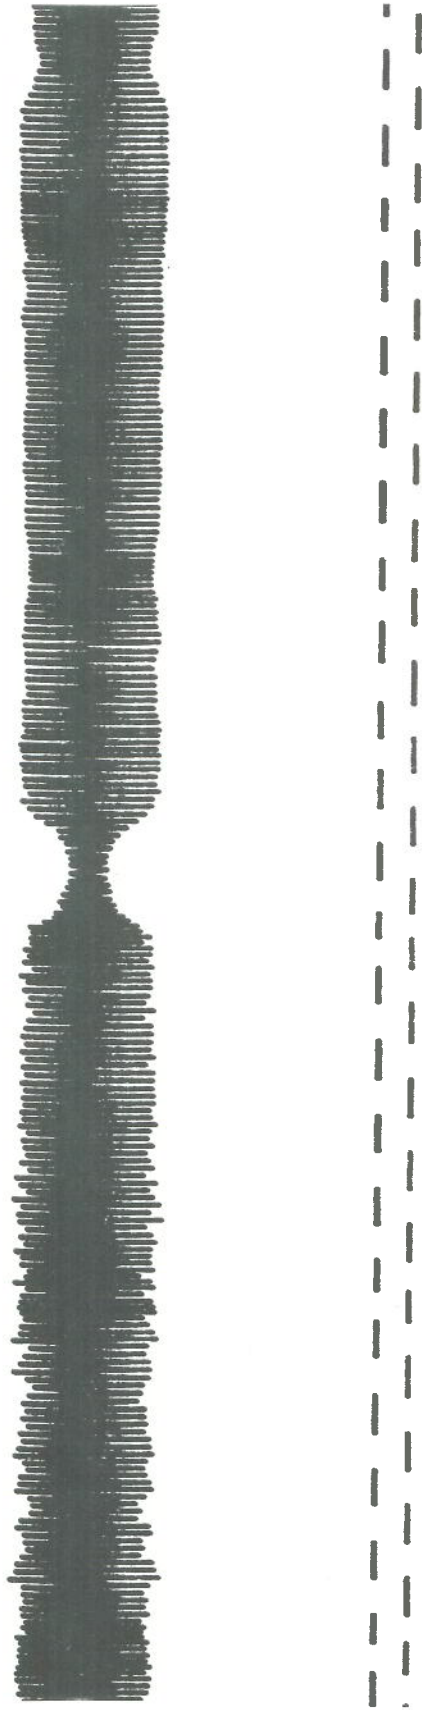
Figure C-4

The effect on the recorded signal of earthing
the lo wire to the CAM

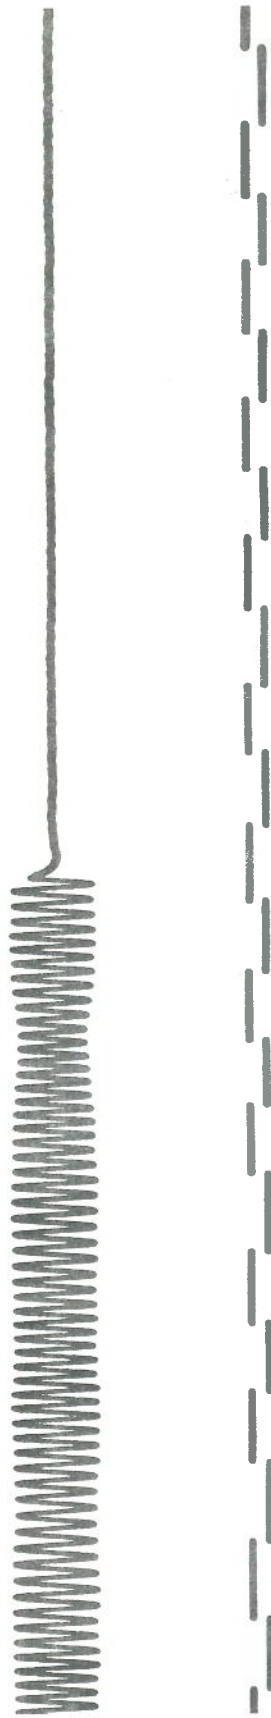
Figure C-5

The effect on the recorded signal of disconnecting
the CAM signal wires

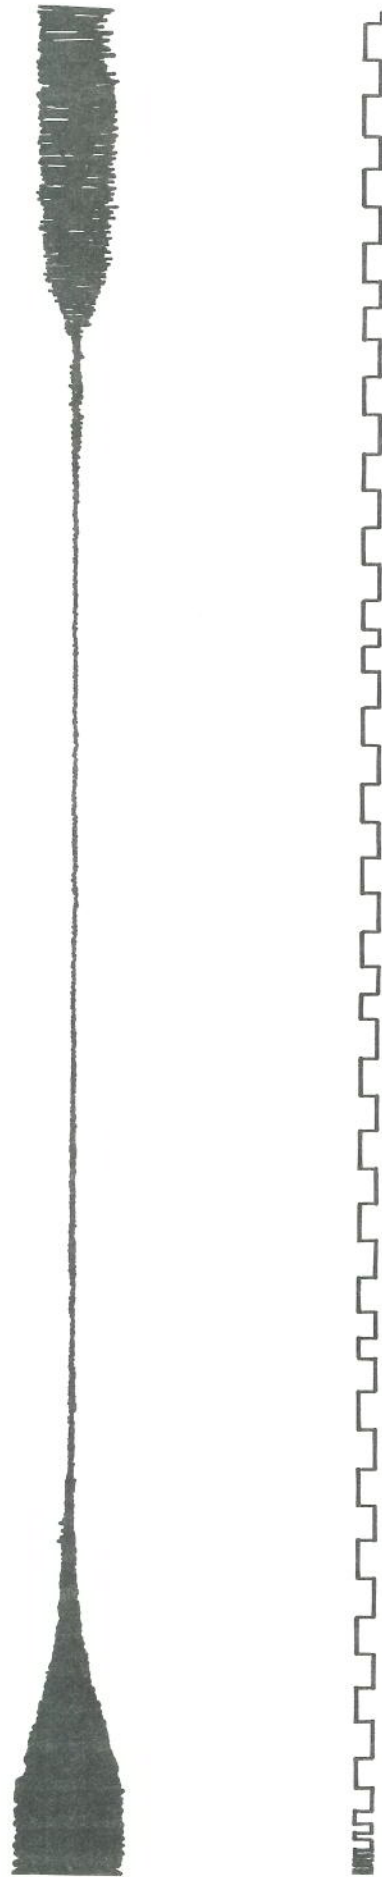
Figure C-6

The effect on the recorded CAM signal of disconnecting
the CVR power supply

In order to respond to events that result in the almost immediate loss of the aircraft's electrical power supply it was therefore recommended during the investigation that the regulatory authorities consider requiring CVR systems to contain a short duration (i.e. no greater than 1 minute) back-up power supply.

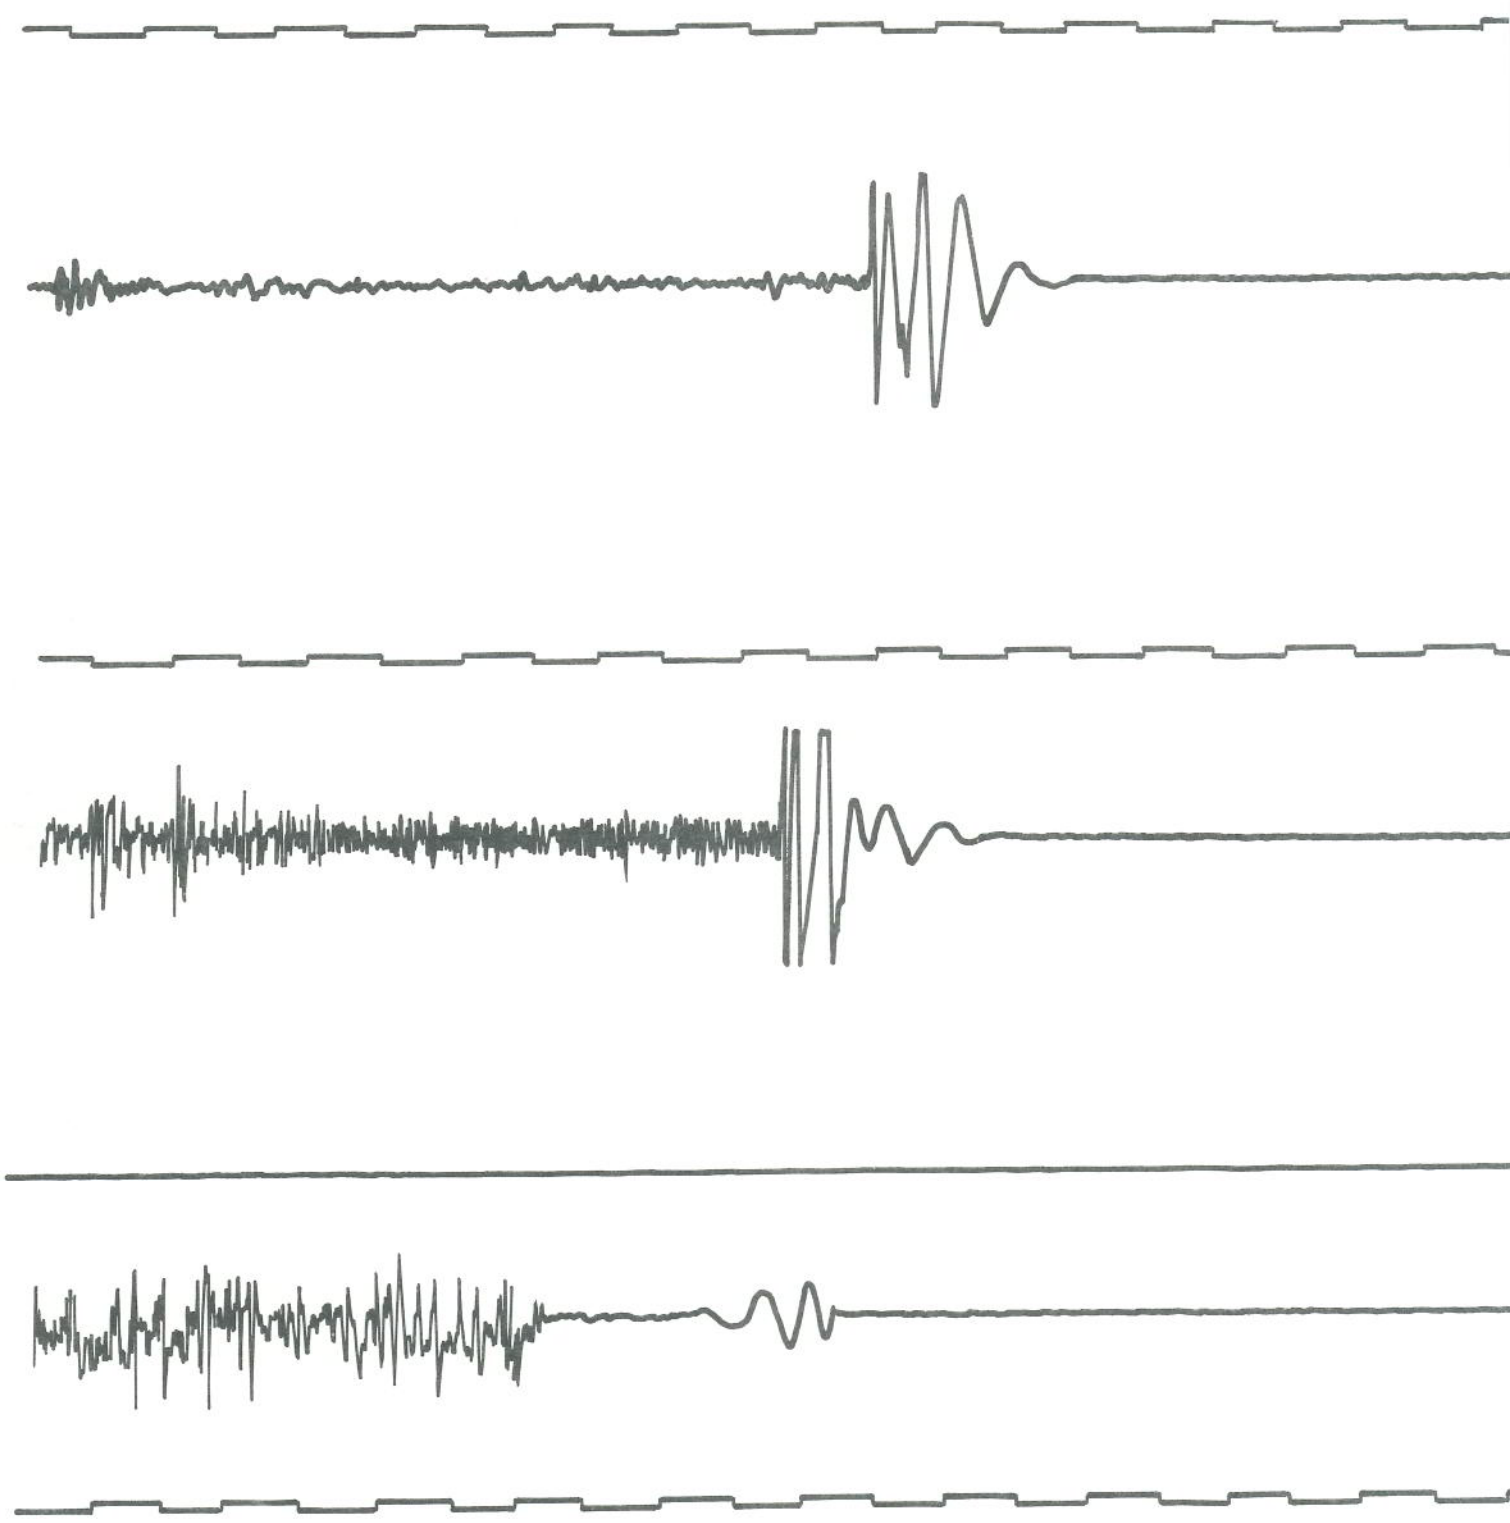
Figure C-10

Three typical end of RTF transmission transients
from N739PA, recorded on the CVR
