APPENDIX B

PHOTOGRAPHS

Boeing 747 - 121 Leading Dimensions

Figure B-1

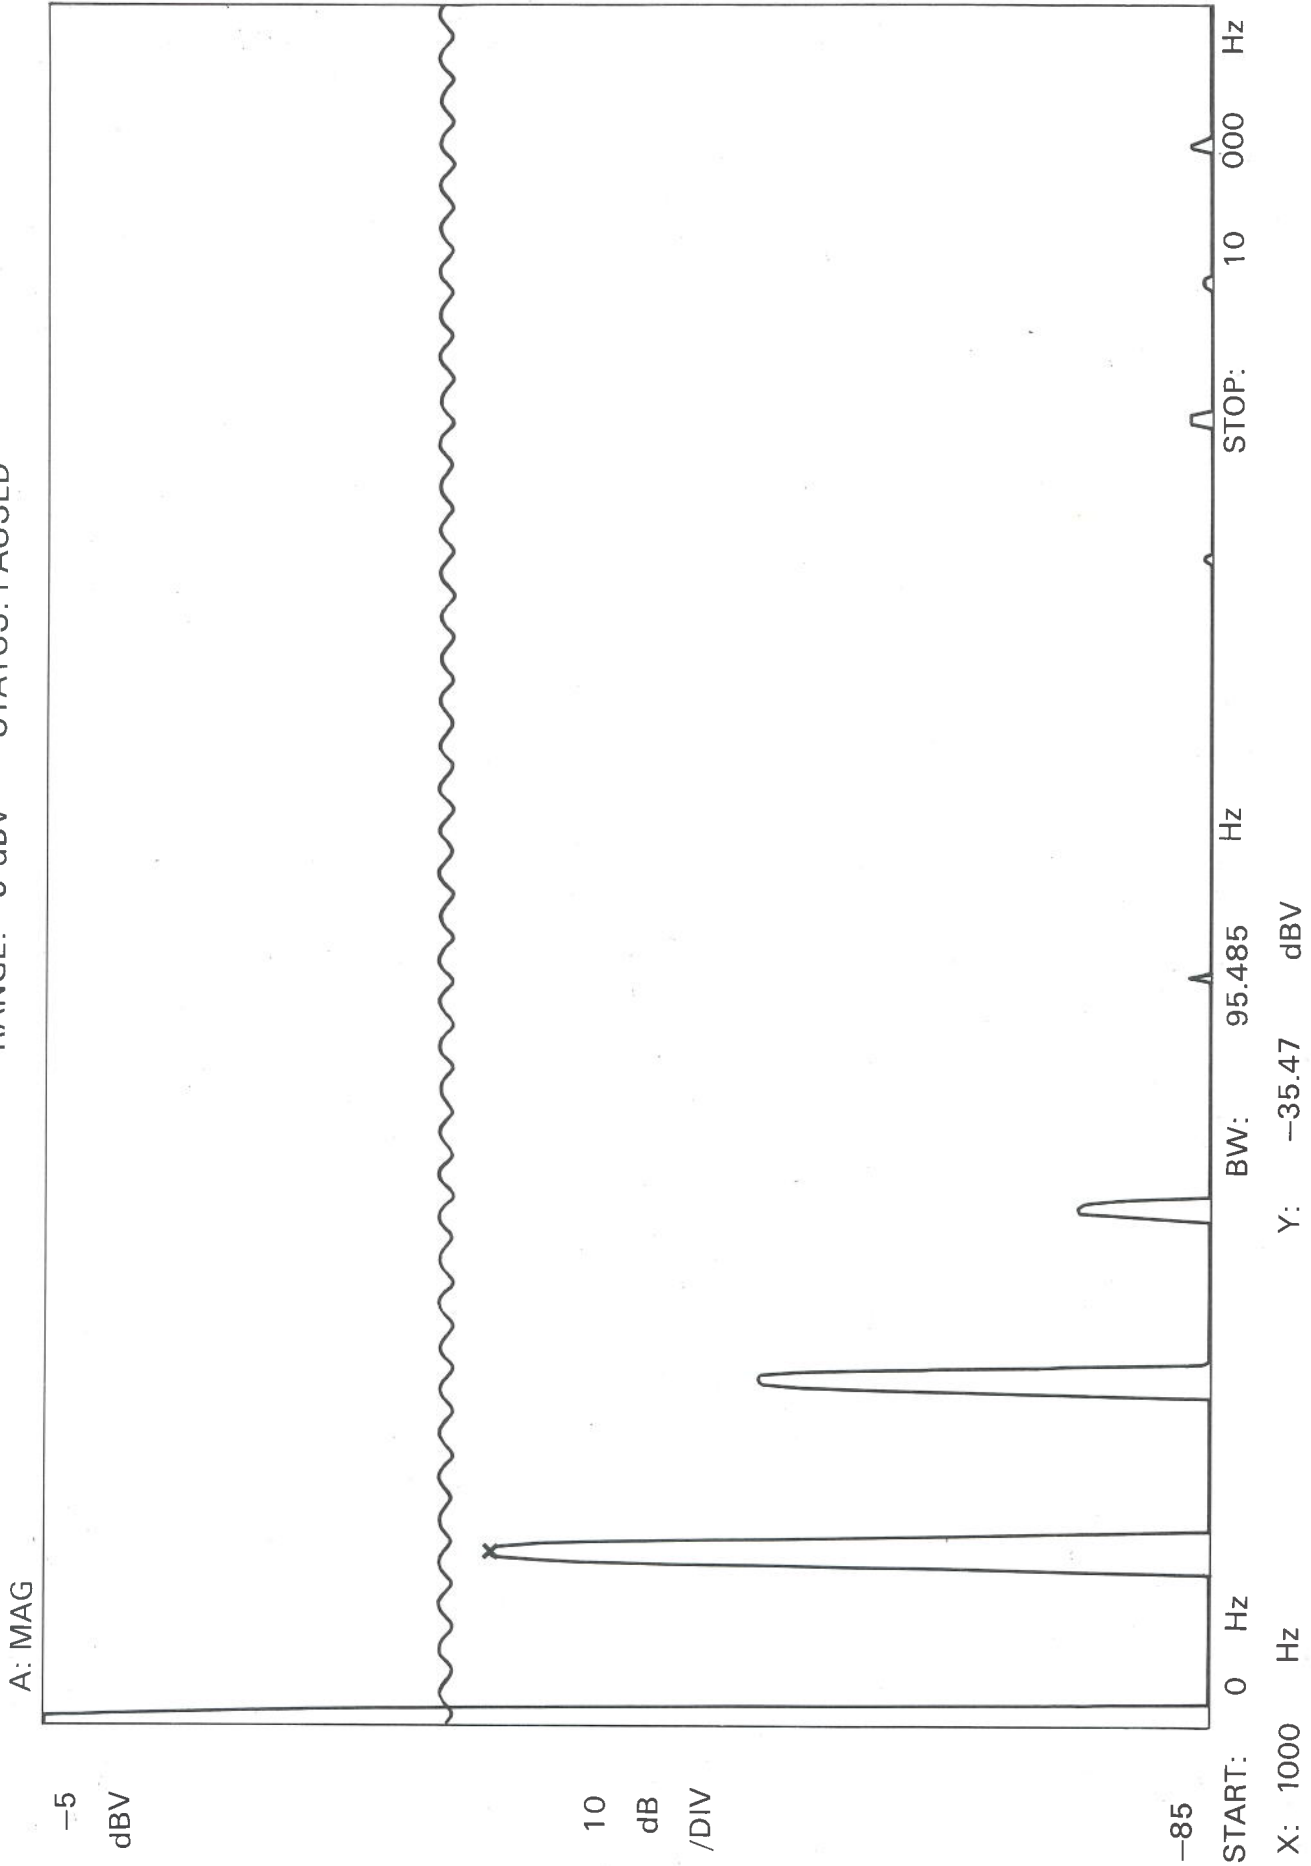
Figure C-11

**Harmonic distortion of a relatively low amplitude
1 KHz signal**

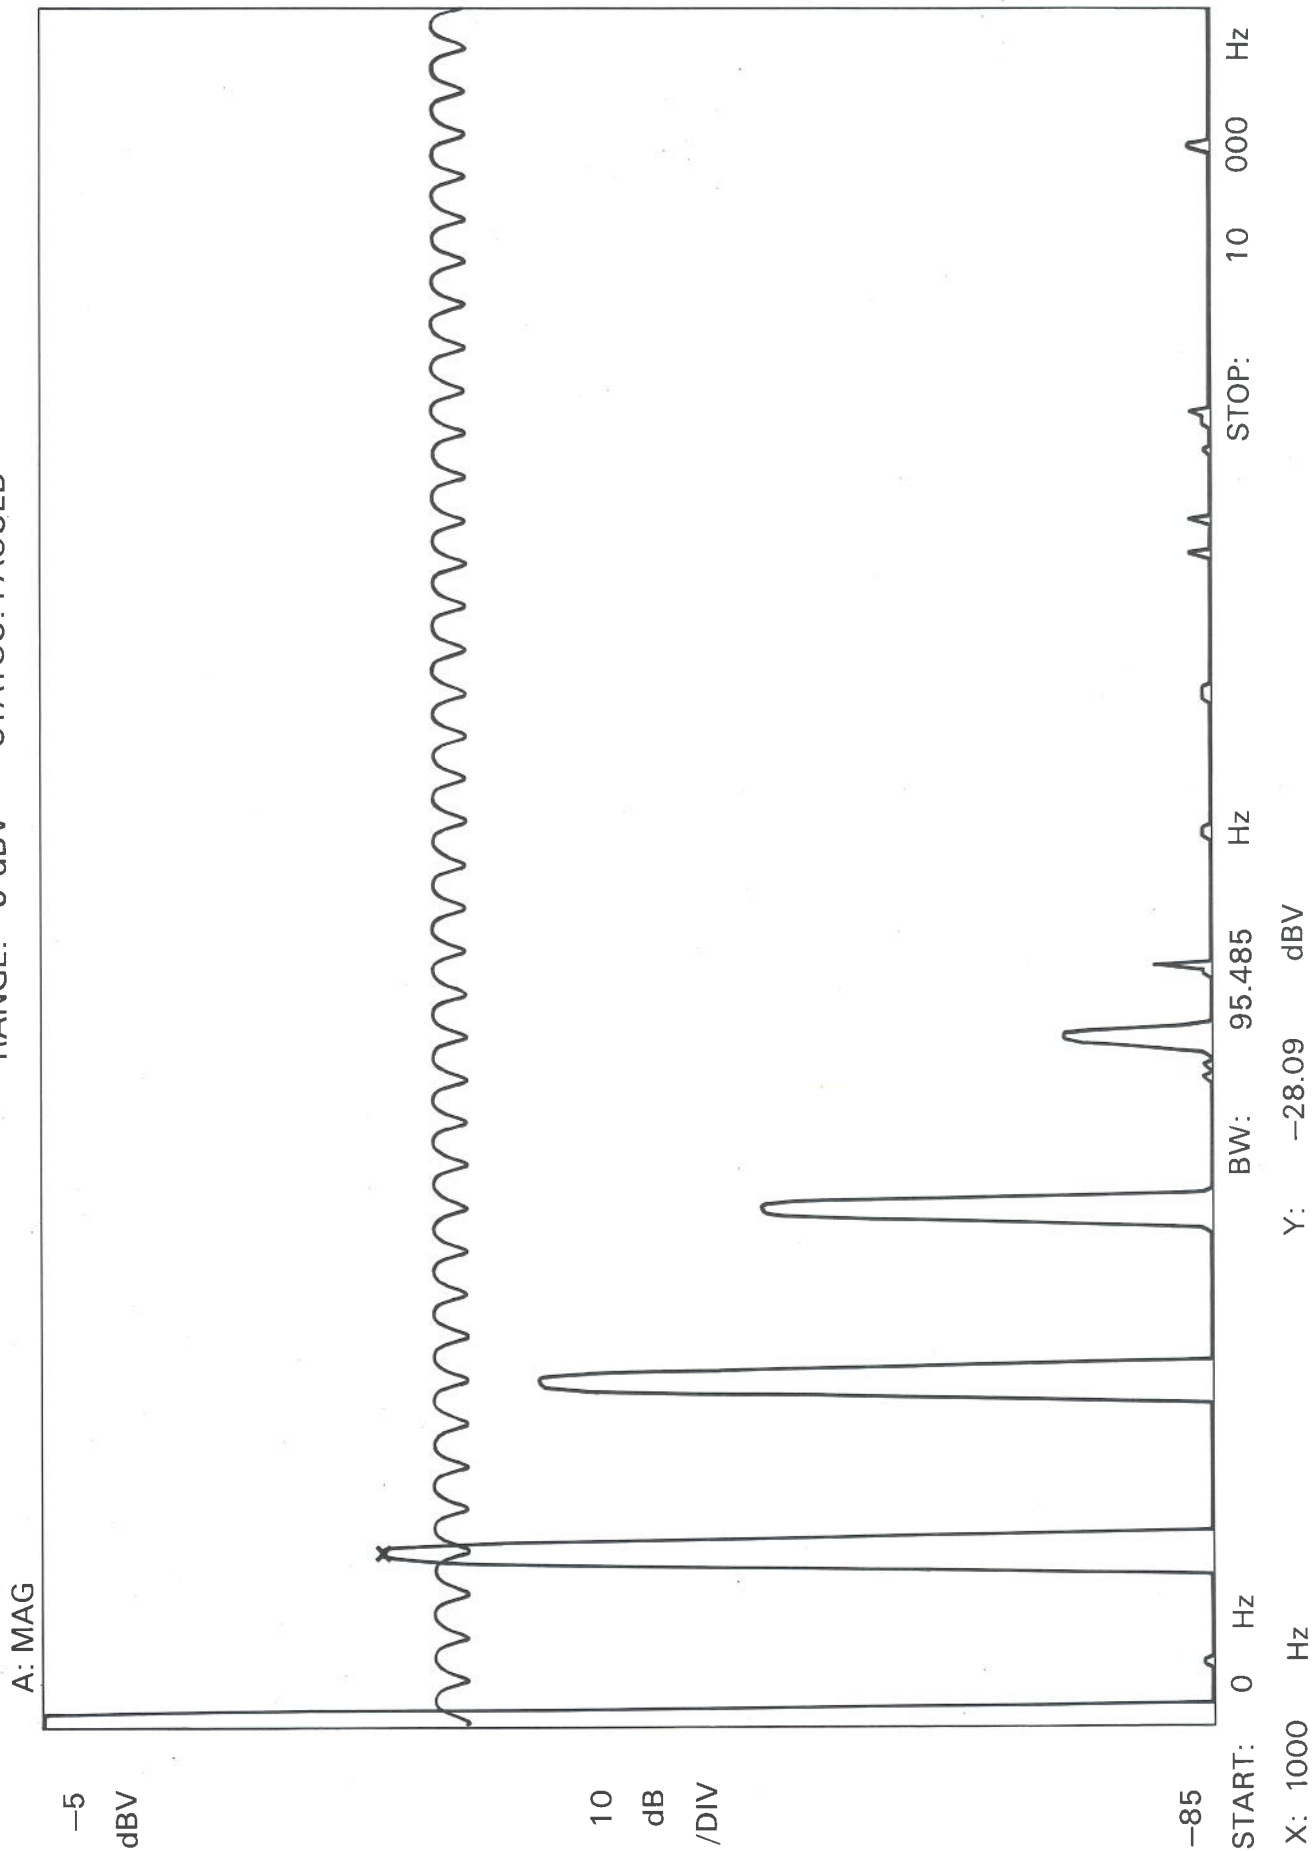
Figure C-12

Additionally some of the frequencies present on the recording were not present in the original sound, but are the result of the rise in total harmonic distortion caused by the increased amplitude of the incoming signal. Outputs from a frequency analysis of the recorded signal for the same frequency of input to the CVR, but at two input amplitudes, are shown in Figures C-11 and C-12. These illustrate the effects on harmonic distortion as the signal level is increased. Finally the recorded signal does not lend itself to analysis by a digital spectrum analyser as it is, in a large measure, aperiodic and most digital signal analysis algorithms are unable to deal with a short duration signal of this type, however, it is hoped that techniques being developed in Canada will enable more information to be deduced from the end of the recording.

Harmonic distortion of a relatively high amplitude

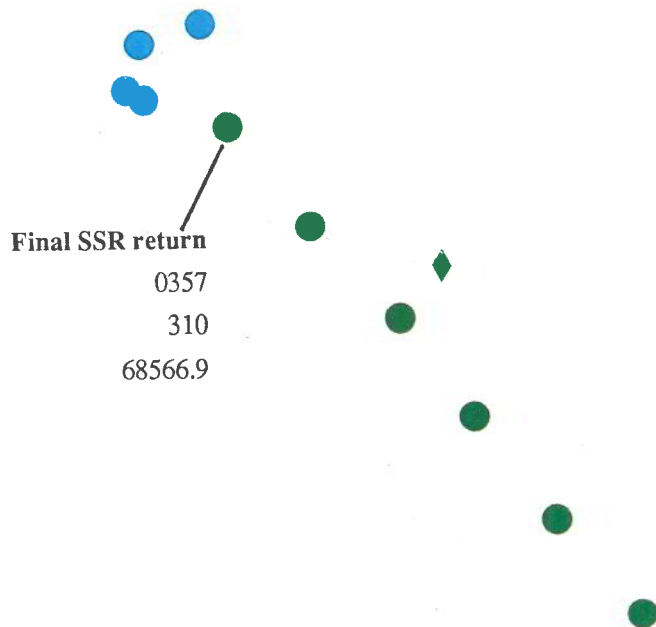
Figures C-14

Eight seconds after the sound on the CVR the Great Dun Fell radar showed 4 primary radar returns. The returns indicated a spread of wreckage in the order of 1 nautical mile across track. On successive returns of the radar, two parallel wreckage trails are seen to develop with the second trail, to the north, becoming evident 30 to 40 seconds after the first.

Radar returns from the final flight of N739PA

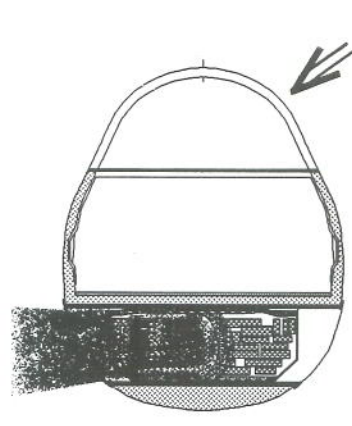
Aim of modified system

- 1) venting through blow-out panel(s) to dissipate peak overpressure quickly
- 2) controlled size of fuselage aperture with 'clean' boundary and no extended cracks
- 3) minimal ducting through cavities
- 4) energy absorbed by baggage in adjoining containers (non-rigid container)

The third layer comprises a pre-determined area of fuselage skin, adjoining the outer end of the vent path, designed to rupture or burst in a controlled manner, providing a large vent aperture which will not tend to crack or rupture beyond the designated boundaries.

A fourth layer of protection has two elements, both intended to limit the propagation of shock waves through the internal cavities in the hull. The first element comprises the closure of any gaps between the vent apertures in the two innermost containment layers and the vent aperture in the outer skin. This effectively provides an exhaust duct connecting the inner and outer vent apertures to minimise leakage into the intervening structure and cavities around the cargo hold. The second element comprises the incorporation of an energy absorbing lining material within all the cavities in the lower hull, to absorb shock energy, limit shock reflection and limit the propagation of pressure waves which might enter the cavities, for example because of containment layer breakthrough.

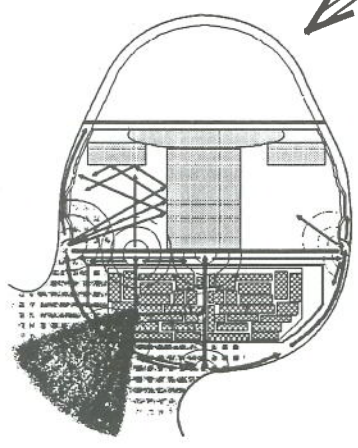
Likely behaviour of unmodified system

- 1) large, uncontrolled starburst rupture of fuselage with extended cracking
- 2) ducting of shock and gas overpressure through fuselage cavities
- 3) local enhancements as ducted shocks/gas overpressures re-combine
- 4) re-radiation into cabin as psuedo explosive sources
- 5) reflection off hard surfaces producing local pressure enhancements

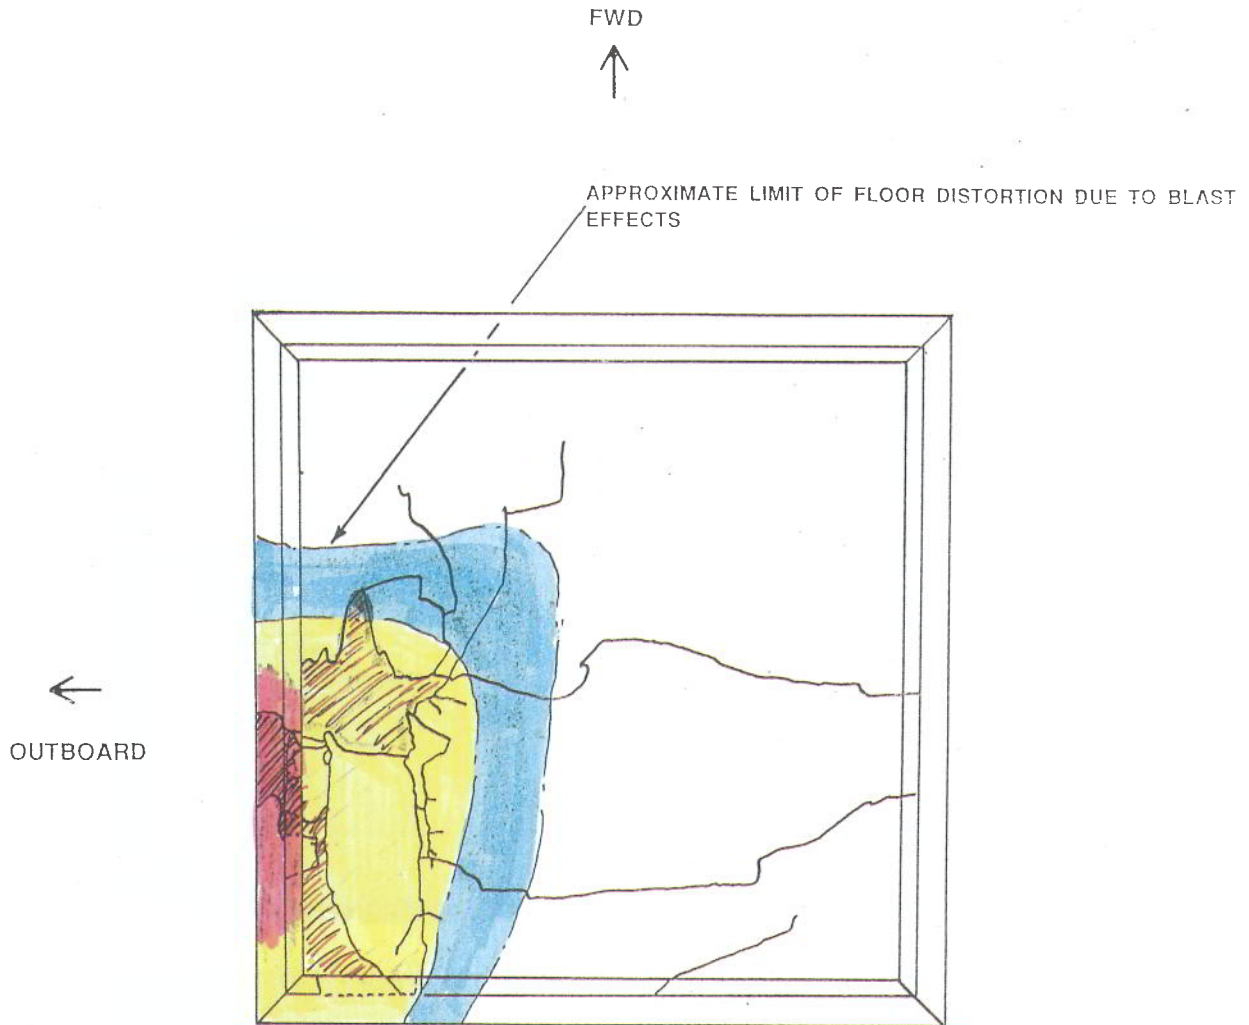
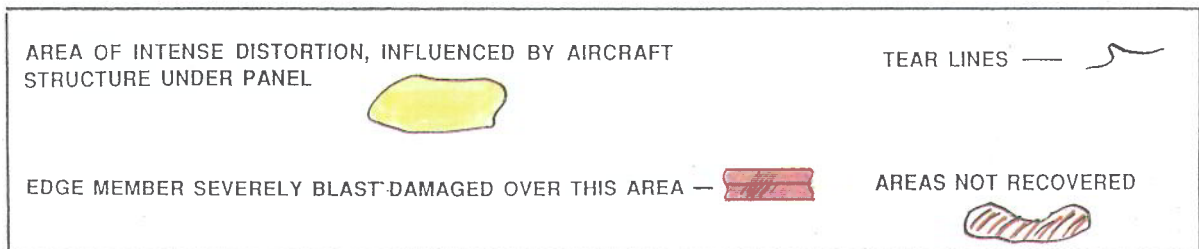
Figure F-4

BAGGAGE CONTAINER FLOOR DAMAGE DIAGRAM

N739PA - FLOOR PANEL MAP FROM CONTAINER

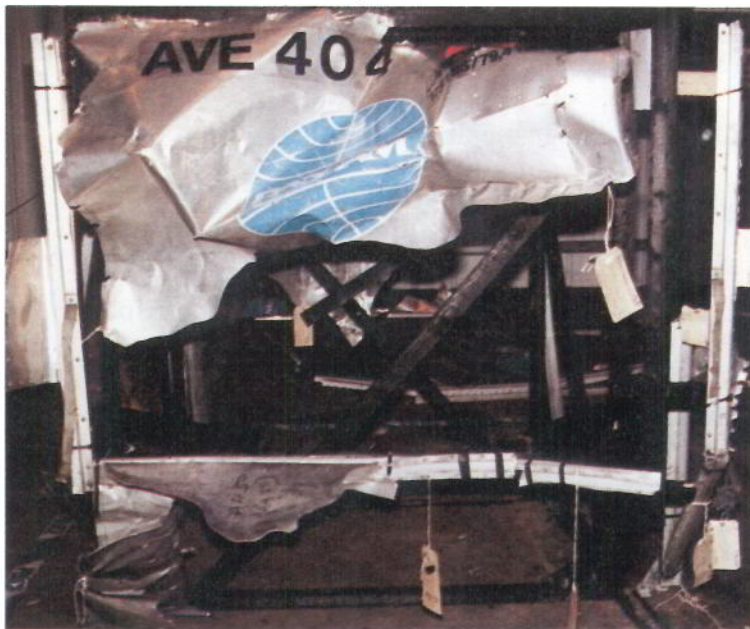
Figure F-6

- a Stiffener section from base of vertical face
- b Vertical face forward edge member, lower stiffener section and skin fragment
- c Distorted upper section of vertical face skin
- d Forward section of sloping face skin, severely distorted
- e Fragment of container skin, provisionally thought to be part of sloping face skin.

Outboard faces of AVE 404

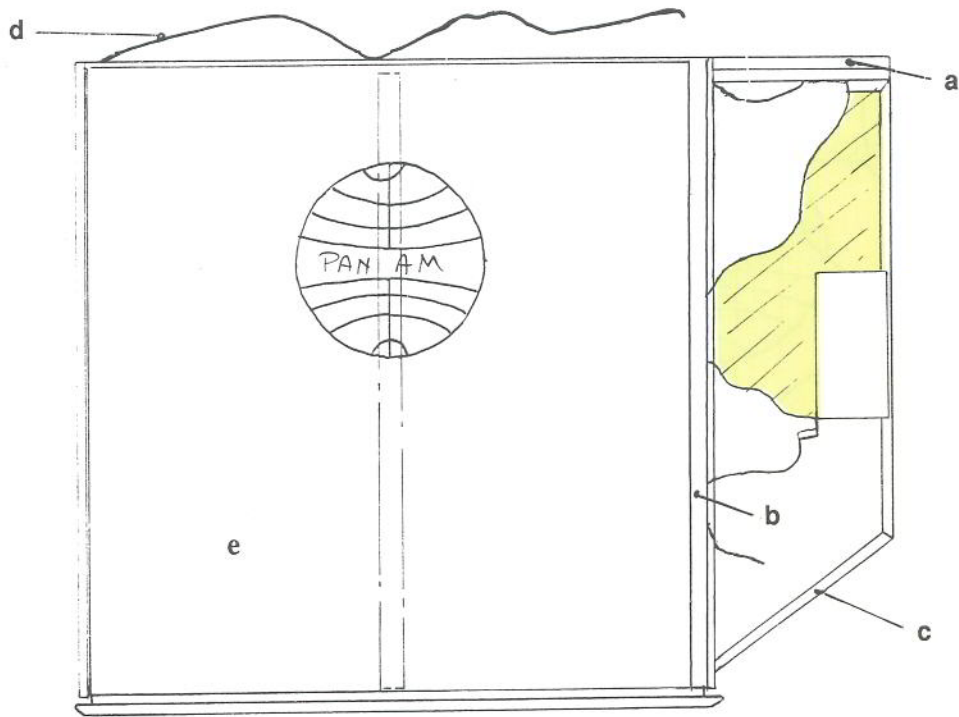
Figure F-7

Outboard section of roof edge member

- b Forward face outboard skin, attached to vertical edge member
- c Forward edge member of sloping face
- d Roof skin panel, complete except for aft outboard corner
- e Forward face panel, complete with top, left and lower edge members

Forward face of AVE 4041 PA

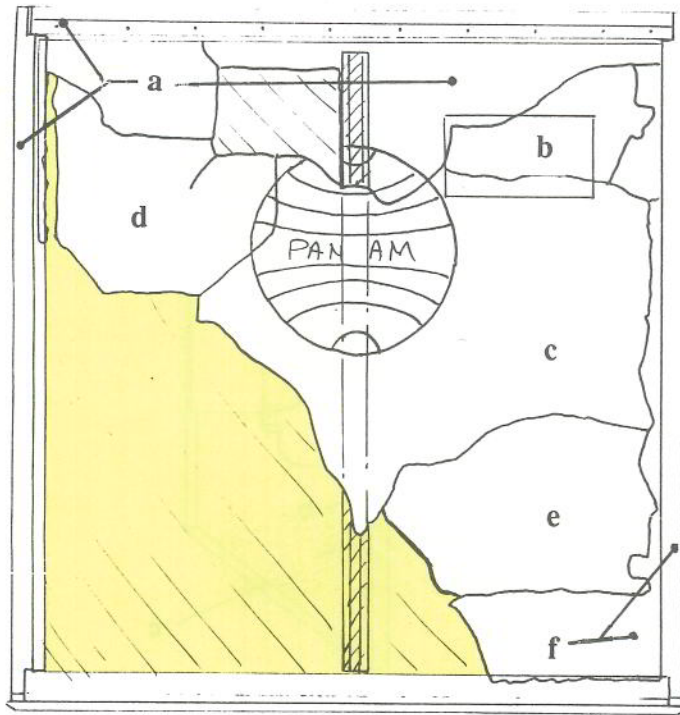
- a Aft, top and roof edge members including upper section of skin
- b Repair patch from upper right side
- c Mid section of skin including stiffener section
- d Upper skin section
- e Lower skin section
- f Right side vertical edge member attached to lower piece of skin

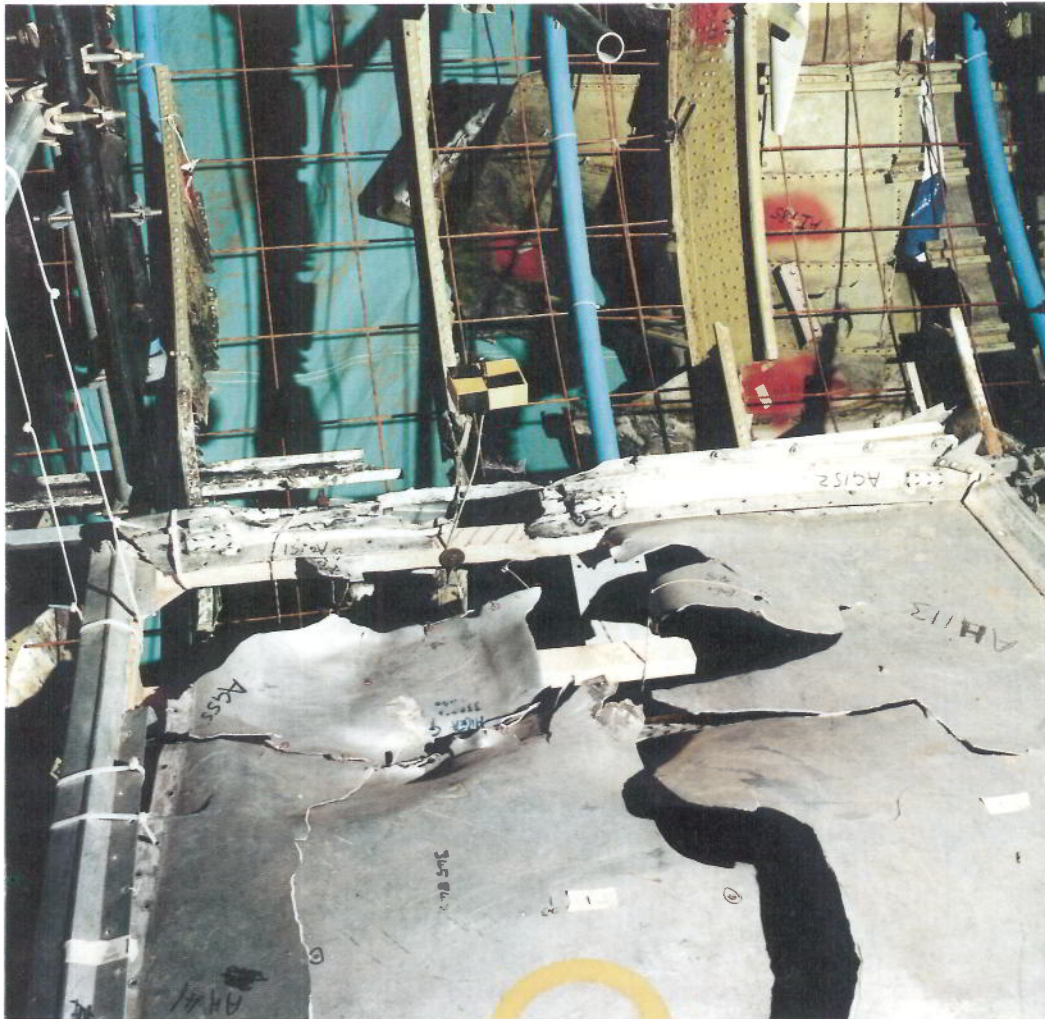
Figure F-11

Installation of container floor inside fuselage reconstruction

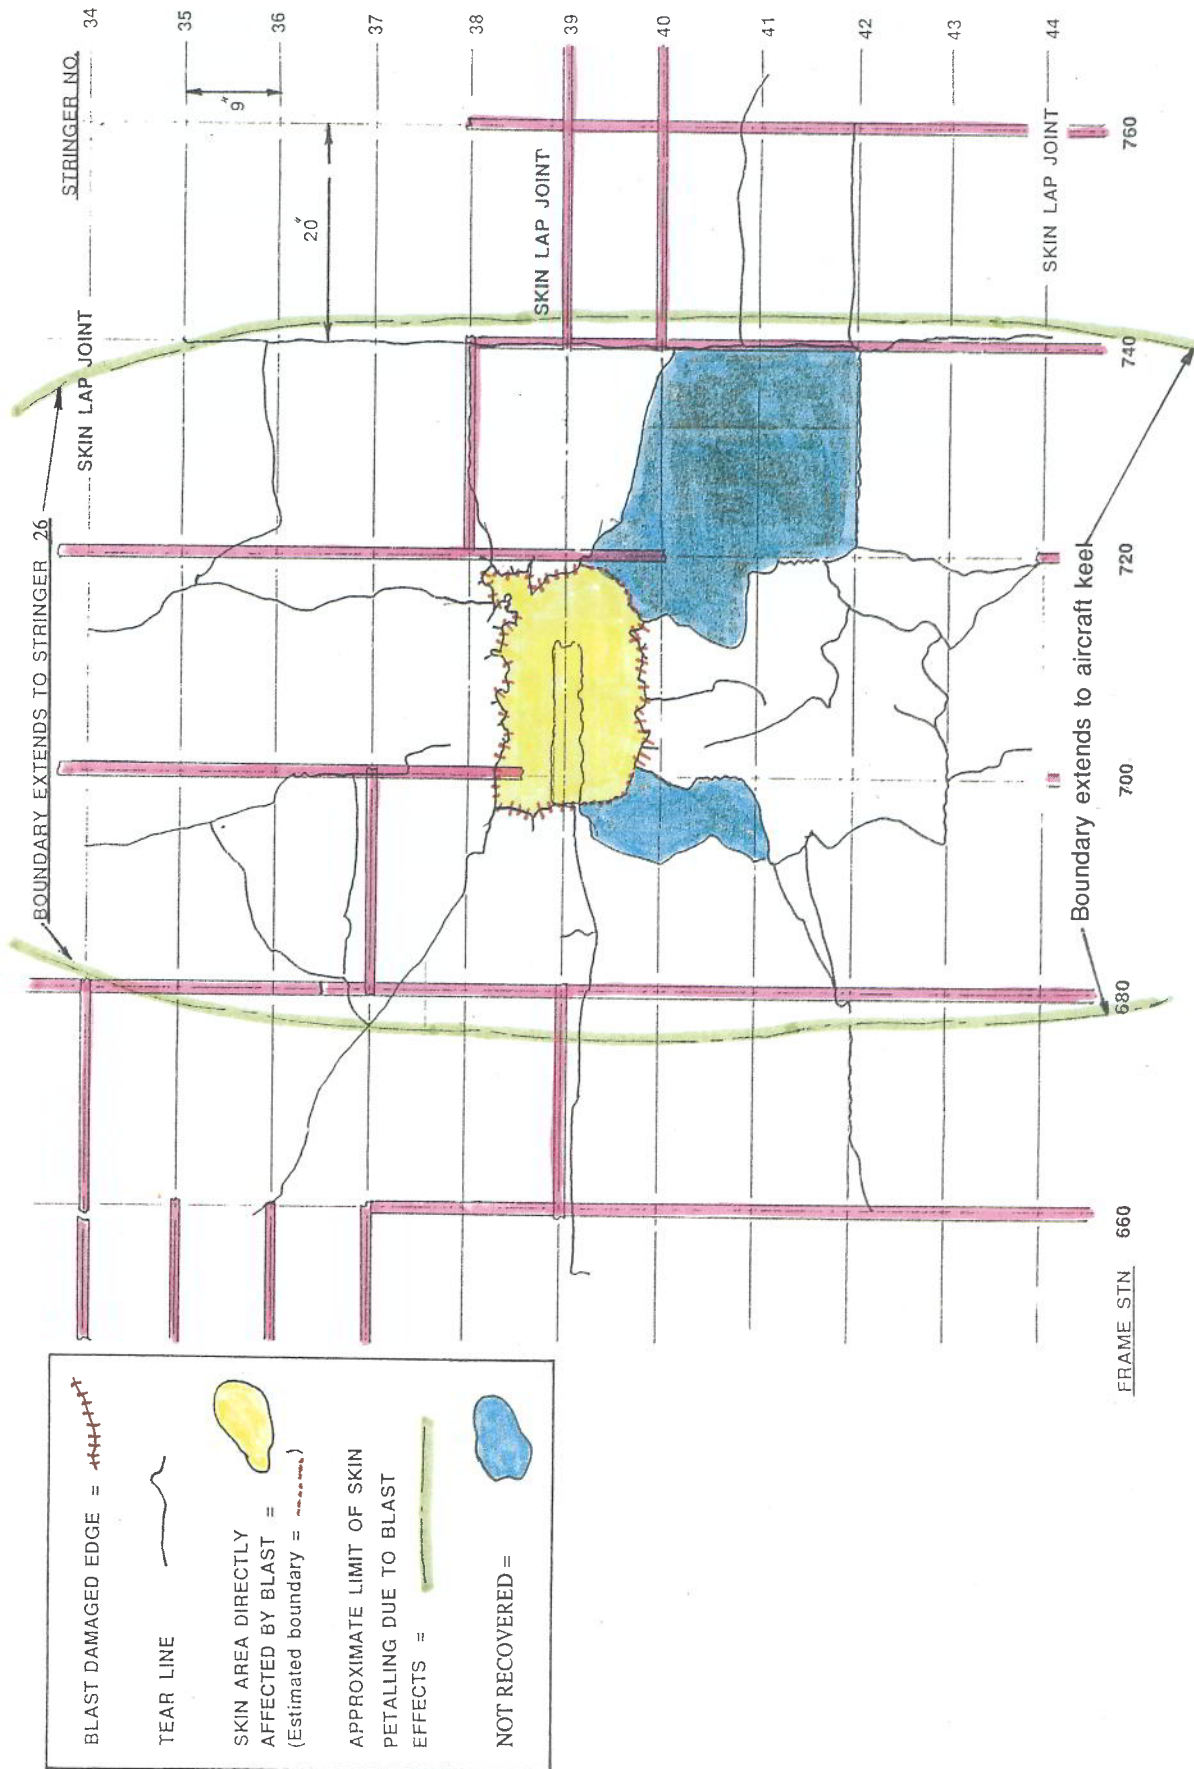
Figure F-12

N739PA Skin Structure Damage Diagram

Likely lateral and vertical position of the IED

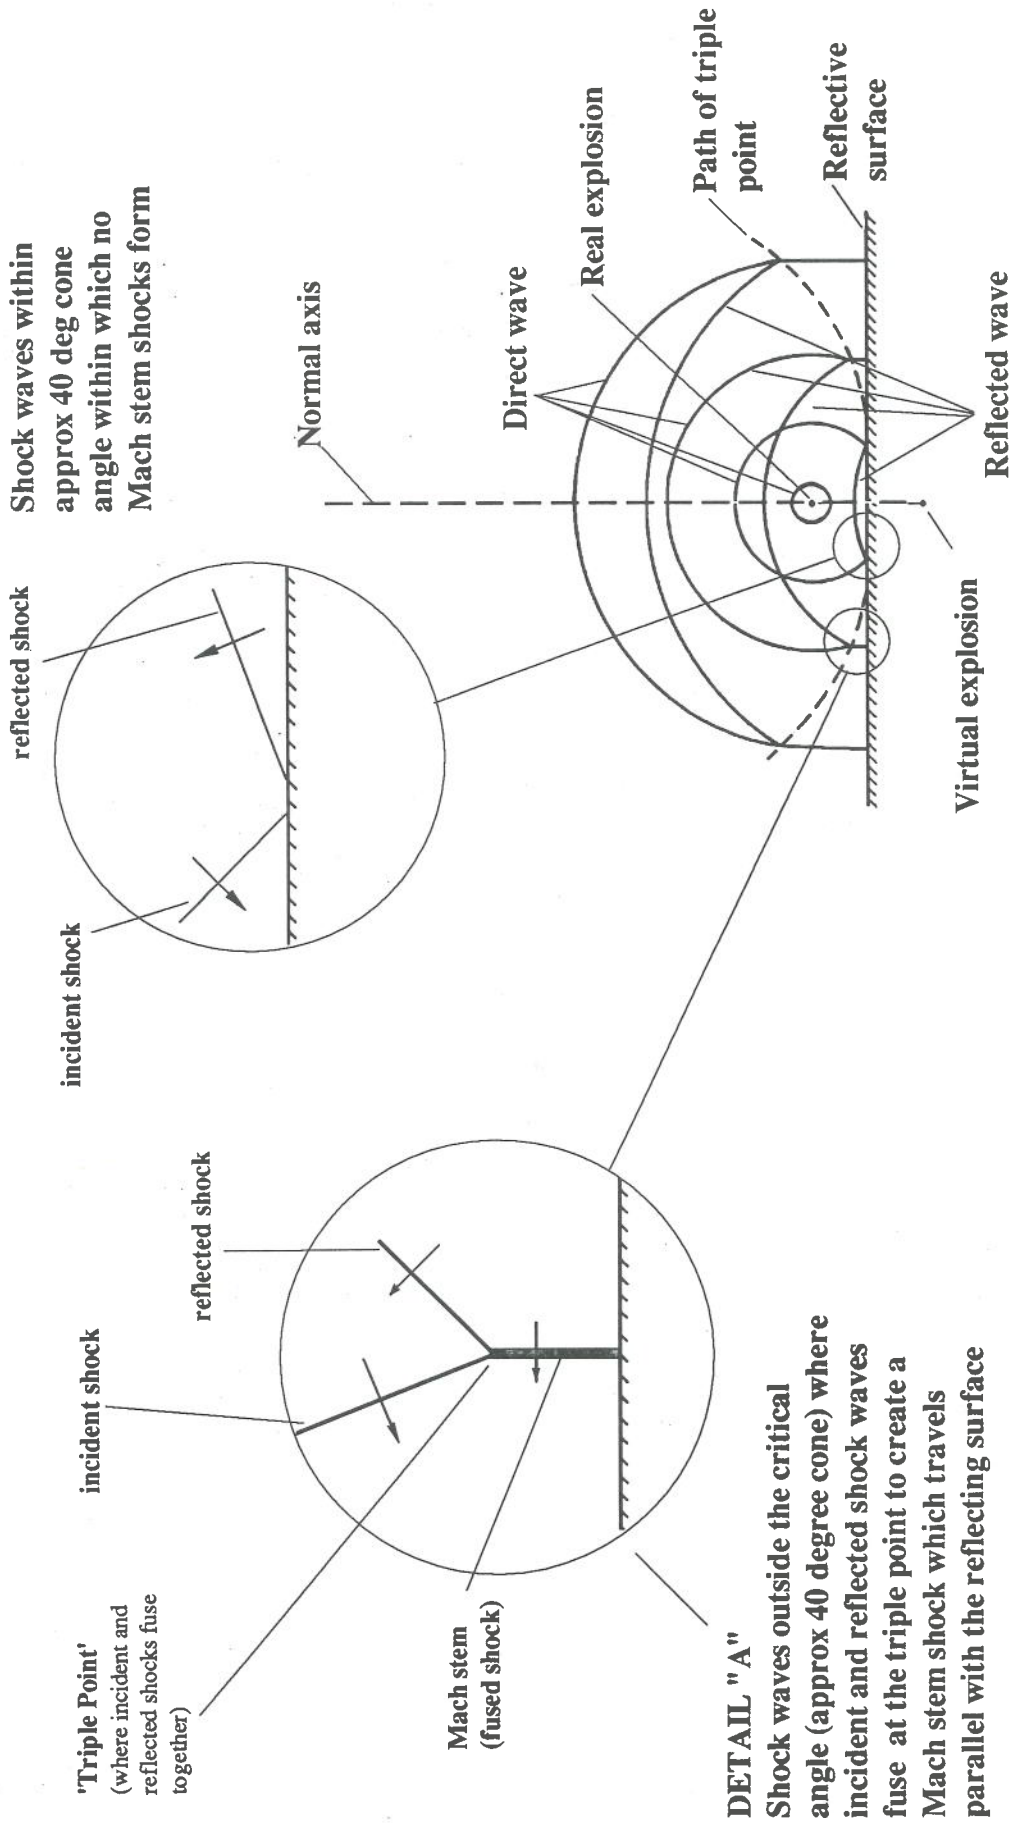
Within the constraint of the likely charge size used on Flight PA103, calculations suggested that the initial Mach stem shock wave pressure close to the region of Mach stem formation (i.e. the shock wave *face-on* pressure, acting at right angles to the skin), was likely to be more than twice that of the incident shock wave, with a velocity of propagation perhaps 25% greater. However, the Mach stem out-of-plane pressure, i.e. the pressure felt by the reflecting surface where the Mach stem touches it, would have been relatively low and insufficient to shatter the skin material. Therefore, provided that the charge had sufficient energy to produce skin shatter within the conical central region where no Mach stems form, the size of the shattered region would be a function mainly of charge standoff distance, and charge weight would have had little influence. Consequently, it was possible to calculate the charge standoff distance required to produce a given size of shattered skin from geometric considerations alone. On this basis, a charge standoff distance of approximately 25 to 27 inches would have resulted in a shattered region of some 18 to 20 inches in diameter, broadly comparable to the size of the shattered region evident on the three-dimensional wreckage reconstruction.

Whilst the analytical method makes no allowance for the effect of the IED casing, or any other baggage or container structure interposed between the charge and the fuselage skin, the presence of such a barrier would have tended to absorb energy rather than re-direct the transmitted shock wave; therefore its presence would have been more critical in terms of charge size than of position. Certainly, the standoff distance predicted by this method was strikingly similar to the figure of 25 inches derived independently from the container and fuselage reconstructions.

Shock waves within
approx 40 deg cone
angle within which no
Mach stem shocks form
