Air Quality and Dust Monitoring Monthly Report - February 2023

Birmingham City Council

A report prepared by EWCs and MWCCs on behalf of HS2 Ltd.

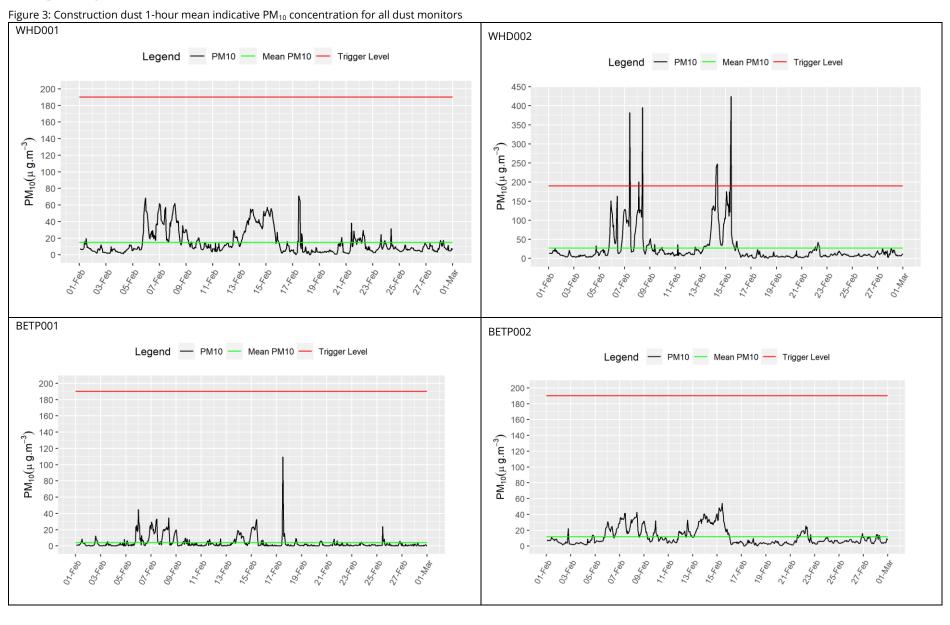
- 1.1.6 The dust monitoring locations and results are presented in Appendix B, Table 1, together with line charts of monthly data from the dust monitors presented in Figure 3. All continuous dust monitoring is undertaken using indicative monitors. Despite being Environment Agency (MCERTS) certified, indicative monitors carry a higher level of uncertainty than reference monitors, and therefore cannot be strictly compared with Air Quality Standards for human health and the environment. The purpose of the monitoring undertaken is to ensure the effectiveness of the on-site mitigations.
