Maritime and Coastguard Agency

## The Merchant Shipping (Carriage of Cargoes) Regulations 1999

**1.1** This document is intended to provide guidance to ship's crew and terminal personnel with respect to the principal areas on bulk carriers that are likely to be susceptible to corrosion or damage.

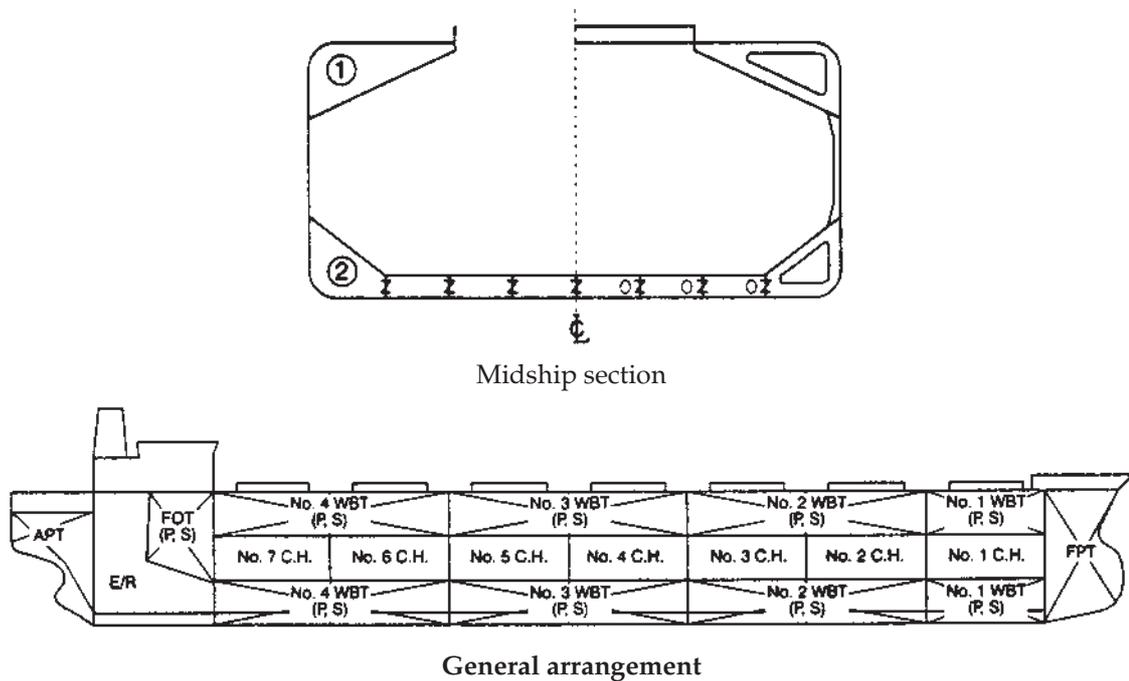
Figure 1 - Typical midship section and general arrangement

4.1 *Bulk carrier*: a bulk carrier is a cargo ship intended for carriage of dry bulk cargoes such as grain, coal, ore, etc., provided with topside tanks at both shoulders and bilge hoppers in both double-bottom wings in the cargo space. Below is a typical midship section and general arrangement.

4.2 *Topside tank*: tanks provided in cargo spaces at both shoulders, as the space (1) shown in the drawing above.

4.3 *Bilge hopper*: a conventional bulk carrier has hopper structures at both bottom wings in cargo holds. This part of the cargo hold is called the 'bilge hopper'. Double-bottom tanks in way of bilge hopper are often called 'bilge hopper tanks'. In the diagram, the space is shown as (2).

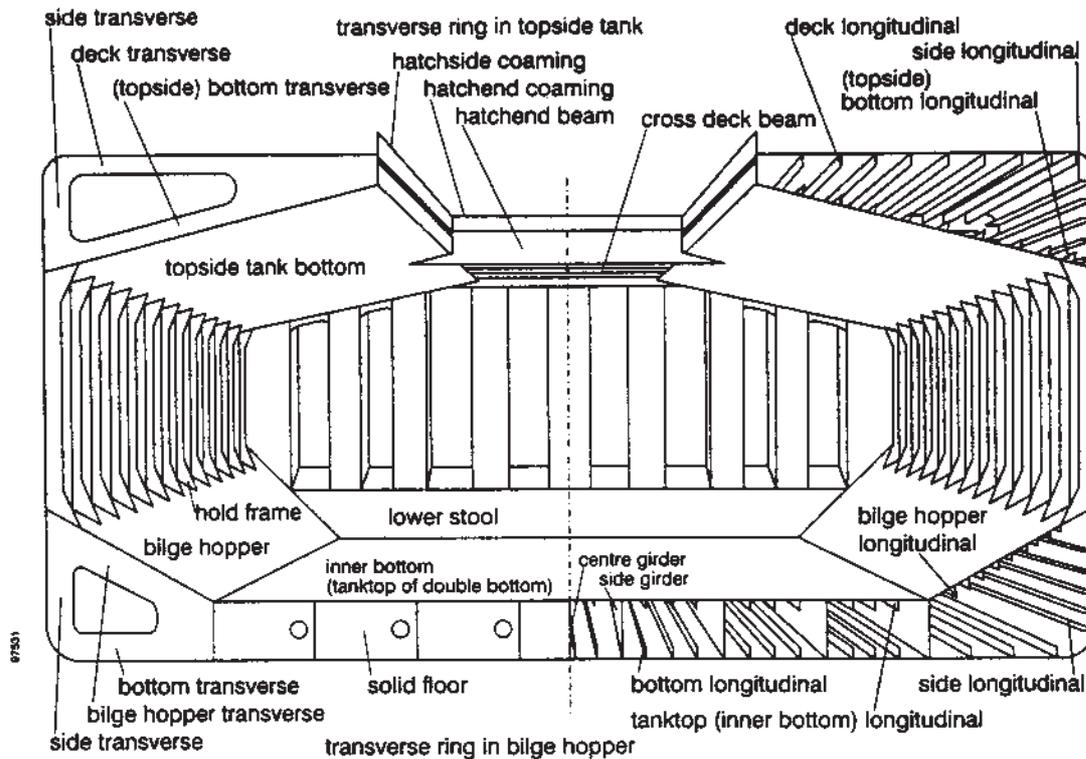
Figure 2 - Typical cross-section of cargo ship (bulk carrier)

4.7 *Framing of various kinds*: on a typical bulk carrier, framing is designed as a longitudinal system in topside and double-bottom tanks and as a transverse system at cargo hold side shell. Framing fitted in ship's longitudinal direction are called 'longitudinals'. To identify them in detail, the name of the plate they are attached to is added, such as 'deck longitudinals', 'side longitudinals', 'bottom longitudinals', etc. Framing attached to the side shell in the cargo holds are called 'hold frames', 'side frames', 'main frames', 'shell frames', etc.

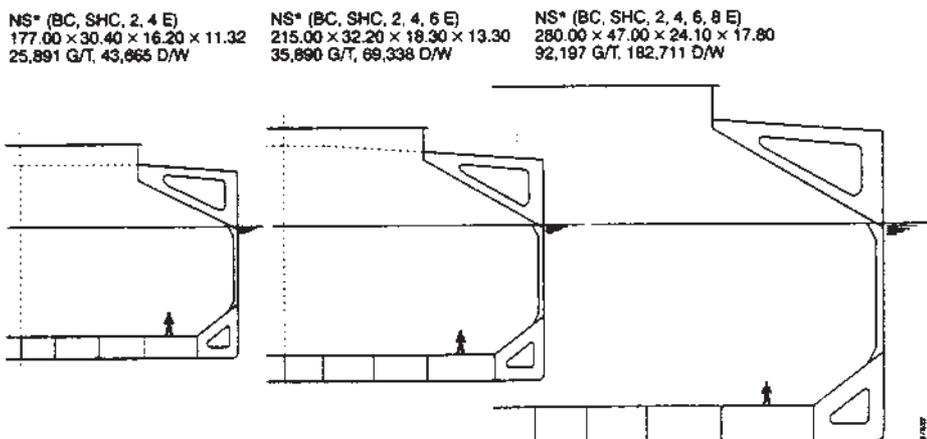
Figure 3 - Various bulk carriers

5.1 In general, bulk carriers are grouped into three categories according to size. These are: capesize, panamax, and other smaller types. Among the smaller types, ships of 30,000 to 45,000 dwt having five cargo holds are called 'handy bulkers'. Panamax bulkers are bulk carriers having a breadth of 32.2 m, and are the largest ships able to transit the Panama Canal. Ships of this kind usually have seven cargo holds and a deadweight of around 50,000 to 60,000 tonnes. Bulk carriers with dimensions greater than the panamax ships are called 'capesize bulkers'. Capesize bulkers have nine or more cargo holds and a deadweight in excess of 100,000 tonnes.

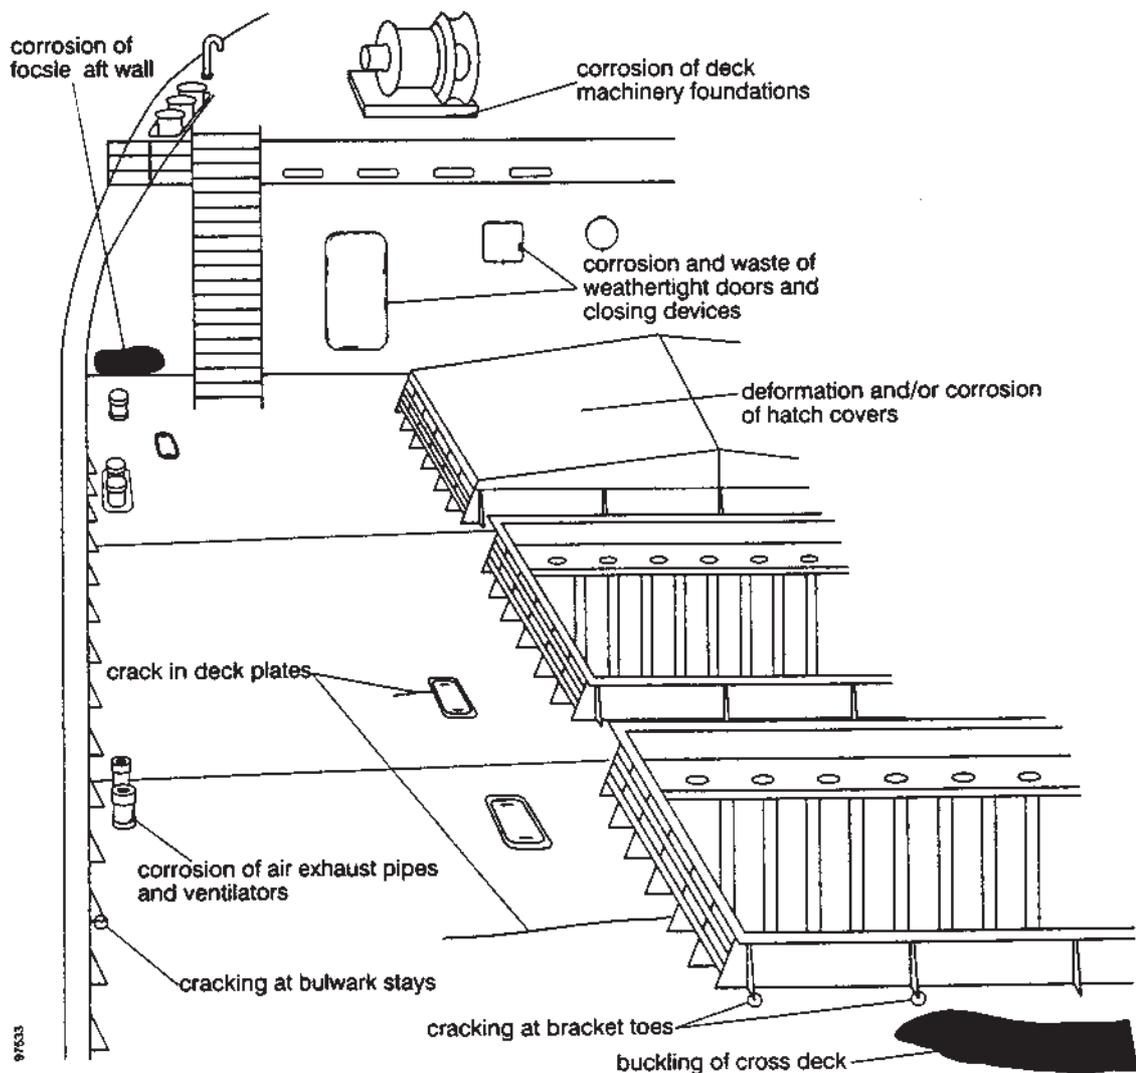
Figure 4 - Check points on the upper deck

6.1.1 The longitudinally continuous upper deck of a bulk carrier suffers hull girder stress. The longitudinal bending causes an axial force on the upper deck that may cause cracking of the deck plate at the locations where the stress is concentrated.

6.1.2 Bulk carriers have cargo hatchways for the convenience of cargo-handling facilities. These hatchways reduce the ship's torsional strength and invite concentrated stress at the hatchway corners which may be evident by cracking of the deck plates in these areas.

6.1.3 Cross-deck strips come under stress by transverse bending. The transverse bulkheads provide transverse strength to a bulk carrier and the cross-deck strips provide the strength to withstand the resultant axial forces in a transverse direction.

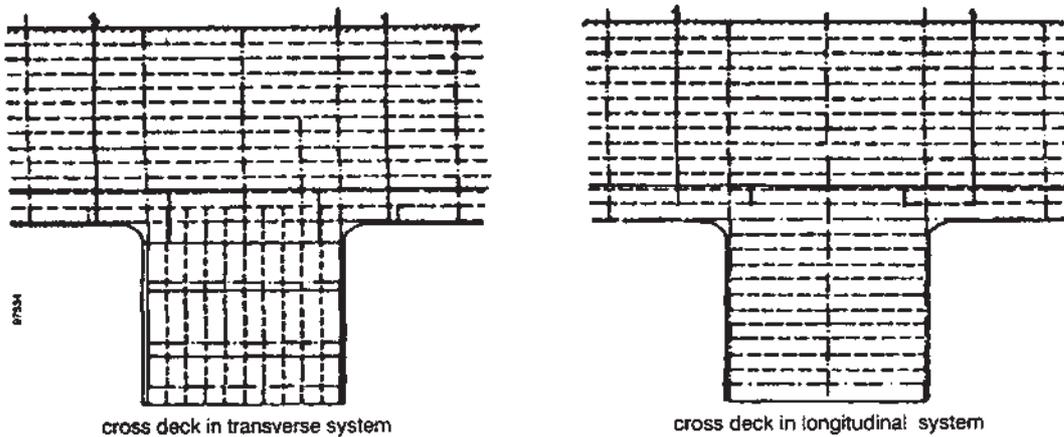
Figure 5 - Comparison of stiffening systems for cross decks

6.1.4 Generally, longitudinal beams are arranged under the longitudinally continuous upper deck outboard of the side lines of the cargo hatchways. This is called the longitudinal system. When the deck beams for cross-deck strips are also arranged in this manner, buckling of the cross-deck strips may take place due to insufficient strength against the axial forces acting on them in a transverse direction. The transverse system is the preferred method of construction for cross-deck members. Particular attention should be given to buckling of the main deck on those ships where the cross-deck strips are arranged in the longitudinal system.

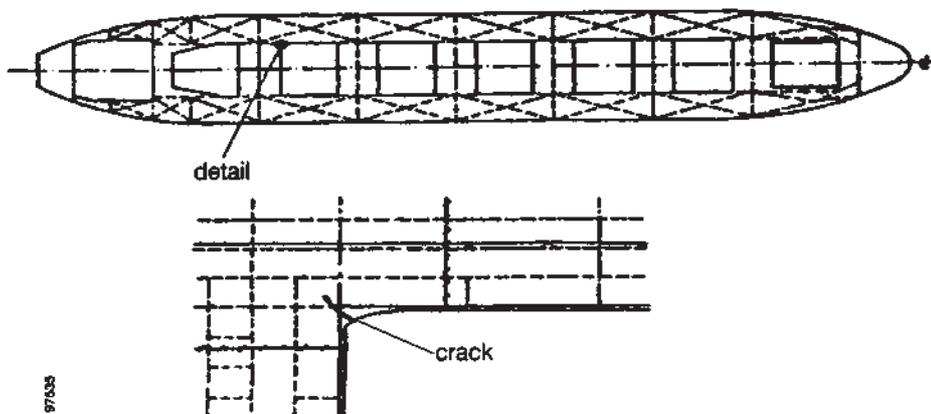
Figure 6 - Cracking at hatchway

The large cargo hatchway openings reduce the torsional strength of the hull and invite stress concentration at their corners on the upper deck. In this regard, upper deck plating at hatchway corners is one of the focal points for cracking. Particular attention should be paid to these areas during inspection.

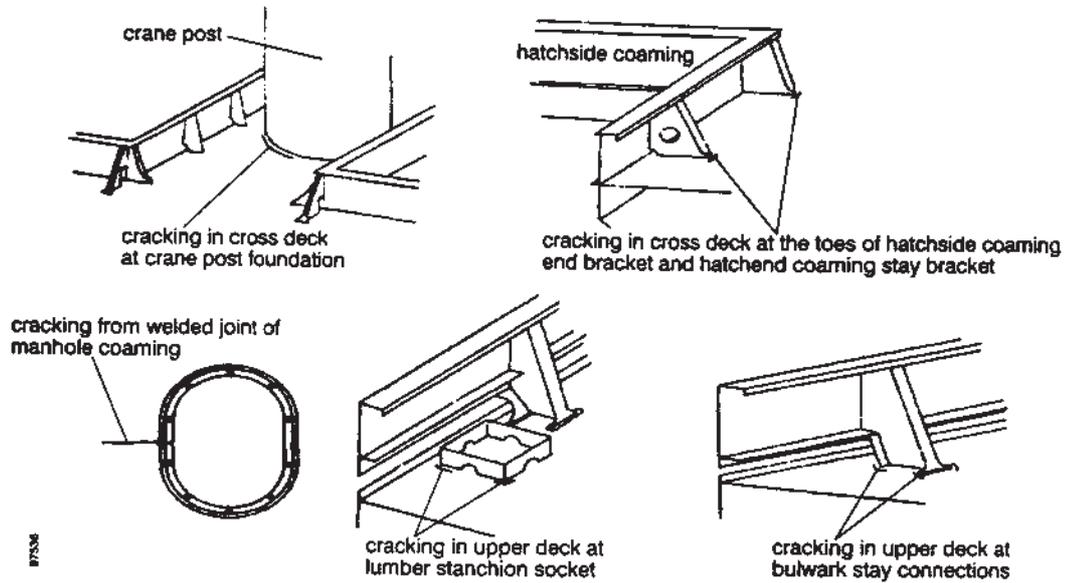
Figure 7 - *Various crackings in upper deck plating*

Various metal fittings are welded to the upper deck plating. These installations may cause stress concentrations at the welded joints or have defects in the welds. Deck platings in the vicinity of manholes, hatchside coaming end brackets, bulwark stays, crane post foundations and deck houses, etc. are to be carefully watched for cracking.

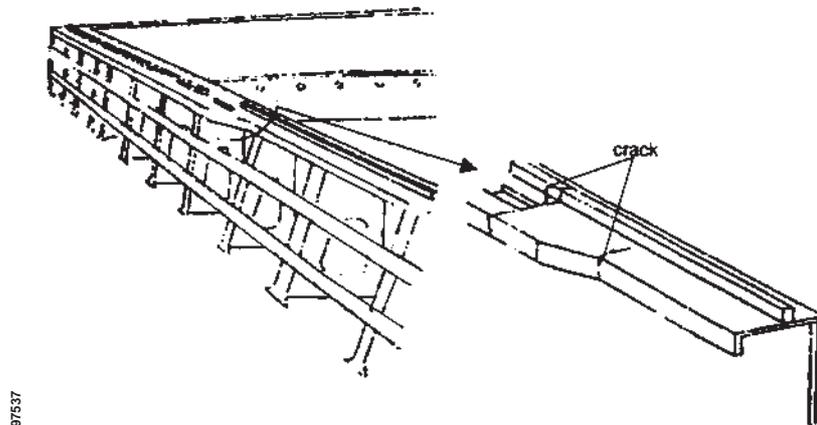
Figure 8 - *Cracking in hatch coaming*

Hatch coamings are subjected to hull girder stress. Although they are not critical longitudinal strength members, they should be watched carefully to ensure that these cracks do not spread. Cracking may be initiated at defects in welded joints and metal fittings to the coamings that will invite stress concentration. Such cracking is considered serious to the ship's safety because it may be the initiation of a fracture on a large scale.

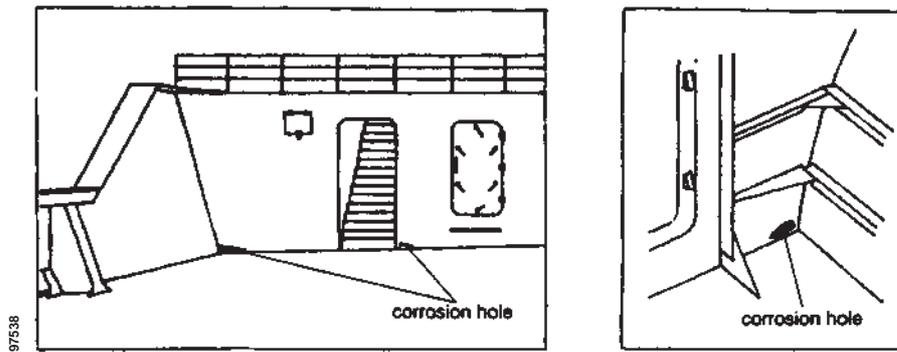
Figure 10 - Forecastle end bulkhead

The bilges in forecastle space may cause corrosion of the bulkhead where it meets the deck. In flush-decked bulk carriers, the boatswain store aft wall may be corroded in the same manner. Large bulk carriers generally do not have forecastle and have their boatswain stores down below the upper deck in forepeak spaces. Bilges left in such spaces also cause corrosion of the aft end bulkhead which separates boatswain store and No. 1 cargo hold. Such wastage may lead to water ingress, cargo damage, cargo shifting, and/or stability problems.

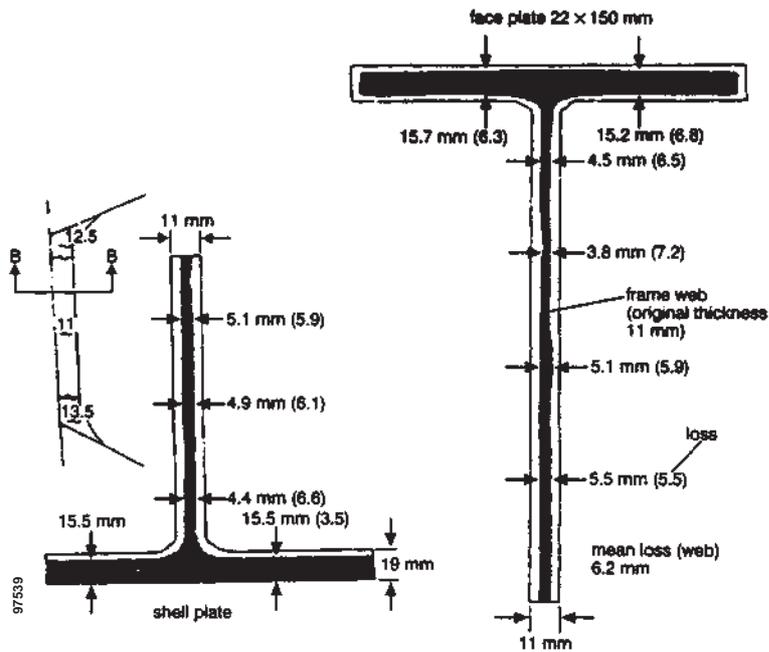
Figure 12 - An example of a corroded hold frame

6.2.4 This may mean accelerated corrosion in the hold frames, the thinnest among all the members in cargo holds. If corrosion and waste become excessive, failure of hold frames invites additional loads to the adjacent ones, which may lead to failure throughout the side shell structure.

6.2.5 Transverse bulkheads may also be susceptible to accelerated corrosion, particularly at the mid-height and at the bottom. Particular care should be exercised when inspecting hold frames and transverse bulkheads, in that these members may appear in deceptively good condition. Tanktop and side shell plating generally corrodes from the steel surface facing the cargo hold and corrosion from inside the double bottom is usually less than that from the cargo hold side.

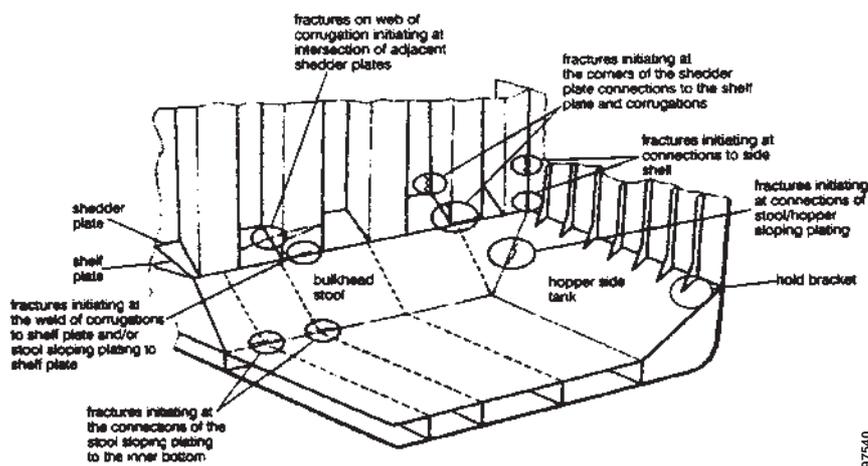
Figure 13 - Typical fracturing at the connection of transverse bulkhead structure

- .1 *Fractures* at the boundaries of corrugations and bulkhead stools, particularly in way of shelf plates, shedder plates, deck, inner bottom, etc.
- .2 *Buckling* of the plating/corrugations, leading to the failure and collapse of the bulkhead under water pressure in an emergency situation.

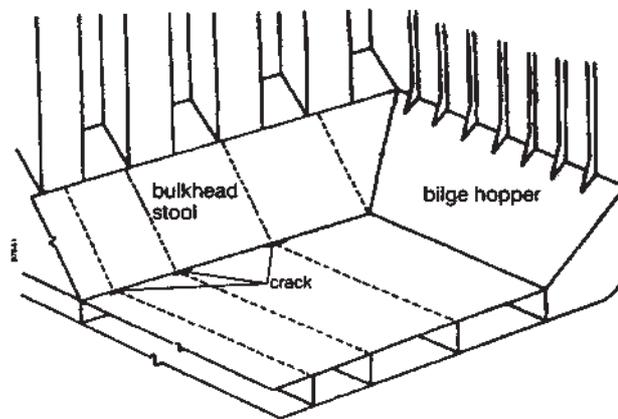
Figure 14 - *Cracking at the connection of bulkhead stool and tanktop*

In bulk carriers having combination cargo/ballast holds, cracks may often be found at or near the connection of the stool of the transverse bulkhead and the tanktop.

All capesize and panamax bulk carriers and some handy bulkers have combination cargo/ballast hold(s) to keep the necessary draught. The bulkhead boundaries of the spaces are designed to comply with the requirements for deep-tank bulkheads. In these holds cracks may often be found at the connection between the transverse bulkhead and the tanktop. These cracks can be detected by visual inspection or by noting leakage from the double-bottom tanks.

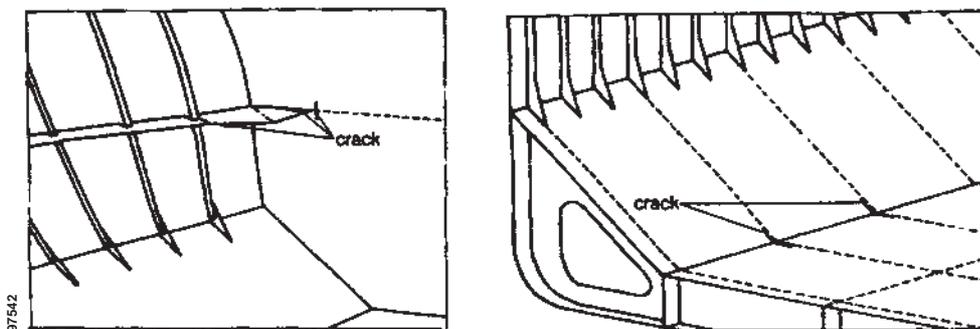
Figure 15 - Cracking around the collision bulkhead    Figure 16 - Cracking in the bilge hopper

Side stringers and/or side shells in way of No. 1 cargo hold along the collision bulkhead are often found cracked. This kind of damage is considered to be caused by insufficient continuity between forepeak construction and cargo hold structure.

On large bulk carriers such as capesize and panamax bulkers, bilge hopper plating around the knuckle line may be cracked along the bilge hopper transverse webs. This is considered to be caused by insufficient local reinforcement.

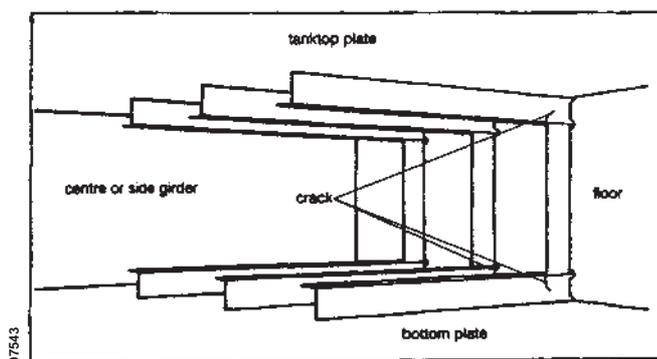
Figure 17 - Cracking in tanktop/bottom longitudinals

Cracks may be found in the side, bottom and/or tanktop longitudinals at intersections with solid floors or bilge hopper transverses. Cracks also may be found in the floors or transverses occurring at the corners of the slots cut for longitudinals.

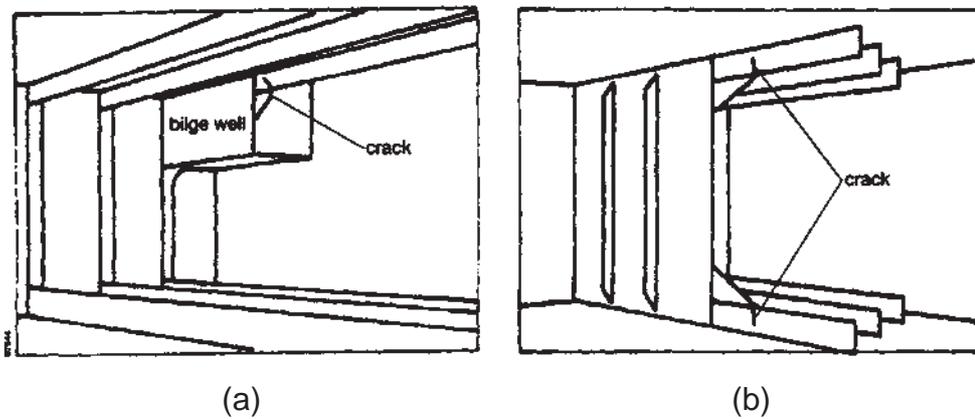
Figure 18 - (a) Cracking at the end connection with side walls of bilge well; (b) Cracking at the end of an additional girder.

Longitudinals may be cracked at the ends of additional (partial) side girders provided in the double bottom below cargo hold bulk heads or at the side walls of bilge wells for cargo holds, due to additional stress concentration caused by the structural discontinuity at those connections.

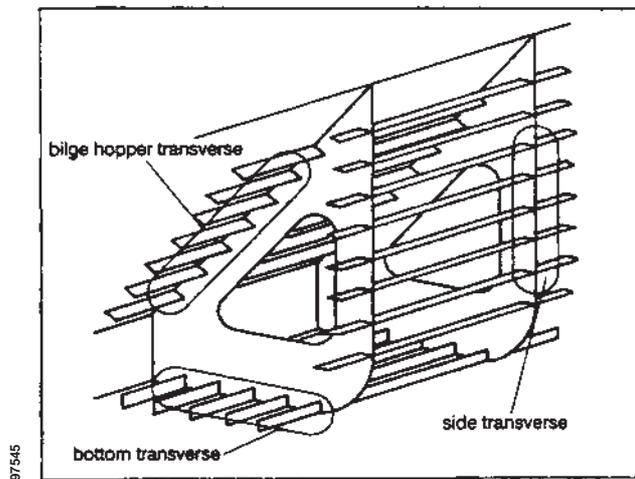
Figure 19 - Check points in bilge hopper transverse

Cracks may be observed in transverse webs in bilge hoppers initiating from the slot openings for longitudinals and at the knuckled corners of the lower ends of the hoppers.

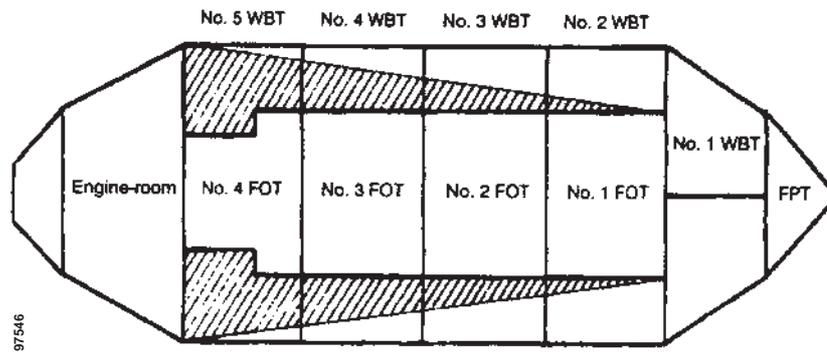
Figure 20 - Areas where heavy corrosion due to heat effect may be found (hatched areas)

Since the late '70s, problems with heavy corrosion in double-bottom water ballast tanks adjacent to fuel oil tanks have appeared. In some cases, the corrosion was worse in areas closer to the fuel oil tank boundaries. In those ships, fuel oil tanks were installed.

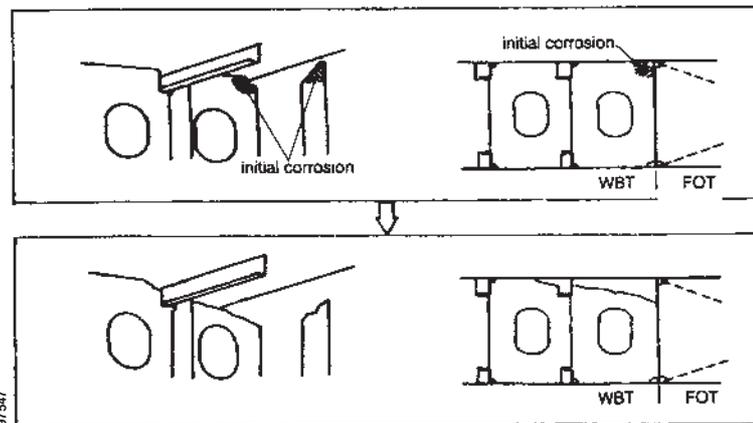
Figure 21 - Progress of corrosion in water ballast tanks adjacent to fuel oil tanks (FOT)

The fuel oil heating system was adopted following changes to the properties of fuel oil, mainly an increase in viscosity. For economic reasons, ship operators began to use low-grade bunker oil which needs heating in order to decrease the viscosity. At the beginning of this trend, the temperature required in the fuel oil tanks was not high enough to accelerate the corrosion of the steel in the adjacent spaces. However, in recent years, the grade of bunker oil being used requires the temperature in the tank to be 80°C or more. Such a temperature can accelerate corrosion of the steel in the tanks, particularly in the vicinity of the boundaries of the fuel oil tanks.

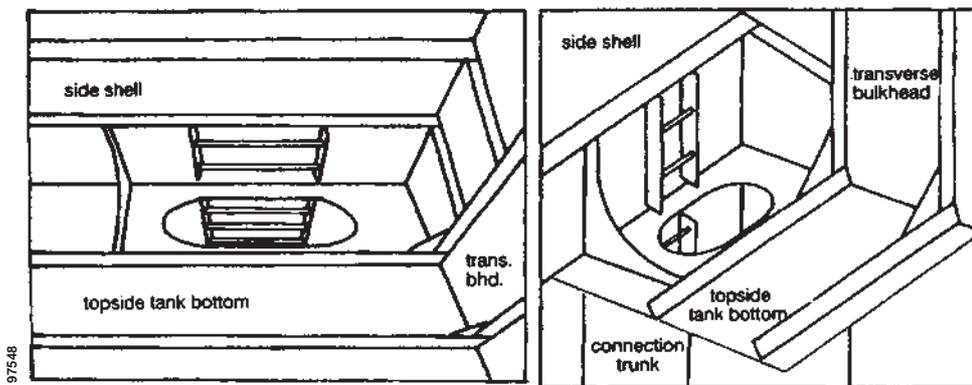
Figure 22 - Connection trunk entrance in topside tank

6.5.2 Connection trunks provided between topside and bilge hopper spaces are to be carefully watched for signs of corrosion and waste of the steelworks inside.

6.5.3 On some bulk carriers, bilge hopper tanks and topside tanks form one integral tank connected with trunk spaces. The inside surface of a connection trunk is liable to corrosion and should be examined carefully.
