Toe structures management manual

Project: SC070056/R

Coastal structures, structure toe, asset management, condition assessment, beach, scour

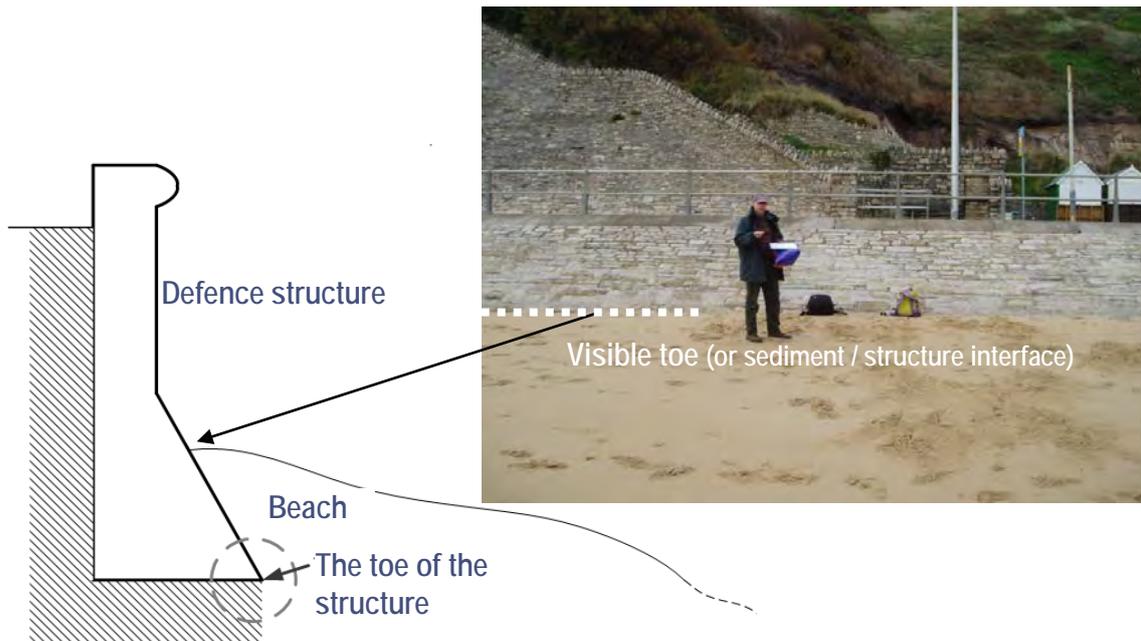
The toe of a coastal defence structure is shown in Figure 1.1.

Figure 1.1 Definition of the structural toe of a defence as opposed to the 'visible' toe

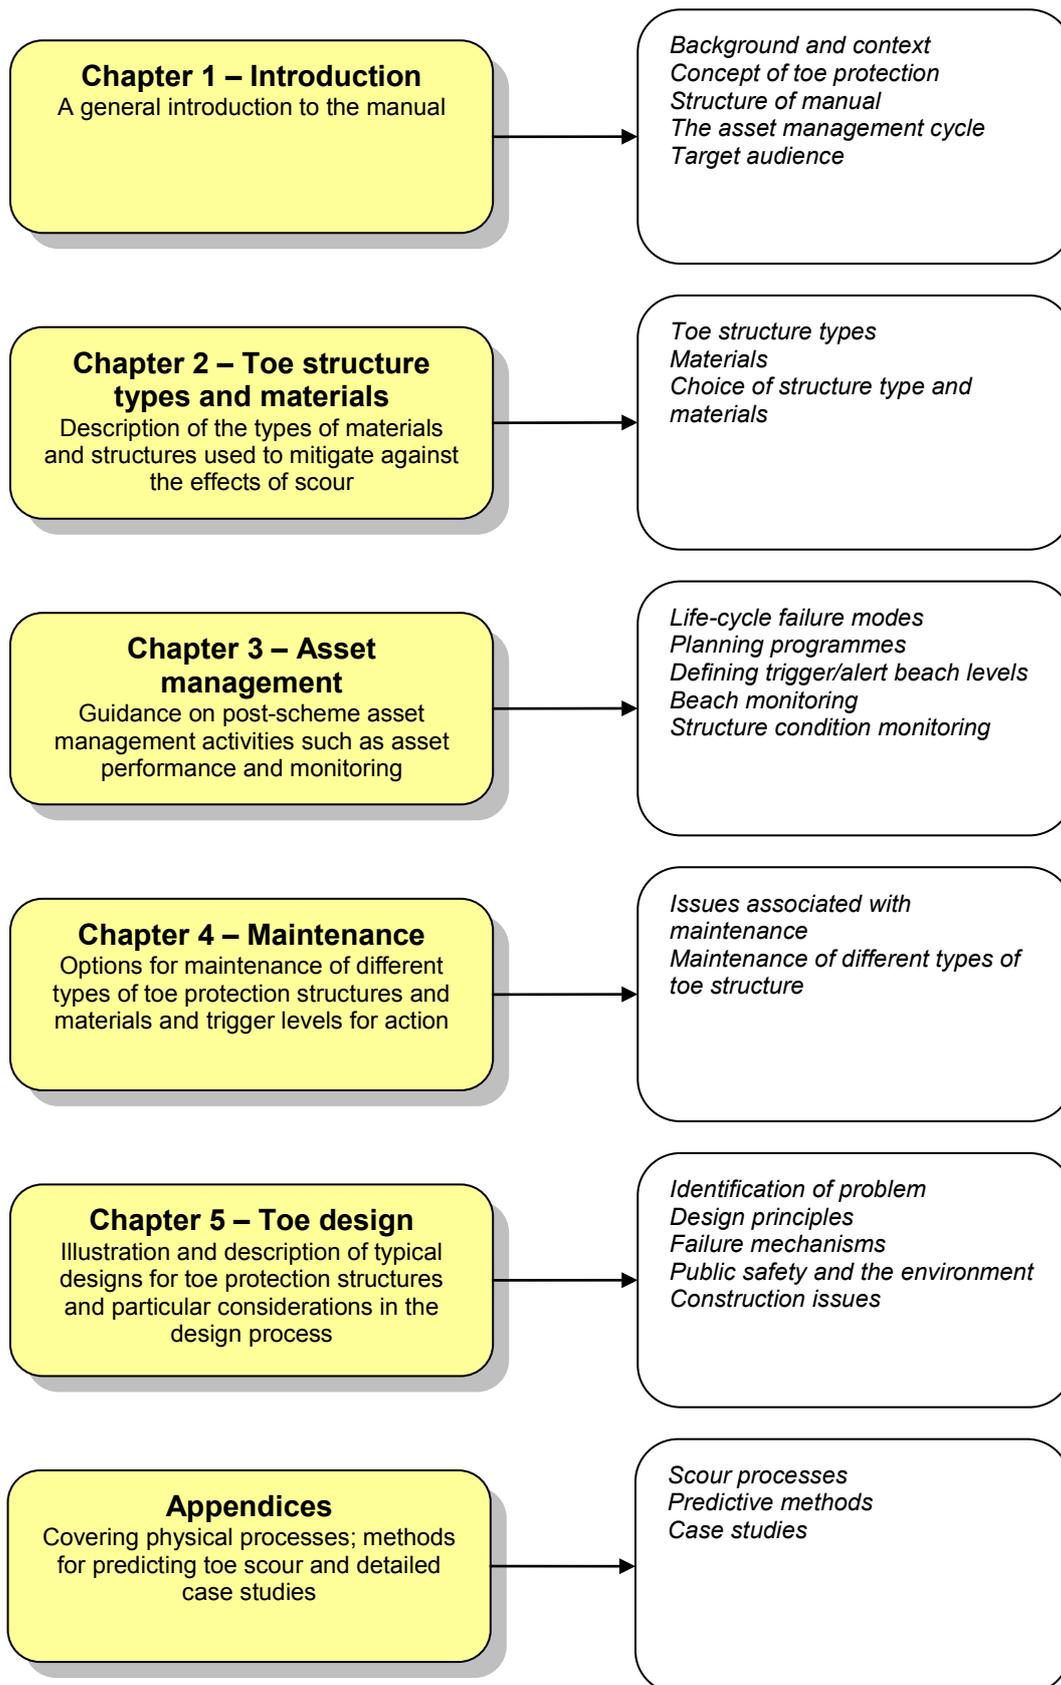
The manual provides information on the key aspects of the management of toe structures as depicted in Figure 1.2, which summarises the contents of the manual's chapters. Throughout the manual, reference is made to case studies from around the UK. These are detailed in Appendix C.

Figure 1.2 Layout of the guide

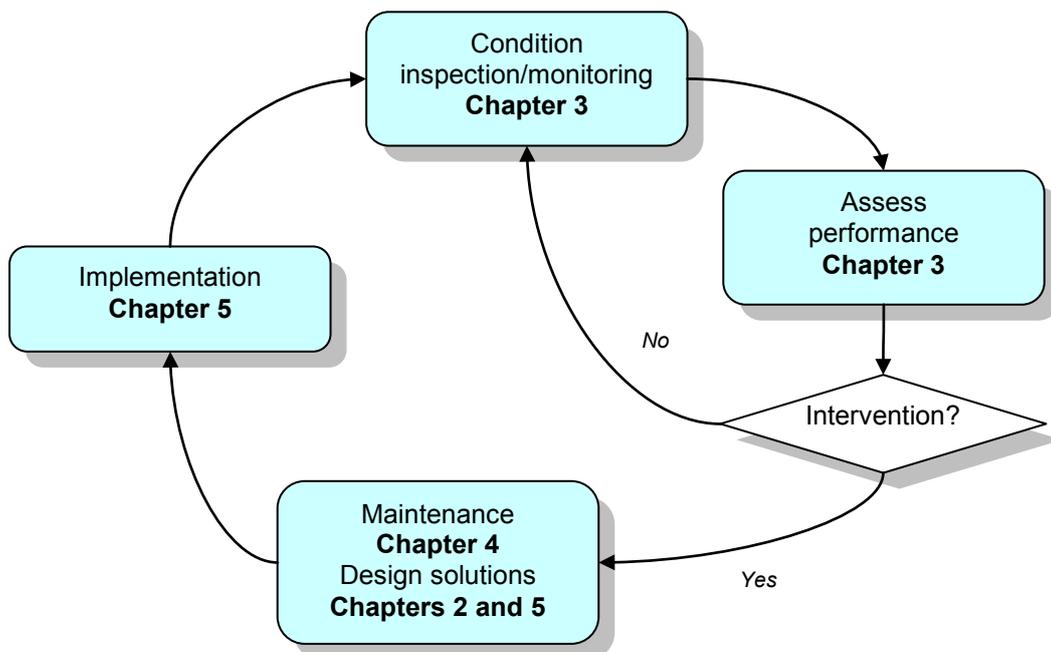
This manual provides information and guidance on the toe protection of coastal defences for practitioners, engineers, designers and managers whose responsibilities may span the life cycle of these structures. Figure 1.3 illustrates how key decision-making and management actions feature in the asset management cycle and indicates where the reader can find relevant information on particular topics in the manual.

Figure 1.3 Document information in relation to the asset management cycle

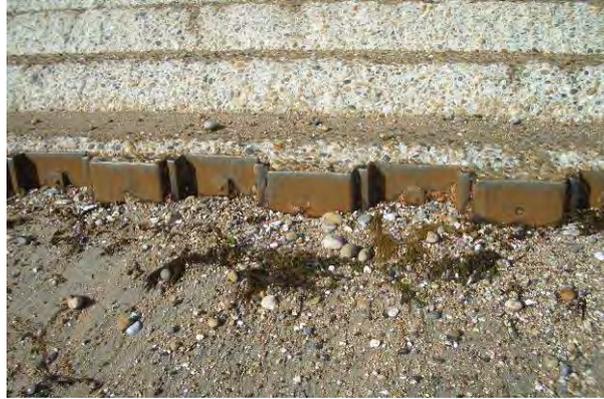
Steel sheet piling is a common means of securing a defence against the threat of undermining (Figure 2.1). This technique is commonly used to stabilise foundations and reduce loss of fill materials, thus prolonging the life of the overall defence.

Figure 2.1 Underpinning of seawall toe with steel sheet piles (courtesy HR Wallingford)

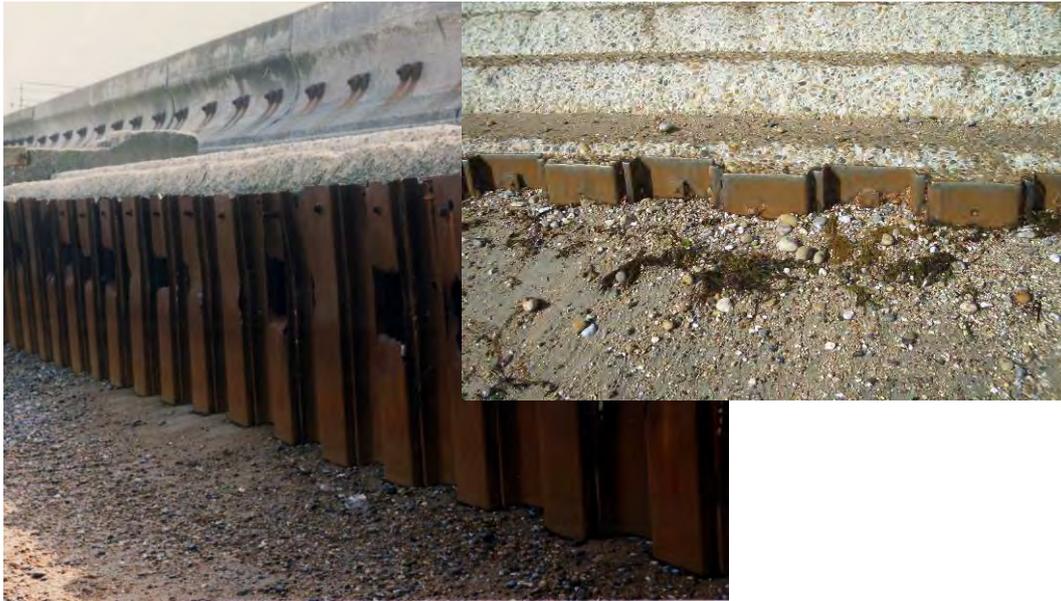
Figure 2.2 shows a further example of the use of sheet piling.

Figure 2.2 Sheet pile underpinning

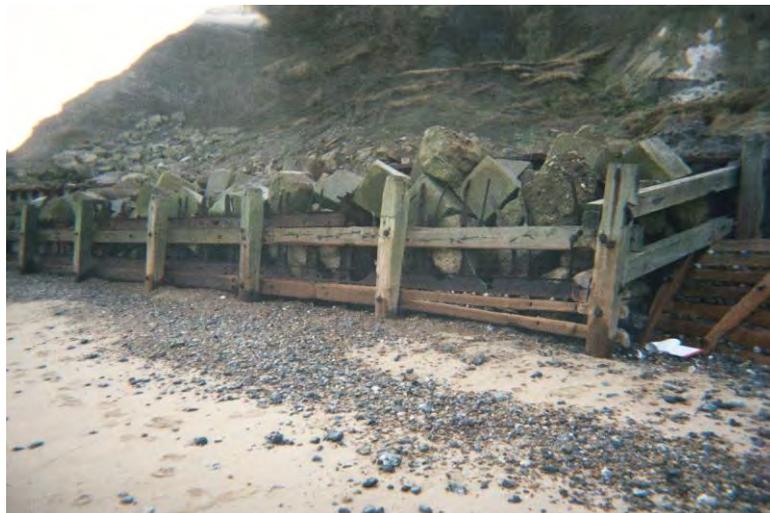
Cribwork is a low-cost form of coast protection comprising rock-filled cages formed by piling and fabricating timber lattices into a continuous structure (Figure 2.3). In essence, they are not dissimilar to gabions except that they are made out of timber or possibly reinforced concrete. Cribwork can protect the toe of defences by absorbing wave energy and preventing scour of beach material and undermining of the structure.

Figure 2.3 Cribwork and concrete block fill, Norfolk (courtesy of North Norfolk District Council)

Timber has been used in cribwork (see Figure 2.3). Timber planks were often used as pilings to seawalls before the introduction of steel piles.

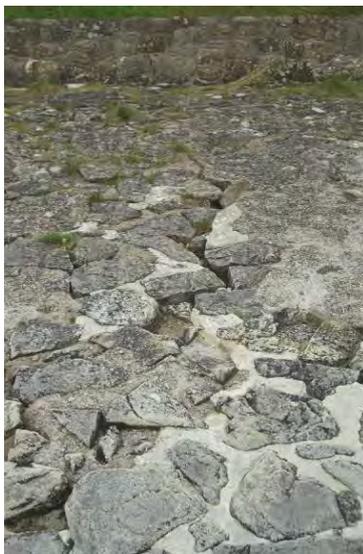
Figure 2.4 Extensive crack in masonry toe (courtesy HR Wallingford)

As soon as deterioration of the toe is identified, steps should be taken to repair the damage before it spreads. In this case, the use of replacement masonry is clearly an option as it offers durability and lack of visual intrusion. This is particularly important if the wall is a listed structure. However, before selecting the option, the cause of the problem (for example, whether it is the result of long-term beach lowering, a severe event or progressive attrition of the previous blockwork) should be determined to identify whether mere reinstatement of the blockwork is sufficient or whether additional measures (such as toe piling) are warranted. Care must be taken to ensure that any voids in the backfill are filled and that the replacement blocks are well founded.

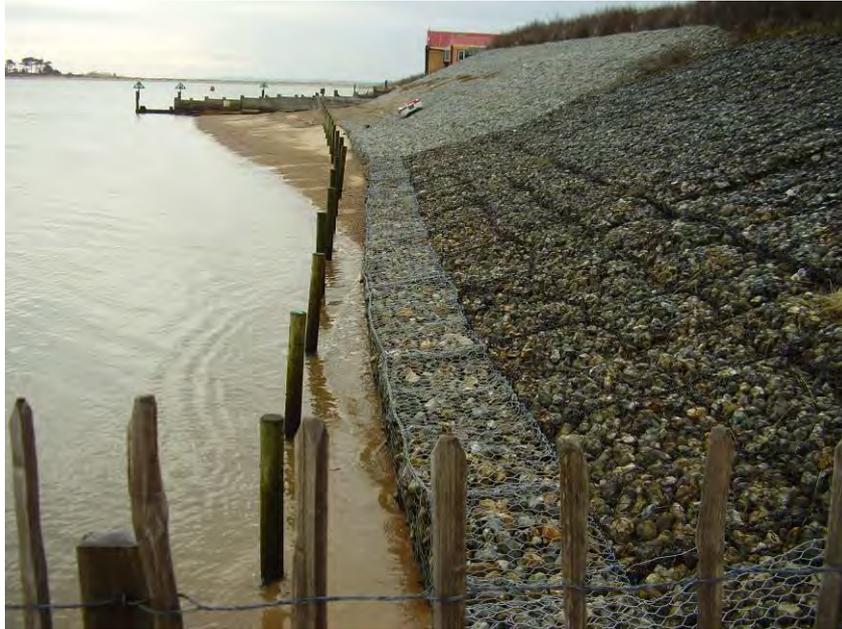
Gabions consist of steel mesh forming baskets that are filled with stones (Figure 2.5). They are available either as gabion boxes (and can be used as a flexible toe), or as mattresses (in which case they are used as a sloping apron where their flexibility allows them to accommodate beach lowering with time).

Figure 2.5 Gabion baskets of rock (courtesy HR Wallingford)

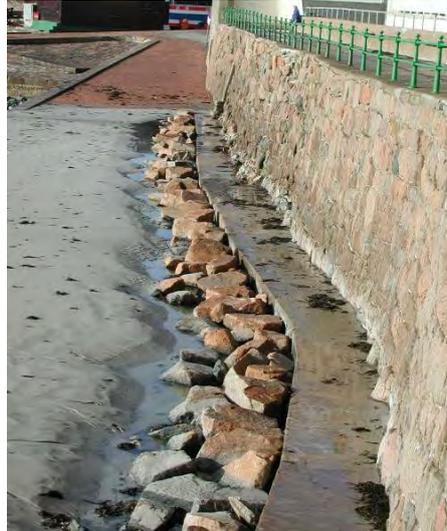
A modest amount of rock placed at the toe of a defence structure may serve to protect its toe from undermining, reduce the abrasion of its front face and even modify the hydraulic performance of the overall defence (Figures 2.6 and 2.7). The latter can result in changed overtopping or different loads on the defence. However, the introduction of the rock toe has at times **increased** overtopping, so it must be carefully considered in the design process. In addition, there are sometimes concerns about the impacts on aesthetics, access and public safety especially where such schemes are installed on beaches of high amenity and recreational usage.

Figure 2.6 Rock infill of scour trough, Le Dicq, Jersey (courtesy HR Wallingford)

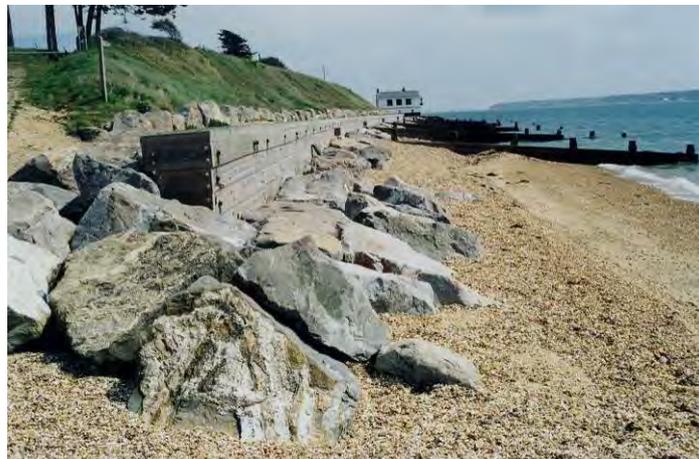
Figure 2.7 Timber bulkhead with rock toe protection at Lepe, Hampshire

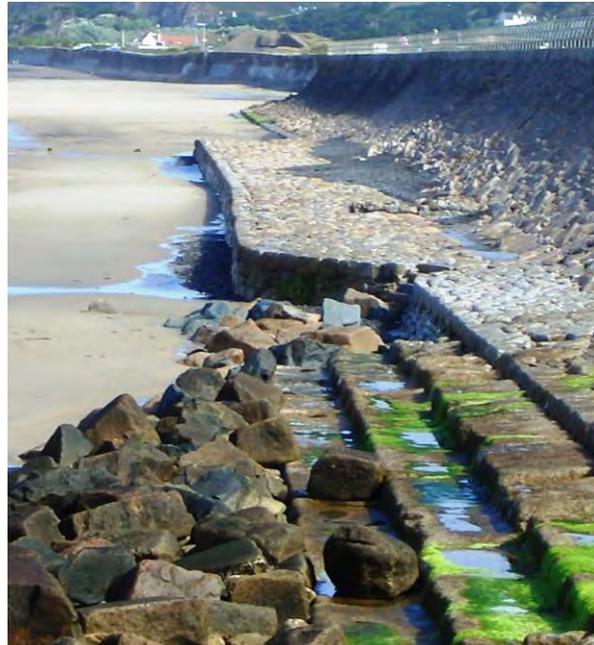
The construction of an apron or steps at the base of an existing structure (Figures 2.8 to 2.10) can prolong the life and add amenity value to the defence, albeit at the expense of losing an area of the beach. This can be achieved at much reduced cost compared with rebuilding the defence entirely. Such additions to a structure will extend it seaward. There is a perceived danger that such seaward extensions of a structure will interfere with longshore sediment transport and hence reduce sediment supply to downdrift beaches. However, this must be put in perspective given the very small extent of the structural intrusion compared with the width of the seaward extent of active sediment transport.

Figure 2.8 Extended scour apron, masonry steps and armour, St Ouens Bay, Jersey (courtesy HR Wallingford)

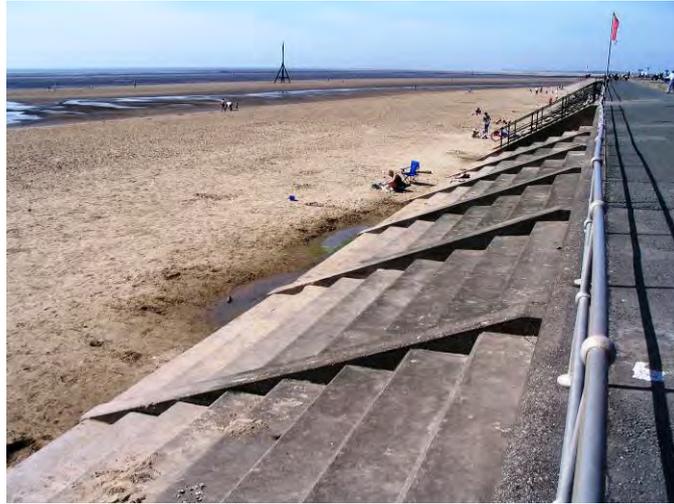
Figure 2.9 Concrete stepped revetment, Crosby, UK (courtesy Sefton Council)

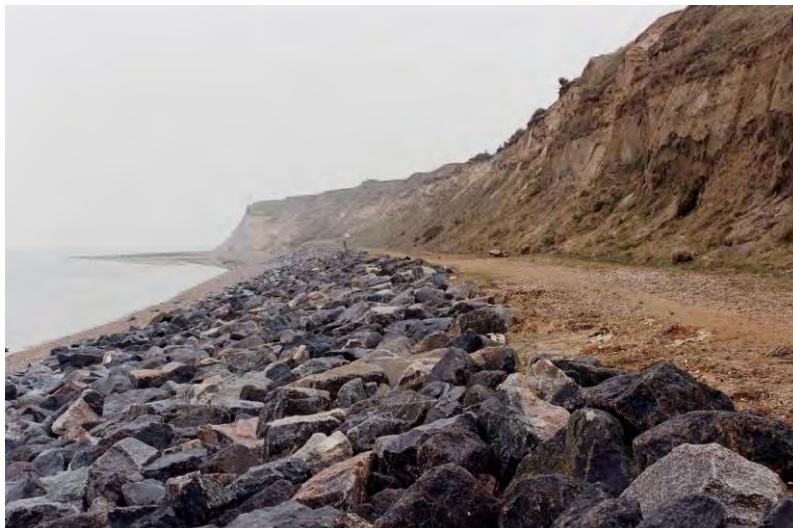
Figure 2.10 Supplemental rock armour revetment (courtesy of HR Wallingford)

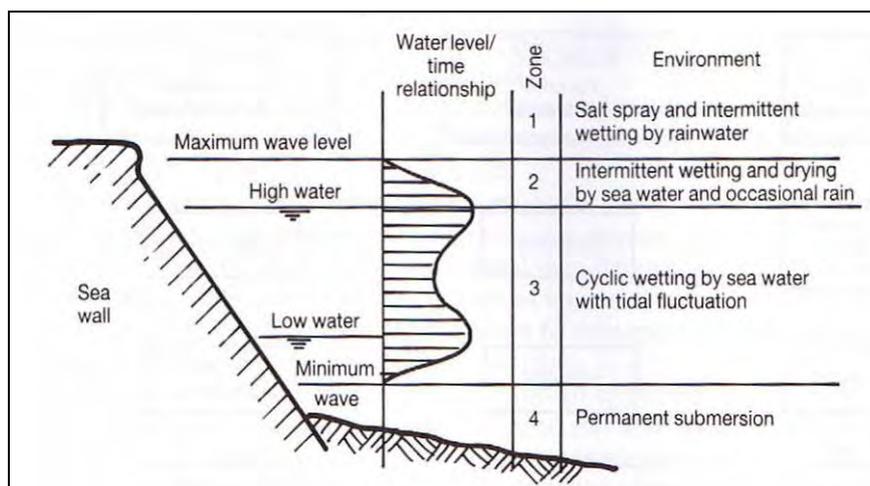
Figure 2.11 shows a seawall demarked into different zones designated 1 to 4 where Zone 1 is at the crest of the wall and Zone 4 is at the lowest level. Depending on the position of the structure in the foreshore, the toe could lie either in Zone 3 (if it is above low water) or Zone 4. These broad demarcations provide a useful reference in the discussions which follow.

Figure 2.11 The weathering zones of a seawall (from Thomas and Hall 1992)

Upper rates of steel loss by corrosion and abrasion are listed by Thomas and Hall (1992). This reference indicates that, depending on the circumstances, the contribution to material loss by abrasion can be considerable, for example up to 85 per cent (of 1 mm per year) in Zone 3 (Figure 2.11) where steel is exposed to a high percentage of gravel and a severe wave climate.

In the case of reinforced concrete, corrosion of steel reinforcement causes the bars to expand leading to fracture and bursting of the concrete (spalling) (Figure 2.15), possibly leading to failure. After spalling, the reinforcement is even more vulnerable to corrosion through direct exposure to air and water. This process is particularly significant in parts of the structure subject to wetting and drying, as illustrated in Zone 3 of Figure 2.11.

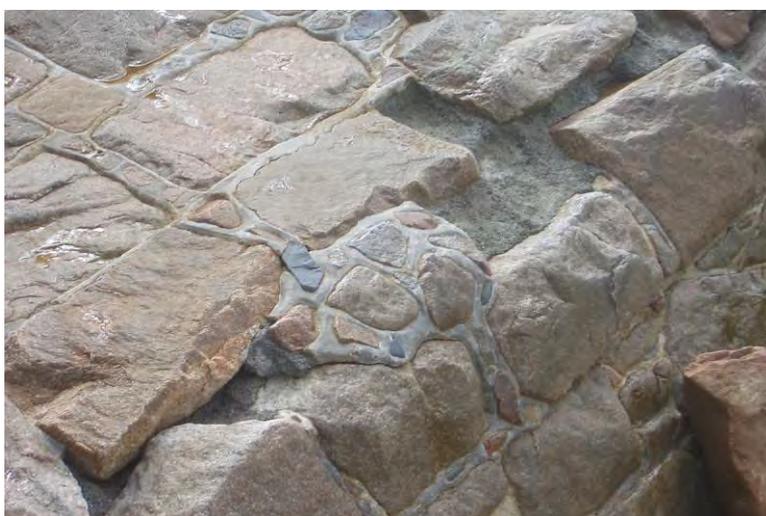
Whereas the term 'rock' is usually applied to loose stone used for armouring a sloping revetment or apron,² the term 'masonry' always refers to stone placed in a compact pattern, usually with a relatively smooth outer surface, often grouted (see Figure 2.12).

Figure 2.12 Grouted stone/masonry (courtesy HR Wallingford)

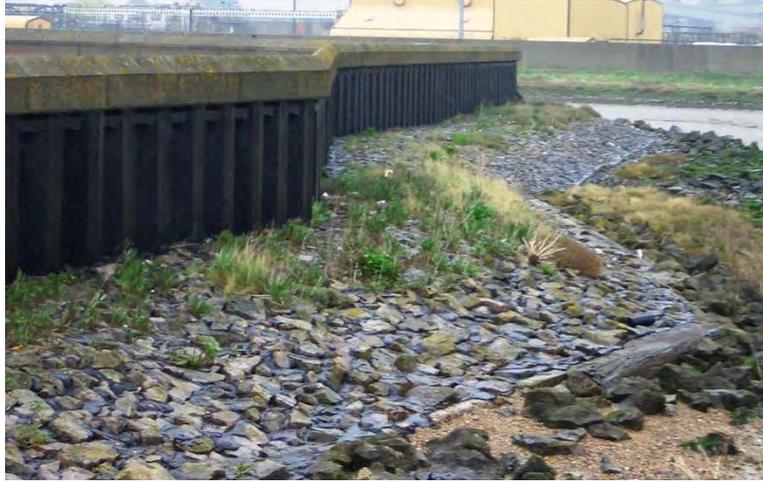
Partial grouting (Figure 2.13) is a reliable and well-established method to meet the requirements for a long-lasting scour protection including sufficient permeability to avoid excess water pressure below the armour layer. Partial grouting means filling the voids in the riprap or stone layer to 35–50 per cent with a special mortar, creating a bonded layer with high resistance and high permeability and sufficient flexibility. Cement-bonded grouting materials are recommended for partial grouting (Heibaum and Trentmann 2010), although the advantages and disadvantages of using asphalt as a binder is discussed in Section 2.3.4.

Figure 2.13 Grouted stone toe apron, Thames Estuary (courtesy HR Wallingford)

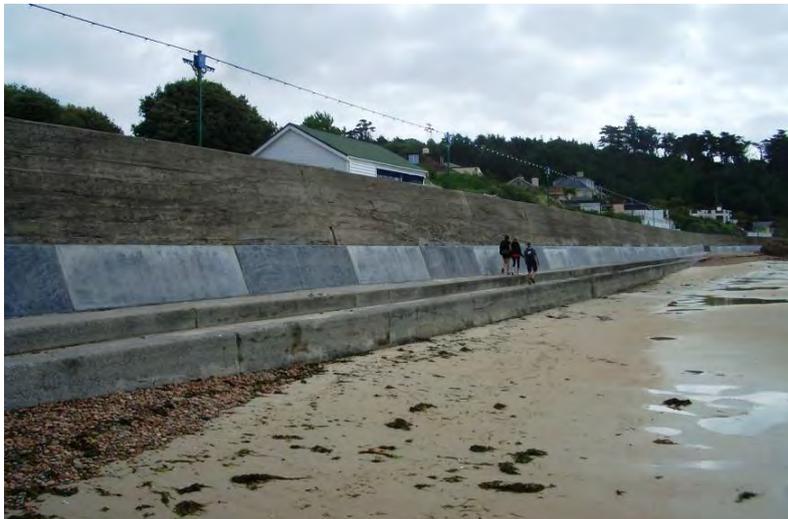
Figure 2.14 Concrete toe beams (courtesy HR Wallingford)

A significant feature of concrete for use in seawalls is that it can be formed to suitable shapes which may be both functional and decorative. The latter attribute is not usually so important in the case of the toe where it is less visible than the upper parts of the structure. Concrete will more commonly be used in toe protection works to provide weight and compressive strength. Figure 2.14 shows an example of the use of concrete toe beams and Appendix C contains a case study describing the use of concrete toe beams for foundation strengthening along the seawall between Dawlish and Teignmouth, South Devon, UK.

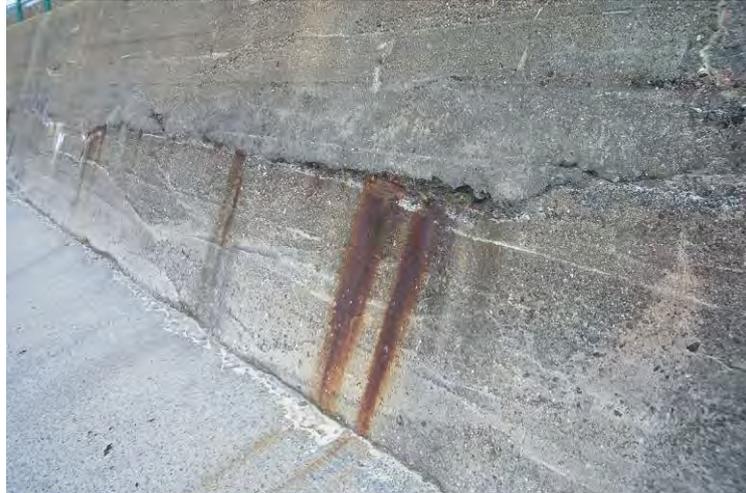
Figure 2.15 Reinforcement rebar corrosion and spalling of concrete (courtesy of HR Wallingford)

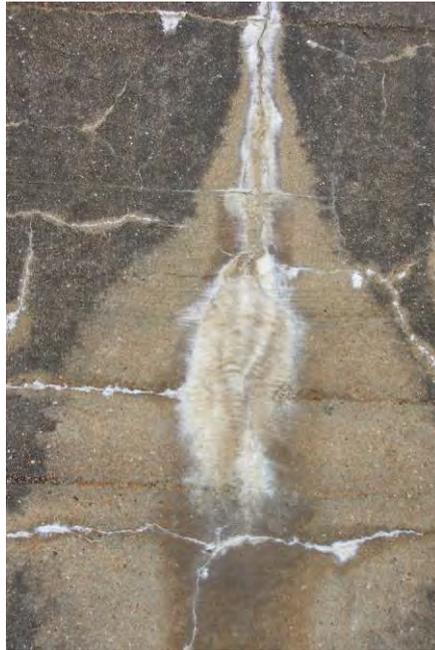
As time goes by and the concrete is subject to repeated cycles of wetting or submergence, chlorides from the seawater penetrate the concrete and reduce its alkalinity. The time for this penetration to seriously affect the steel depends on the thickness of cover and the permeability of the concrete (for example, penetration of 25–75 mm would typically take about ten years). The quality of the concrete is important as chlorides can penetrate very small cracks. Figure 2.16 shows an example of salt deposits with associated cracking, while Figure 2.17 shows the failure of a concrete toe beam on a Jersey beach.

Figure 2.16 Surface salt deposits and associated cracking from alkali–silica reaction in concrete (courtesy of HR Wallingford)

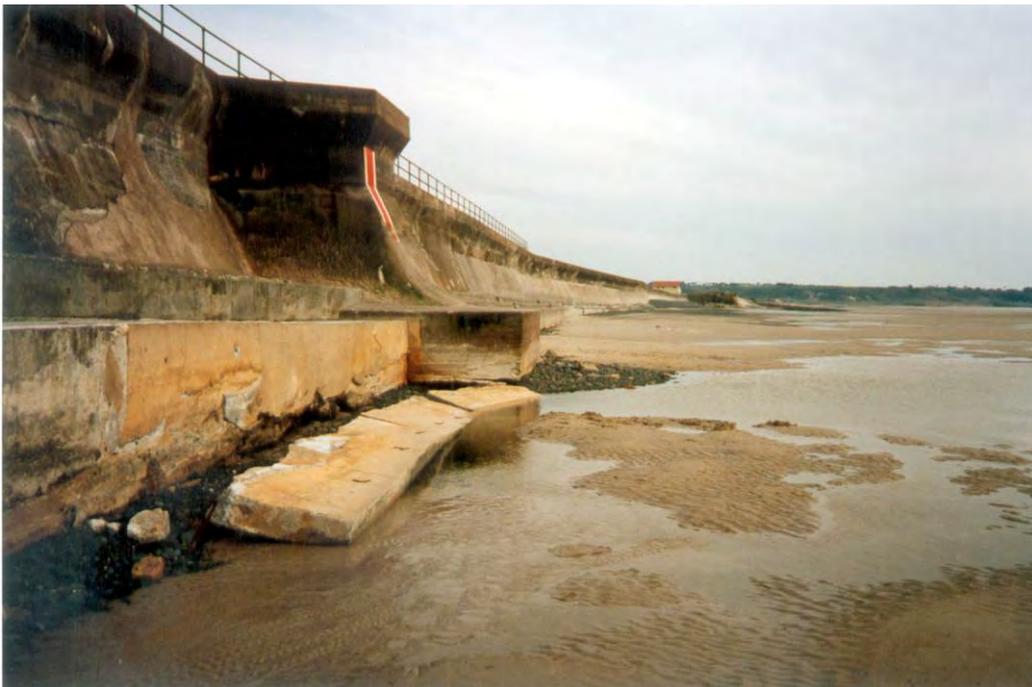
Figure 2.17 Failure of a concrete toe beam at St Ouens Bay, Jersey (courtesy HR Wallingford)

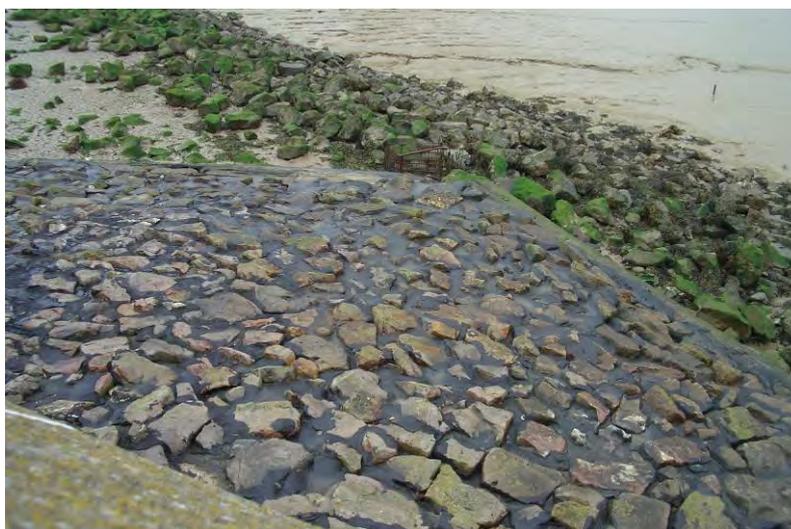
Figure 2.18 shows the use of asphalt to grout a stone revetment.

Figure 2.18 Asphalt grouted stone revetment in the Thames Estuary (courtesy HR Wallingford)

Concrete slopes and steps have been used frequently around the UK and new techniques have been developed, for example, using a sloping asphalt apron (see Figure 2.18) to both protect the original structure against undermining and abrasion, and to reduce wave overtopping.

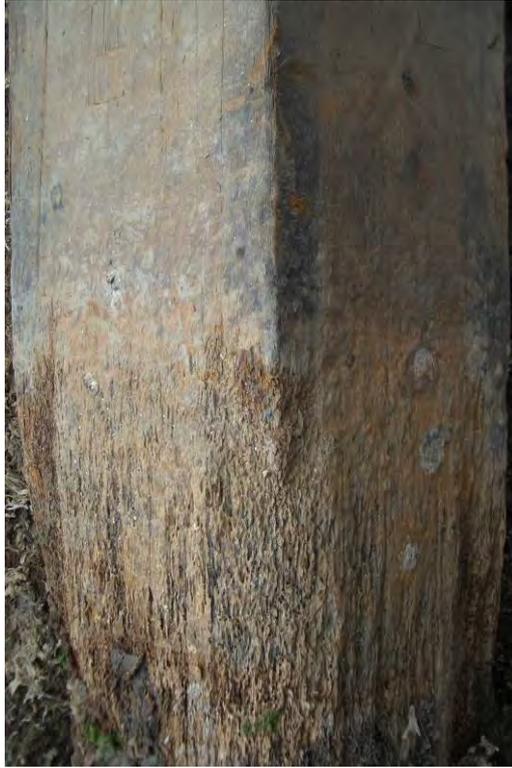
Figure 2.19 Gribble attack on Timber pile at the sediment line (courtesy of HR Wallingford)

(Figures 2.19 and 2.20) and 'Teredo'. Gribble attacks the surface of exposed timber, mainly below mean tide, penetrating a few millimetres below the surface, whereas Teredo destroys the internal composition of the wood. Both gribble and Teredo are encouraged by clean warm water discharges and are less prevalent in more polluted environments. The more durable hardwoods used for marine construction tend to be resistant to biological attack and are thus able to provide a good service life in excess of 20 years or much longer in certain cases.

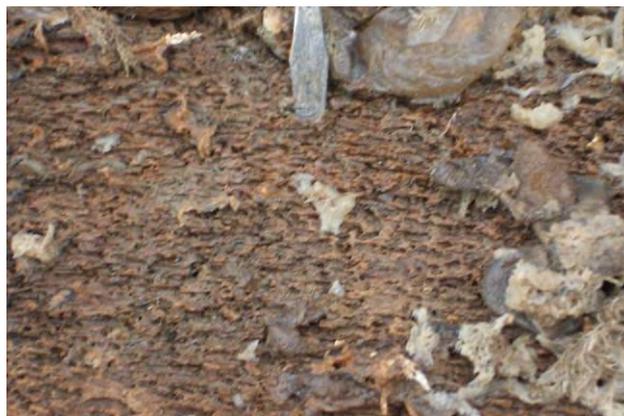
Figure 2.20 Close up of gribble damage to timber (courtesy of HR Wallingford)

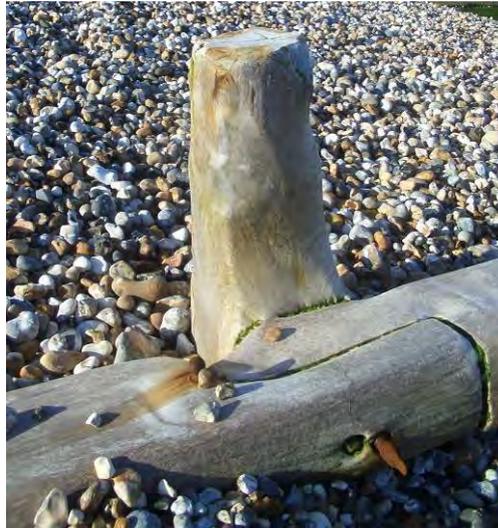
Figure 2.21 Rounding of groyne timbers by beach shingle (courtesy HR Wallingford)

- **Abrasion.** Persistent abrasion by both sand and shingle has the effect of rounding off the corners and details of timber in the sea (Figure 2.21). As this effect tends to be concentrated close to the bed where sediments move more, the abrasion tends to be concentrated over a short length – a feature

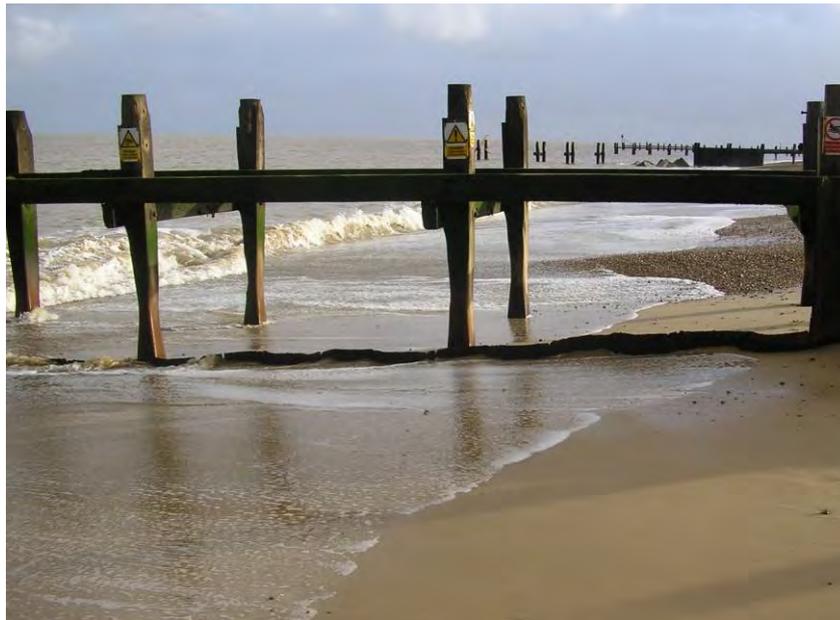
Figure 2.22 Necking in derelict timber piles (courtesy ENBE)

sometimes referred to as necking (Figure 2.22). Evidence of necking high above the bed can be indicative of a low beach (compared with normal or former times).

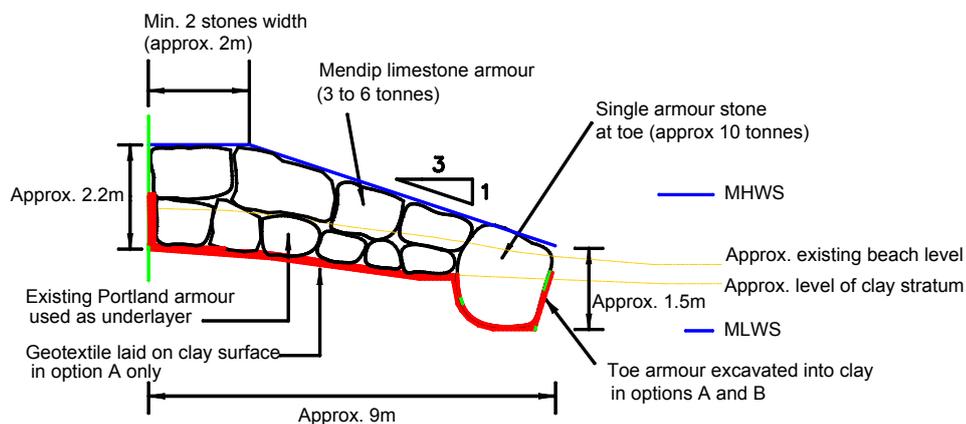
The most complex design (A) is illustrated below and includes both geotextile and excavation for the toe rock. The intermediate design (B) omitted the geotextile and the least complex (C) did not include any geotextile or toe excavation.

Three different designs, representing varying degrees of complexity, were built with the time taken and ease of construction monitored. The performance of the different designs will be assessed during future monitoring.

Potential savings afforded by the designs were discussed with the contractor prior to the works being undertaken and observed on site. The toe of the structure was found to be critical since this is most affected by weather and the 'tidal window'. Construction of the slope could occur on a rising tide providing the toe had been placed properly. The time saving resulting from the omission of geotextile was relatively small (approximately 30 minutes for the 20 m section of revetment) and savings were found to be minimal since the same plant (one tracked excavator with a bucket and one with a rock grab) were required on standby for the whole of the work. The omission of an excavated toe provided a further saving of 10 minutes; however, again both excavators were still needed as the mobile beach had to be profiled even though the toe was not excavated into the clay.

The least complex section did, however, provide significantly more flexibility in construction which enabled work to be carried out during neap tides and in poor weather conditions. This provided minimal savings in the example, but could have had a significant benefit, enabling programme to be maintained, during more extensive works. However, the savings made during construction must be gauged alongside the longer term performance of the scheme.

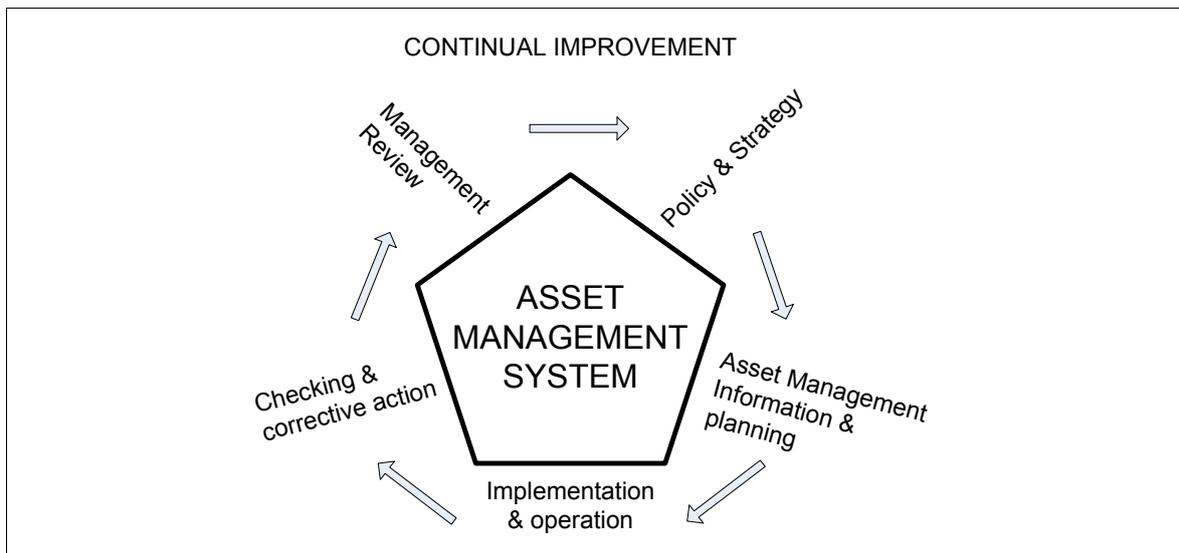
Figure 3.1 The PAS 55 Plan – Do – Check – Act framework (from BSI 2008)

The generic 'Plan – Do – Check – Act' framework in PAS 55 (Figure 3.1) provides a template against which industries can develop or check their own approach to the management of physical assets. The framework covers:

This manual provides information on, and analytical tools for, beach levels and structures at the toe of coastal defences that should aid asset managers or practitioners in the ‘risk assessment and planning’, ‘implementation and operation’, and the ‘checking and corrective action’ phases of the asset management system (AMS) cycle in Figure 3.1. The following sections discuss:

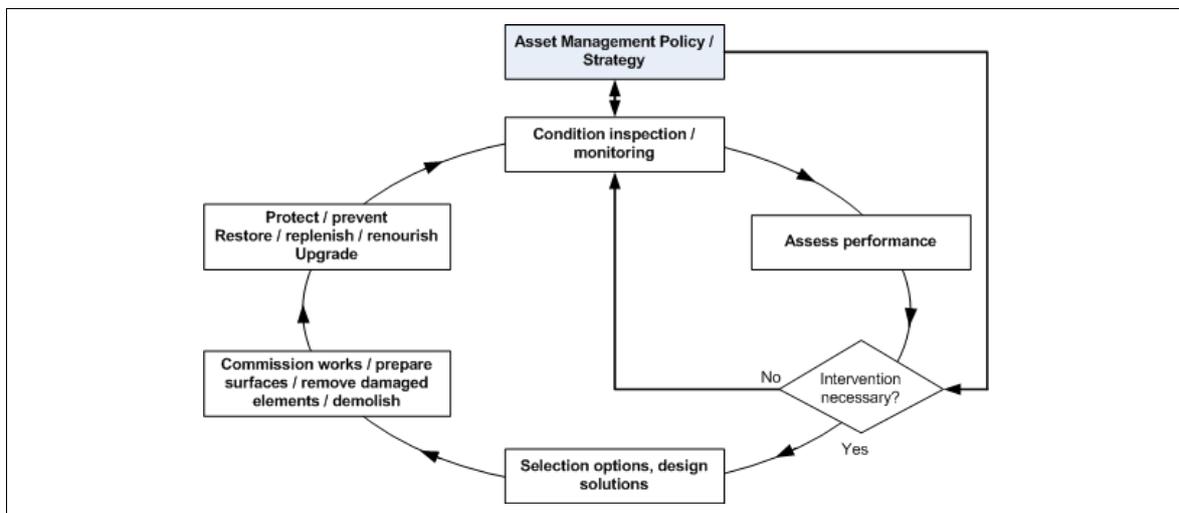
Figure 3.2 Key phases for asset management of existing coastal defence structures

The majority of toe protection works undertaken are not ‘new build’ or ‘capital’ works, but are commissioned for other reasons such as remediation, maintenance or repair, reconstruction and augmentation, or strengthening of existing defence structures. Within the context of asset management, maintenance, repair and reconstruction can be seen as stages within the management cycle which occurs throughout the lifespan of the defence structure. That is, continuous or intermittent monitoring and performance assessment will/should determine whether interventions are necessary in order to maintain the level of performance desired and offset deterioration. Figure 3.2 illustrates this as a cycle of asset management processes and decisions.³

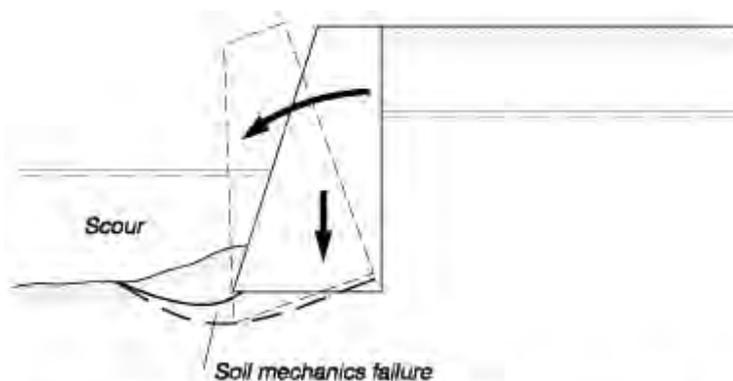
Seaward overturning and settlement of gravity wall

- Scour in front of the wall reduces both the passive resistance and the bearing capacity of the foundation soil.
- The resulting load from the active backfill pressure, the high groundwater table and the weight of the wall cause a bearing capacity failure in the soil resulting in a forward overturning and some settlement of the wall.

Waves can cause scour holes at the toe of the seawall. Scour holes develop underneath the base of the wall and reduce the surface of the base of the wall, which is supported by the underlying foundation of the soil. The loading (weight of the structure, horizontal ground force and horizontal hydraulic force) of the structure thus has to be distributed over a decreasing foundation area. The developing scour hole results in a decreasing width of foundation until there is insufficient force to support the structure (Figure 3.3). If the structure has not been designed to withstand such pressures and the condition is not prevented or quickly addressed, the structure will move in response and progressively fail, or even fail completely. The point at which this is calculated to happen is known as the ‘disturbing moment’ or the ‘ultimate limit state’ (ULS).

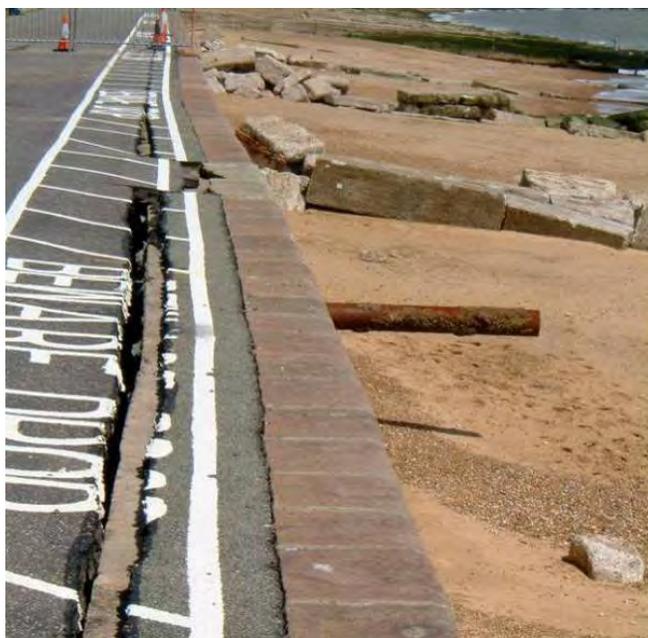
Figure 3.4 A seawall in the process of overturning (courtesy of Black & Veatch)

Figure 3.4 shows an example of a seawall in the process of overturning.

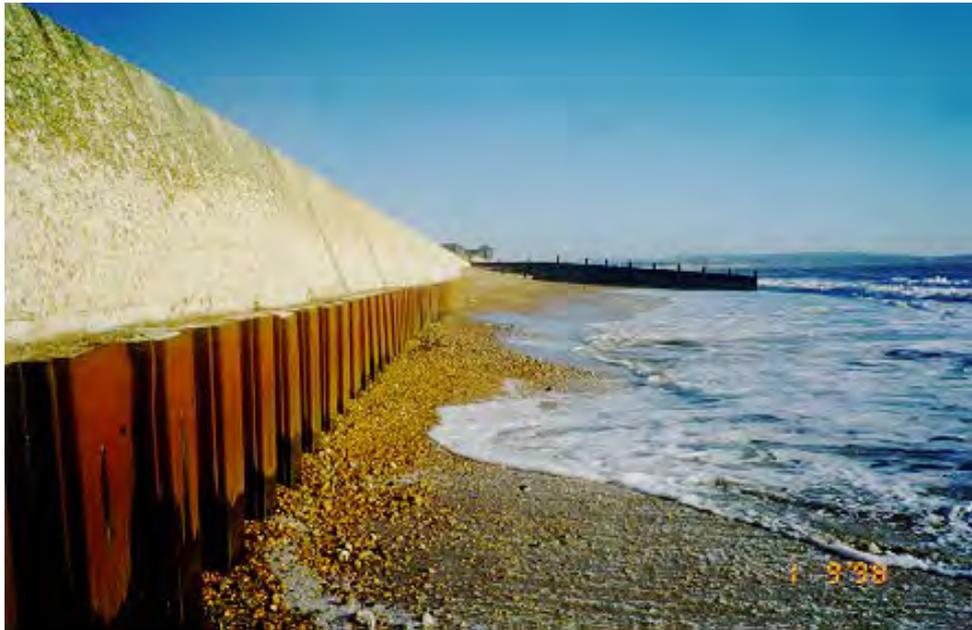
Figure 3.5 Exposure of interlocking steel piled toe arising from beach lowering (courtesy A P Bradbury)

- Beach levels reached the crest of the wall at the time of construction and the wall was well protected, with shingle, limiting wave attack on the structure toe.
- Falling beach levels have exposed the structure toe piling (which extends 7 m below the pile tops) (Figure 3.5). Although the structure continues to resist overturning and sliding, increased water depths at the structure toe allow larger waves to attack the structure.

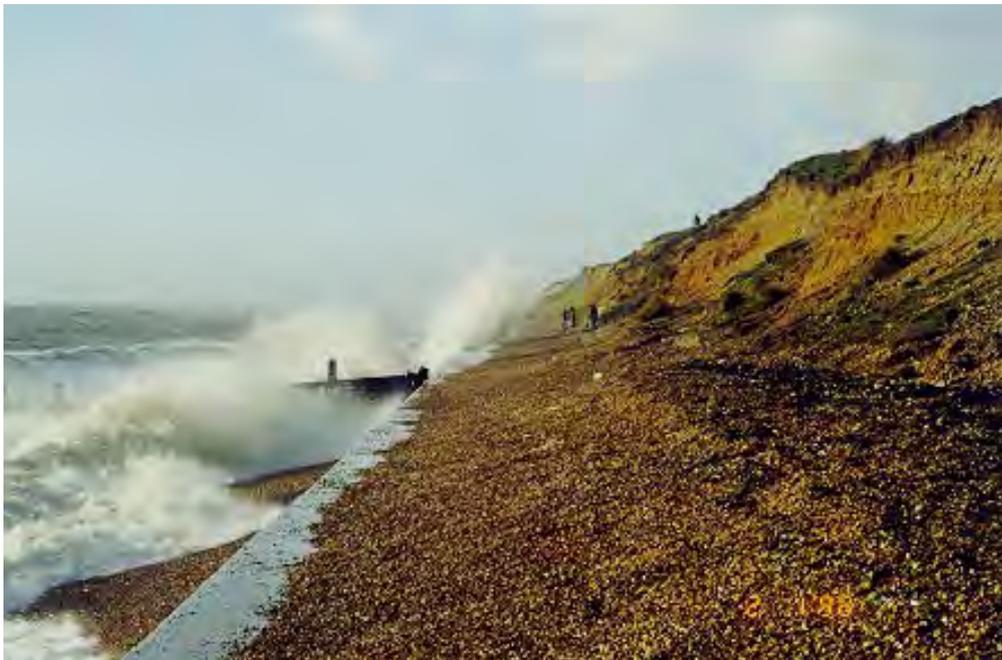
Figure 3.6 Frequent overtopping causes build-up of pressure on landward side of seawall (courtesy A P Bradbury)

- Regular overtopping has occurred under even relatively benign conditions as a result of increasing water depths at the toe (Figure 3.6). Water percolation seawards of the seawall crest has caused a build-up of pressure to landwards of the seawall.

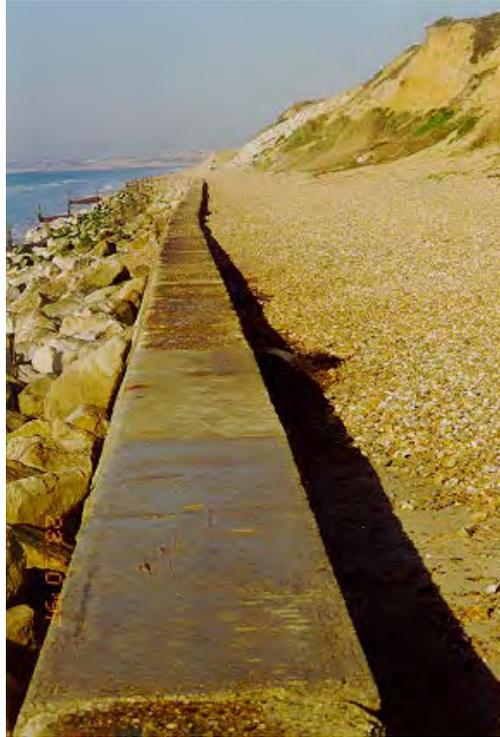
Figure 3.7 Repaired wall showing failed realignment. Rock armour has been added at the toe (courtesy A P Bradbury)

- Repairs to the structure have been undertaken, which include construction of a rock toe to resist further lowering (Figure 3.7). Note the kink in the alignment of the wall which has arisen due to the structure failure and subsequent seaward displacement of upper wall sections.

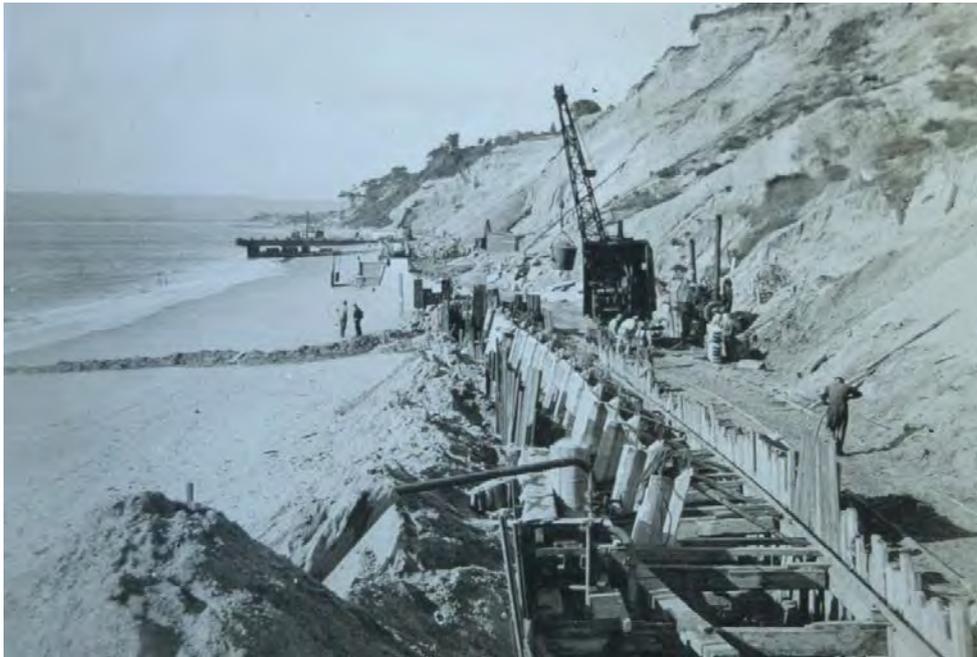
Figure 3.8 Promenade wall under construction (courtesy Poole Borough Council)

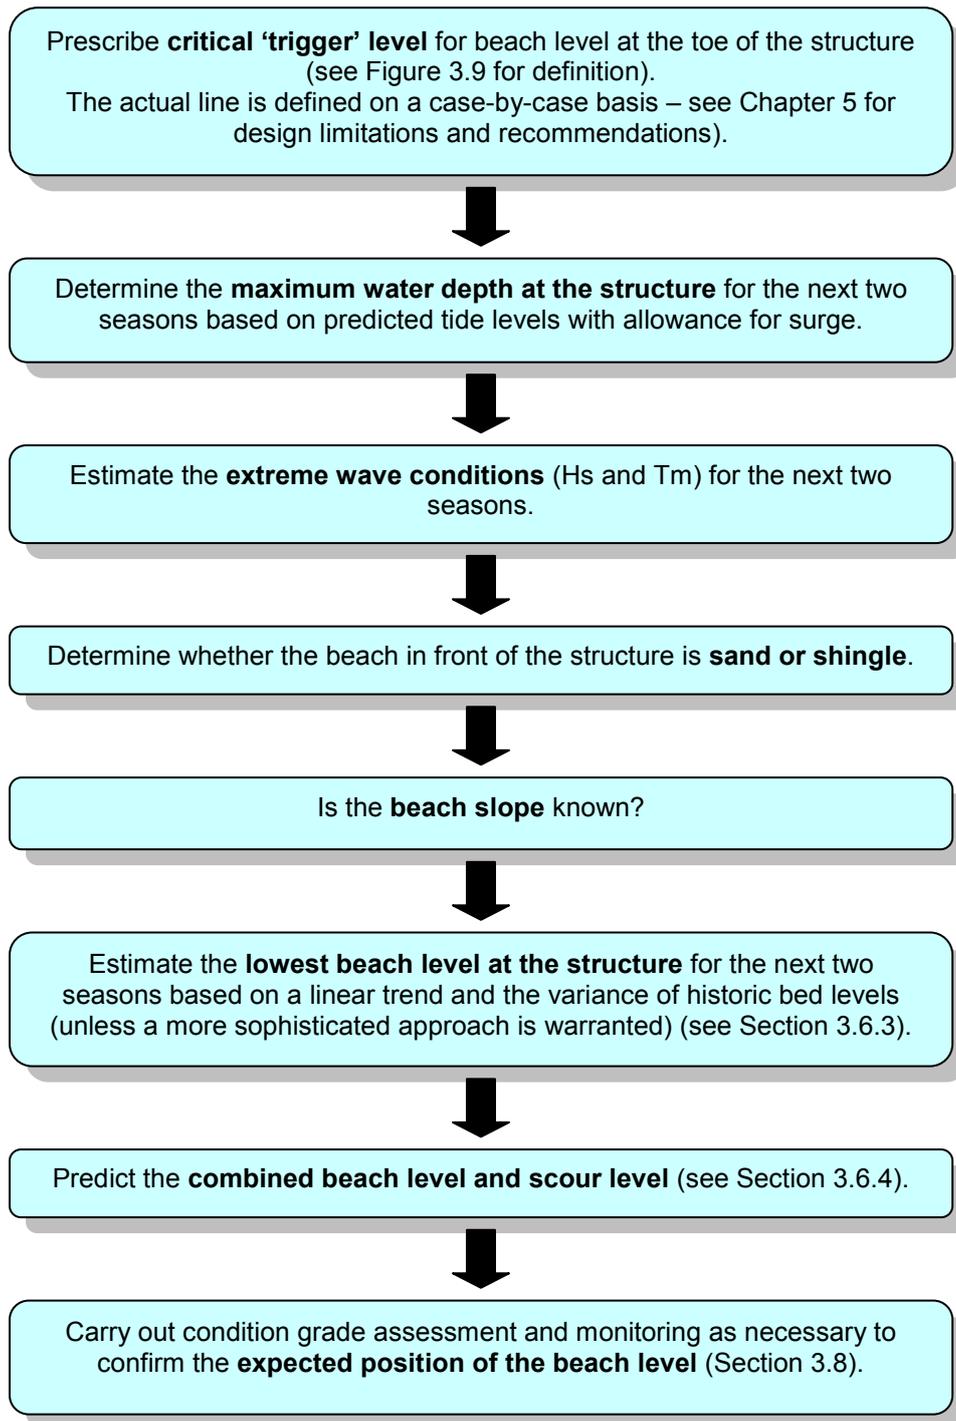
Figure 3.9 Information required to assess toe scour

For each location being considered, the engineer needs to determine a trigger or 'alert' level for intervention (see Section 3.5). This will be based on key parameters related to structural performance, beach safety and so on. Once this level has been set, a simple assessment for any section of a structure can be determined (initially) on a seasonal (for example, summer and winter) six-monthly basis, possibly supplemented following storm events. The suggested approach is outlined using the eight steps shown in Figure 3.8.
