Toe structures management manual

Project: SC070056/R

Coastal structures, structure toe, asset management, condition assessment, beach, scour

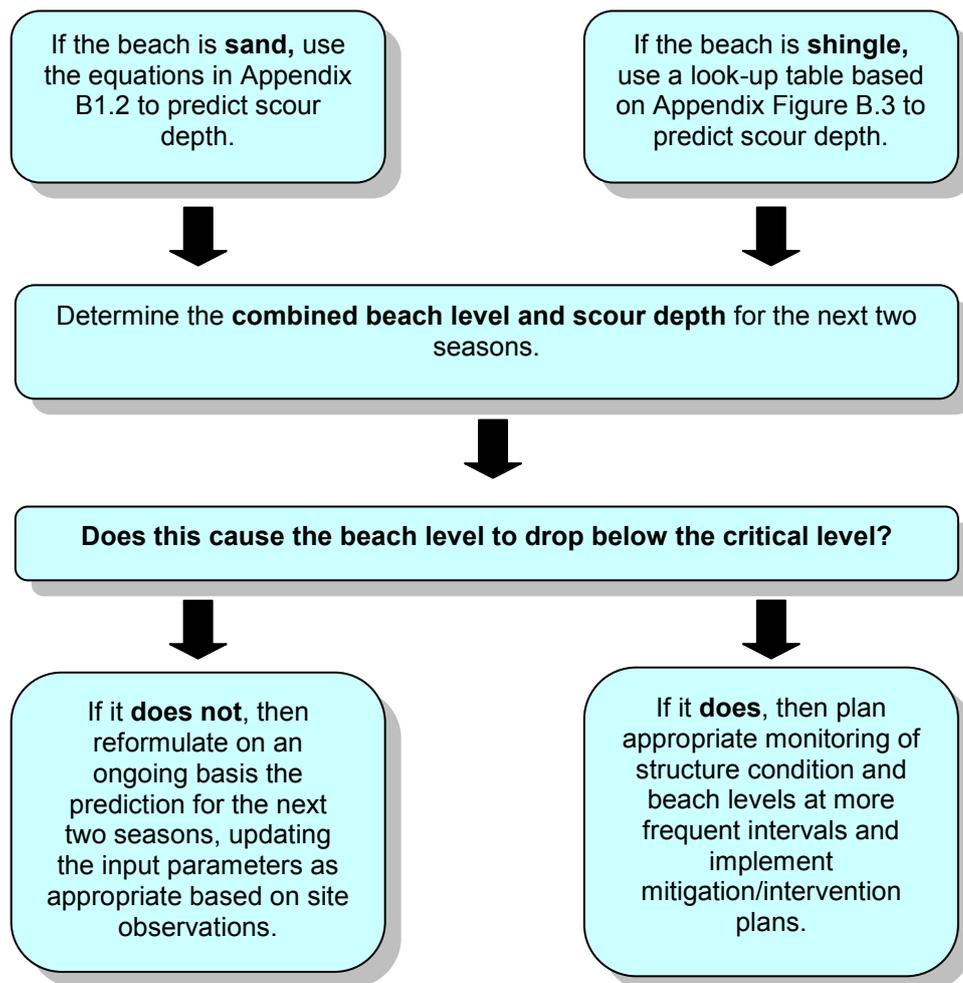
Figure 3.10 Assessment of toe scour decision process

Once this information has been obtained, the decision process shown in Figure 3.10 is implemented.

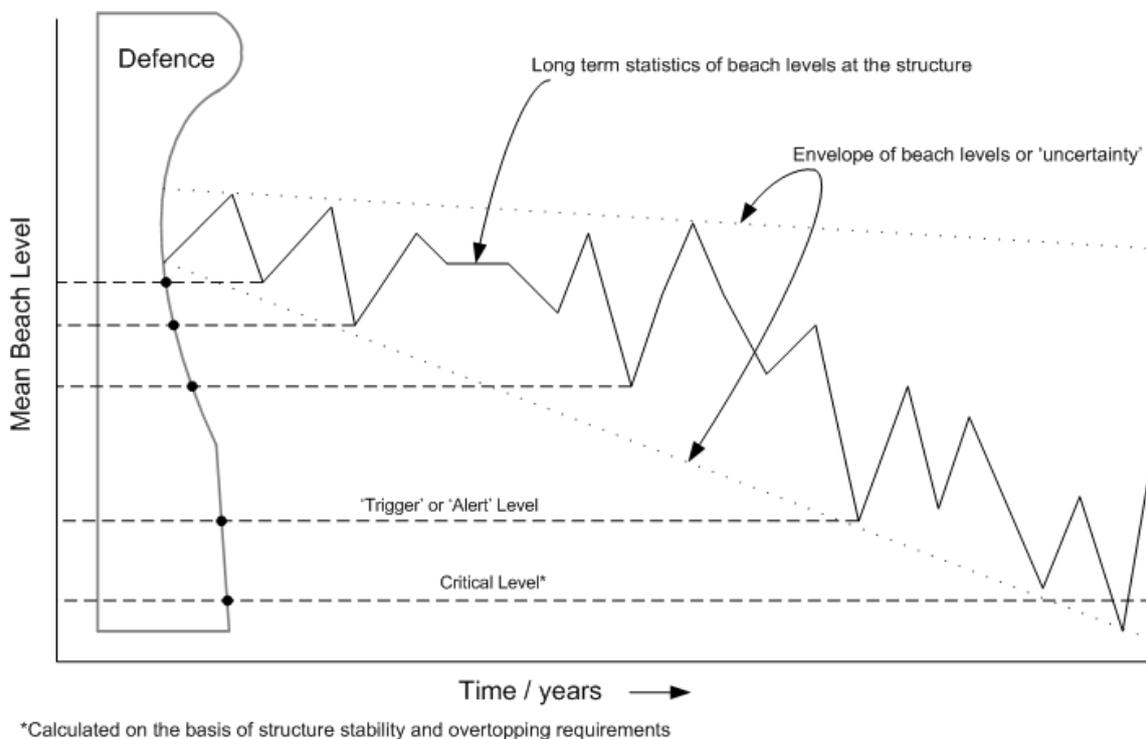
Figure 3.11 Relationship between long-term statistics on beach levels at the structure, uncertainty, and 'trigger' and critical levels

The examination of statistics on mean levels at the toe of a structure over a number of years, together with prediction methods and structure geometry information (level of the structure toe), provides sufficient information for the asset manager to determine the physical limits and timescale within which intervention options should be considered (that is, beach re-nourishment, remedial defence works, decommissioning and so on). This concept of the critical level is illustrated in Figure 3.11. The trigger for a more detailed asset inspection could therefore be the exceedance thresholds gained from results of the extrapolation of beach level data.

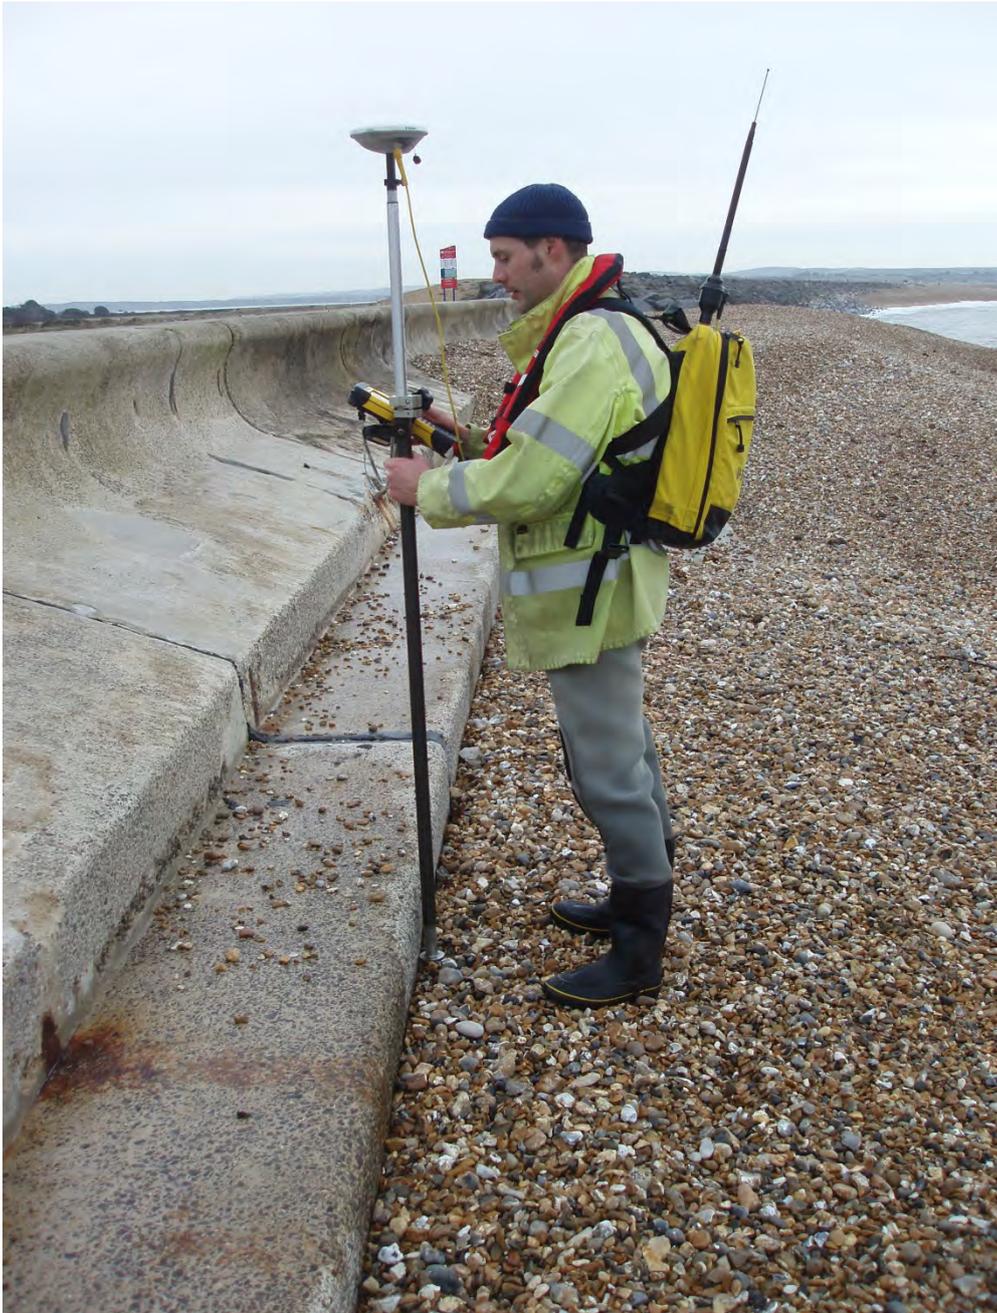
Figure 3.12 Beach survey using global positioning equipment (courtesy Channel Coastal Observatory)

Baseline beach surveys should enable the beach plan-shape to be described adequately and be in context with existing control structures (for example, groynes). This will assist with the understanding of sediment transport patterns and the effect of sediment control structures on sediment transport rates (and therefore beach volume). Such surveys will also assist with the determination of the best places for subsequent monitoring locations, particularly if the orientation of the beach crest(s) varies significantly along the frontage. Contour and three-dimensional (3D) measurements can be achieved by a variety of methods and tools including terrain modelling using results from a real-time kinematic global positioning system (RTK GPS) (Figure 3.12), light detection and ranging (LiDAR), photogrammetry and bathymetric surveys.

Shore parallel profiles are extremely valuable tools for monitoring beach structure interaction. Profiles are conducted by measuring elevations of the beach and structure intersection (see Figure 3.12). The example presented shows the spatial and temporal variability of the beach structure intersection level (Figure 3.21). Each elevation is measured at predefined locations along the seawall; in this instance these are defined using kinematic GPS and a data logger with a stakeout control file to ensure that each point is precisely relocated on each survey.

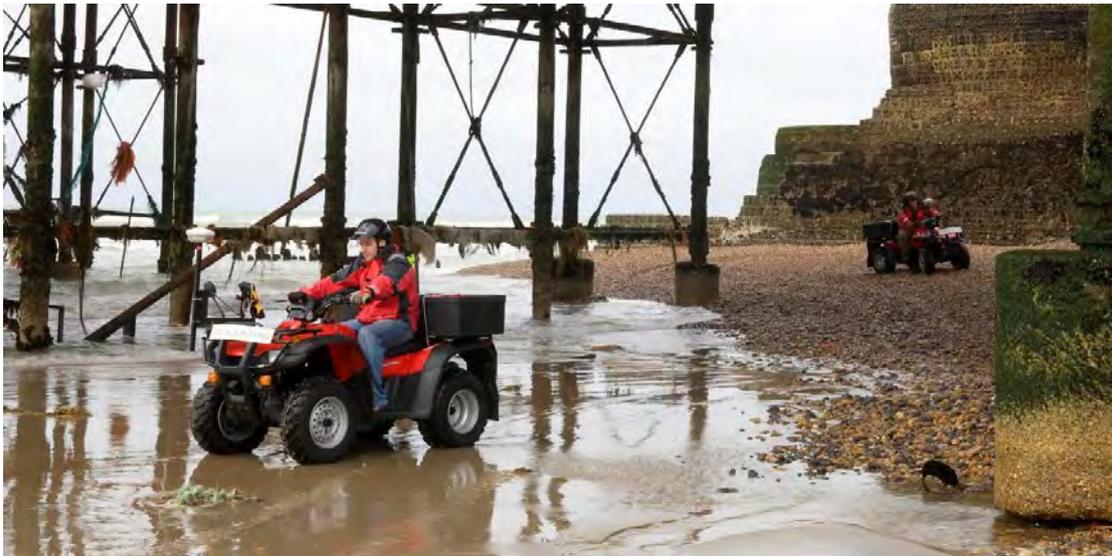
Figure 3.13 All terrain vehicle fitted with GPS equipment for coastal topographic surveying (courtesy of Worthing Borough Council)

RTK GPS can now provide a vertical accuracy of ± 30 mm and plan accuracy to ± 15 mm. For rapid coverage, GPS can be mounted on suitable 'all terrain vehicles' (Figure 3.13). For further information the reader is referred to Section 5 of the *Beach Management Manual* (CIRIA 2010a).

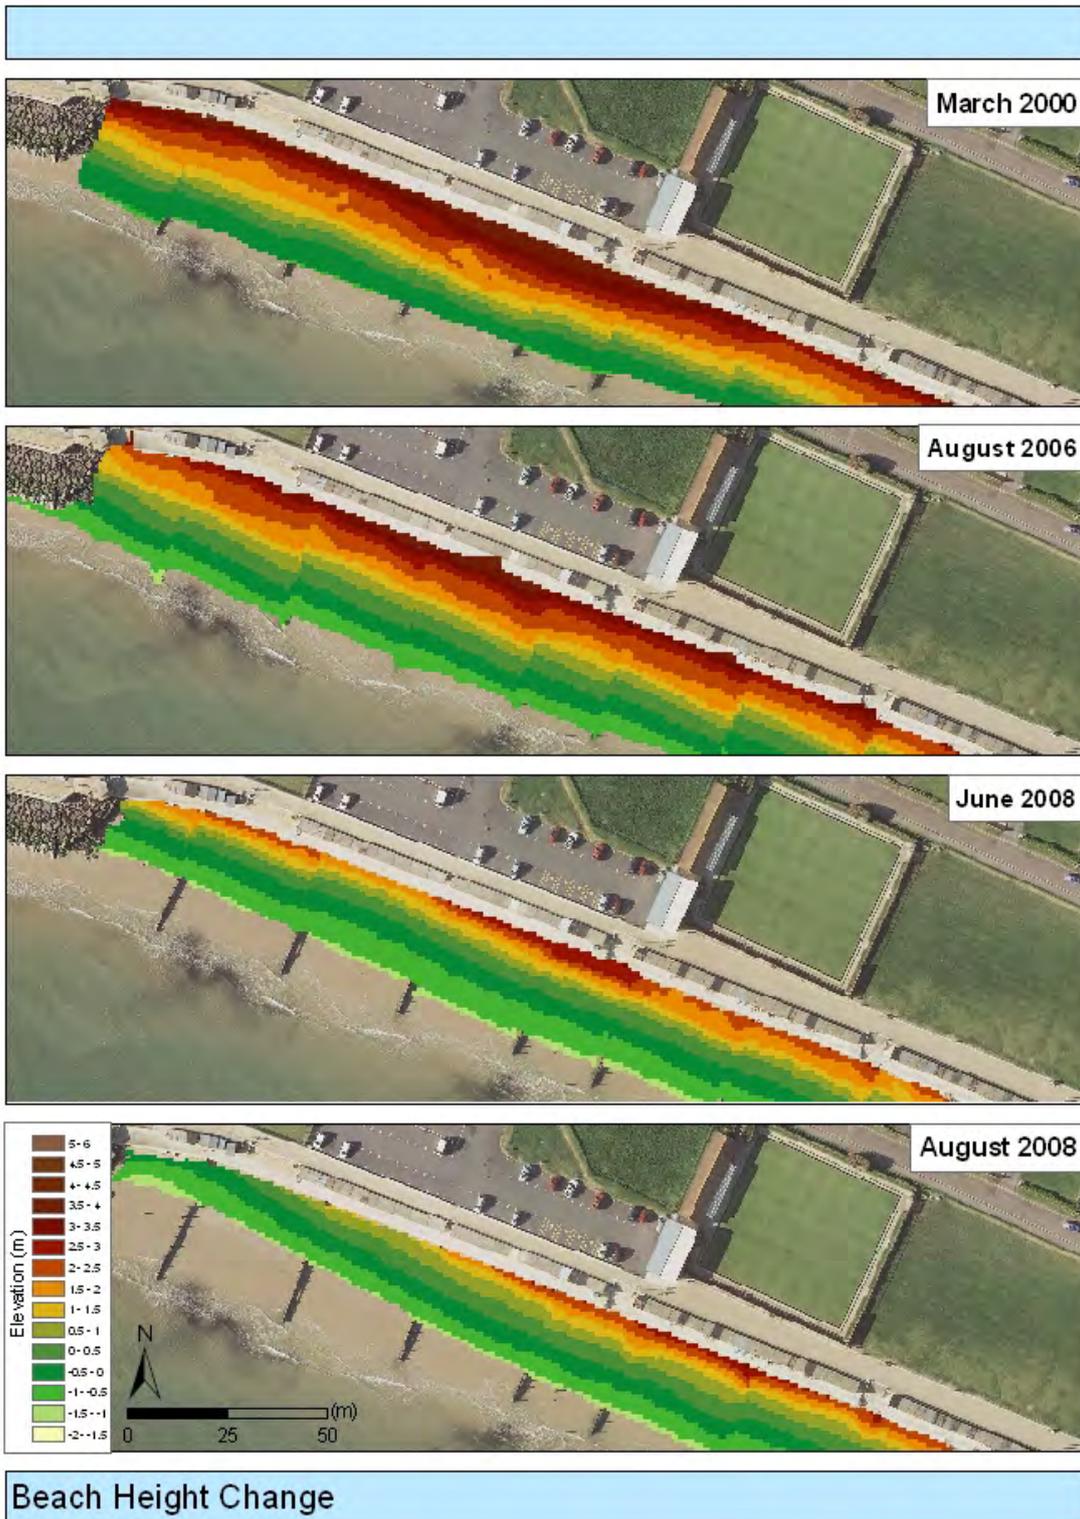
Figure 3.14 Digital terrain models showing beach evolution adjacent to seawall with changing structure alignment (courtesy Channel Coastal Observatory)

The sequence of colour-coded beach elevation plots shown in Figure 3.14 demonstrates clearly that the beach is becoming smaller over time. Note that the rate of change has increased with time and that the survey frequency has been increased to capture the more rapid changes, as the structure toe becomes more vulnerable. Surveys identify considerable beach narrowing at the updrift end. Much of the structure remains well protected and vulnerable areas of the structure toe can be isolated to a frontage of about 50 m, where detailed monitoring efforts can be focused.

The net sediment drift direction at this site is from west to east, and this is reflected by a declining beach volume at the structure toe at the updrift end of the beach. The pattern shown demonstrates clearly the influence of an updrift change in structure alignment, which has an adverse effect on beach supply to the western (updrift) end of the beach. This change in alignment is a typical cause of falling beach elevations at a structure toe. Changes in structure alignment are highlighted generally as potential

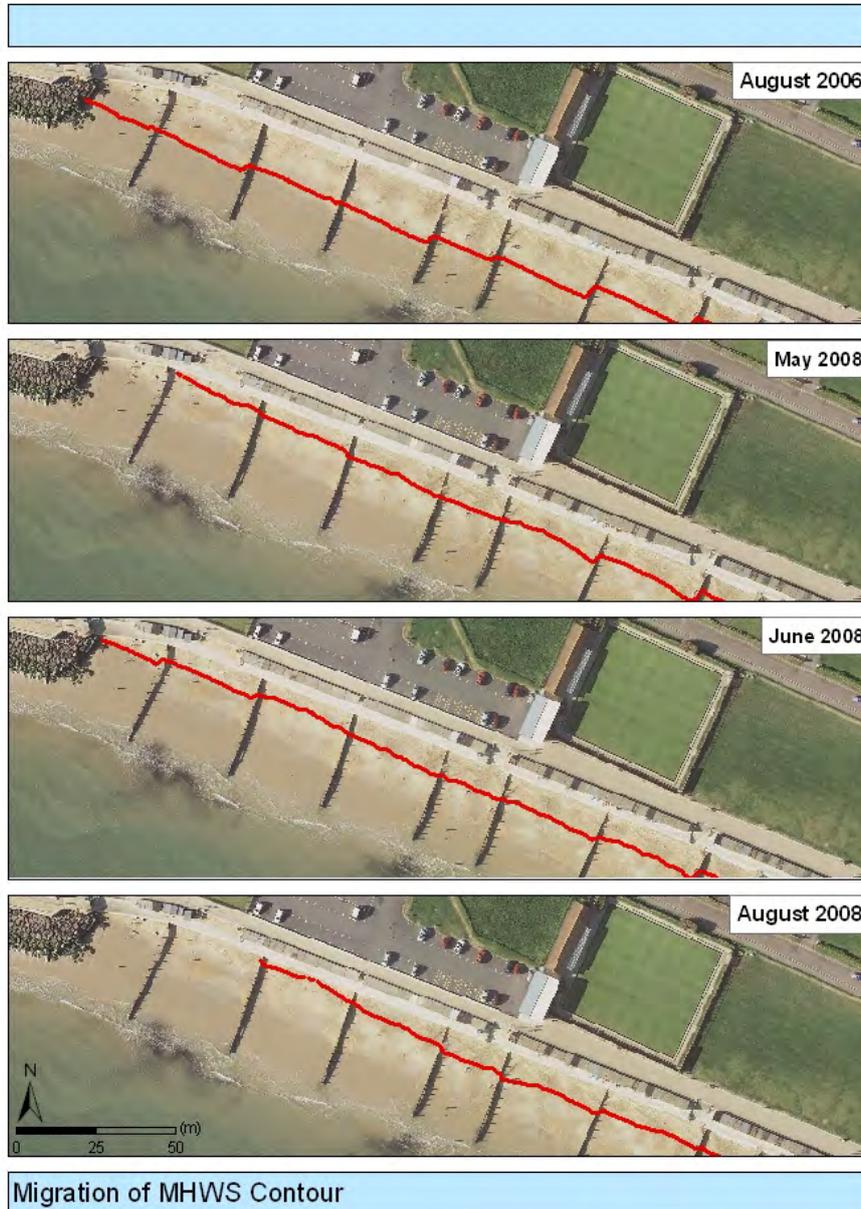
Migration of the mean high water spring (MHWS) beach contour can serve as a useful indicator that a structure toe is becoming under an increasing frequency of loading. Figure 3.15 illustrates the migration of the MHWS contour over a period of less than two years, yet shows a significant trend of migration towards the wall.

Figure 3.15 Migration of MHWS contour towards seawall (courtesy Channel Coastal Observatory)

The location of the MHWS contour suggests that 50 m of the structure frontage may be regularly under direct wave attack, in accordance with the tidal cycle. The survey frequency increased from April 2008, triggered by the rapid movement of the beach contours towards the wall (Figure 3.16). The pattern indicates that standing water will have occurred at the seawall at several stages during this period, over the upper part of the tidal cycle. Any wave activity during these periods will certainly have impacted on the wall. Parts of the wall will be offered some protection by the beach over most of the length monitored, but it is clear that the frequency of attack at the western end has

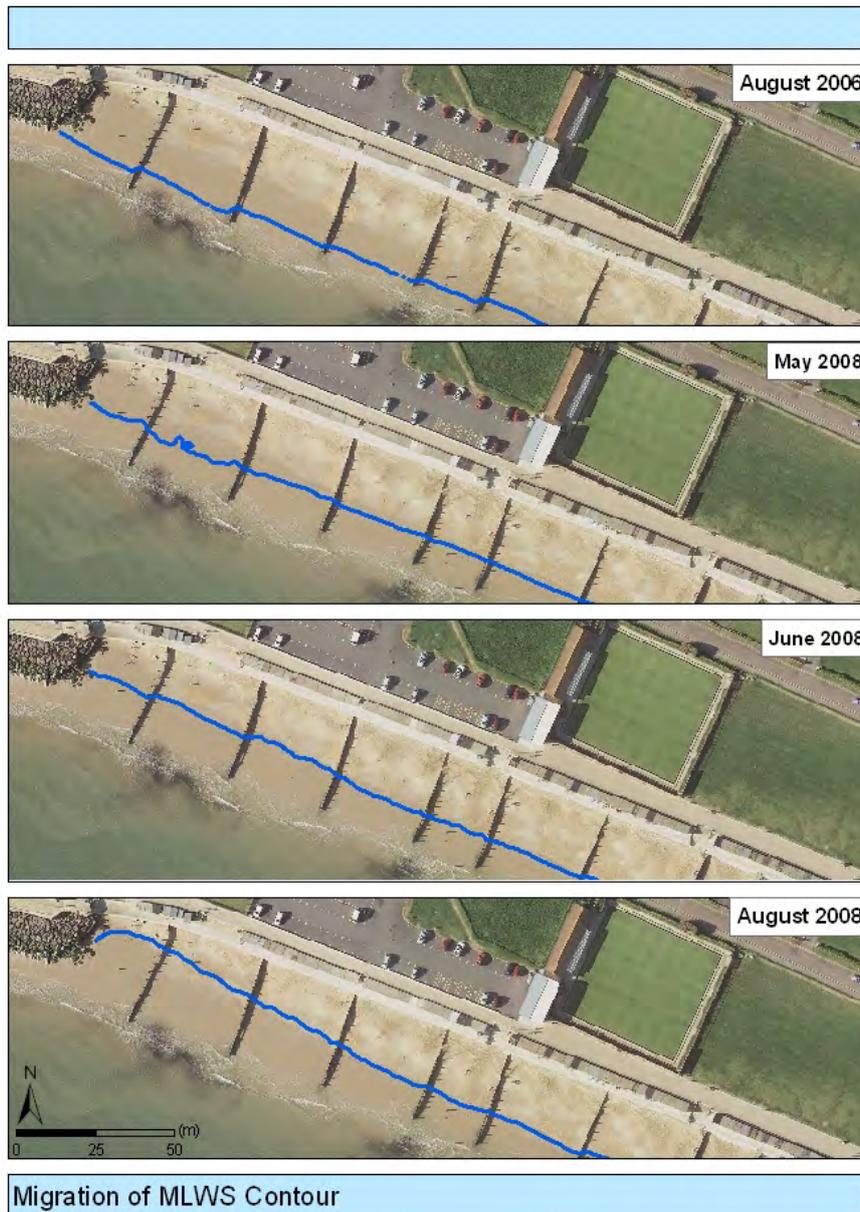
increased over time. Such observations should act as a catalyst for more vigilant observations of structure toe performance. This is generally a useful indicator for assessment of overtopping risks that may be affected by toe scour.

Figure 3.16 Migration of MHLs contour towards seawall (courtesy Channel Coastal Observatory)

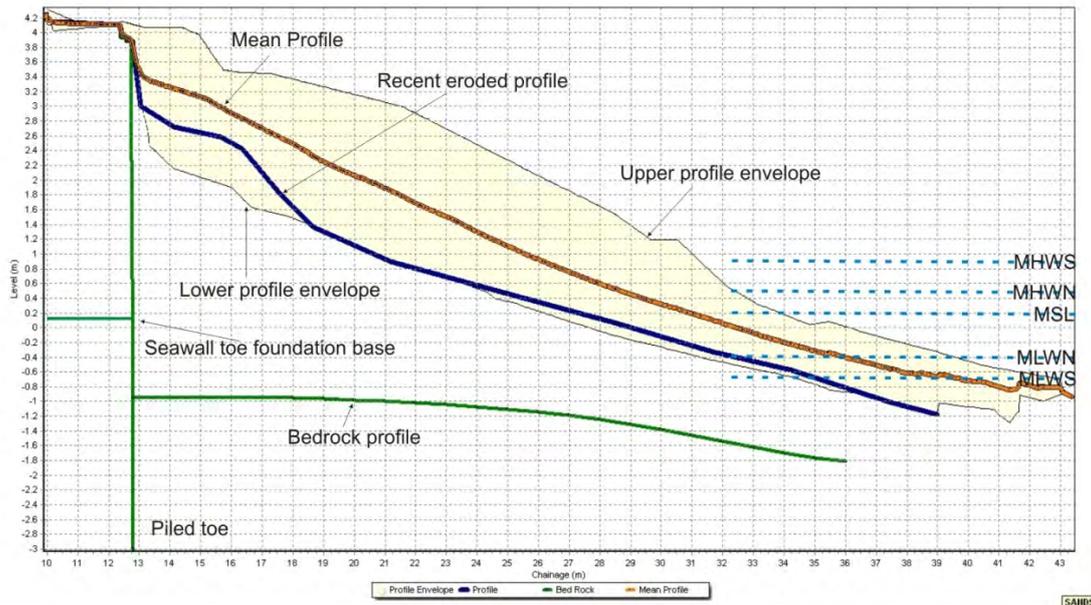
Regular beach profile surveys can be used to develop an indication of changes to protection of a structure toe. All of the key descriptors identified in Section 3.5.2 are shown on the simple plot presented in Figure 3.17. The long-term profile envelope indicates the lowest and highest points that the beach has reached over the course of the monitoring.

Figure 3.17 Beach profile and structure descriptors used in structure toe analysis (courtesy AP Bradbury)

Procedures linked with standard specifications for some of the regional coastal monitoring programmes require surveyors to feature code survey data; this will provide indications of bedrock elevation where this is seen on each survey. Each point has 3D coordinates and a surface type attribute. Feature coded survey data can be extracted from a number of surveys and combined over a period of several surveys to provide the basis for development of a primitive surface model of the bedrock surface. These data can be supplemented by surveying elevations of spot heights of bedrock, determined during excavations for the repair and construction of structures such as groynes. For example, this has been used effectively at Bournemouth and Milford-on-Sea to provide a more detailed bedrock surface. Where these data have been captured, it is possible to measure absolute beach volume changes by using this as a master profile rather than changes relative to an arbitrary surface (Figure 3.17). Such an approach may not, however, be feasible at many sites.

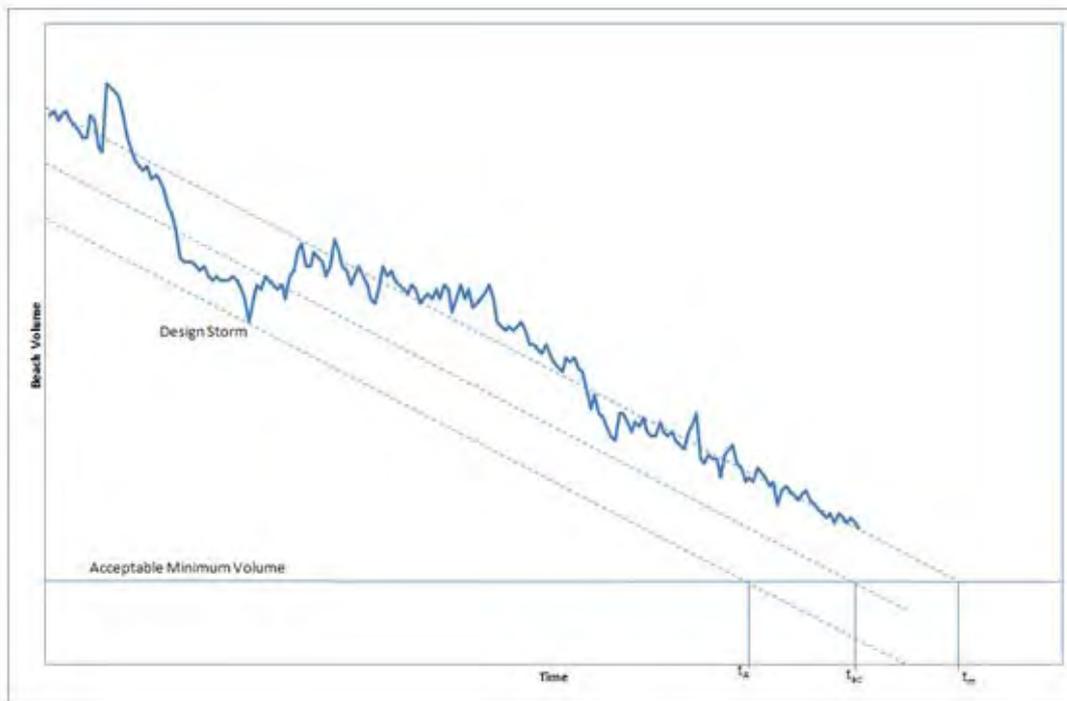
Figure 3.18 demonstrates a lengthy time series during which the general trend is of erosion, but with periods of recovery. A series of storm events of varying intensity punctuate the long-term profile trend and these are associated with defined combinations of wave and tidal conditions. Wave data can ideally be derived from a nearby wave buoy in shallow water (see Figure 3.20). Alternatively, hindcast modelled offshore data can be transformed to the nearshore zone. Several of these storm conditions are highlighted in Figure 3.20. Interestingly, the most severe hydrodynamic conditions are not always associated with the greatest damage or beach loss. A number of the notable dips in beach cross-section are associated with swell wave or bimodal wave conditions that would not generally be considered to be damaging events.

Figure 3.18 Beach profile cross-sectional trend analysis

A trend line is fitted through the data set, indicating the mean profile. The profile envelope is represented by lines parallel with the mean profile. The maximum departure from the line is associated with the design storm, which denotes the maximum departure from the envelope line. Application of a storm response line provides an indication of the anticipated maximum reduction in cross-section on a defined storm event. This is based on conventional topographic surveys and does not consider additional lowering that may take place during the storm but which is not detectable by conventional survey techniques. Additional allowance must be made for such changes (see Section 3.6.4). Using the critical cross-sections determined for each site (Section 3.5), a critical acceptable volume trigger can be added to the graph. Linear projection of the trend, envelope and storm damage lines can be used to estimate the potential timing for intervention.

The example shown represents changes over a 20-year monitoring period. These data can be used in combination with a trend analysis of beach cross-sectional area above a defined surface (master profile) (Figure 3.18). Where available, the master profile should be defined by the bedrock profile, thereby enabling absolute changes in beach volume to be determined; this profile cannot be defined at many sites and only relative changes can be measured. An at-a-glance assessment of the relative state of the beach to historical conditions is provided by comparing the most recent survey with the profile envelope and the mean profile.

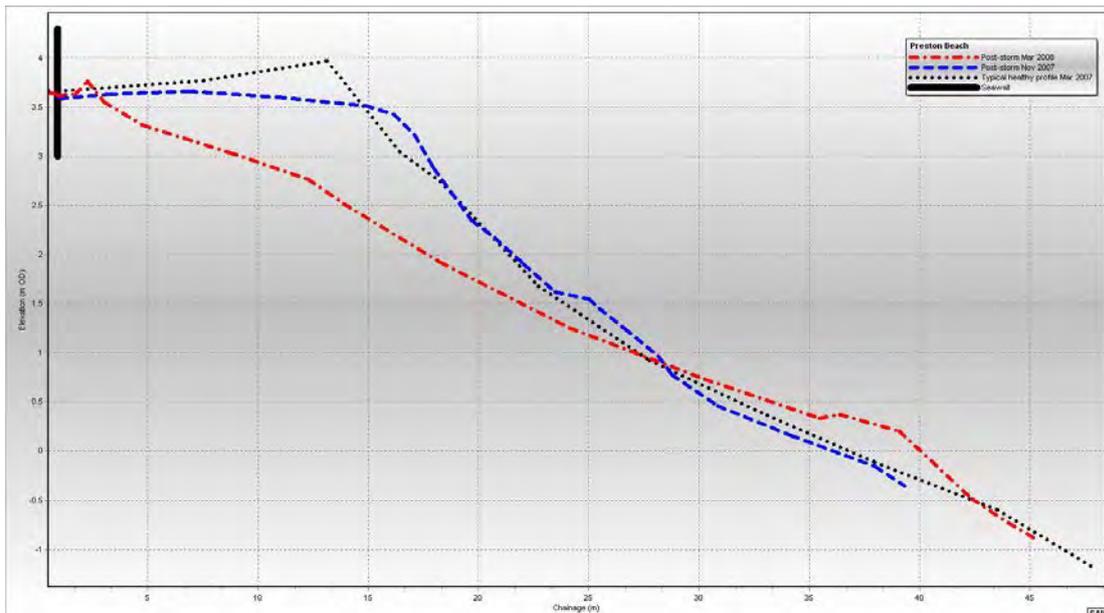
The shape of individual profiles can provide a useful indicator of beach performance and its interaction with the structure. A shingle beach will normally form a distinct berm with a well-defined run-up crest on a healthy beach, where the dynamic equilibrium profile is able to develop fully (Figure 3.19). Where there is inadequate cross-section available for the dynamic equilibrium profile to form, the profile may be characterised by a planed off crest or even a dip at the seawall intersection. The crest invariably forms at a lower level. The implication here is that the beach and structure intersection is under wave attack. The planed surface arises from wave reflections from the seawall increasing the backwash. This observation is generally considered to provide a preliminary indication that the structure is undergoing increased loading and might merit more regular inspections.

Figure 3.19 Beach profile evolution in the presence of seawall (courtesy Channel Coastal Observatory)

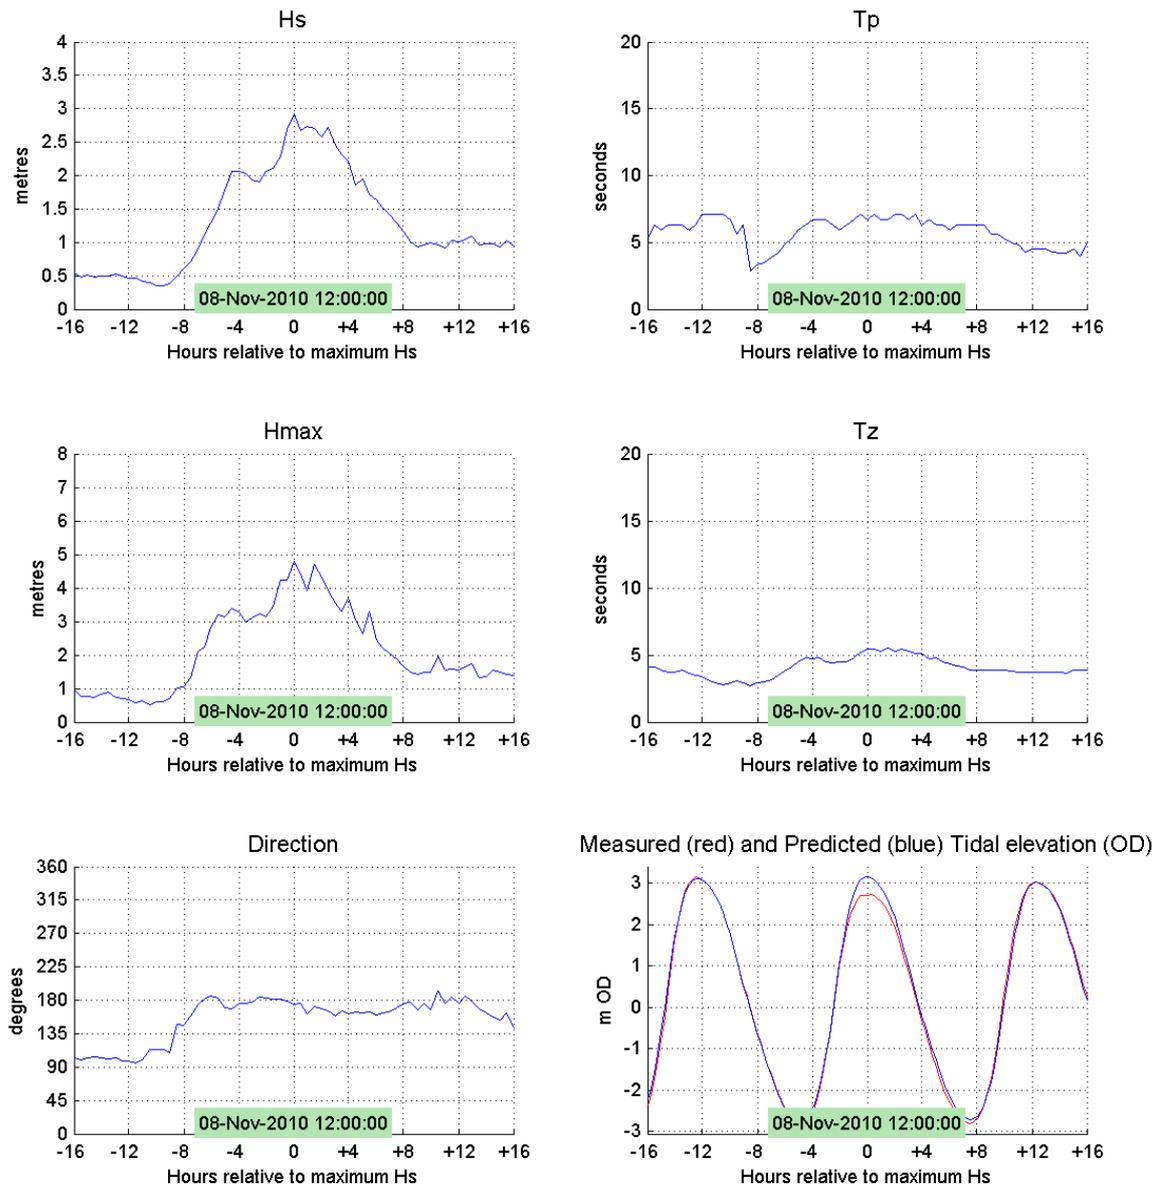
Folkestone - Storms during Sep 2010 to Aug 2011

It is beneficial to collect hydrodynamic data in conjunction with post storm survey data and to present these as an event time profile of hydrodynamic conditions (Figure 3.20). This should normally describe the whole of the event cycle including the build-up, storm peak and decay, and should where possible include integrated parameters for H_s (significant wave height nearshore), T_z (zero-crossing period), T_p (peak wave period) direction and spectral data. These should be supported by tidal profiles and wind data when possible.

Figure 3.20 Typical hydrodynamic conditions used in the analysis of a storm event (courtesy Channel Coastal Observatory)

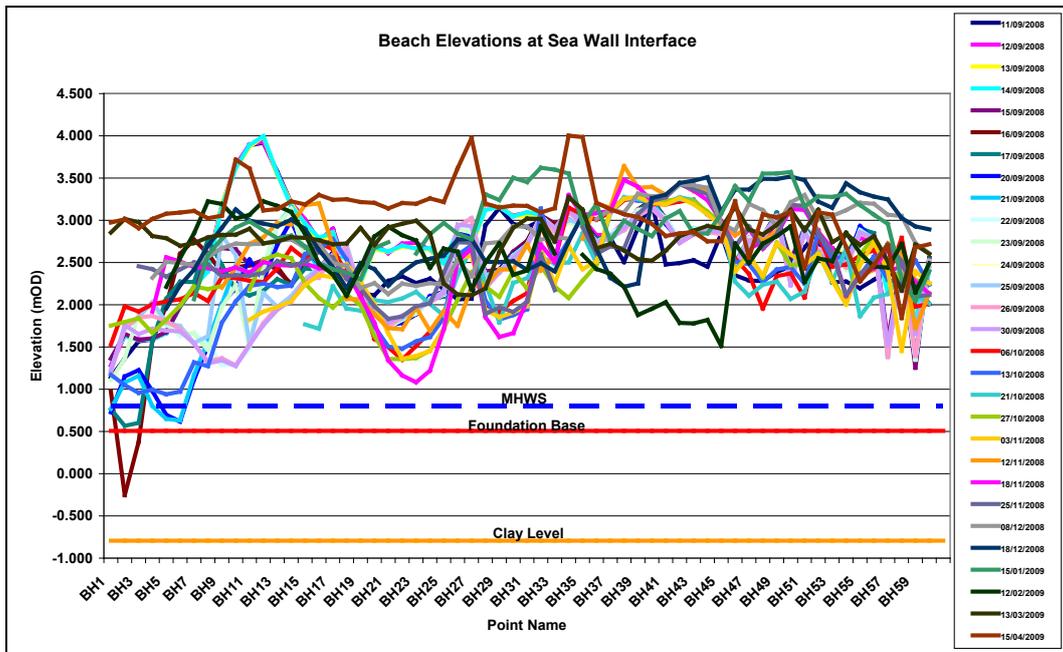
The example presented covers a frontage distance of approximately 200 m. The time series covers a period of about seven months. It demonstrates not only the vertical extent of changes but also indicates how quickly these changes may occur. The temporal intensity is extremely high at this location; this reflects the fact that the toe of this structure was considered to be very vulnerable. The key variables plotted are the foundation base elevation, bedrock elevation and tidal levels. The structure toe becomes increasingly vulnerable as the beach elevation falls closer to the foundation base.

Figure 3.21 Temporal and spatial distribution of beach and structure toe intersection elevations (courtesy Channel Coastal Observatory)

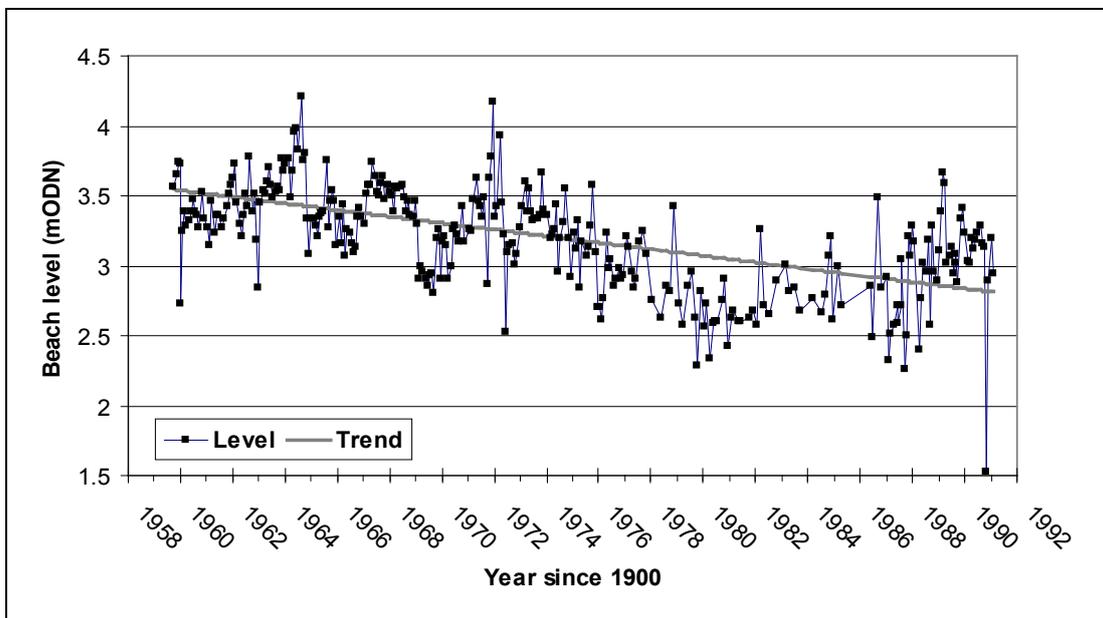
An alternative representation of the evolution of a single point elevation at the toe of a structure in Mablethorpe, Lincolnshire, is shown in Figure 3.22.

Figure 3.22 Temporal distribution of beach and structure toe intersection elevations (courtesy HR Wallingford)

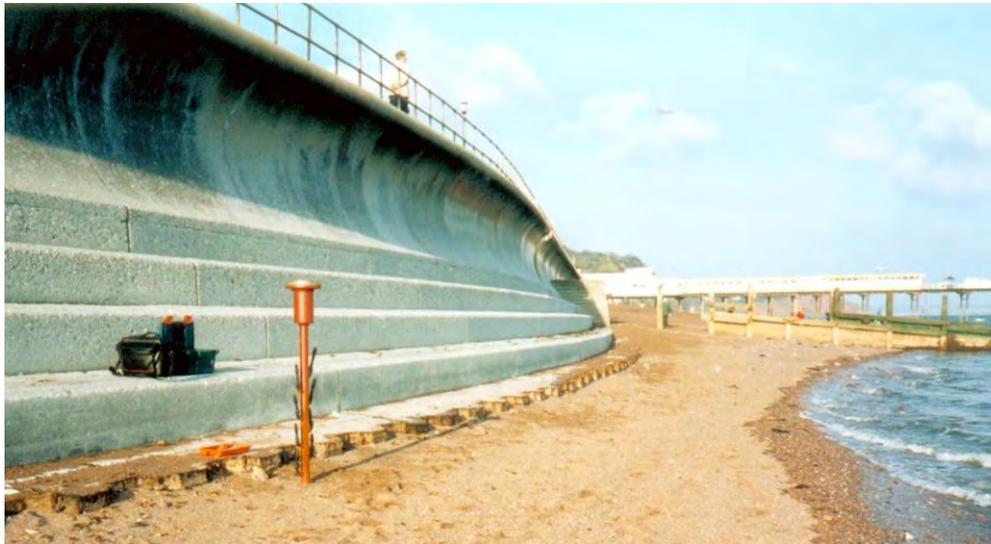
The deployment of scour monitoring systems that remain on-site, just in front of a toe structure operating at all water levels, for periods of weeks at a time may currently be the only realistic way of assessing the site specific variability of a beach surface with time. Figure 3.23 shows scour monitors deployed on a beach. Scour measurements can be conducted using, among other things, the following devices (Sutherland et al. 2007) installed at locations where the beach at the toe of the structure is exposed at low tide:

- HR Wallingford's 'Tell Tail' scour monitoring system (Figure 3.23) is based on a linear array of omni-directional motion sensors buried in the seabed adjacent to the structure. Identifying the elevation of the lowest active sensor places an upper limit on beach level. The system records the onset of scour, the depth of scour reached and the in-filling of scour holes following storm events. Tell-Tail scour monitors have been deployed in front of seawalls at Teignmouth (Whitehouse et al. 2000), at Southbourne (Pearce et al. 2006; HR Wallingford 2006a) and at Blackpool (Sutherland et al, 2006a).
- Linear array of electrical conductivity meters (Ridd 1992; Cassen et al. 2005), which rely on the fact that seawater has a high electrical conductivity, while dry sediment has a low conductivity and saturated

Figure 3.23 Scour monitors in operation on a shingle beach to obtain data on within tide changes in bed levels (courtesy HR Wallingford)

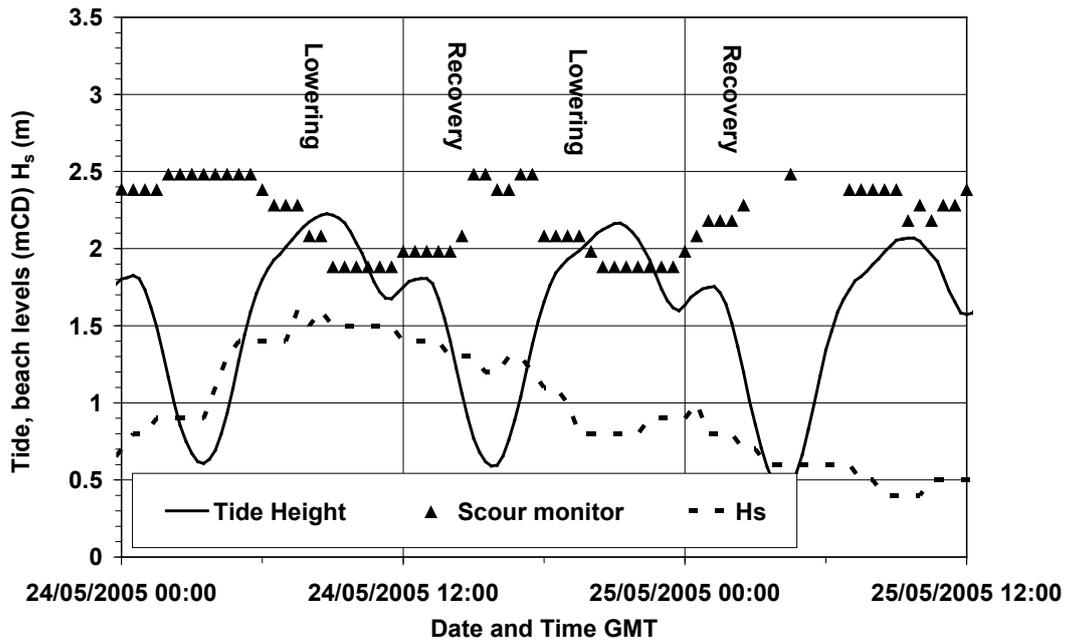
The somewhat limited number of historical deployments of scour monitors means that empirical statistics of performance are limited and estimation of scour is difficult. None of the deployments have taken place during particularly severe conditions and the application of results to date should be used with some caution. A reasonably typical plot is shown (Figure 3.24), which indicates intertidal fluctuations of about 0.6 m, under fairly benign wave conditions ($H_s = 1.5$ m). The type of pattern observed, on a sand beach, seems reasonably typical of other sites, with maximum scour occurring over the high water period and with a cyclic return over the low water period.

Figure 3.24 Fluctuations in sand bed levels over a tidal cycle (from Pearce et al. 2006)

Complementary laboratory work (Pearce et al. 2006) suggests similar relationships between scour depth, wave height and water depth to those shown in Figure 3.24. While the science is not yet well advanced, the preliminary empirical framework suggested by Pearce et al. (2006) appears to be supported by field scour measurements.

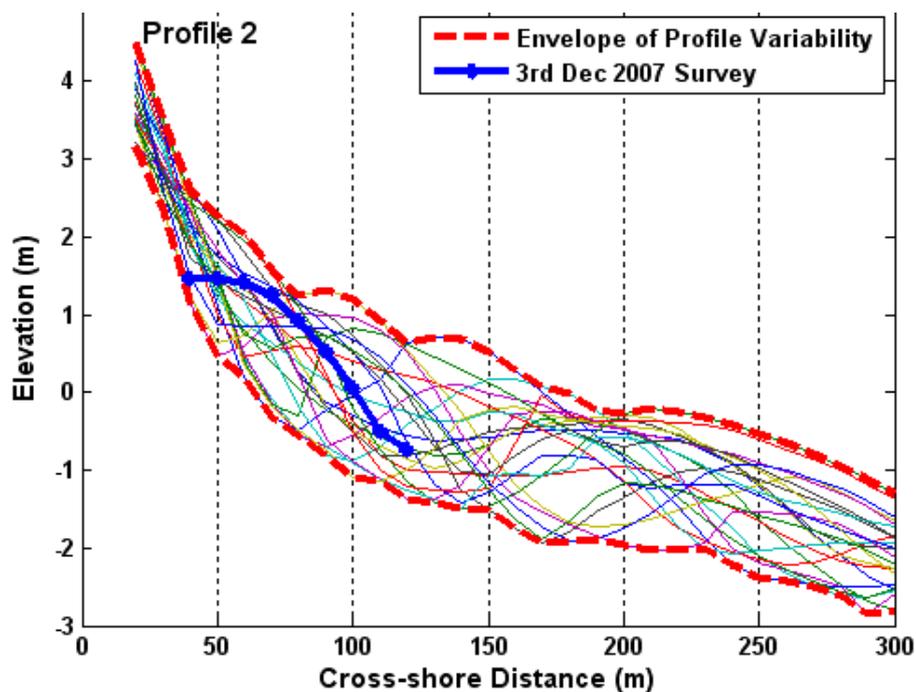
The images obtained by the Argus video system provide spatial and temporal resolution that enables the study of sediment transport patterns in groyne fields and the effect of storms. Profiles derived from an Argus system are compared with those using traditional methods (Figure 3.25). The large variability and advantage of the extended length of the Argus survey through the dynamic zone should be noted.

Figure 3.25 Comparison of traditional profile with Argus profile envelope (from Green and Illic 2009)

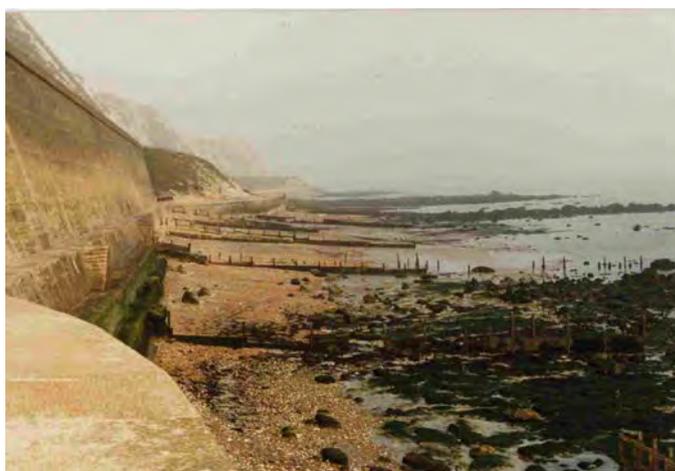
The performance of a beach depends largely on the volume of material present and the limits to its plan and profile changes. Where there is a net loss of sediment, beach recovery is an issue. Where there is clay beneath sand or shingle, then it is unlikely that a beach will recover naturally once the clay layer is exposed. Figure 3.26 shows an extreme example of beach depletion and foreshore down-cutting.

Figure 3.26 An extreme example of beach depletion, foreshore erosion and down-cutting – note the level of the base of the access steps in relation to the level of the beach (courtesy HR Wallingford)

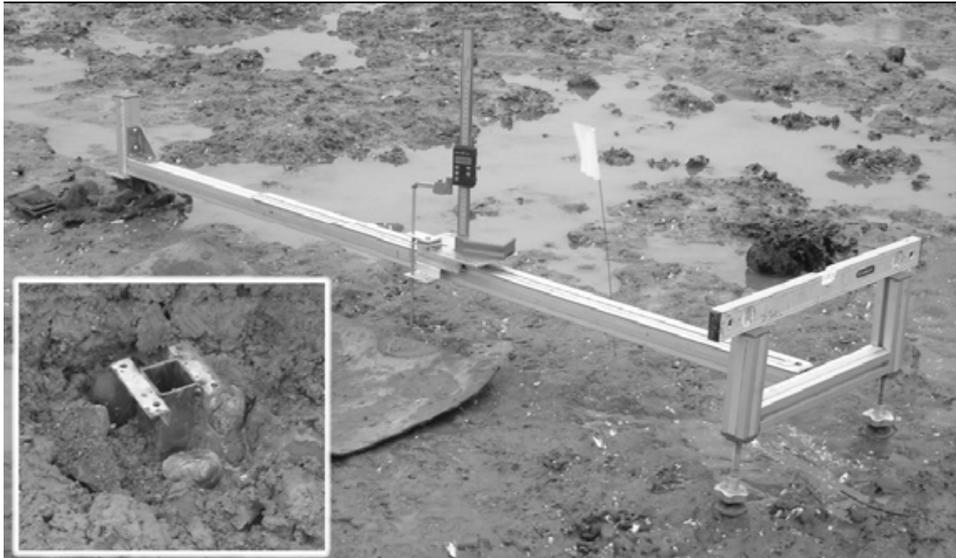
Various instruments and methods have been used in studies to assess down-cutting or down-wearing of shore platforms (see Sutherland et al. 2007). One such monitoring instrument is the traversing erosion beam (TEB) as shown in Figure 3.27.

Figure 3.27 A traversing erosion beam instrument

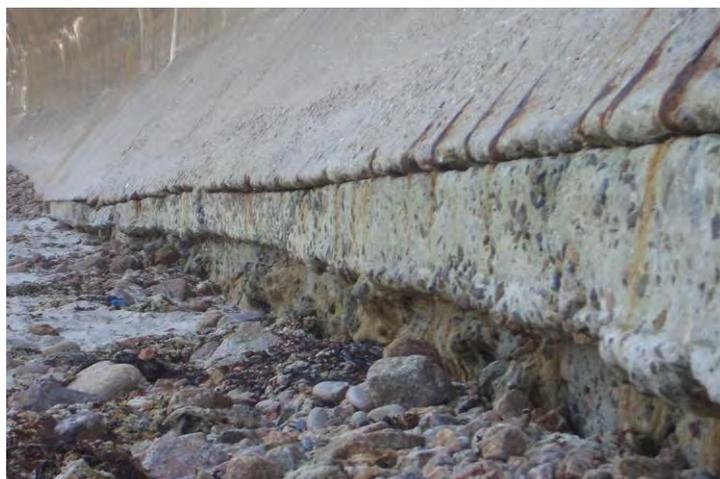
Once beach levels fall below the top level of a toe structure, it is exposed to the elements of wave attack and abrasion by mobile sediments. In the case of concrete and steel piles, this also means that chemical and biological processes may also ensue.

Accelerated low water corrosion (ALWC) is a biological process of degradation that can lead to loss of section (width) of unprotected steel in the tidal zone. Chemical reactions in concrete caused by saline intrusion can contribute to crack expansion, spalling (surface flaking) and oxidation of internal steel rebars and reinforcing mesh. Abrasion of concrete by mobile sediments (Figures 3.28 and 3.29) can erode the structure and, if left un-remediated, can cause a serious loss of its mass leading to a reduction in function and performance and eventual failure (also see Section 4 on maintenance of concrete structures).

Figure 3.28 Abraded concrete toe and onset of undermining (courtesy of HR Wallingford)

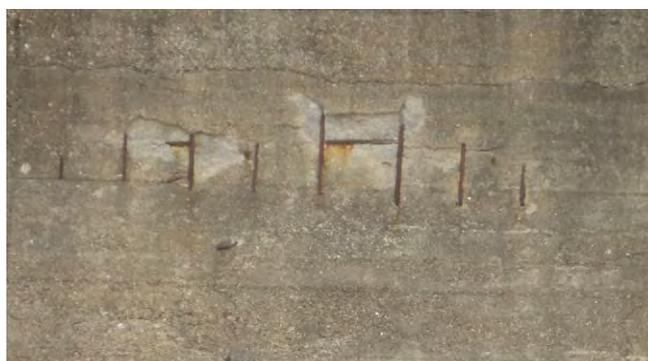
Figure 3.29 Exposed reinforcing mesh due to steel oxidation and resultant cracking and flaking of concrete cover layer (courtesy HR Wallingford)

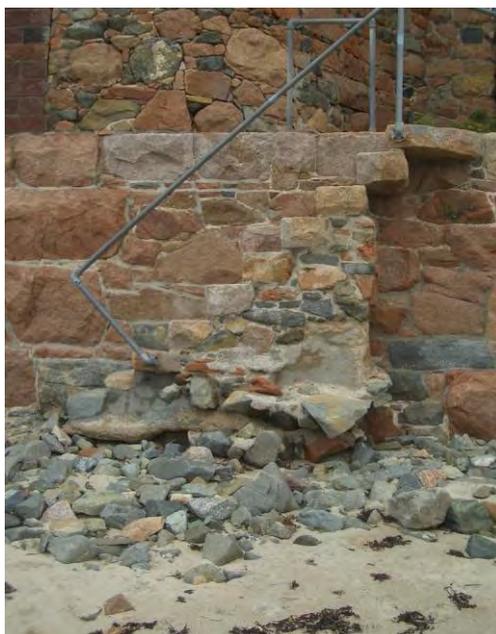
Figure 3.30 Beach lowering at access steps (courtesy HR Wallingford)

Problems with lowering beach levels may first become apparent from complaints about access – either pedestrian or vehicular or both (Figure 3.30). Beach levels falling dangerously below the lower extent of access steps or below the seaward end of slipways (performance features) can be a handy early warning to monitor the beach closely for what could be a relatively localised short-term issue or could be signs of a longer term and wider problem.

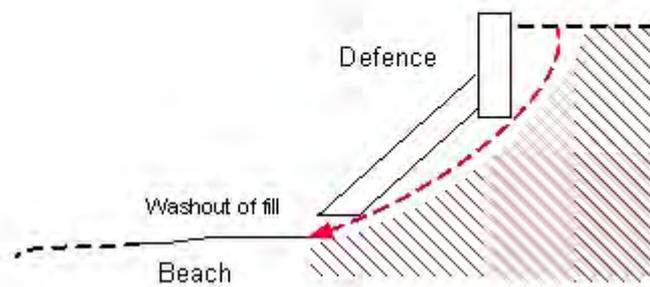
Figure 3.31 Schematic of backfill washout

Figure 3.31 illustrates this case where, over time, a stepped concrete revetment has been effectively undermined – the fill material removed by water entering beneath the toe of the structure leading to eventual collapse of the pavement behind (Figure 3.32). However there are no visible signs of deteriorating condition of the revetment or the seawall that may have contributed to this. This appears to be an extreme case but such failures are alarmingly common. It illustrates the importance of maintaining design beach levels. If this is not possible, there should be prudent consideration of structural remediation or adaptation of the defences.

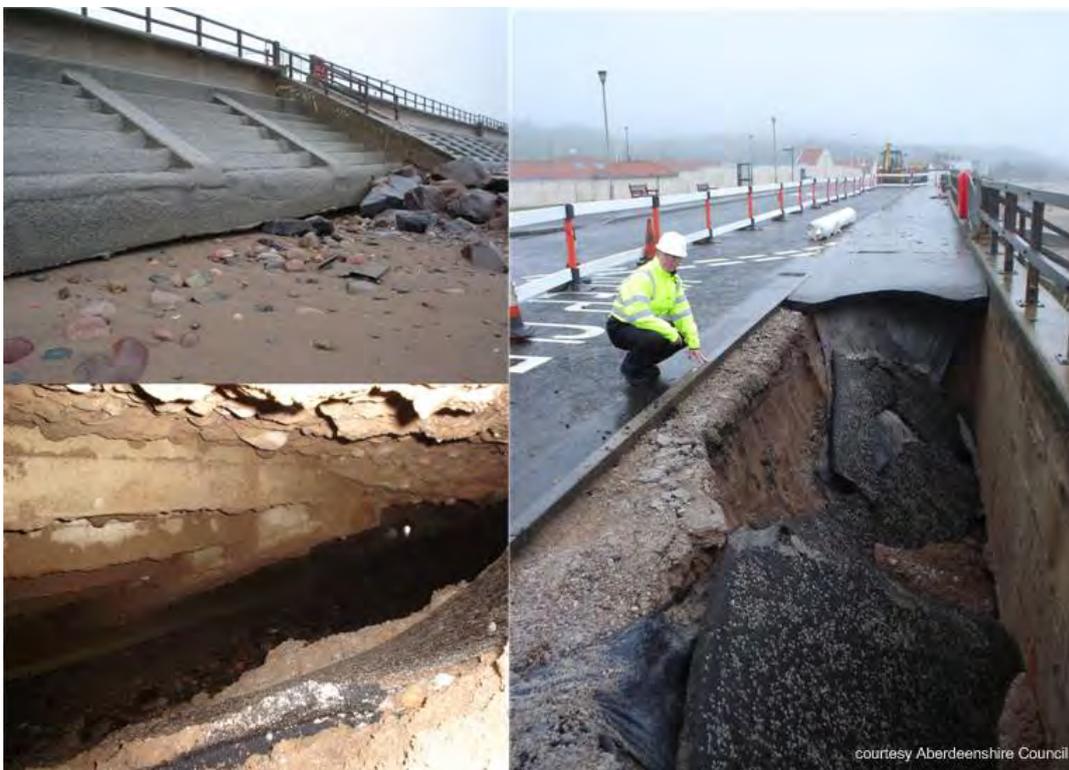
Figure 3.32 Undermining and fill washout of stepped revetment and wave return wall

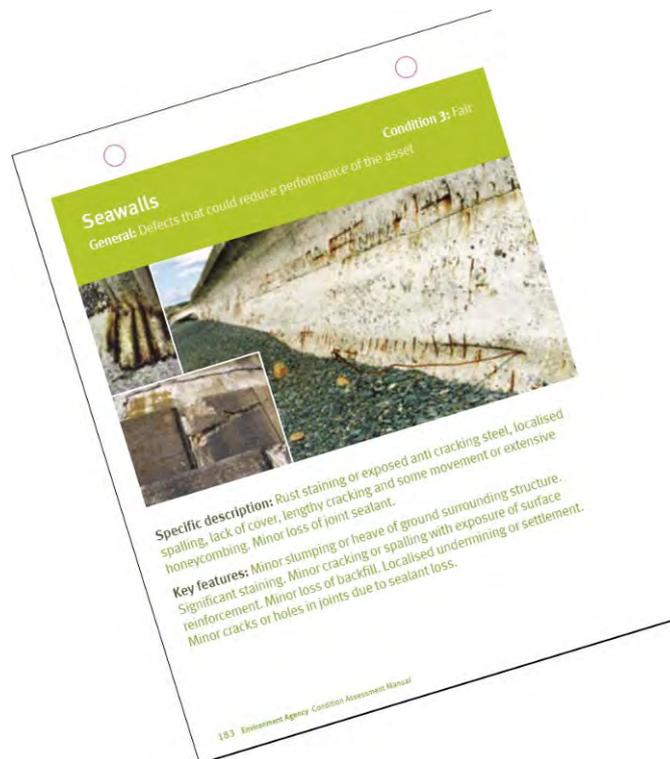
Figure 3.33 An example of a page from the ‘Seawalls’ section of the Environment Agency’s *Condition Assessment Manual* (2006)

For the purpose of visual inspection, however, toe structures can be inspected according to the relevant materials and structure inspection guidance (Figure 3.33) in the Environment Agency's *Condition Assessment Manual* (2006). The importance of maintaining good design and construction records, as a source for comparison, is emphasised.
