Toe structures management manual

Project: SC070056/R

Coastal structures, structure toe, asset management, condition assessment, beach, scour

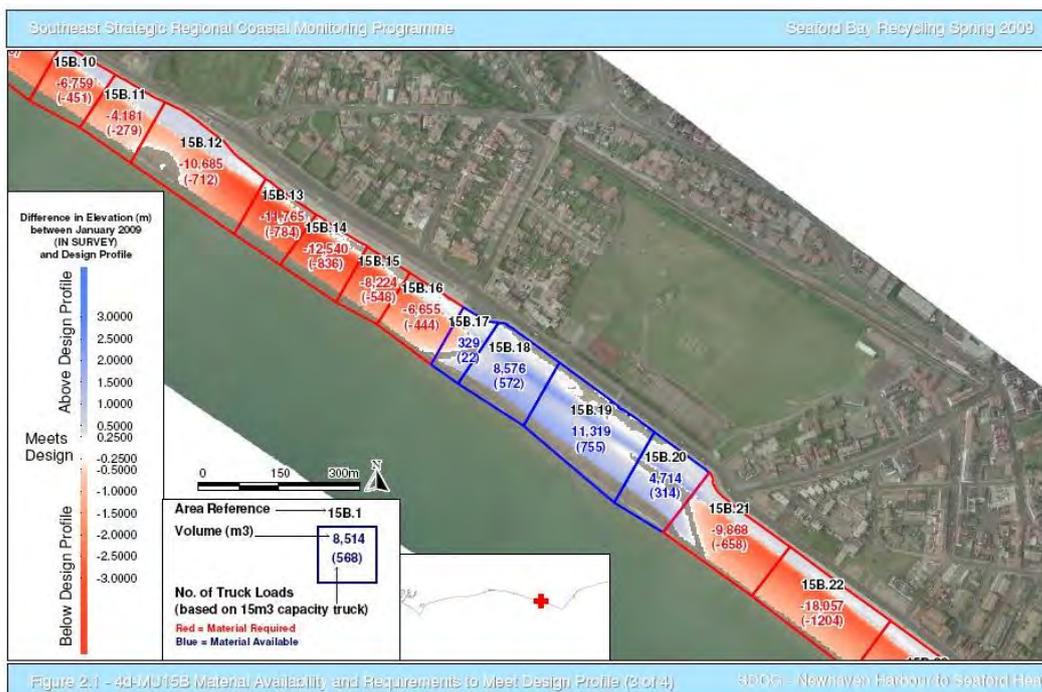
Figure 4.1 Application of monitoring data to identify beach zones beneath trigger levels (courtesy Worthing Borough Council)

The approach using regular detailed baseline topographic surveys allows generation of digital terrain models and calculation of beach volumes relative to trigger levels. The approach adopted in Figure 4.1 highlights the volume necessary to maintain the required design management levels at a site fronting a seawall. The approach locates and quantifies volumetric shortfalls within groyne compartments, identified by survey. Possible recycling sources are also shown within zones containing a surplus above the required management profile. The number of truck loads required in each groyne bay is highlighted, providing the basis for logistic planning of maintenance operations. The maintenance undertaken at this site is at a very large scale relative to most UK sites. Alternatively, material may be imported from offsite sources in order to achieve the required beach levels.

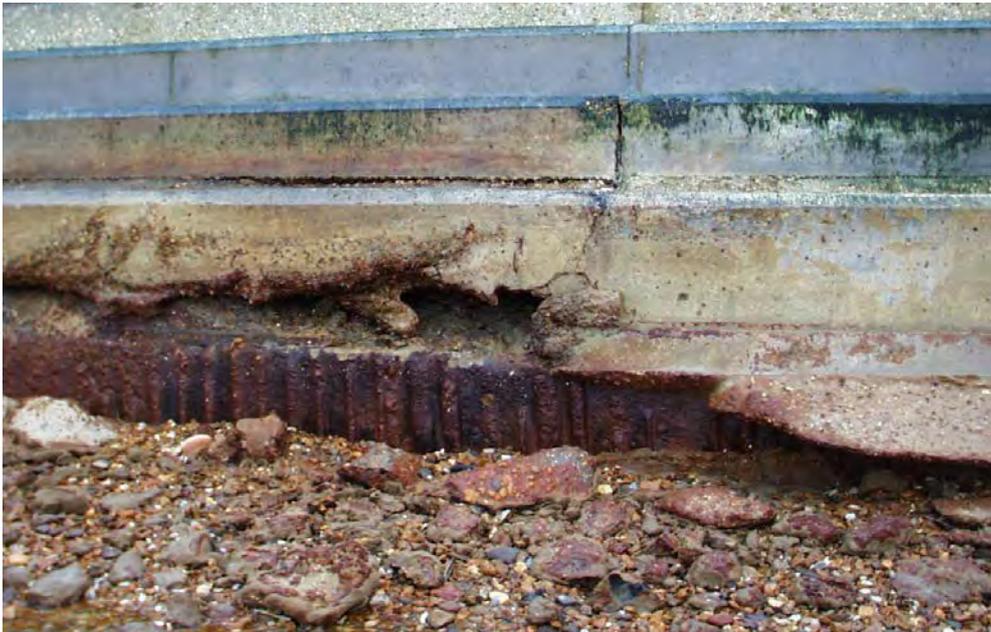
Figure 4.2 Beach that has reached trigger level prior to repair and recharge (courtesy Poole Borough Council)

On some occasions trigger levels are set on the basis of visual identification of key features on the structure toe. The example shown in Figure 4.2 has an intervention trigger when the interface between the bottom step and foundation shutter is exposed. This structure has not been designed to allow direct wave attack at this elevation on the toe.

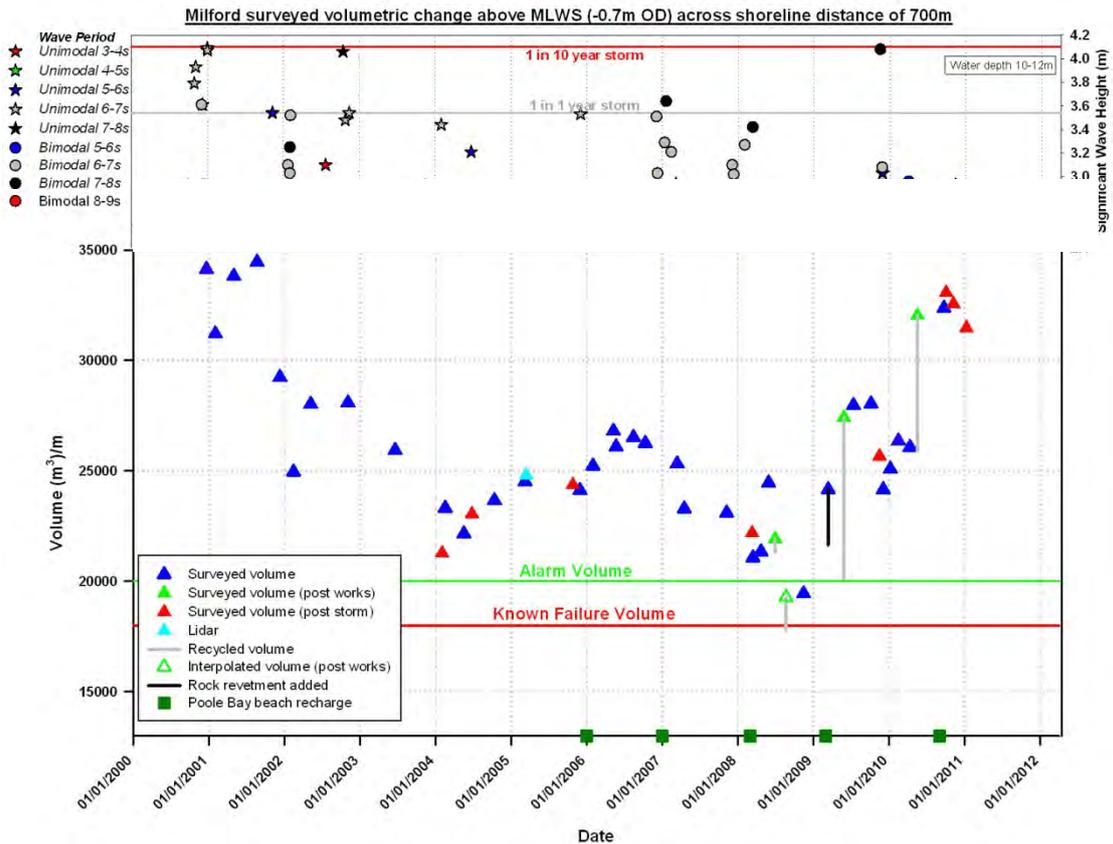
Figure 4.3 Application of monitoring data to identify long term beach performance in context with structure toe triggers (courtesy Channel Coastal Observatory)

Figure 4.3 provides a valuable summary assessment of toe scour management using beach recycling and small scale recharge. Trigger levels are shown. The experience of previous toe failure at this site has been built into the maintenance plot. The experiences and linkages between beach losses and storm events can be identified. A series of small recharge operations have been conducted to maintain the beach above trigger levels and there is a clear annual trend of loss which can be used to plan for the requirements of further intervention. The vertical grey lines indicate interim recharges, which are small in size (approximately 1,000–7,000 m³ each).

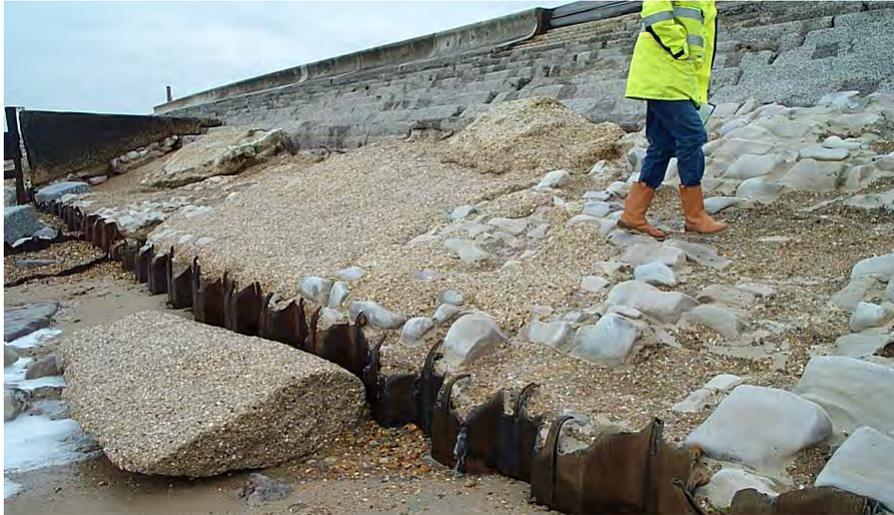
Figure 4.4 Typical damage to tops of steel interlocking piles (courtesy AP Bradbury)

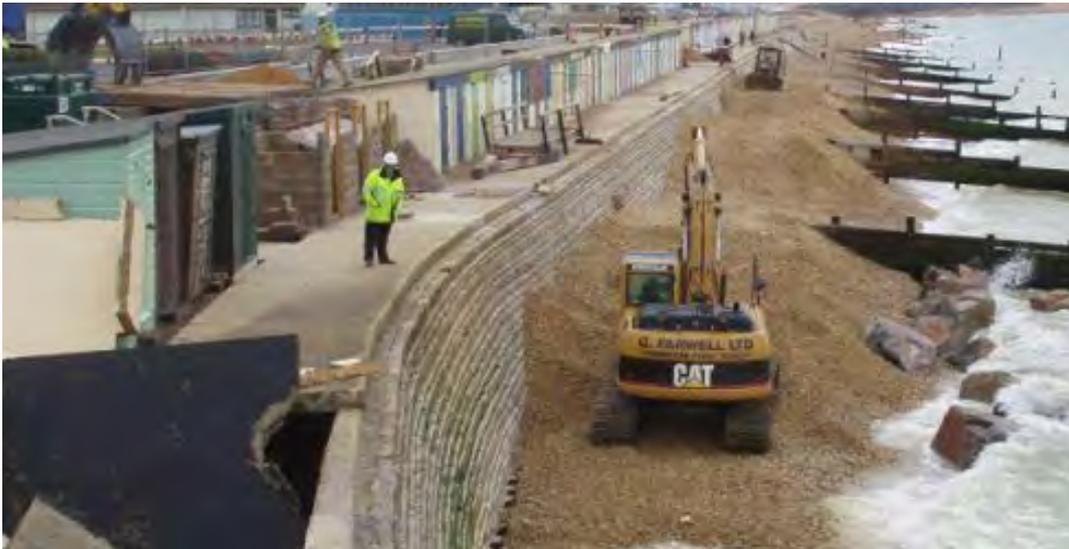
Figure 4.5 Temporary access road constructed from local beach material (courtesy New Forest District Council)

Access to the toe is a major problem at many sites and, where access is not possible at the crest of the structure, access via temporary haul roads may be required (Figure 4.5). In this instance, access is required over a number of closely spaced timber groynes. The simplest solution is often reshaping of beach material to form a temporary access way, although this approach is often fraught with the difficulties arising from inadequate beach volume and wave action which may regularly destroy the access.

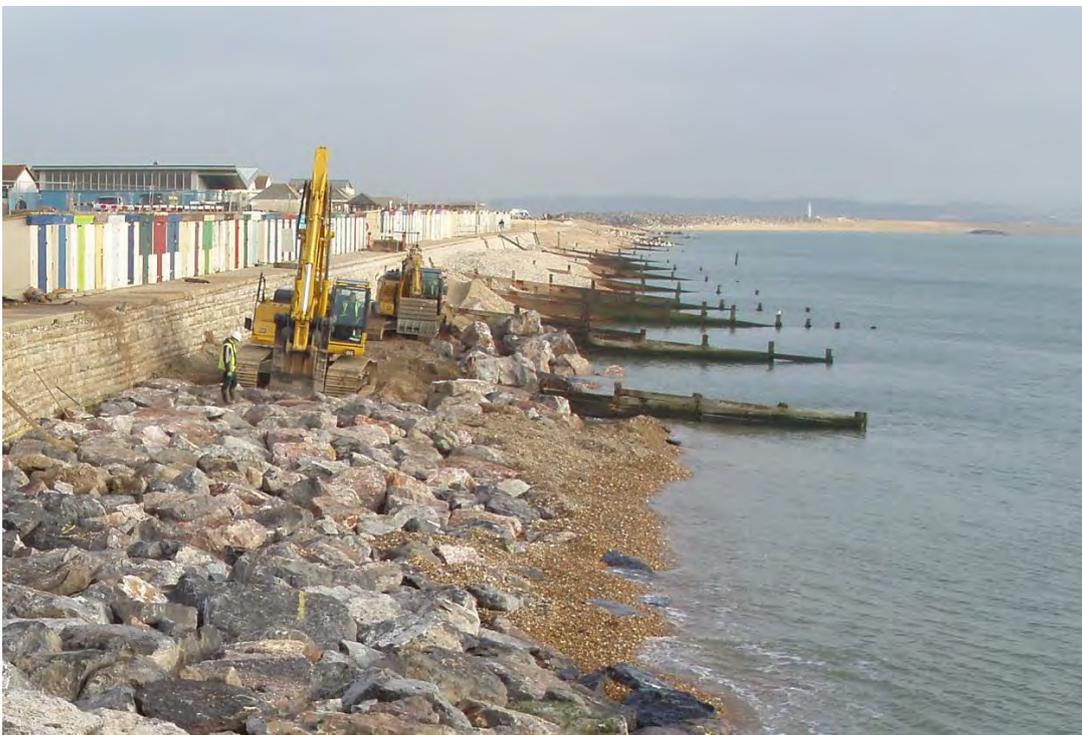
Figure 4.6 Improvement of access by construction of rock toe with wide crest berm suitable for plant access (courtesy New Forest District Council)

Maintenance activities may provide the opportunity to enhance access to a site. Addition of a rock toe (Figure 4.6) to support a vulnerable structure has provided the opportunity to improve access along the toe of the same structure as shown in Figure 4.5. The crest berm has been constructed to provide a suitable width to enable a tracked excavator to move safely along the top of the rock toe at all states of the tide. This approach is quite costly, since more rock is required for construction. In addition, the structure has considerable hydraulic benefits in reducing overtopping by the dissipative berm and reducing the volume of beach material required to recharge the site following completion of the toe maintenance works.

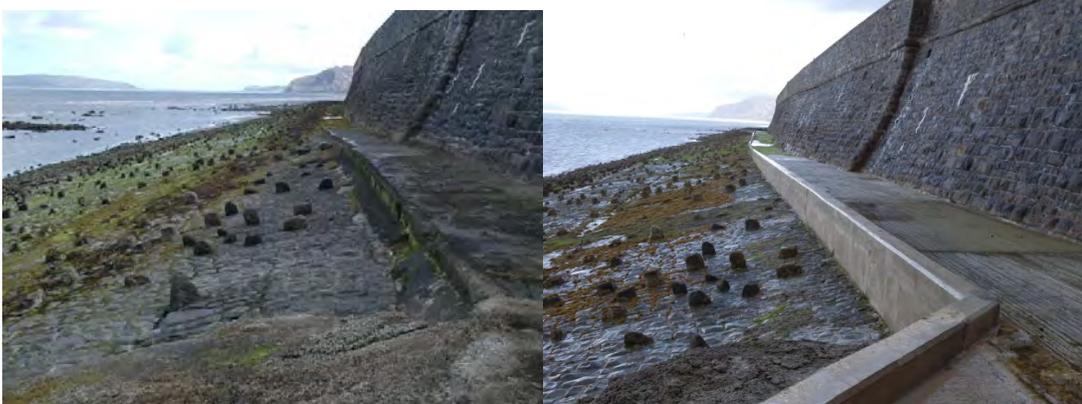
Figure 4.7 Improvement of access by construction of concrete roadway suitable for plant access (courtesy Alan Williams)

An example of improvement of an existing dilapidated access along the interface between a mid-19th century vertical wall and a toe revetment, at Llanfairfechan, North Wales, is shown in Figure 4.7. The later shot (to the right) shows how the access was upgraded for maintenance works that were carried out to the toe revetment.

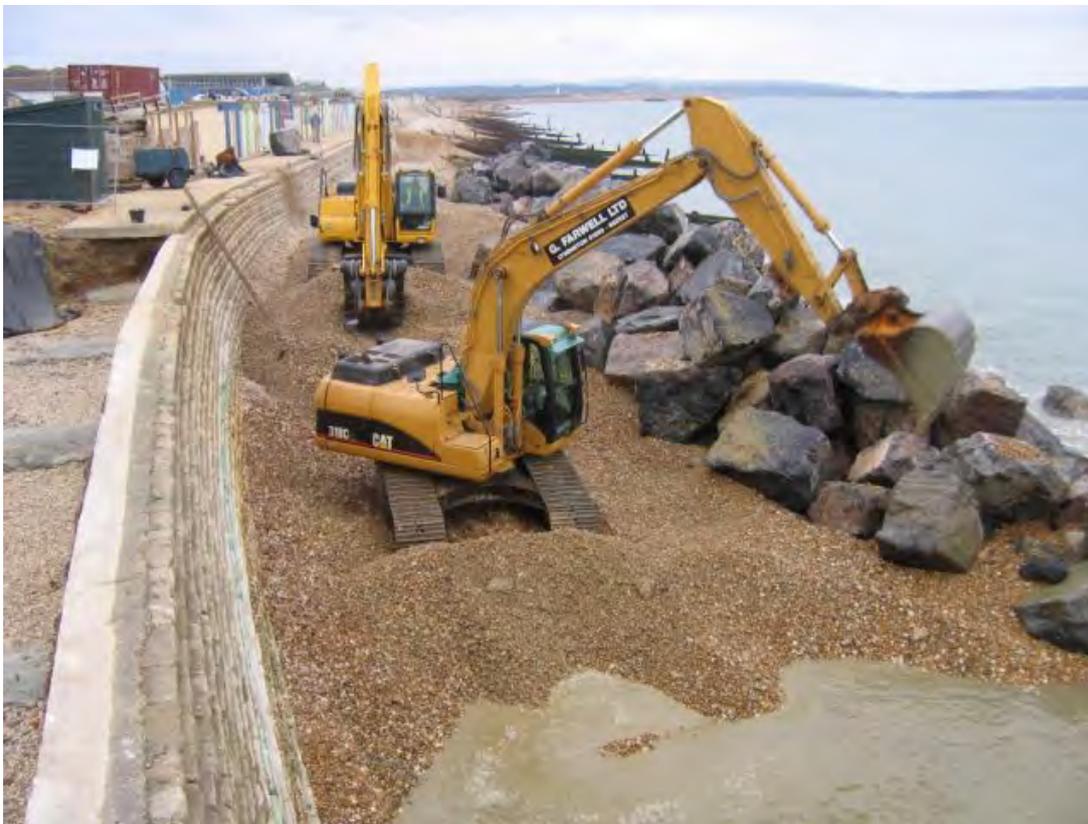
Figure 4.8 Temporary rock bund to provide safe working area for plant during toe repairs (courtesy New Forest District Council)

Maintenance works often need to be undertaken in difficult conditions. Working is often required at extreme low water and any small wave activity is likely to reduce the safety of operatives. Rock armour, which is eventually used to provide an additional toe, may be used to provide a temporary bund to achieve safe working adjacent to the wall (Figure 4.8).

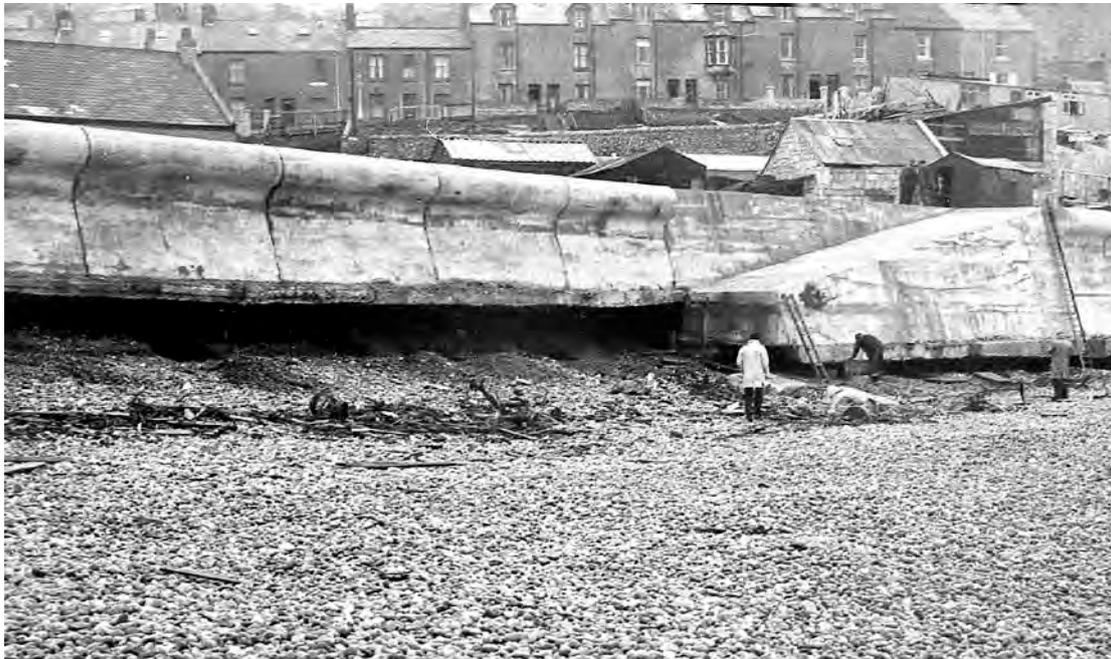
Figure 4.9 Unsupported section of reinforced mass concrete seawall following major undermining (Chesil Cove 1962) © Stuart Morris

concrete walls to remain unsupported over fairly long stretches, at least on a temporary basis (Figure 4.9). This occurs commonly where the structure foundations are perched within the tidal limits and where the original foundation construction has not closed onto bedrock. Support beneath the wall is required quickly to avoid cracking and failure under tension. This may often be conducted by underpinning the wall using mass concrete to provide a new foundation.

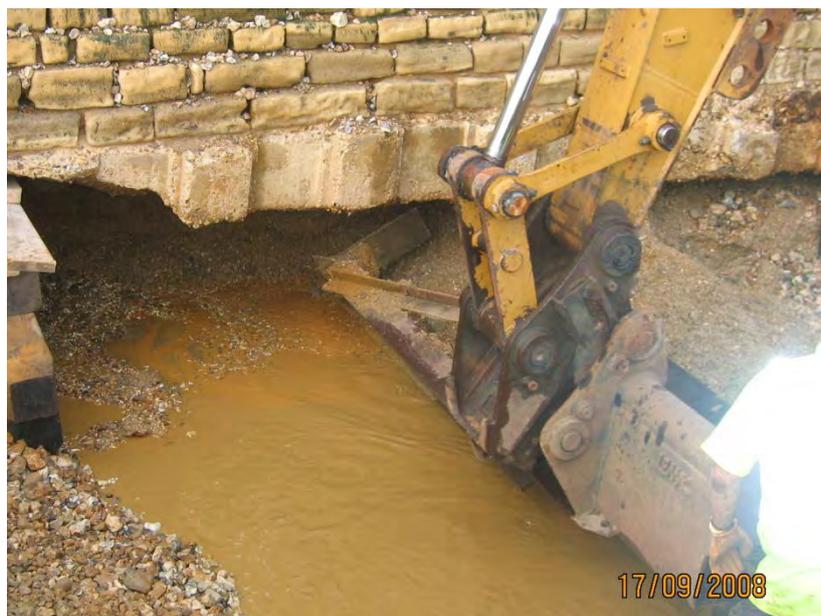
Figure 4.10 Preparation of foundation excavation beneath wall for underpinning, using bespoke plant to ensure safe working beneath seawall (courtesy New Forest District Council)

Maintenance operations which require underpinning are challenging and sometimes require the bespoke development of specialist tools to achieve safe working and to maximise the structural integrity of the repair. This often requires removal of failed or loose material from beneath the undermined wall. A modified excavator bucket is used to rake loose material from beneath the bridging wall while maintaining safety for operatives (Figure 4.10). Excavations should ideally close onto competent bedrock material, but this is not always possible due to the depth of beach sediments.

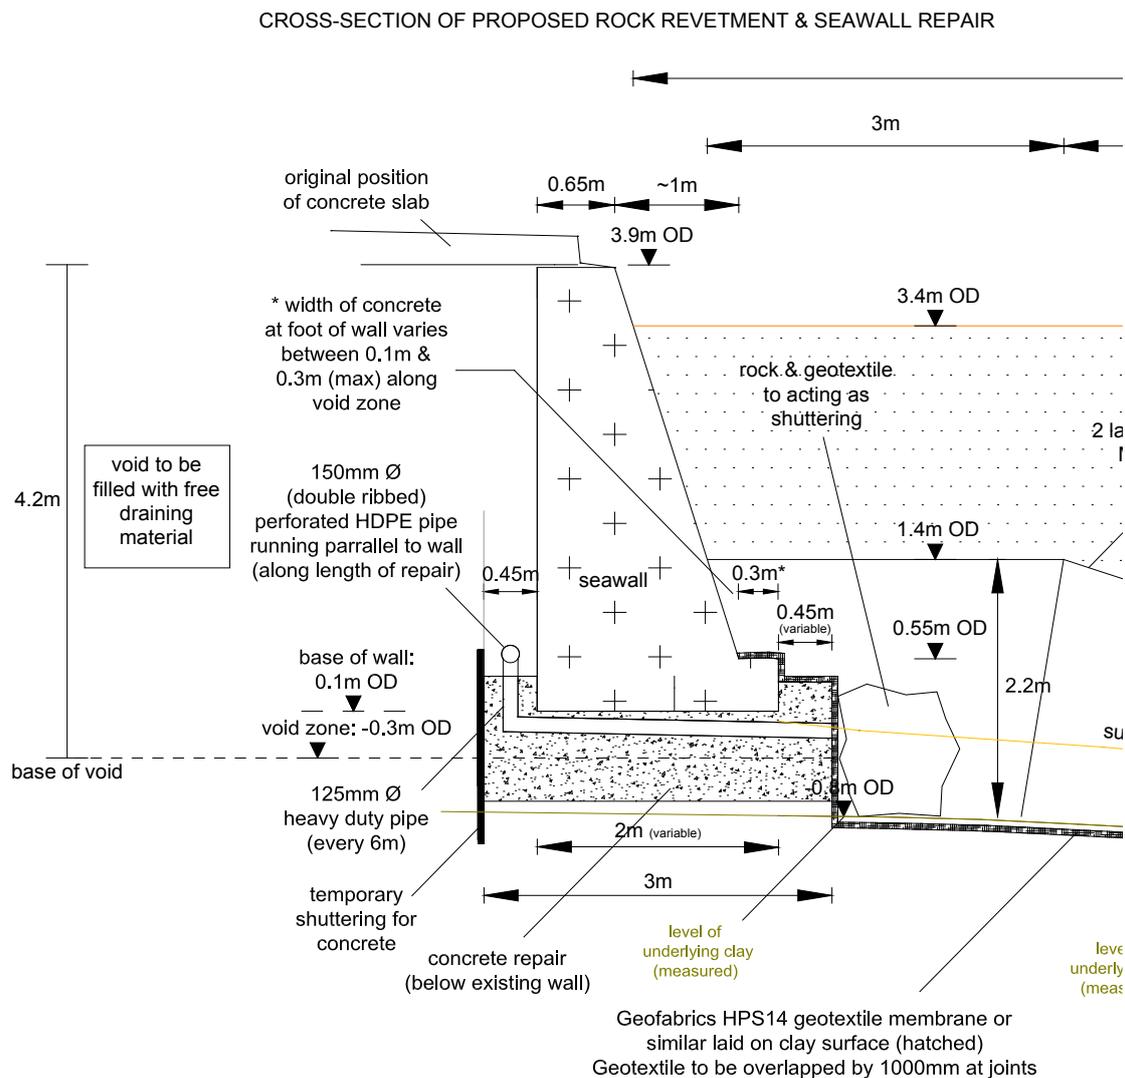
Figure 4.11 Underpinning detail for seawall foundation repair (courtesy New Forest District Council)

The detail provided in Figure 4.11 shows an underpinned toe repair with the following characteristics:

- The base footprint of the repair underpinning is wider than the original foundation.
- Drainage is secured by regularly spaced high density polyethylene (HDPE) pipe placed within the underpinned foundation.
- The void behind the wall has been filled with coarse free-draining material.
- Loose material has been removed from beneath the old foundation.
- The new foundation closes out onto bedrock (this is not always possible).
- The underpinning concrete is tied into the old structure by way of cast interlocking upstands on either side of the underpinned foundation.
- Shuttering is provided by geotextile material held in place by rock armour and shingle on the seaward face.

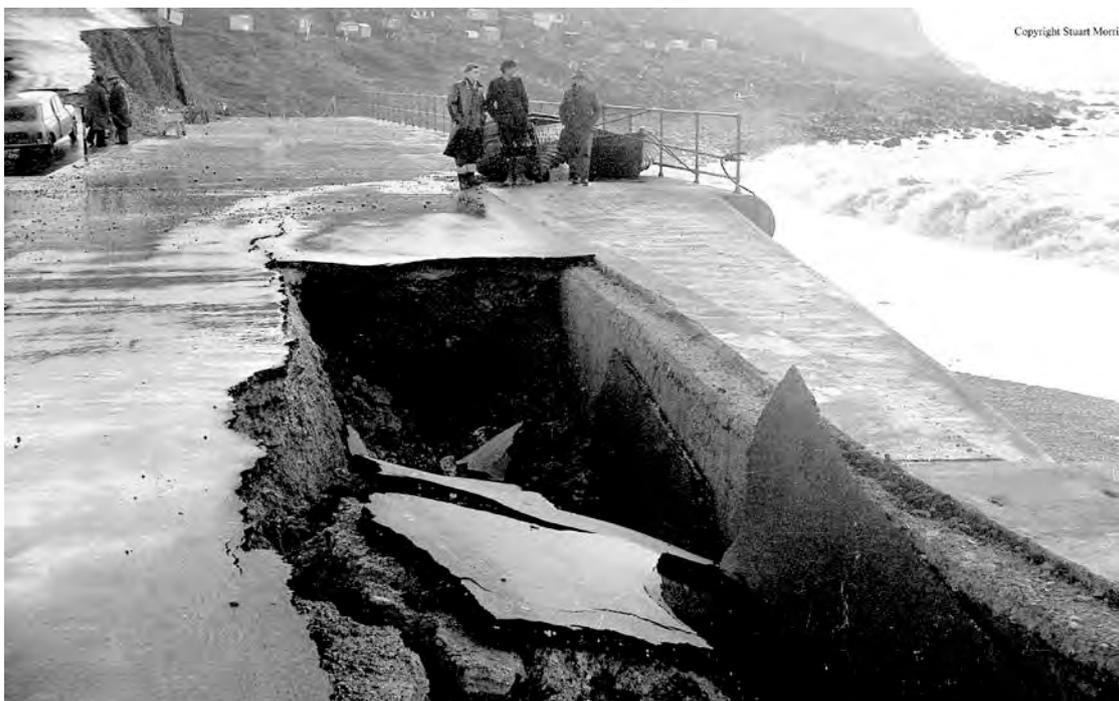
Figure 4.12 Typical collapse of promenade decking following undermining of backfilled mass concrete wall and washout of fine core (Chesil Cove 1962) © Stuart Morris

Promenade deck failures of the type shown in Figure 4.12 are fairly common and occur as a direct result of toe failure. Historical construction of mass concrete walls typically included a locally won backfilled material. This material is quite likely to have a significant fines content. Repairs of the backfill zone, following structure toe failure, should ideally be replaced with a coarse compacted granular fill that is free of fines. This will assist with drainage of water from the landward side of the structure and should prevent subsidence of the surface and formation of a void beneath decking, which may often be a cast concrete slab – although the example shown is a simple asphalt surface.

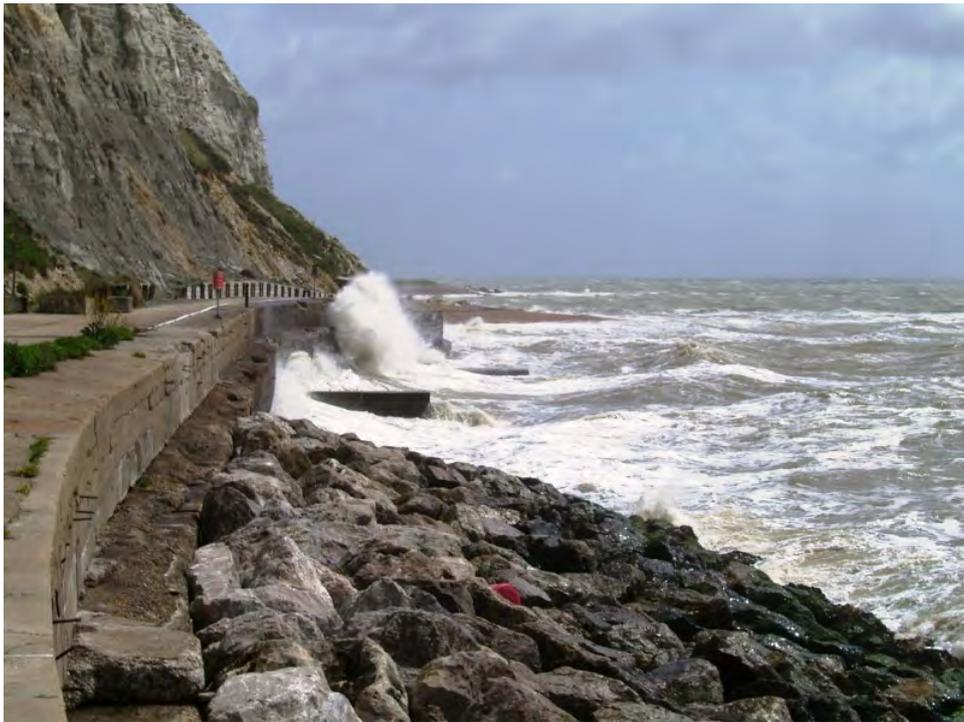
Figure 4.13 Contrast between concrete toe and modified rock armour toe Folkestone Warren (courtesy Bryan Curtis)

5. It is clear, however, that rock toe structures are far better at energy dissipation than vertical concrete structures (Figure 4.13).

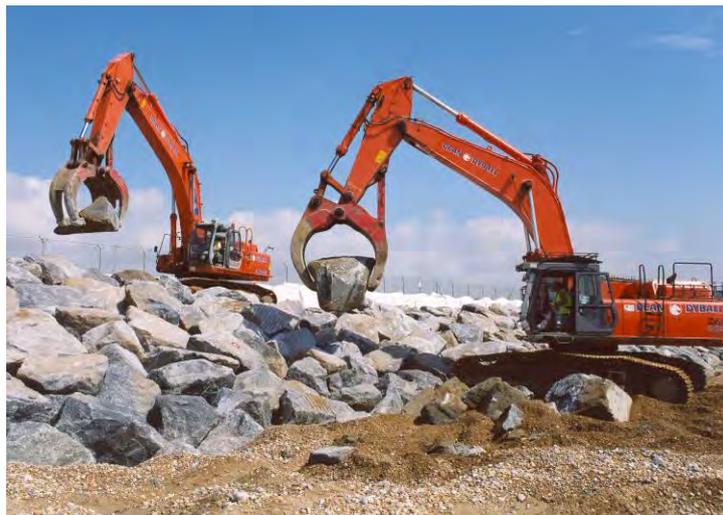
Figure 4.14 Manoeuvring armourstone blocks in a revetment (courtesy Dean and Dyball Ltd)

Provided access is possible, Repositioning or reprofiling of dislodged armourstone in a toe structure may be a relatively straightforward maintenance option for limited repairs (Figure 4.14).

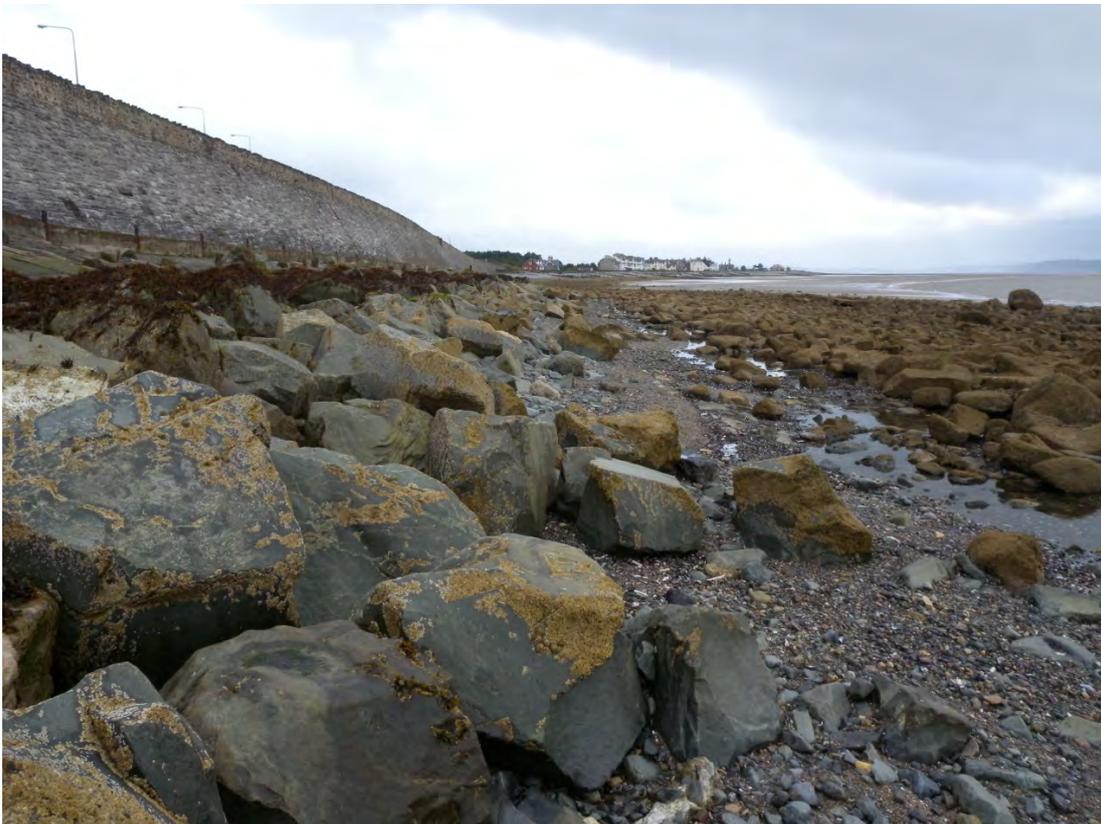
Figure 4.15 Armour displaced from a rock toe, Llanfairfechan, North Wales (courtesy Alan Williams)

When rock armoured toes have been constructed as part of the defence (see Chapter 5), these may regularly suffer damage (Figure 4.15). A frequent problem arises as the rock toe settles, particularly when this is placed on soft bedrock material. Settlement may result in displacement and reduced interlock of some of the armour, which may require reconstruction to maintain structure integrity. The benefit of the rock armour at the toe is that it is self-healing at the point of bed settlement and will move with the bed. This has the advantage that the structure will not become undermined. The consequence of settlement though is that more material is generally needed to top up the profile. Allowance for settlement of a falling toe is often built in to the design of a rock toe.

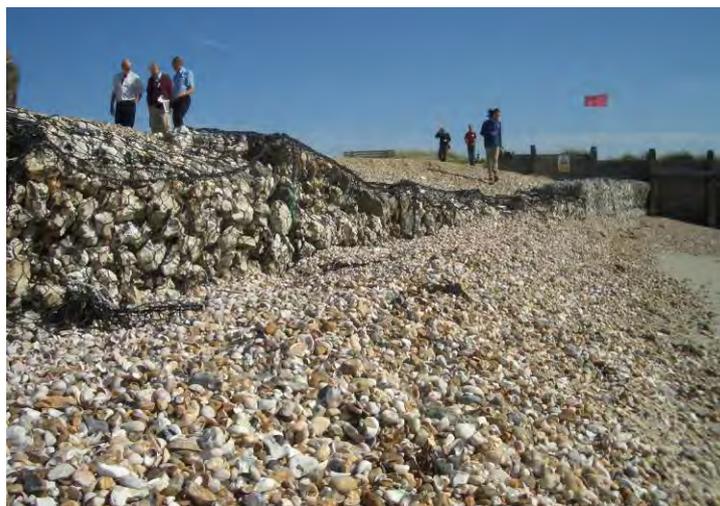
Figure 4.16 Weathered gabions at East Head, Chichester Harbour, West Sussex (courtesy HR Wallingford)

Gabions placed in even relatively mild coastal conditions usually require extensive maintenance and are not generally recognised as efficient toe structures. The contents can settle within the gabions or may escape altogether, with contortion of the mesh or breakage (Figure 4.16). Gabions that have simply 'settled', which remain intact and are relatively in shape may just require topping up with fill material. Sometimes 'leaked'

contents may be reused if they remain close by. Replacement fill material should be close to or larger than the size of the original. Gabions that have distorted badly or collapsed altogether will usually require replacement of the whole gabion unit.

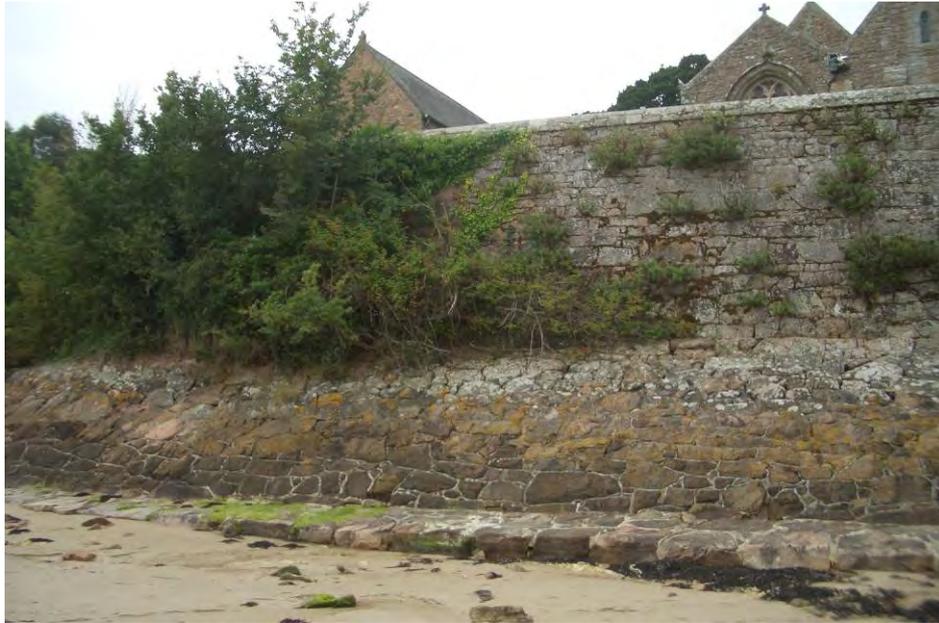
Figure 4.17 Vegetation colonising joints in a masonry coastal defence
(courtesy HR Wallingford)

If allowed to grow, vegetation such as bushes and trees can cause deformation and movement in the structure – forcing blocks apart or out of the section (Figure 4.18). Hence vegetation should not be allowed to take root in such structures and should be cleared as necessary. Problems associated with vegetation are more likely to prevail in the higher parts of the wall structure rather than at the toe.

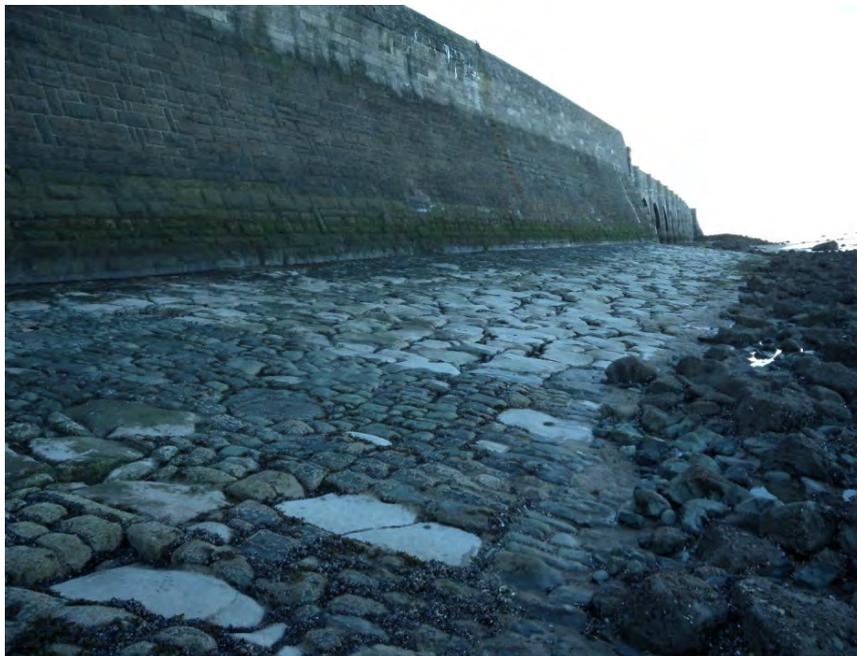
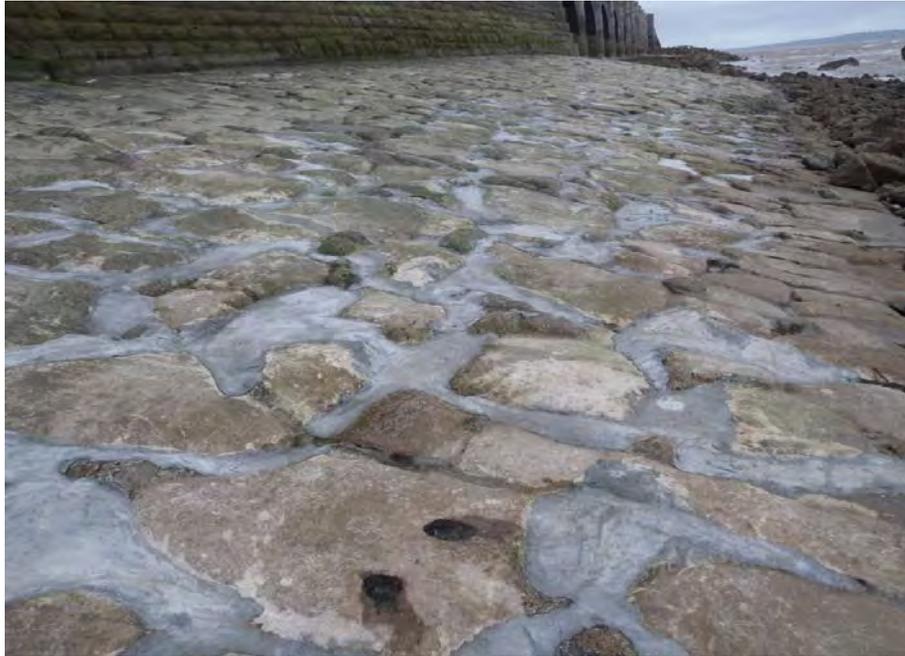
Figure 4.19 Prior to and following maintenance of grouted masonry toe (courtesy Alan Williams)

Figure 4.19 shows a masonry toe before and after repointing. A durable grout should be used for pointing to ensure effectiveness and regular inspections made to identify any damage or weaknesses, and to record general deterioration in joint grouting over time.

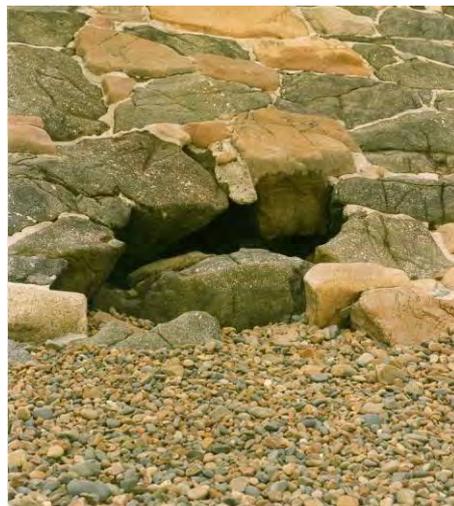
Figure 4.20 Dislodged masonry blocks from revetment toe (courtesy HR Wallingford)

Dislodged masonry blocks at the structure toe may act as a catalyst to rapid toe failure. Under severe storm conditions, failure of the whole defence could quickly ensue. Figure 4.20 illustrates such a situation, which if left unaddressed could cause rapid development of damage to the revetment, together with possible collapse. Major damage arising from this initially small problem would result in significantly greater costs of repair than replacing the single displaced block. Maintenance has to be undertaken soon after damage occurred, if progressive damage is to be avoided. This, in turn, implies regular inspection of defences (and inspection after storms) so that damage can be quickly observed and acted on.

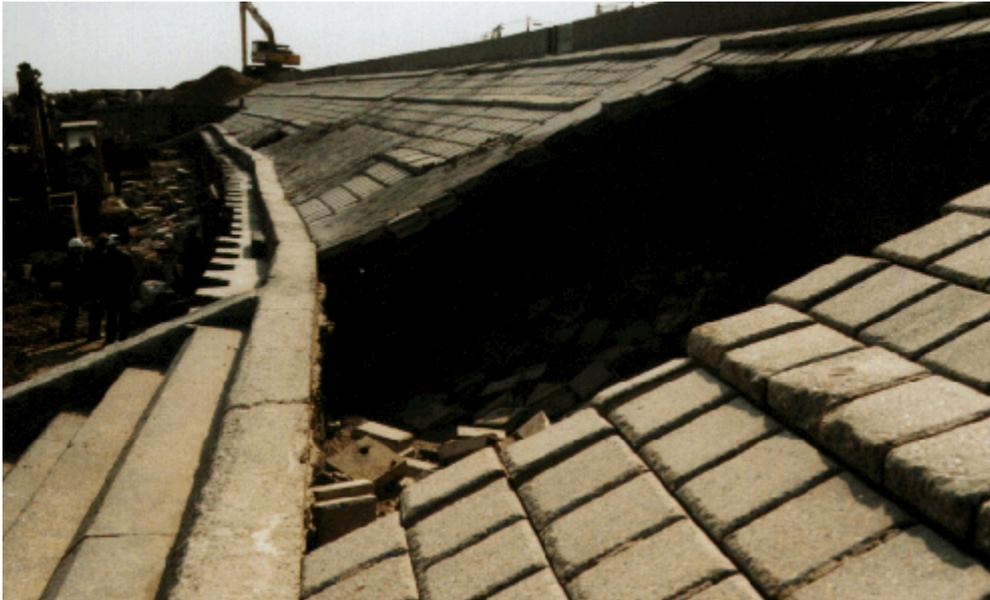
Figure 4.21 Washout and collapse of block revetment following block removal (courtesy Canterbury City Council)

Collapsed, dislodged or missing blocks from toe revetments can quickly lead to more major problems, with washout of fill material and further structural instability and eventual failure (Figure 4.21).

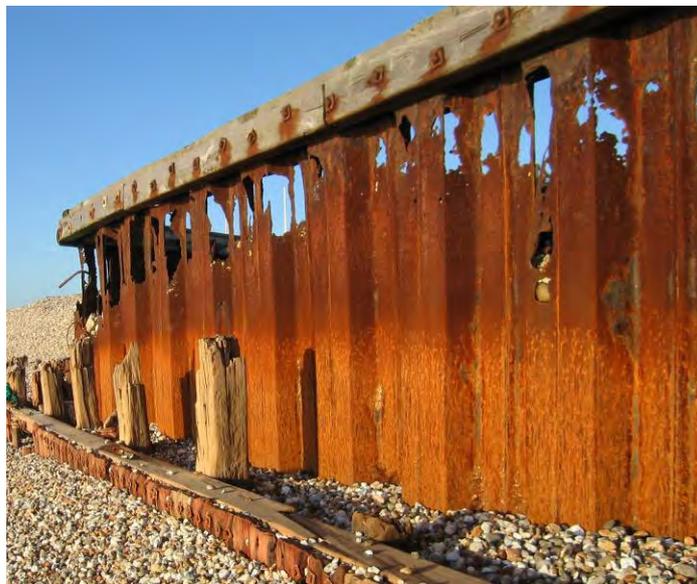
Figure 4.22 Deteriorated sheet piles

Sheet piles need replacement or repair where they have deteriorated over time either through rusting, abrasion and erosion of section, or through accelerated low water corrosion (ALWC). More generally, failure is manifested by holes in the piling rather than failure of the pile as a structure (Figure 4.22). In the more extreme cases, the thinning sections can become razor sharp. Remedial action should be taken immediately where corroded exposed piles pose a hazard to people or animals.

While the extreme damage shown in Figure 4.22 is generally unsuitable for repair by welding on steel plates, welding may provide a suitable repair method at locations where the damage is localised and small holes or thinning of the piles has occurred.

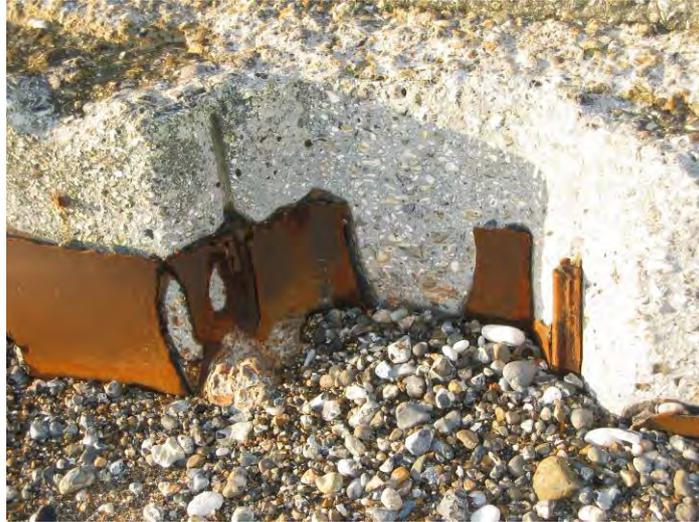
Figure 4.23 Complete loss of section of sheet piles in an area exposed to sediment movement

Damage to the tops of piles on toe structures is very common, especially when they are subject to rapid abrasion in a sediment-charged environment. Where the piles simply form a shutter to the mass concrete behind, this may not be a particularly serious issue (Figure 4.23).

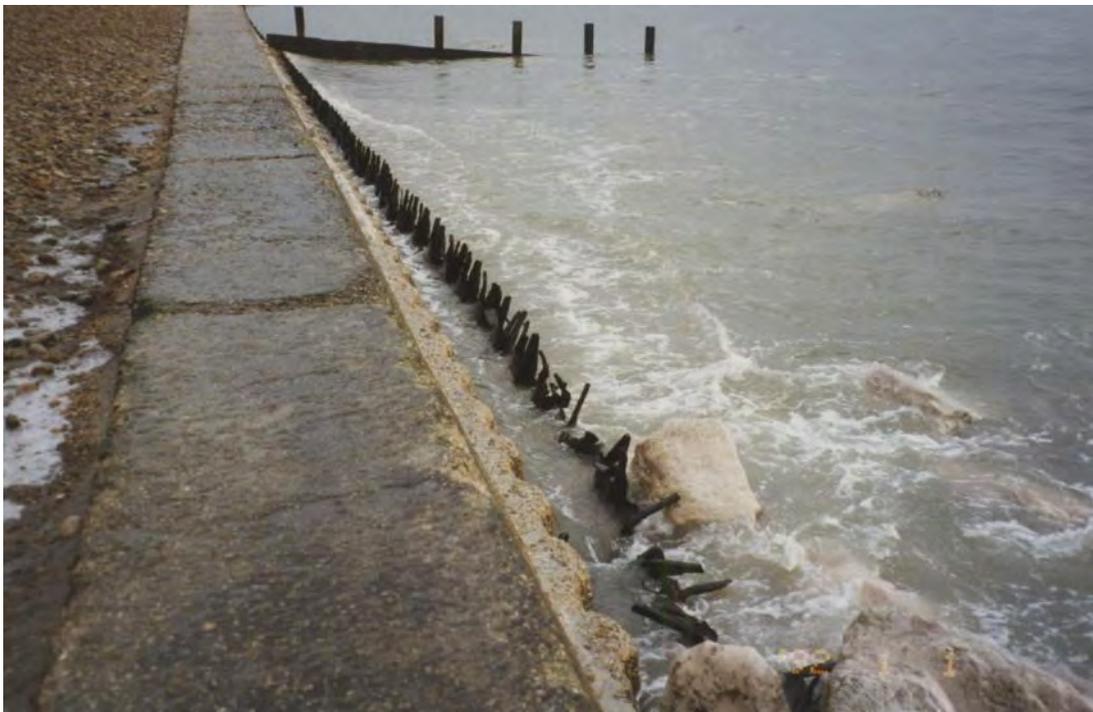
Figure 4.24 Damaged interlocking steel piles requiring maintenance to make site safe (courtesy A P Bradbury)

Where damage is noted to the pile tops, reference should be made to the original design to determine the role of the piling in the structure. In those instances where the pile is simply forming a shutter, without a structural role, the piles can be maintained by burning or cutting the tops to remove sharp edges or by covering with rock armour. This is generally a safety measure (Figure 4.24).

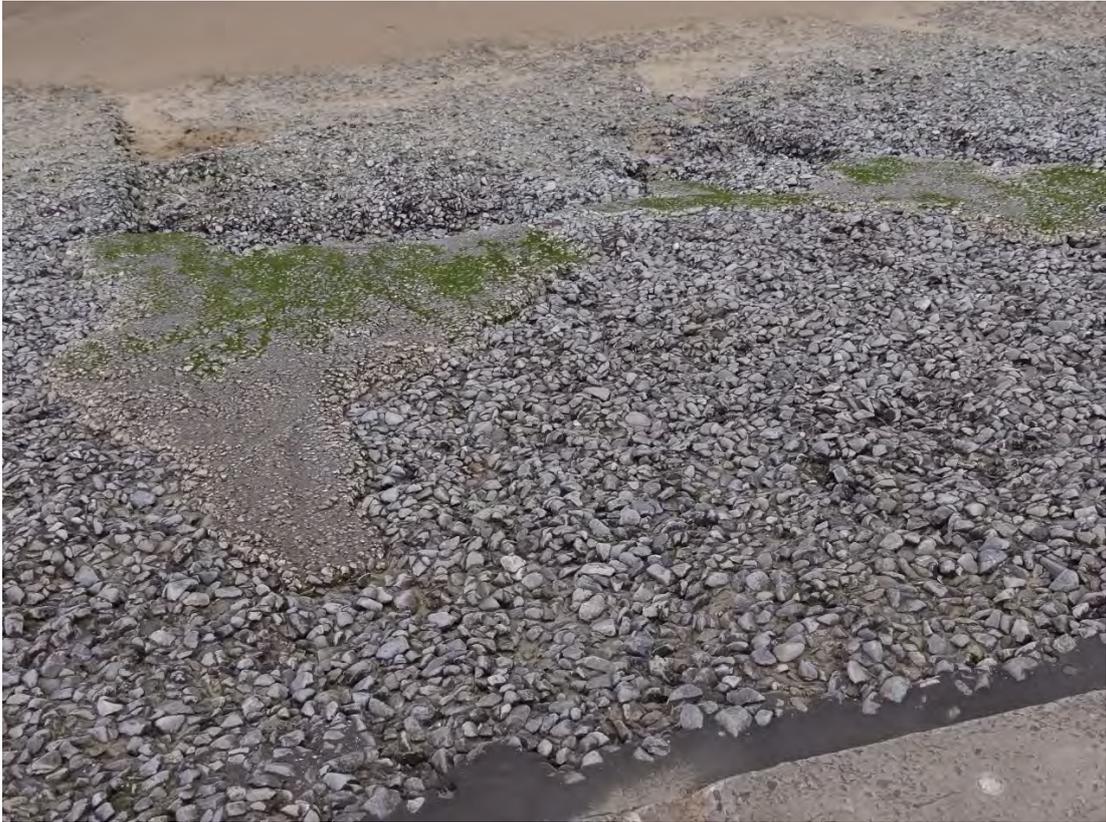
Figure 4.25 Repairs to open stone toe at Prestatyn, North Wales (courtesy Alan Williams)

Figure 4.25 shows both concrete and neat bitumen being used to repair holes in an open stone toe apron at Prestatyn, North Wales. While this is not best practice and has potential impacts for the permeability of the structure if used extensively, it is clearly cheaper especially for small repairs and has been effective particularly as a stop gap. The concrete appears to have adhered reasonably well to the open stone asphalt, probably due to the surface roughness of the open stone asphalt and good preparation before the repair was effected. There has been no obvious change in the condition of the repair at the example site over a five-year period.

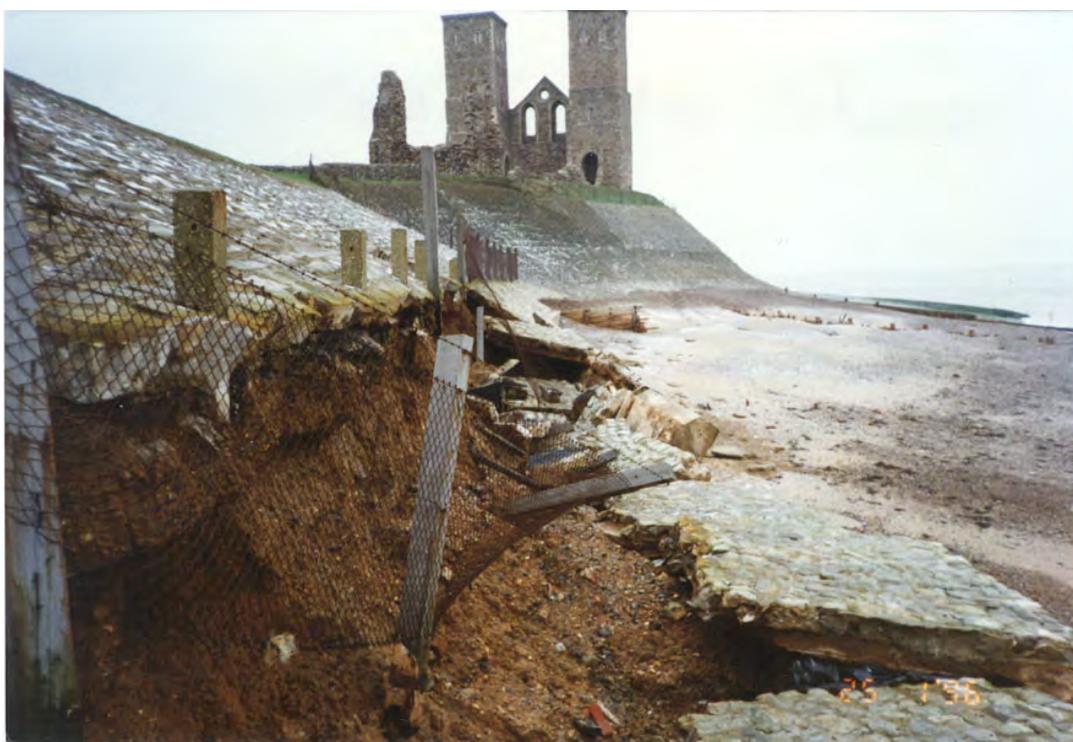
Figure 5.1 Toe failure example

In the case of geotechnical failure (undermining), the principal consideration is the long-term beach lowering (or perhaps an initial inadequacy of the defence). Transient loadings such as those due to storm action may be secondary, except in so far as they lead to short-term beach lowering and possibly an increase in hydrostatic head across the defence structure. Figure 5.1 shows an example of toe failure.

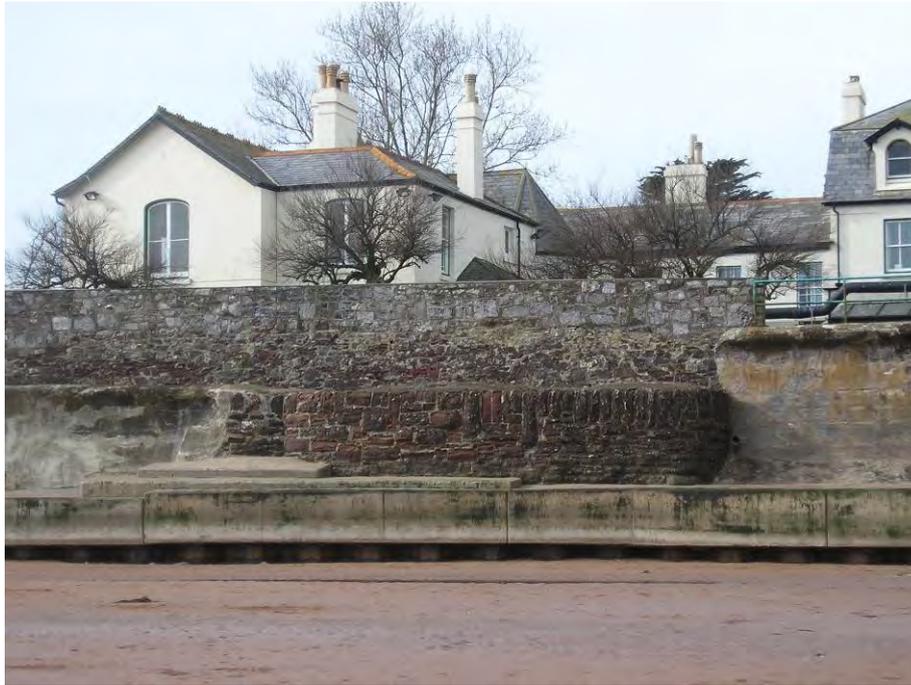
Figure 5.2 Goodrington Sands Seawall, Paignton (courtesy of ENBE)

Figure 5.2 shows the seawall at Goodrington Sands, Paignton. Numerous additions to the wall since original 19th century construction can be seen, the last being the concrete/pile toe added by Torbay Council in 2007.

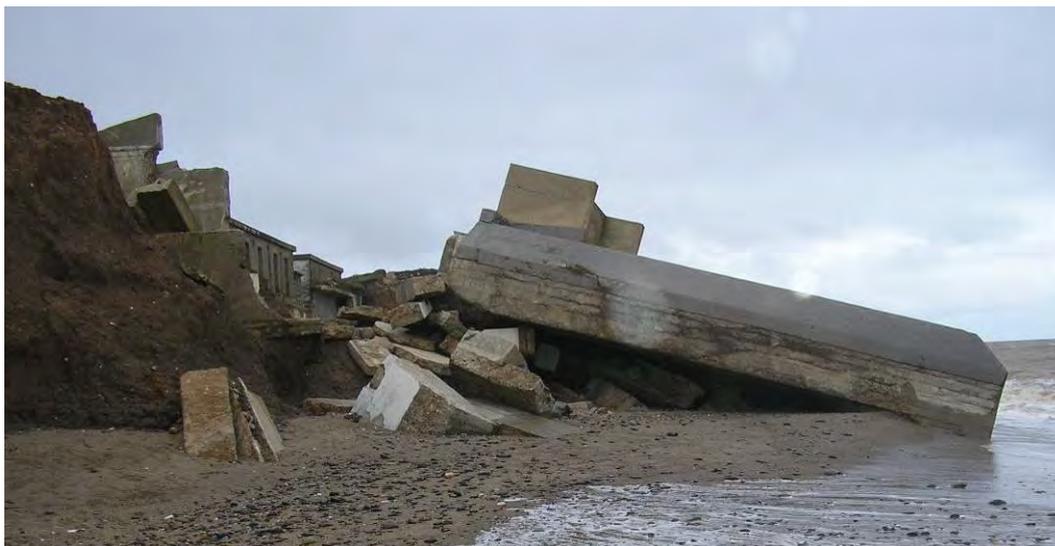
Figure 5.3 Undermining of wartime coastal structures at Kilnsey, Holderness (courtesy of ENBE)

The term ‘undermining’ is not consistently defined in technical or non-technical literature. Perhaps this is because other modes of failures are likely to have occurred before a structure becomes truly undermined; see also USACE (2012). The case study from Corton, Lowestoft, in Appendix C describes a case of true undermining of a piled wall (also Figure 5.3). For discussion purposes here, and generally in these guidelines, ‘undermining’ is simply taken to mean the condition at which the beach is below the bottom of the main defence structure such that further beach lowering would lead to erosion beneath the structure.

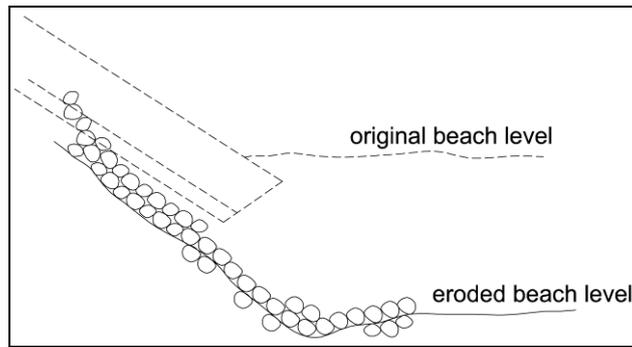
Figure 5.4 Undermining failure of a revetment

Figure 5.4 illustrates toe failure of a revetment due to undermining:
