Toe structures management manual

Project: SC070056/R

Coastal structures, structure toe, asset management, condition assessment, beach, scour

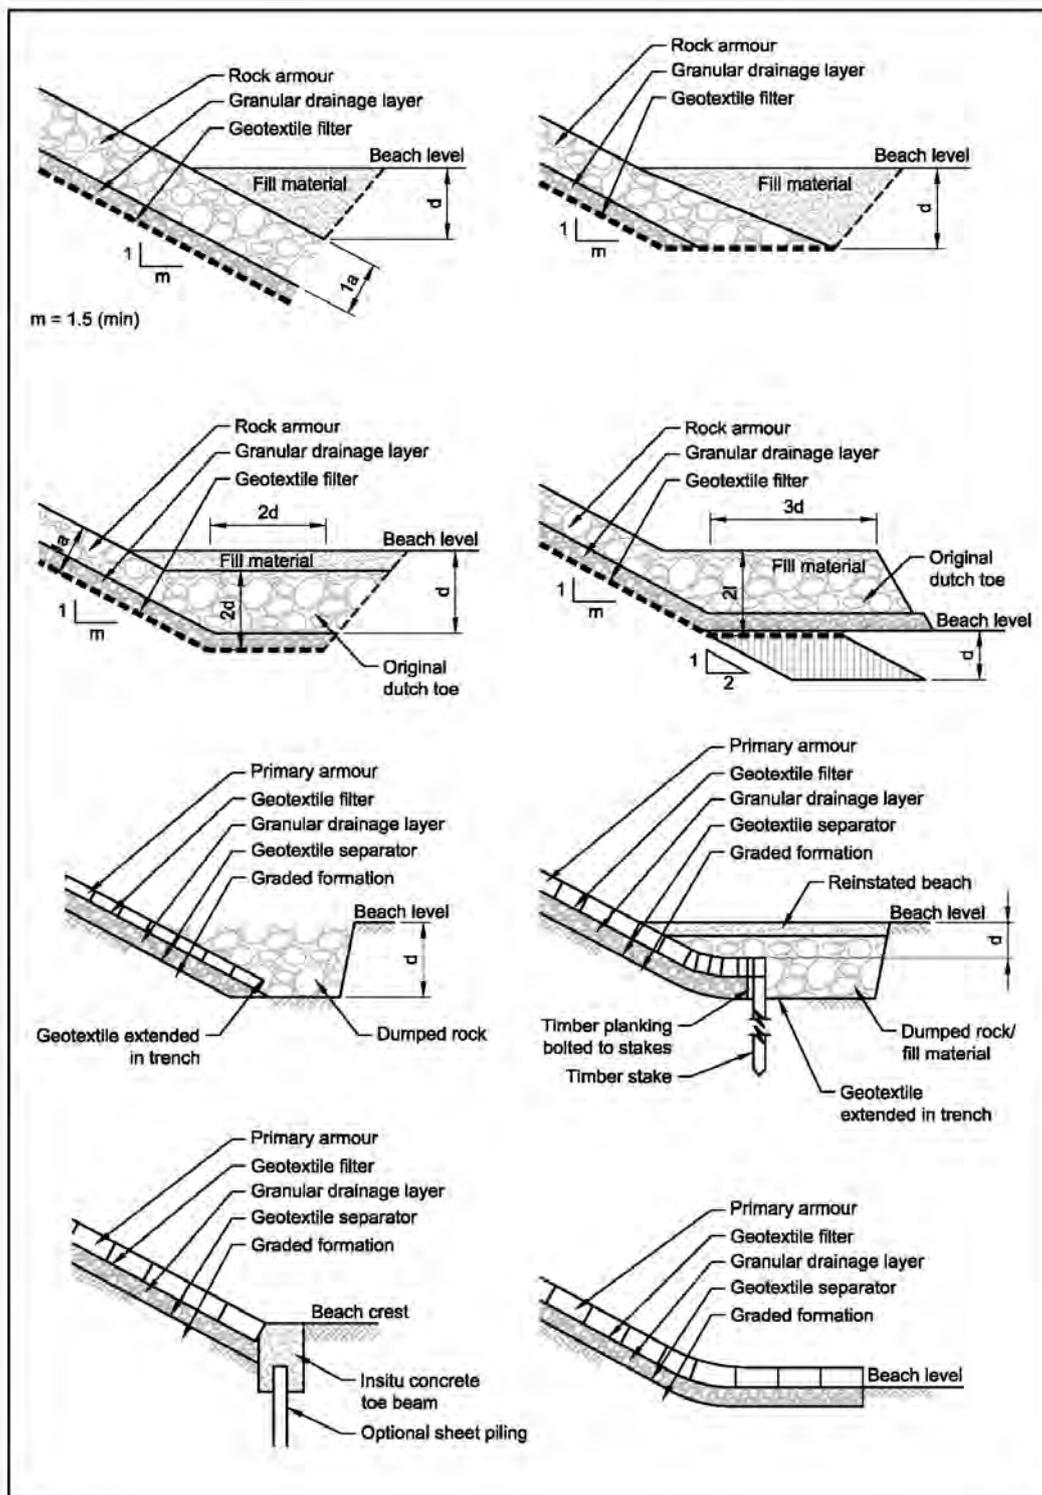
Note: 'd'_s is anticipated scour depth and '1:m' is structure slope.

Figure 5.5 Typical toe details (after McConnell, 1998)

Figure 5.5 illustrates a variety of toe structures as applied to revetments armoured with rock or other proprietary type units.

Toe structures, including those depicted in Figure 5.5, mitigate against undermining of the superstructure in one of two ways:

Readers are recommended to consider the design methodology for rock structures as described in *The Rock Manual* (CIRIA et al. 2007) as the state-of-the-art methodology (as of 2012). Typical toe details are also given by McConnell (1998), see Figure 5.5.

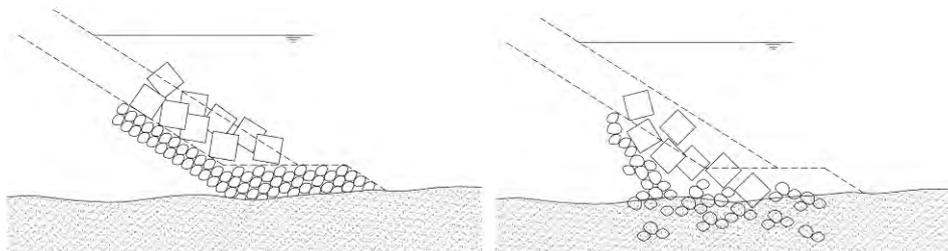
Figure 5.6 Sinking of armour units into liquefied seabed

For rubble structures and shallow concrete toe structures, liquefaction can result in rock or heavy concrete units sinking into the liquefied bed material – illustrated in Figure 5.6.

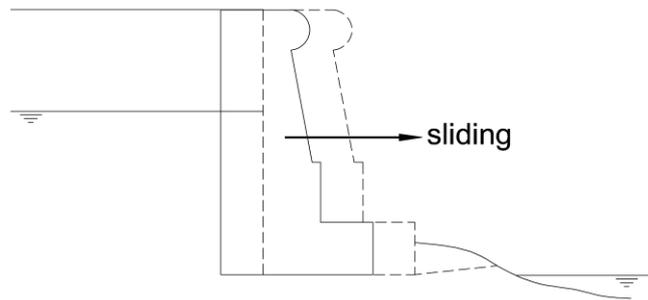
Figure 5.7 Sliding failure of gravity wall

Sliding failure is confined essentially to monolithic type structures (Figure 5.7) while overturning failures are associated mainly with vertical or near vertical monolithic or piled defence structures (Figures 5.8 and 5.9). See also the case study from Lowestoft South Beach in Appendix C.

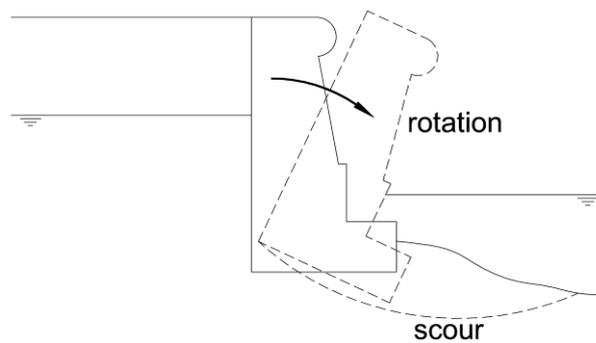
Figure 5.8 Overturning failure of gravity wall

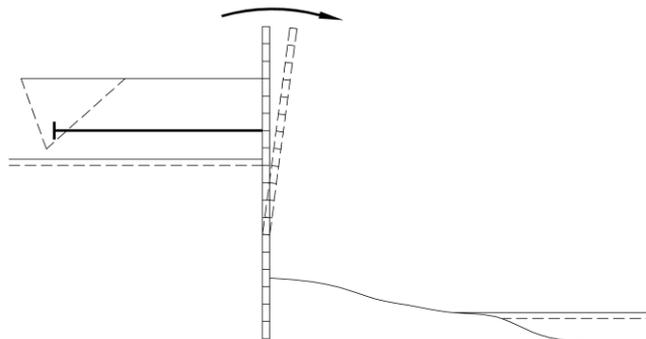
Figure 5.9 Rotation failure of sheet piled wall

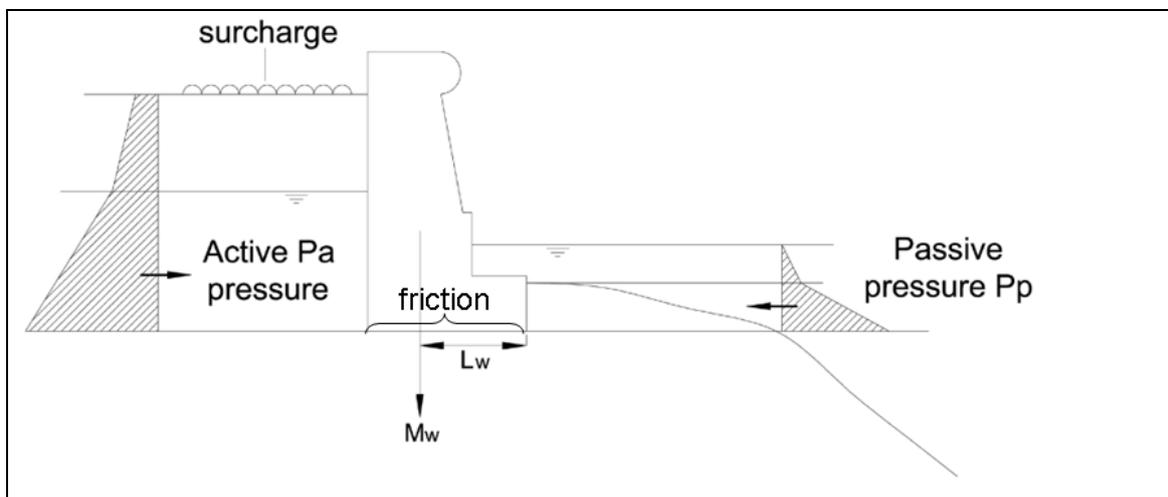
Figure 5.10 Simplified forces on a gravity wall

P_a = sum of active geotechnical and hydrostatic forces (that is, on the landward side, tending to push the seawall outwards) (Figure 5.10)

P_p = sum of passive geotechnical and hydrostatic forces (that is, on the seaward side, tending to resist the active pressure and movement) (Figure 5.10)

F_b = the friction on the base of the wall, also tending to resist the active movement of the wall (equals the weight of the wall multiplied by the friction coefficient of the wall base on the ground beneath).

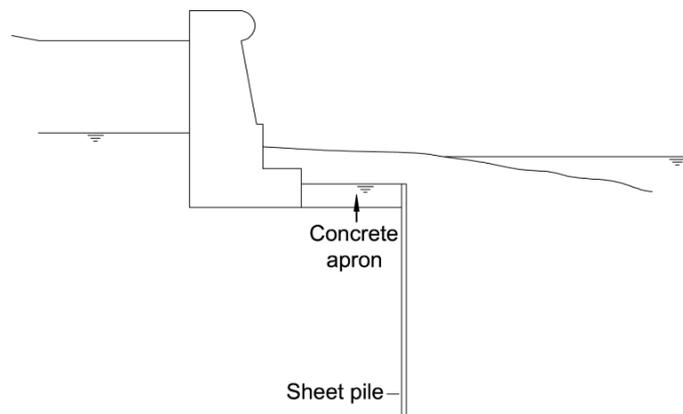
Figure 5.11 Example of thrust block and piled toe

A concrete mass placed between an existing wall and a new sheet piled wall/toe structure can also provide part of the resistance to sliding and overturning of the main wall. If the beach level is already close to the base level of the existing wall, it may be undesirable to build the new wall to a much higher and, therefore, obtrusive level. In this case, a concrete block can act both as resistance and as a thrust block to transfer active load through to the new pile. Note that in this case, the position of the thrust and its magnitude will have a sensitive effect on the new pile design – see Figures 5.11 and 5.12, and the case study from Lowestoft South Beach in Appendix C.

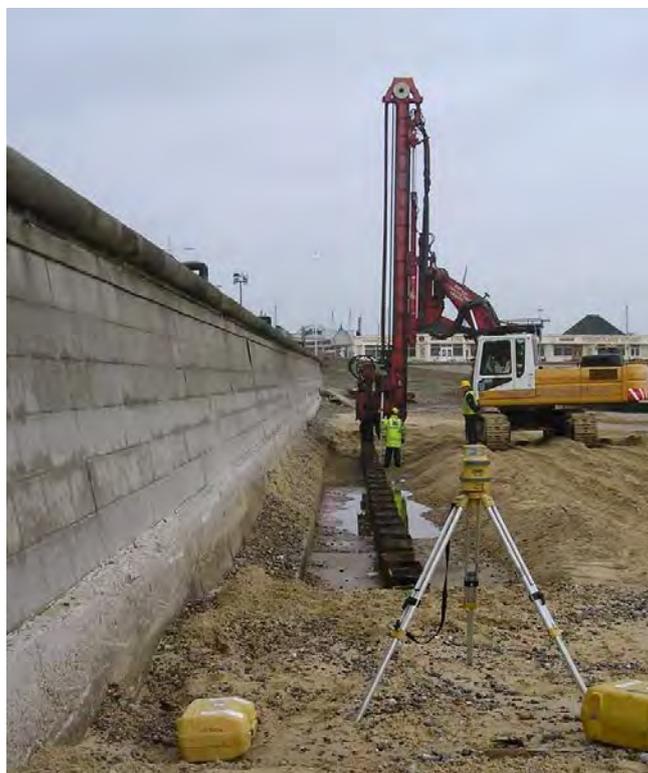
Figure 5.12 Geotechnical support for the concrete seawall at Lowestoft (courtesy Waveney District Council)

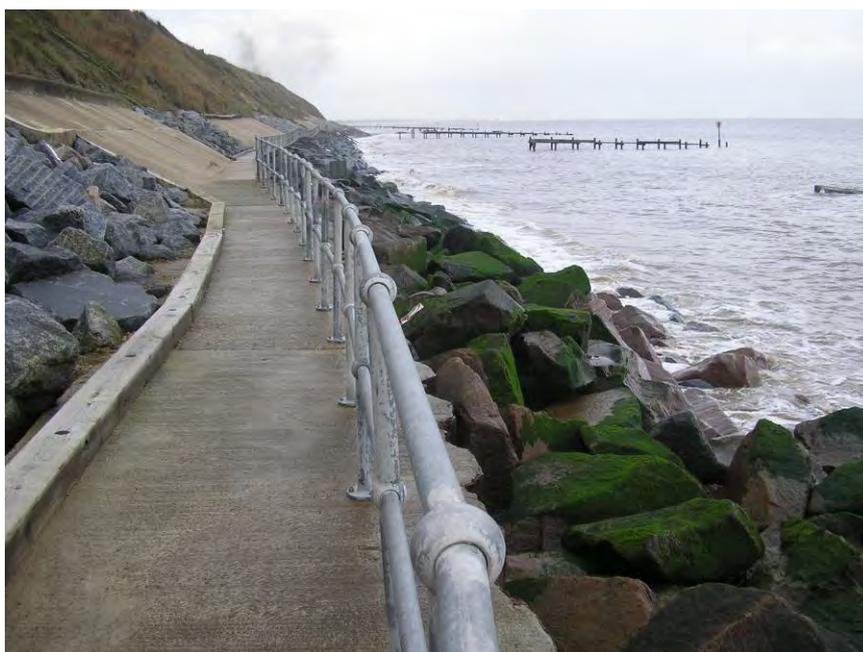
Figure 5.13 Example of rock used to provide passive support

It is wise to design for a longer service life than the immediate urgencies might suggest (for example, 10 years rather than 2 years), as the very act of providing some relief can have the effect of changing priorities. An example is provided in Figure 5.13.

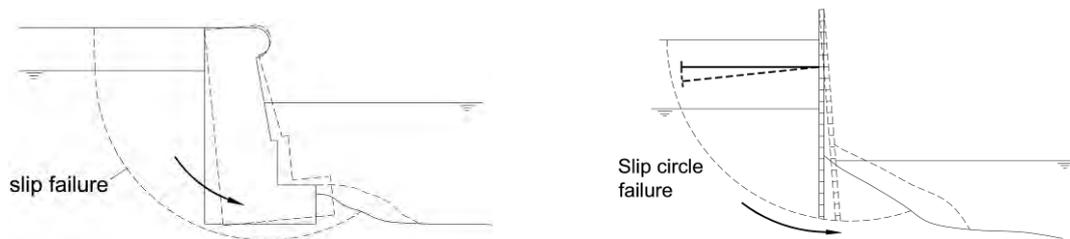
Slip circle failure is a form of slope instability. Where the failure is deep seated, it can pass beneath a coastal defence structure including a piled wall (Figure 5.14).

Figure 5.14 Slip circle failures

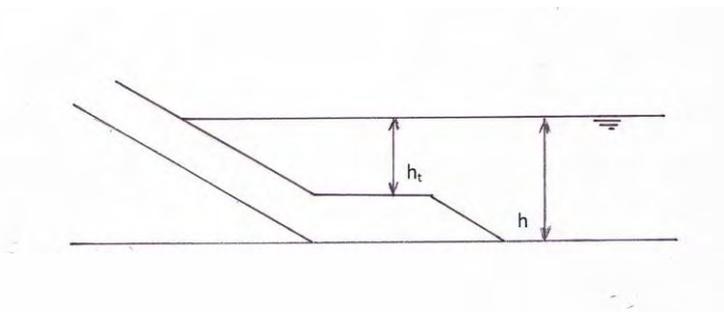
The interaction between a rock armoured toe and the incident wave field depends crucially on the relative depth of the toe, h_t/h (Figure 5.15).

Figure 5.15 Relative depth of toe

If the h_t/h ratio is low (<0.5), that is, the toe is relatively close to the surface in relation to the ambient water depth, then the design tends towards that of an armoured slope that is partially or substantially submerged. Corrections derived by Vermeer (1986) and

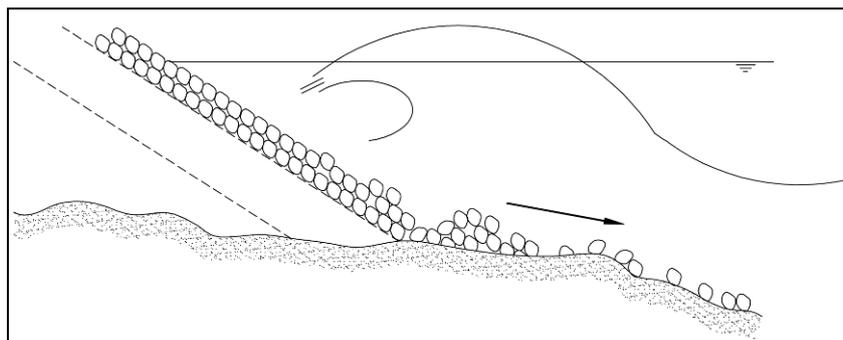
In cases where the toe structure is founded on a hard substrate, the stability of the leading edge of the armour is likely to be reduced due to reduced friction, especially under the action of breaking waves (Figure 5.16). These rocks are more vulnerable to movement due to the reduced friction resistance at the bed and the absence of the mutual support of rocks on the seaward side.

Figure 5.16 Sliding of toe armour on hard substrate

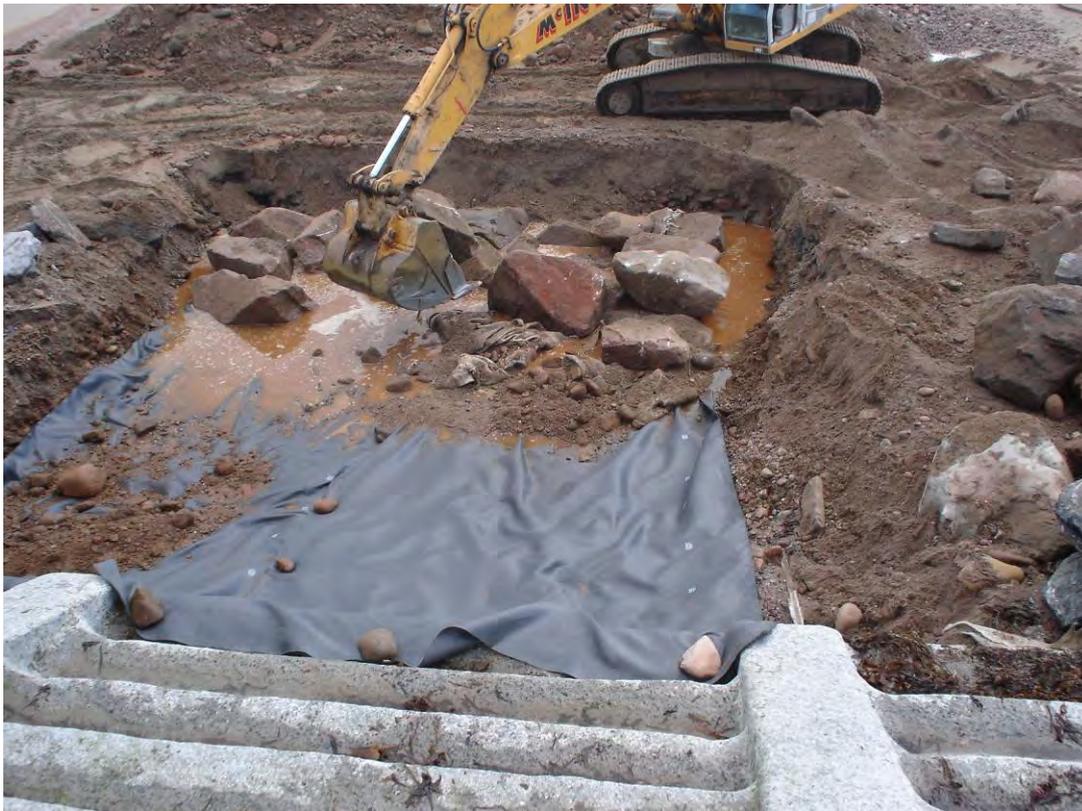
Loss of bed material through the voids in rock layers can lead to a lowering of the bed beneath the rocks with consequent lowering of the rock itself until it becomes embedded – an effect akin to that of liquefaction. Unless an allowance is made for this, as for example in the case of a falling toe, it should be prevented. It can also be the case that rock armour will entrain beach sand, but under storm conditions, this will usually be washed out and sediment loss through the armour from the bed will ensue unless prevented. Erosion of bed material through a rock layer can be avoided by installing granular filters or suitably designed geotextile of appropriate specification (Figure 5.17).

Figure 5.17 Geotextile being incorporated as part of a toe structure

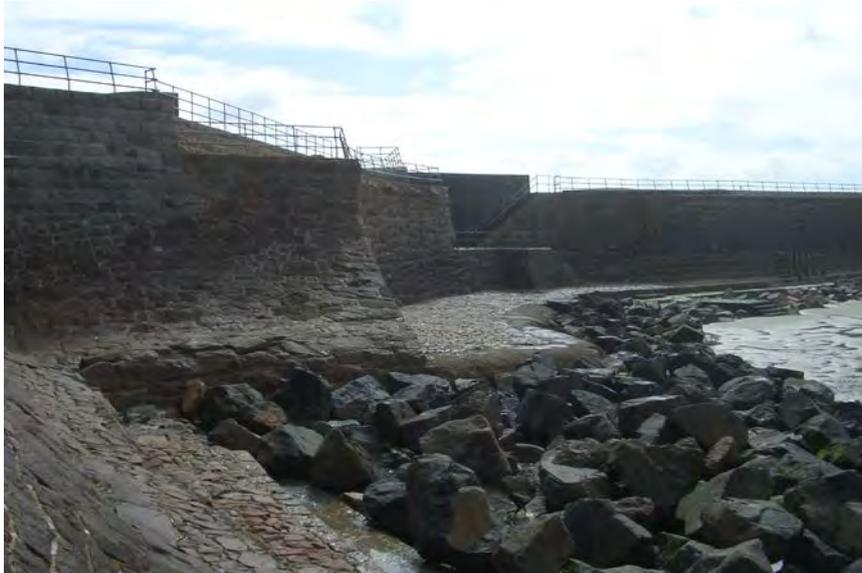
Figure 5.18 shows an example of a rock apron:

Figure 5.18 Example of rock apron (courtesy Jersey States Government)

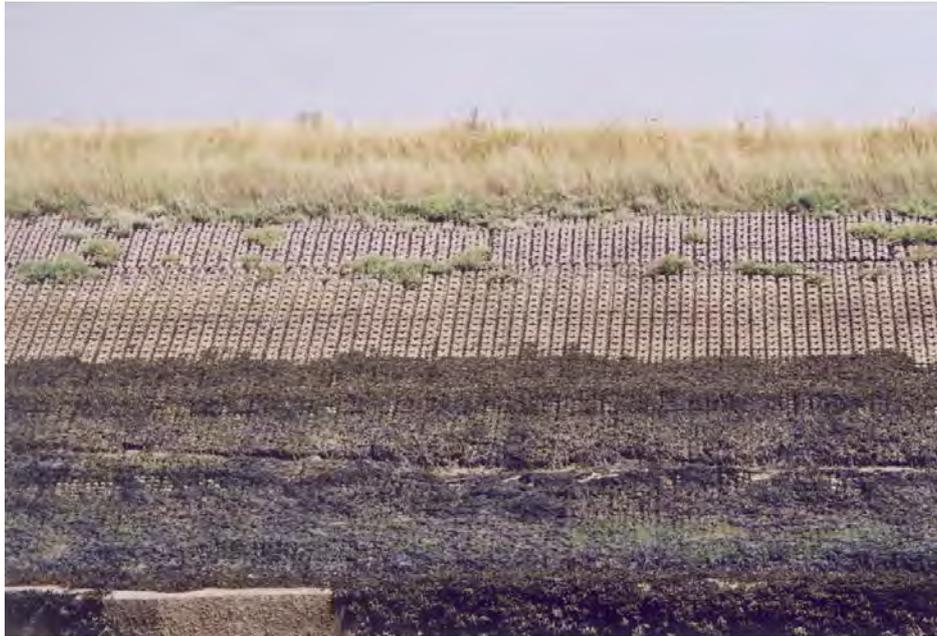
These systems consist of concrete blocks joined together with cables, or attached to a geotextile sheet, to form closely spaced pattern of armour (Figure 5.19).

Figure 5.19 Example of a flexible armoured revetment

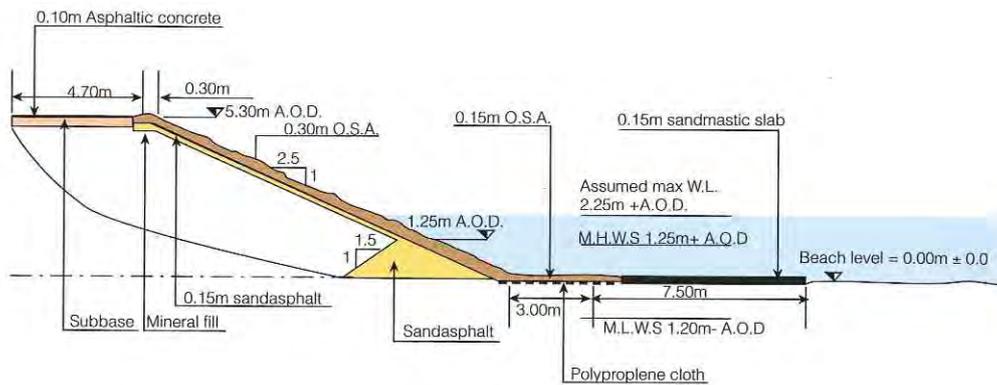
Figure 5.20 shows an early (1979) application of bitumen to a large coastal structure in the UK, which was initially constructed with a falling apron as shown in the diagram. Following beach lowering, it was discovered that there were various buried obstacles and debris which fouled the apron. To counter this, subsequent design (1987–1988) adopted a more robust design which used a 6 m long horizontal toe slab of grouted stone on a geotextile and a seawards sheet pile cut-off with some loose rock placed in front of it.

Figure 5.20 Caister on Sea, UK 1979: cross-section phase I with open stone asphalt revetment and a sand mastic asphalt toe slab (from Schönian 1999)

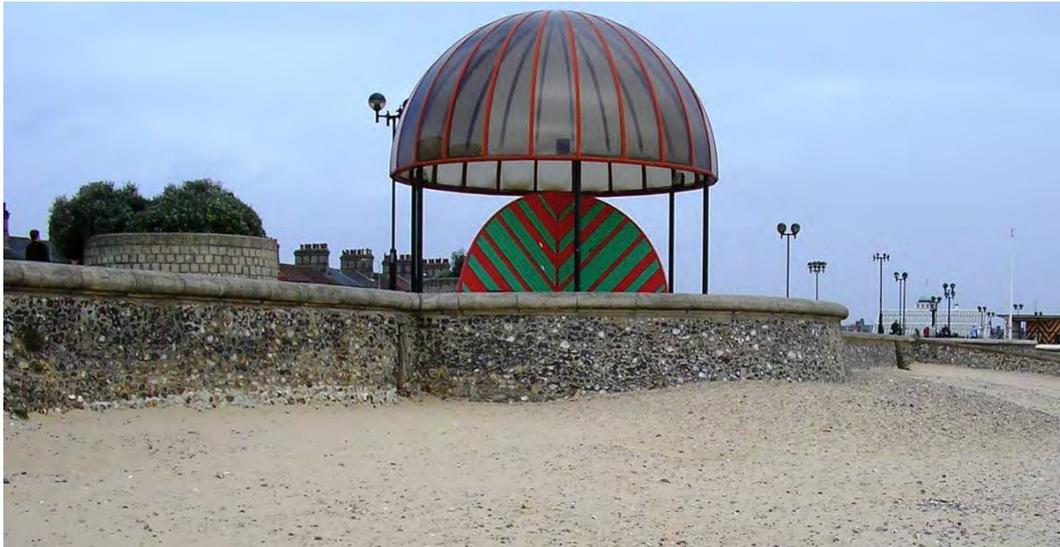
Figure 5.21 Heritage interest – the flint-faced seawall at Lowestoft South Beach

Heritage and visual impact considerations may include the appearance of a toe structure when it becomes exposed. The relevant planning authority should be able to advise on such issues during the appraisal stage of a project and on the suitability of design alternatives during the outline design stage (Figure 5.21).

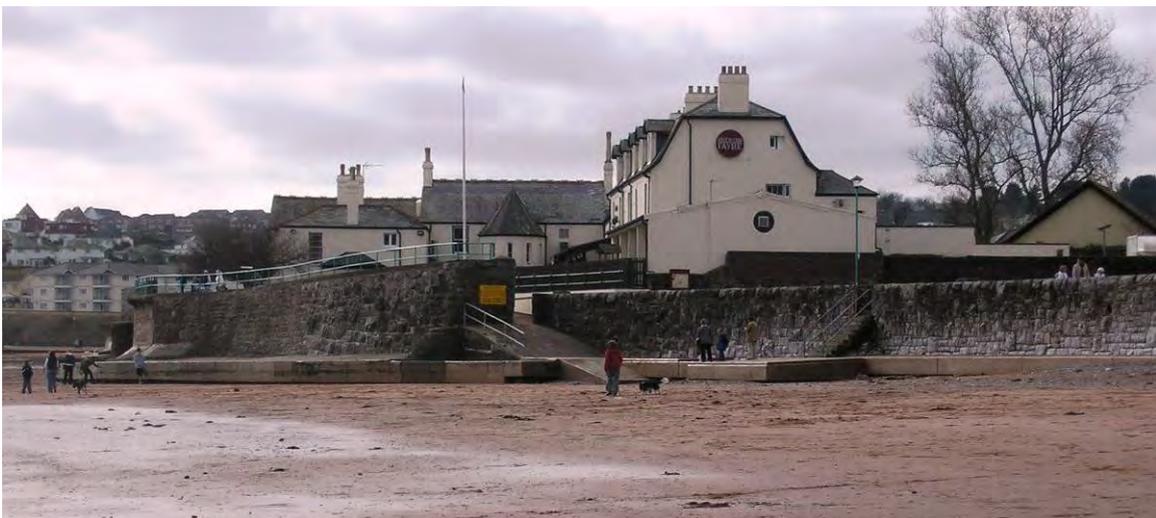
Figure 5.22 Toe apron proves walking platform – Paignton, Devon (courtesy of ENBE)

Large exposed aprons or other obtrusive toe structures have a negative impact on amenity by eliminating part of the otherwise available beach area. In some cases, though, the installation of steps or an apron can improve amenity. If the apron is too high above average beach levels, however, then there may be demands for hand rails which are very liable to storm damage and corrosion. The issue is very site- and project-specific (Figure 5.22).

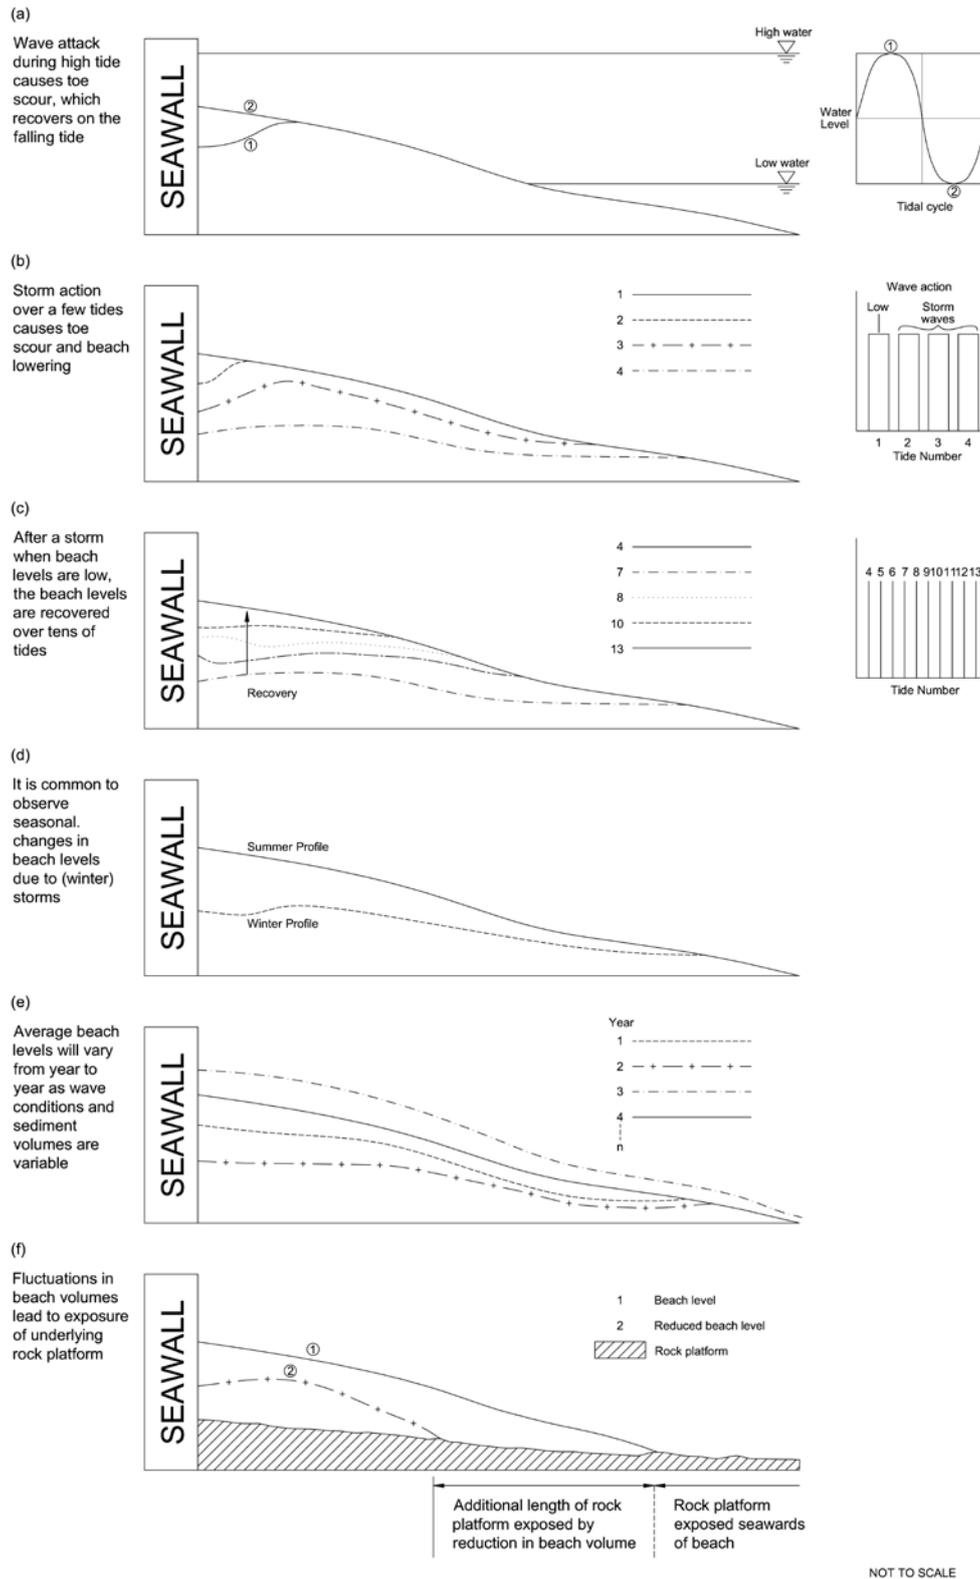
Figure A.1 Conceptual model of beach profile response in front of a seawall

- **Seasonal variability** (Figure A.1d) – commonly it is observed that beach levels draw-down more in winter (due to storm-induced erosion) and build up during summer, leading to a seasonal variation in beach profiles and hence levels at the toe of a structure.

- **Inter-annual variability** (Figure A.1e) – the wave climate varies from year to year, altering the nett magnitude (and possibly direction) of longshore drift and generating erosion or accretion of the beach. The annual wave climate affects the whole coastline so its effects are felt over the scale of the sediment cell, say tens of kilometres alongshore and by of the order of one or two kilometres cross-shore.
- **Coastal evolution** (Figure A.1f) – changes in the coastal profile are driven by sea level rise and wave climate, and dominated by longshore transport controlling coastal evolution. Coastal erosion occurs over longer timescales and even larger spatial scales than beach changes due to variations in annual conditions. Coastal erosion is often associated with the lowering of ground levels caused by the erosion of a rock platform.

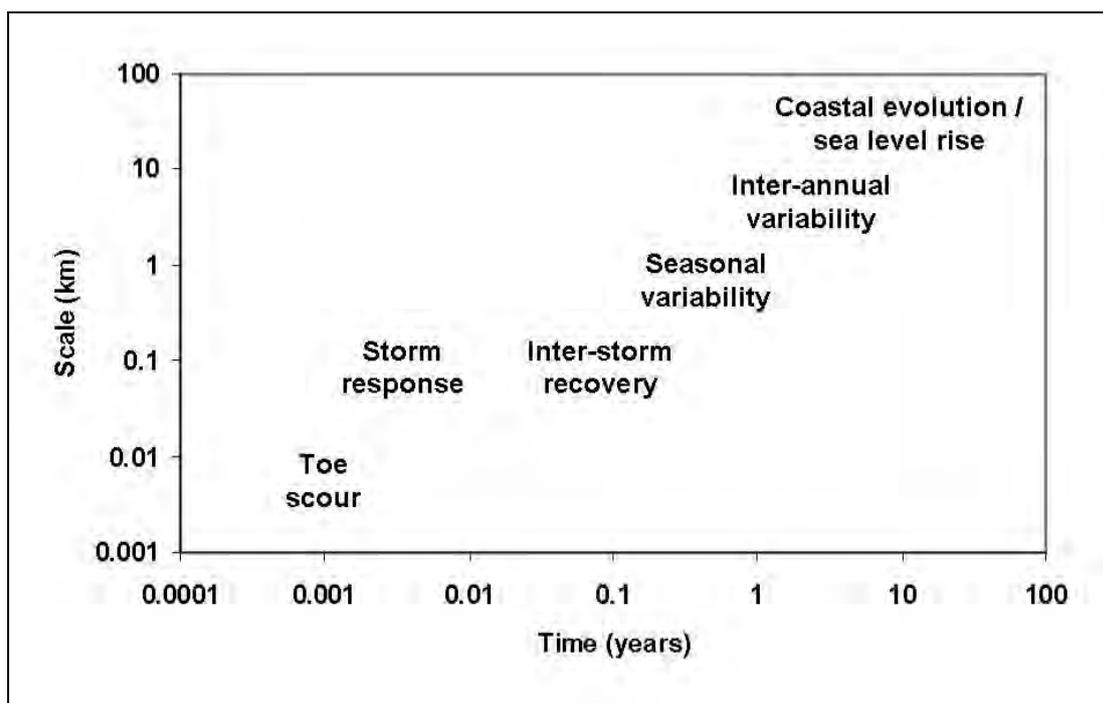
Figure A.2 Beach responses to natural forcing, indicating associated length-scales and timescales (from Sutherland et al. 2007)

Figure A.2 relates to scour and erosion caused by sediment transport. Another process, wave-induced liquefaction, may also be important in the assessment of the performance of the toe of coastal defence structures as it can reduce the bearing capacity of the seabed in front of a structure. Generally liquefaction is associated with shorter length scales and smaller spatial scales than toe scour and occurs in finer sediments; it would not be expected to occur in a permeable shingle beach experiencing wave loading.

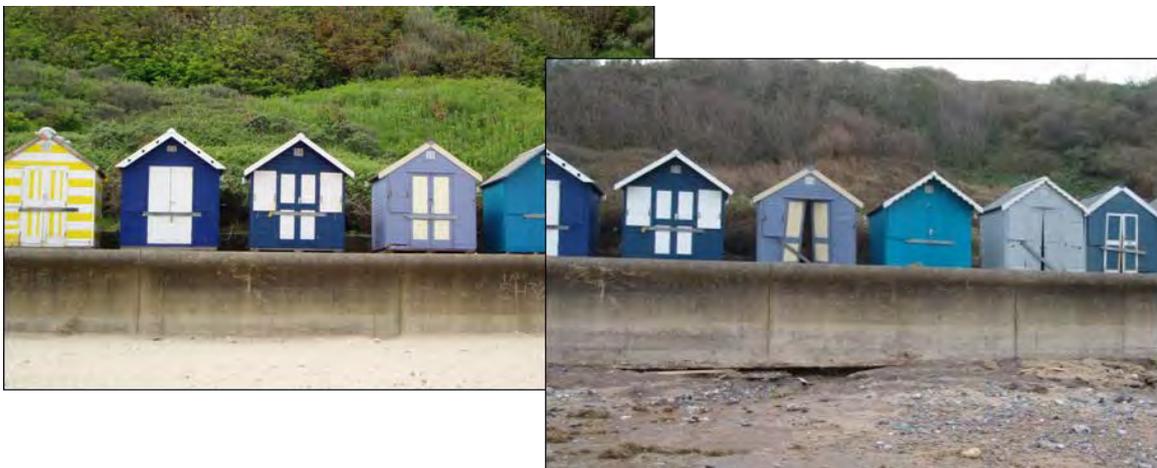
Processes such as the drawing down of beach material from the top of a beach during a storm and the gradual recovery of the beach level after the peak of the storm lead to bathymetries in front of coastal defence structures (and in natural undefended beaches) that vary in space and time. This phenomenon leads to beach variability. Figure A.3 illustrates this phenomenon where a storm event removed sediment locally to a level below the toe of the defence (right image); the subsequent image (on the left) which was taken after a calm period of weather over several months shows sediment levels have recovered considerably once more (without active intervention).

**Figure A.3 Storm event sediment scour (right) and post event recovery (left)
(courtesy of Peter Frew, NNDC)**

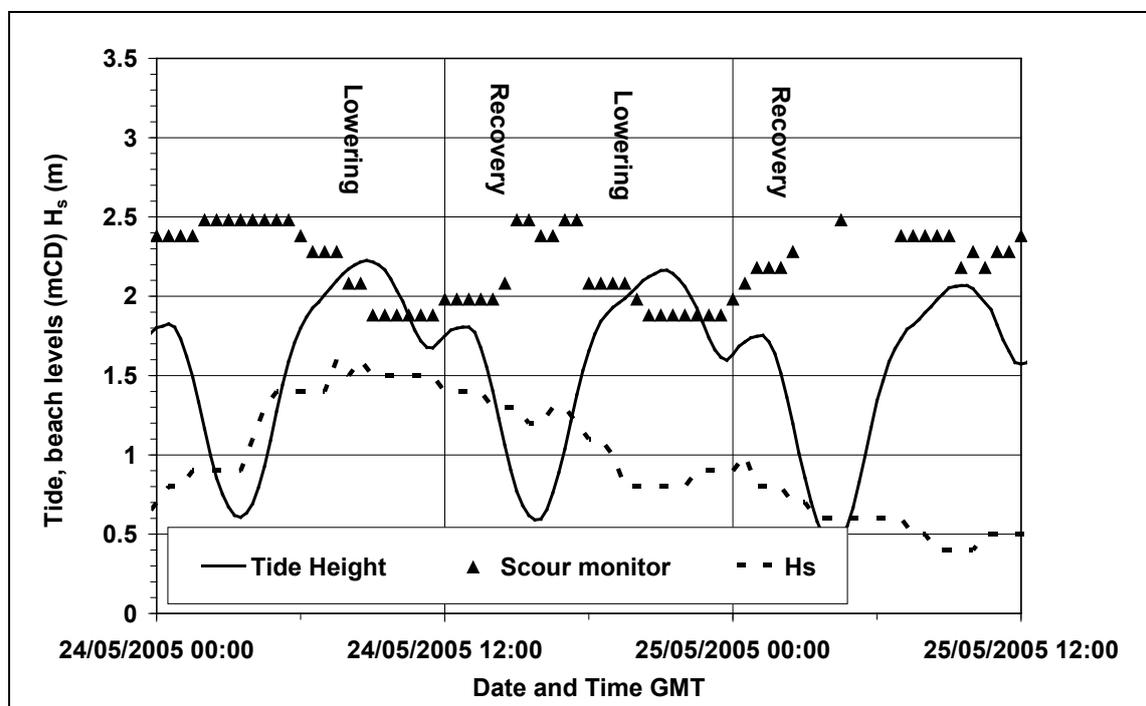
Figure A.4 shows that, as the wave height and water level rose during the morning of the 24 May, the beach level dropped by at least 0.60 m. The bottom monitor became exposed, so there is no record as to exactly how far the beach level dropped below this level. However, as water levels fell during the afternoon, the beach recovered to its previous low-tide level. The beach level fell again as water levels rose during the afternoon of 24 May, even though wave heights were lower. The bottom scour monitor again became exposed and again the beach recovered fully by low tide. There was only a small change in bed level during the next high tide as water levels were lower and wave heights were smaller.

Figure A.4 Scour monitor data showing beach lowering and recovery during a tide measured at Southbourne

The results from Southbourne and extensive analysis of scour monitor data collected at Blackpool between 1995 and 1998 (HR Wallingford 2006a) showed that beach levels frequently drop and recover to, or close to, their original level within a single tide, providing the water levels and wave heights are high enough. This beach lowering and recovery *could not have been detected* from beach profiles conducted at low tide, even if the profiles had been collected at successive low tides before and after the tide in question, as the beach levels recovered partially or completely during the falling tide.

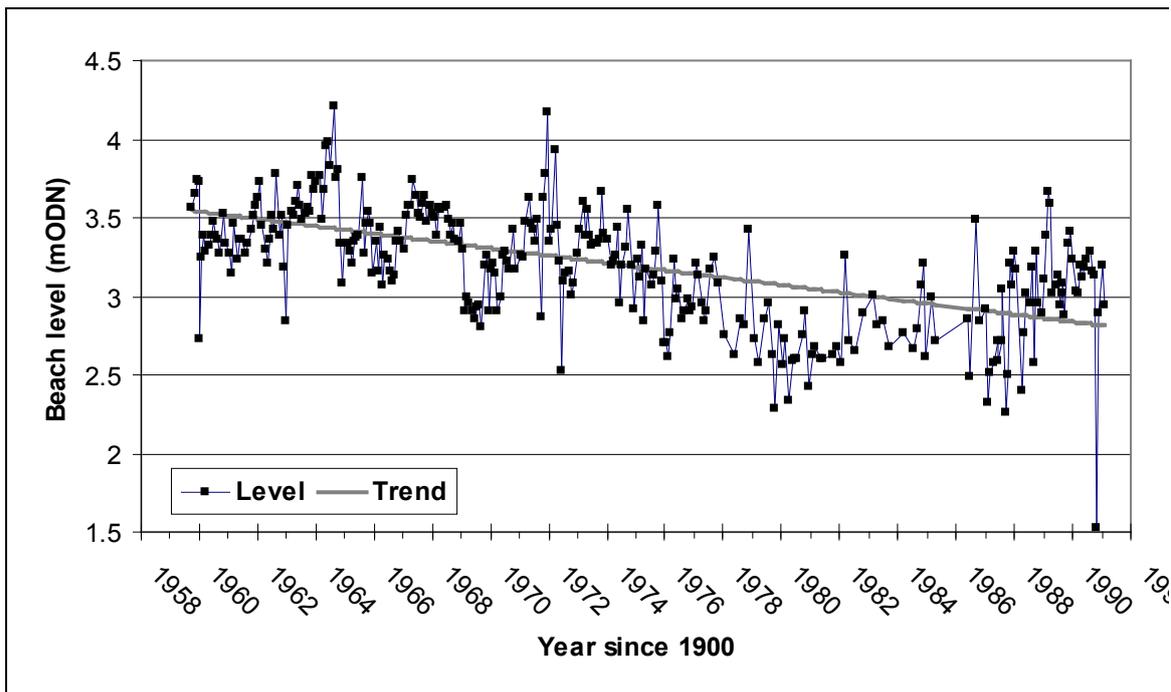
A time series of beach levels measured at a single point in front of the seawall at Mablethorpe Convalescent Home at approximately monthly intervals between 1959 and 1991 is shown in Figure A.6 (Sutherland et al. 2007). The trend line is the best-fit straight line through the points, which fell at an average rate of 23 mm per year during

this period. Figure A.6 shows that there is a significant amount of variability about the best-fit straight line and that this variability occurs over different timescales.

Figure A.6 Time series of beach levels in front of a seawall at Mablethorpe in Lincolnshire

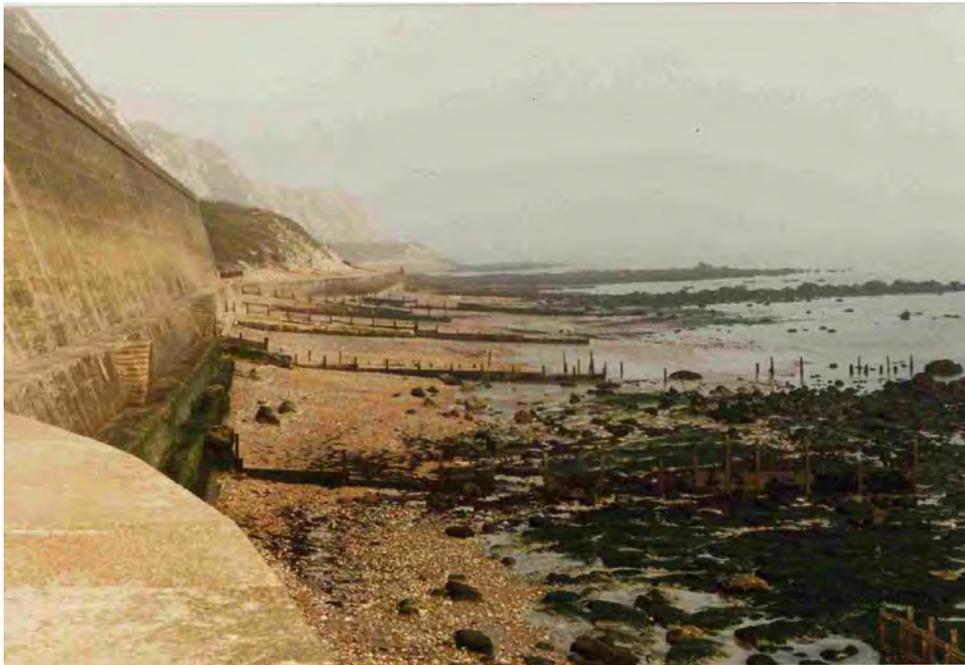
Figure A.7 Beach and shore platform lowering, Shakespeare Cliff, Thanet

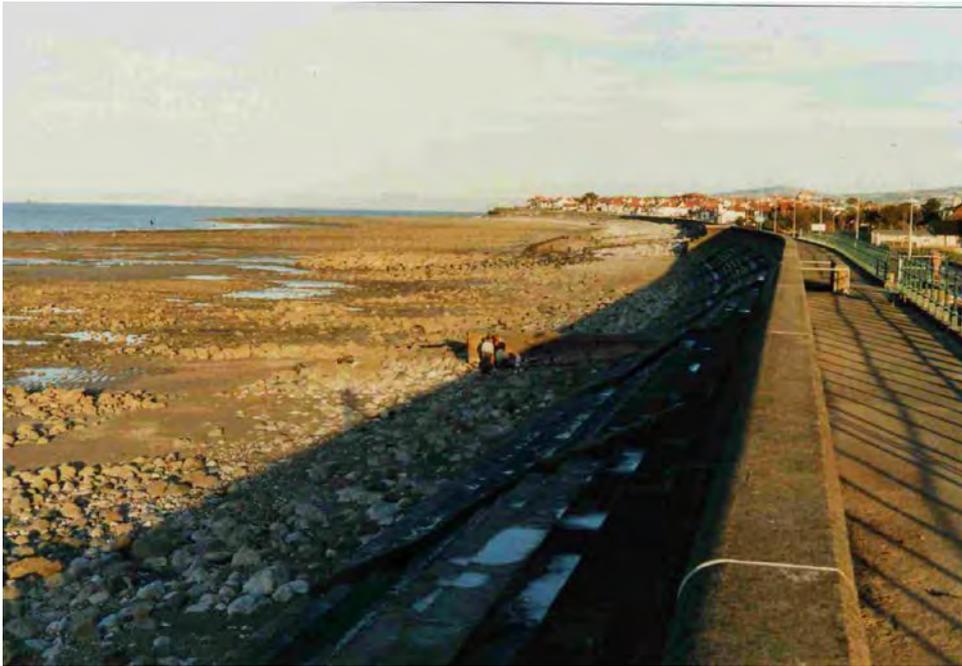
Figure A.8 Removal of beach sediments from shore platform, Penrhyn Bay

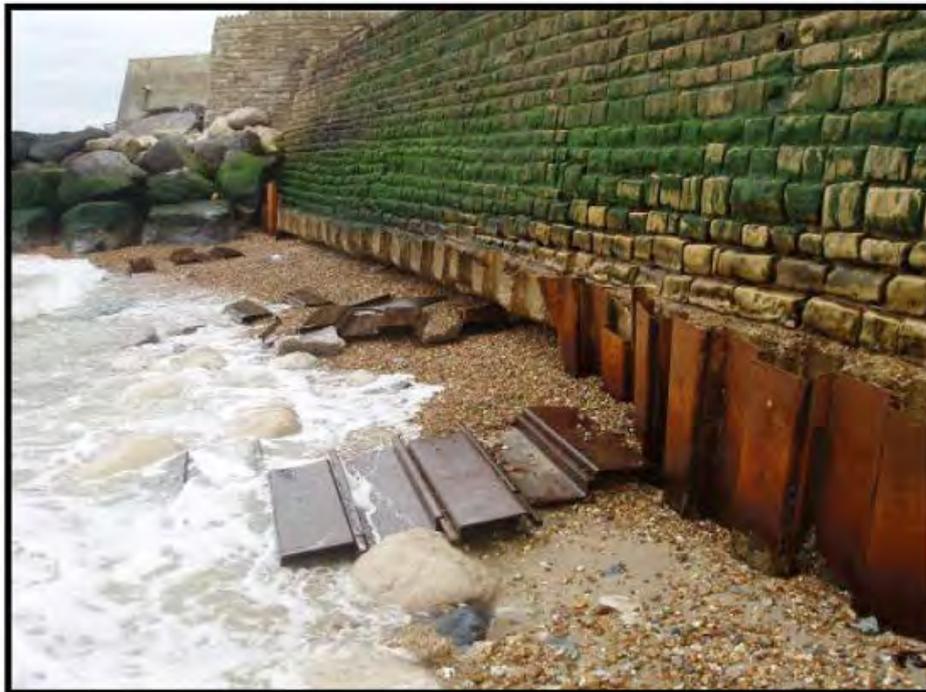
The removal of sediment may lead to the exposure and potential failure of the structure's toe, as shown in Figure A.9, which shows exposed sheet piling, some of which has been removed from the toe as a result of erosion and is lying on the beach.

Figure A.9 Example of structural damage to a seawall at Milford-on-Sea (courtesy Andrew Bradbury, New Forest District Council)

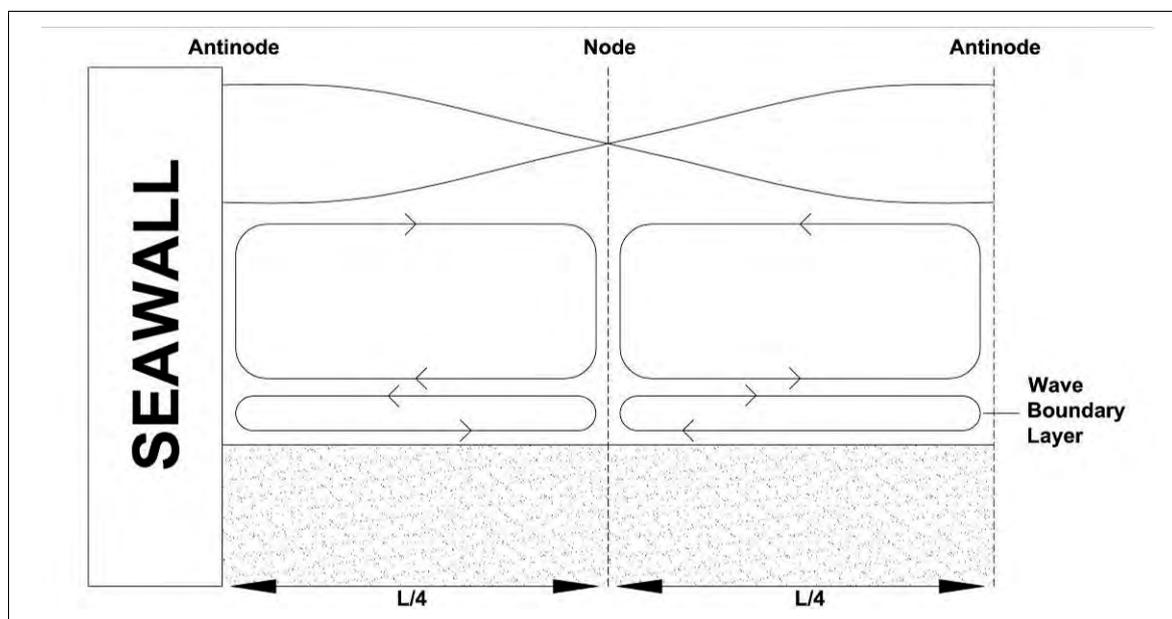
A regular non-breaking wave with wavelength L reflecting off a vertical wall generates a standing wave, as shown in Figure A.10. The incident and reflected components are in phase at the wall, so an anti-node (zone of maximum vertical amplitude) is formed. This is an area with a relatively high root mean square (RMS) surface elevation but zero horizontal velocity. On moving away from the wall, the incident and reflected components move out of phase until they are completely out of phase (when the incident and reflected surface elevations cancel each other out, so there is no surface movement but a maximum in horizontal velocity) and a node is formed. This occurs at a distance of a quarter of a wavelength in front of the wall. On moving further out, the incident and reflected components move back into phase and another anti-node occurs at a distance of half of a wavelength from the wall.

The standing wave generates steady streaming (a small net current) in the thin wave induced bottom boundary layer (Longuet-Higgins 1953, 1957). This streaming is manifested as a slow recirculating current from anti-node to node at the bottom of the bottom boundary layer and from node to antinode at the top of the bottom boundary layer – as shown in Figure A.10 for the two-dimensional (2D) normal incidence case. The current at the top of the boundary layer drives a counter-rotating recirculating cell in the (much thicker) body of water above the boundary layer. This work was extended to oblique-incidence by Carter et al. (1973).

Figure A.10 Recirculating currents due to streaming under regular standing waves on a horizontal bed

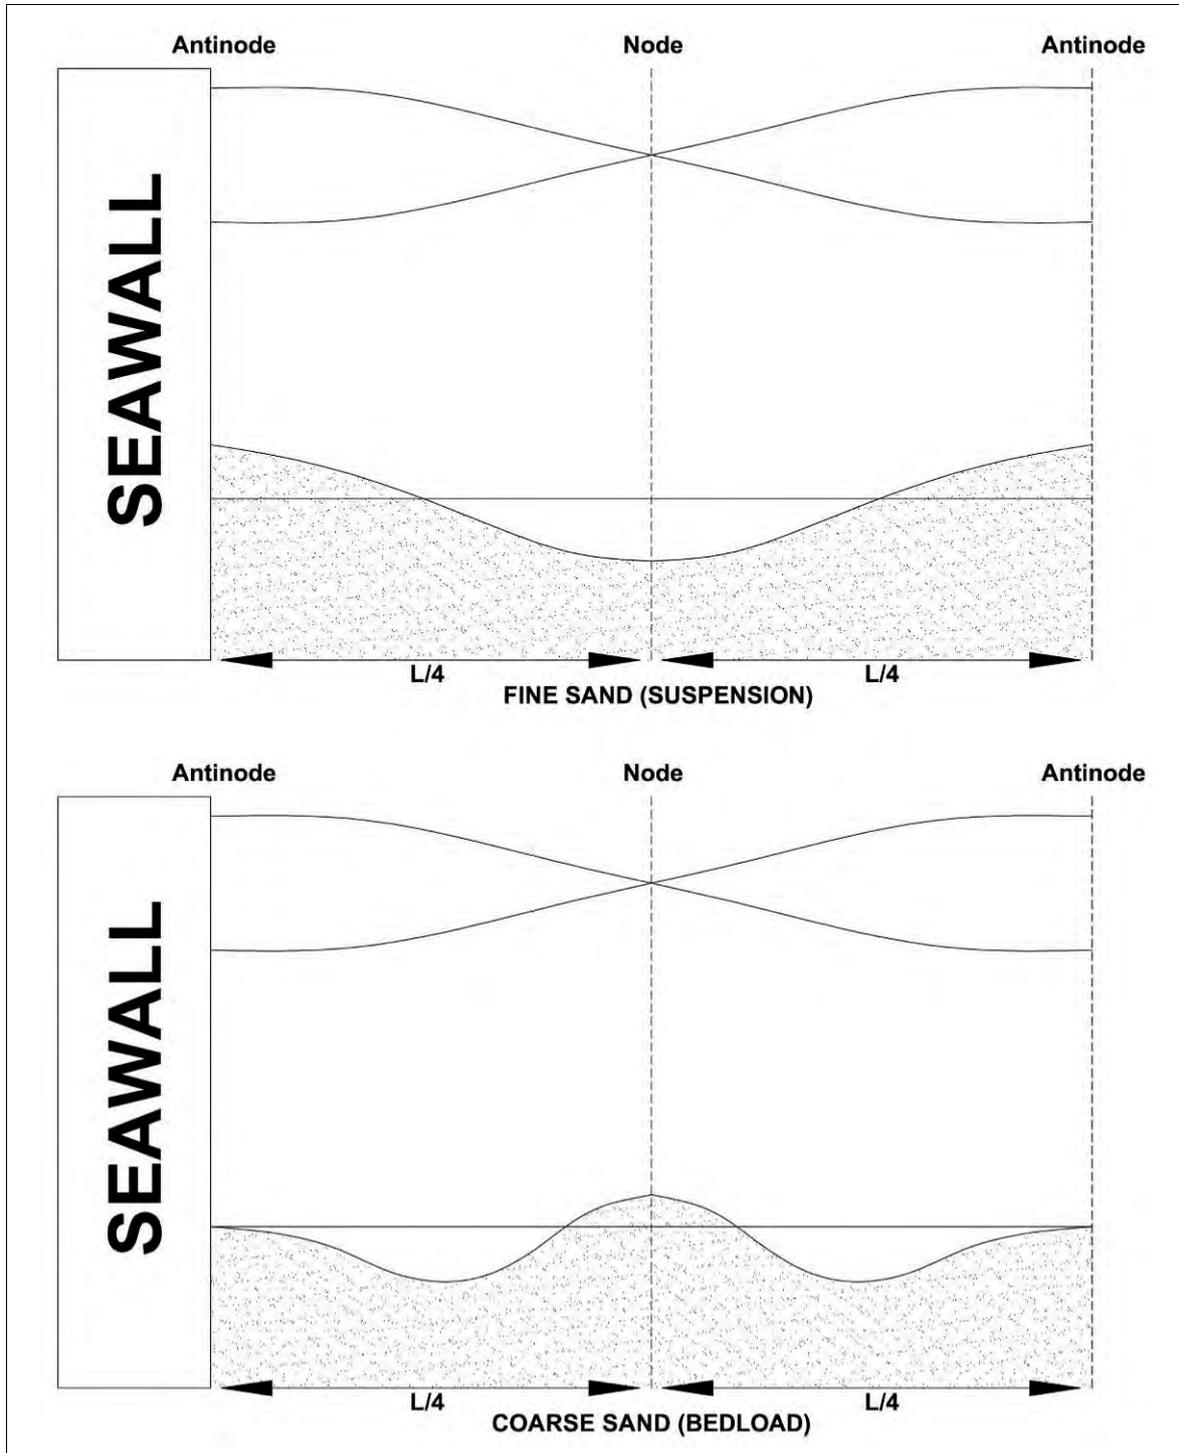
Figure A.11 Scour and deposition patterns on a horizontal bed over half a wavelength in front of a vertical seawall: Upper panel: Suspended sediment transport ('L-type'; Xie 1981); Lower panel: bedload sediment transport ('N-type'; Xie 1981)

These definitions are indicative of the behaviour that can be expected, although the mode of scour and pattern will be different with random waves and with wave breaking, and with a sloping beach – as opposed to a horizontal bed.

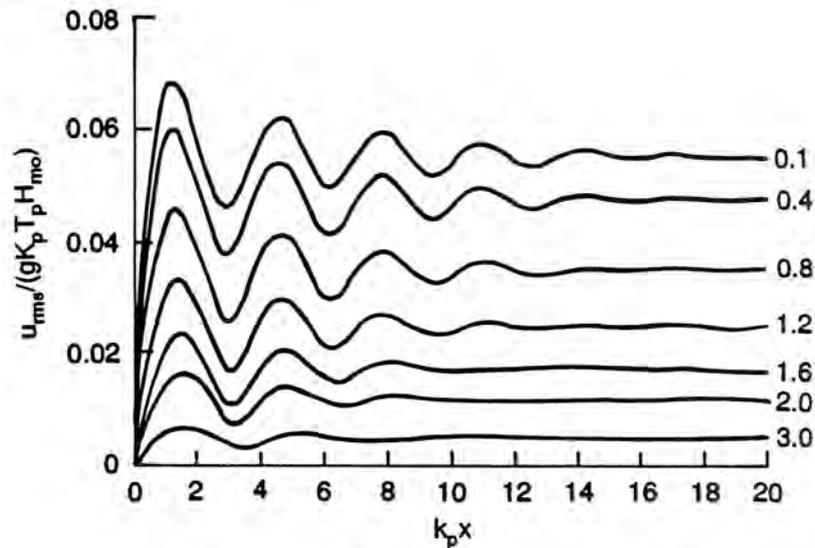
Figure A.12 Non-dimensional plot of RMS wave orbital velocity on the bed as a function of cross-shore position for different relative water depths (after Hughes and Fowler 1991)

The pattern of scour under random waves reflects the kinematics of the waves that generate it. Bed level changes (final minus initial elevation) at the end of four laboratory experiments (after 3,000 waves) conducted with random waves, fine sand and a vertical seawall are provided in Figure A.13 (data from Sutherland et al. 2007). The wavelength in these tests was such that the scour plotted in Figure A.13 is over a distance of half of a wavelength (at a water depth of 0.4 m) to almost one wave length (at a depth of 0.1 m) – to compare with Figure A.11 – and the scour type in the model was a mixture of bedload and suspended load type. This also covers a distance of $k_p x$ to a value of 3 (at a water depth of 0.4 m) to 5.9 (at a depth of 0.1 m), which means that it covers the most intense part of the variation in wave orbital velocity plotted in Figure A.12.
