Toe structures management manual

Project: SC070056/R

Coastal structures, structure toe, asset management, condition assessment, beach, scour

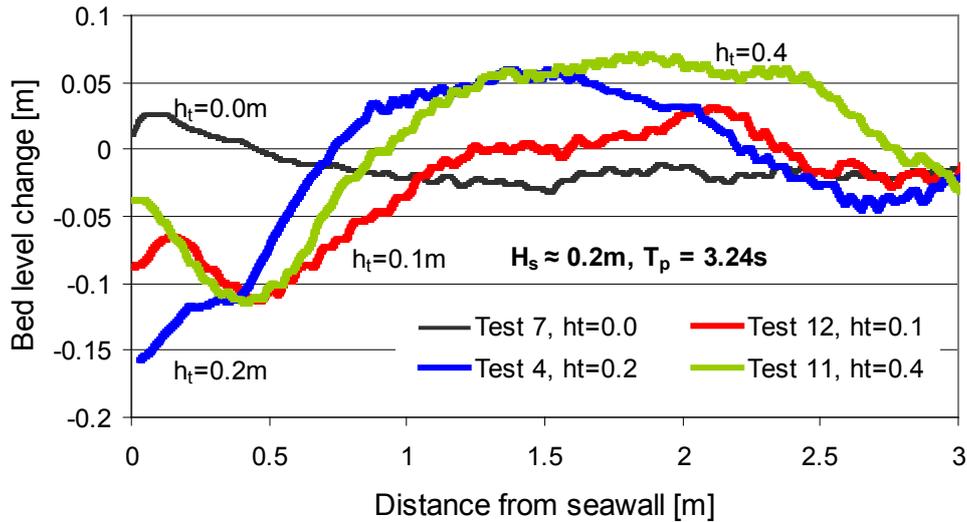
Figure A.13 Variation in final scour depth with water level for a vertical wall measured in laboratory experiments with a sand bed (from Sutherland et al. 2007)

During Test 7 ($h_t = 0.0$ m), the waves broke offshore and the wave energy was largely dissipated before the waves reached the wall in the swash zone. As a result there was a slight accretion at the wall but a general lowering throughout the rest of the profile. The vertical seawall was situated within the surf zone during Test 12 ($h_t = 0.1$ m) and some breaking occurred onto it, although most of the larger waves had already broken by the time they reached the seawall. The resulting scour profile includes a small dip at the toe of the seawall caused by turbulence and a deeper scour hole at about 0.5 m from the structure toe.

The pattern of scour under random waves reflects the kinematics of the waves that generate it. Bed level changes (final minus initial elevation) at the end of four laboratory experiments (after 3,000 waves) conducted with random waves, fine sand and a vertical seawall are provided in Figure A.13 (data from Sutherland et al. 2007). The wavelength in these tests was such that the scour plotted in Figure A.13 is over a distance of half of a wavelength (at a water depth of 0.4 m) to almost one wave length (at a depth of 0.1 m) – to compare with Figure A.11 – and the scour type in the model was a mixture of bedload and suspended load type. This also covers a distance of $k_p x$ to a value of 3 (at a water depth of 0.4 m) to 5.9 (at a depth of 0.1 m), which means that it covers the most intense part of the variation in wave orbital velocity plotted in Figure A.12.

In Figure A.13 negative values represent scour while positive values represent accretion. These four tests had the same initial bed profile (a 1:30 slope), the same wave period ($T_p = 3.24s$) and the same offshore incident wave height ($H_s \approx 0.2m$), but different initial water depths at the toe of the seawall ($h_t = 0.0, 0.1, 0.2$ and $0.4m$ respectively). These tests show the controlling influence of water depth. A comparison has been drawn between these four tests as they resulted in very different breaking wave conditions at the wall and hence different bed profiles. Thus the scour profiles shown in Figure A.13 are for random, breaking waves in sand on a sloping beach.

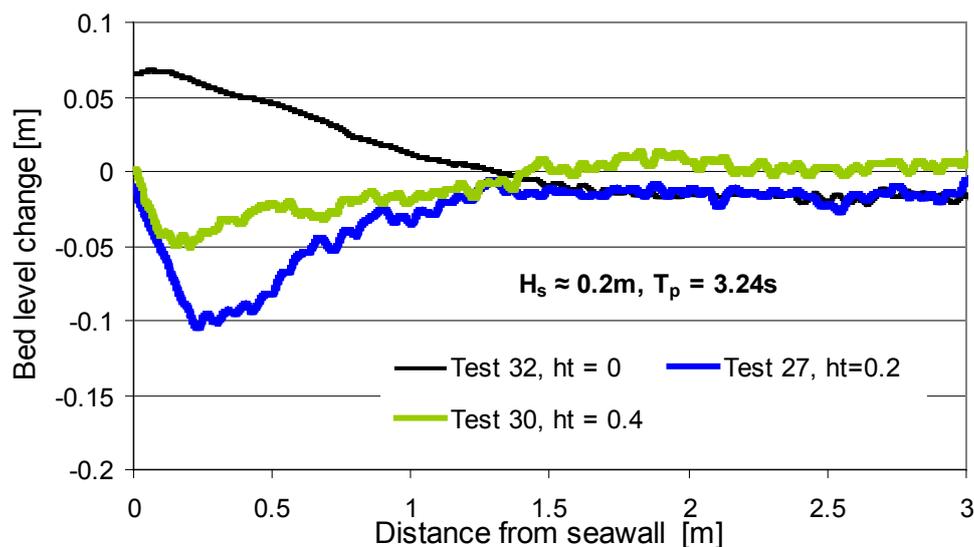
Figure A.14 Variation in final scour depth with water level for a 1:2 sloping wall (h_t is initial toe water depth in m)

(Sutherland et al, 2007).

Bed level changes (final minus initial elevation) at the end of three laboratory experiments (that is after 3,000 waves) conducted with random waves, fine sand, and a 1:2 (V:H) smooth sloping seawall are provided in Figure A.14. Negative values represent scour, while positive values represent accretion. These three tests had the same initial bed profile, wave period ($T_p = 3.24\text{s}$) and similar offshore incident wave height ($H_s = 0.19\text{m}$ to 0.24m) but different water depths ($h_t = 0.0\text{m}$, 0.2m and 0.4m respectively). A comparison has been drawn between these three tests as they resulted in very different breaking wave conditions at the wall and hence different bed profiles.

In Test 27 the wave down-rush reached the sediment bed and caused the greatest scour, whereas in Test 30, the water depth was sufficient to ensure that the down-rush did not reach the bed and a lower scour depth occurred. In Test 32, the water depth at the toe of the structure was initially zero – the still water and sand beach intersected at the seawall. In this case there was accretion at the toe of the seawall, caused by sediment transport in the swash zone.

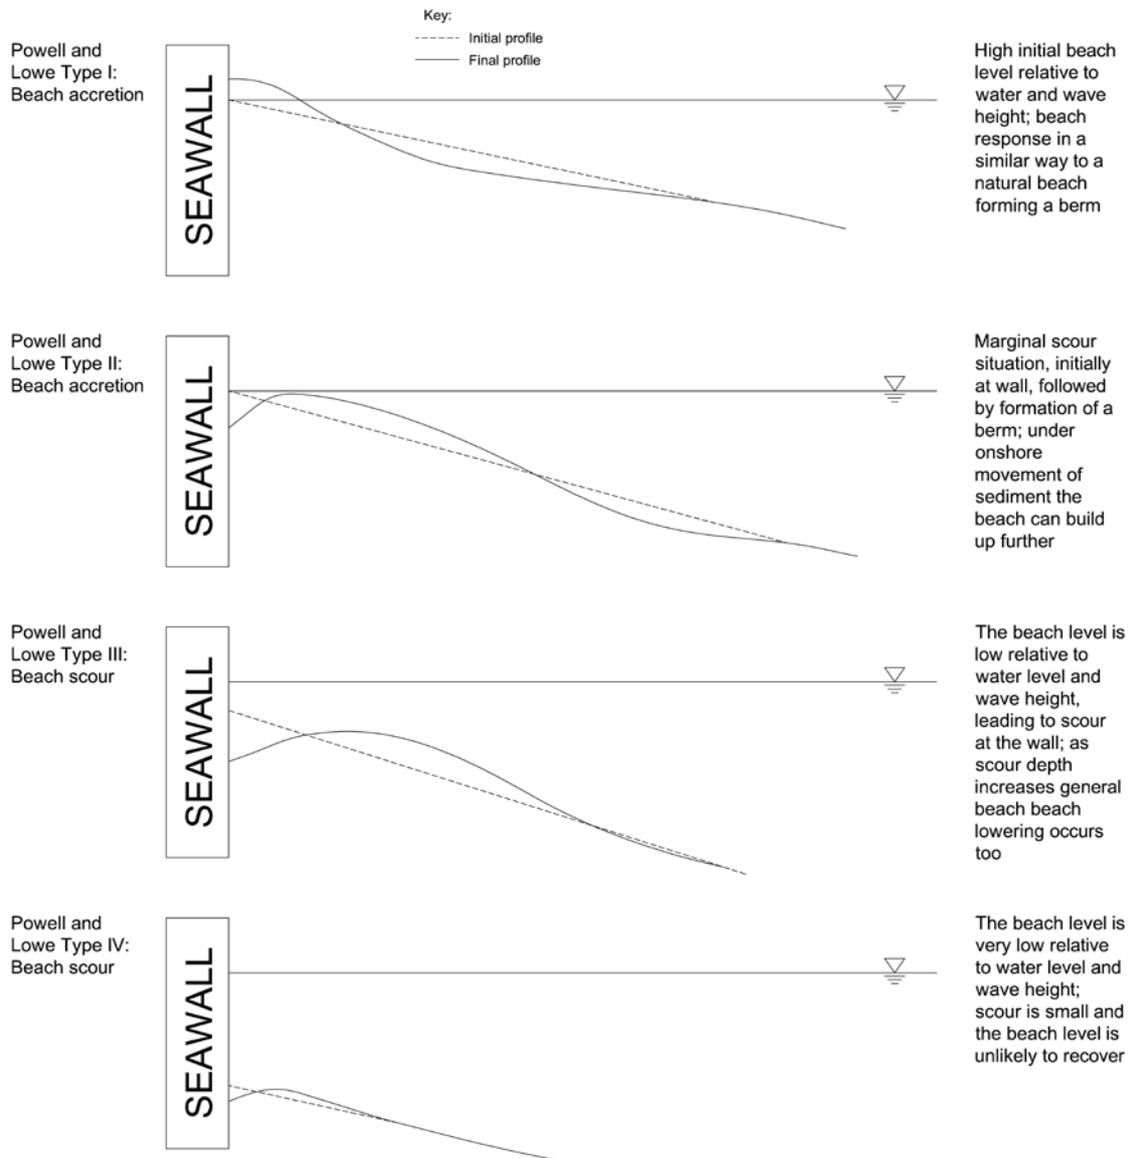
Figure A.15 Schematic diagram of beach profile and scour response under wave attack in shingle – based on model tests of Powell and Lowe (1994)

As with sand, scour of a shingle beach in front of a seawall will be controlled by water depth and wave conditions. The scour profiles in Figure A.15 show how the response of the beach changes from accretionary in Types I and II, with a minor formation of toe

scour at the seawall in the latter case, to scouring in Types III and IV. The toe scour in Type III is maximised owing to the particular combination of water depth and wave height occurring, and in Type IV the toe scour is reduced owing to the deeper water depth.

The duration of the wave/water level conditions is also an important control on toe scour development. Scour is not an instantaneous process – the trough deepens over a number of waves. Powell and Lowe (1994) used physical wave flume models of a coarse grained beach to demonstrate how scour develops until a quasi-equilibrium is obtained within about 3,000 waves. There was rapid initial scour that declines exponentially towards the equilibrium depth. In Type I and II and Type III scour (Figure A.15 in Appendix A)

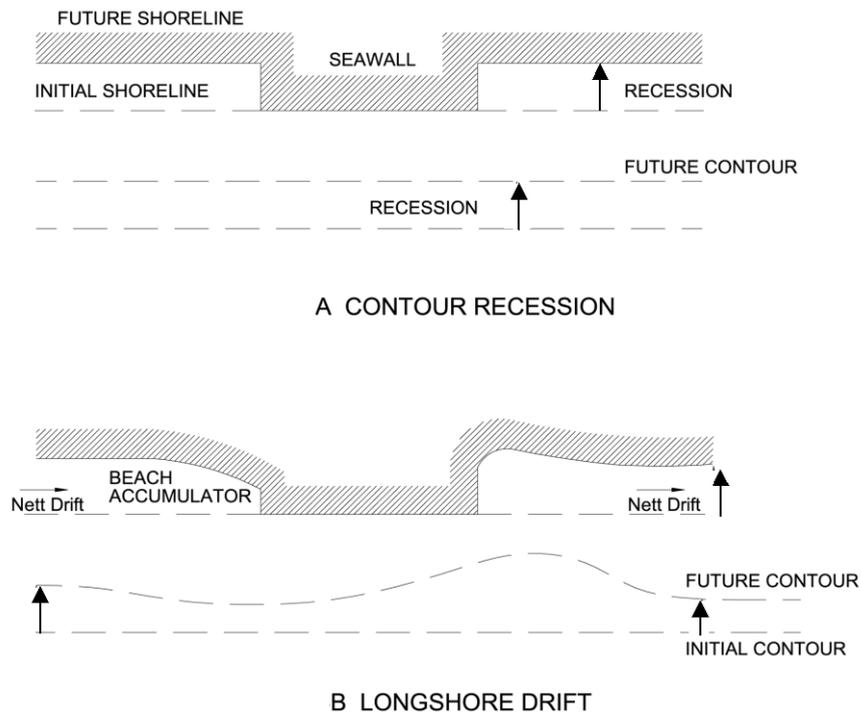
Figure A.16 Conceptual sketches of the effect of a seawall on coastal erosion

The principal cause of coastal recession in this situation is the continual erosion of the shore-platform where the wave-induced water velocities are high, particularly in the breaker zone and just outside it.

Where for example a seawall is built to protect an eroding shoreline, as sketched in Figure A.16, it will not directly prevent erosion of the adjacent sections of that coastline. In this hypothetical situation, it is assumed that there is no longshore sediment transport and that the material eroded from the coastline and the shore platform is so

The simple example sketched in Figure A.16 for a short length of seawall may not apply for situations, such as at Blackpool or Bournemouth, where seawalls stretch along many kilometres of coastline. A further complication arises when different types of seawall are present along a stretch of coastline, since the lowering of the beach in front of one section of an energy-dissipating seawall may be altered by the effects of adjacent, more reflective structures.

Conversely, the interruption of longshore drift by the seawall results in greater downdrift erosion problems, at least locally, than would have occurred otherwise (for example the situation at the end of the seawall shown in Figure A.18 – Zanzibar). This localised erosion problem will be often reflected in the beach/shore/platform levels just downdrift of the wall, and the ground level contours in front of the wall can be expected to be lower at its downdrift end than at its updrift end (see Figure A.16B).

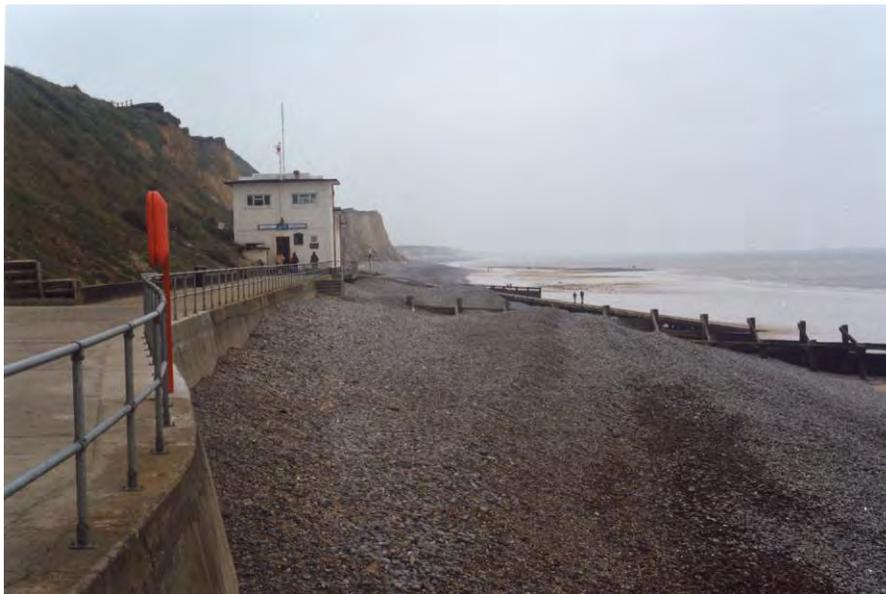
Figure A.17 **Accumulation of shingle at updrift end of seawall, Sheringham, Norfolk**

Many coastal erosion problems are a result of the interruption or alteration of the rates of sediment transport along the coastline (that is, littoral drift). If we consider the simple situation above, but now assume that there is a beach and a nett longshore drift rate, then the seawall will interfere with that sediment transport (Figure A.16B). Experience has shown that the normal effect of a seawall on longshore drift is to reduce its rate in front of the wall. Van de Graaf (2004) suggested that, as the water depth in front of the seawall deepens, the longshore transport rate will decrease. As a consequence of the differences between the drift rates in front of the wall and beyond either end of it, there tends to be an accumulation of beach sediments 'updrift' of the wall and corresponding erosion 'downdrift'. On the updrift end, the accumulation of beach sediments will tend to compensate for any trend of long-term recession of the shoreline and indeed may prevent this from occurring (for example the situation at the western end of the promenade at Sheringham in Norfolk – see Figure A.17).

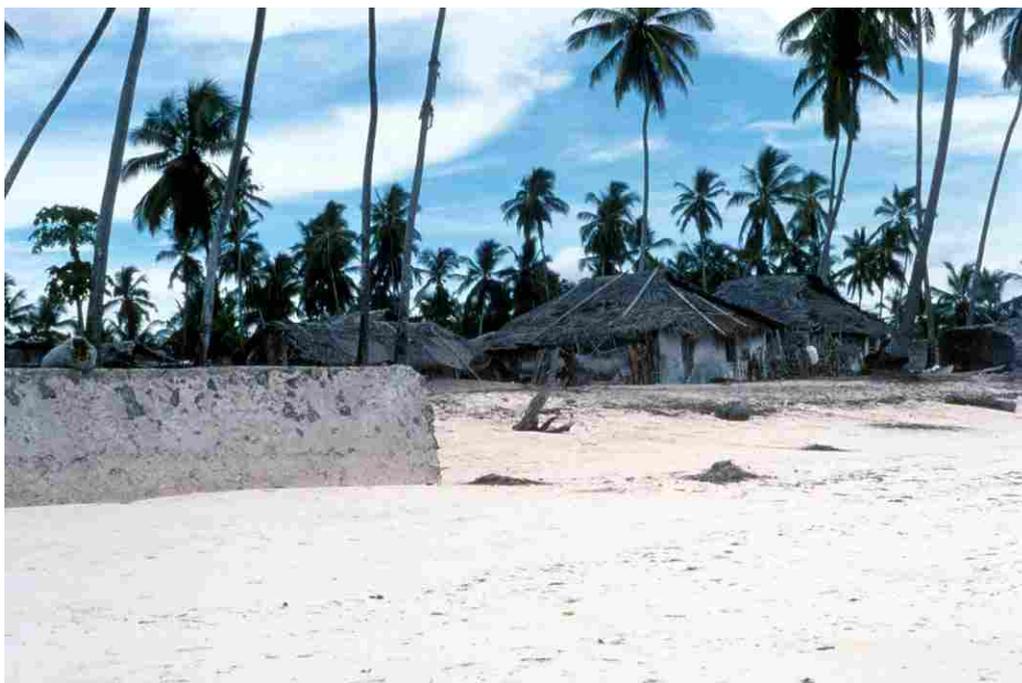
Figure A.18 Erosion at downdrift end of seawall, Zanzibar

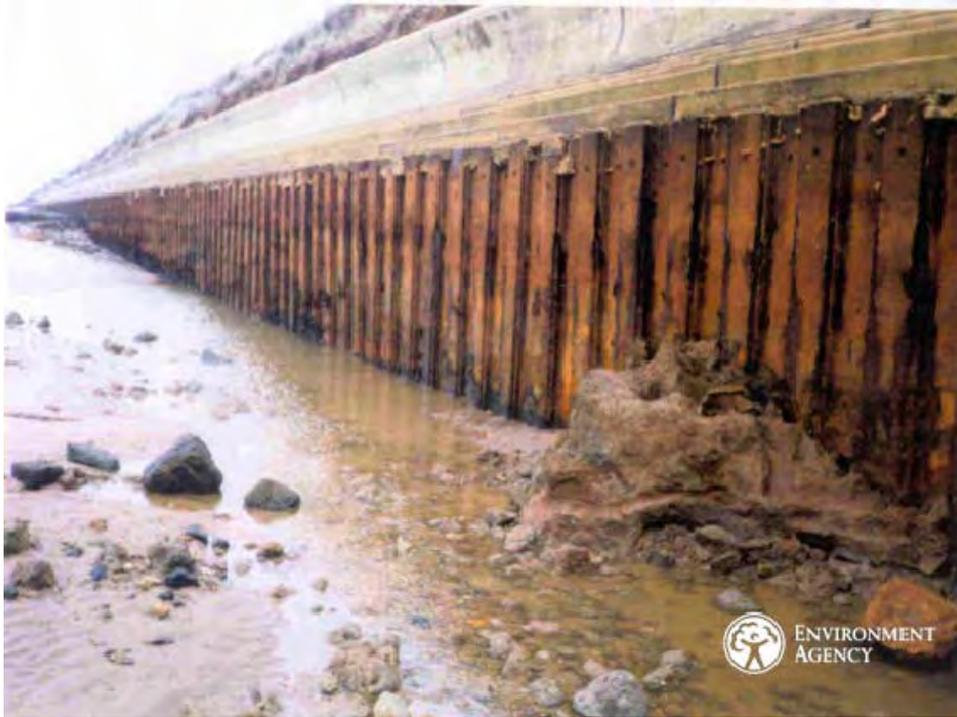
Figure A.19 Erosion of a cohesive shore platform at the toe of a seawall

A shore platform and coastal defence is similar to a shore platform and cliff system. Indeed many shore platform and defence systems used to be shore platform and cliff systems. Defences may have been added when cliff recession threatened valuable assets and while these defences can halt the erosion of the subaerial cliff, they do not stop the erosion of the foreshore, as illustrated in Figure A.19.

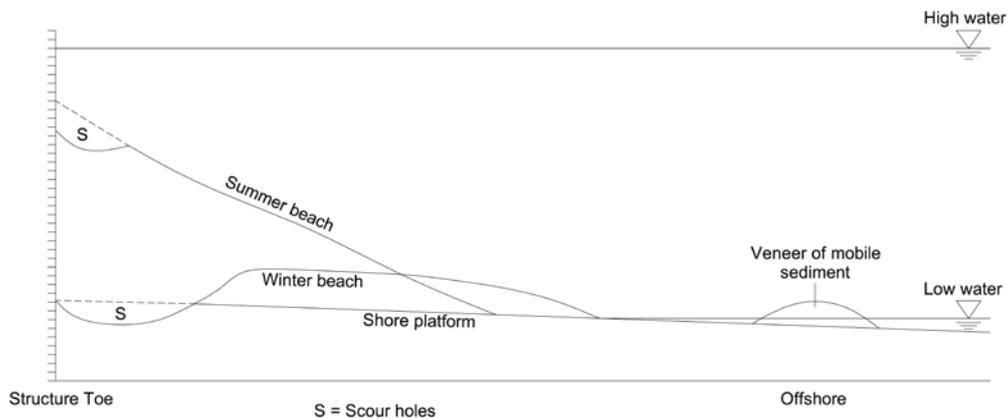
Figure A.20 Seawall founded in cohesive shore platform with beach

Consider the case of a vertical seawall with its toe in the shore platform, but where a sand beach is normally present, as sketched in Figure A.20. If a storm were to occur when the beach level was already low (probably in winter), then it may be possible for a section of shore platform in front of a seawall to be exposed by the scouring away of the sand beach. The exposed section of shore platform may then be eroded through abrasion or excess shear stress, causing a local lowering of the level of the shore platform. When the storm subsides, the scour hole is likely to fill up with sand (see Section A.2.1) leaving little trace of the presence of a scour hole in the sand and none of the erosion of a shore platform. If the non-cohesive beach were to be completely lost, the same location may be eroded more than nearby locations due to the increased levels of turbulence.

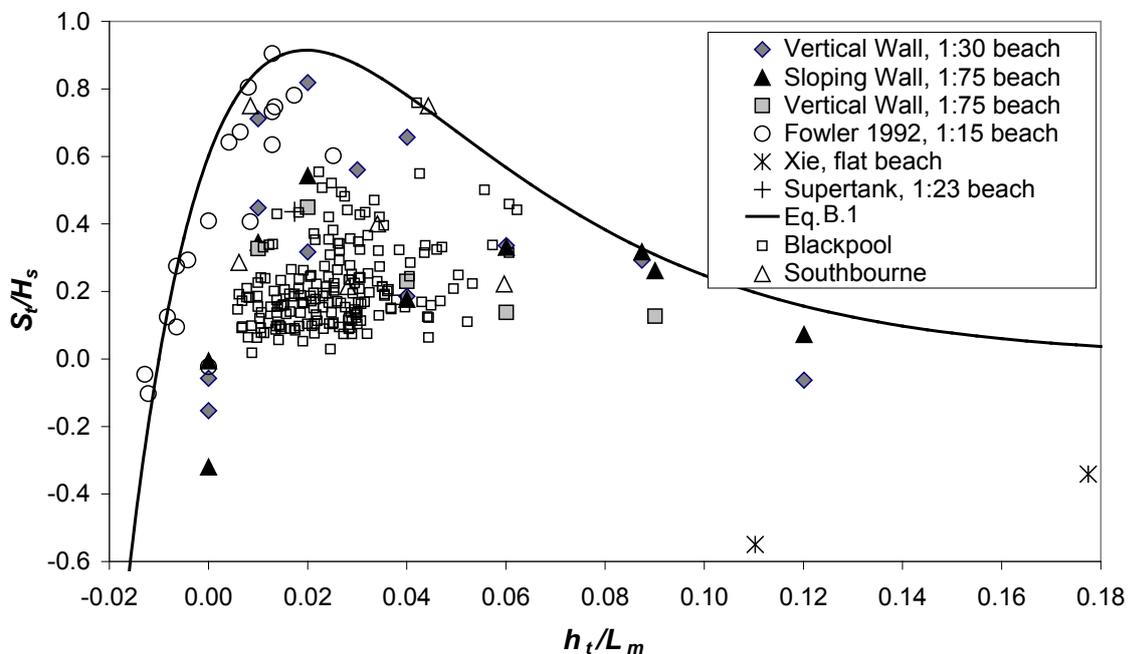
Figure B.1 Measured and predicted laboratory and field data of relative toe scour depth in sand (Sutherland et al. 2007)

The range of validity of Equation B.1 is given in the square brackets in terms of h_t and L_m , which is the wavelength.

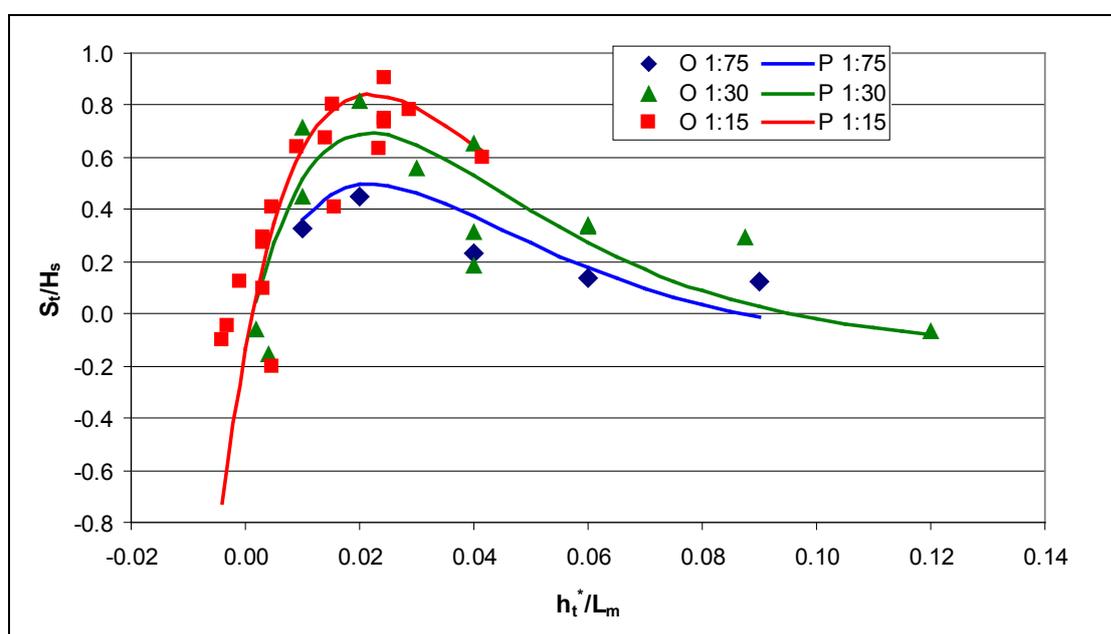
Figure B.2 Measured and predicted (Equation B.2) relative toe scour depths as a function of relative toe depth in sand (Sutherland et al. 2007)

The best-fit straight line (fitted to that predicted against measured data) has a slope of 0.999 and an intercept of zero. This indicates that the relationship between relative toe scour and relative toe depth has been represented accurately. Moreover, there are relatively low errors for the high relative scour depths, which are likely to be the most important, while the largest errors in the predictions occur for negative observed scour depths (that is, accretion at the toe of the structure). However, these cases are relatively unimportant – at least as far as the stability of a structure is concerned.

Equation B.2 is plotted with the measured data in Figure B.2, where 'O 1:N' and 'P 1:N' are the observed and predicted scour depths with a beach slope of 1:N (with N = 15, 30 or 75) respectively. Equation B.2 has zero bias and systematic error and predicts the highest toe scour depths relatively well. In Figure B.2, Equation B.2 is plotted for the range of h_t^*/L_m for which data was obtained at that particular beach slope. The water depth h_t^* includes a correction for wave set up which will be most influential at low value of h_t .

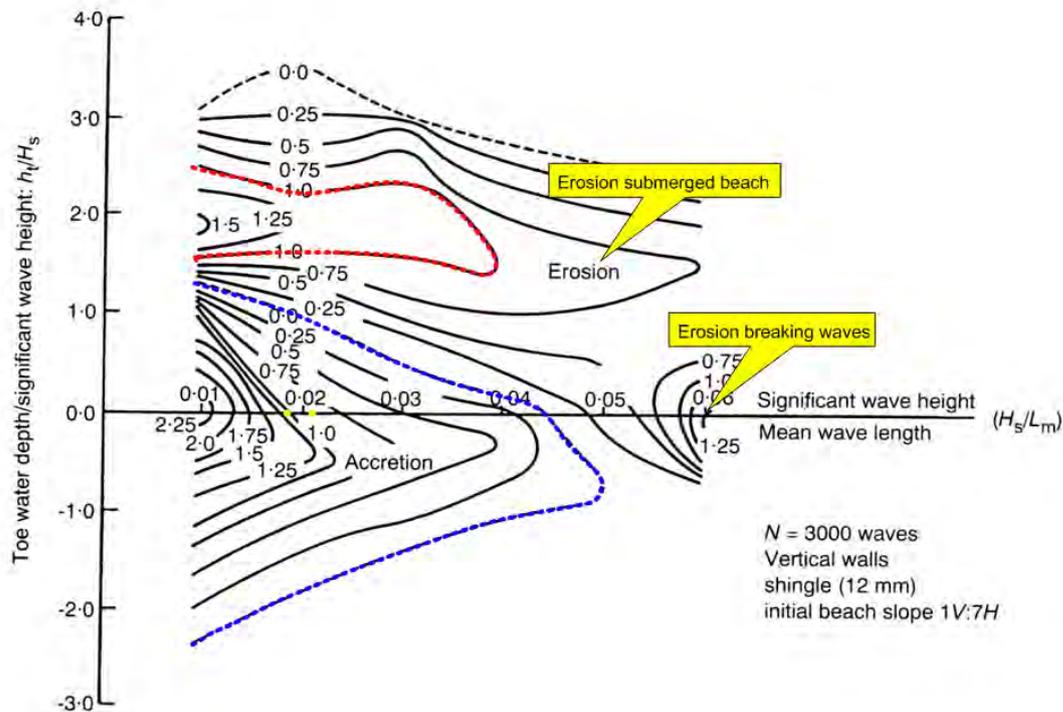
Figure B.3 Prediction diagram for contours of S/H_s scour (erosion) and accretion at vertical seawalls with shingle beaches (after Powell and Lowe 1994)

To select the worst possible scour, look at the dimensionless scour values for all h_t/H_s values below the maximum relative water depth corresponding to the wave steepness, H_s/L_m , and select the greatest relative scour height, which can exceed H_s . The plot gives the scour after 3,000 waves; a correction must be used to predict scour for time intervals other than 3,000 waves – see Section B.1.3.

Figure B.3 shows contours of S/H_s plotted on a graph with axes of relative depth, h_t/H_s and relative wave steepness, H_s/L_m , where:

- h_t/H_s : relative water depth
- h_t is the initial water depth at the wall
- H_s is the extreme unbroken deep water wave height
- H_s/L_m : wave steepness
- L_m is the mean wavelength of the unbroken wave (using $T^2g/2\pi$)
- S : scour depth after 3,000 waves.

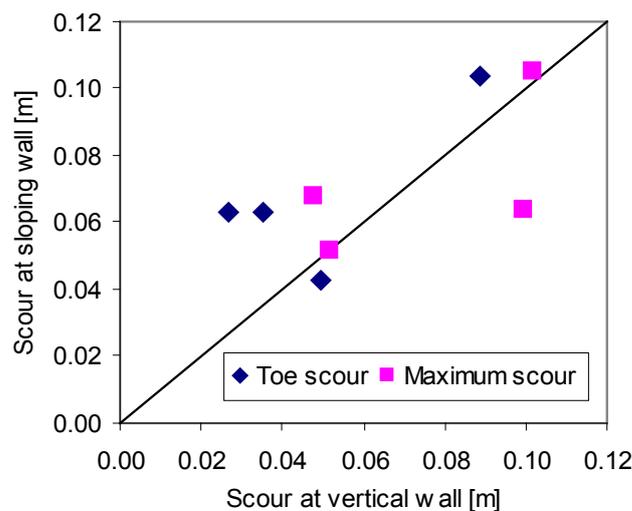
Figure B.4 Comparison of scour depths in sand at a 1:2 sloping wall and at a vertical wall for the same offshore wave conditions (Sutherland et al. 2006a)

In shallow water, the depth of scour is controlled by waves breaking on the wall and turbulence reaching the seabed. Under these circumstances the effect of reducing the seawall slope can be insignificant. It is only when water depths at the toe of the structure are sufficient to prevent turbulence reaching the seabed that a systematic reduction in scour depths with wave height can be expected. Moreover, for a sloping seawall, the antinodes will not occur exactly at the seawall, as there is a phase shift on reflection (Sutherland and O'Donoghue 1998a) so the position of deepest scour may change.

- Sutherland et al. (2006a) compared the maximum scour depths and the toe scour depth at a 1:2 (27° above horizontal) sloping impermeable wall to those at a vertical impermeable wall for four different offshore wave conditions and water depths with $H_{si}/h_t = 0.5-1.0$, where H_{si} is the incident significant wave height and h_t the toe water depth. The results are shown in Figure B.4 and show no systematic reduction in scour depth with wave height. In these cases, the downrush from the highest waves was reaching the seabed in some cases, which caused scour to occur.

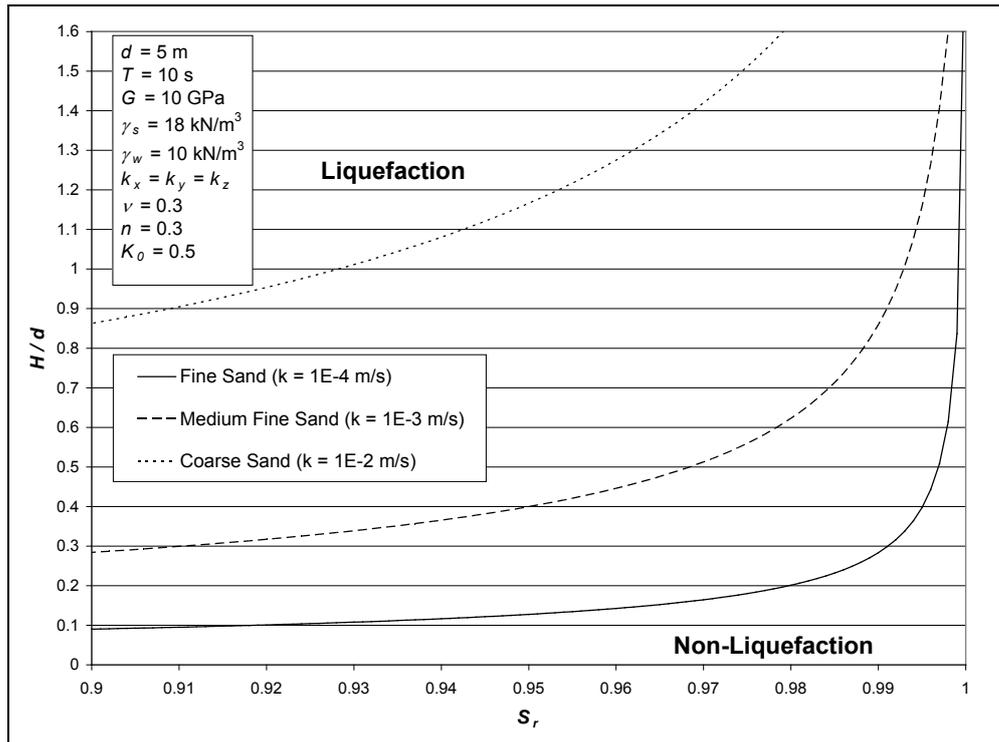
Figure B.5 Wave-induced liquefaction potential around a marine structure founded on a saturated/unsaturated seabed subjected to various standing wave loadings with a water depth of 5 m (Sutherland et al. 2007)

The effects of wave height (H) and degree of saturation of the seabed (S_r) on the occurrence of liquefaction to a fine sand bed in a water depth of 5 m is shown in Figure B.5 for a typical storm wave period of 8 s. The degree of saturation of the seabed ranges between 0.9 and 1.0. Esrig and Kirby (1977) reported that the in situ values of the degree of saturation S_r for marine sediment normally lie in the range 90–100 per cent. Mory et al. (2007) observed from their field data that the S_r value of sand bed on the Atlantic coast of France ranged from 94 per cent to 100 per cent for the top 0.5 m of the sand bed.

The wave height, H , presented in the figures is the wave height of the combined incident and reflected waves. Liquefaction occurs in the seabed when both wave condition and seabed condition fall into the area above the line. For instance, the medium fine sand bed, with S_r value of 0.98, starts to liquefy under the wave condition with wave height greater than $1.3d$ ($d = 2$ m, see Figure B.5).

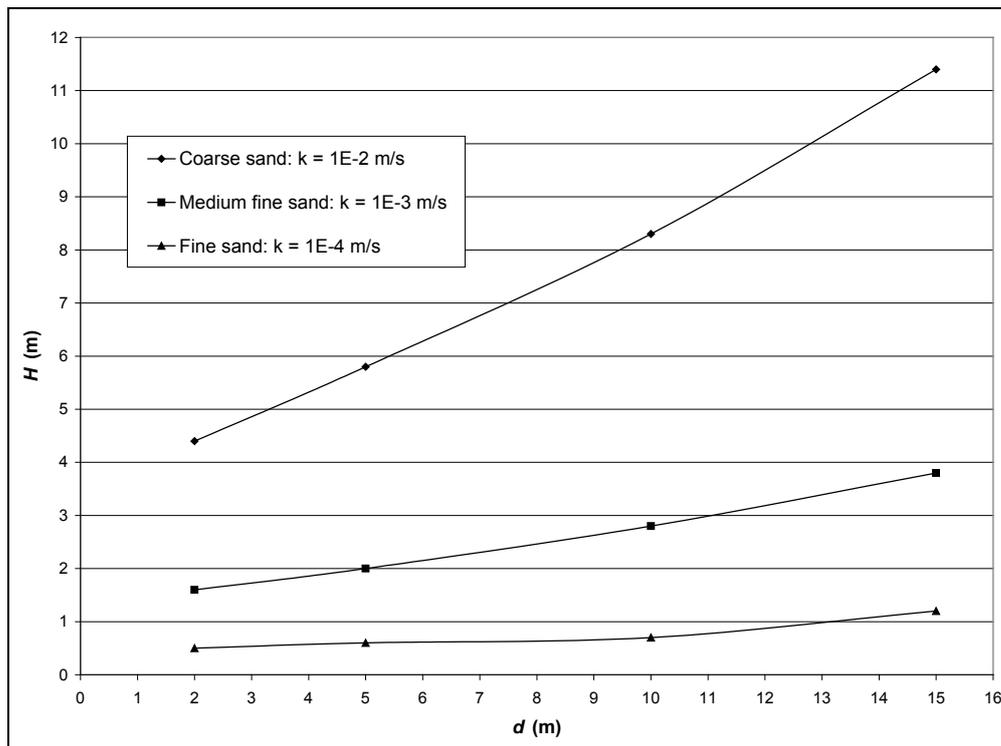
Figure B.6 Wave heights required to liquefy three different types of sand bed with given permeability, k , and with degree of saturation of 0.95, at various water depths (Sutherland et al. 2007)

To assess liquefaction potential with Figure B.6, first select the water depth, d , and then determine the combined wave height, H , from the incident wave height, H_i (that is, $H = 2H_i$). If the value of H is greater than $1.6d$ then H is limited to $H = 1.6d$. Select the most

representative bed sediment grading and, if the value of H is equal to or greater than the value of H on the y-axis, then momentary liquefaction can occur.

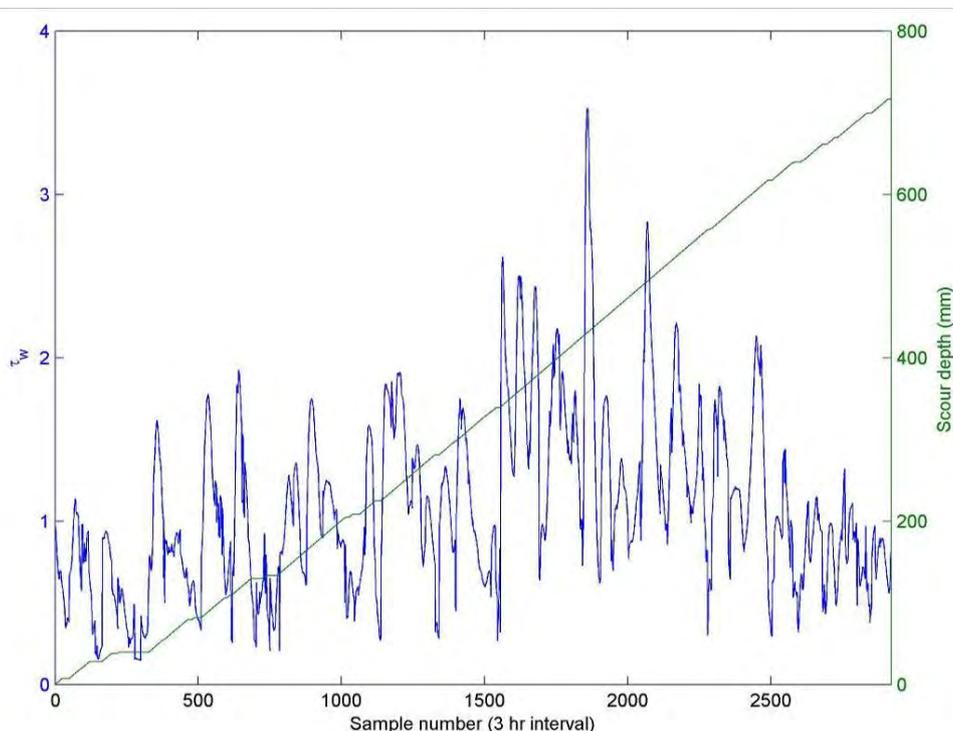
Figure B.7 Time series of bed shear stress and scour depth assuming a constant erosion rate above the threshold (Whitehouse, 2006)

Example time series of bed shear stress and scour depth at a point are shown in Figure B.7 for a soft clay bed and relatively long period waves. The shear stress distribution varies spatially in front of the structure due to variations in the velocity field. It follows that the erosion profile varies spatially as well, as shown in Figure B.8, where the time taken to reach scour depths of 0.5, 1.0 and 2.0 m is plotted against the distance from the structure toe.

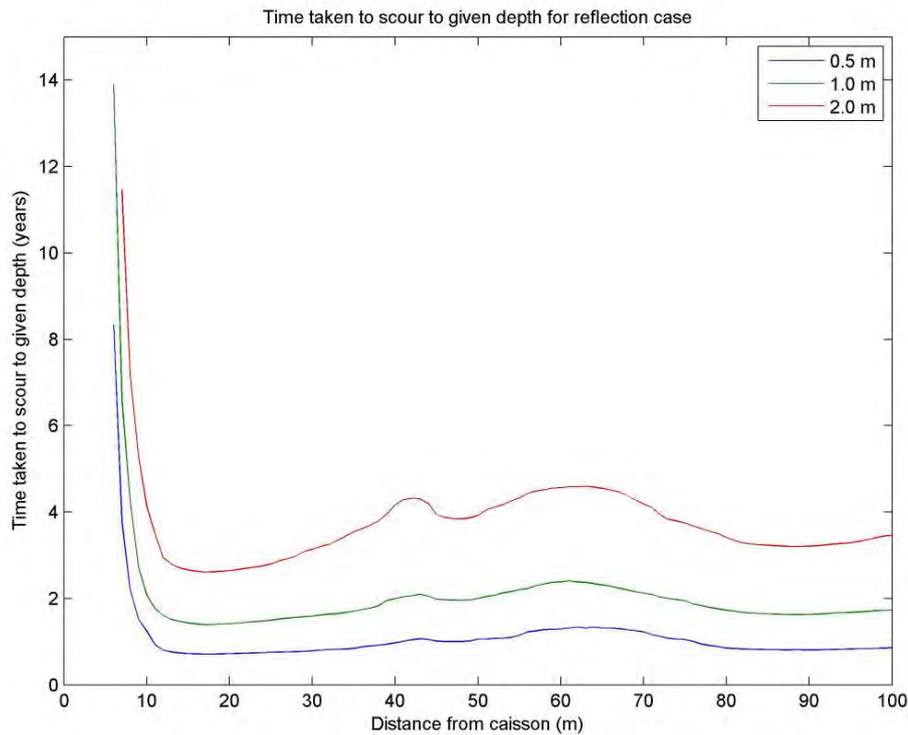
Figure B.8 Time taken to scour to given depth for reflection case

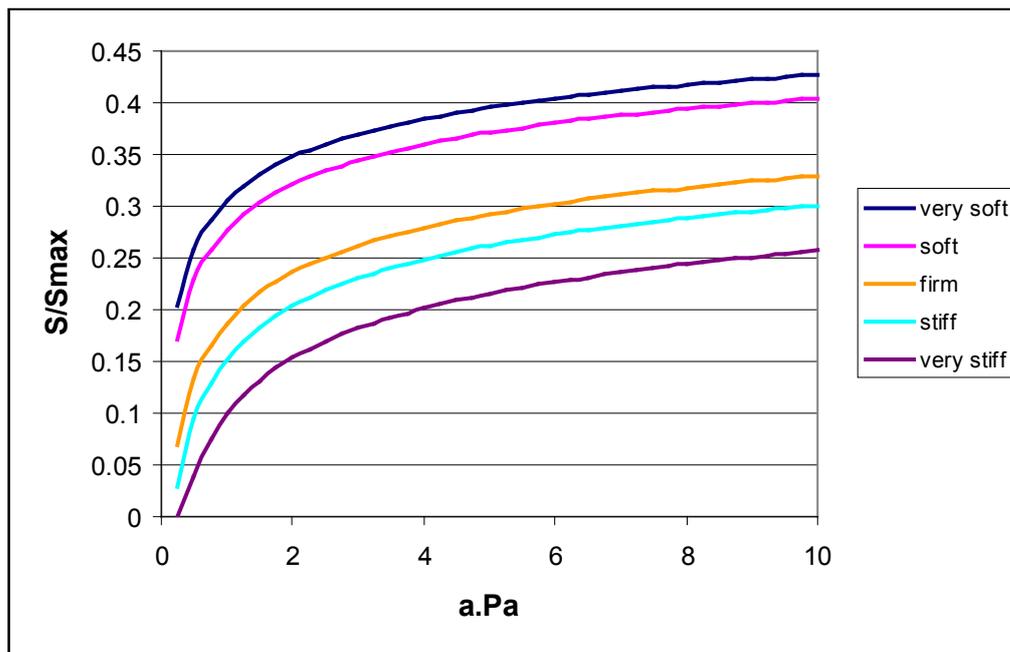
Figure B.9 Curves of reduction in scour depths in soft rock

In practice, if $P_a > P_R$ (the stream power required for the erosion of the top layer of the seabed) then the entire seabed will erode. In this case we assume that the base of the scour hole will fall with the eroding seabed. The results produced can be summarised for generic soil types as shown in Figure B.9. This shows the variation of relative scour depth on the y-axis with wave forcing quantified on the x-axis, the following plausible behaviour is observed:

- relative scour depth is less than the scour depth that would be experienced in non-cohesive fine sand;
- relative scour depth increases with wave forcing;
- relative scour depth decreases with increasing soil stiffness.

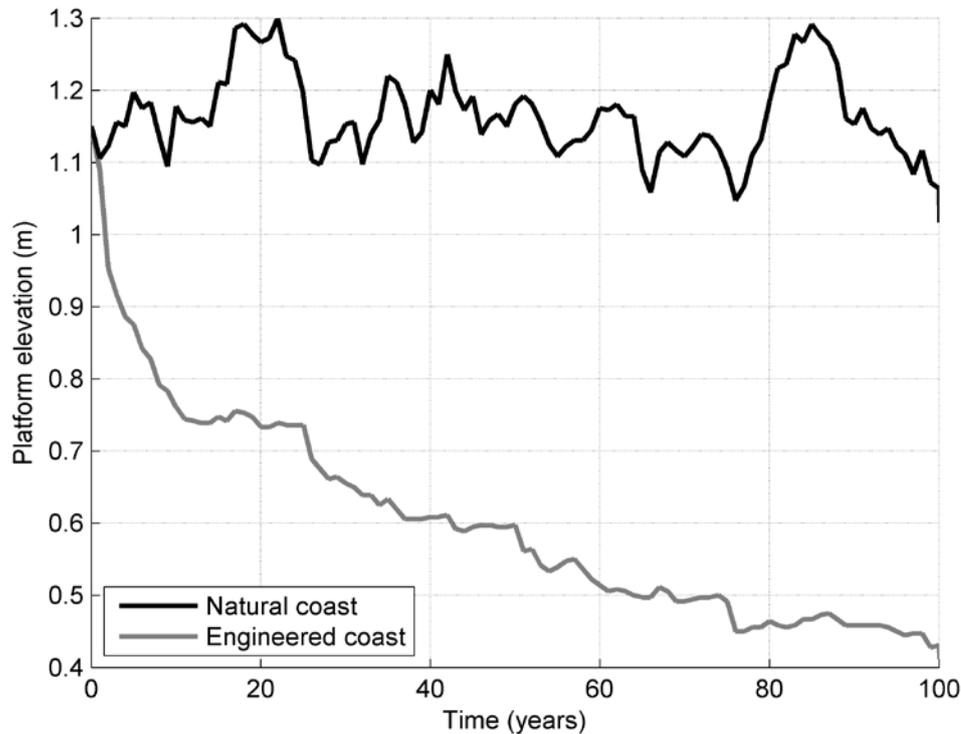
Figure B.10 Downcutting of shore platform predicted by SCAPE model (Walkden and Rossington 2009)

An example application of SCAPE to the platform elevation change in front of a coastal structure is shown in Figure B.10. This figure demonstrates that (at least for this specific application, which is for a cliffed coast) continued erosion of the cliff leads to the release of sediment onto the foreshore which maintains the platform elevation above 1 m (line labelled

'Natural coast'). Where the scenario of a seawall is introduced (line labelled 'Engineered coast') the platform is predicted to undergo a progressive reduction in elevation, in this case by 0.7 m over a period of 100 years. The average rate of 0.007 m/year is in the same ballpark as the observed rates in Table B.1. The model results were averaged between 10 m and 20m from the cliff toe or seawall toe, and not at the toe itself.

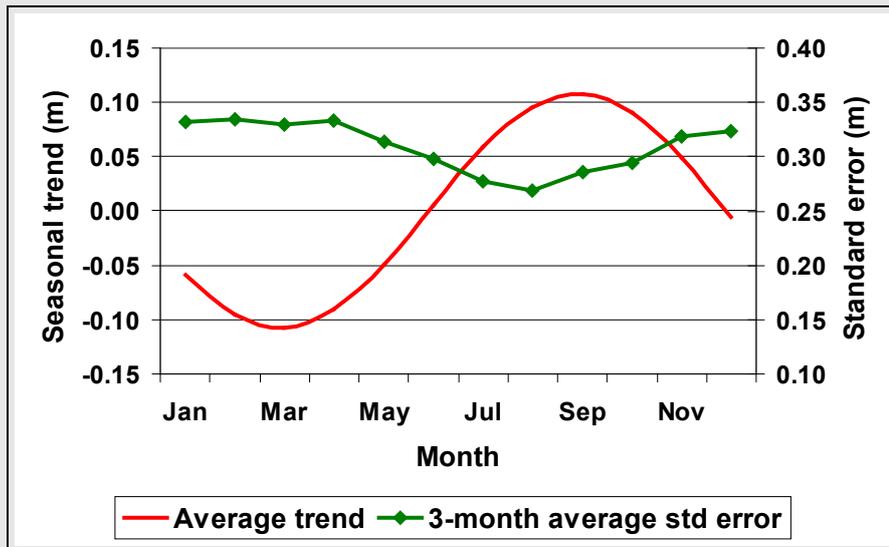
Figure B.11 A best-fit seasonal trend from Lincolnshire stations

Figure B.11 shows the best-fit seasonal trend for the seven stations calculated. Six out of seven stations had seasonal trends between 0.1 m and 0.2 m in amplitude, which had their highest values in August or September. The other profile, from the convalescent home, has a much lower amplitude (22 mm) and peaked in October. The average profile had an amplitude of 110 mm and peaked in September, with its lowest value coming in March.

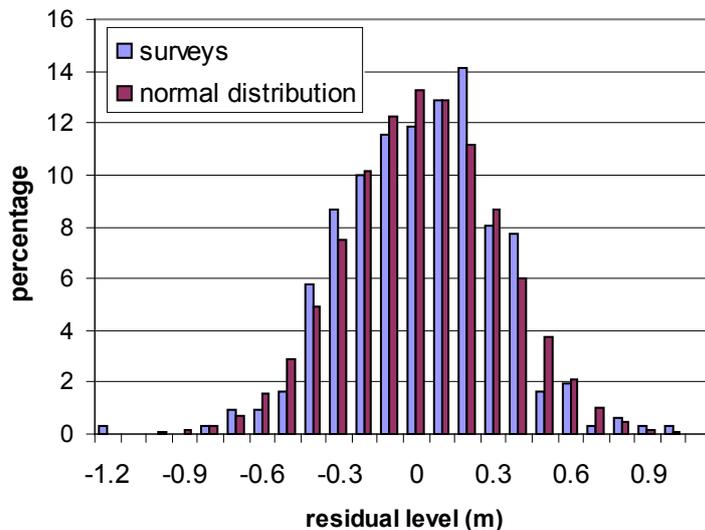
Figure B.12 Measured and Gaussian distribution of residual beach levels at Mablethorpe convalescent home

Residual beach levels are obtained when the long-term trend is removed from a time series of beach levels. The seven Lincolnshire datasets were de-trended by subtracting the best-fit straight line from the time series. The probability distribution of residual beach levels was then calculated and plotted with a Gaussian distribution, which had measured average and standard deviation (HR Wallingford 2006b, Section 3.1.3). The plot for Mablethorpe is shown in Figure B.12.

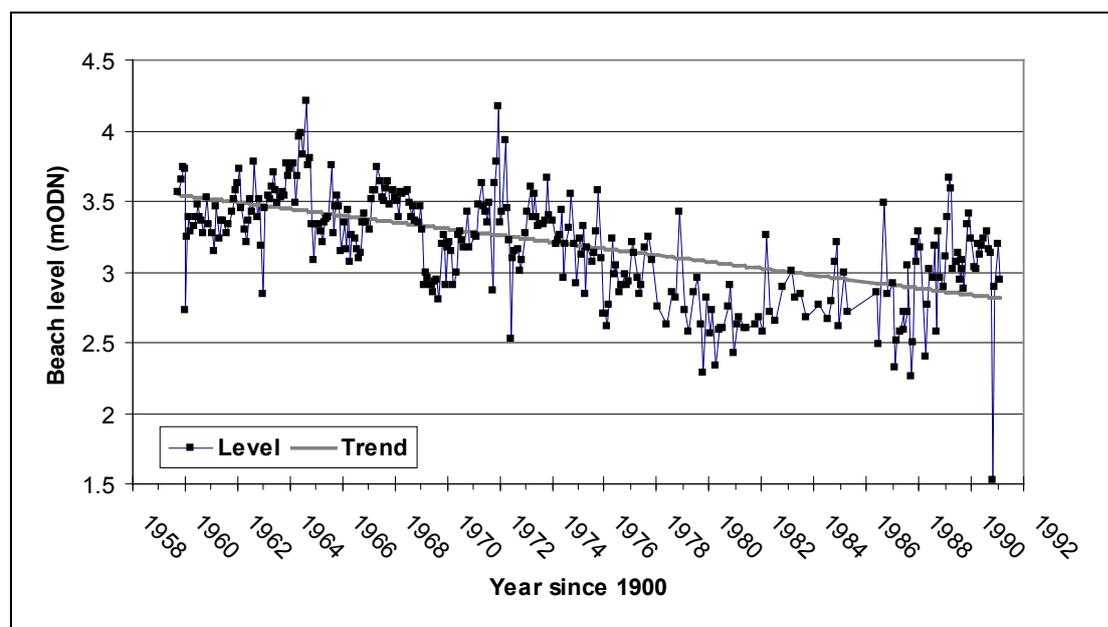
Figure B.13 An example of time series beach levels

The linear analysis of beach level data is demonstrated here using a set of beach profile measurements carried out at eight locations along the Lincolnshire coast between 1959 and 1991, as described in HR Wallingford (2006c, Section 3.1). Locations backed by a seawall were chosen and time series of beach levels were output at points near the seawall toe. An example of a time series has been given in Figure B.13.

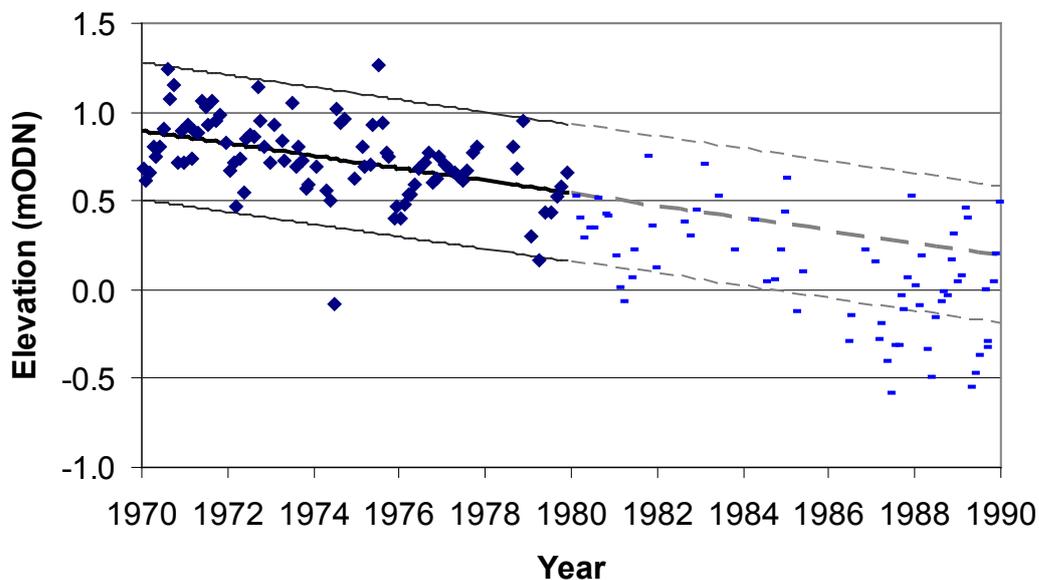
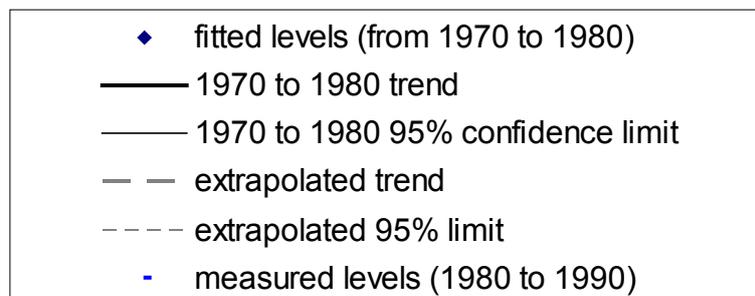
Figure B.14 Linear trend in beach levels at Boygrift outfall from 1970 to 1980 and extrapolated trend from 1980 to 1990 plotted with measured beach levels

and 95 per cent confidence limits

The use of an extrapolated trend to hindcast beach levels is illustrated using data collected at Boygrift Outfall between 1970 and 1990. A linear trend in beach level was fitted to the data from 1970 to 1980 and the 95 per cent confidence limits were calculated on the assumption of a Gaussian distribution of residual beach levels (see Box 3.2). Figure B.14 shows that only three out of the 92 measured beach levels between 1970 and 1980 fell outside the 95 per cent confidence limits. The linear trend between 1970 and 1980 was then extrapolated between 1980 and 1990, as were the confidence limits. Over a quarter of the measured beach levels from 1980 to 1990 were outside the extrapolated 95 per cent confidence limits.

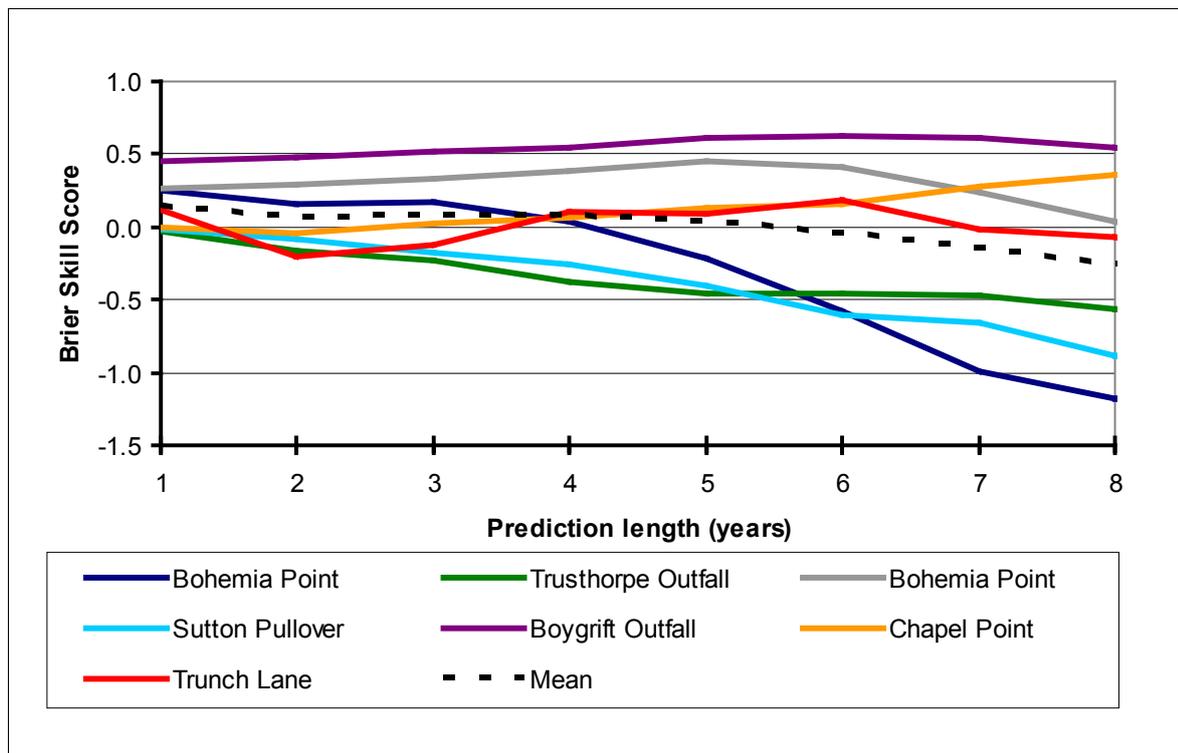
Figure B.15 Brier skill scores versus time for Lincolnshire profiles based on linear trends fitted to 10 years of data (Sutherland et.al. 2007)

An example of this for beach level data at the toe of a seawall in Lincolnshire is shown in Figure B.15, where the Brier skill score is plotted against duration of prediction for seven locations. The prediction horizon is the duration at which the average BSS decreases to zero.

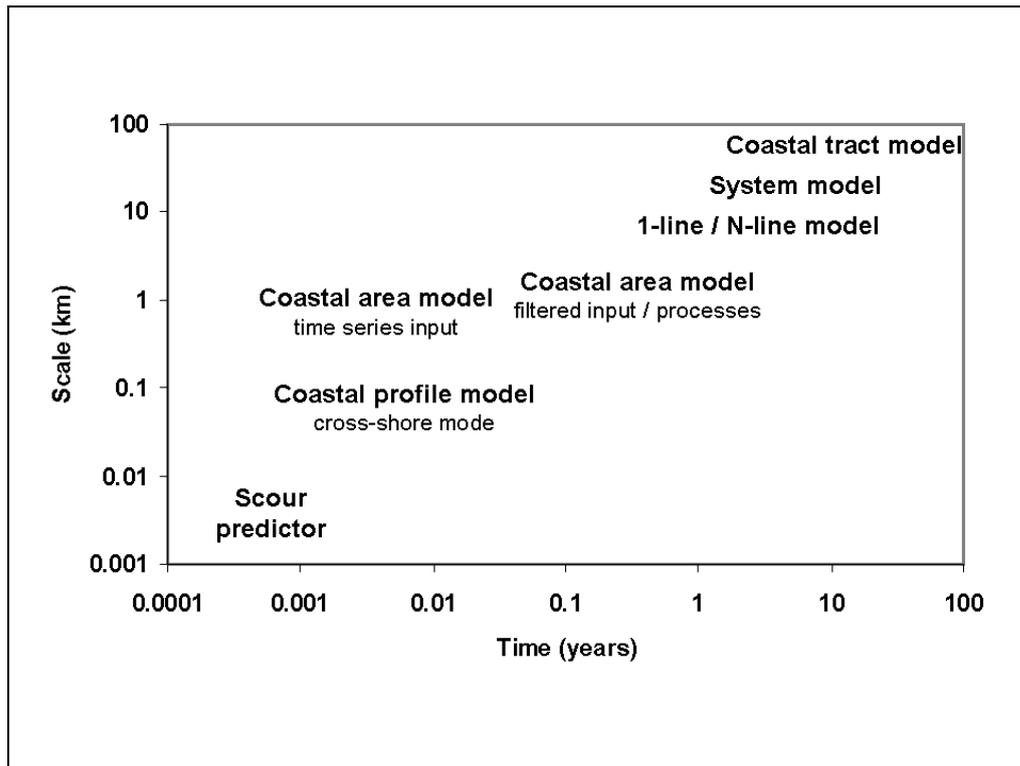
Figure B.16 Indication of spatial scale and length of prediction for different numerical model types

The approximate limitations and applicability of the types of existing numerical models are illustrated in Figure B.16. Coastal tract models are based on sediment budgets. Figure B.16 shows that the numerical models attempt to describe fewer and fewer processes in detail as the spatial and temporal scale over which they are deployed increases.
