Toe structures management manual

Project: SC070056/R

Coastal structures, structure toe, asset management, condition assessment, beach, scour

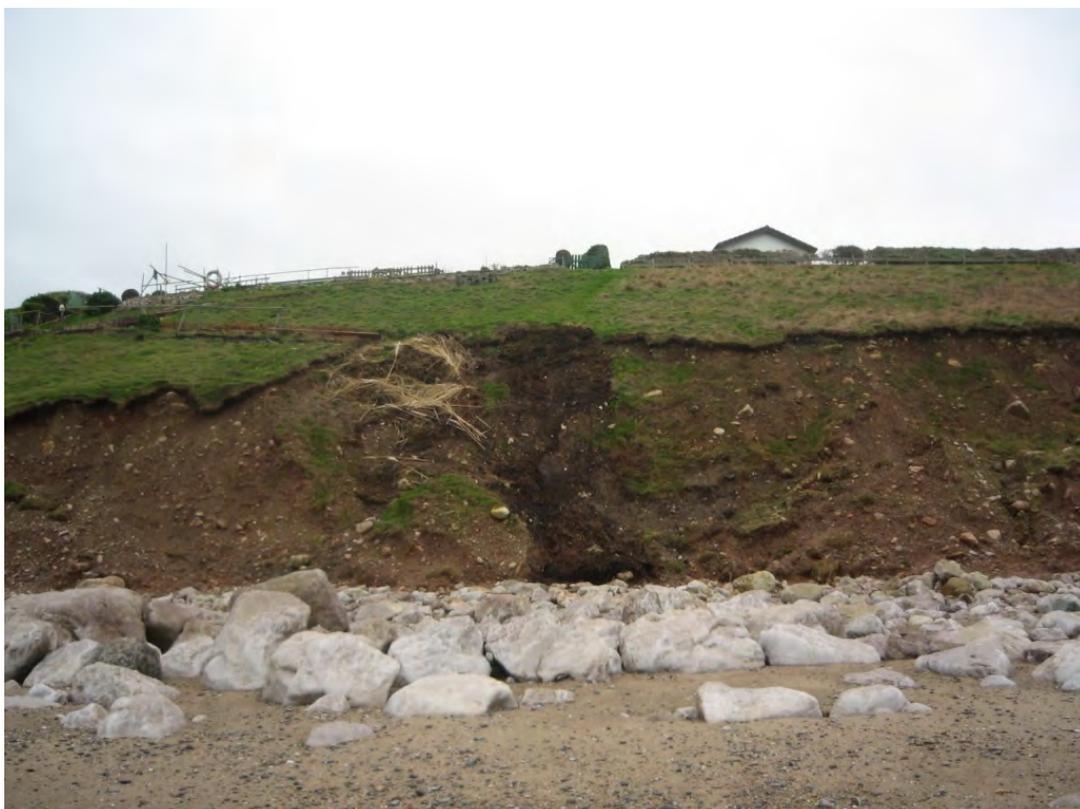
Figure C1.3 Coast protection measures constructed as a condition of the development

condition for building these later properties, the developer was required by the (then) local authority, Aberconwy Borough Council, to provide coast protection. These measures entailed regrading the cliff and constructing a revetment. According to local observers, the revetment was formed by pushing the indigenous boulders from lower down the foreshore up to the toe of the cliff (Figure C1.3). Larger boulders were set at the bottom of the mound, with smaller boulders at the top.

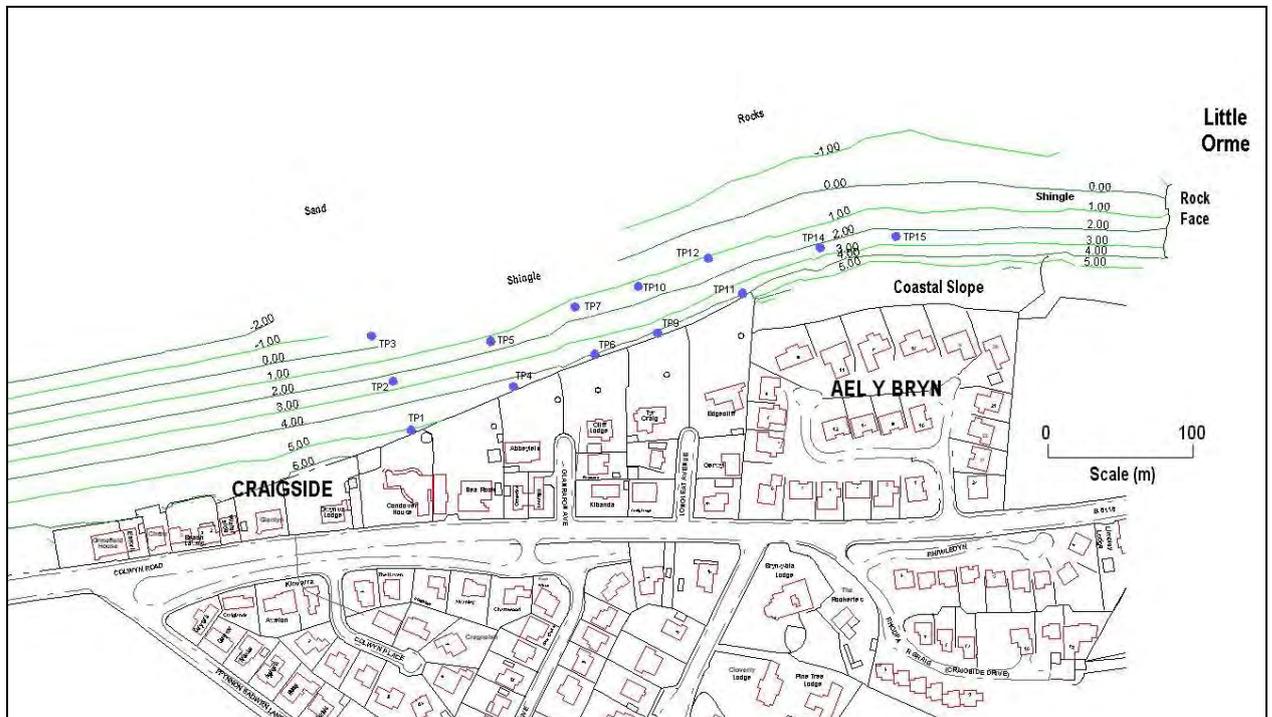
Figure C1.4 Position of foreshore trial pits

A ground investigation was carried out including trial pits (Figure C1.4) and boreholes. However, the latter proved problematic due to the percussion tool hitting boulders.

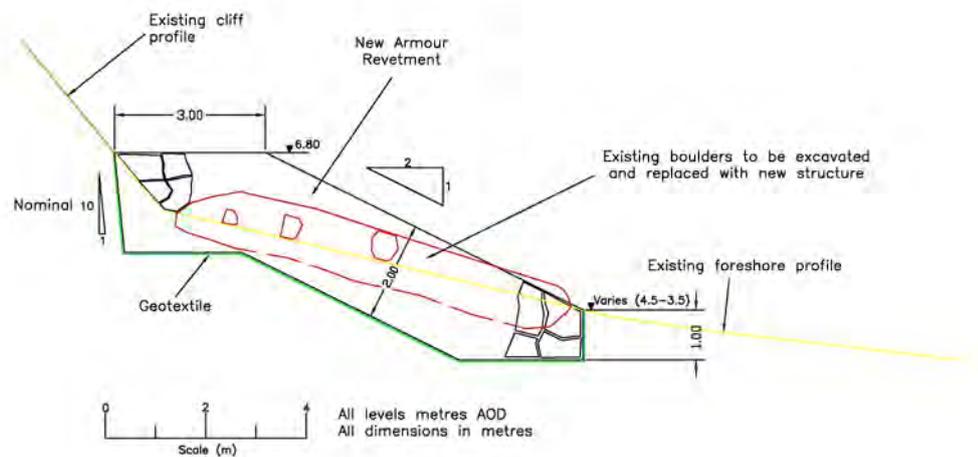
Figure C1.5 Typical cross-section

The detailed design was prepared by the local authority. Figure C1.5 shows a typical cross-section which comprised:

- re-grading and reseeded of the cliff face;
- a crest of level of +6.8 mODN;
- a revetment consisting of 1–3 tonne rock rip-rap laid at a 1 in 2 slope on geotextile placed on the cliff face;
- a toe, buried into the beach to about 1 m depth or less if underlying clay was encountered.

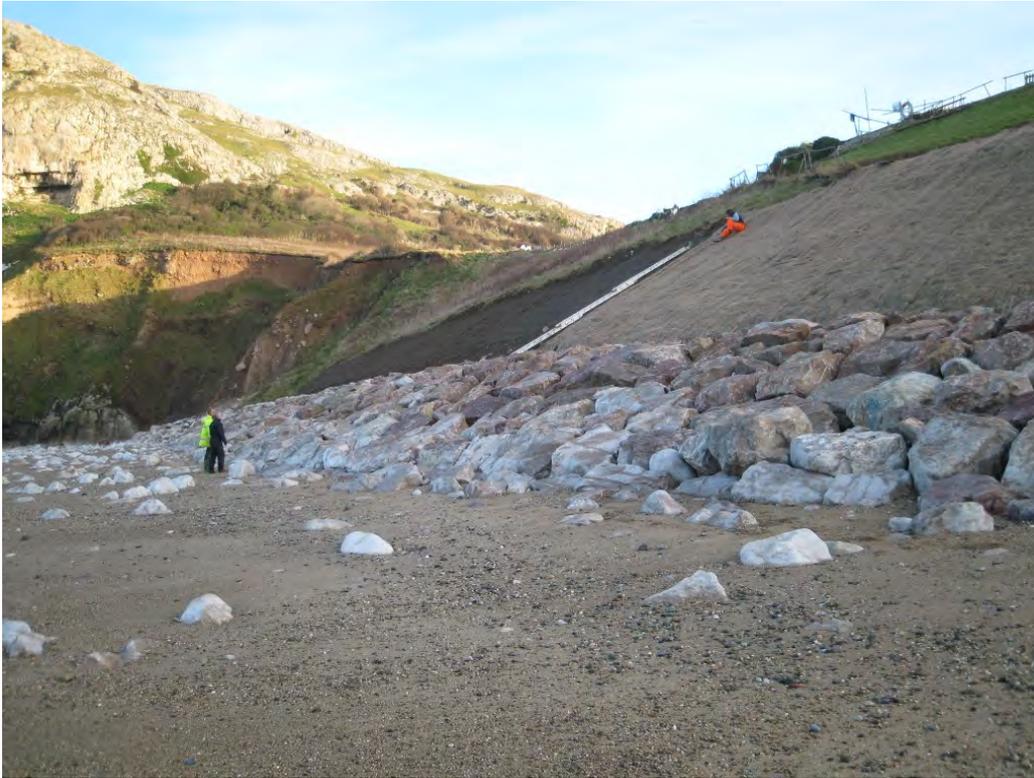
Figure C1.6 **Regraded cliff face**

The capital works scheme was procured through competitive tender. Further to the reuse of the local rounded boulders, rock was obtained from local quarries. This limestone had been used elsewhere where it was known to be performing well after 30 years' service. Given its position at the foot of the cliff, access to site needed careful consideration. To facilitate access, a temporary haul road was created from the paddling pool (see Figure C1.2), the latter area also being allocated for the contractor's compound. Figure C1.6 shows the regraded cliff face.

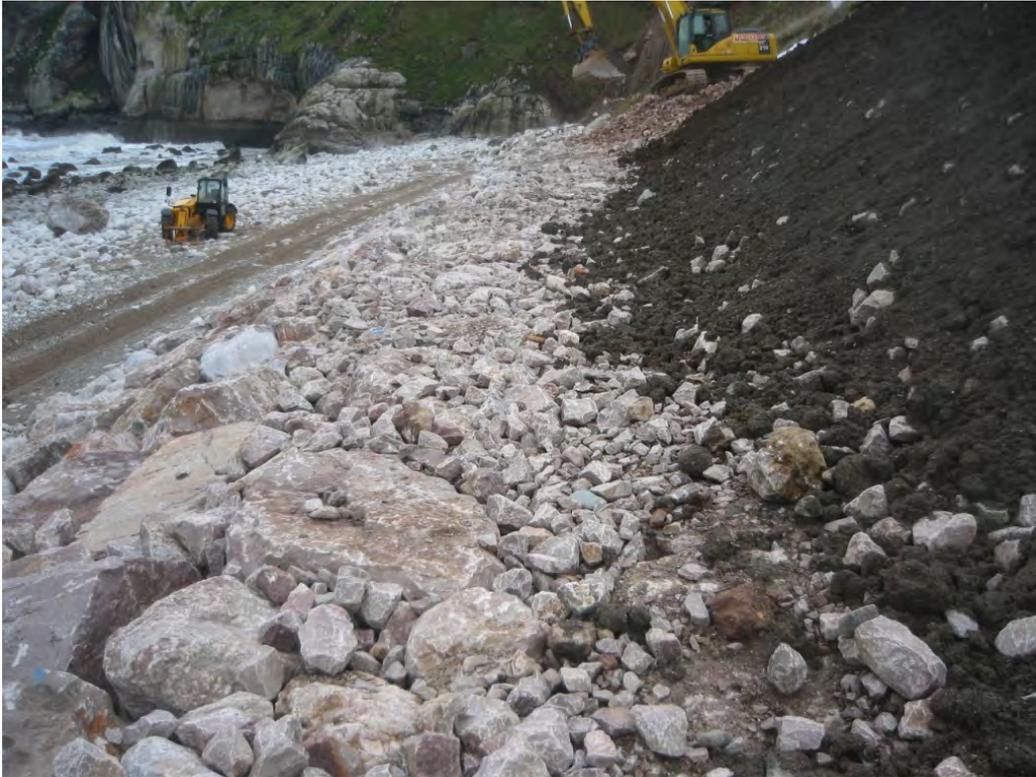
Figure C1.7 **Construction in progress**

The construction works were at a high elevation in the beach profile but still required shift working in line with the tidal window and weather conditions (see Figure C1.7).

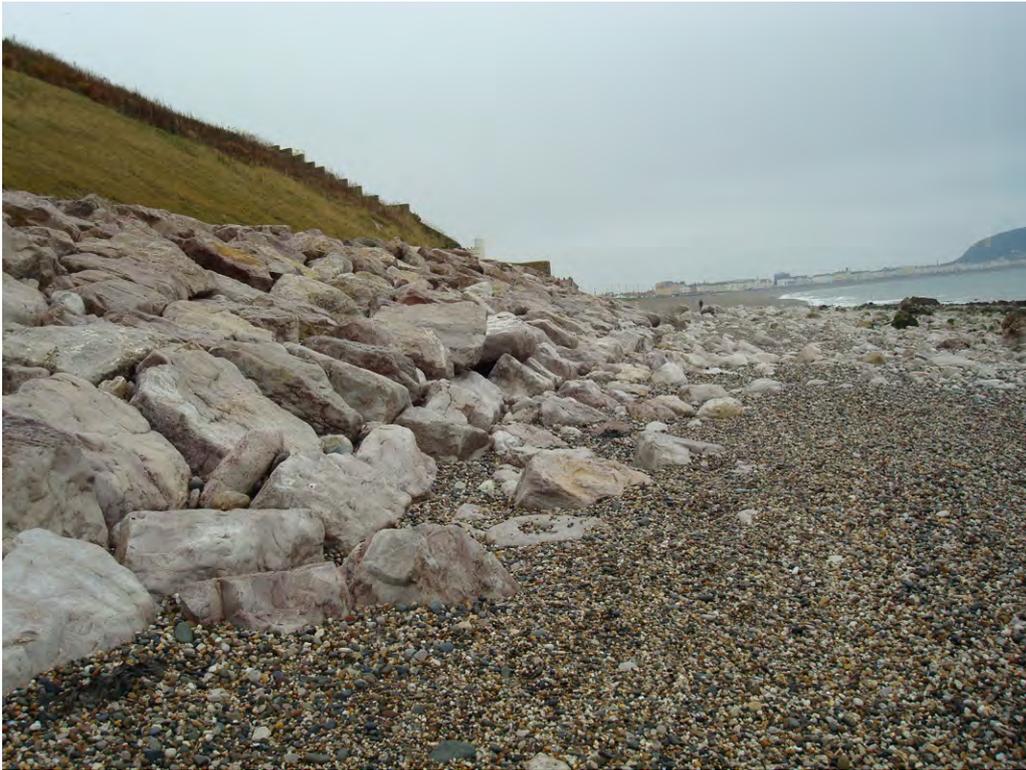
Figure C1.8

The completed scheme

The completed scheme is shown in Figures C1.8 and C1.9. Beach surveys and an inspection of the site are carried out twice a year; there is an annual report. No problems have been encountered with the toe of the revetment. Public perception of the scheme is good.

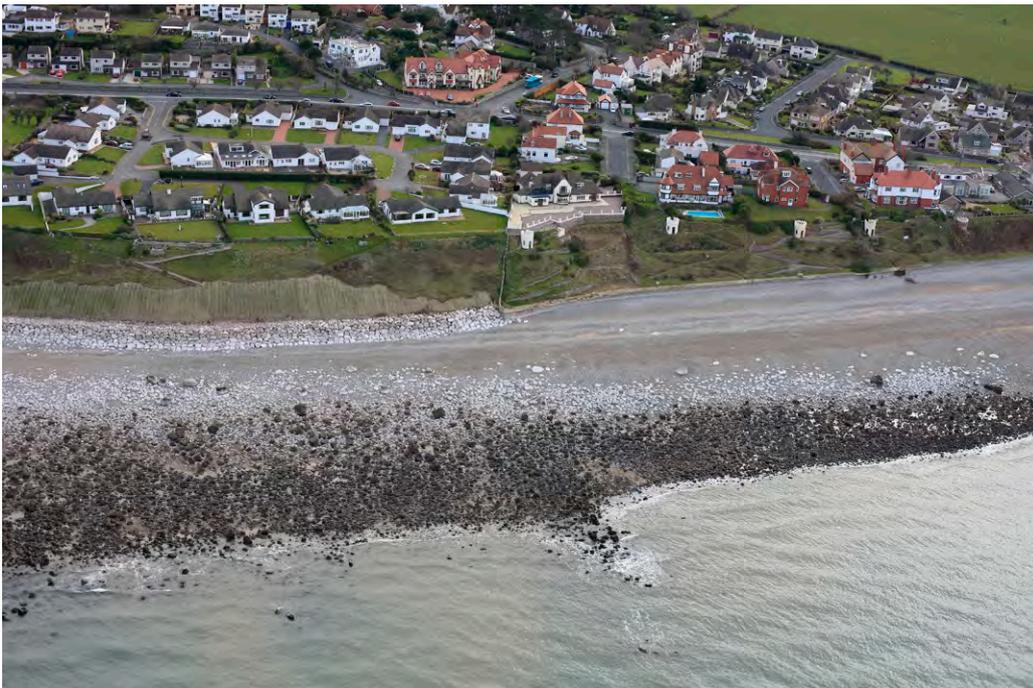
Figure C1.9

Aerial view of the project (note Craigsidde vertical wall to the west of the revetment)

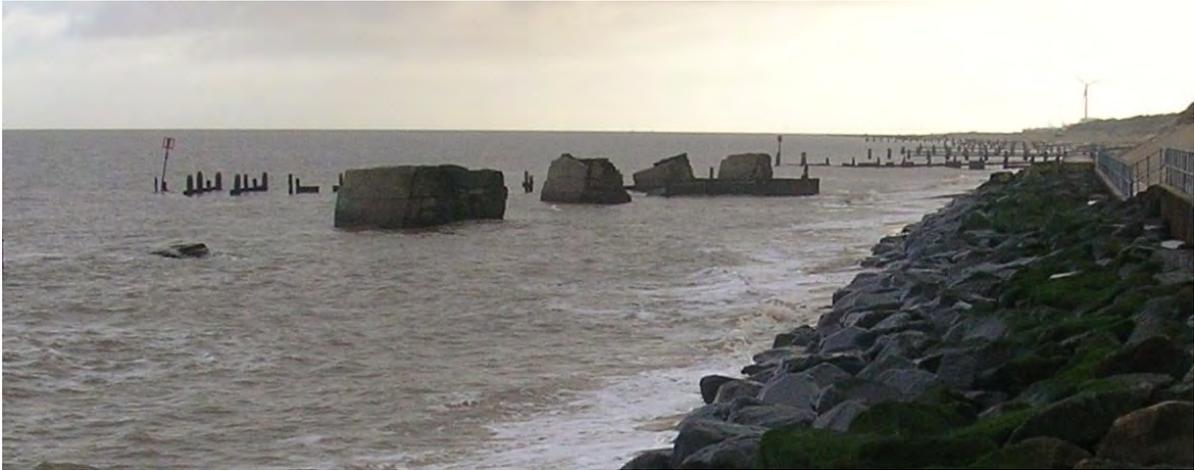
Figure C2.2 Detached concrete relics of 1870 Colman coast defences

In 1870 the Colman family had concrete and timber coastal defences built to protect their property between the middle and the southern end of Corton. Relics from these early defences are still evident today (Figure C2.2).

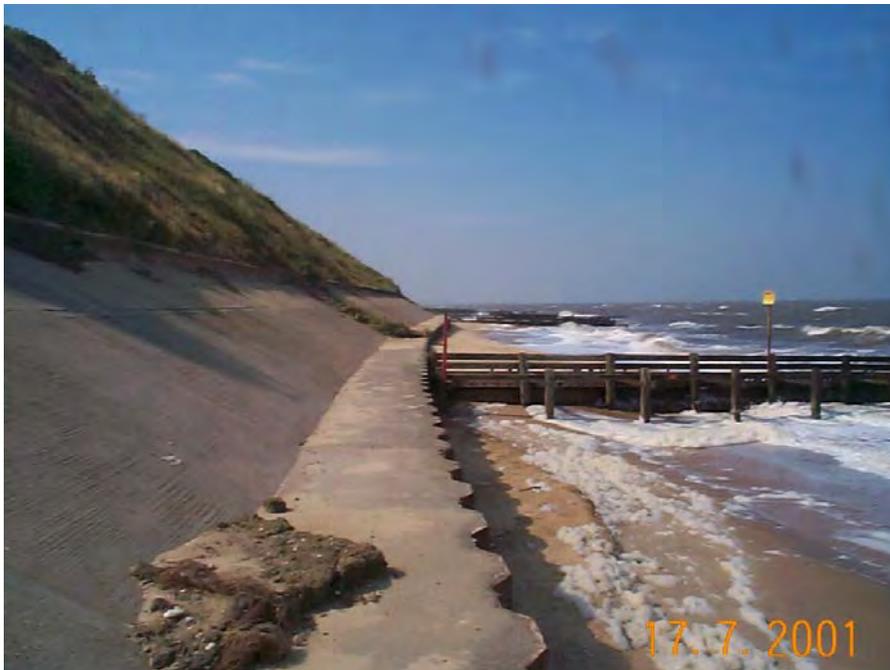
Figure C2.3 Typical 1960–1967 toe and revetment structure (note date of photograph)

The seawall built prior to the works described in this paper originated from 1960 and 1967 and consisted of a steel sheet piled toe behind which was a mass concrete berm and a raked concrete slab covering the lower cliff face (Figure C2.3). In addition to the new seawall, timber framed/steel sheet faced groynes were installed along the frontage.

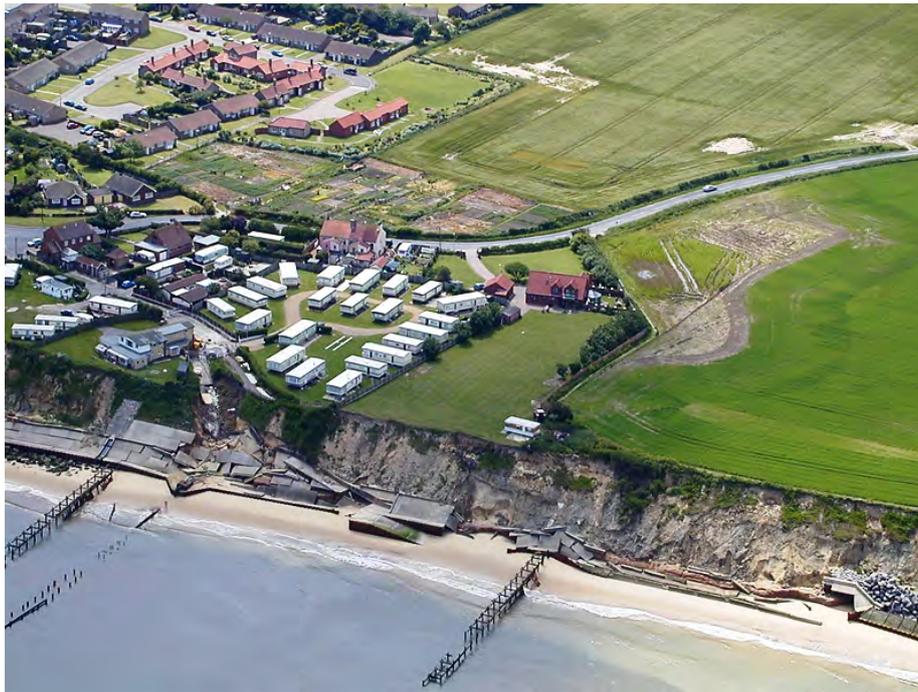
Figure C2.4 Failure of the seawall in winter 2000–2001

In 1986, 50 metres of the 1960s seawall failed due to undermining. By this time, the groyne field was also in poor condition due to abrasion of the steel piles. The failed section of seawall was rebuilt together with two groyne; otherwise only routine maintenance was applied. However, the shoreline continued to retreat and further collapses of the seawall occurred in November 1999 and April 2000 (Figure C2.4). It appears that the beach level dropped below the toe of the sheet piles but that the metal ties restrained them close to the top, resulting in the piles kicking out at the toe (Figure C2.5). Where scour penetrated behind the piles, the whole structure collapsed with the concrete berm articulating over the piling.

Figure C2.7 shows two design cross-sections through the revetment. The upper section shows the cross-section of the new defence where the original construction was totally destroyed (see Figure C2.4); the lower section shows the typical section to the south of this where, partly for cost reasons, the original cliff apron slab survived and was incorporated into the section.

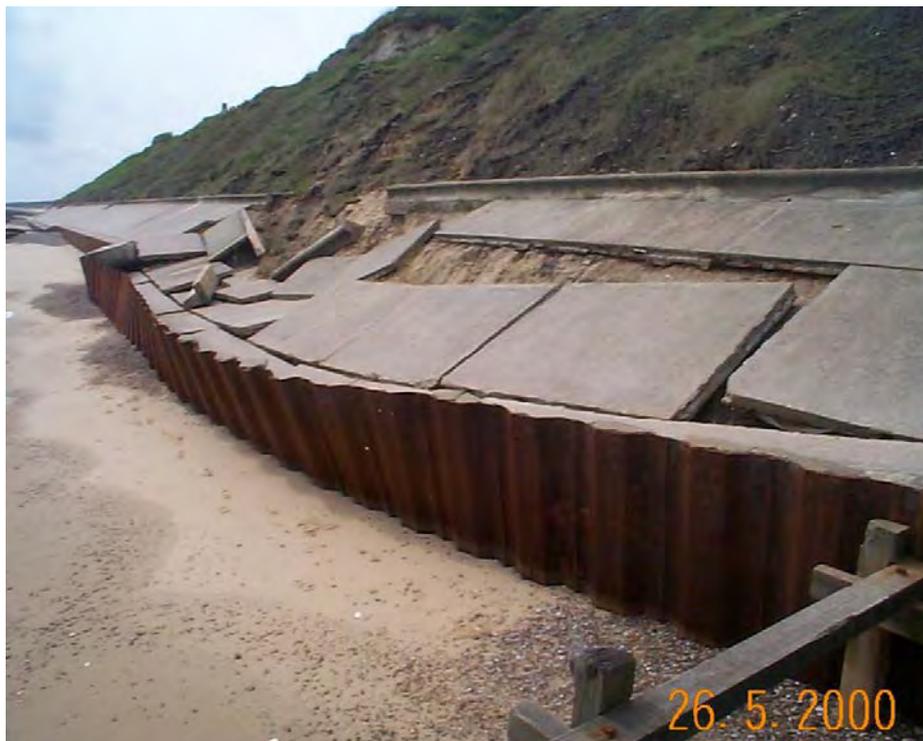
Figure C2.5 Rotation of the toe piling (photograph taken after the 1999 failure)

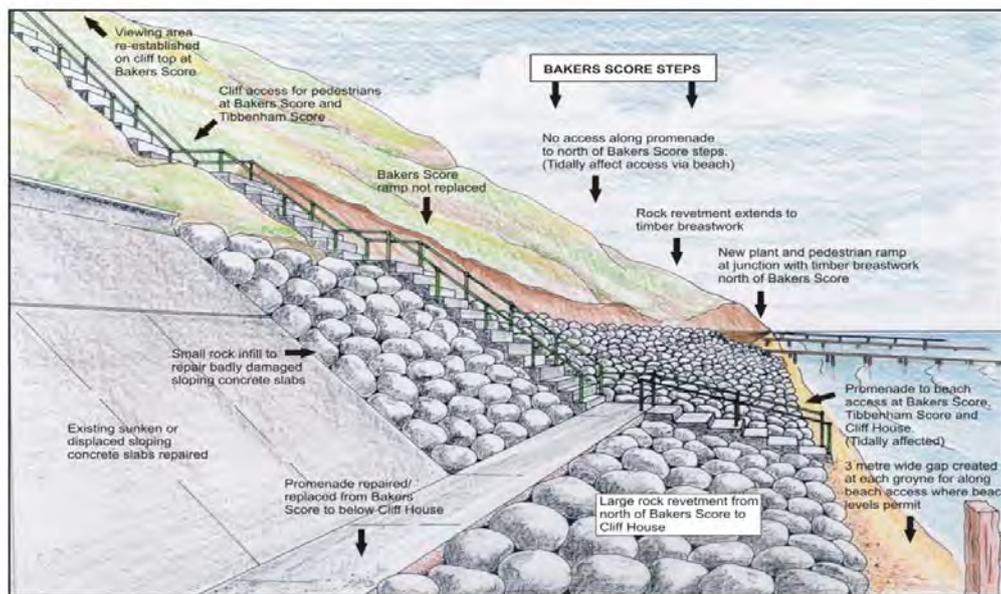
Figure C2.6 Schematic of the outline design

Figure 5: PREFERRED SCHEME OPTION AT BAKERS SCORE

Figure C2.6 shows a schematic of the outline design.

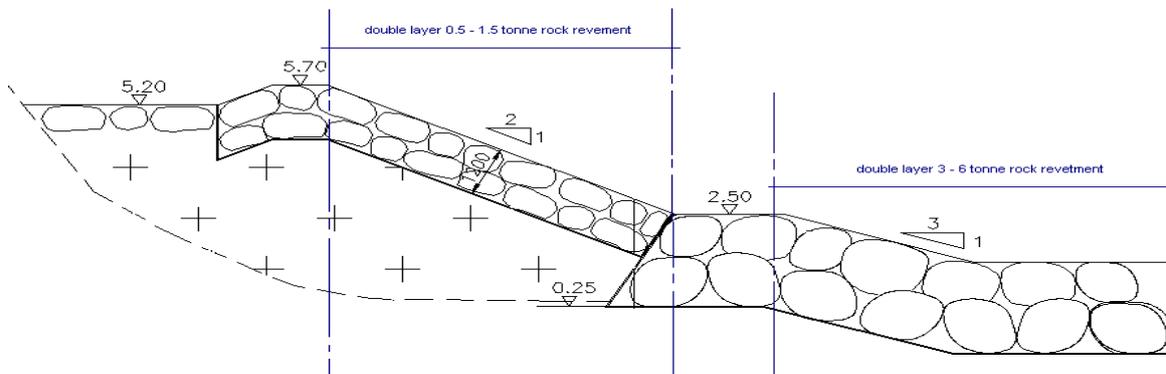
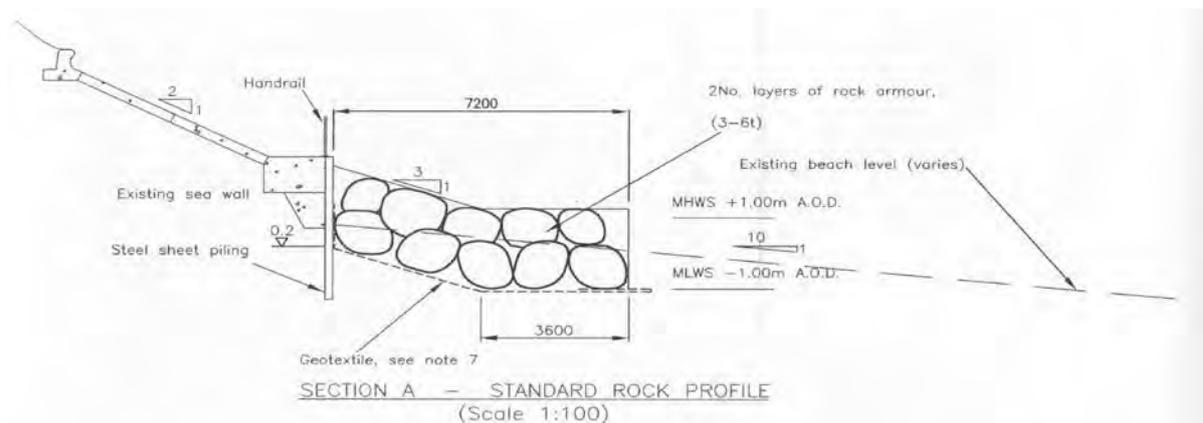
Figure C2.7 Design cross-sections

Full reconstruction over northern part

Revetment fronting remaining 1960s structure

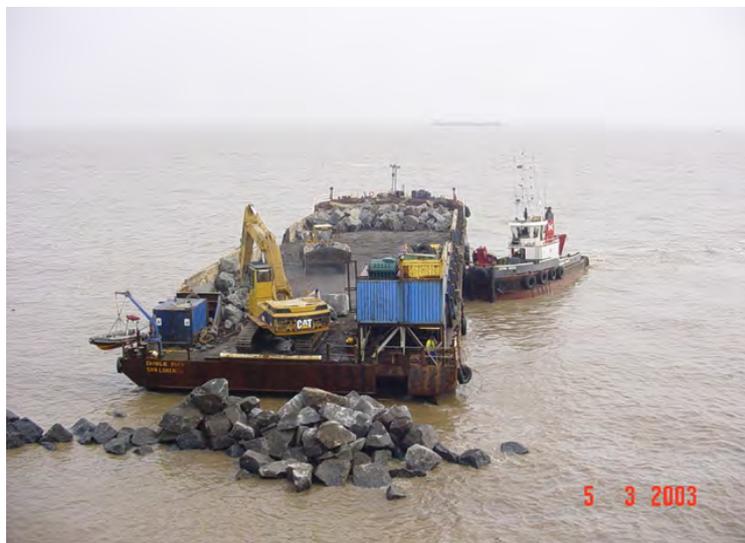
Figure C2.8 **Rock delivery**

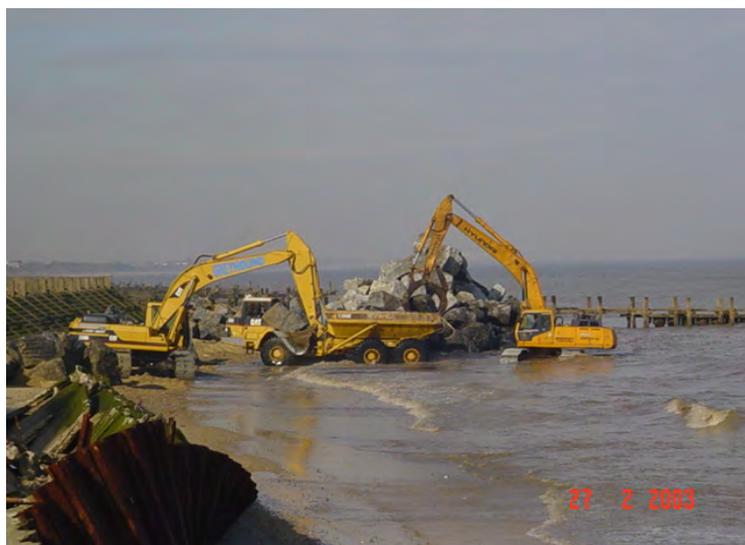
Figure C2.9 **Rock recovery**

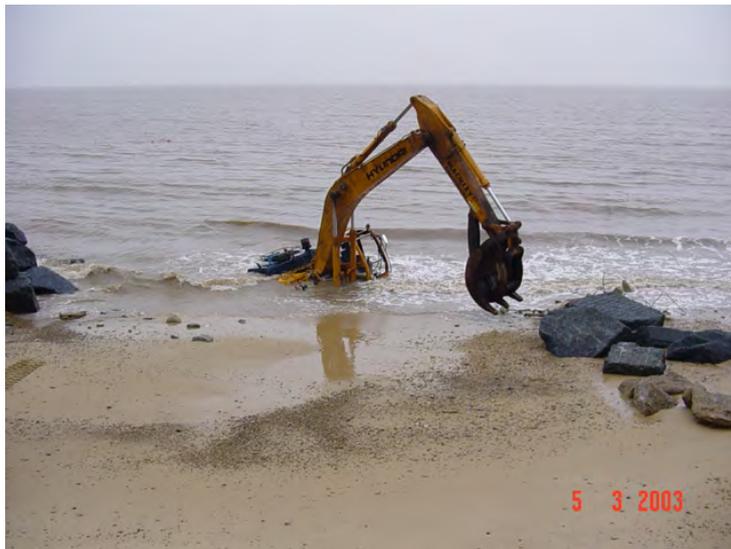
Figure C2.10 **Excavator loss**

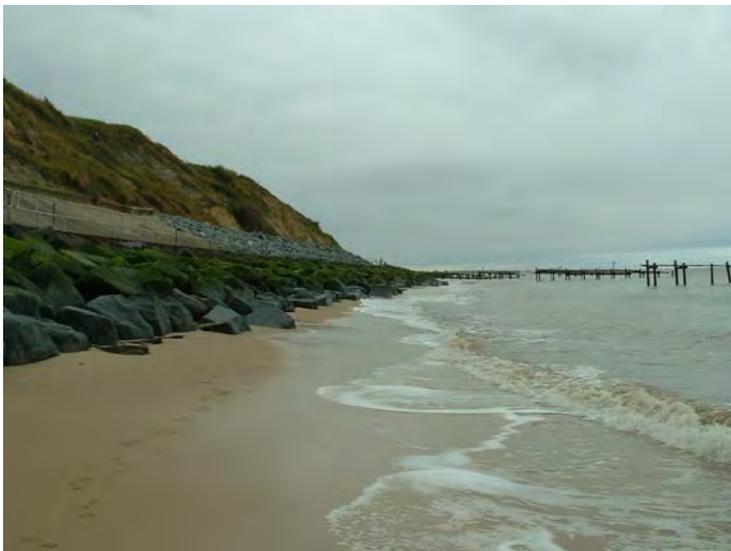
Figure C2.11 **Finished works**

The completed scheme is shown in Figure C2.11.

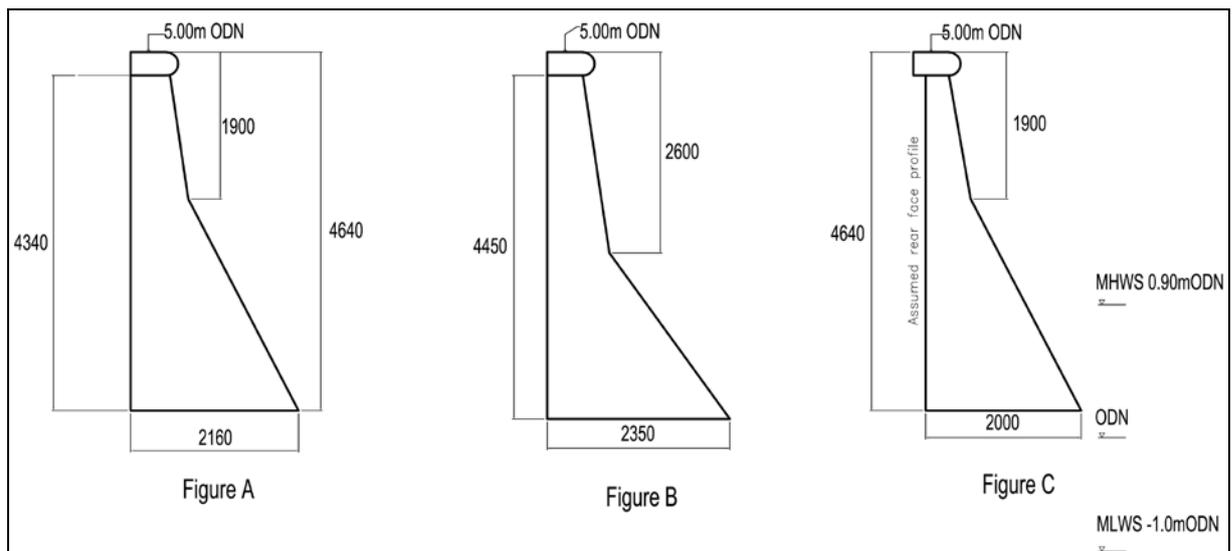
Figure C3.4 Old Flint Wall sections

Site investigation showed that the Old Flint Wall was rather variable in cross-sectional geometry (Figure C3.4). The results of the geotechnical analysis are shown in Table C3.1.

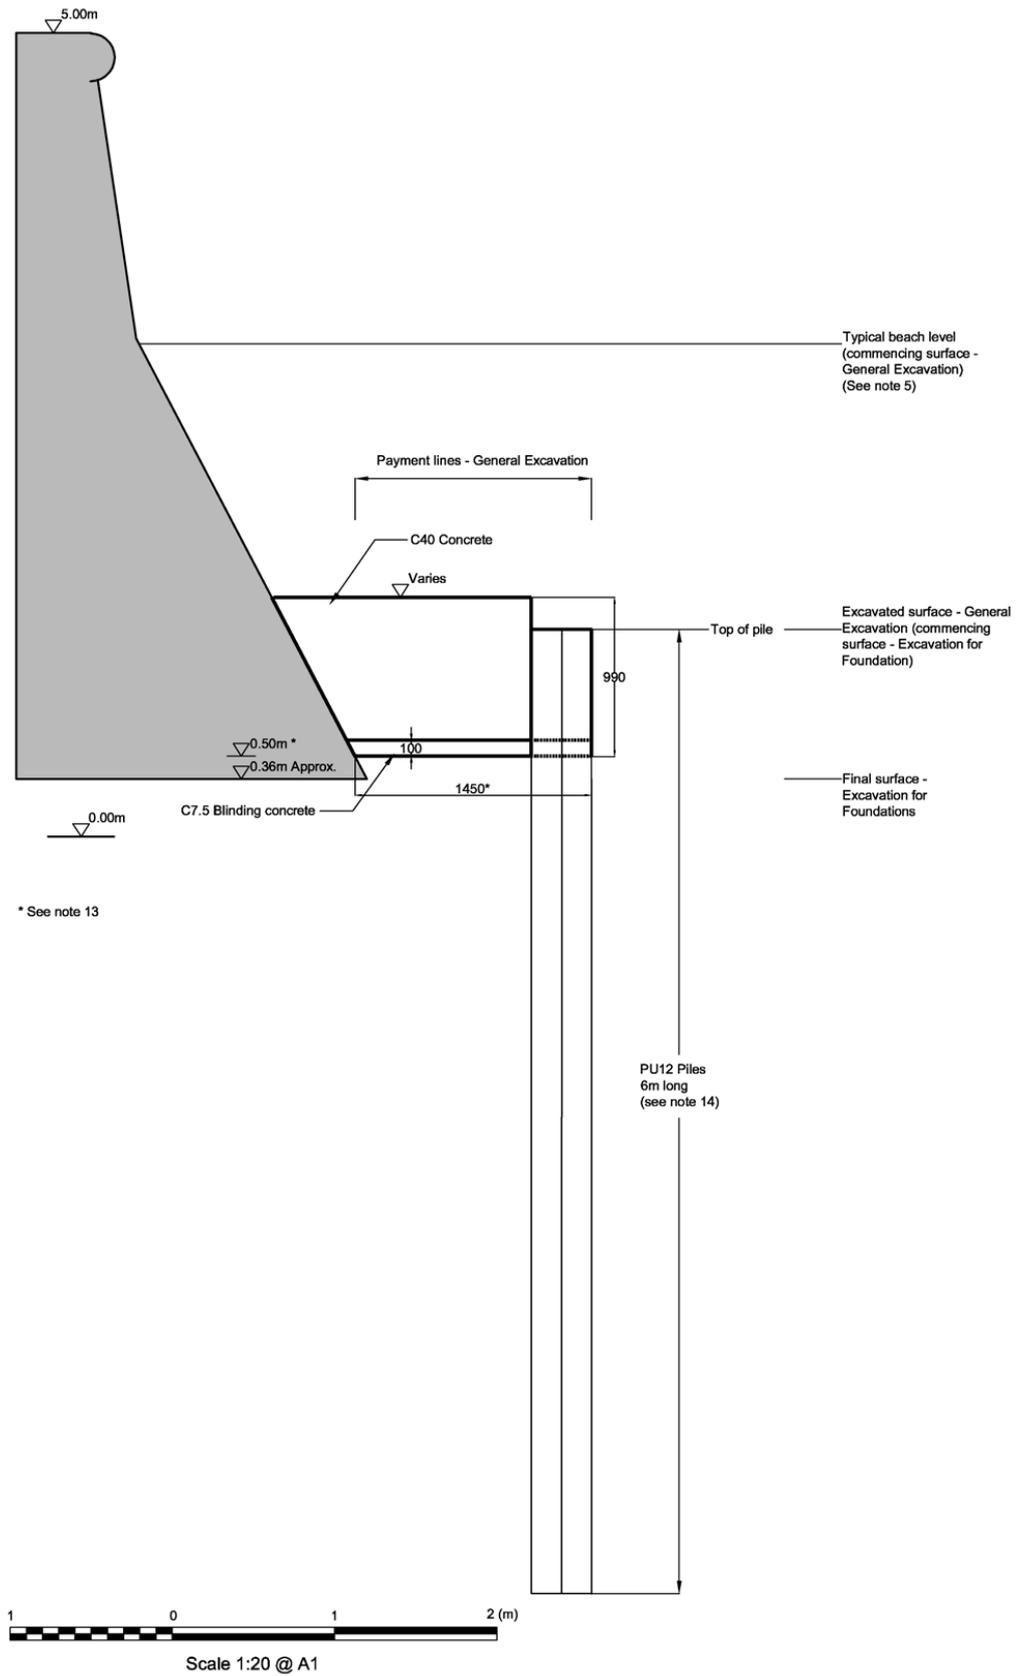
Section B-B
Section through Old Flint Wall and restoration

Figure C3.5 Old flint wall design cross-section

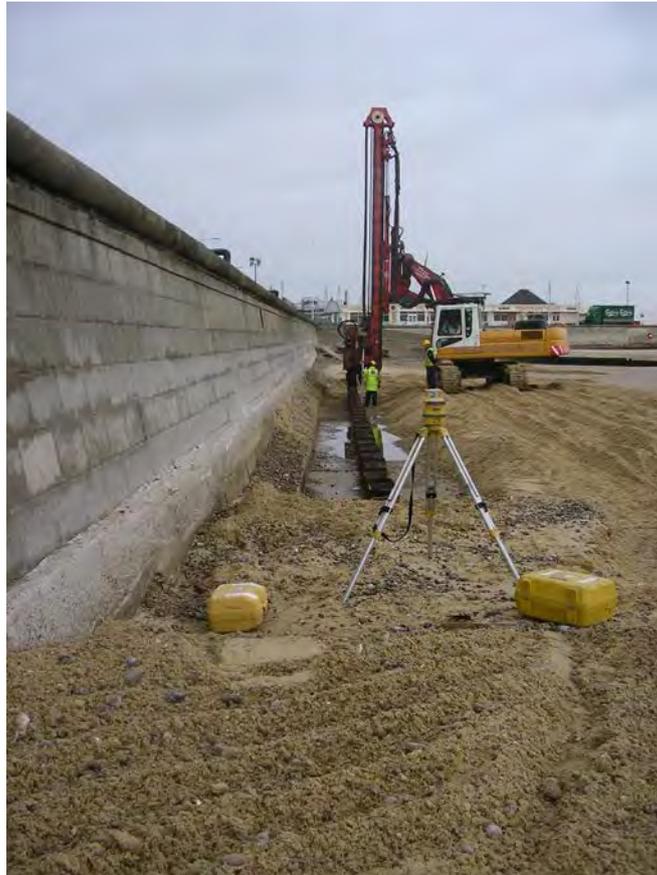
Figure C3.6 Toe piling being installed (at concrete wall section)

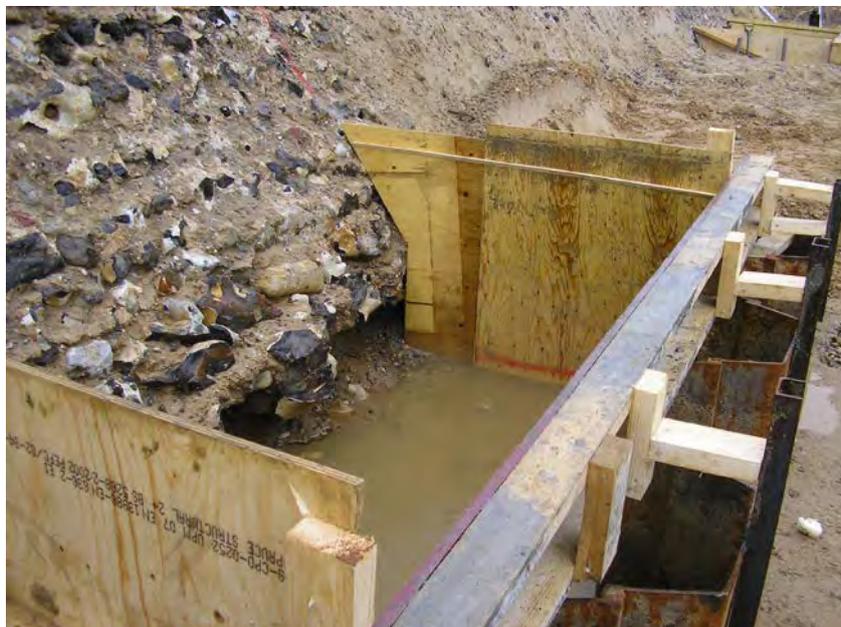
Figure C3.7 Shuttering for concrete thrust block (apron) – old flint wall section (note water ingress and exposure of the toe of the existing wall)

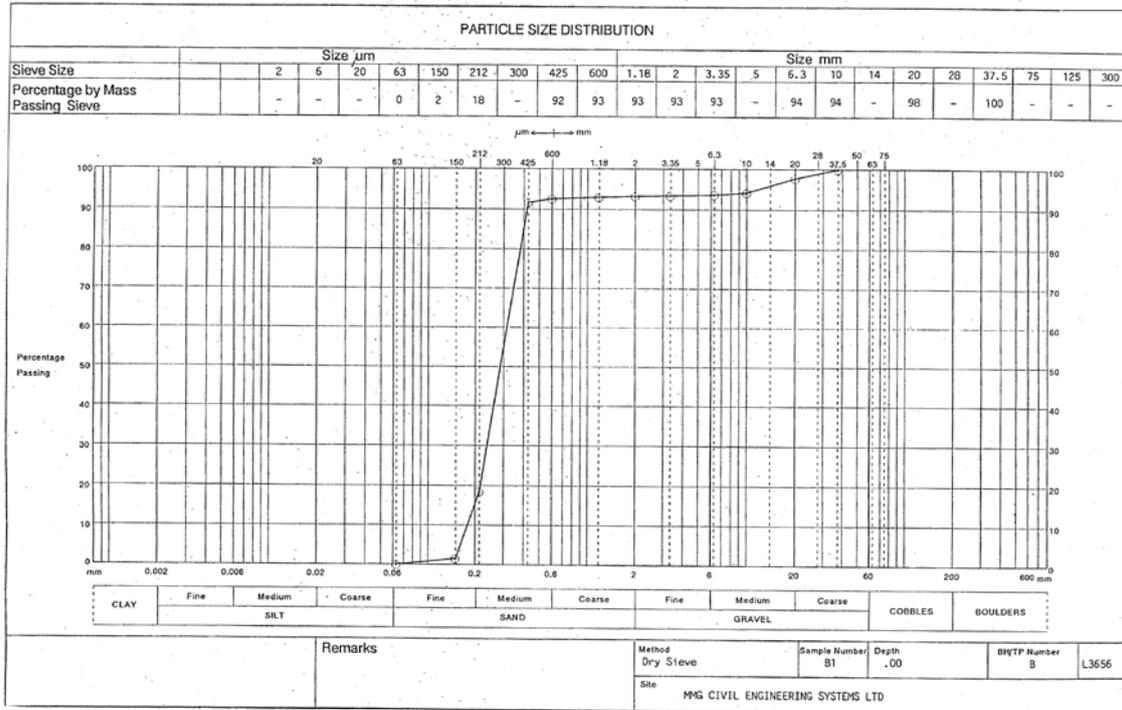
Figure C4.3 Example grading curve

A grading curve of a beach sample taken from the site (Figure C4.3) shows it to comprise predominantly sand with some gravel.

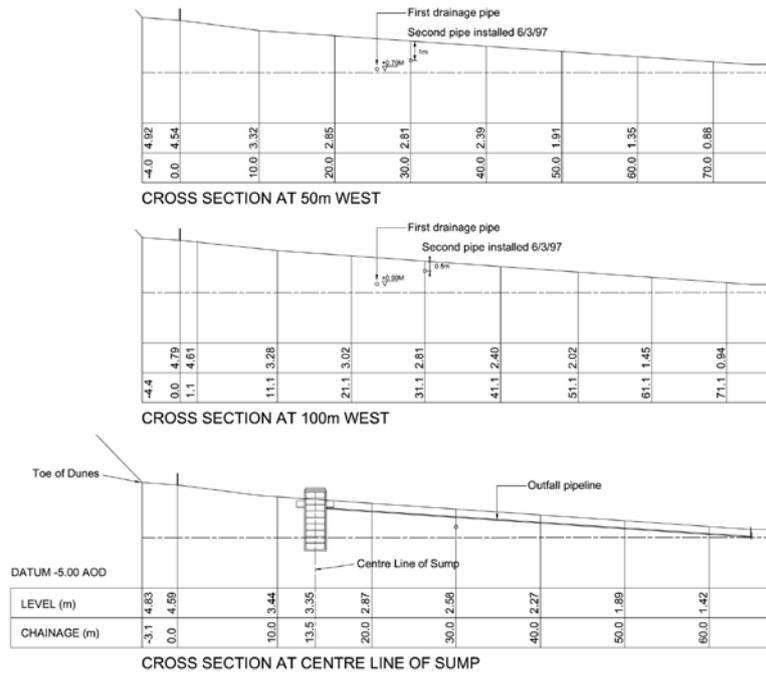
Figure C4.4 Beach sections

Basically, the scheme comprised a 200 m shore parallel drainage pipe set about 30 m from the toe of the dunes. In fact two drainage pipes were used to yield the overall capture width of 200 m. These two pipes drained into a sump which contained a pump. The pump discharged the collected water back to sea through a higher outfall pipeline. Figure C4.4 shows cross-sections for the west limb together with a schematic section taken through the pump sump.

Initial observations, following installation of the first drainage pipes at 0.7–0.9 mODN, showed little or no effect in terms of drying of the beach. A second pipe was installed at a higher level (see Figure C4.4). After installation of the second pipe, the beach surface in the vicinity of the pipe appeared to be drier but, over the trial period, there was no change to beach levels that could be confidently attributed to the drainage system. During construction of the sump and operating the system, the water levels in the beach were noted to be very high at all times and states of the tide, so much so that the beach drainage system would be working by siphon effect even at low tide.

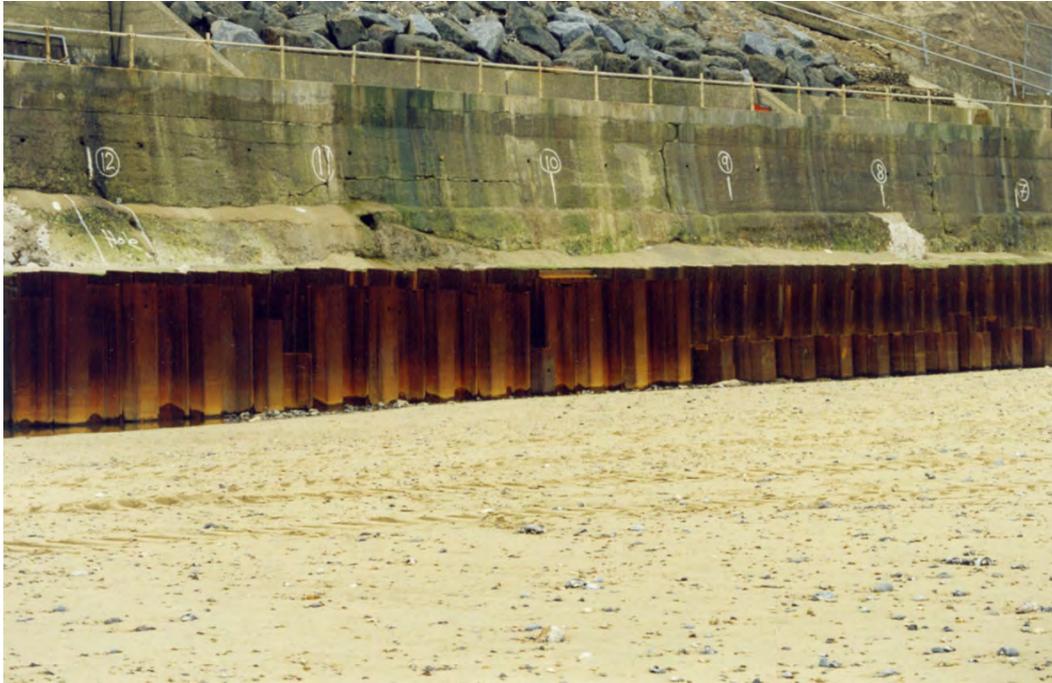
Figure C5.3 **The original wall**

Prior to construction of the present structure, the coastal defence consisted of a sheet pile toe behind which there was a lower concrete apron, concrete retaining walls and a higher concrete apron, all containing the coastal cliff to a height of about 25 mODN. The old sheet piles were badly corroded and there were holes in some of the pile pans. The whole structure was believed to date from c.1908. Figure C5.3 shows part of the wall that did not fail.

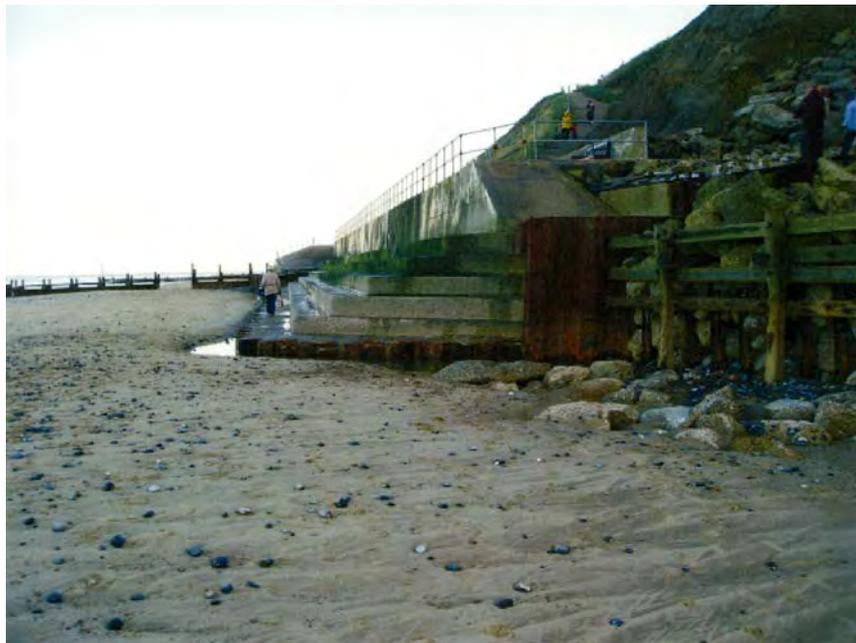
Figure C5.5

End detail

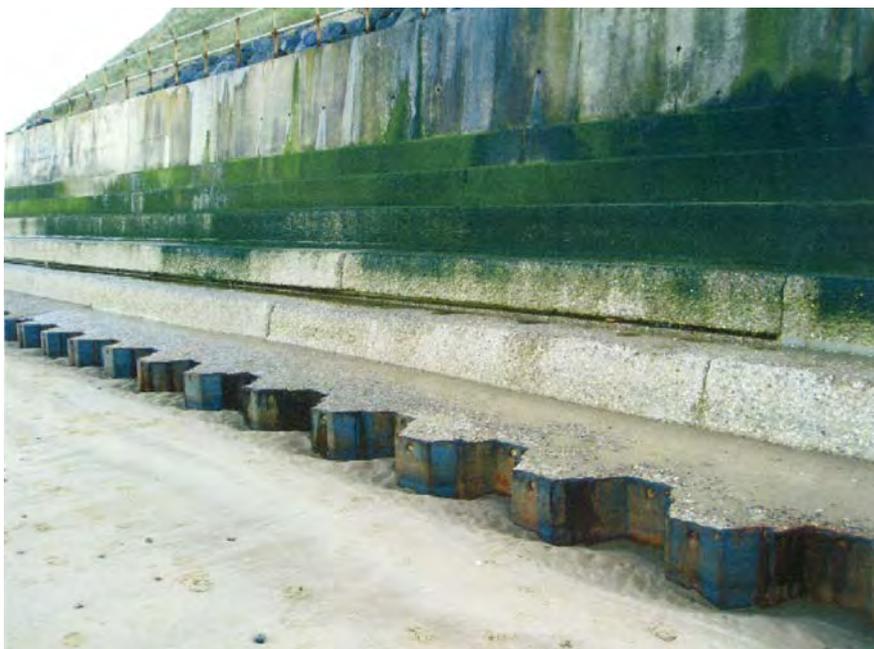
Figure C5.6

Finished toe and wall

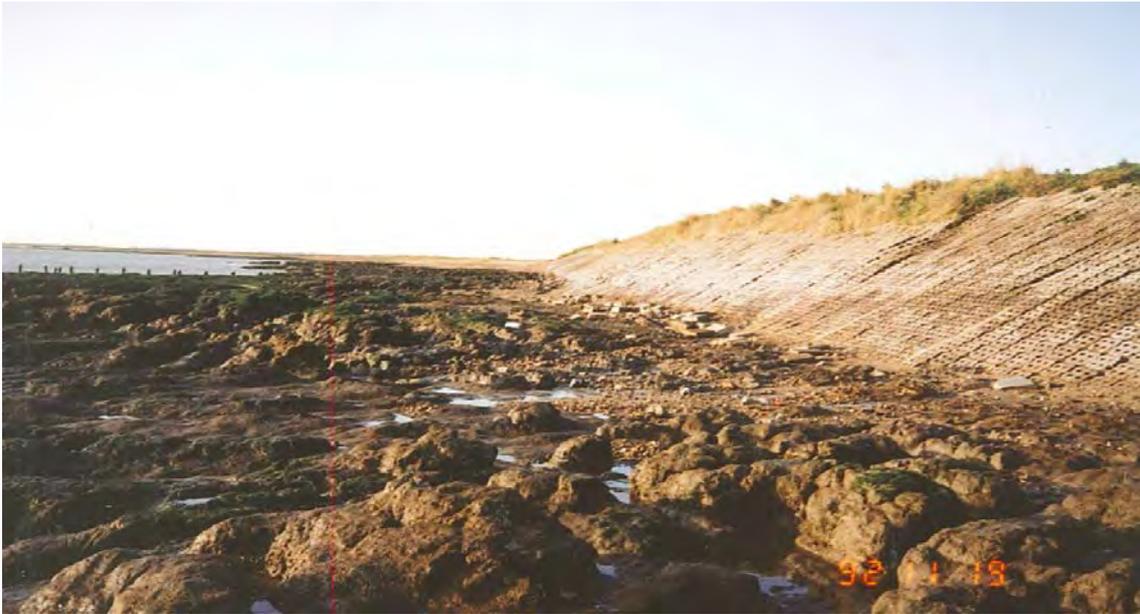
Figure C6.2 Flexible armoured revetment (earlier defence structure)

Earlier attempts were made to arrest erosion of the spoil site by placing interlocking mattresses on the embankment (Figure C6.2). However, these were inadequate for the given exposure and were soon destroyed by storm wave action (Figure C6.3). An alternative low-cost revetment was sought.

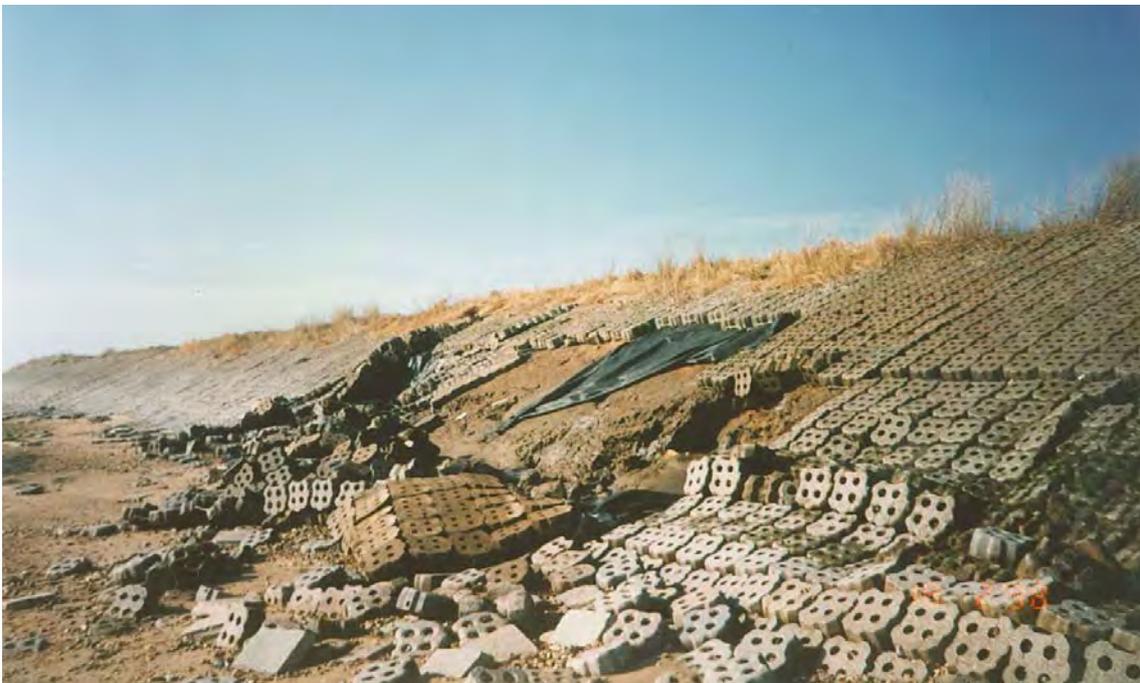
Figure C6.3 Failed flexible armoured revetment

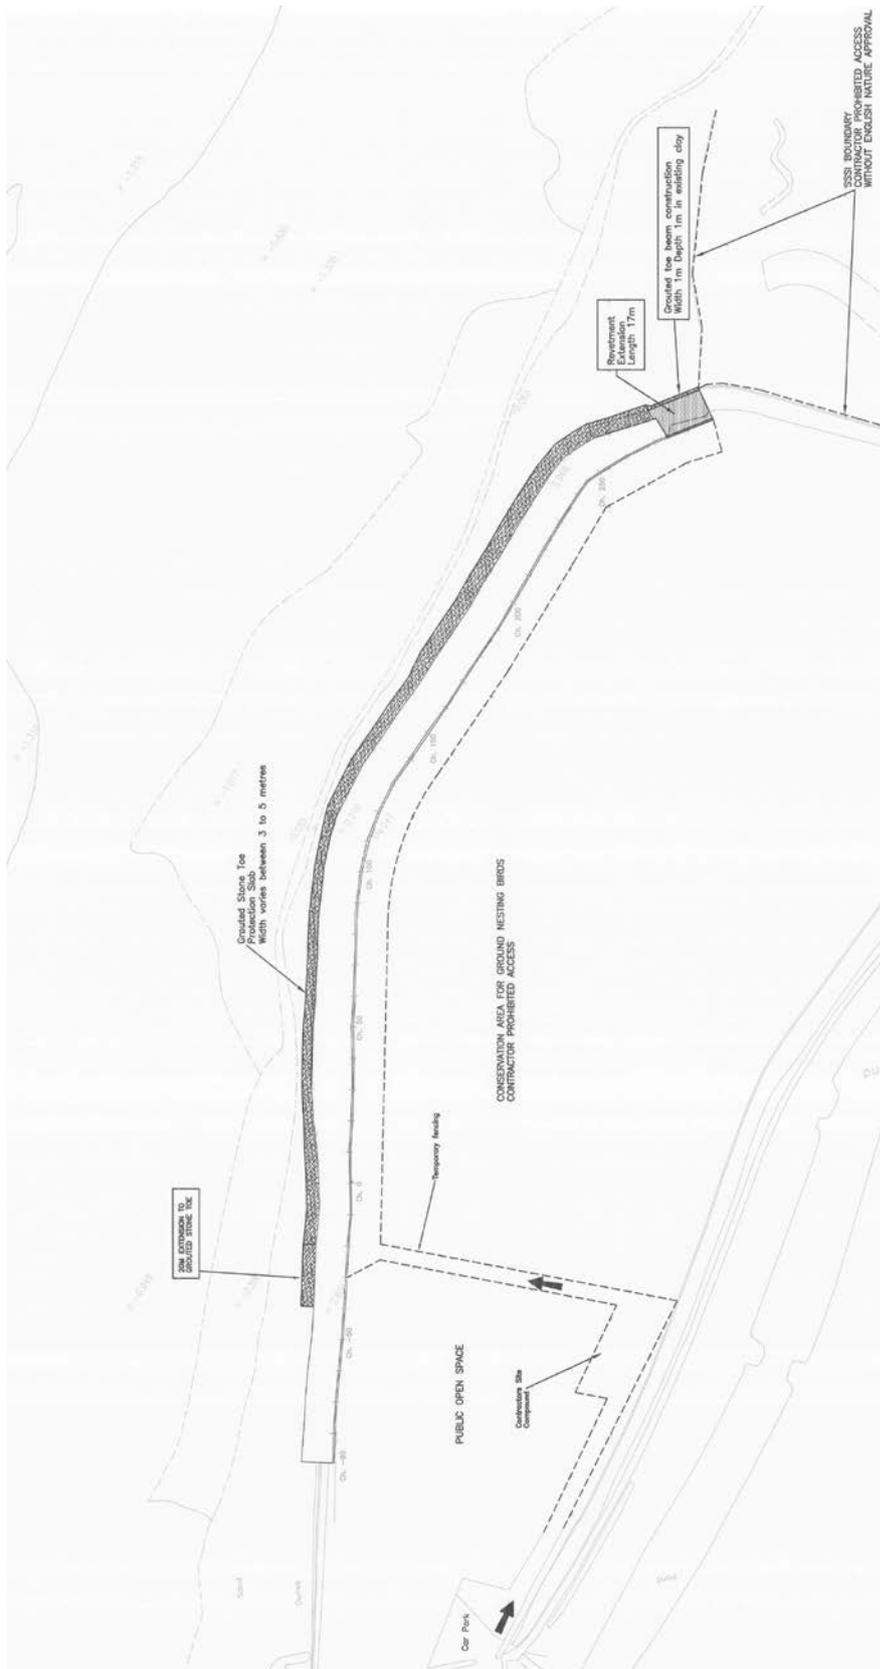
Figure C6.4 Plan extent of revetment
