Toe structures management manual

Project: SC070056/R

Coastal structures, structure toe, asset management, condition assessment, beach, scour

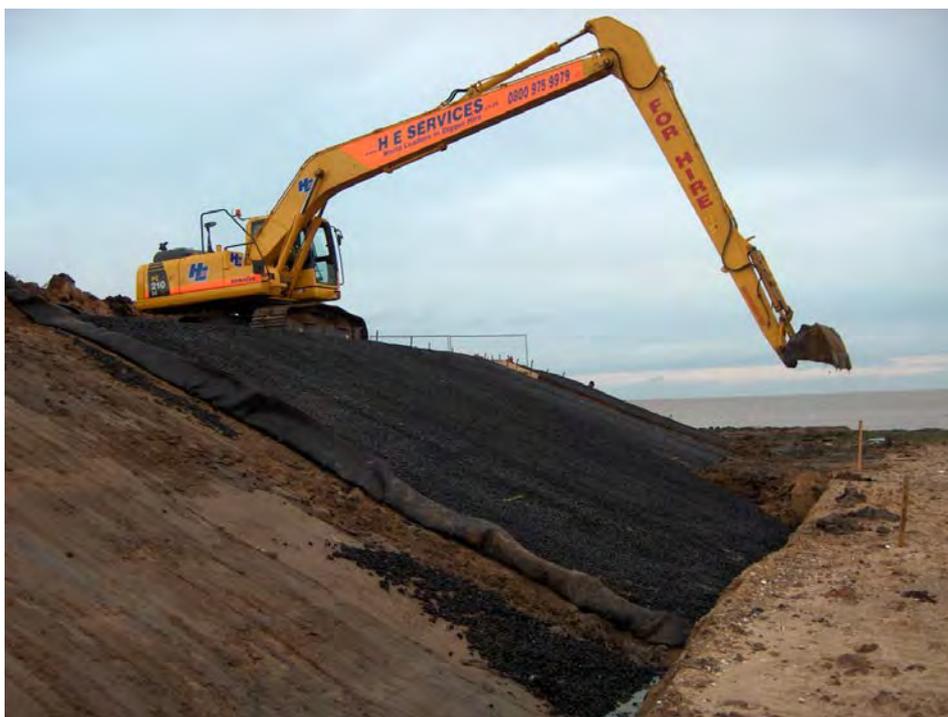
Figure C6.6 **Revetment construction**

Beach excavation and toe construction were undertaken using plant on the foreshore. Plant operated from the crest of the embankment for placing asphaltic materials on the revetment. Construction of the works was straightforward except for some damage to the top landscaped area due to plant movement; see Figures C6.6 and C6.7.

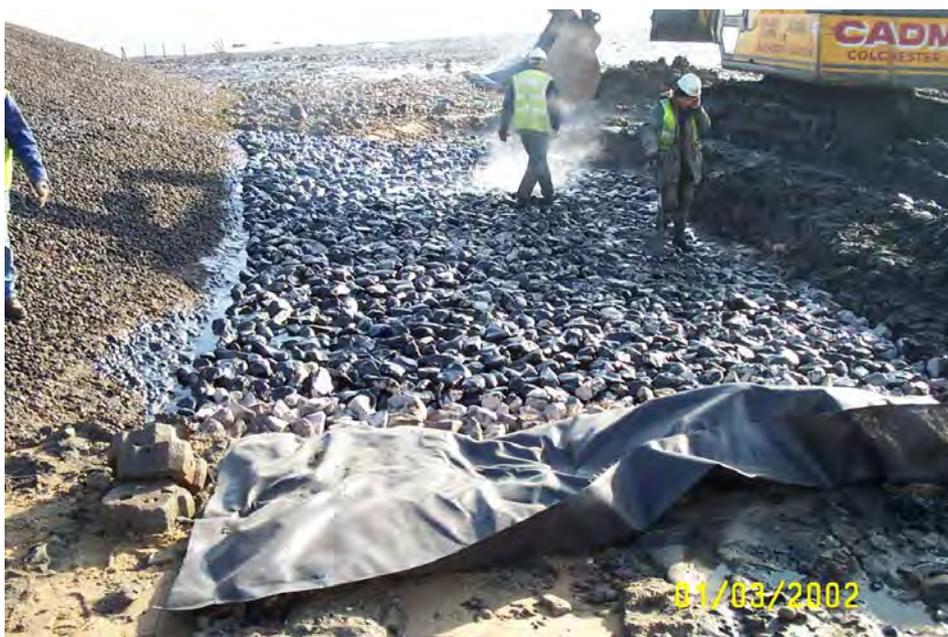
Figure C6.7 **Toe construction**

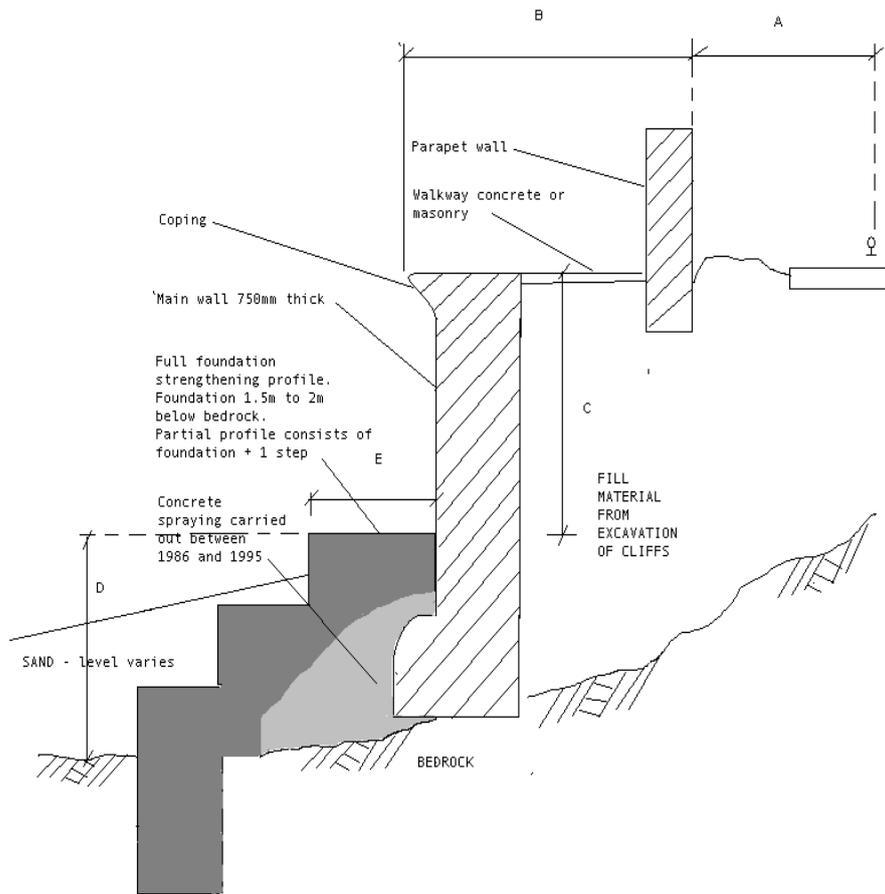
Full Foundation Strengthening

Typical cross section with full foundation strengthening to be found at :
 205m 36c to 205m 51c
 207m 46c to 208m 09c (Smugglers Cove to Spray Point)

Mileage	A	B	C	D	E	Bedrock AOD	Walkway AOD	Track AOD
205m 48c	2.56	3.56	3.08	4.00*	2.41	N/A	5.82	5.75
208m 04c	2.19	3.31	2.97	4.00*	2.14	N/A	5.46	N/A

Figure C7.2 Typical cross-section: full foundation strengthening (not to scale)

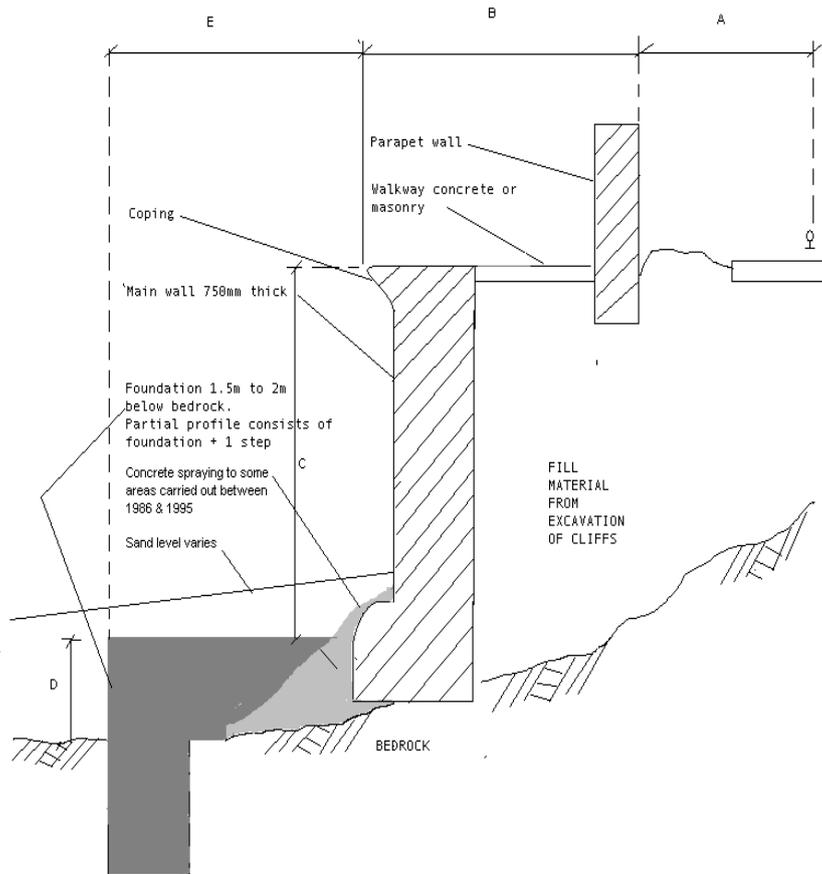
Partial Foundation Strengthening

Mileage	A	B	C	D	E	Bedrock AOD	Walkway AOD	Track AOD
205m 25c	2.40	3.31	5.0*	1.00*	N/A	N/A	N/A	N/A
205m 71c	2.06	3.16	5.70	1.20*	4.00*	N/A	5.90	6.08
208m 39c	2.40	2.72	4.86	1.00*	N/A	N/A	5.93	N/A

**Typical cross-section: partial foundation strengthening
(not to scale)**

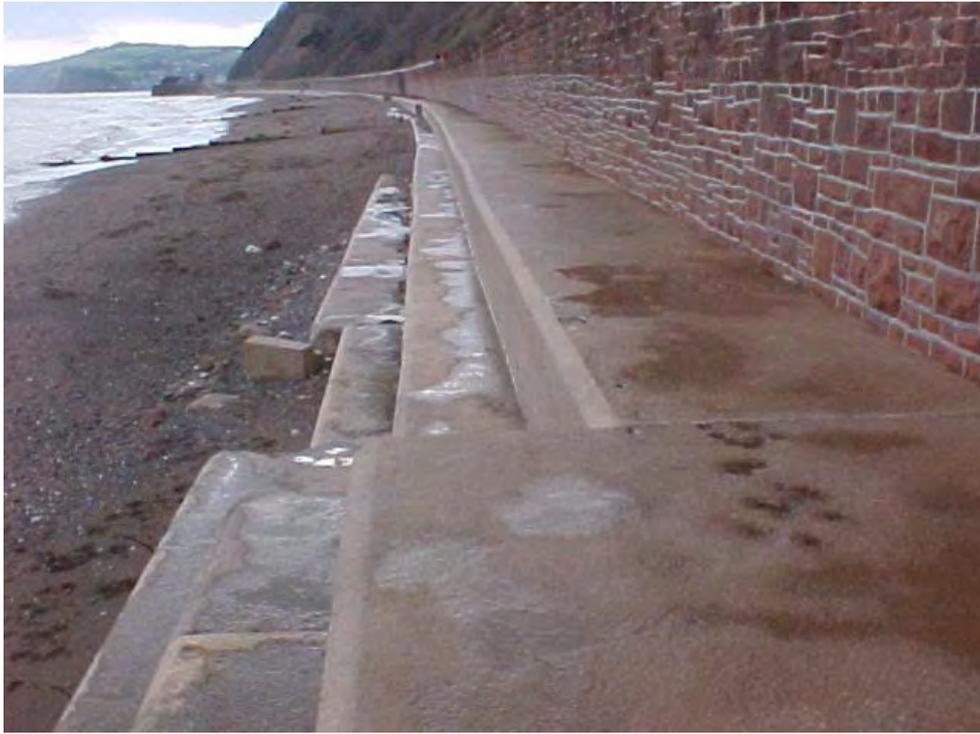
Figure C7.4 Full foundation strengthening, Smugglers Cove to Sprey Point

Locally, provision in the detailed design was made to extend existing steps to the beach downward, to provide ramped sections where necessary, to negotiate features, and to make provision for watercourse outlets. Figures C7.4 and C7.5 show the full foundation arrangement at Smugglers Cove and Rockstone respectively. Figure C7.6 shows partial foundation strengthening.

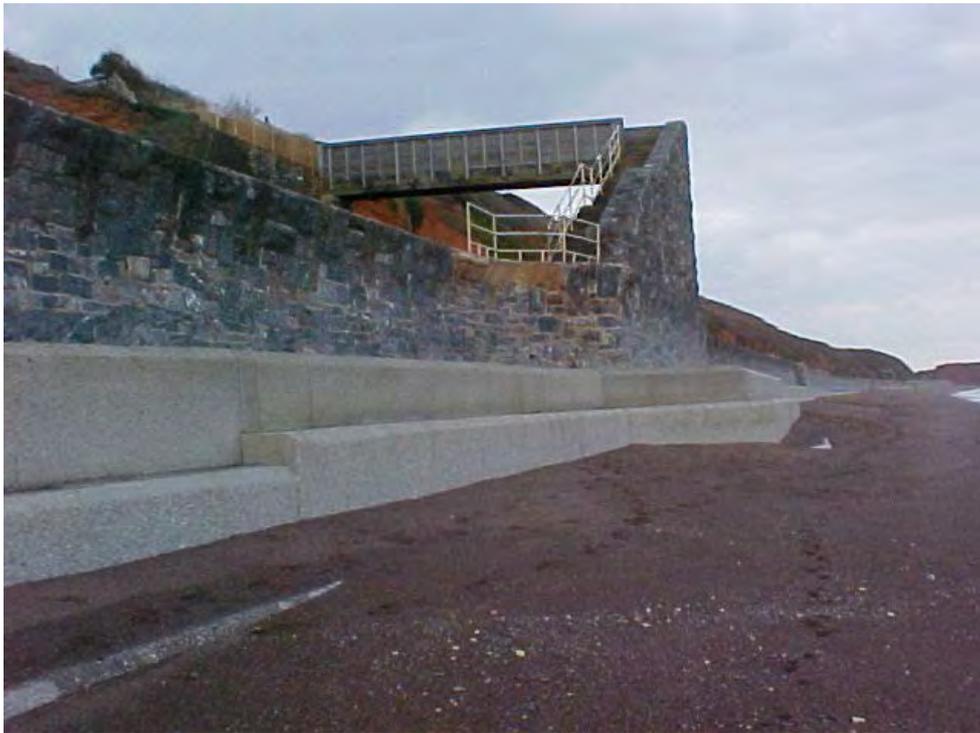
Figure C7.5 Full foundation strengthening – Rockstone footbridge

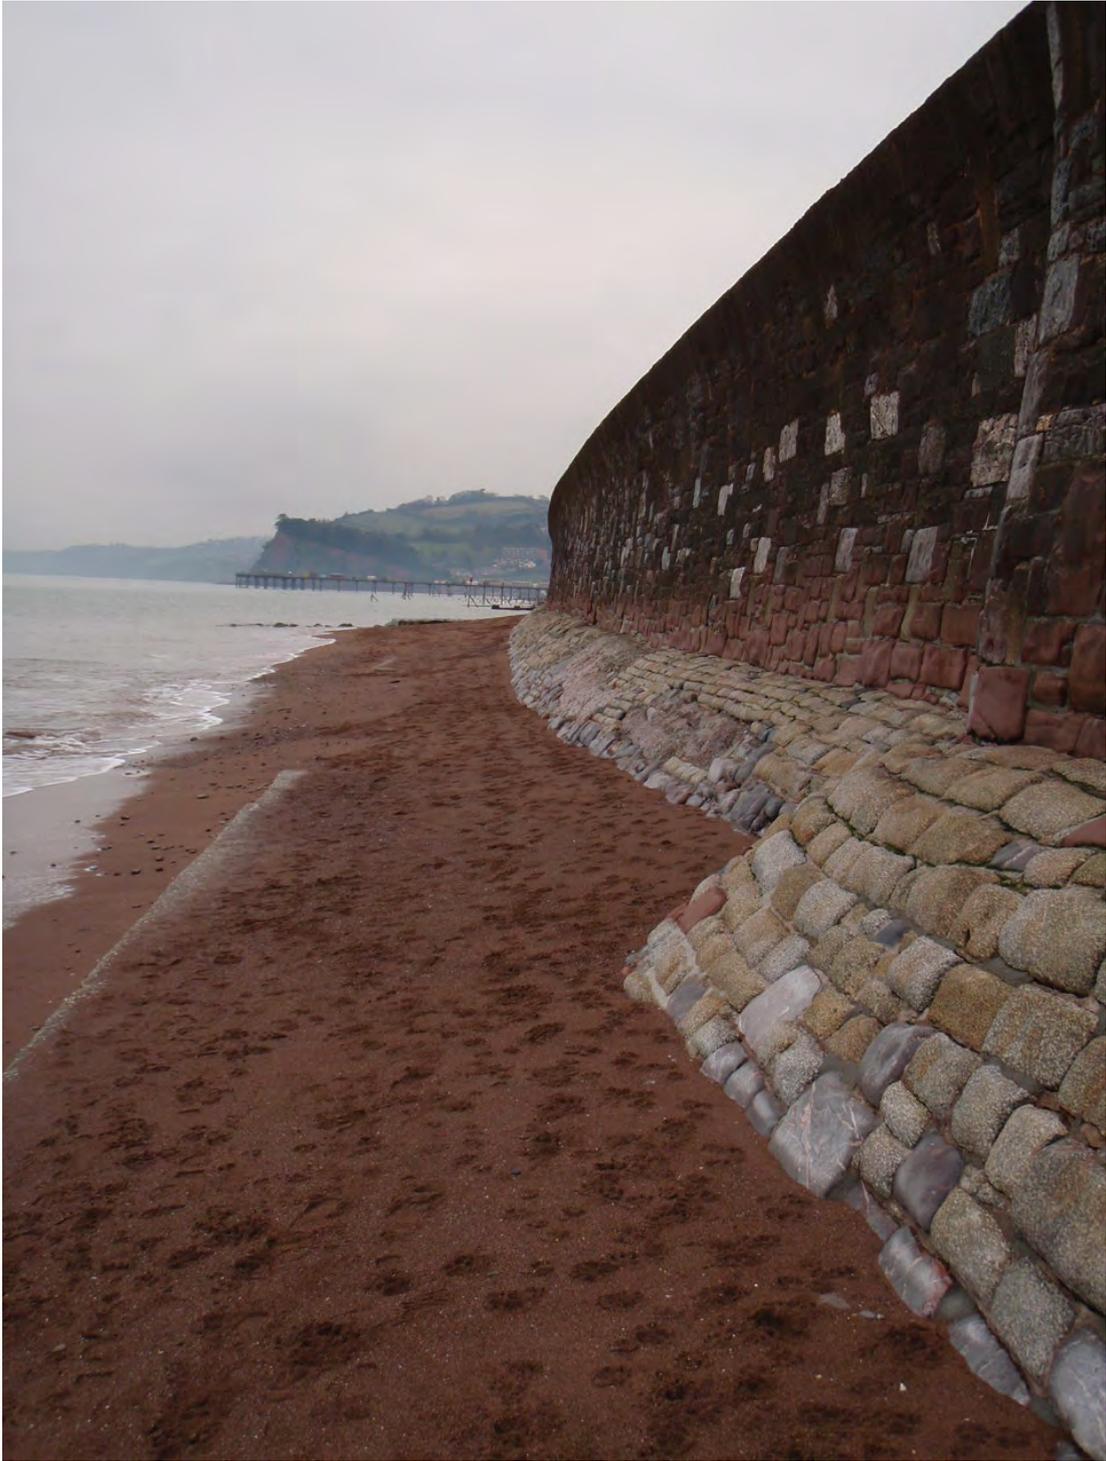
Figure C7.6 Partial foundation strengthening – Sprey Point to Teignmouth (note only outer edge of single step visible at the time photo was taken)

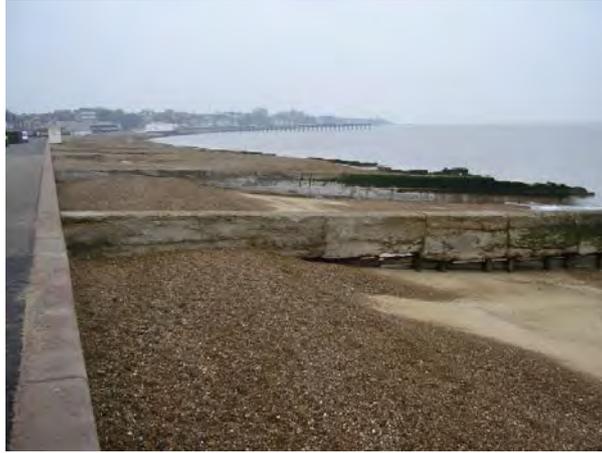
Figure C8.2 Seawall and groynes at the SCDC frontage, 2005

The earlier coastal defences consisted of a mass concrete seawall and promenade, constructed in 1903. The seawall was fronted by a mixed shingle–sand beach, with timber groynes encased in concrete, spaced at approximately 30 m centres (Figure C8.2). The beach was in a poor condition, sediment loss having been accelerated by wave reflection from the exposed vertical wall. Severe overtopping occurred regularly, damaging the promenade and causing localised flooding.

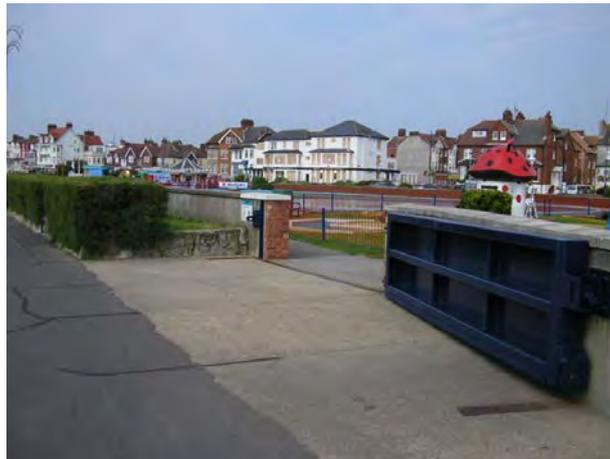
Figure C8.3 Floodwall and gate

Approximately 20 m landward of the promenade, there is a 1983 floodwall of a sheet piled construction; this is clad in concrete with facing bricks (Figure C8.3). This floodwall was in good condition in 2006 and provided a standard of protection of 1 in 200 years. However, its performance as a flood defence depended on the closure of floodgates and, in any case, was conditioned by the frontline seawall which was calculated to have a standard of protection of less than 1 in 1 year based on critical overtopping for damage. Furthermore, the seawall was at imminent risk of collapse due to undermining. It was estimated that following failure of this seawall, failure of the crucial floodwall would occur within five years.

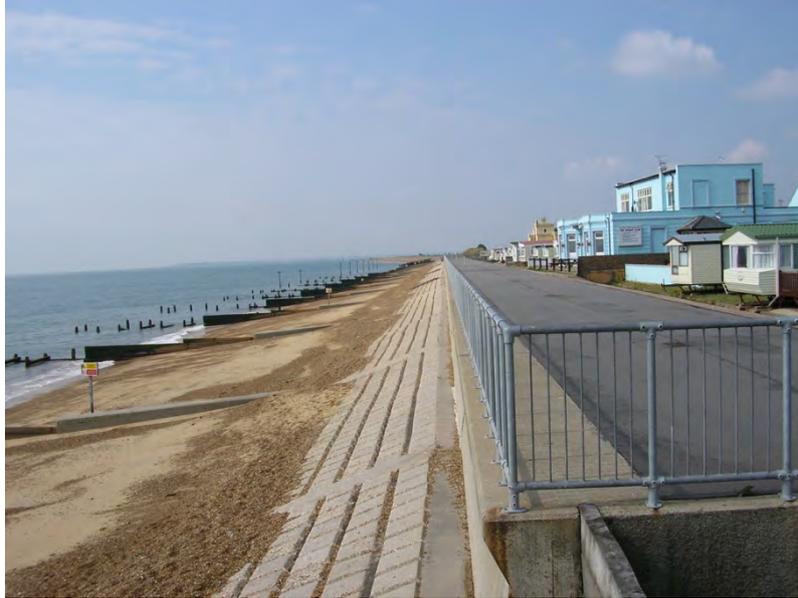
Figure C8.4 Environment Agency seawall and flood defence, 2005

- the Manor Terrace (northern) section of the wall was constructed in 1981 and has a concrete block revetment (Figure C8.4);
- the Landguard Common (southern) section of the wall was constructed in 1985 and has a stepped concrete apron.

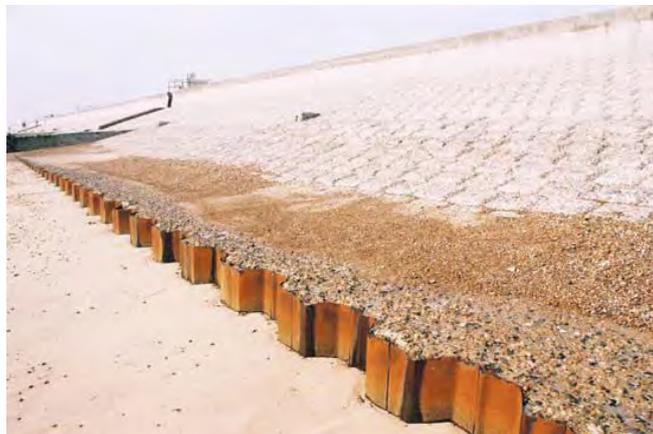
Figure C8.5 Exposed toe piling at Environment Agency frontage, 2003

Failure of some groynes in 2003 on the Environment Agency frontage resulted in a rapid fall in beach levels (Figure C8.5), requiring urgent repair works to the groynes and blockwork.

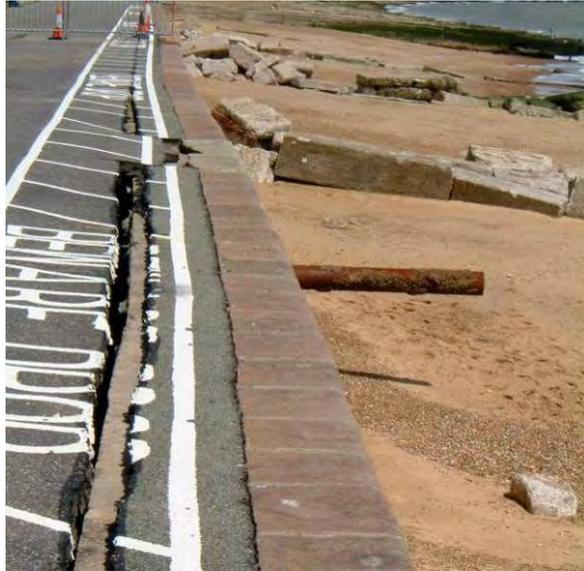
Figure C8.6 Rotating seawall, 2006

Again, due to very low beach levels, the SCDC section of the frontage was undermined in May 2006 resulting in collapse of 150 m of the seawall (Figure C8.6). SCDC undertook emergency works in response to the damage, costing around £900,000 in total (Figure C8.7). Had action not been taken, the loose backfill behind the seawall would have washed away leading to rapid retreat, thus putting the floodwall at risk and indeed the low lying land behind. This temporary restoration was replaced with a permanent structural repair as part of the later main works.

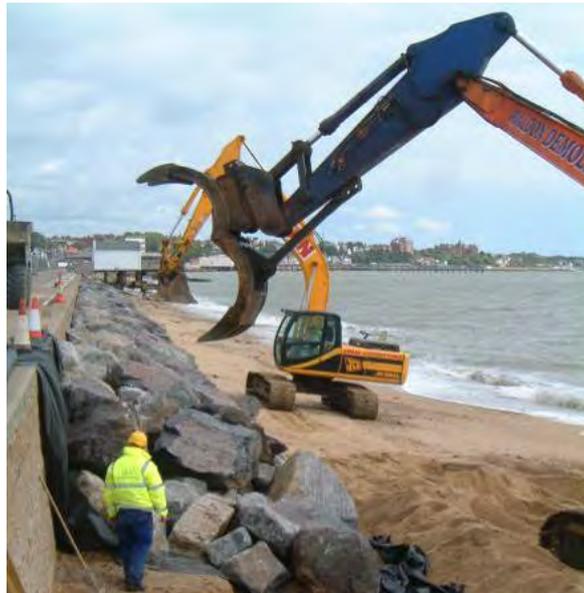
Figure C8.7 Emergency repairs to the seawall, 2007

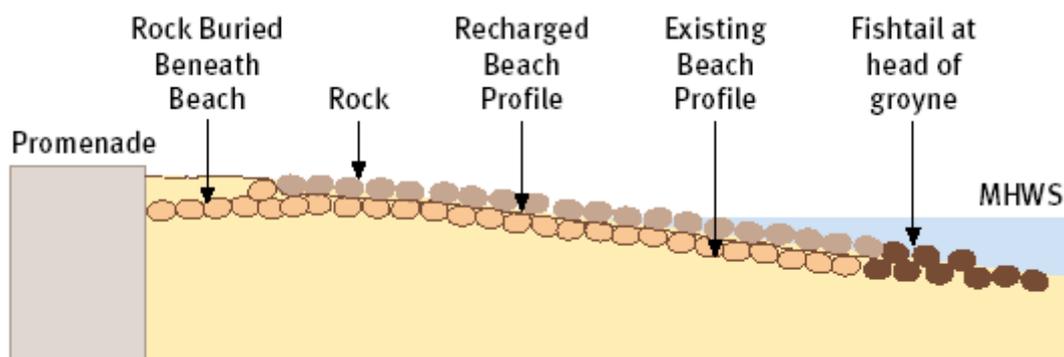
Figure C8.8 Fishtail rock groyne with buried rock root

The proposed scheme involved the construction of 21 rock fishtail groynes, 200,000 m³ of beach recharge material and 150 m of sheet piling to reinstate the failed section of seawall. Figure C8.8 (taken from the PAR) illustrates the basic form of the groyne cross-section.

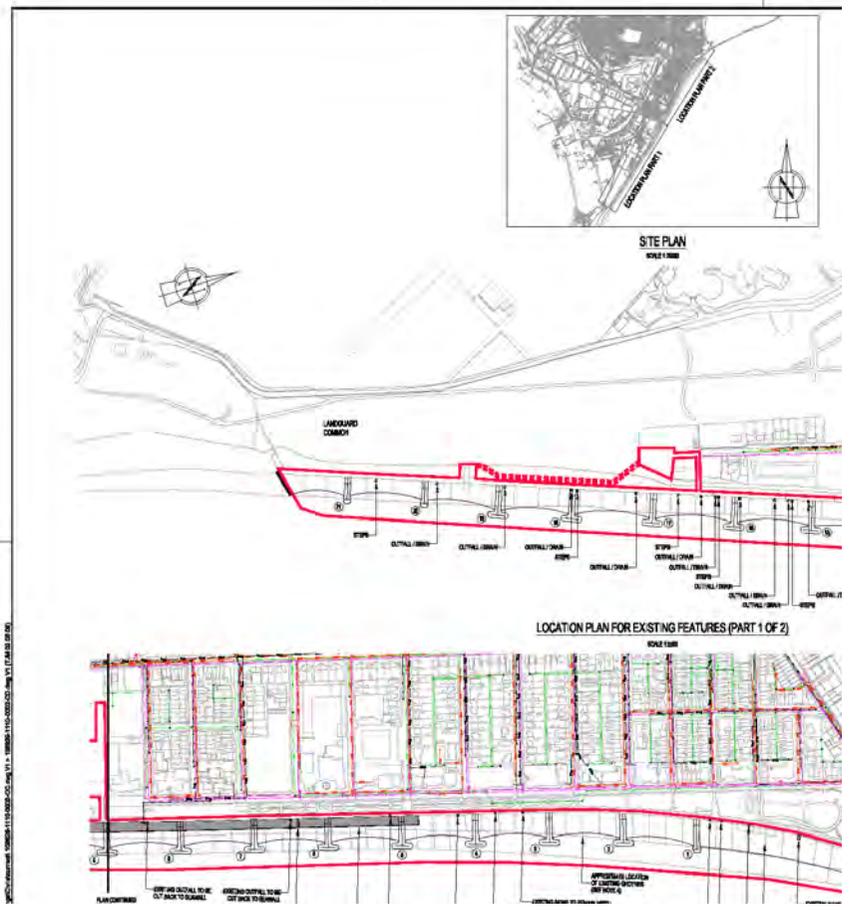
Figure C8.9

Extract from detailed design drawings – layout

Figures C8.9, C8.10 and C8.11 show extracts from the detailed designs drawings of the layout and groyne structures. Figure C8.12 shows a design cross-section for the permanent repair over the 150 m failed seawall.

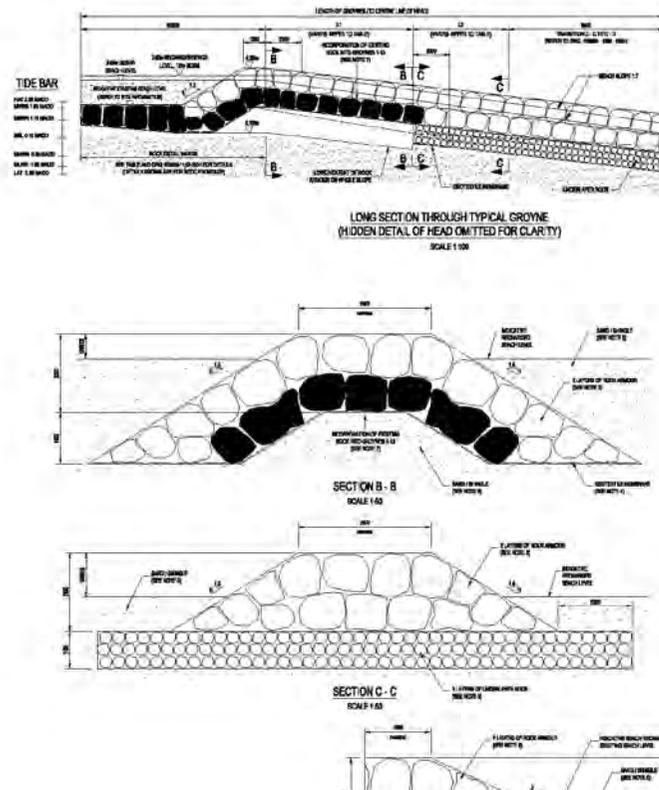
Figure C8.10 Extract from detailed design drawings – sections through rock groynes

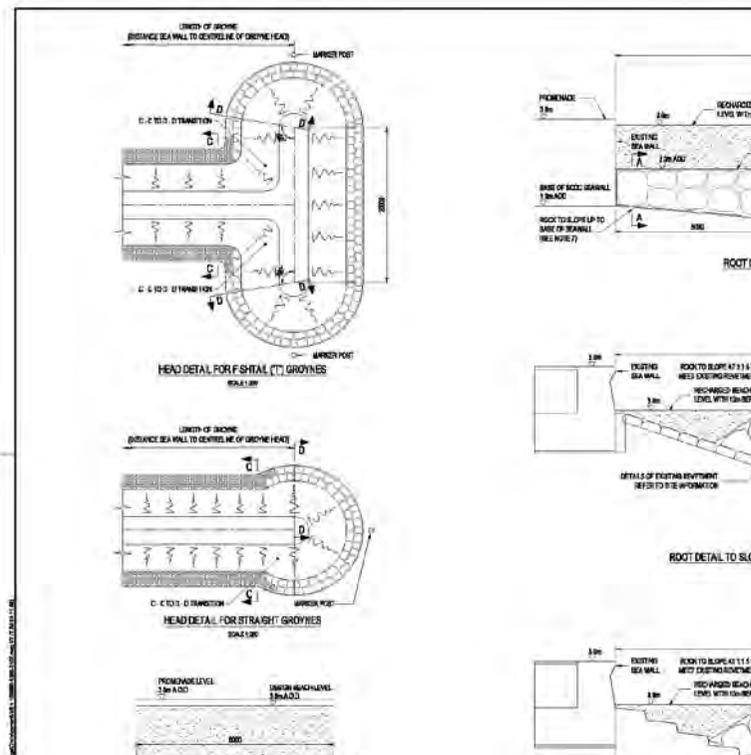
Figure C8.11 Extract from detailed design drawings – root connections with existing seawall/toe

At the landward end, the groyne section extended down to the foundation of the seawall. Excavation below the foundation level was therefore minimised in design (Figure C8.11). Although the form of construction of the seawall beneath the promenade and behind the seawall face was not known, it was known from the behaviour of the seawall that it did not rely purely on material on the seaward side for support. The team were confident that excavation at the seawall would not lead to instability providing that the wall was not undermined. No issues were encountered in the groyne construction.

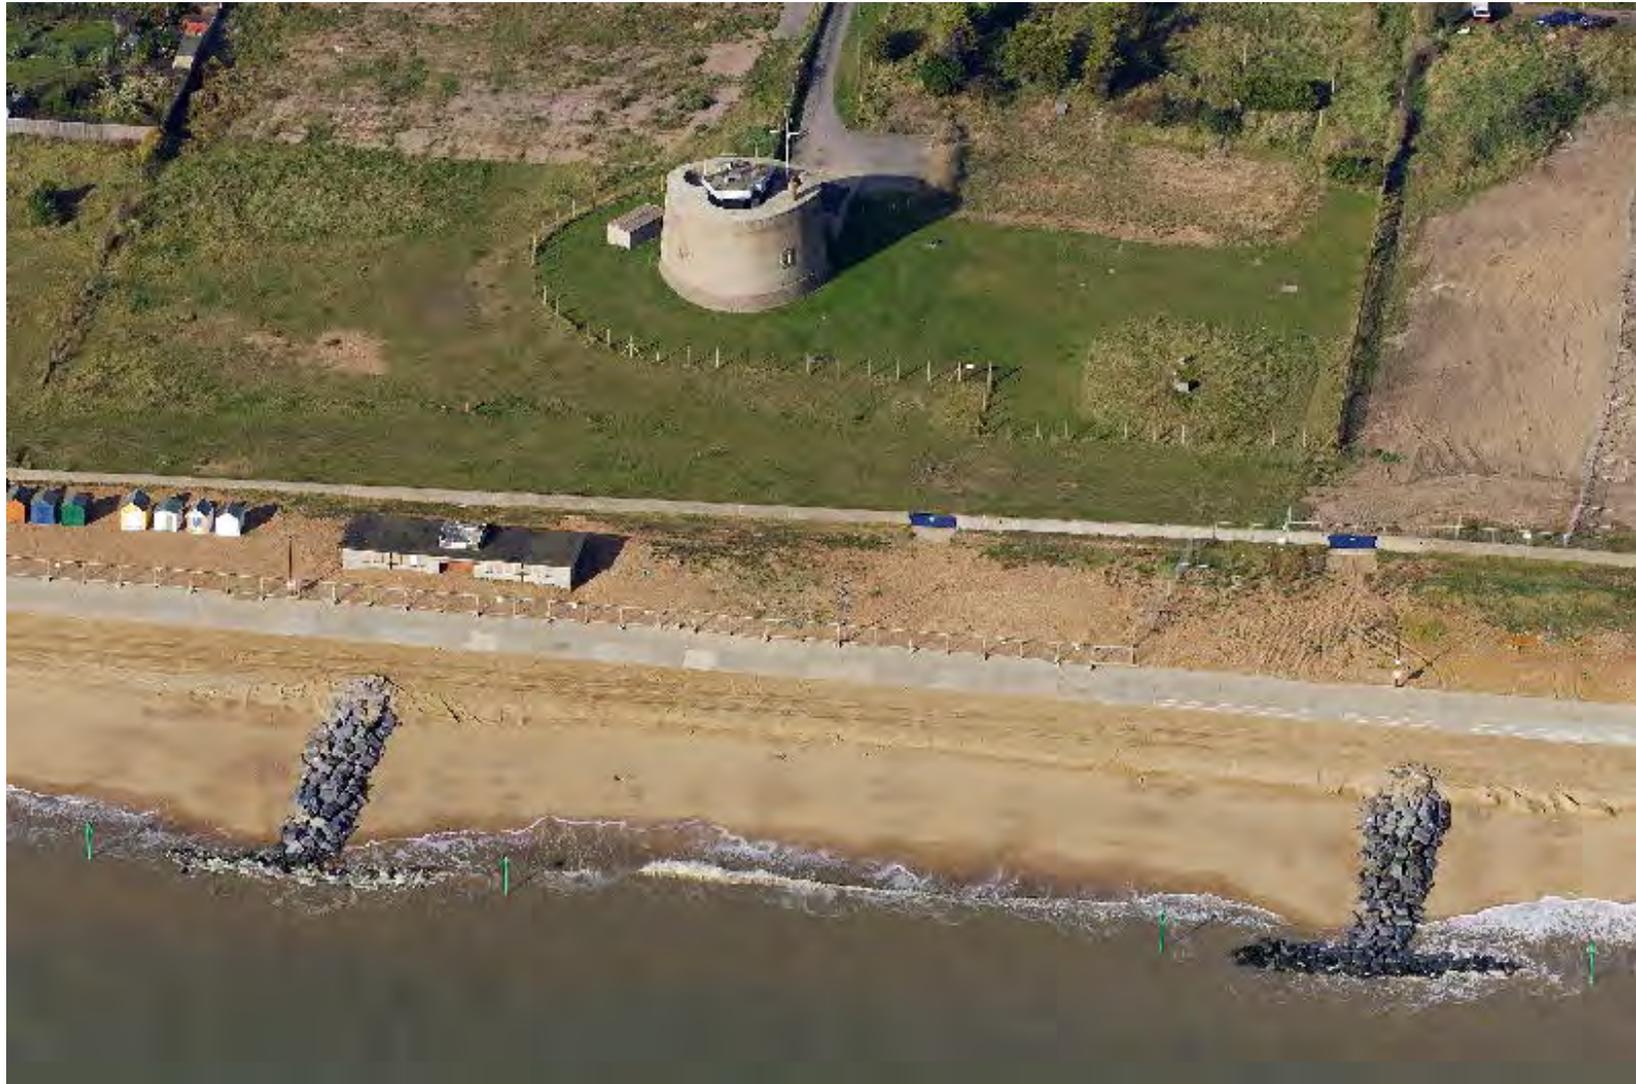
Figure C8.13

Southern Felixstowe – the completed scheme

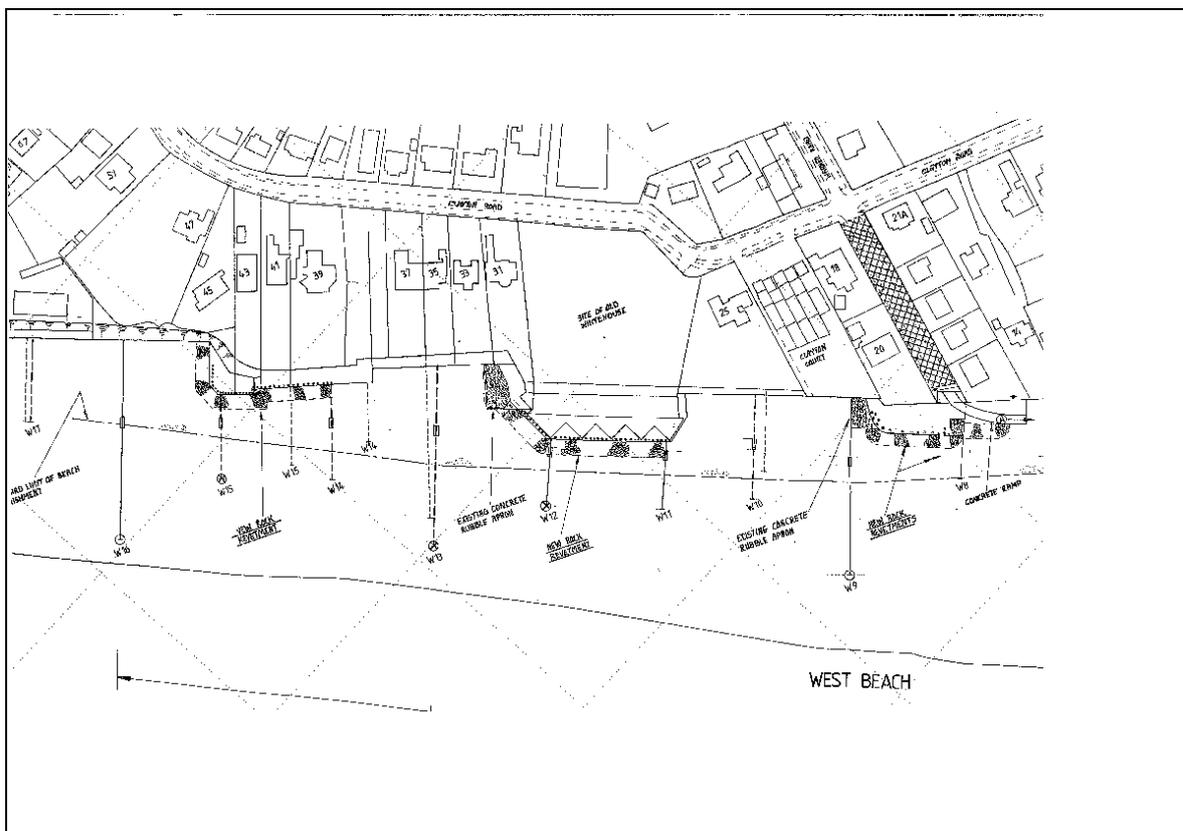
Figure C9.2 Site plan showing the promontories created by selectively holding the line

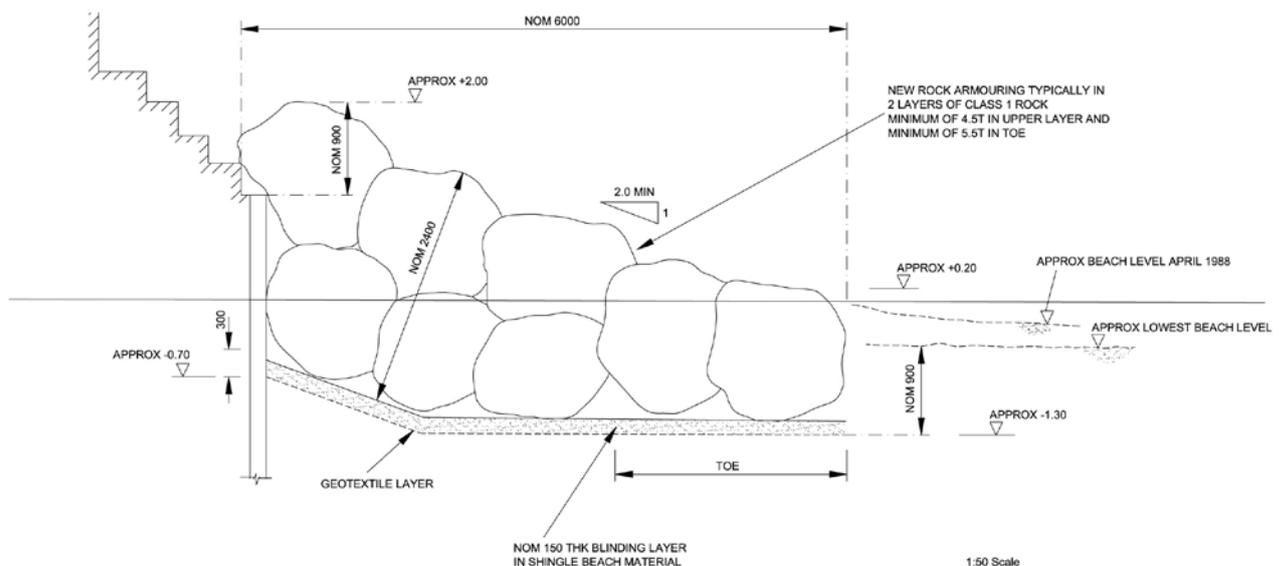
Figure C9.3

Typical cross-section through the revetment

Four different cross-sections were prepared which encompassed the variations in the existing wall profile and beach variations. The designs were of sufficient detail that there was effectively no requirement for the contractor to adapt or develop the design either before or during construction.

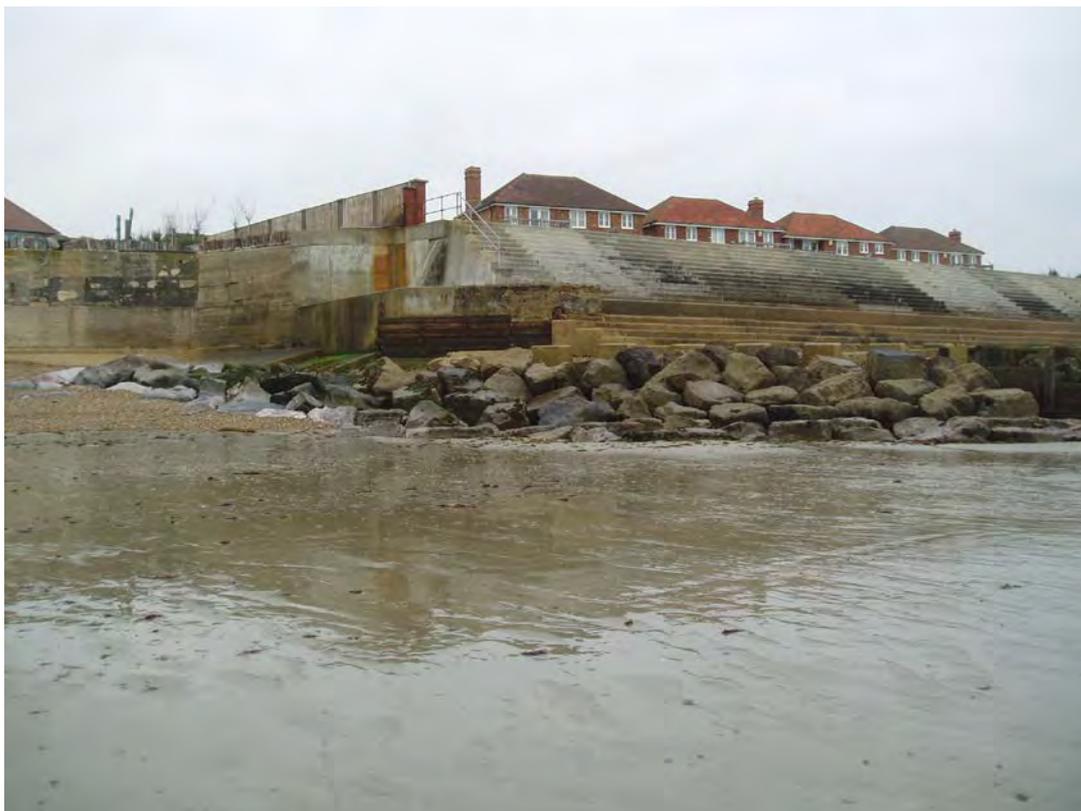
Figure C9.4 The completed armour revetment

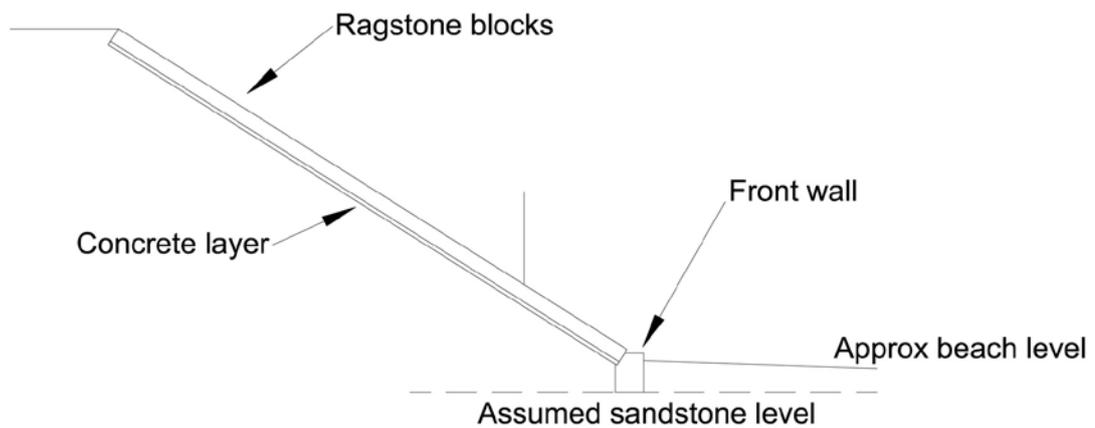
Figure C10.2 Sketch of former wall section (1965 construction)

- a mass concrete block (formed in 6 m lengths) founded on the sandstone;
- bearing onto this from above was a revetment (variable slope) which contained the mixed fill embankment.

The revetment consisted of a concrete bed over which were laid Ragstone blocks.

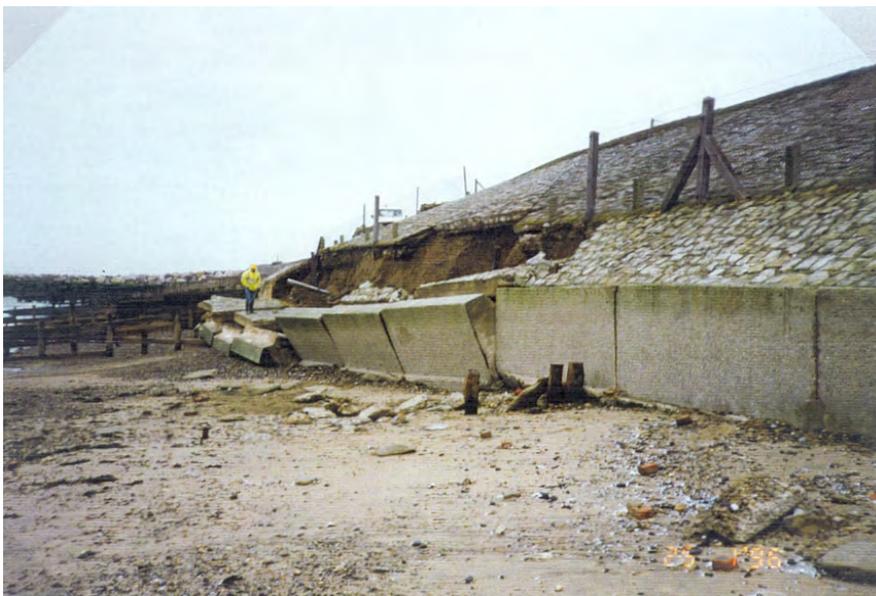
Figure C10.3 Failure damage, 1996

A storm with an estimated return period of 10 years occurred in February 1996, resulting in substantial destruction of the old wall. About half the Ragstone blocks came off the revetment. It appeared that the large toe blocks had just turned over rather than being undermined. An estimated 4 m of erosion occurred within four days as the mixed fill became exposed to subsequent wave action (Figure C10.3).

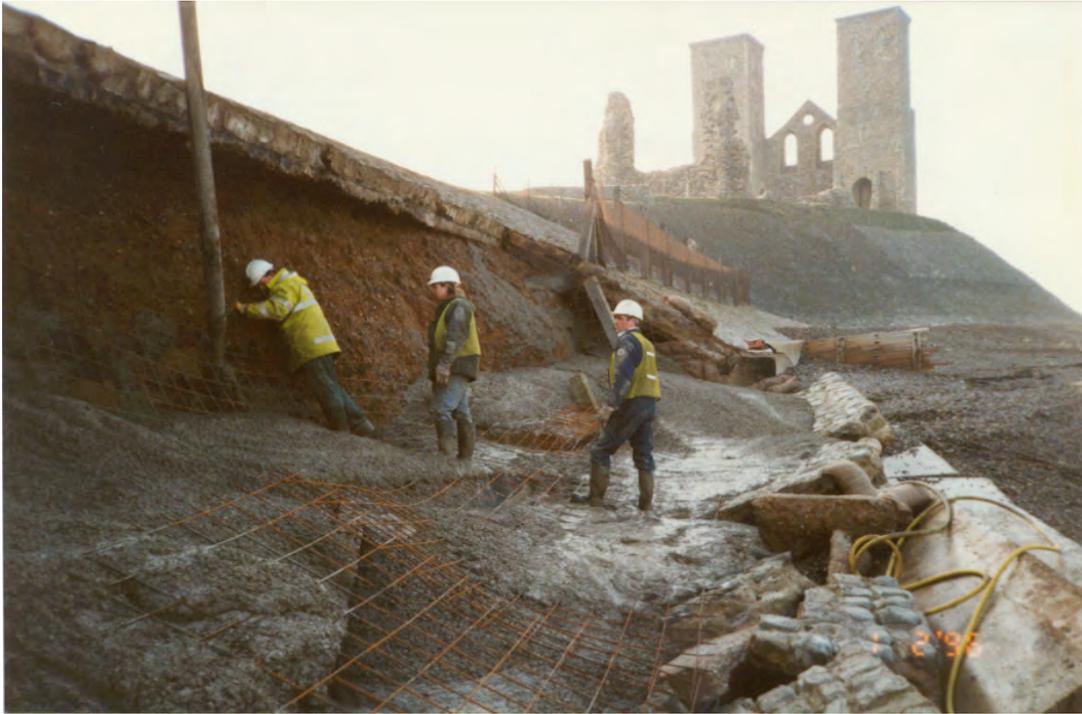
Figure C10.4 **Emergency repair works, 1996**

An immediate fix was needed to prevent further retreat, which might have put the archaeology at risk. This was achieved by backfilling the remaining toe blocks using pumped concrete and then carefully shoring up the exposed face (Figure C10.4). These emergency works were carried out in February 1996 and consisted of about 100 m³ of mass concrete to the failed toe and 90 m² of sprayed concrete with mesh reinforcement to the exposed slope face. The cost of emergency repairs was about £27,000 in 1996. Further works to the slopes were again necessary in May 1996 with further concrete infilling (costing about £10,000). These emergency works then remained intact until the permanent works commenced in August 1998.

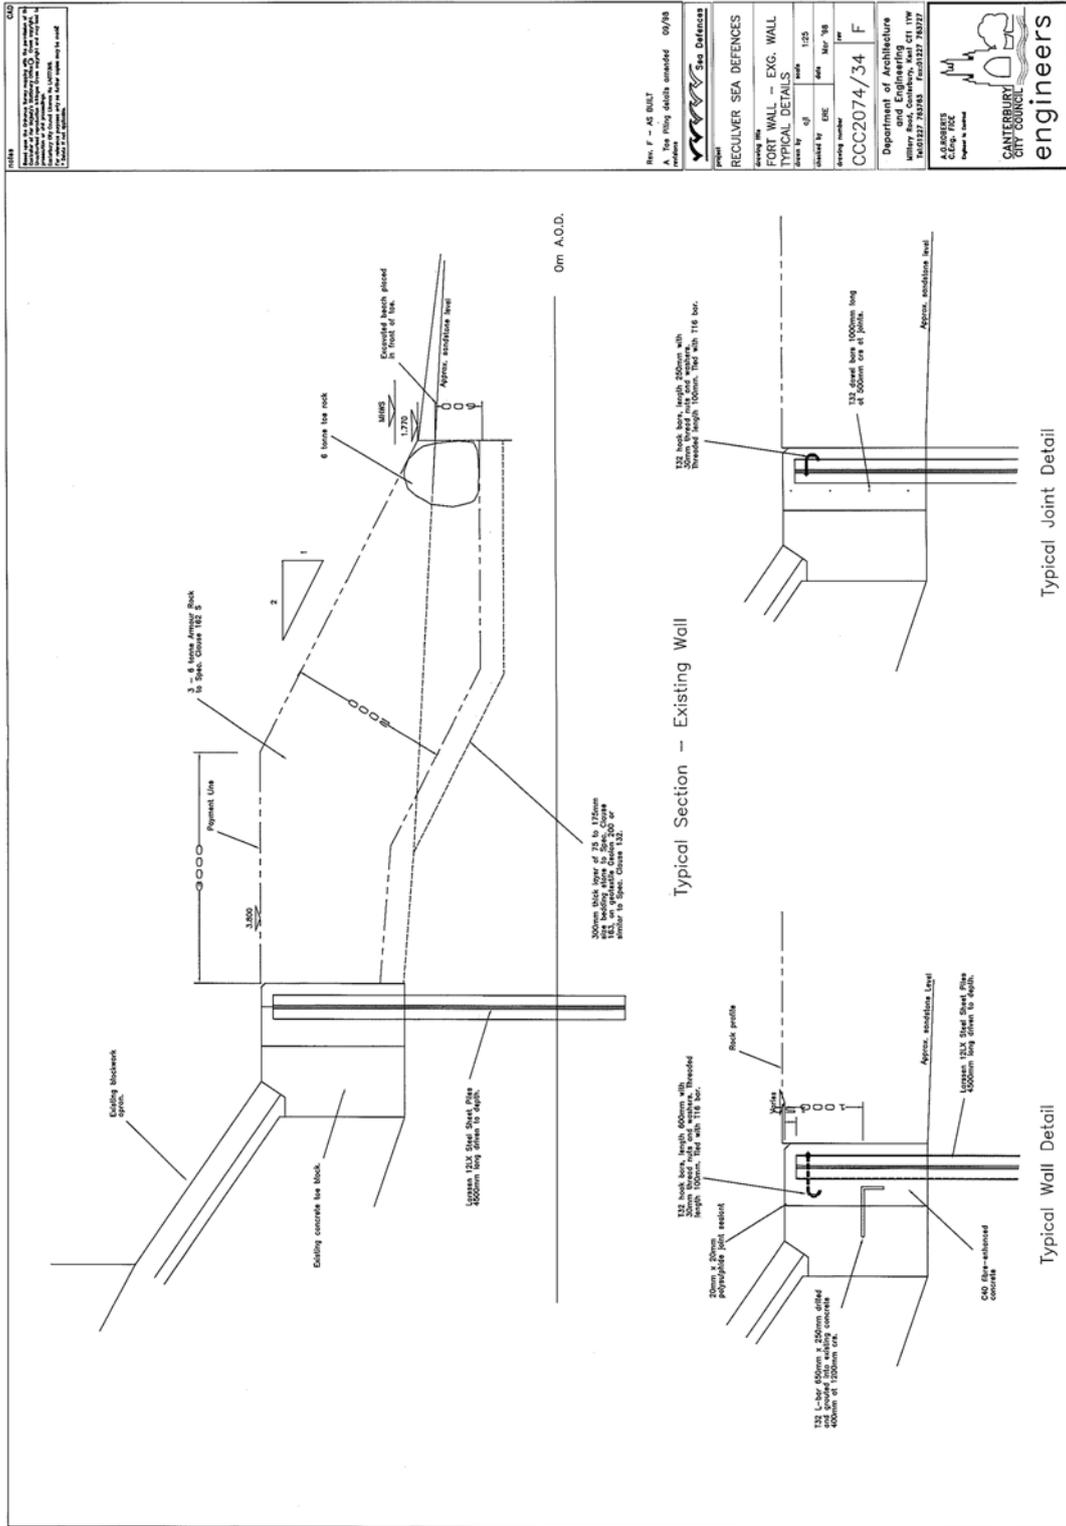
Figure C10.5 New design (extract)

- steel piling driven into the sandstone;
- concrete capping that would encompass the old concrete wall;
- a rock armoured revetment in front of the piled wall;
- a replacement concrete and Ragstone composite revetment.

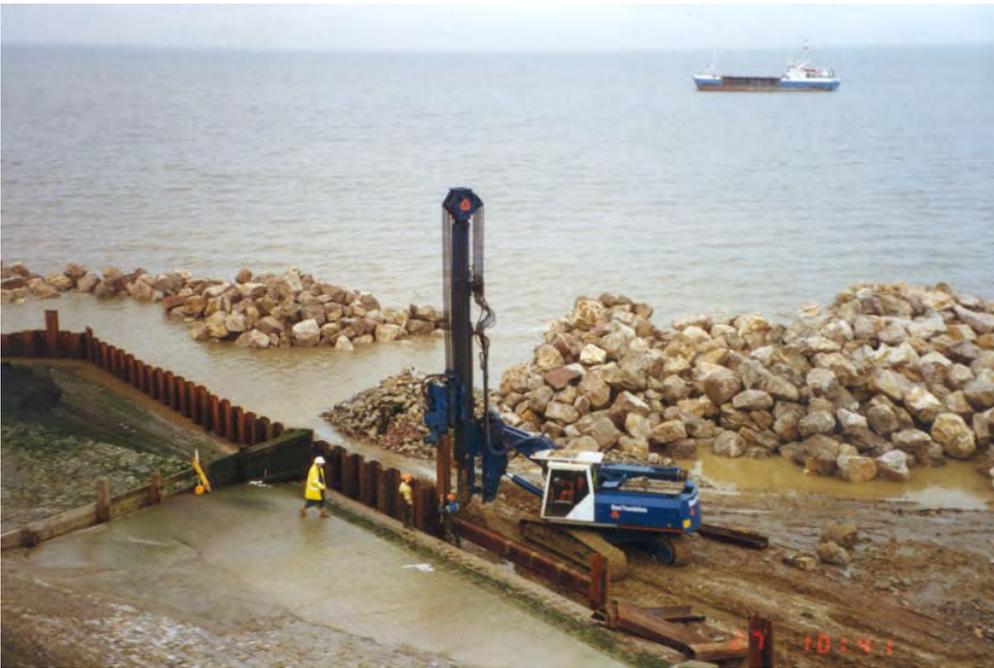
Figure C10.7 **Pile driving**

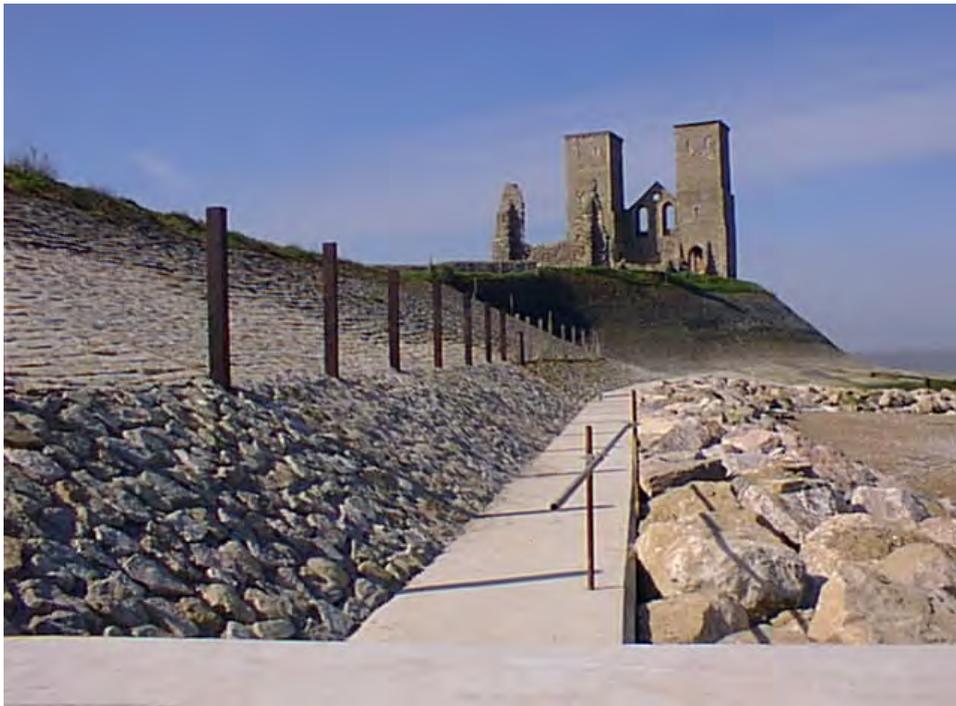
Figure C10.8 **Final construction**

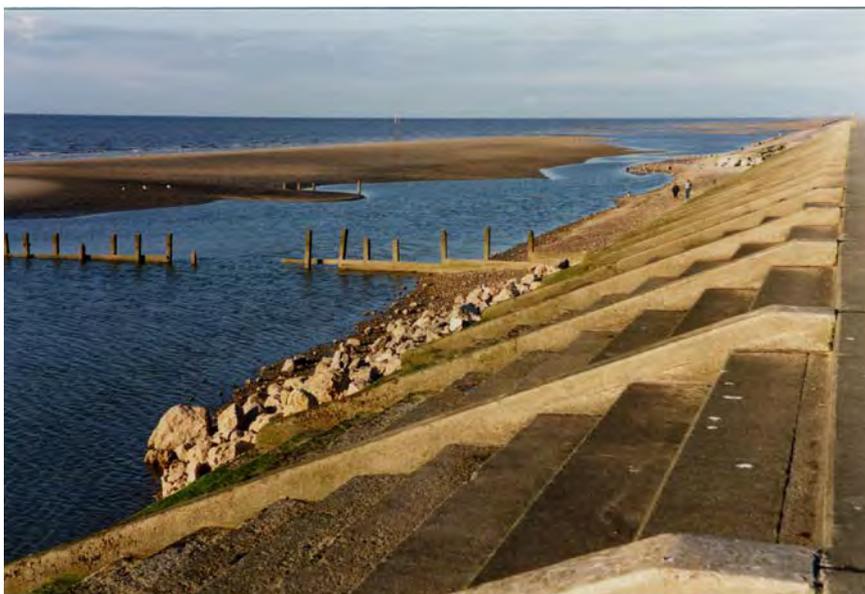
Figure C11.1 Toe scour in front of stepped concrete seawall, 1990

The photograph shown in Figure C11.1, which was taken in early 1990, shows the tidal runnel very close to the wall. Note that the runnel extends a considerable distance alongshore, cutting across several timber groynes. All that remains at the toe of the wall is a narrow strip of pebbles. Some emergency works in the form of a fillet of rock armour-stone can be seen at the toe of the wall. The growth of algae on the concrete steps indicates frequent wave overtopping.

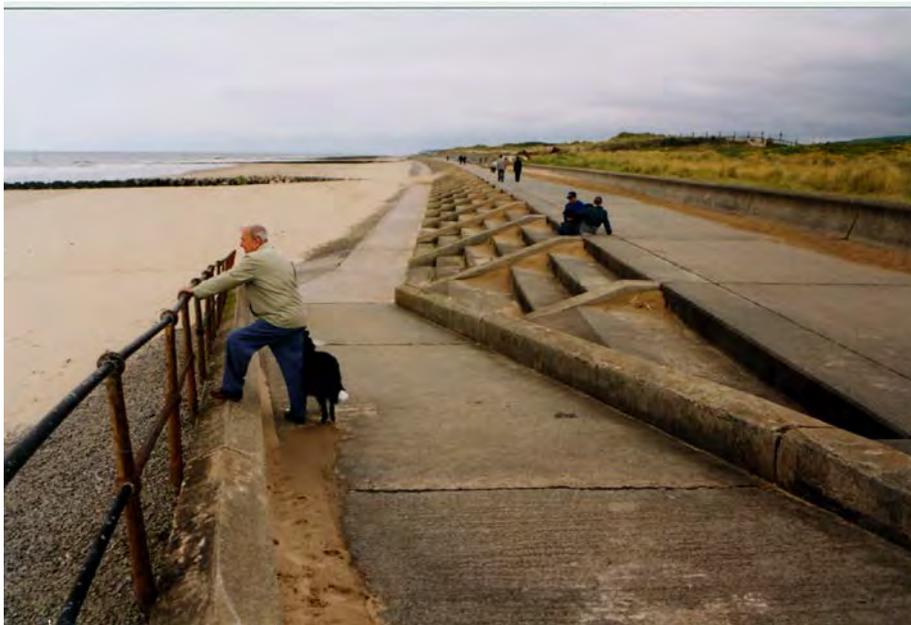
Figure C11.2 Sloping asphalt apron and rock groynes in front of steeped concrete seawall

The increased height and width of the upper foreshore has resulted in the disappearance of the ridge and runnel features from in front of the seawall. The high foreshore levels have also removed the problems of wave overtopping. Figure C11.2 shows the swash limit along the line of the new sloping revetment. There is some sand build up above the revetment and on the seawall steps. The amenity value of the promenade, at the crest of the wall, has also been greatly improved.
