Toe structures management manual

Project: SC070056/R

Coastal structures, structure toe, asset management, condition assessment, beach, scour

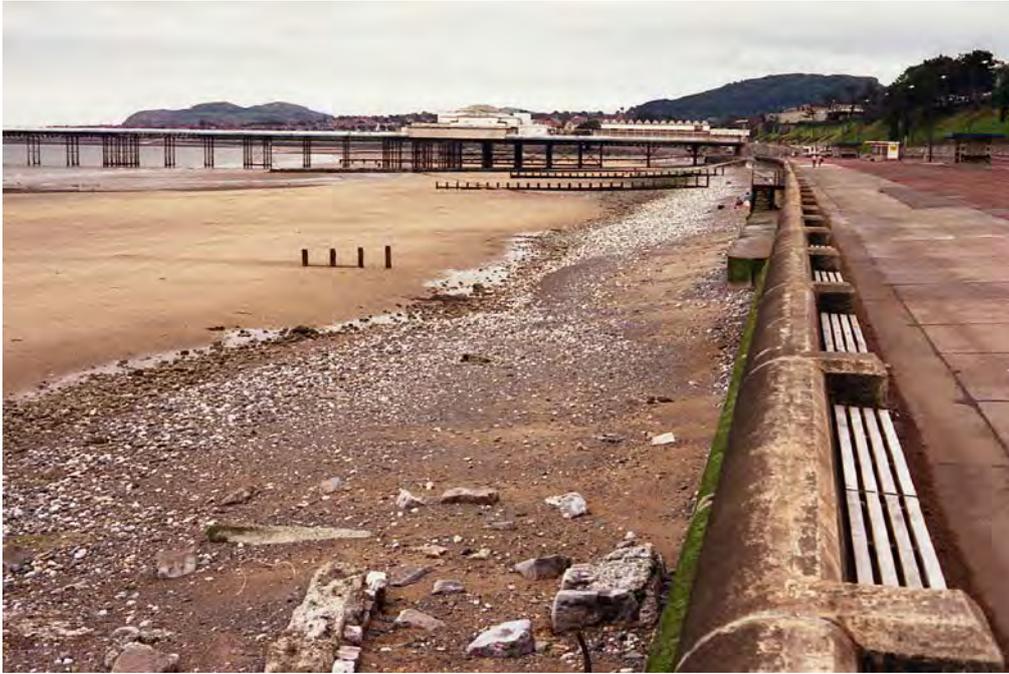
Figure C12.2 Beach lowering in front of vertical seawall, Colwyn Bay

The construction of sea defences at Colwyn Bay dates back to the late 19th century. The masonry seawall has, over the years, suffered considerable damage, requiring extensive repairs and reconstruction. In the 1970s there was a groyned upper beach of shingle, with an almost continuous sand cover over the flatter, lower part of the beach. Subsequently the groyne system fell into disrepair, allowing beach levels at the wall toe to fall. Thus, by the 1980s the shingle beach had largely disappeared from the wall toe, causing foundation problems (Figure C12.2). In addition, the falling sand levels had exposed the underlying pebbles over much of the lower foreshore.

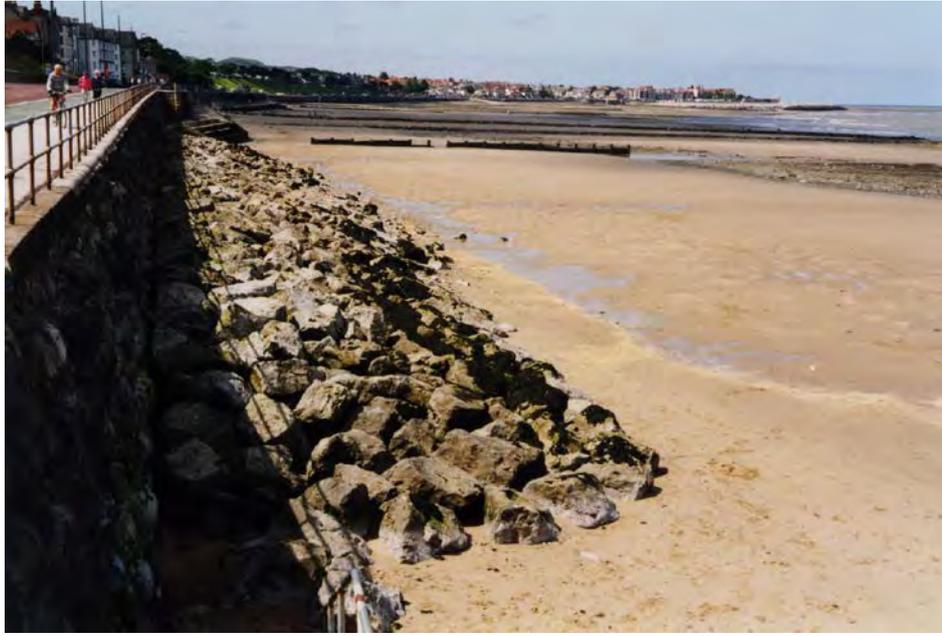
Figure C12.3

This scheme is a good example of how relatively modest defences can be used effectively to improve beach levels. The photograph in Figure C12.3, which was taken in 2002, shows the sand build up at the foot of the seawall. The long rock groynes can (just) be seen in the background, while a redundant timber groyne can be seen in the middle distance.

Rock berm in front of vertical seawall, 2002

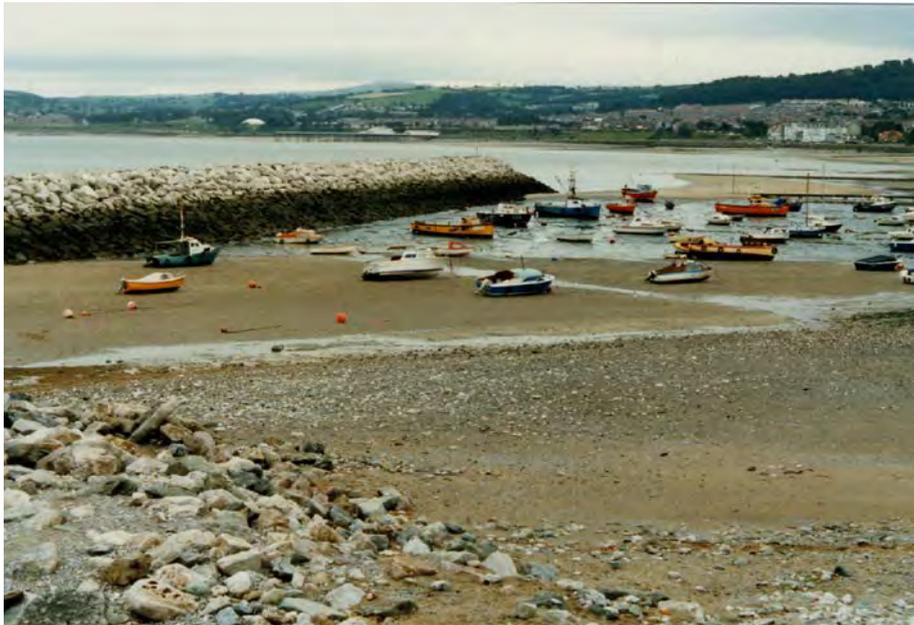
Figure C13.2

View to the east showing usage by small boats

The breakwater has eliminated the problems of wave overtopping that were becoming increasingly more serious to the south of Rhos Point. The sheltered conditions in the lee of the breakwater have allowed small boats to anchor there (Figure C13.2). This has been possible because the breakwater is sited some distance away from the wall, but not so far offshore that its sheltering effect would be significantly reduced. The low groyne has been overtopped by beach material and shingle and sand have tended to collect in the lee of the breakwater, further reducing any potential risk of wave overtopping (Figure C13.3).

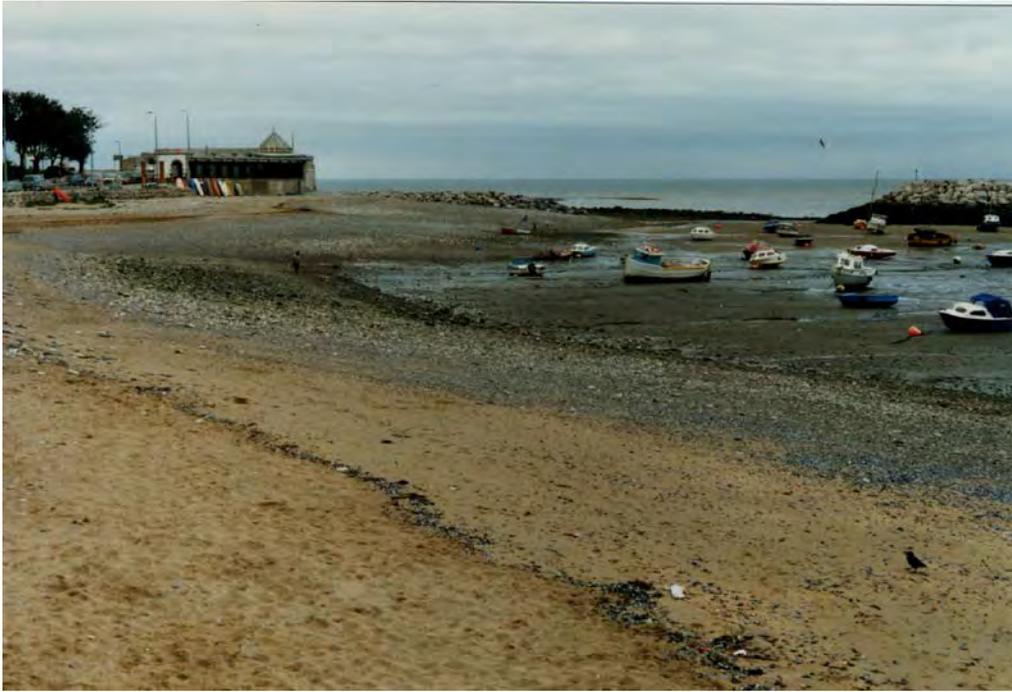
Figure C13.3 **View to the west showing beach recharge**

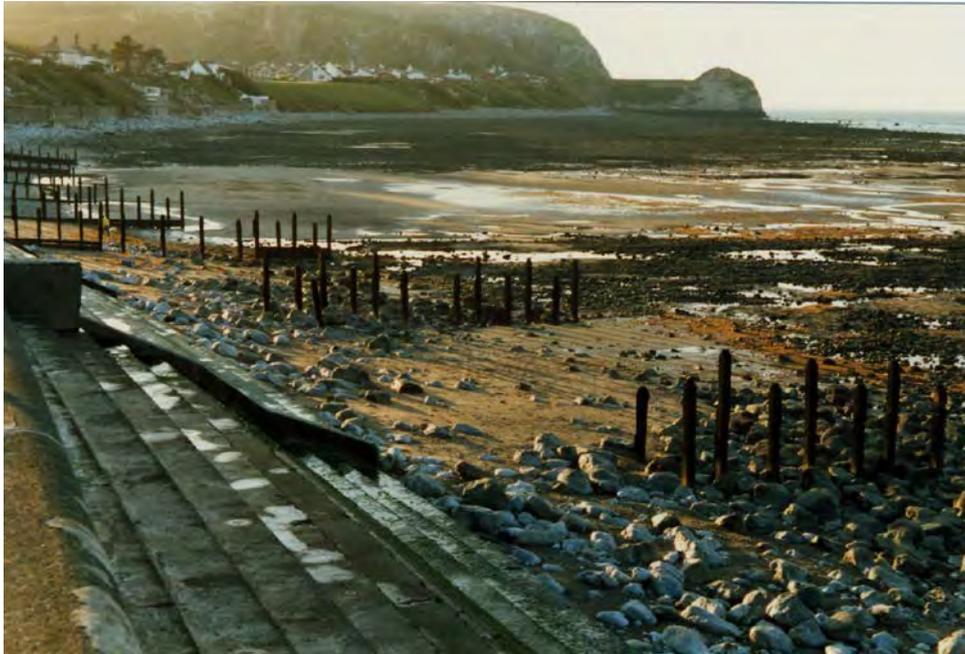
Figure C14.2 Lowered beach exposing shore platform

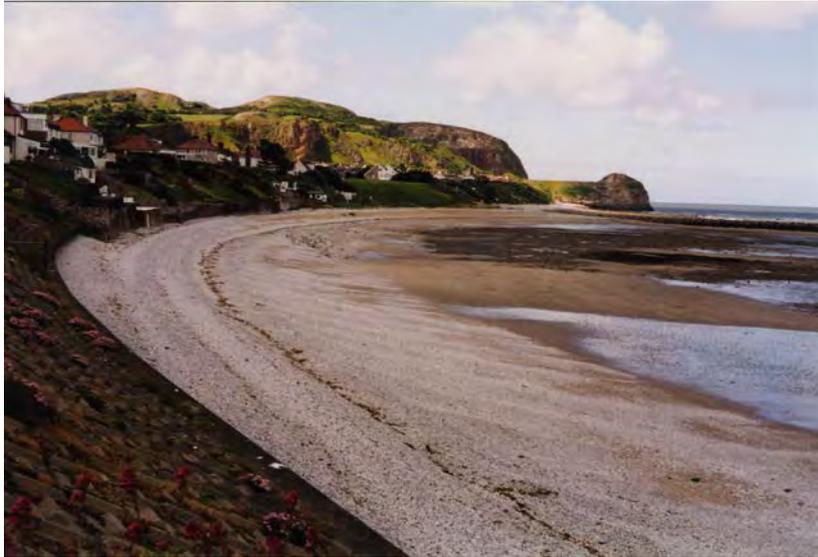
The beach was graded from sand in the west to an (artificial) cobble beach formed of quarried rock in the east. Movement of the material has caused a mixing of sediments to occur with mixed sand and shingle tending to stay in the (sheltered) western corner of the bay (Figure C14.3).

Figure C14.3 View of beach recharge in western part of Penrhyn Bay

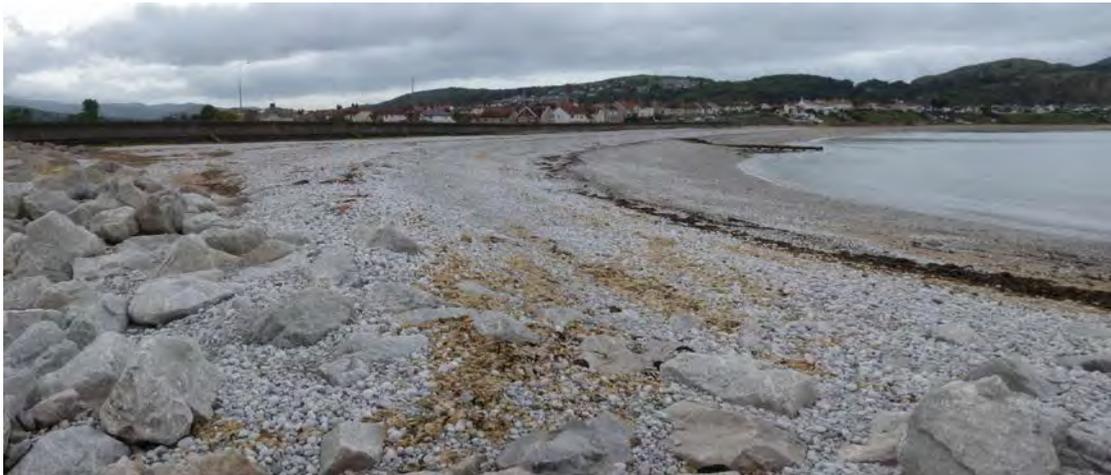
Further east, material from the centre of the embayment tends to be moved towards the easterly groyne where it can overtop the root of the groyne structure (Figure C14.4). Regular recycling of material back towards the centre of the bay (once or twice a year) is carried out in order to maintain Standards of Protection.

Figure C14.4 View from easterly groyne (CEUK)

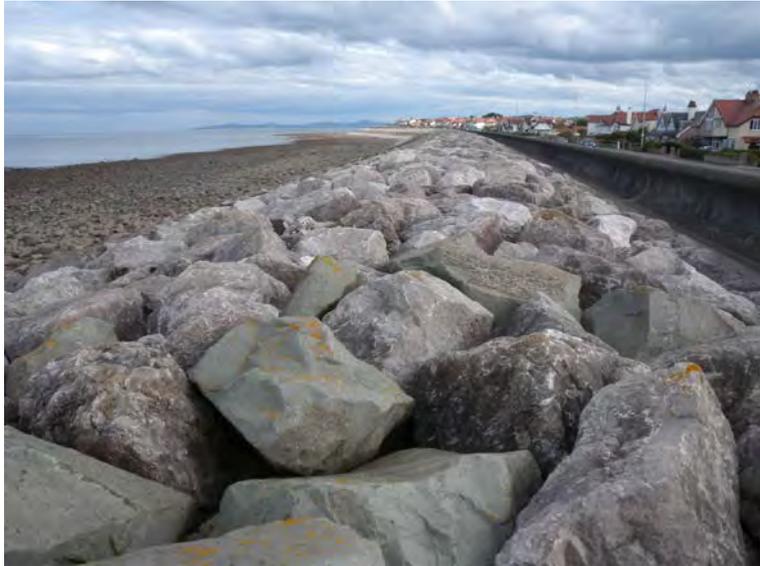
Further to the east beach levels remain low but reasonably stable and devoid of fines (Figure C14.5).

Figure C14.5 **View along rock revetment protected frontage to east
(CEUK)**

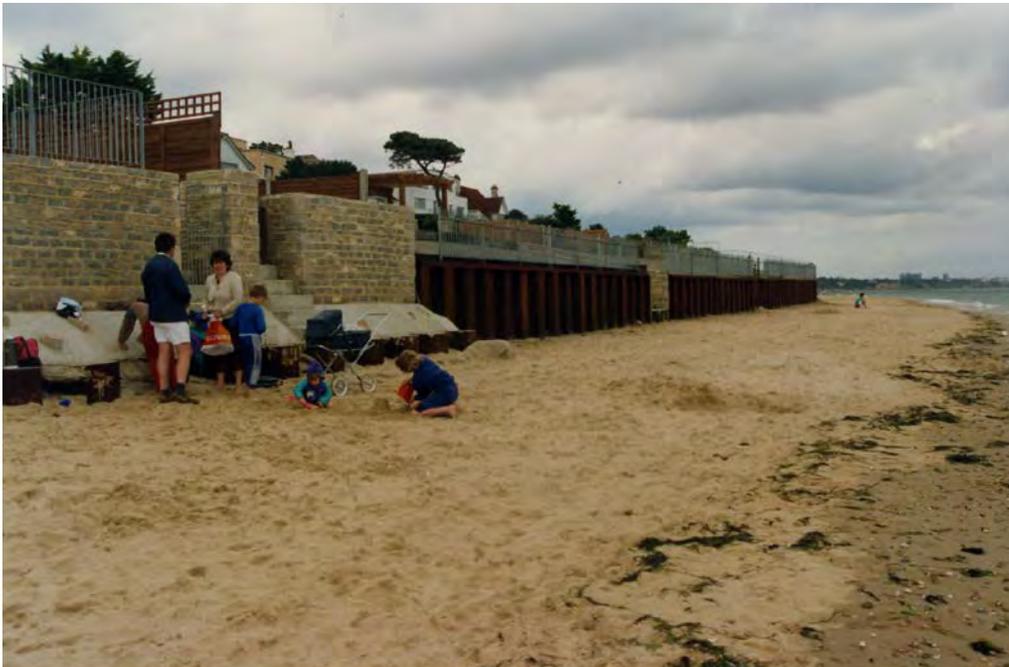
Figure C15.1 Vertical wall and low beach near Haven Hotel, Sandbanks, c.1998

The sand beaches along the Sandbanks peninsula were originally protected by a system of crib type rock groynes. Historic charts show that these maintained high beach levels over much of the frontage. However, these groynes fell into disrepair, being removed in 1991 for health and safety reasons. Beach lowering was noted subsequently, becoming most serious at the western end of the frontage, where a seawall surrounds the head of the peninsula (Figure C15.1). The offshore transport of sand, due to waves being reflected from the wall and its subsequent removal by the fast tidal currents, caused concerns that the wall would become undermined.

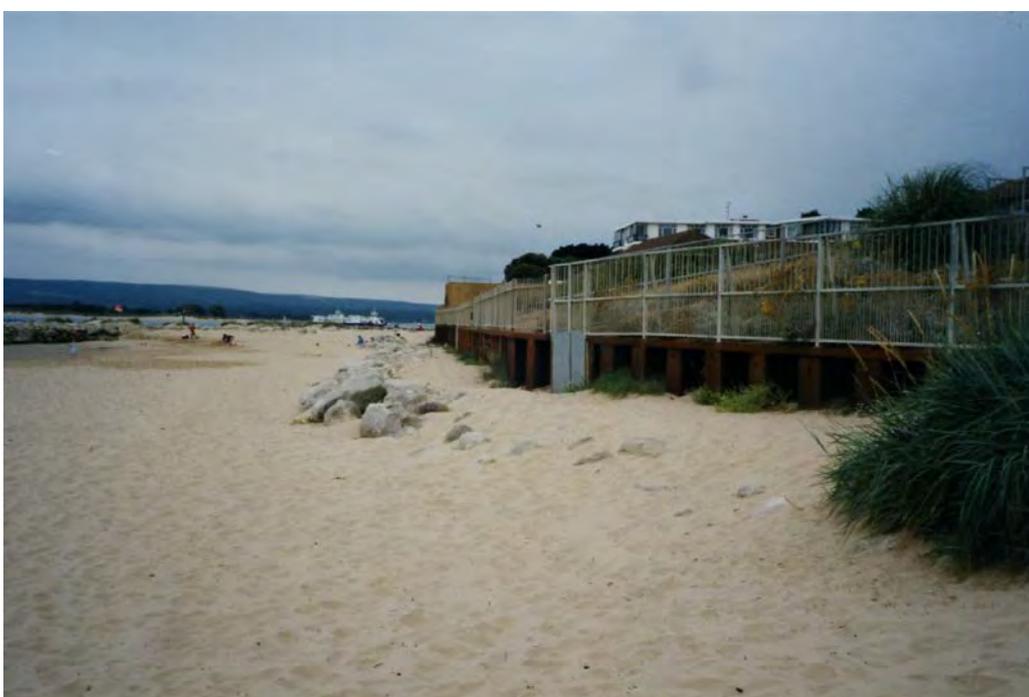
The scheme was constructed in 1995–1996. Overall, this was a great success with the earlier beach erosion being reversed and sand dunes forming where there were previously low beach levels (Figure C15.2).

Figure C15.2 Widened beach after installation of sill and rock groynes, 2002

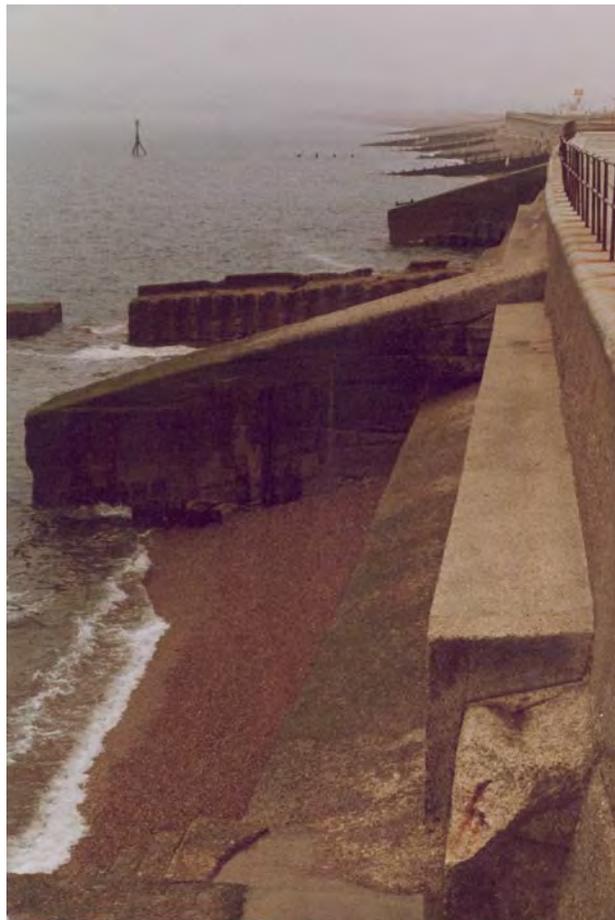
Low beach levels and damaged concrete seawall, c.1982

The subsequent development of the port of Newhaven has included the construction of training walls to prevent the littoral from blocking up the new entrance. Successive extensions of the western training wall were necessary as the beach to the west of the entrance accreted. This meant that the shingle beach at Seaford has received a dwindling supply of shingle. This has caused beach levels in front of the seawall to fall at an increasing rate during the last century. By 1980, the beach in the eastern half of the frontage had fallen to such an extent that it was providing very little support to the old mass concrete seawall; this wall was originally a secondary defence behind a then substantial shingle ridge. In places, erosion had exposed the underlying chalk platform, allowing waves up to 6 m high to reach the wall without breaking. In 1981 parts of the wall had become badly damaged and in 1985 undermining had caused local collapse of the promenade. Figure C16.1 shows the situation around 1982.

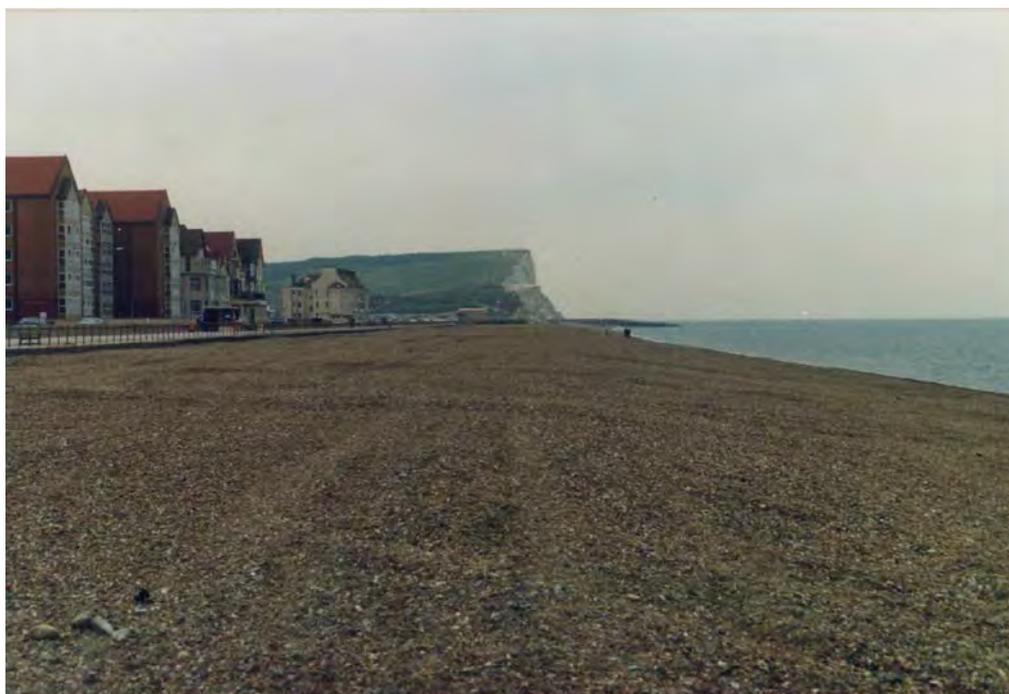
In 1987 the central and eastern end of Seaford was nourished with 1.5 million m³ of shingle won from offshore (Figure C16.2). The material was won by using a trailer-suction dredger, extracting the material from an existing licence area on the Owers Bank, south of Selsey Bill. The material was spread over a 2.5 km frontage. The western frontage was left untouched, as the beach there was already wide.

Figure C16.2 Beach after renourishment

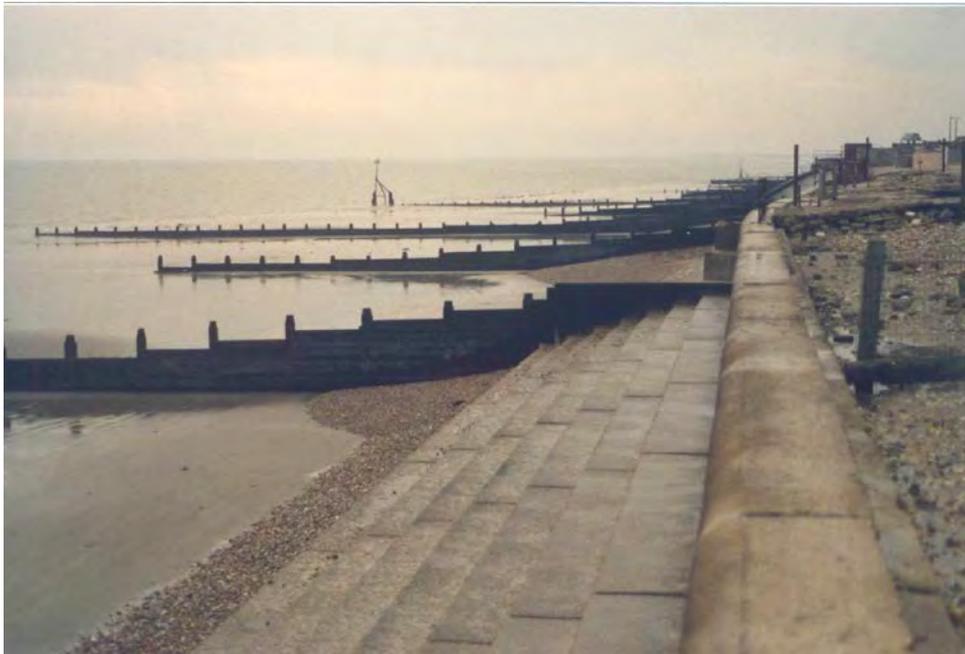
Figure C17.1 Low beach levels in front of stepped concrete wall, 1988

Sea defences were begun in the 1950s. With an onshore supply near the Bill, the beaches did not deteriorate as rapidly as might have been expected in view of the earlier very rapid rates of retreat. By the late 1980s, however, the walls had deteriorated through continuous wave action and falling beach levels. Figure C17.1 shows the situation in 1988.

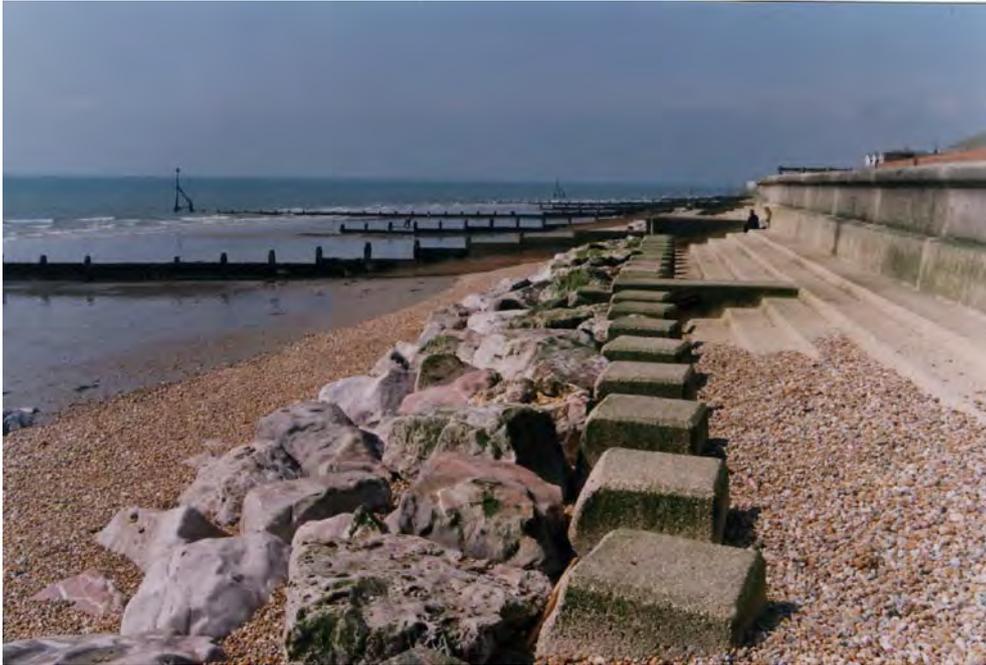
In 1992 a major scheme was initiated along much of the Selsey frontage. At Selsey West Beach, the seawall was reconstructed at strategic locations where heavy overtopping could not be tolerated. In other areas the wall was strengthened. In places the wall was extended by the addition of concrete armour units and a rock berm, as shown in Figure C17.2. In addition, some shingle was added to the upper beach, to help fill the groyne compartments.

Figure C17.2 Toe berm of rock and concrete armour units, 1994

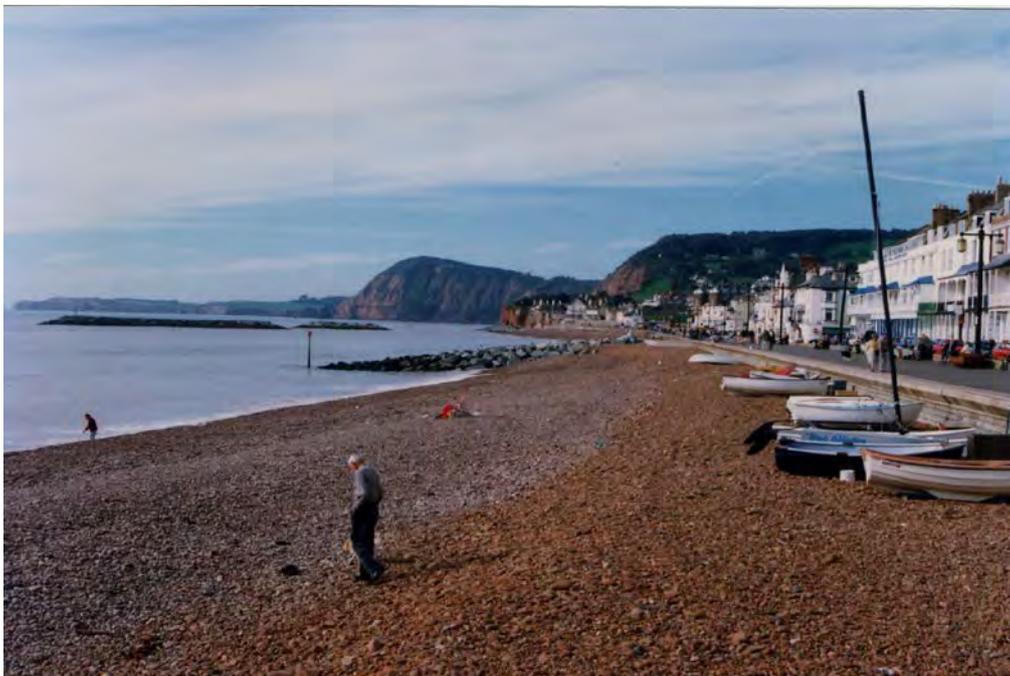
Following model testing at HR Wallingford, a beach nourishment scheme was implemented using local beach material, together with the construction of two offshore breakwaters and a groyne at the eastern (downdrift) end (Figure C18.1). The purpose of the two breakwaters at the western end of the frontage is to protect the town frontage against the predominant westerly storms. The groyne is there to prevent material from being transported out of the area by the net west to east drift.

Figure C18.1 Beach recharge, groyne and offshore breakwaters

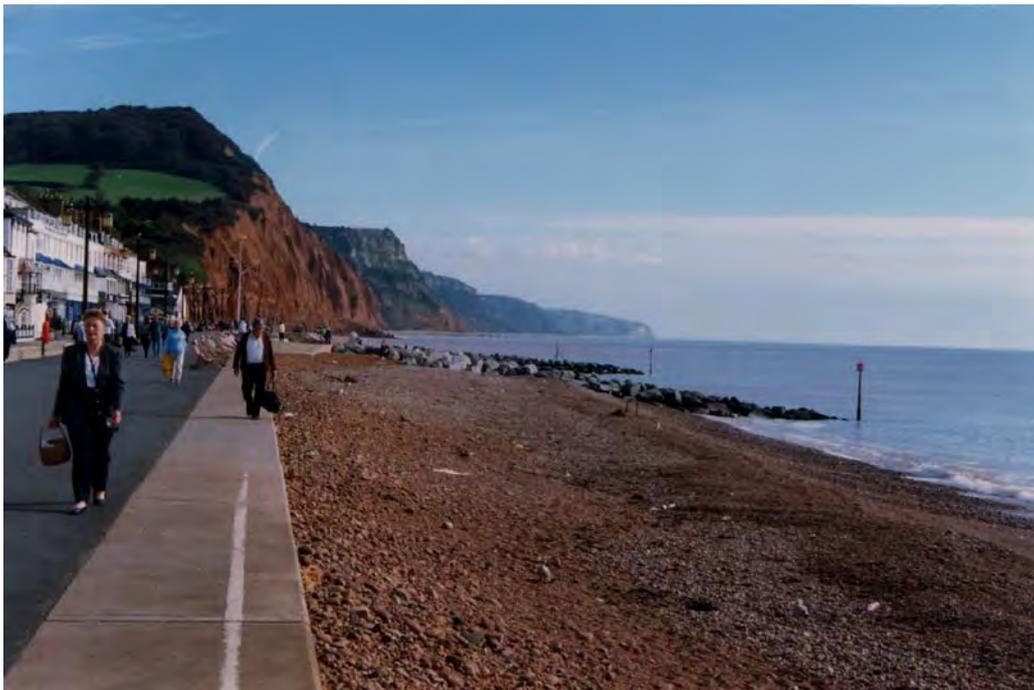
Figure C18.2 shows the eastern end of the nourished frontage. The improvement in beach width has not only effectively reduced the former problems of beach lowering but has also provided a more attractive beach. In addition, the offset breakwaters are also not visually intrusive, being below the horizon at promenade level.

Rock groynes and beach recharge, eastern end of promenade

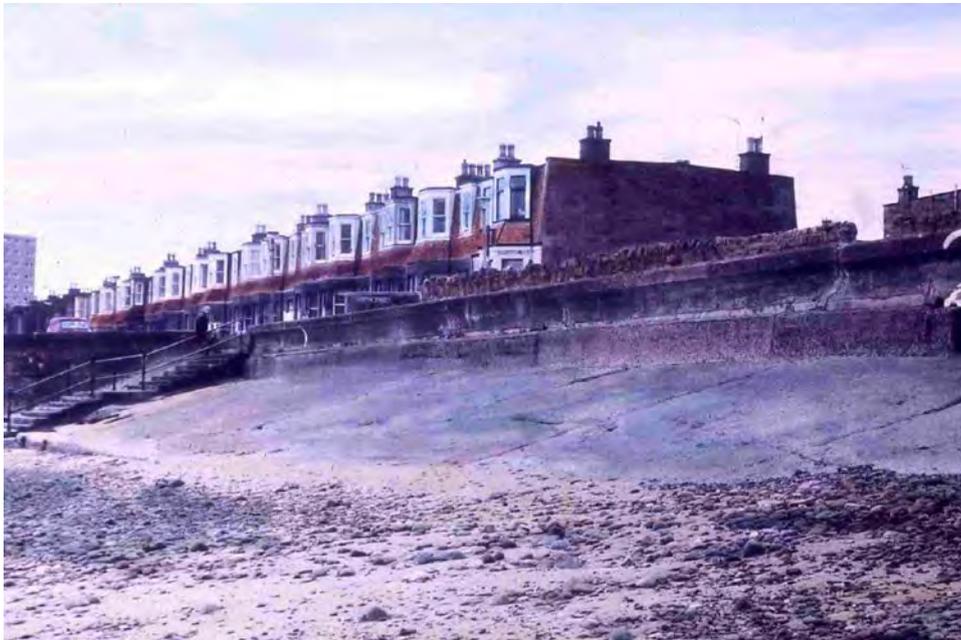
Figure C19.1 Portobello Beach, c.1970

The justification for many beach nourishment schemes in the UK has been that the cost of nourishment is considerably less than the cost of reinstating existing hard defences. One of the first schemes to be justified on this basis was carried out at Portobello Beach, Edinburgh. This beach is situated on the western side of Edinburgh and faces directly into the mouth of the Firth of Forth. It became denuded as a result of sand abstraction for the glass industry, which began in the 19th century and continued up to the 1930s. The promenade seawall at Portobello dates back to 1860. By the late 1950s the lowered beach meant that the wall was under continuous wave attack, with resulting frequent serious overtopping (Figure C19.1). By this time the beach had flattened and the median sand grain size was 0.2 mm.

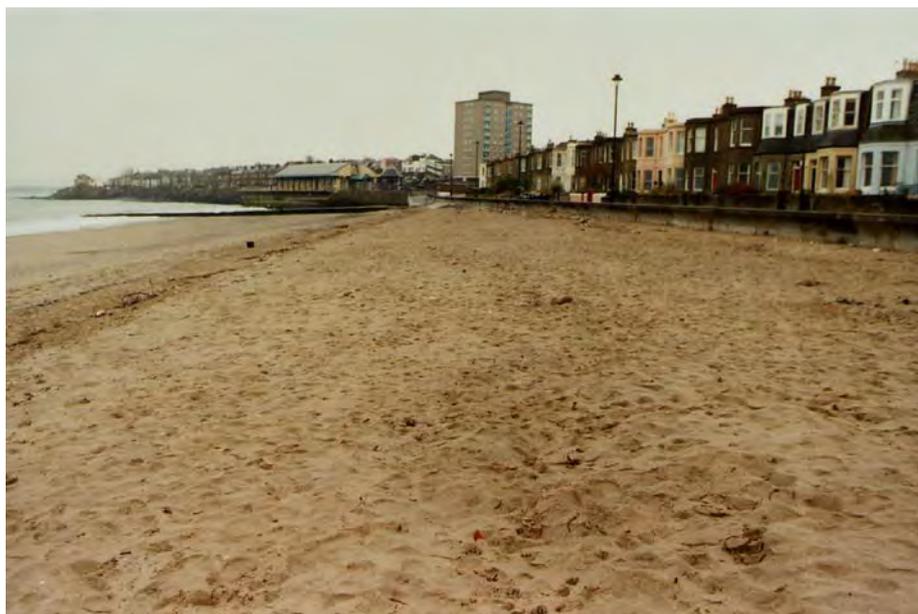
Some 180,000 m³ of coarse sand was extracted from a borrow area by bucket dredger, transported by barge and pumped over a 1.6 km frontage to a foreshore gradient of 1 in 20. The material was placed over a depleted beach whose gradient had fallen as a result of beach lowering to about 1 in 42. The nourished beach was held in place by a

number of timber groynes, with an (easily adjustable) gabion-type groyne at the eastern (updrift) end of the frontage (Figure C19.2).

Figure C19.2 Post-nourishment view at Portobello
